The City of Chilliwack 2007 Ditch Maintenance Program Environmental Monitor's Report

**Prepared for:
The City of Chilliwack**

By
David Blair, Fisheries Tech. Dipl.

**Nova Pacific
Environmental**

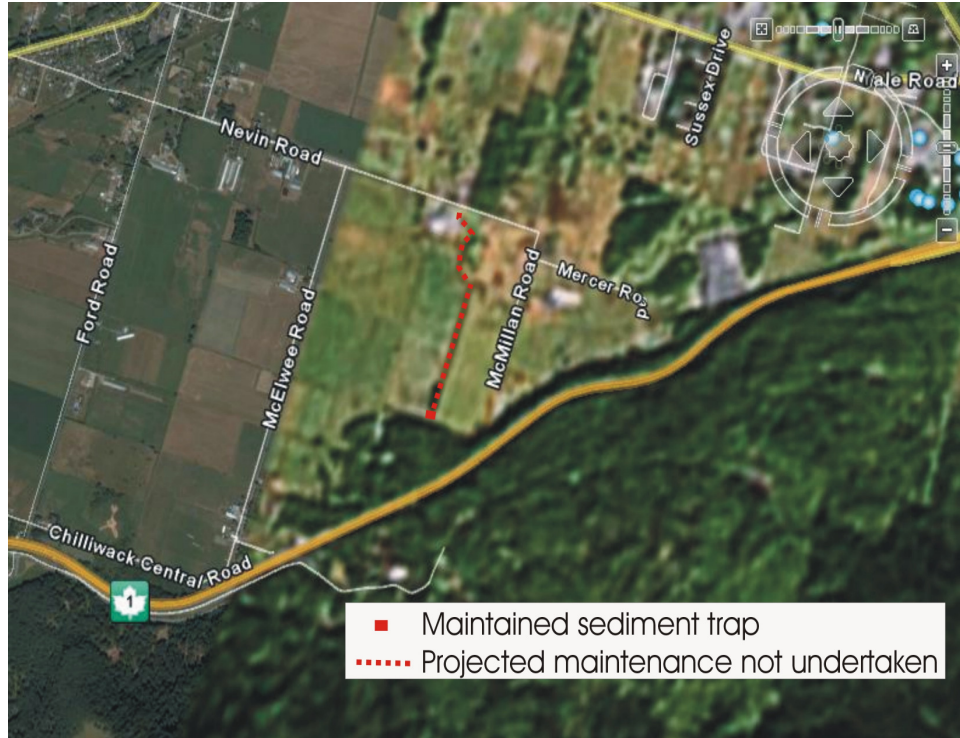
Figure 2.

The projected work on Nevin Creek called for the excavation of the sediment trap and creek section immediately downstream of the sediment trap for a distance of 1400m. Ultimately, only the sediment trap was excavated (Photo 1) due to the discovery of a population of tailed frogs (*Ascaphus truei*) within the creek section. As this species and its habitat is protected under federal and provincial jurisdiction, the monitor immediately halted works upon its discovery. The tailed frogs were encountered while electro-fishing the creek section immediately downstream of the sediment trap. A total of four specimens were captured from the area and released un-harmed. The environmental monitor contacted the relative representatives from the Ministry of Environment (MoE) and the DFO and informed them of the previously un-documented population of frogs. As a result, a site meeting was arranged with the environmental monitor, Chilliwack's public works supervisor, an endangered species specialist from the MoE, and a habitat biologist from the DFO. During the course of the meeting, discussions were held regarding the implementation of an environmental management plan for future drainage maintenance work at Nevin Creek.

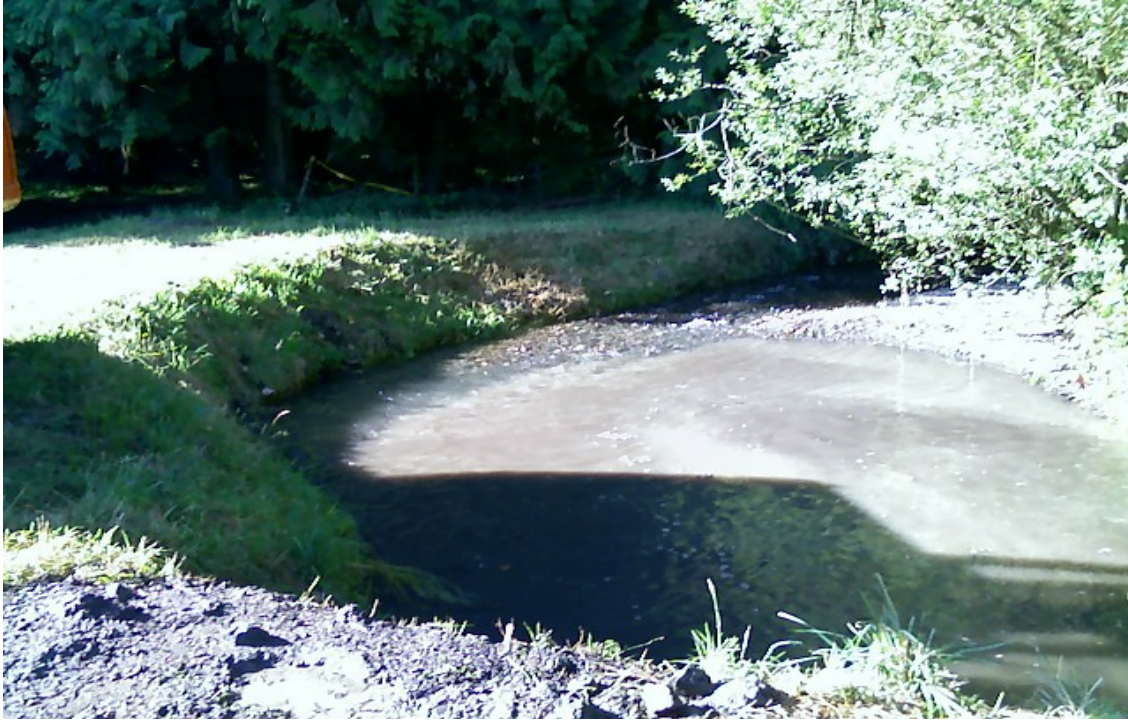
Photo 1. Nevin Creek sediment trap during excavation.

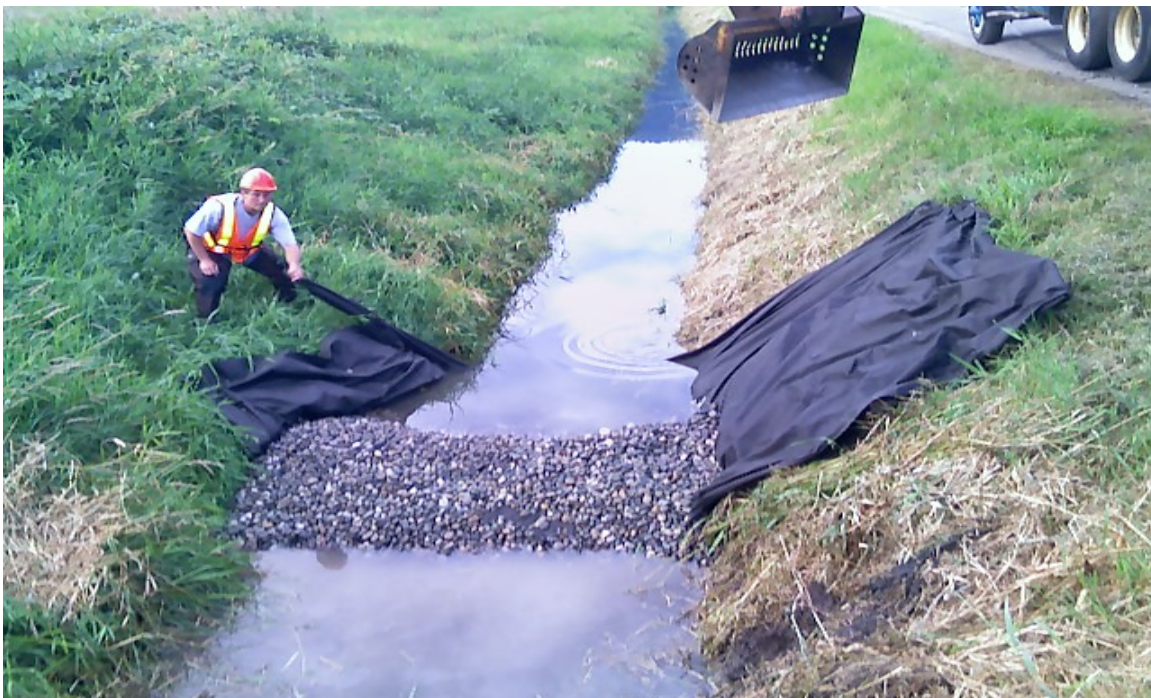
In-stream vegetation and fine sediment was removed from the channel from Prairie Central Road, upstream for a distance of 1200m (Figure 8). Turbidity downstream of works was kept below 75 NTUs by the installation of a gravel check dam lined with geo-textile clothe (Photo 2). Banks were mowed and the monitor ensured that no desirable native riparian species were lost (Photo 3). Gravel weirs installed in previous years remained in tact and the monitor ensured that they were not excavated (Photo 4). Prior to undertaking fish salvage, the stream channel was cleared of instream vegetation that would otherwise hamper fish salvage efforts (Photo 5). This was achieved by using light equipment and hand tools. Big Ditch is a highly productive trout and salmon producer and also supports a population of the SARA listed Salish Sucker *Catostomus catostomus* in its lower reaches. Details pertaining to Big Ditch Salish Sucker associated with the 2007 works can be found in Appendix 3 of this report.

Photo 2. Turbidity control measures at downstream end of maintenance area.

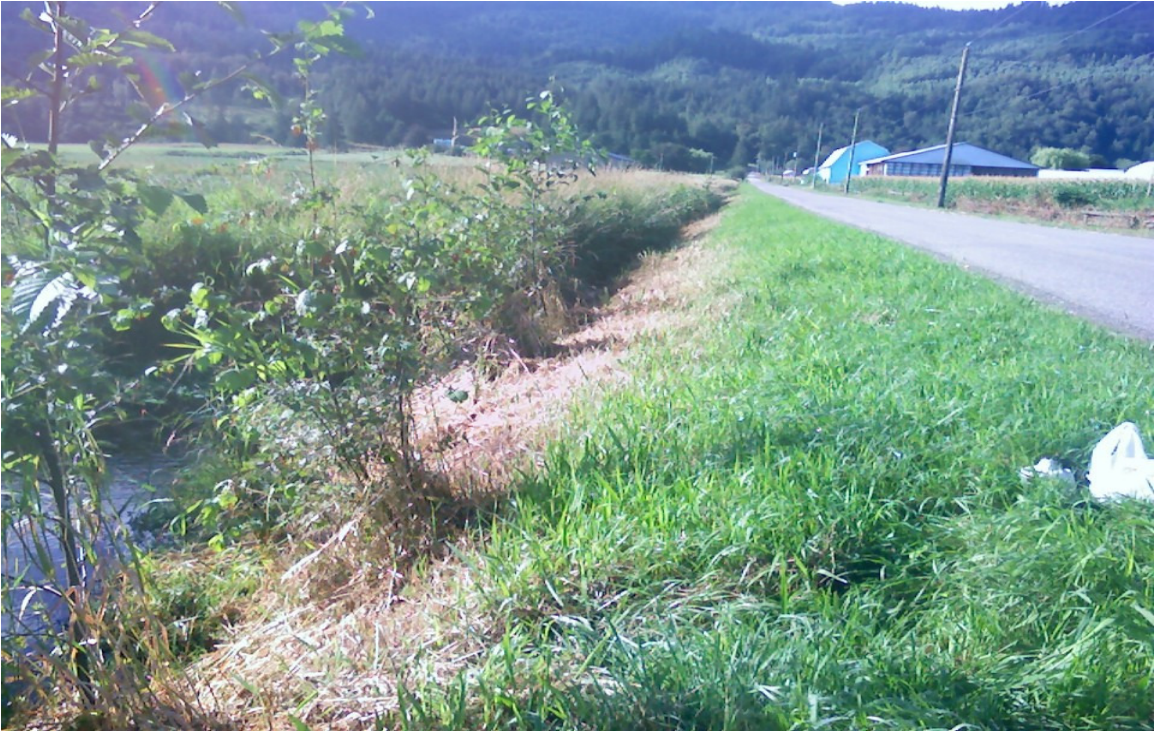
Photo 3. Native riparian trees left intact after bank mowing.

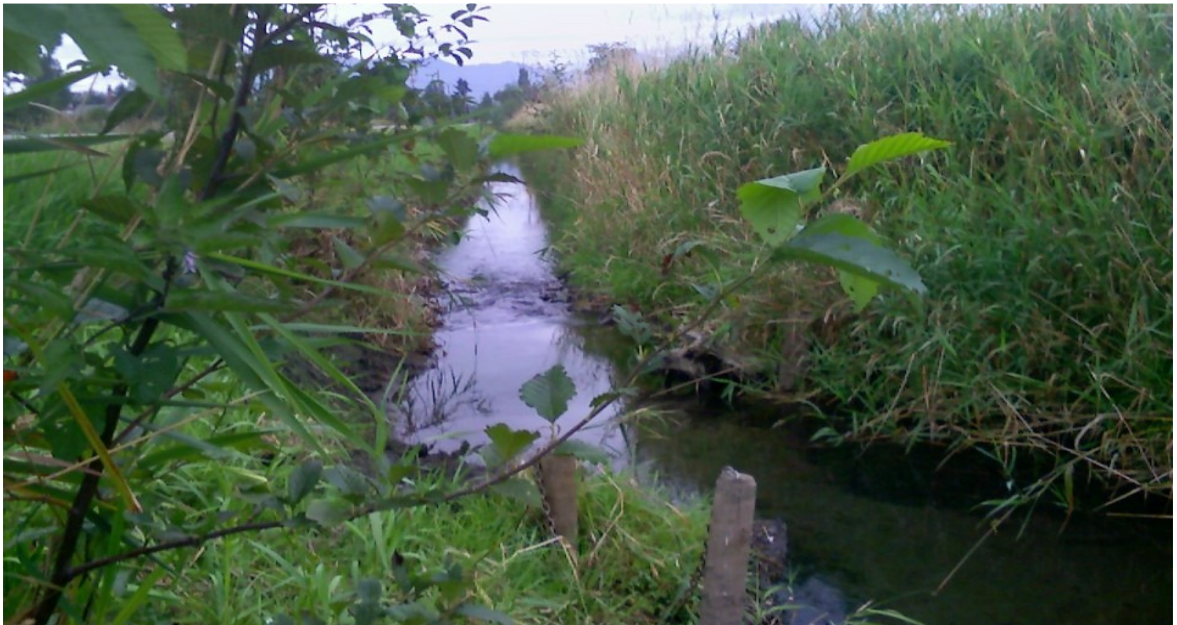
Photo 4. Gravel weir left intact after channel excavation (centre frame).

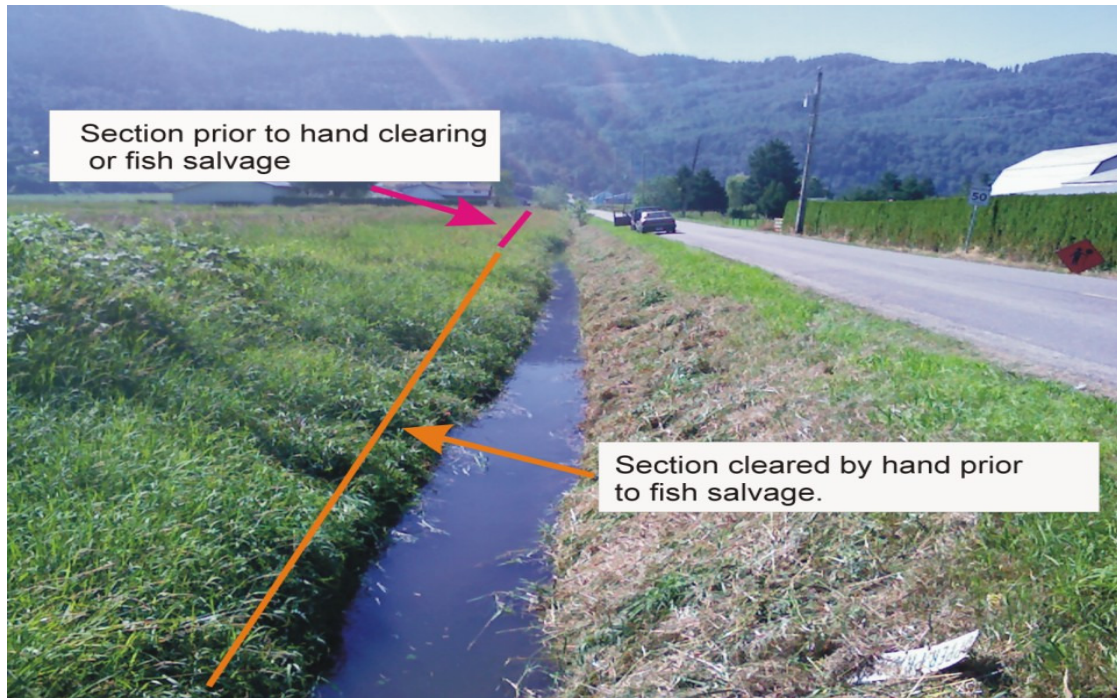
Photo 5. NPE field crew pre-clears vegetation to allow for effective fish salvage.

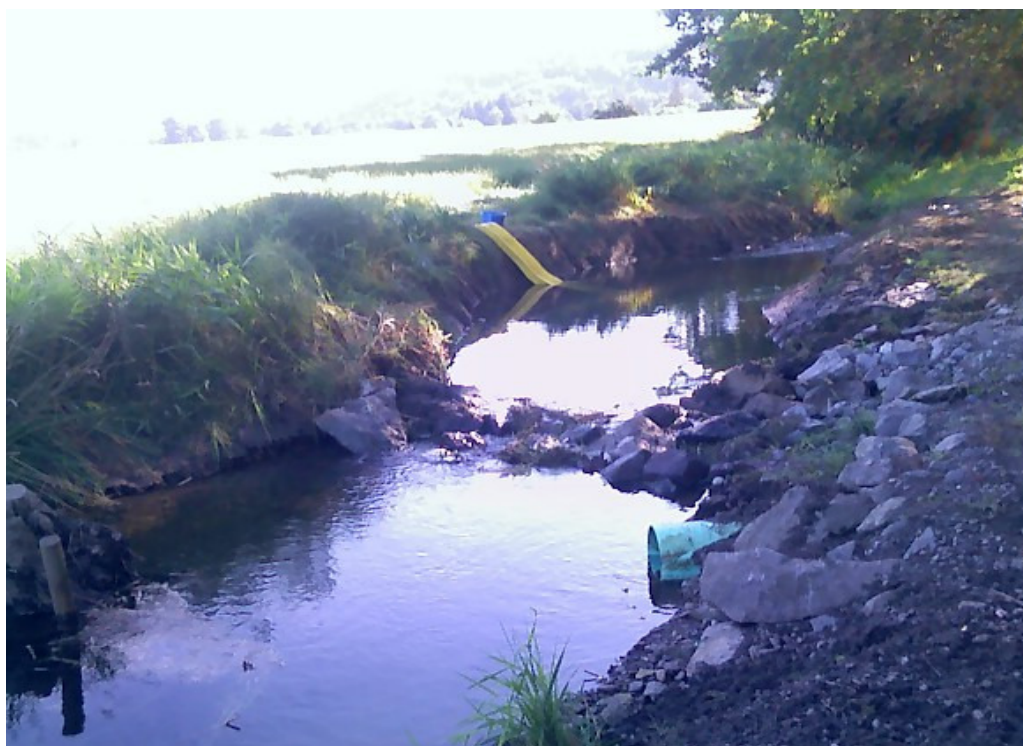
Instream bed load material and vegetation was removed from the sediment trap for an approximate length of 35m. The traps functionality had been significantly reduced due to in-filling since its excavation during the 2006 fisheries works window. Works at this site in 2007 also included enlargement of the sediment trap to reduce the frequency of future drainage maintenance works downstream. Stream-side planting at this site will be undertaken in the spring of 2008 (as per authorization compensatory habitat conditions). A rock weir was installed at the mid-point of the trap to increase habitat and flow complexity (Photo 8). Large woody debris pieces installed in 2005 were left intact.

Photo 8. Big Ditch sediment trap post-maintenance.

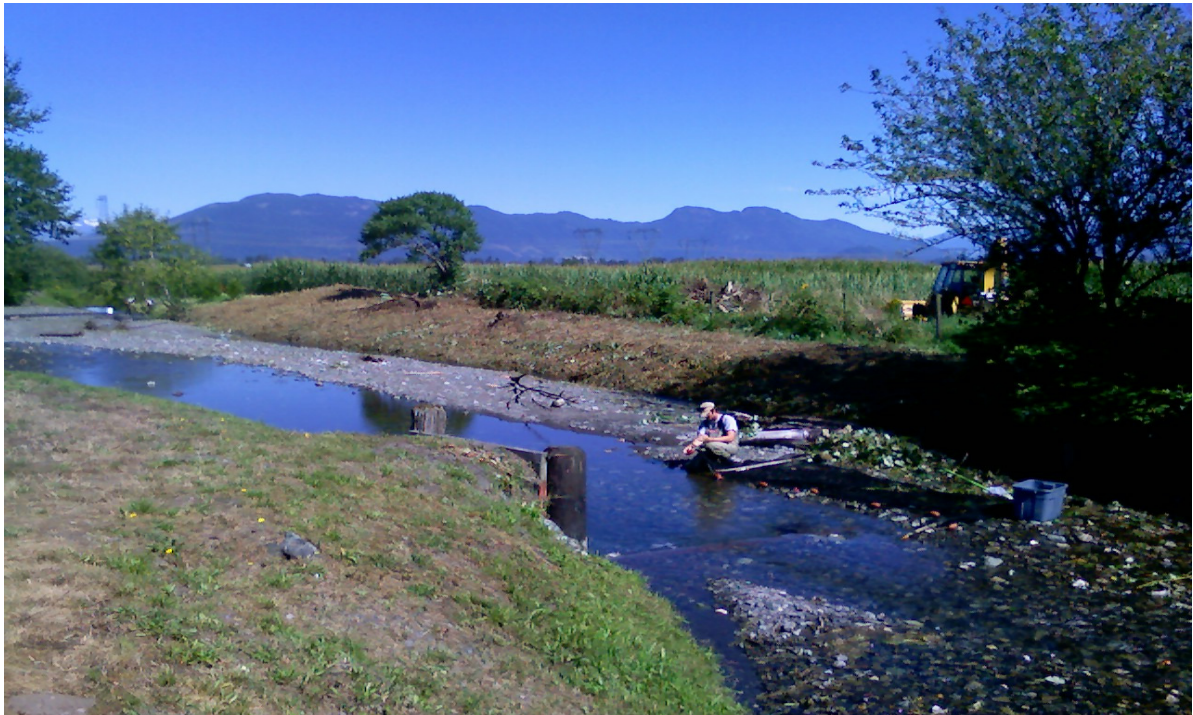
Bed load material was removed from the sediment trap located downstream of Prairie Central Road. The maintenance area was approximately 125 linear metres that included two large sediment traps. The traps had aggraded more sediment than in previous years and flow through the area existed as shallow riffle and glide with no pool habitat (Photo 9). The lack of pool habitat explains lower fish densities encountered during the 2007 fish salvage work. Salvage crews employed a combination of seining and electro-fishing at this site.

Photo 9. Elk Creek sediment trap in-filled to capacity and limiting pool habitat.
