# **Fish Passage Culvert Assessments (Mid Coast TSA) Final Report**

**International Forest Products**

March 6<sup>th</sup> 2009

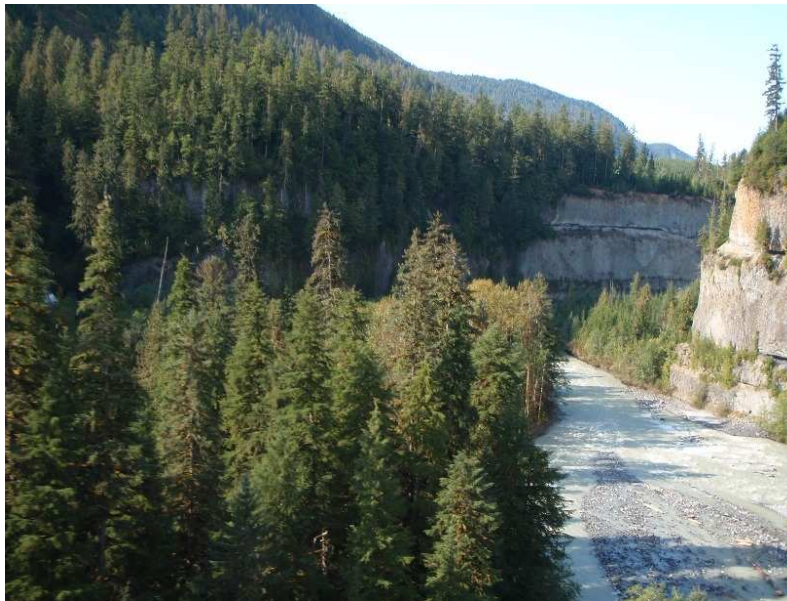
The Machmell river road system has very few culverted sites that were located on areas where slopes were  $\leq 30\%$ . The one culverted site that was assessed was passing fish and was located on the flood plain where the Machmell meets Owikeno Lake. The Machmell river is mostly contained within sharply incised canyons and the value of this river into upper reaches is negligible (Figure 1). We also completed an overview flight of the Machmell river and confirmed the low fish habitat values outside of the main river.

Figure 1. Photo of typical incised canyons within the Machmell River.

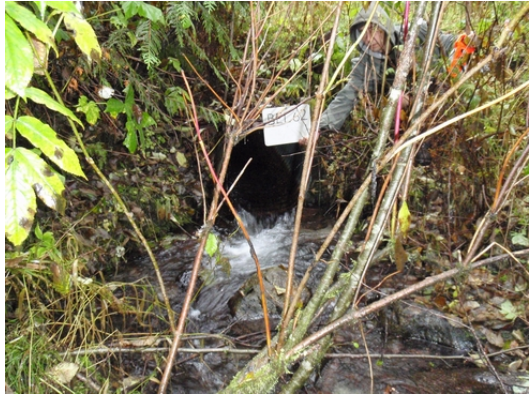
BEL62 – Outlet

Moderate quality fish habitat stream with suitable rearing habitat. 50mm fish noted within stream.

Culvert Dimensions: 600 mm x 10.0 m

Stream Width: 2.8 m

Fish Habitat Quality: Moderate

Site No.	Barrier Score	HGI	Proposed Solution 1	Span (m)	Cost Estimate (\$K)	Proposed Solution 2	Cost Estimate (\$K)	Cost Benefit 1	Cost Benefit 2
NUS01	26	15	CB	6	40	3200x10 SS	36	0.38	0.42
BEL62	21	2.5	CB	6	40	2000x10 SS	45	0.06	0.05

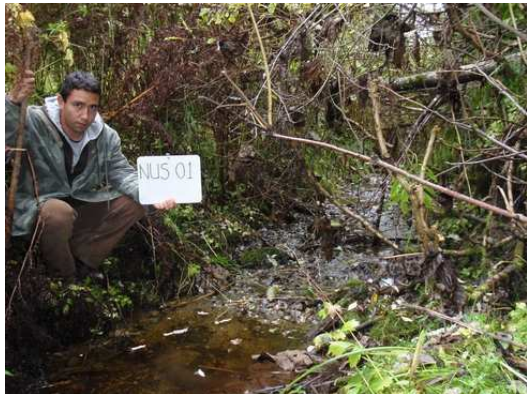
NUS01 – Upstream

Moderate quality habitat stream with potential for rearing and over wintering upstream and downstream of culverted site. Fish seen within creek.

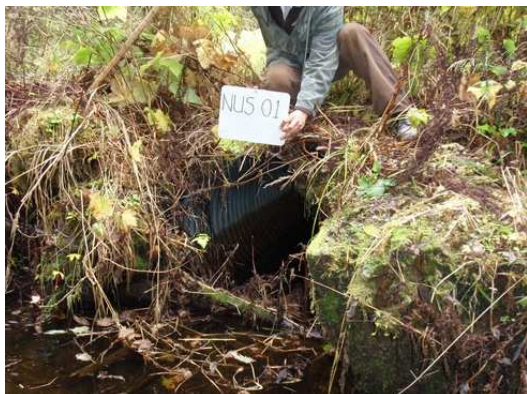
NUS01 – Inlet

Culvert Dimensions: 800 mm x 10.0 m

Stream Width: 1.2 m

Fish Habitat Quality: Moderate
