San Juan River Watershed: Fish Passage Assessments

March 2011

FIA Project Number - 4031504

Watershed - San Juan River

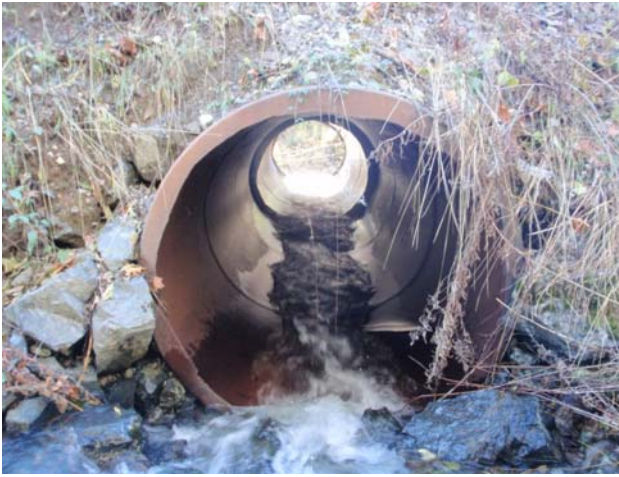
Figure 1: Inlet of a barrier culvert

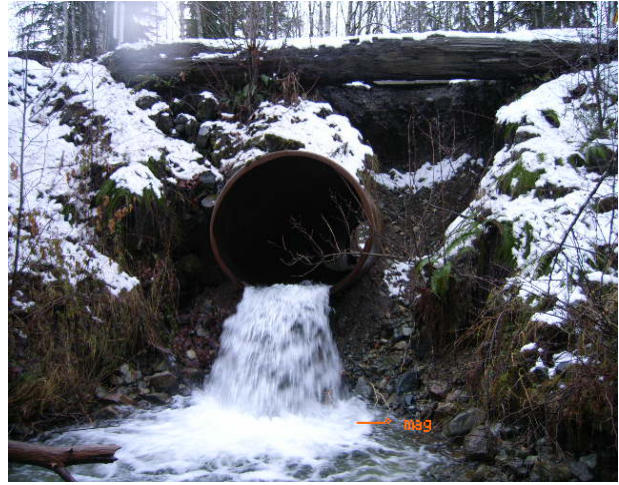
Figure 2: Outlet of a barrier culvert

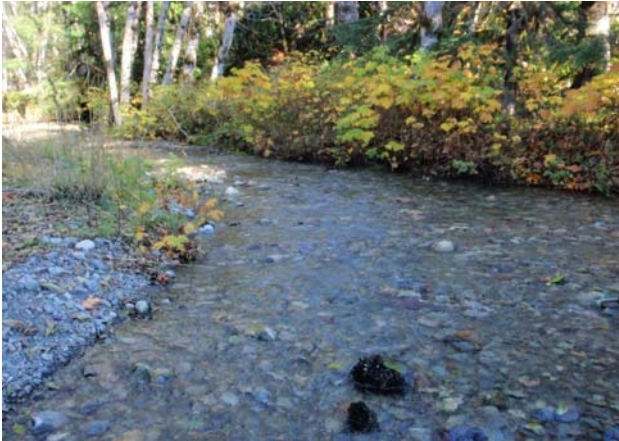
Figure 3: Habitat upstream of the crossing
This habitat is currently inaccessible to fish

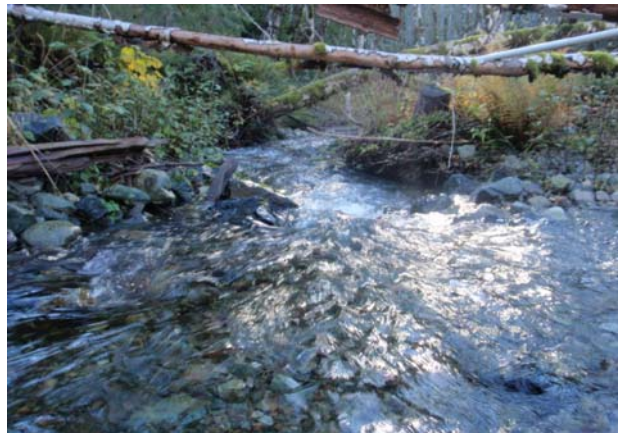
Figure 4: Habitat downstream of the crossing
