FISH PASSAGE – CULVERT INSPECTIONS

UPPER FULTON RIVER and HAROLD PRICE CREEK WATERSHEDS

January 2005

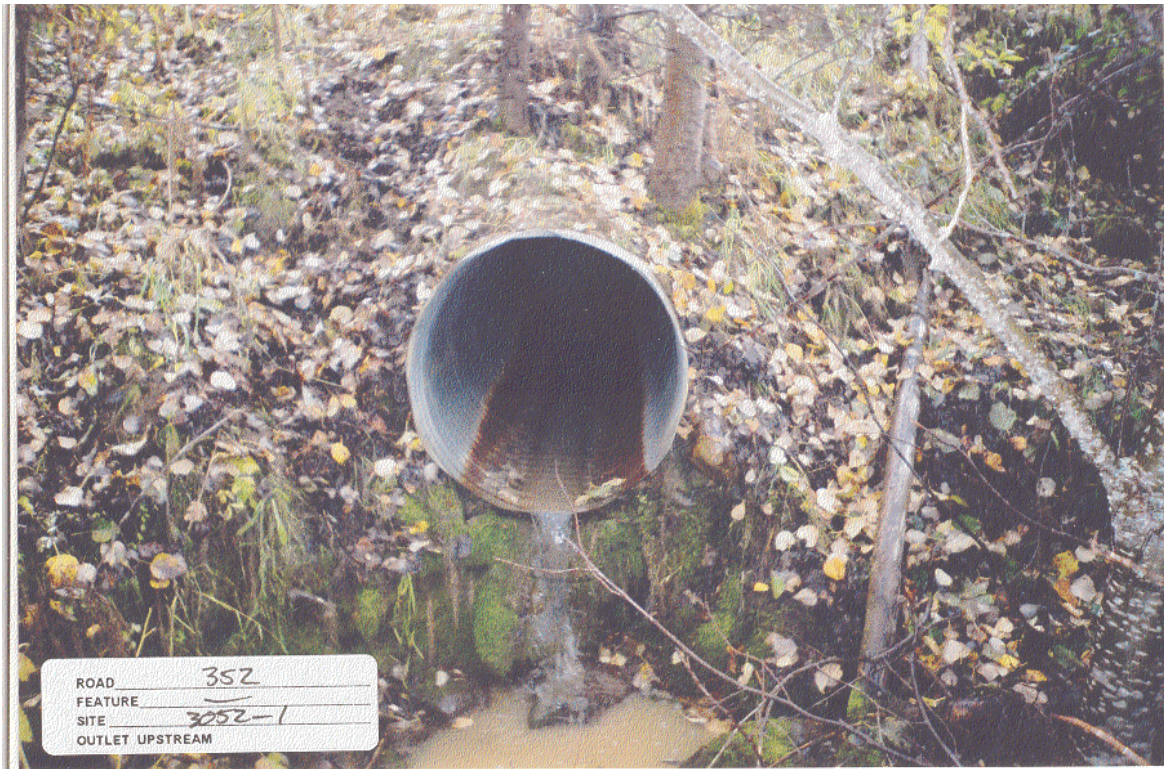
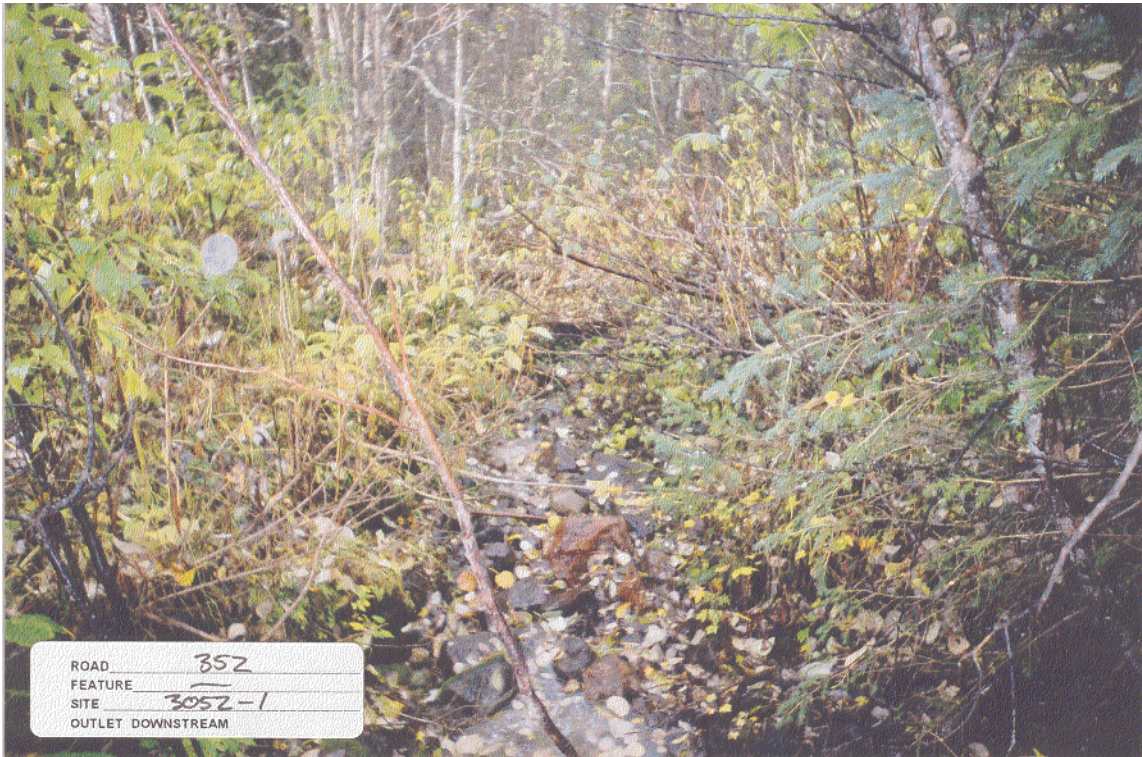
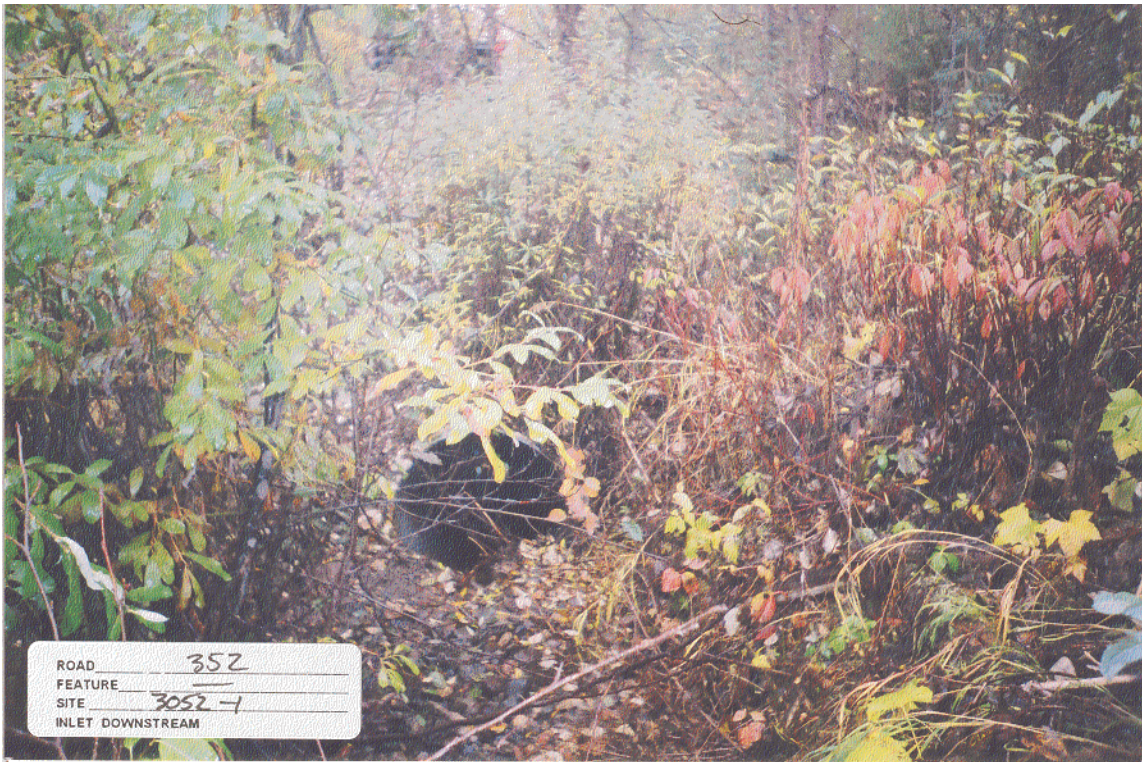
Site 3052-S1
Form A – Fish Passage Culvert Inspection – Side 1

Site 3052-S1 on the 352 Spur Road contains a full barrier to fish travel upstream through the crossing. The culvert is hanging at the outlet and contains a high gradient which would not allow for passage of fish. This site is ranked moderate due to its proximity to a known fish bearing stream and length of habitat upstream of the crossing.

Barrier – Full/Partial/None/Undetermined:	Full
Barrier Type:	Culvert outfall drop (0.65 m with 0.18 m deep outfall pool) is a barrier to all fish. No staging possible for jumping. Culvert slope (10.9%) creates a barrier to all fish.

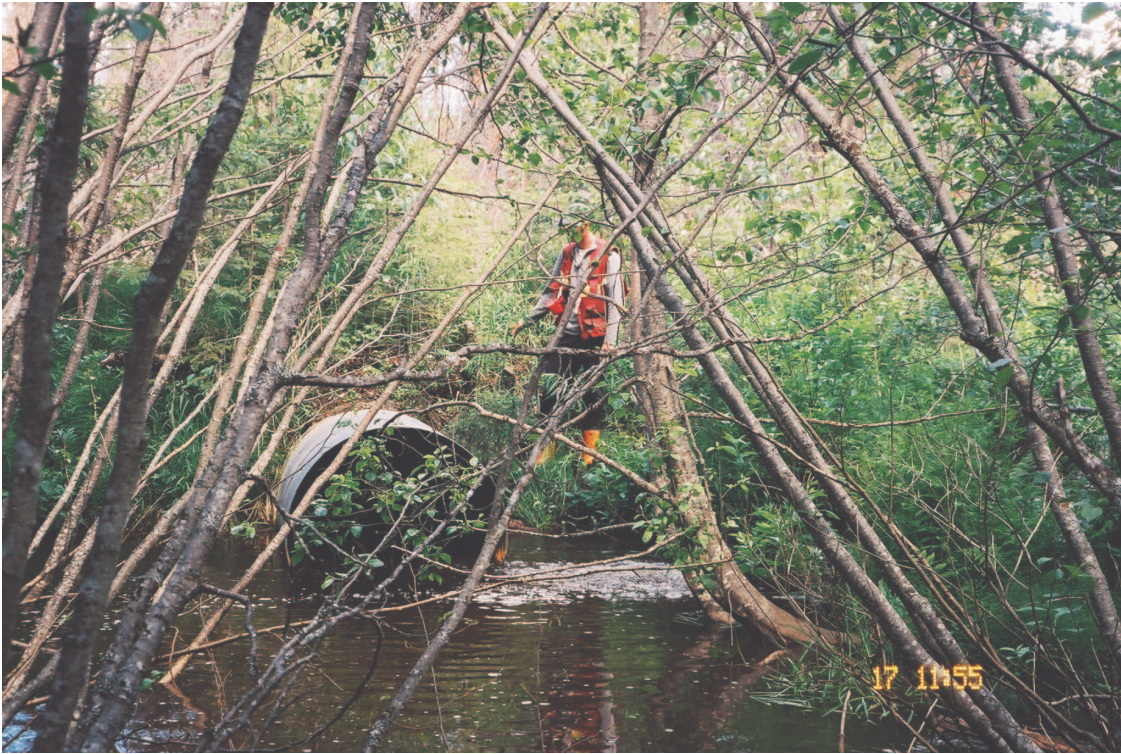
Beaver dam on upstream side of road is built up above running surface of road. Culvert is approximately 5 cm above bed at outflow pool, but no outfall drop due to water depth in culvert. No flow through culvert. Flow is through upstream side of road, then across road surface and down new channel into outflow pool.

Site 25/1718 : Outlet.

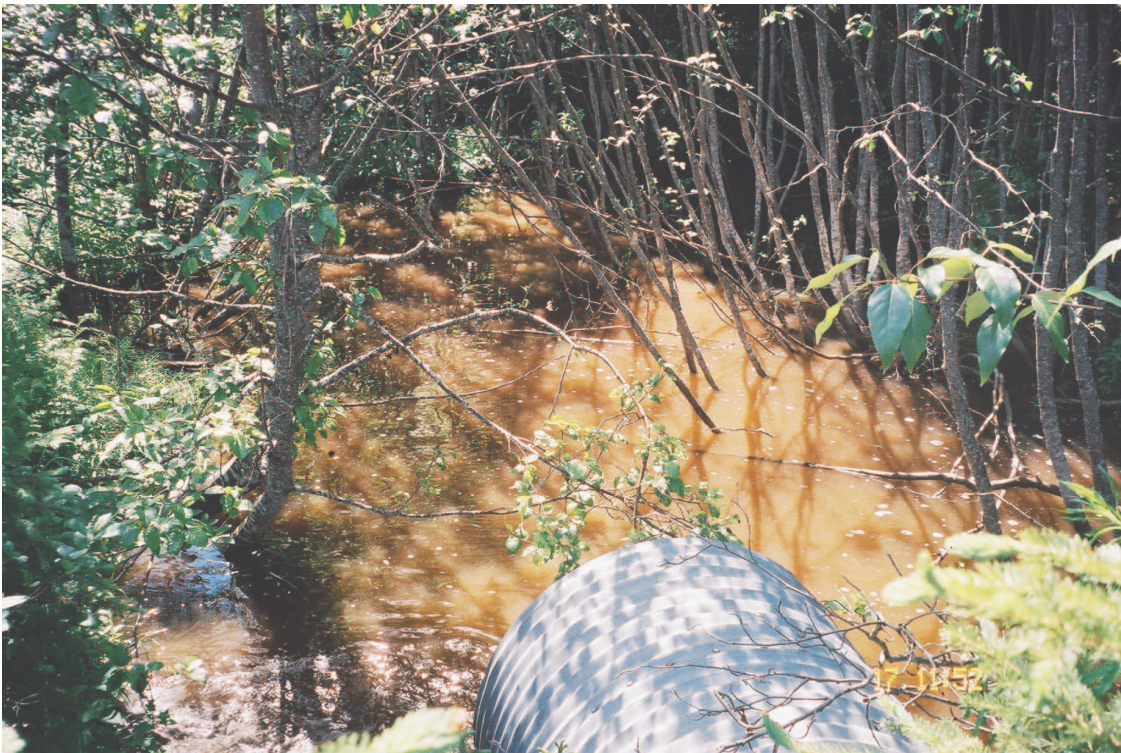
Site 25/1718 : Outlet downstream view.

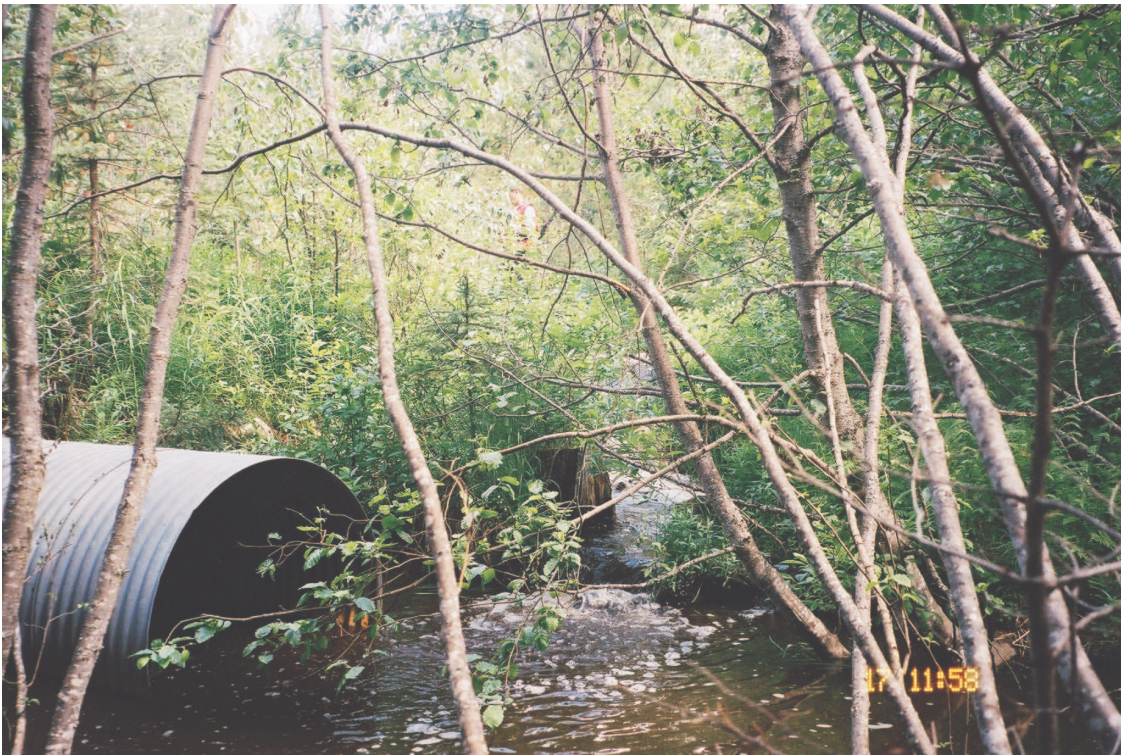
Site 25/1718 : Outlet with channel entering outlet pool on right.

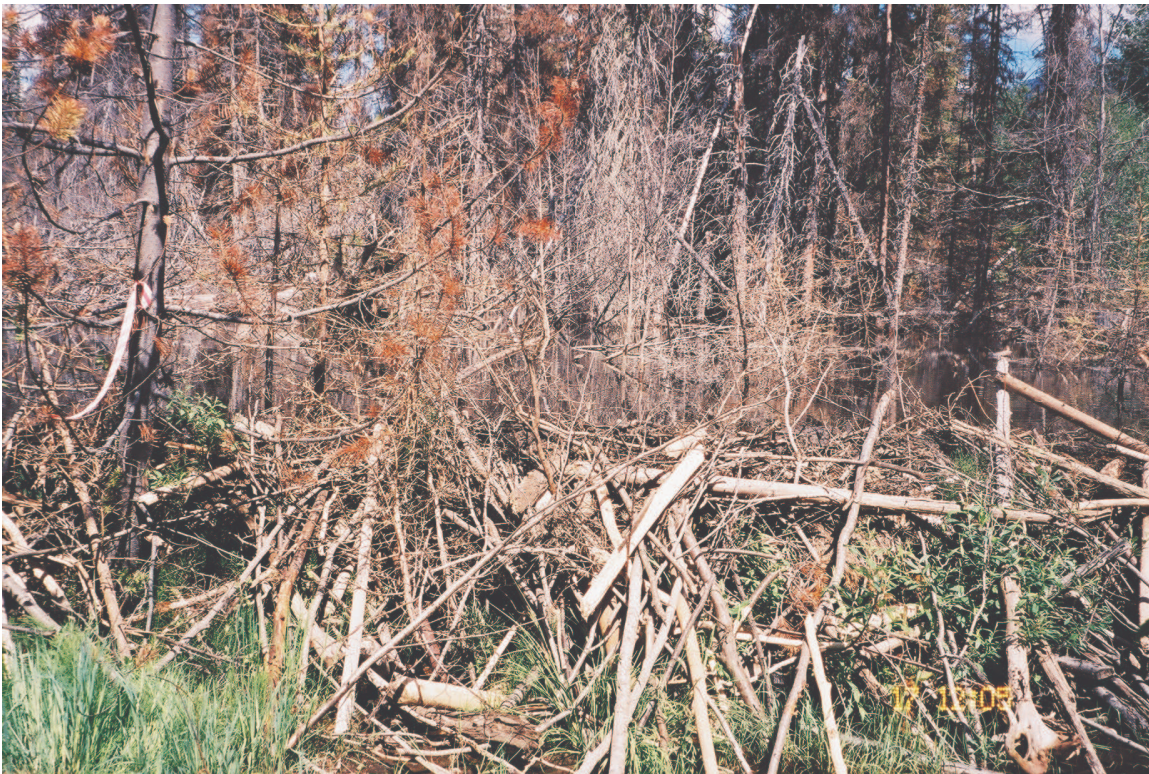
Barrier – Full/Partial/None/Undetermined:	Partial
Barrier Type:	Beaver Dam/ plugged culvert.

Comments:
Moderate priority due to beaver dam which is causing a partial barrier and blockage of culvert. Culvert is also undersized based on Q100 estimate.

Site 25/1718 : Beaver dam atop the inlet.

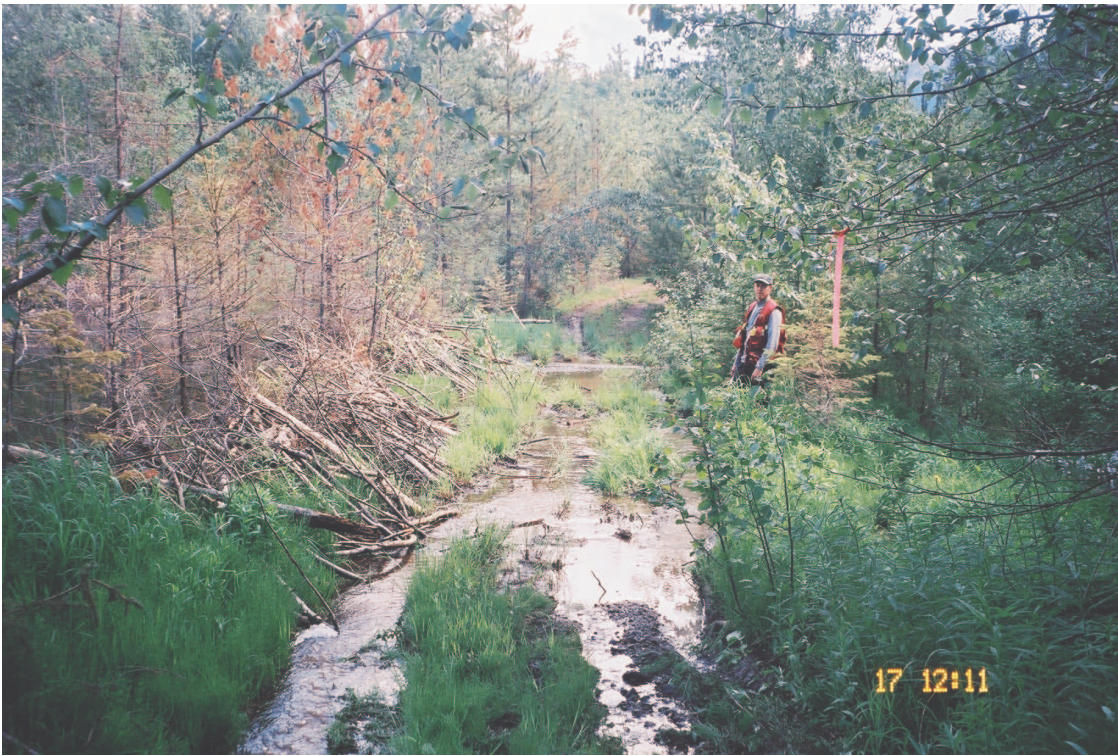
Site 25/1718 : Flow along road surface. Crew person standing above culvert outlet.

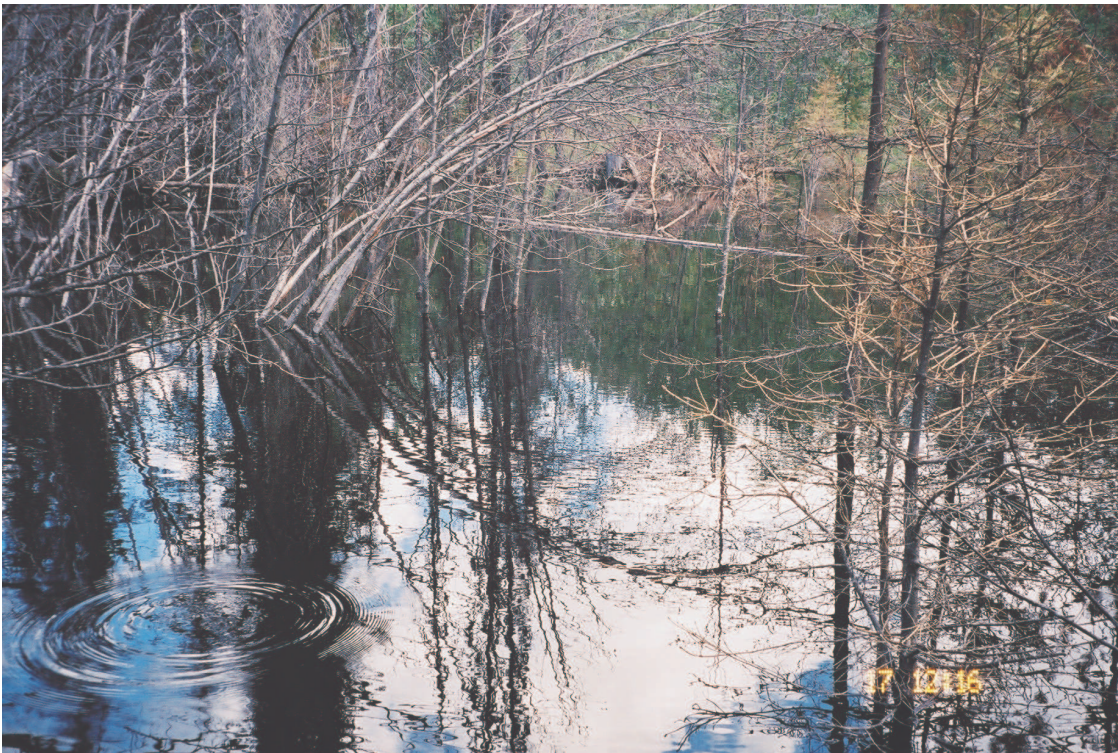
Site 25/1718 : Fish rising in beaver pond.
