STREAMFLOW AND FLUVIAL GEOMORPHOLOGY
OF THE LOWER GOLDSTREAM RIVER

- SUPPLEMENTARY ANALYSIS AND REVIEW

prepared for BC Parks

April 2008

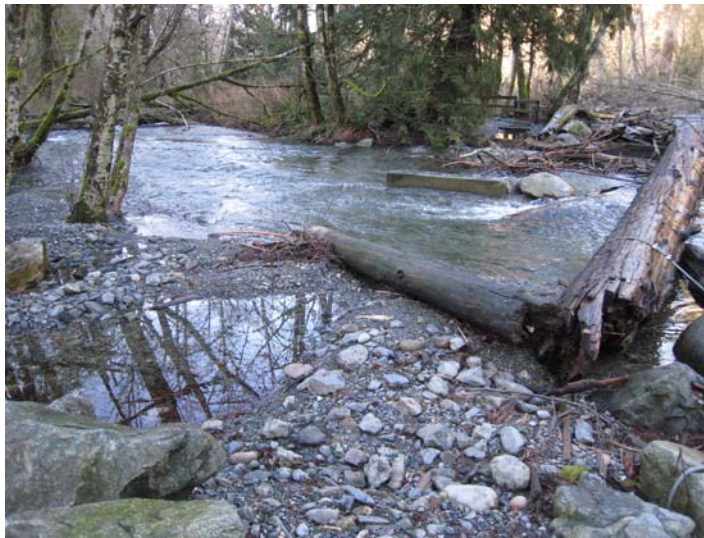
Photo 1

Inlet to the west channel showing channel widening and near top of bank flow. Chip surface material and trail fill has eroded in high flow and deposited around base of trees on the left bank.

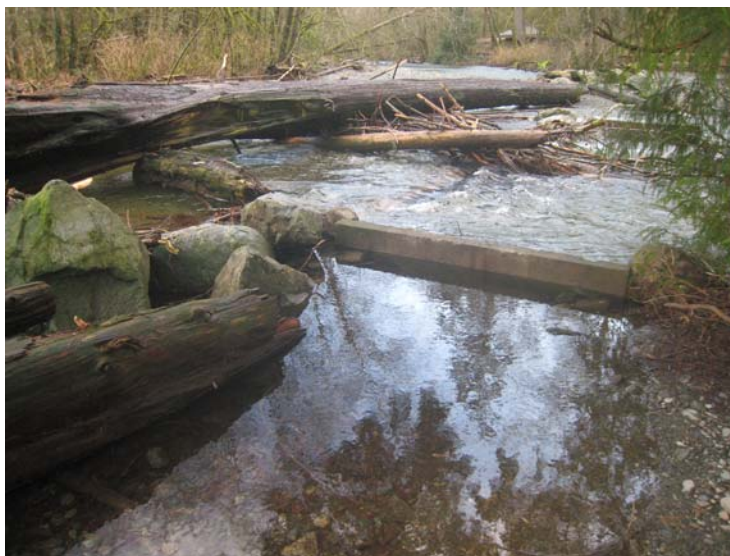
Photo 2

Same location from opposite bank showing suspended debris log and hydraulic drop associated with sill log installed in 2004 to deflect flow into centre channel. Concrete berm prevents low flow diversion down trail but high flows overtop it and flow down trail.

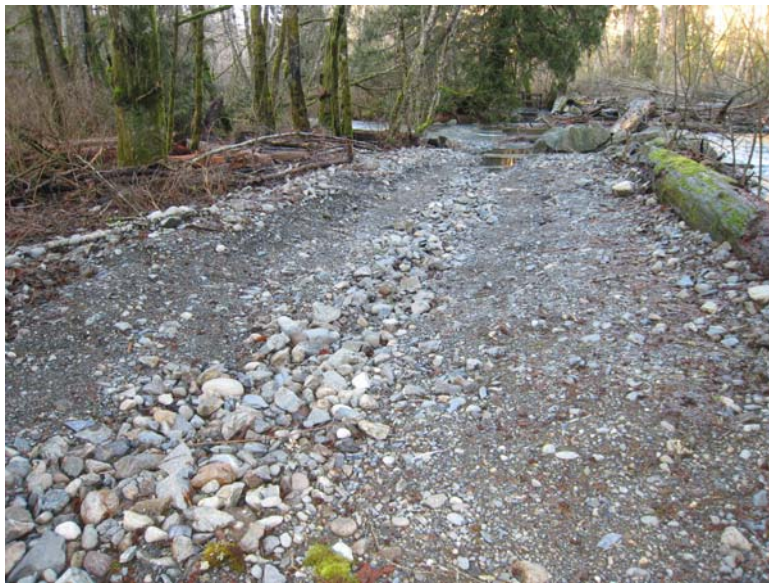
Photo 3

Conditions are currently in place for another potential avulsion if the river begins to cut through the meander on the left bank side of the debris jam. Bank over topping flows are already down cutting the existing trail. This situation could worsen if additional debris accumulates behind the log sill and suspended log at the upstream crossing. Natural re-adjustment of the river through this section may improve the alignment of the river. Partitioning of high flow down this section would reduce sediment scour in the west channel and accelerate aggrading and widening in the west channel.

Downcut trail fill behind bank revetment below the public viewing area leading to the former bridge crossing shown in Photo 1 and 2 in far background

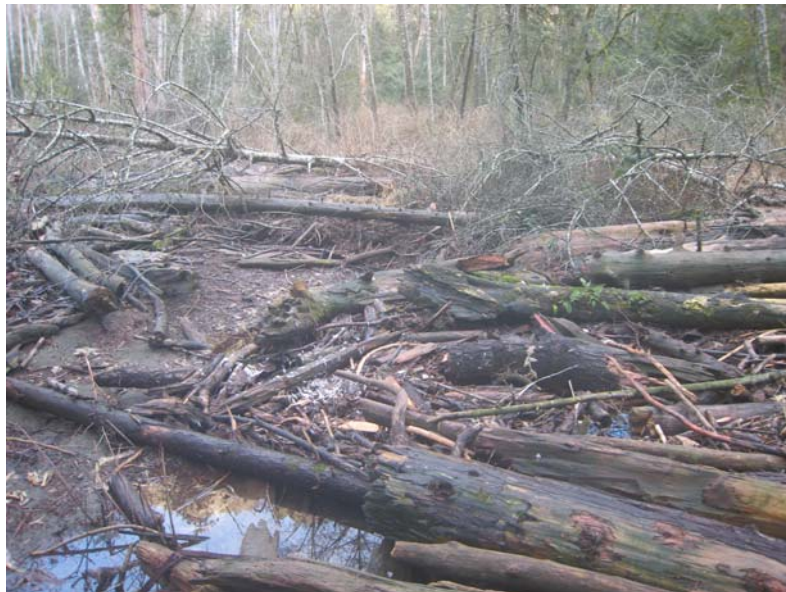
Photo 4

In 2006 winter storms resulted in formation of an extensive debris jam that now occupies the upper half of what was the centre channel R1-SC2 (former main channel). The November 16, 2006 storm was noted for accompanying high winds that resulted in extensive windthrow across Vancouver Island. Consequently, with the exception of side channel flow in the eastern side channel R1-SC1, all flow appears to be now diverted through the west channel.

There is visual evidence of high amounts of fine sediment deposited behind debris in the former centre channel. Removal of debris would be expected to expose high amounts of stored sediment. Further investigation would be needed to determine if removal of the debris

Debris and sediment clogged centre channel

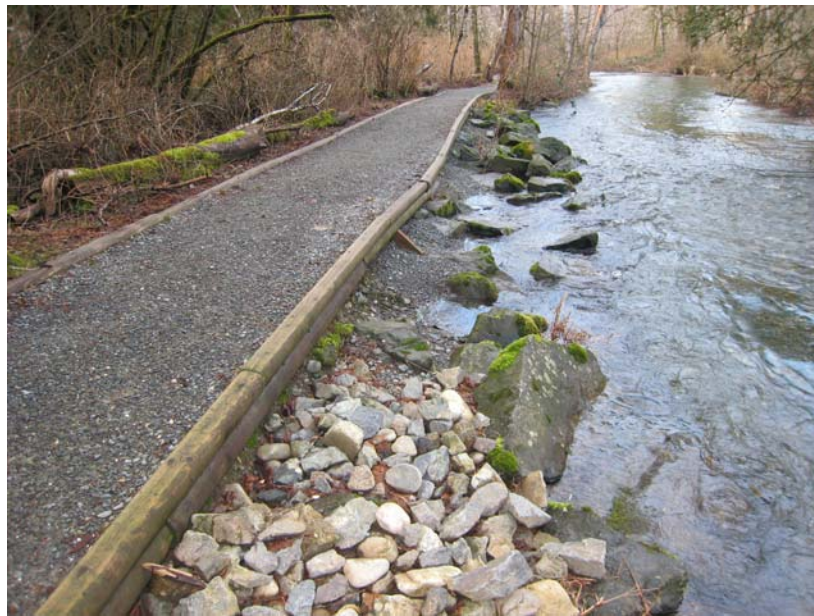
Photo 5

Undermining of the boardwalk where rock protection has collapsed into the stream

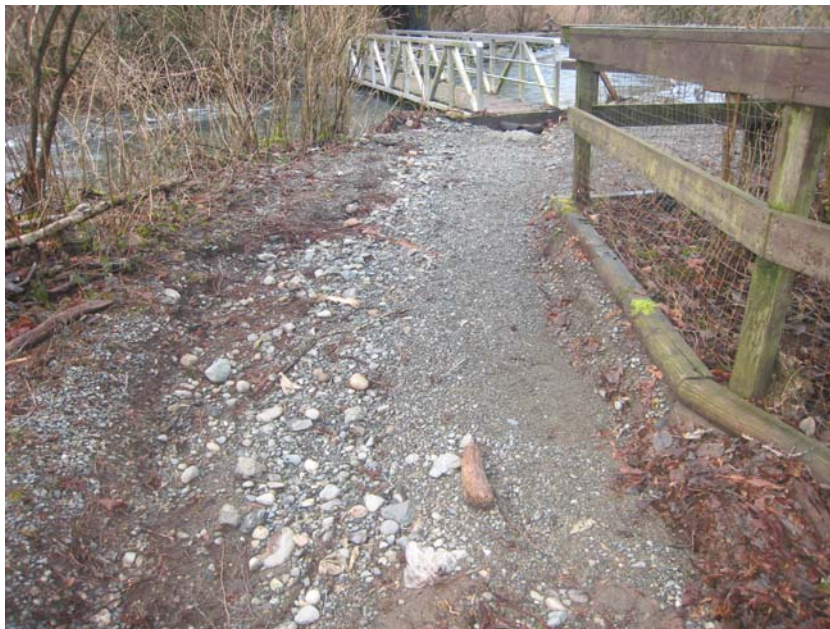
Photo 6

Erosion caused by flooding along a trail between bridge crossings.
