Lower Coquitlam River Fish Habitat and Flooding Assessment

Prepared for
Watershed Watch Salmon Society and
Kwkwetlem First Nation

Prepared by
Tanis Douglas, RPBio
Fernhill Consulting

Project # 07 COQ.01

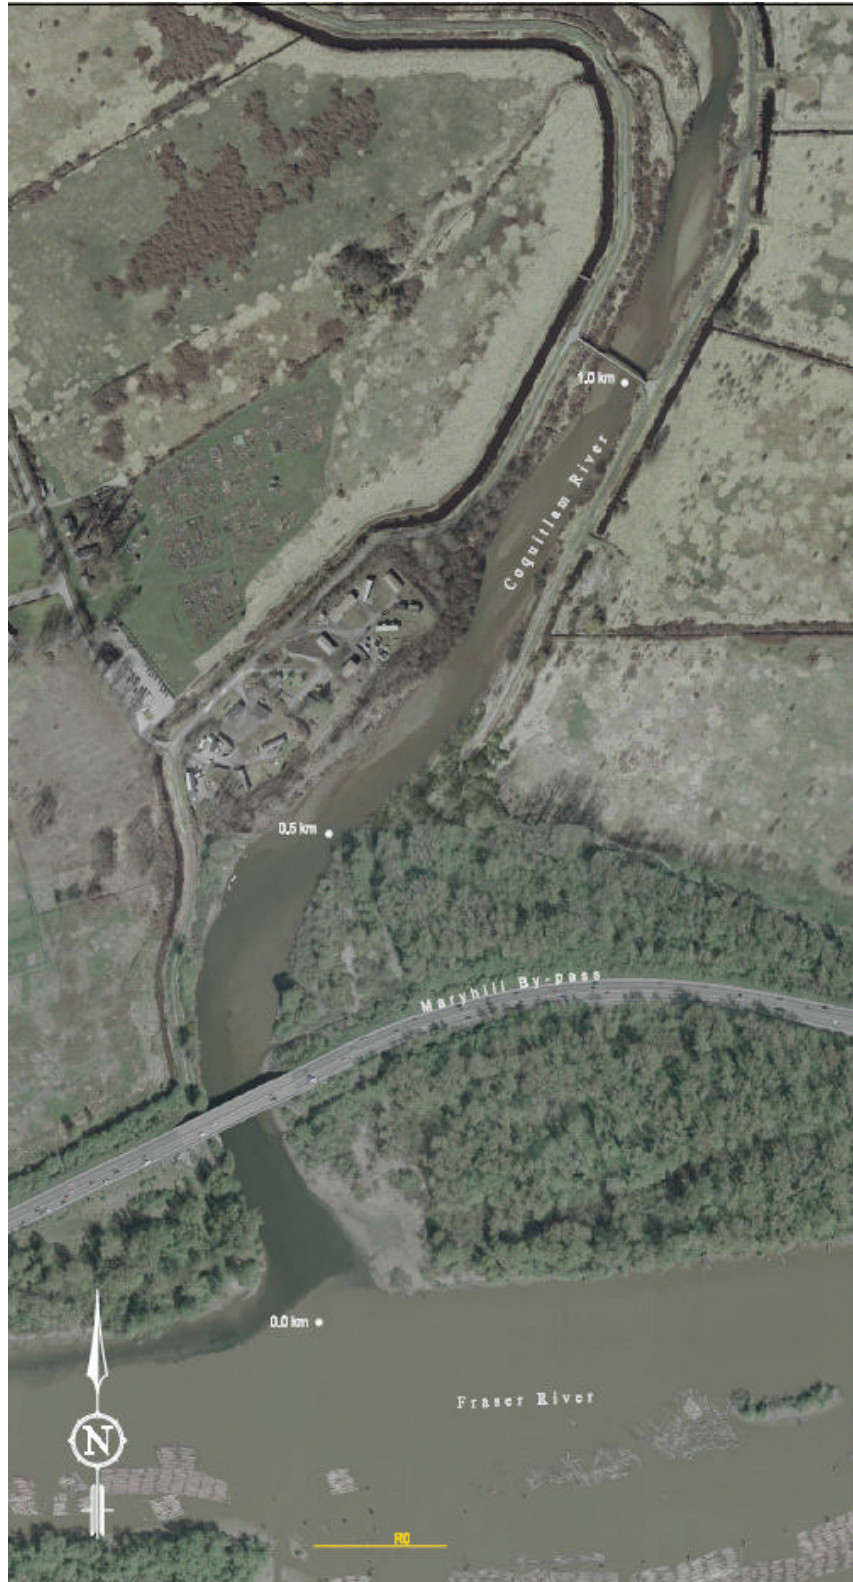
Figure 1: The mouth and lowest part of the Coquitlam River. Note the Wildlife Management Area at the mouth, IR#1 on the west bank, and the field habitat provided by Colony Farm and the Forensic Psychiatric Institute

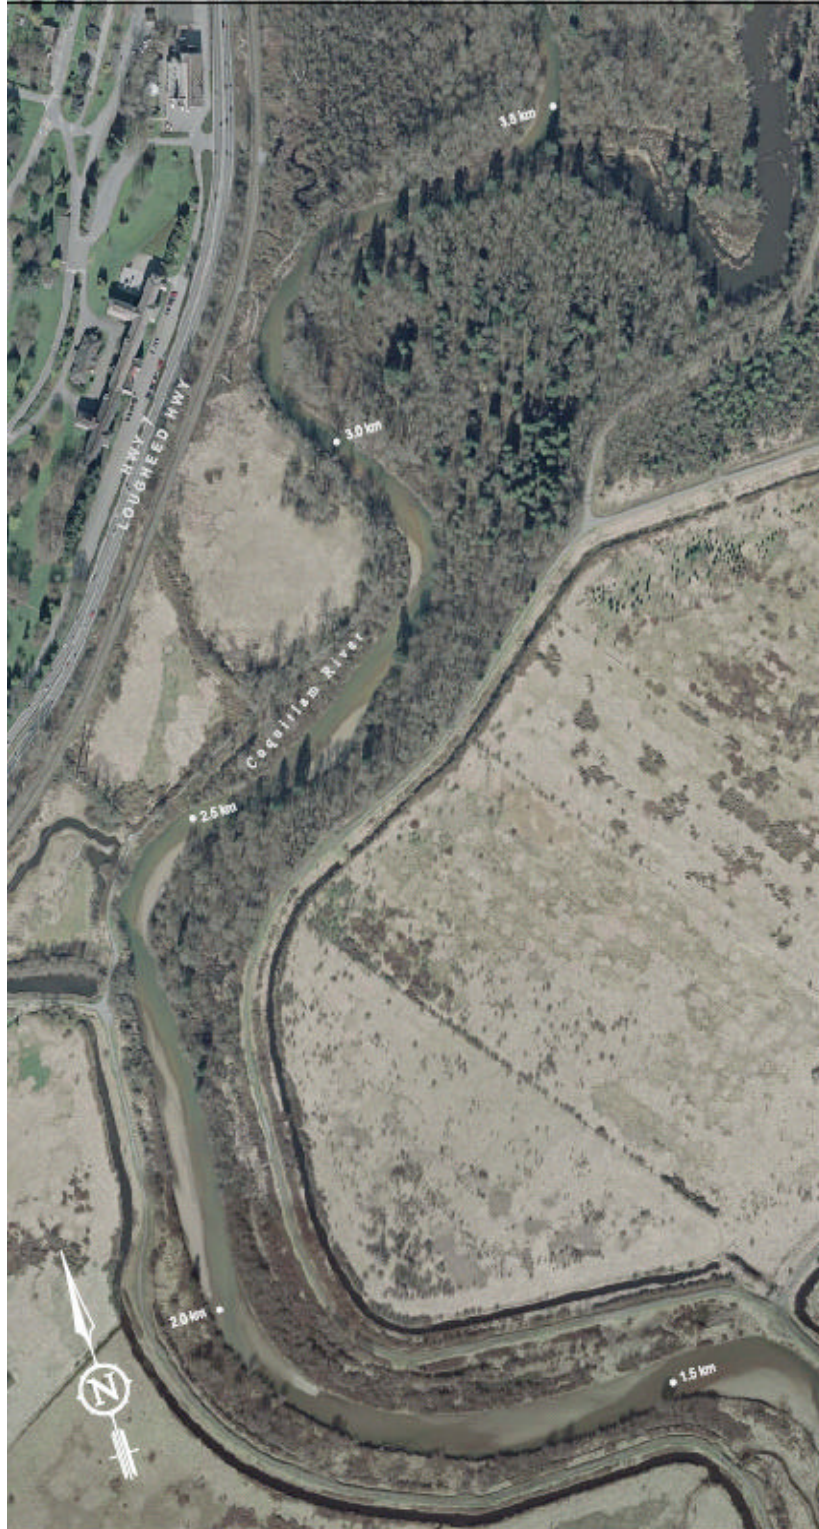
Figure 2: Figure 2: Colony Farm and the lower portion of IR#2, including the oxbow. The sheep paddocks are the uppermost three fields on the west bank. The habitat enhancement (constructed channel) is visible in the lowermost sheep paddock. The Upper Wilson Farm (a wildlife management zone within Colony Farm park) is on the east side of the river.

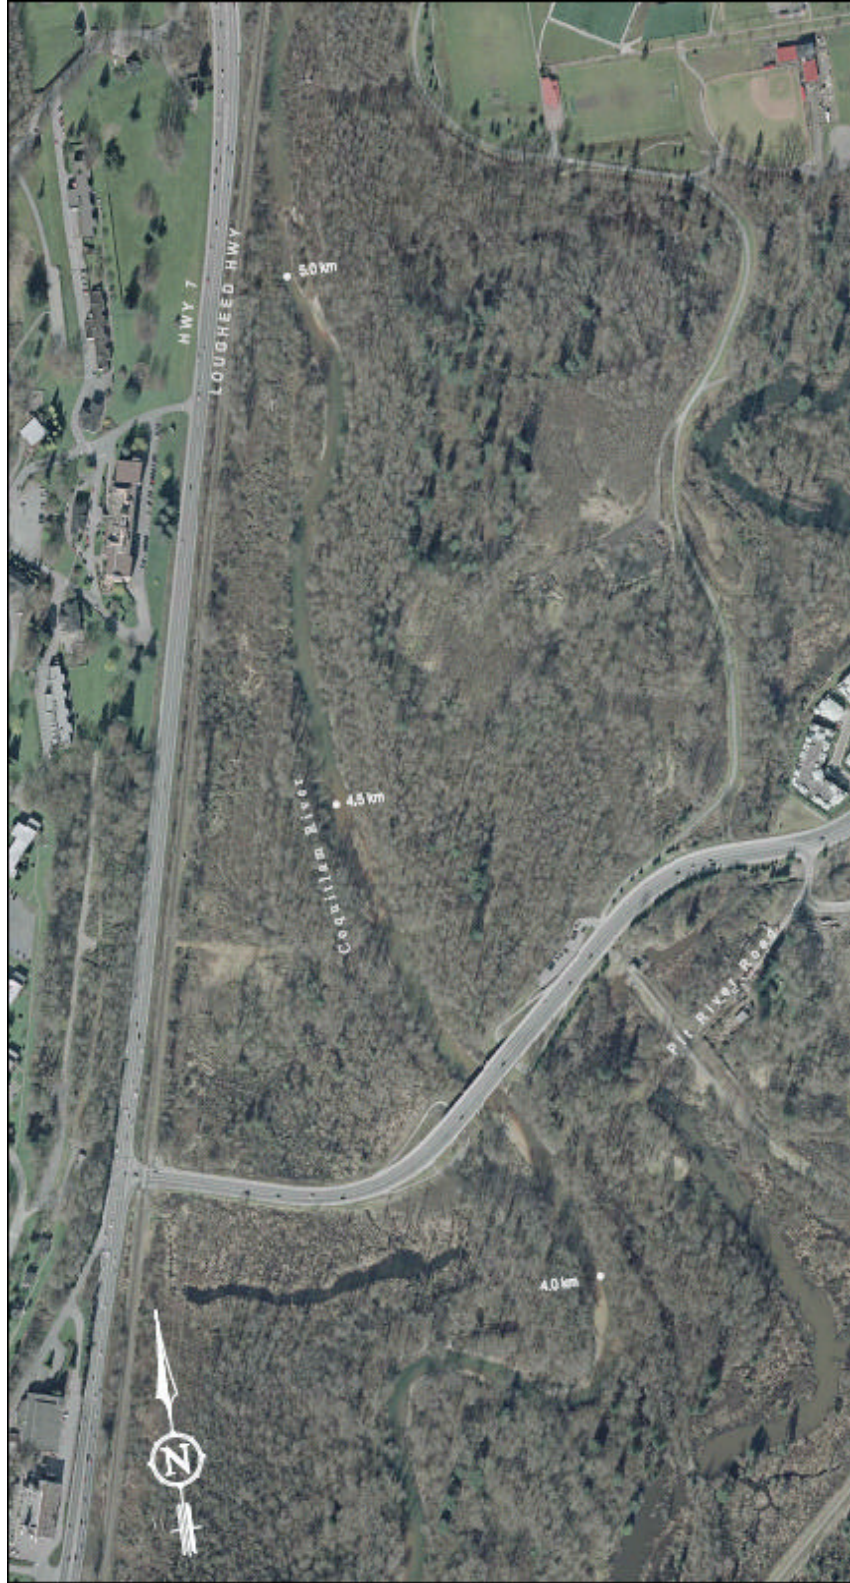
Figure 3: The upper part of IR#2 is visible on the west bank below Pitt River Road. On the east bank a habitat compensation project is seen. Above the Pitt River Road a standard set-back dike is visible on the east (Port Coquitlam) side of the river and older dikes line the river.

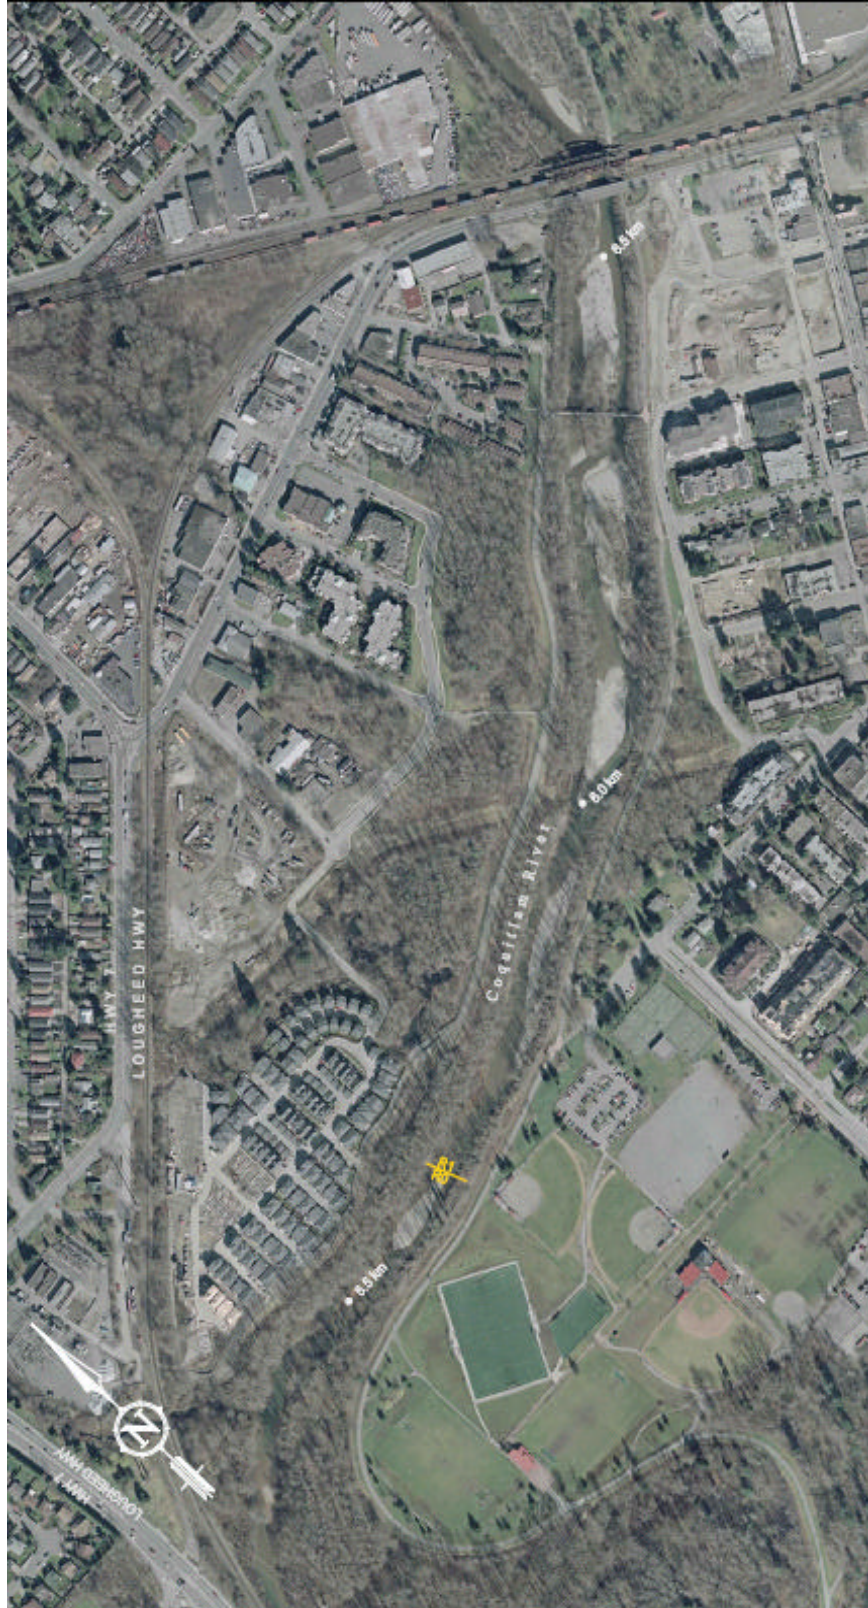
Figure 4: Gates Park is seen on the west bank. Standard dykes constrain the river in a narrow channel. Gravel bars are seen above km 5.5. whereas the substrate downstream is mostly sand.

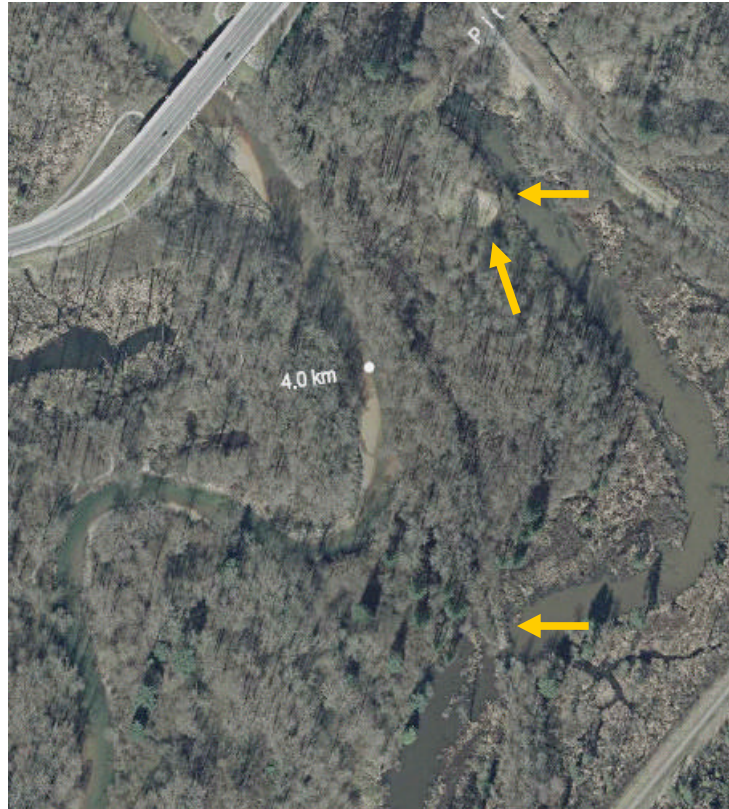
Figure 5: Indian Reserve #2 is on the east (right) of the main channel. The oxbow is shown here. The cemetery is adjacent to the top of the oxbow and is indicated by two arrows. Also shown is a constriction where an older dike crosses the oxbow. The bridge in this location has been removed.

The cut-off oxbow (slough) on the reserve adjacent to the cemetery has been the subject of interest for potential improvements to fish habitat. A study was done in 2001 (Kerr, Wood, Leidal Associates Ltd. 2001) to look at the feasibility of side channel reactivation (i.e., creating better connections between the oxbow and the mainstem in order to provide better fish habitat). The oxbow was seen as having the potential for improved coho (*Oncorhynchus kisutch*) wintering habitat. A direct upstream connection to the river was not recommended, but a groundwater fed option from the Port Coquitlam pump house (located at the top of the oxbow and currently draining into the mainstem river) was seen as the preferred option. This option raises water quality concerns as the pump house is moving stormwater out of nearby subdivisions. As reported by Urban Systems Ltd. (2005) there was also interest in creating a channel or an intake that connected the oxbow to the mainstem river. Either option to create more flows might create more problems at the cemetery due to increased water levels and caution should be exercised (Urban Systems Ltd. 2005).

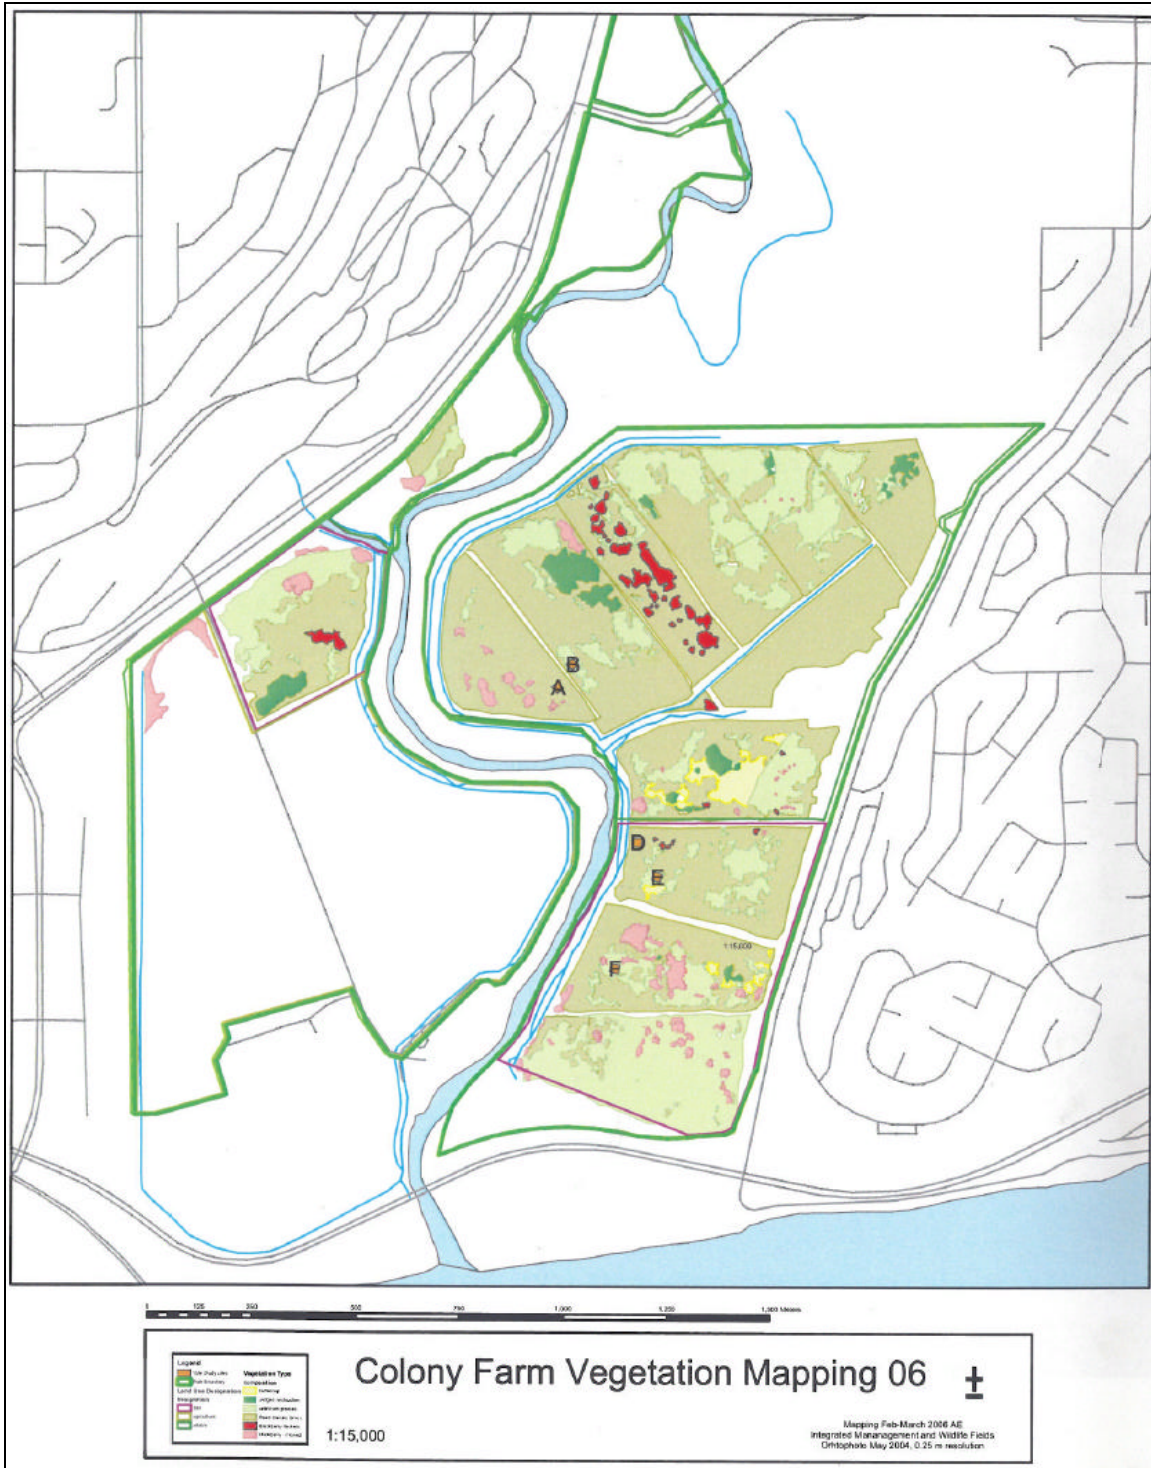
Reed canary grass dominates the fields in Colony Farm Park (see Figure 7). This grass prefers full sun in moist to wet habitats, but also tolerates extended periods of both wet and drought conditions (Graham 2003). It is likely native to British Columbia, but has hybridized with varieties from elsewhere, increasing its adaptability and making it a more aggressive invader. Reed canary grass is capable of near total dominance over native wetland plant communities (Graham 2003). At Colony Farm, attempts have been made to control this grass in two ways: i) maintaining drainage of the fields (ditch maintenance and continued use of the Wilson Farm pump station) to facilitate drier conditions that may allow other grasses to persist or establish, and ii) a field 'renovation' project that took place in 2006.

Figure 7: Vegetation mapping in the Wildlife Management Areas and Integrated Wildlife Management Area at Colony Farm, based on 2004 orthophotos (Taitt 2006). The olive green is reed canary grass, light green is unknown grass, red is blackberry thickets and pink is mown blackberry. This mapping predates field ‘renovation’ done in a field in the upper Wilson Farm.

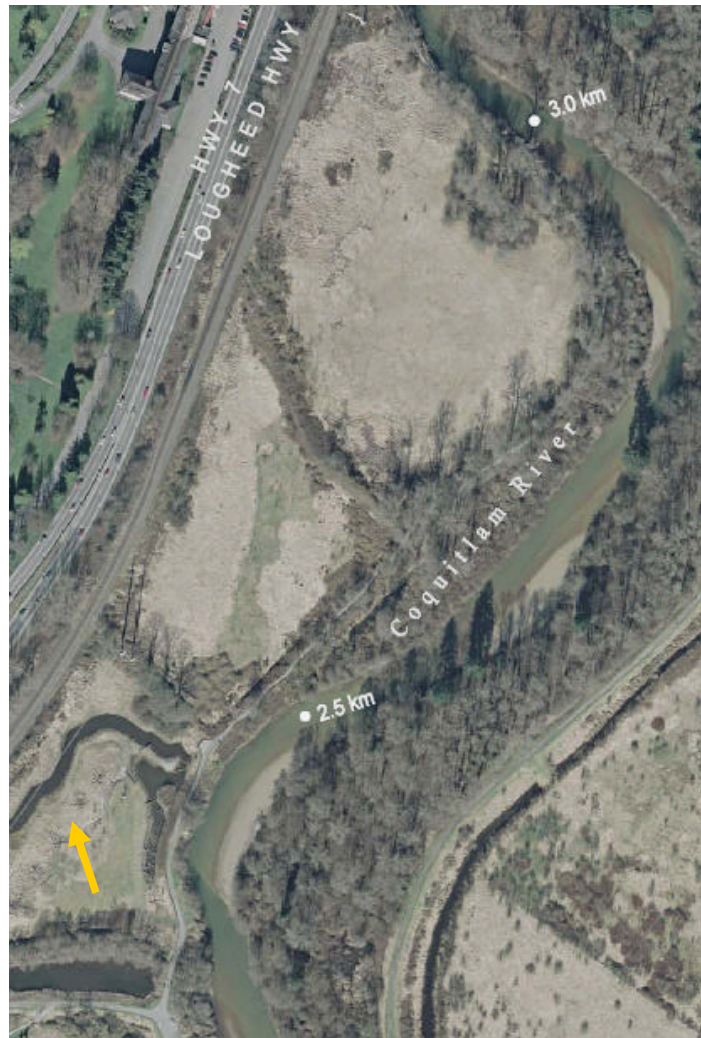
Figure 8: The sheep paddocks in 2006. The constructed channel is seen in the lower paddock, and feeds into the river via the slough (Munday Slough) seen running perpendicular to the Coquitlam River.

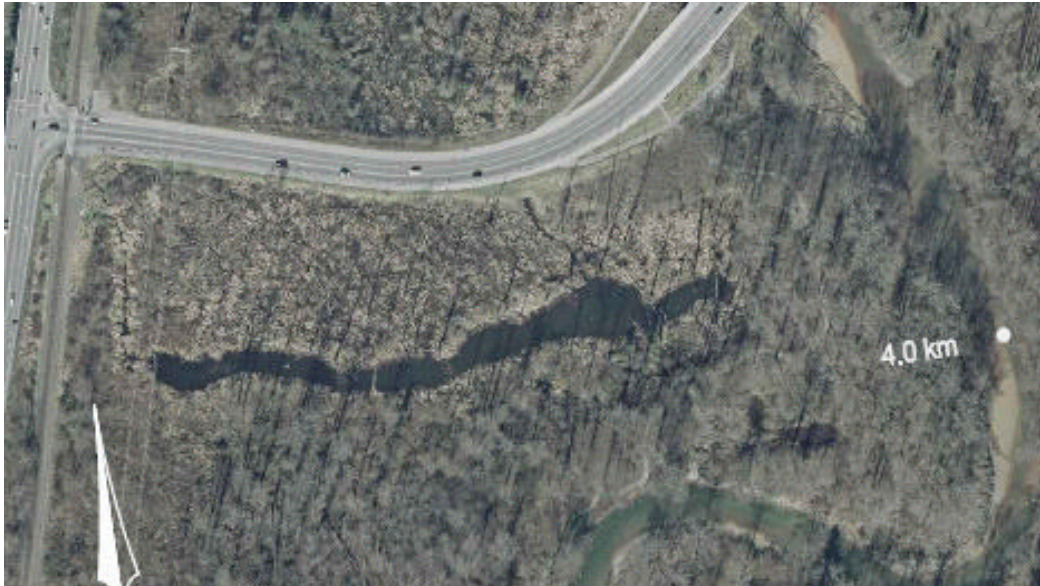
In 1995 a fish habitat compensation project (compensation for fish habitat lost to development elsewhere) was constructed in the upper west part of Colony Farm Park – see Figure 9. This was to provide off-channel rearing and over-wintering habitat. However, the outlet to the channel was not designed taking into account likely beaver activity. As a result, the area has instead developed wetland habitat, with a channel that connects to the river only at high tide and high water levels. In addition, the channel outlet(s) under the river dyke appear to be designed in such a way that continued flows are not assured – in fact the outlets are highly constricted. These outlets should be assessed against their original design to determine whether corrective action should be taken to maintain a connection to the river. Overall, the project is not meeting its goal. However, the wetland habitat created is still valuable, and while not intended, is a

Figure 9: Fish habitat compensation project constructed in 1995 (see channel running parallel to the Pitt River Road).

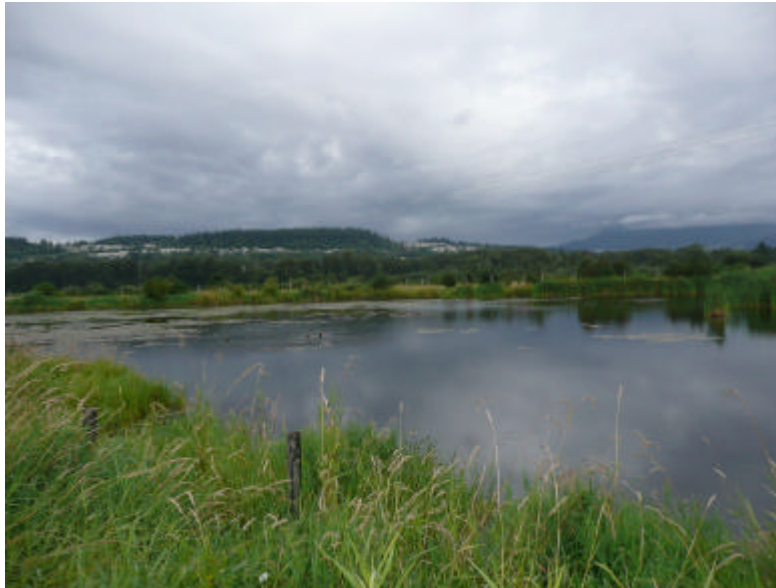
Figure 10: Wilson Pond in July 2007.

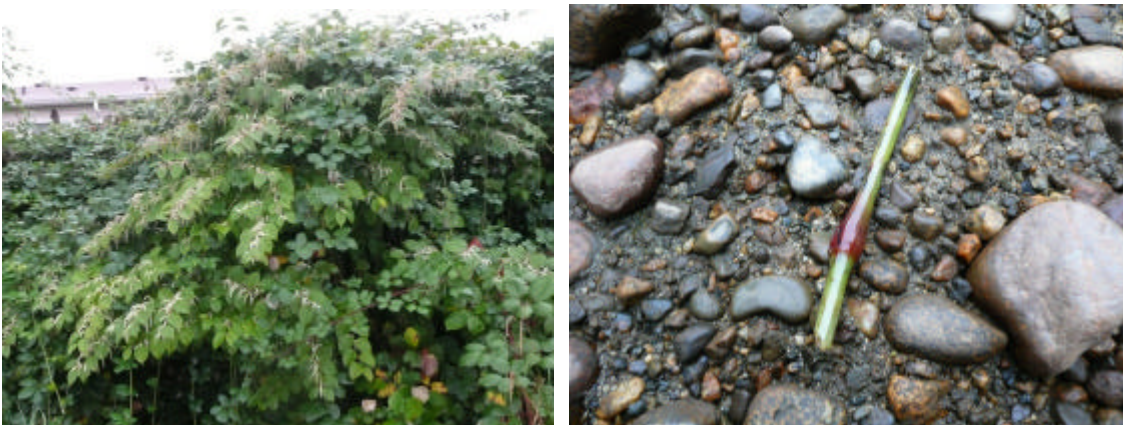
Japanese knotweed (*Polygonum cuspidatum*) is found in patches in Colony Farm and upstream. This bamboo-like plant prefers riparian areas, and is extremely difficult to eradicate. It will even grow through asphalt. It forms dense thickets that exclude other vegetation, and dies back in wintertime, leaving exposed soil. New plants can form from even small fragments of rhizomes left behind during control efforts, and even tiny fragments of the plant can form new rhizomes (Graham 2003). This is one way the plant distributes itself along riparian areas – by rhizomes and fragments moving downstream – see Figure 11. Because control is so difficult, the best method is to prevent establishment by monitoring areas and eradicating new infestations before they become established. A combination of cutting and glyphosate (Roundup) is likely the superior method of control (Graham 2003). Controlling the extent of Japanese knotweed is a high priority because of its persistent and aggressive nature and potential to colonize extensive areas.

Figure 11: Knotweed on Colony Farm, and a knotweed propagule found in the mainstem below the Pitt River Bridge.

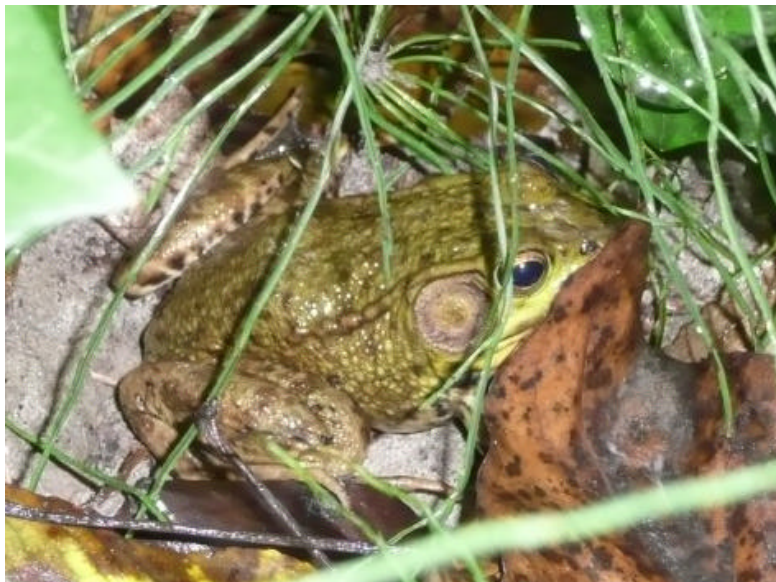
Figure 12: Green frog (*Rana clamitans*) along the bank of the Coquitlam River (Reach E)

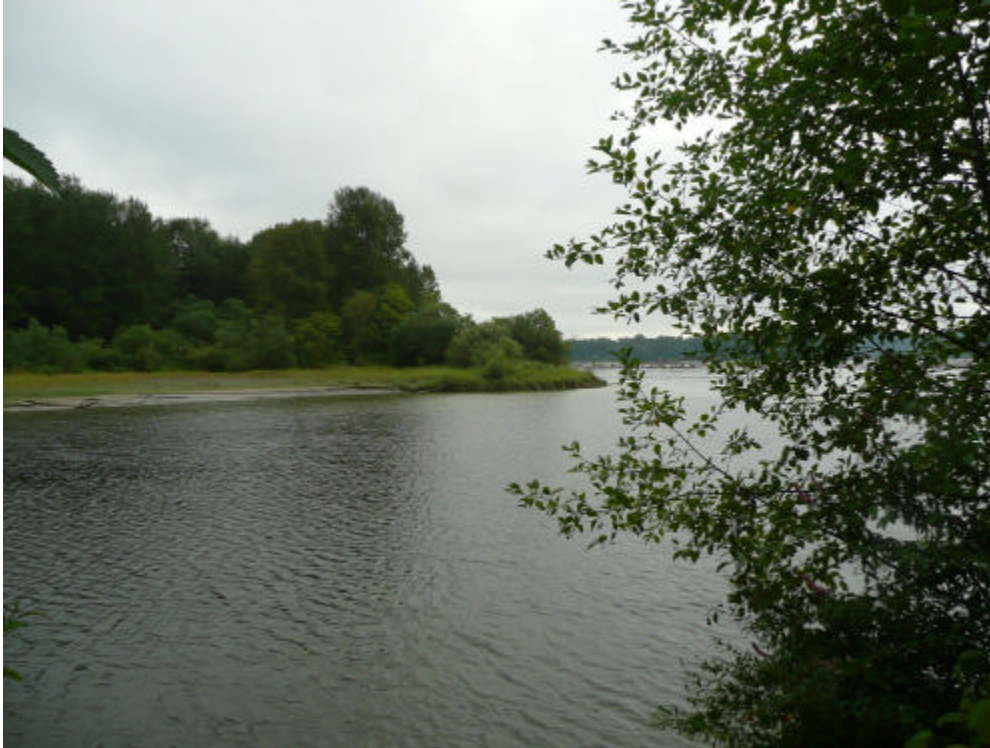
Figure 1: A view of the river mouth (Reach A), including a tidal marsh and the Fraser River

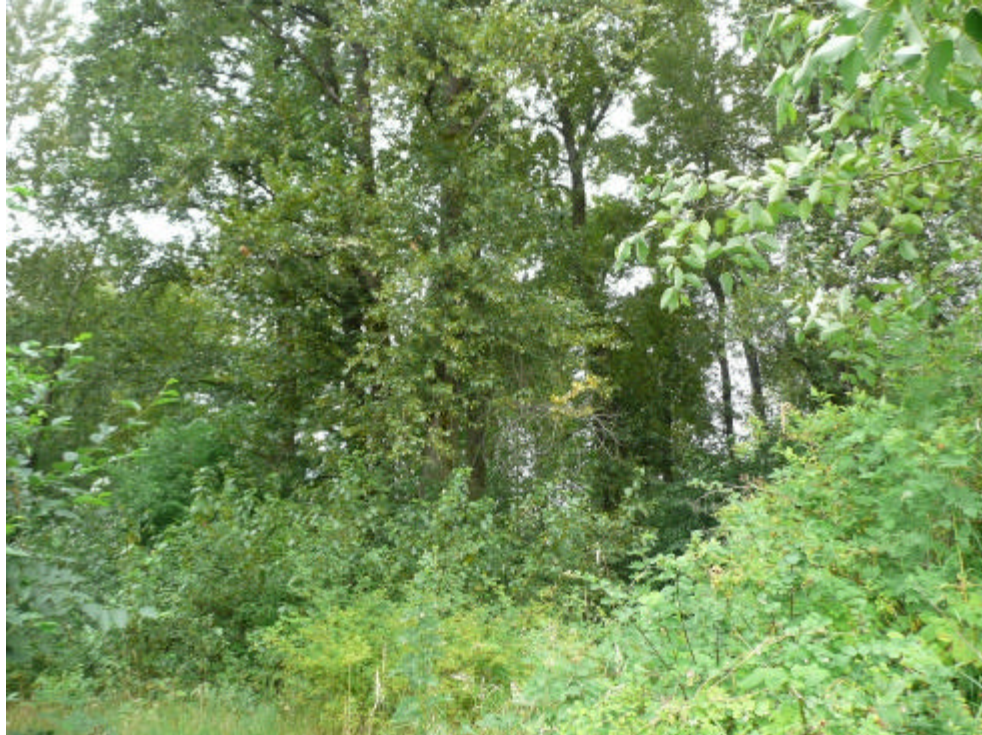
Figure 2: Riparian vegetation in the Wildlife Management Area (reach A) at the mouth of the Coquitlam River, on the west bank.

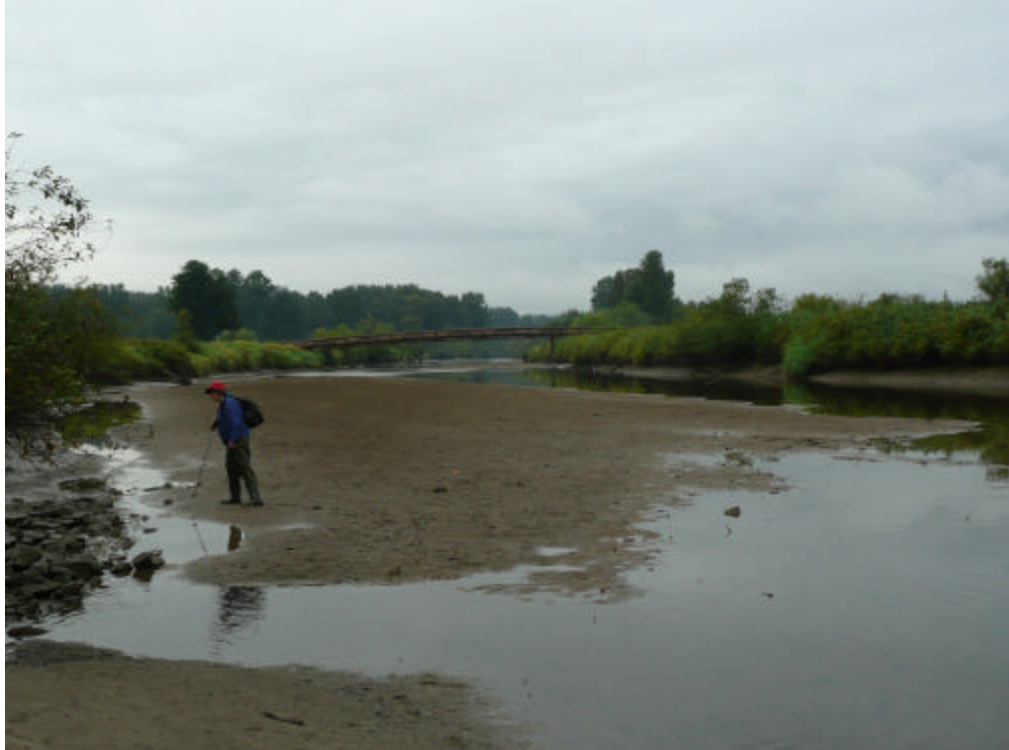
Figure 3: Reach B at low tide, looking downstream towards the footbridge. Note sand bars.

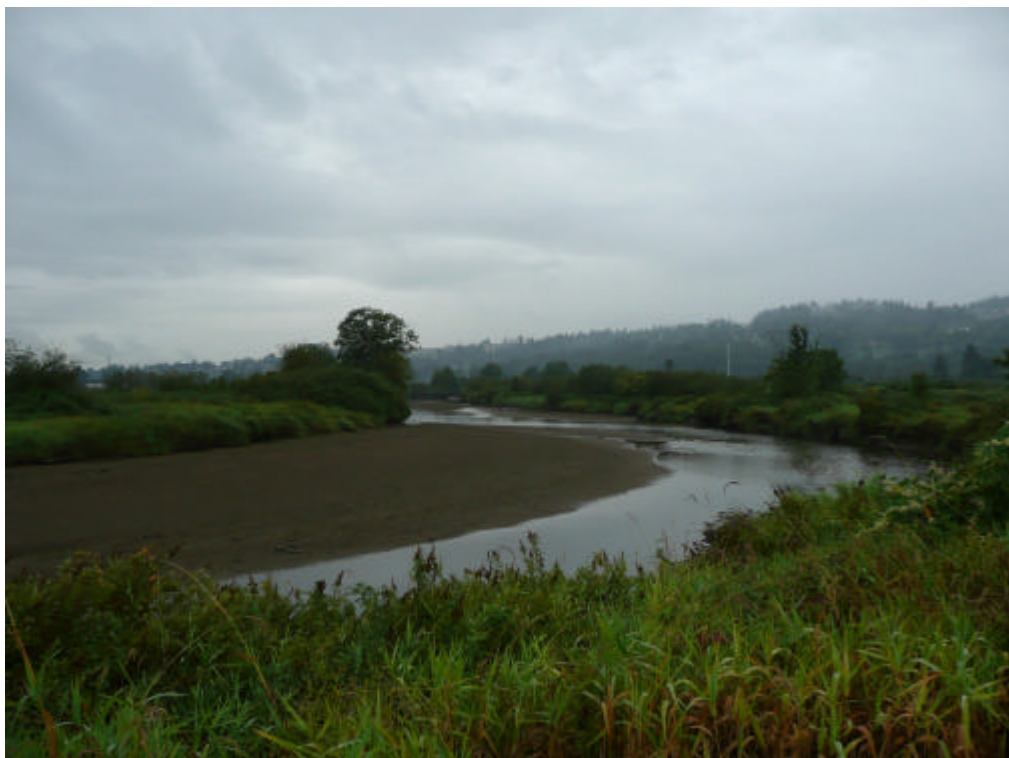
Figure 4: Reach C looking upstream at river kilometre 1.5. Note the shrubby riparian vegetation.

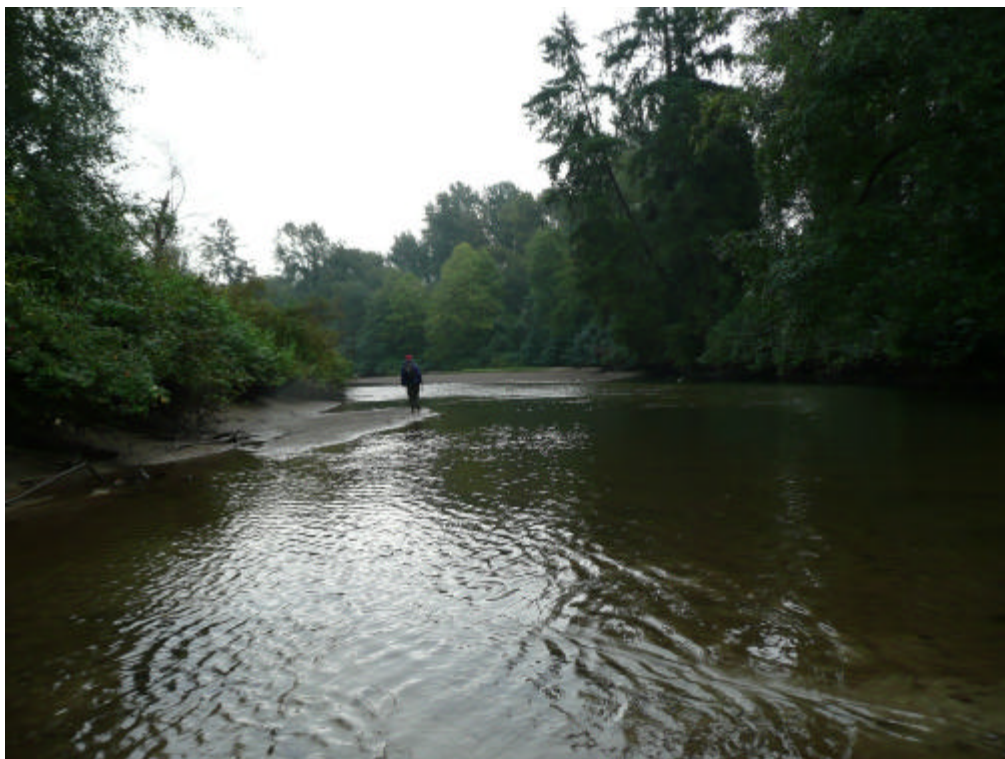
Figure 5: Reach C looking upstream from approximately river kilometre 2.8. Note riparian trees including a sitka spruce.

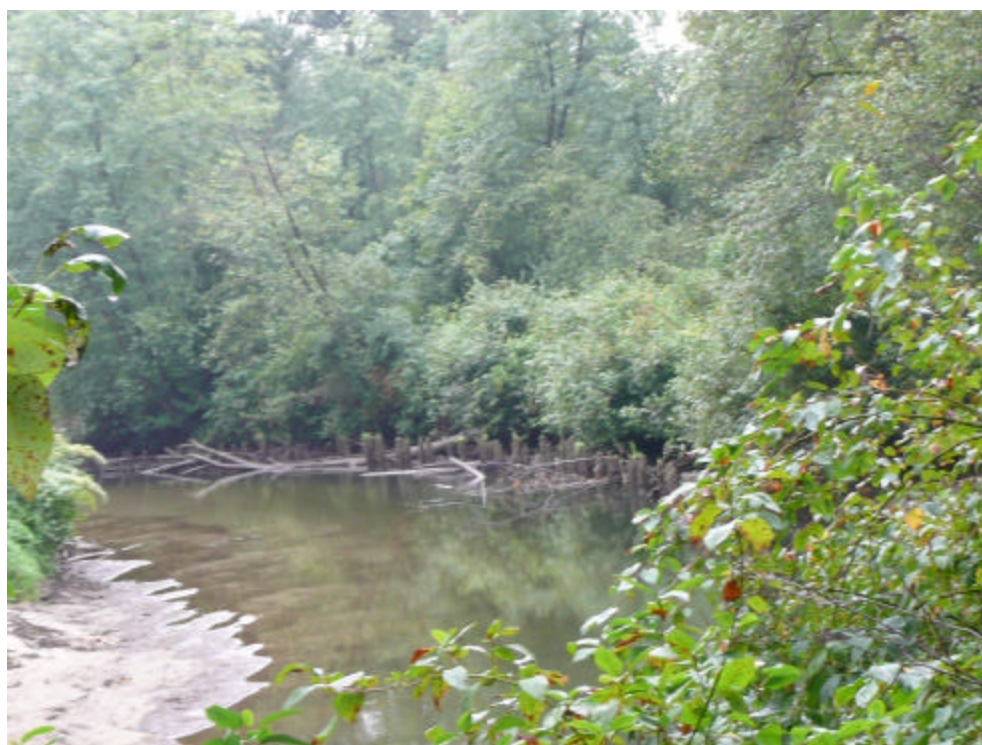
Figure 6: Reach C looking downstream towards historical bank protection works at km 3.75. The bank has eroded significantly from its original location.

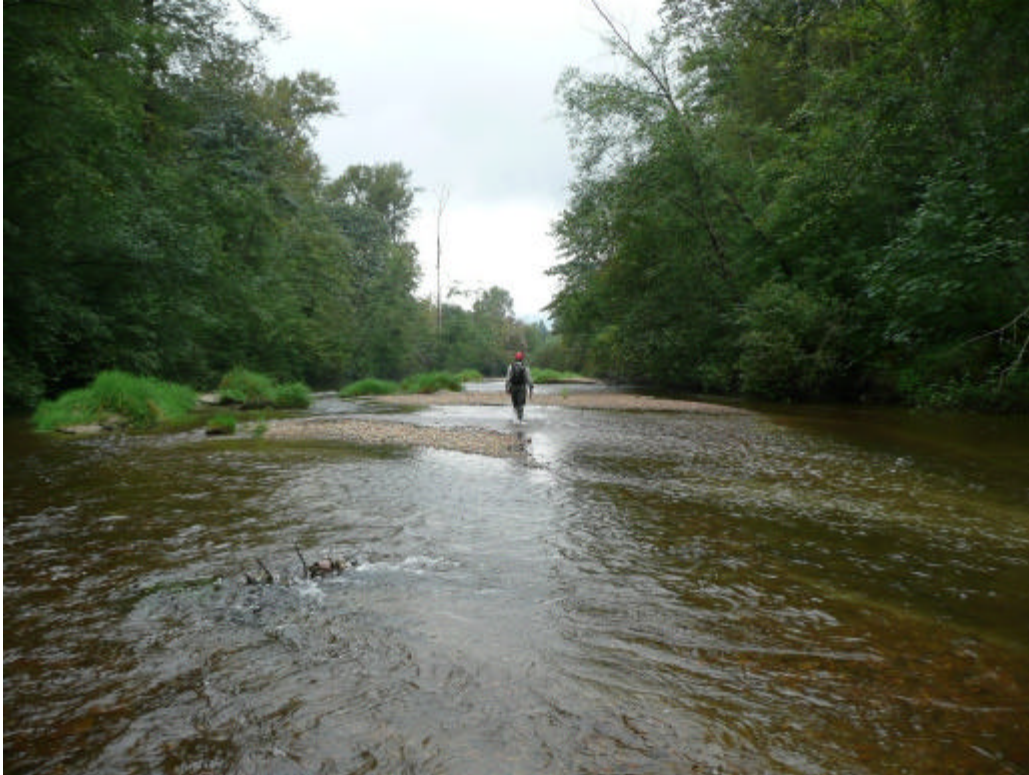
Figure 7: Reach D gravel deposits at approximately river kilometre 4.3, upstream of the Pitt River Bridge.

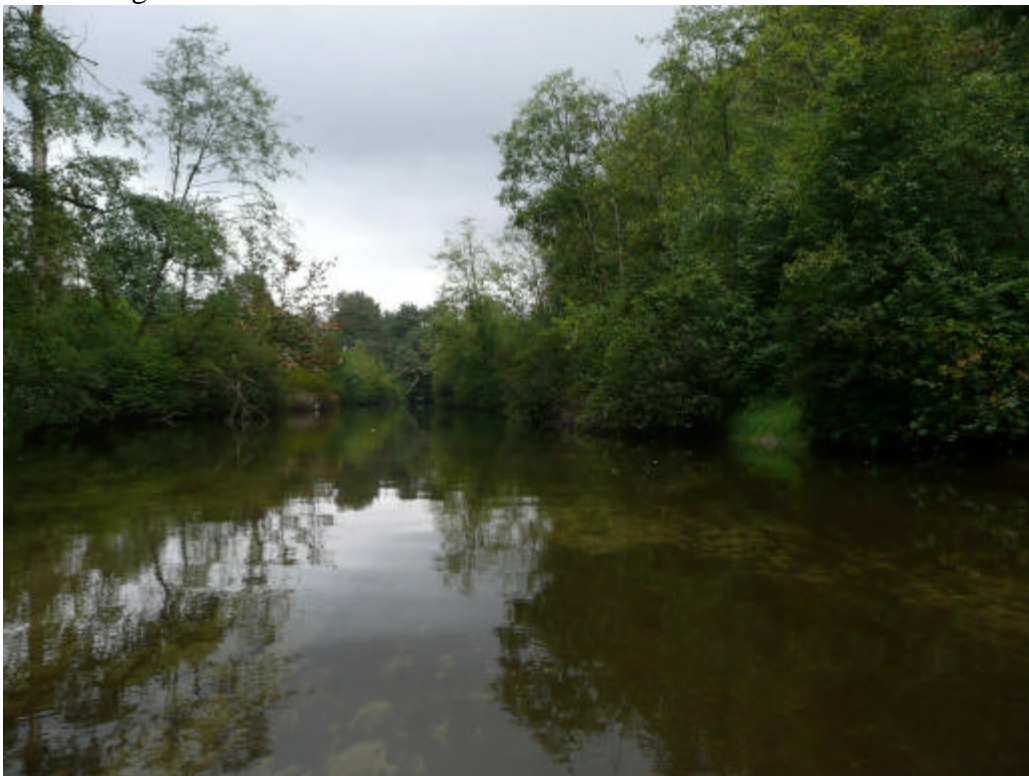
Figure 8: The slow moving run habitat characteristic of much of Reach D.

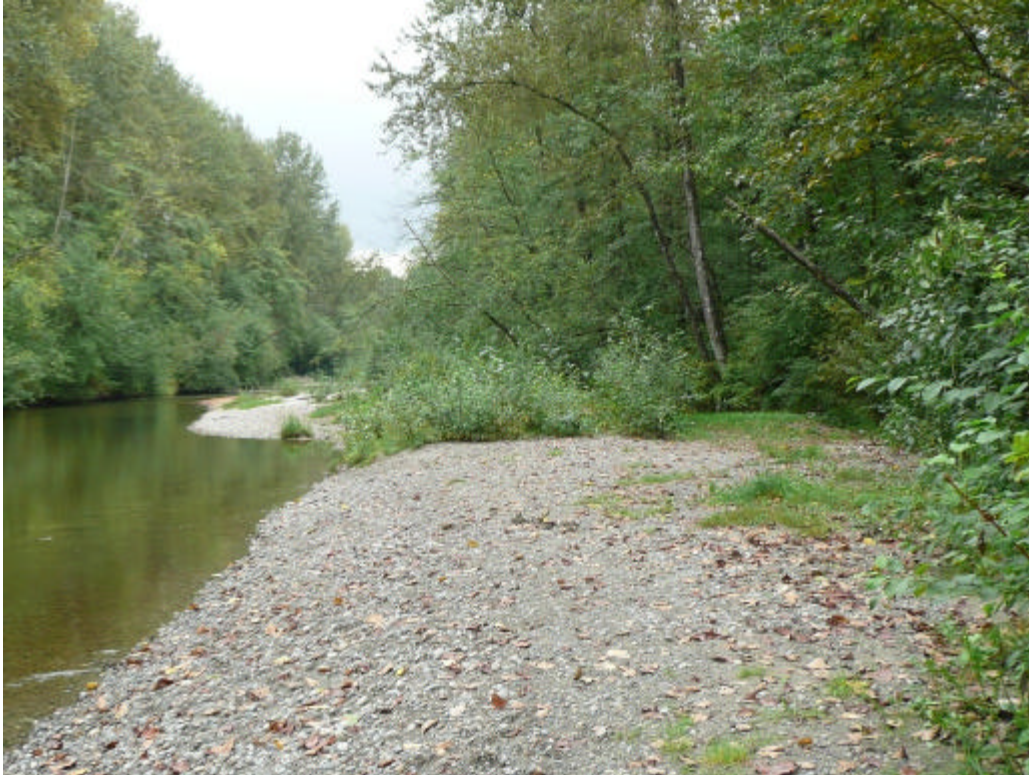
Figure 9: gravel bar typical of Reach E: note the vegetation colonizing the bar and the continued lack of instream complexity.

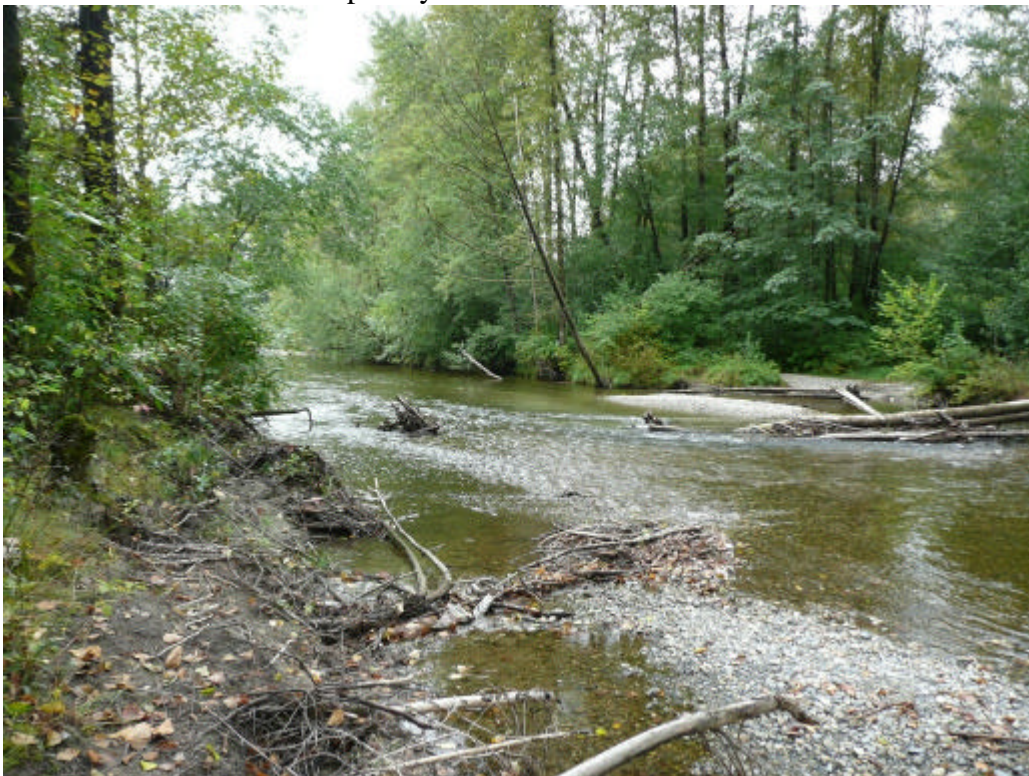
Figure 10: Reach E at approximately river kilometre 6.3. Note the instream wood, the most seen at any location.
