## 2012 Fish Passage Assessments in BCTS Kootenay Business Area (PD13TFE006)

Prepared By:  
**VAST Resource Solutions Inc.**  
4500 Mennie Road  
CRANBROOK, BC  
V1C 4J1

Prepared For:  
**Ministry of Forests, Lands and Natural Resource Operations**  
Kootenay Business Area, BC Timber Sales Office  
1907 Ridgewood Road  
Nelson, BC, V1L 6K1

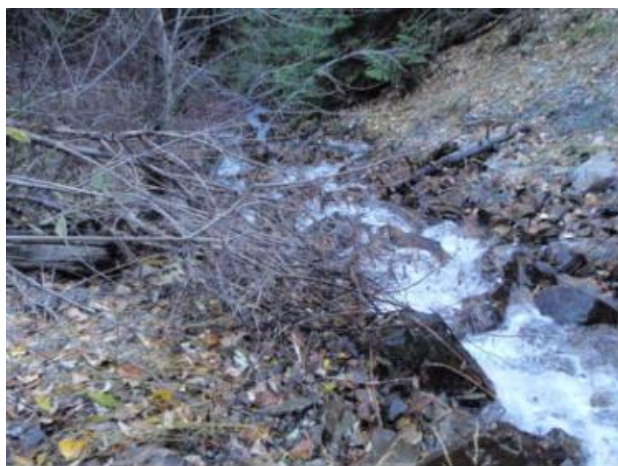
Priority Sites\_BLOO045\_Barrel

- BLOO045  
The Crossing is located on an unnamed tributary to Bloom Creek. It consists of an arch culvert and a round culvert, which are perched at the outlets and not properly embedded. There are records of mature BT captured throughout the Bloom Creek watershed, including in the tributary where the crossing is located. The creek has deep pools, good spawning substrate, and likely provide spawning habitat to Koocanusa BT population. WCT also occur throughout the watershed. The confirmed habitat gained upstream of the crossing is 6.3 km. The replacement of the current structure with a bridge crossing 7 m long is recommended.

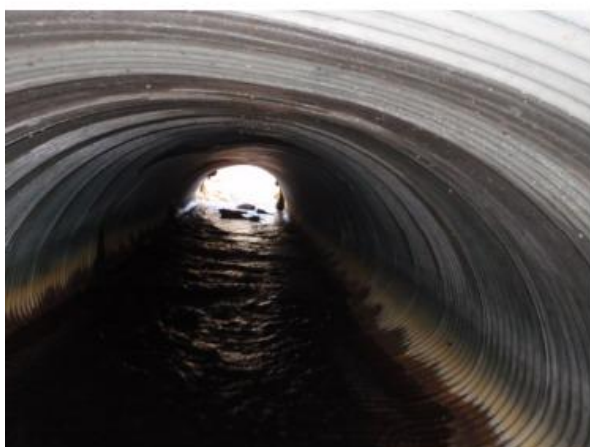
Priority Sites\_SAND011\_Downstream

- SAND011 and SAND012  
These crossings are located on Little Sand Creek along Baynes Lake Road. Both crossings consist of large round culverts, which are not properly embedded, creating velocity barriers. Sand Creek and Little Sand Creek are known spawning streams for Kookanusa Bull Trout and Kokanee populations. Westslope Cutthroat Trout also occur throughout the watershed. Approximately 40Km of fish habitat is available upstream of these crossings. The replacement of the current culverts by a bridge or an arch structure is recommended. The minimum recommended span of the replacement structures for SAND011 and SAND012 is 10 m and 12 m respectively.

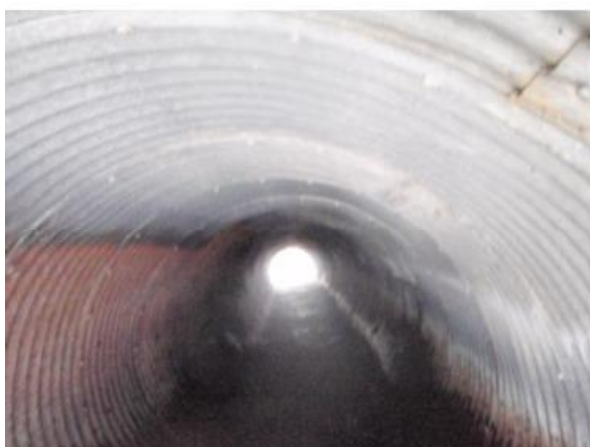
Priority Sites\_MWHT055\_Downstream

- MWHT055  
The crossing is located on Kotsats Creek, a tributary to the middle branch of the White River. BT records exist for this stream, which likely provide spawning habitat for the species. The crossing consists of a perched round culvert which is not properly embedded, creating a velocity barrier. The site was already identified as a priority crossing for restoration in 2000 (Naito, 2001). The creek provides good to fair spawning substrate and high quality rearing habitat. The potential habitat gain upstream of the culvert is 16.8 km. The replacement of the current crossing by a low profile open bottom arch structure (diameter ~5m) is recommended.

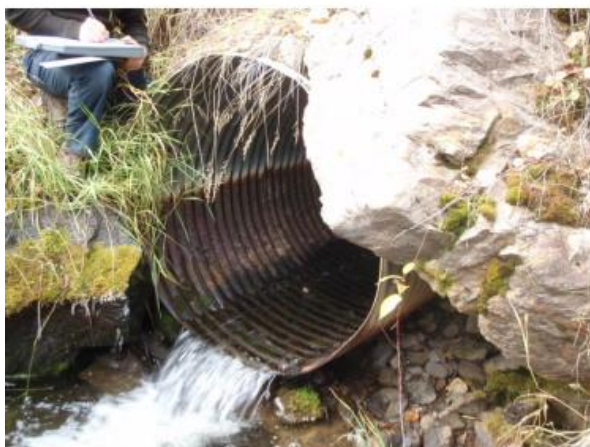
Priority Sites\_MICH016\_Upstream

- MICH016  
The crossing is located on Fir Creek, a tributary to Michel Creek, and consists of a round culvert with a perched outlet. The stream has good to fair rearing habitat with deep pools and provides some spawning opportunity. WCT and Eastern Brook Trout (EB) have been recorded in the creek and BT is known to occur throughout the Michell Creek Watershed. The potential habitat gain upstream of the crossing is 14.9 km. Replacement of the current structure with a bridge is recommended. Based on the measured stream width, the span of the replacement structure should be at least 7 m.

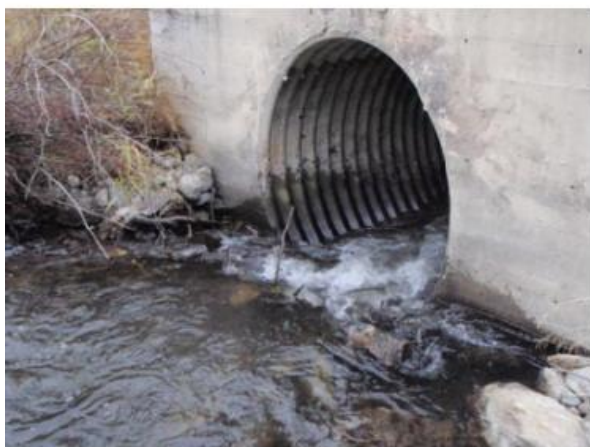
Priority Sites\_JOSP007\_Outlet

- JOSP001, JOSP002, JOSP004, JOSP005, JOSP006, JOSP007  
These 6 crossings are located on the lower reaches of Joseph Creek near the confluence with the St Mary River. The structures are not properly embedded, creating velocity barriers to juvenile fish. These crossing were selected due to the recorded presence of two listed fish species in the stream (BT and WCT) and the large potential upstream habitat gain. However, it should be noted that Joseph Creek flows through the town of Cranbrook, likely resulting in a deterioration of instream habitat. Some barriers may exist within the city limits that have not been assessed during this study. Further study is needed. Nevertheless, restoration of fish passage within the Joseph Creek watershed is highly beneficial to the stream's fish community. Replacement of existing closed bottom structures by open bottom structures, such as low profile arches, is recommended.

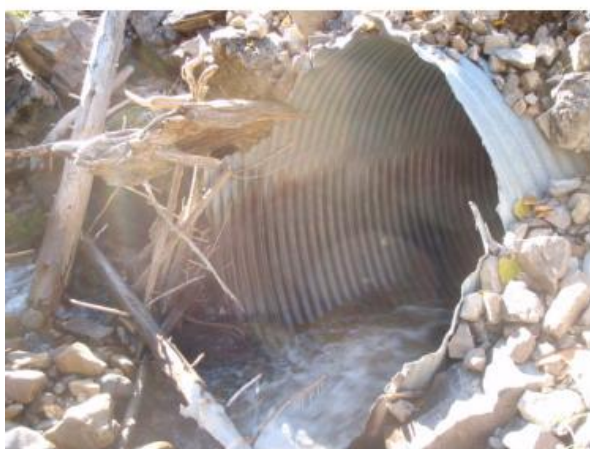
Priority Sites\_GRAV009\_Outlet

- GRAV009  
The crossing is located on Grave Creek, a tributary to the Fording River. The large culvert is perched creating an impassable barrier to all species and life stages. The creek has deep pools, suitable spawning substrate, and good rearing habitat. Both WCT and BT have been recorded in the watershed. Approximately 7.9 km of fish habitat has been confirmed upstream of the crossing. Replacement with an open bottom arch structure with a diameter of 8 m is recommended.

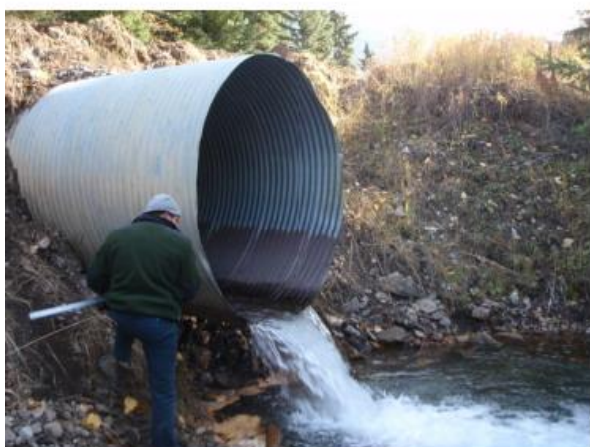
Priority Sites\_GRAV004\_Upstream

- GRAV004  
The crossing is located on an unnamed tributary to Grave Creek. The round culvert is perched creating an impassable barrier. Both BT and WCT have been recorded in the watershed. The creek offers good spawning substrate and rearing habitat. Approximately 11.2 km of fish habitat has been confirmed upstream of the crossing. Replacement by an open bottom structure with a 8 m span/diameter is recommended.

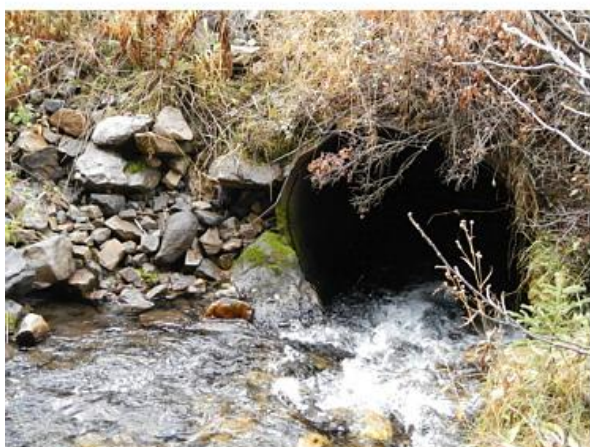
Priority Sites\_GRAC022\_Outlet

- GRAC011, GRAC015, GRAC010, GRAC022  
These four crossings are located on the Grace Creek mainstem, a tributary to the Fording River. All sites consist of single and double round culverts with perched outlets, creating a series of impassable barriers on the creek. The creek has deep pools and good spawning substrate. WCT have been recorded in the lower reaches of the creek. BT also occur on the Fording River below Christina Falls and are likely to use Grace Creek for spawning and/or rearing. The Grace Creek road is in poor condition and seems to receive limited use. Removal of the crossings structure may be an option if the road is to be deactivated. Otherwise, the current culverts should be replaced by open bottom structures. Potential HGI on Grace Creek is 13.2 km.

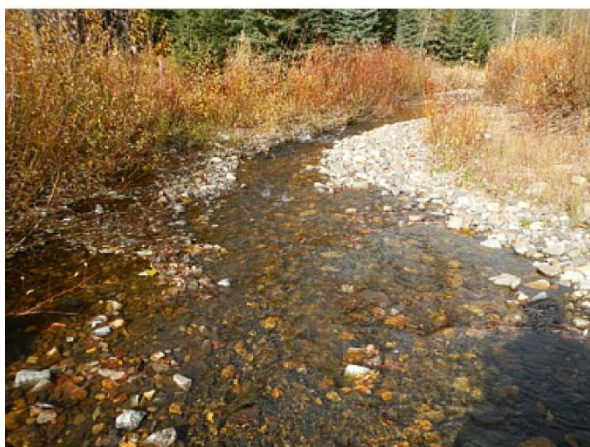
Priority Sites\_FORD213\_Inlet

- FORD079, FORD213  
These two consecutive crossings are located at the confluence of Dry Creek and the Fording River under the Fording Highway and the CPR railway. They both consist of large diameter double culverts, which are not properly embedded, creating velocity barriers to juvenile fish. Dry Creek has high habitat value with up to 26.2 km potentially available to fish. Although restoration costs at these locations will be high, the replacement of these culverts by open bottom structures is recommended. Alternatively, additional substrate material could be added to the current structure to improve fish passage.

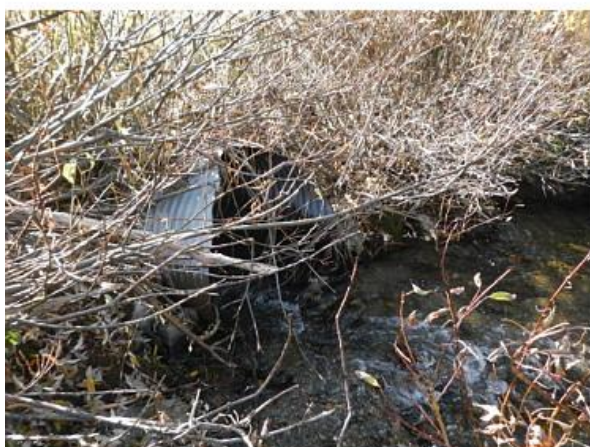
Priority Sites\_EWIN008\_Outlet

- EWIN008  
The crossing is located on Todhunter Creek, a major tributary to Ewin Creek. The culvert outlet is perched, creating an impassable barrier. The creek has deep pools, suitable spawning substrate, and good rearing habitat. WCT occurs throughout the watershed. Up to 23.6 km of fish habitat may be available upstream of the crossing but a fisheries investigation is required to confirm the true extent of upstream habitat. Replacement of the current structure with a 5 m diameter low profile arch is recommended at this site.

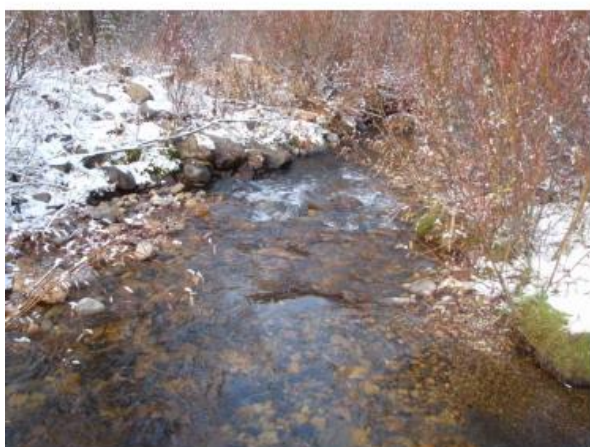
Priority Sites\_ELKR044\_Inlet

- ELKR044  
The crossing is located on Weary Creek, a tributary to the Elk River. It consists of two round culverts that are not properly embedded, resulting in a velocity barrier. Both BT and WCT have been recorded in the watershed. The creek has deep pools and suitable spawning substrate. Approximately 5.8 km of fish habitat is available upstream of the crossing. Replacement by an open bottom arch structure is recommended at this site. Based on the measure stream width, the replacement structure should be at least 7 m in diameter.

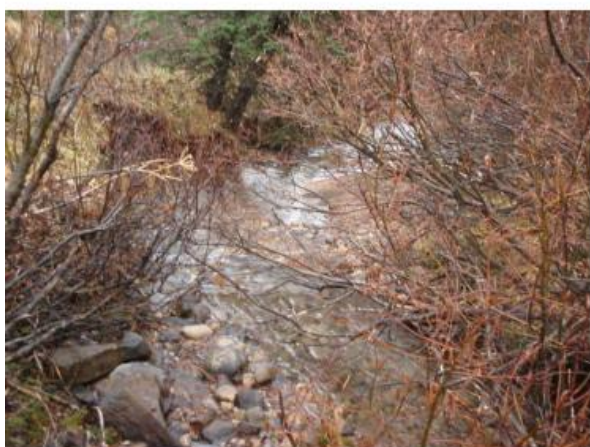
Priority Sites\_ELKR000\_Inlet

- ELKR000  
The crossing is located on Tobermory Creek, a tributary to the Elk River. The large culvert is perched creating an impassable barrier to all species and life stages. The creek has suitable spawning substrate and good rearing habitat for salmonids. Up to 17.3 km of inferred fish habitat may be available upstream. Both WCT and BT have been recorded in the watershed. The replacement of the current culvert by a bridge structure with a minimum span of 7 m is recommended.

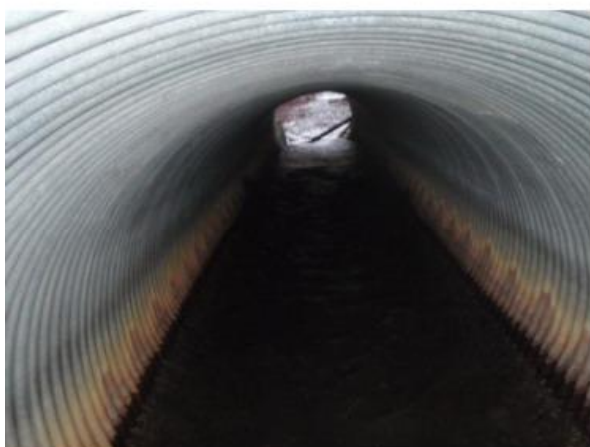
Priority Sites\_CAVE418\_Downstream

- CAVE 418  
The round culvert is located on Caven Creek and is not properly embedded, creating a velocity barrier. Two blue-listed fish species, WCT and BT, have been recorded in the watershed. Approximately 47.3 km of fish habitat is available upstream of this crossing. Replacement of the current structure by a bridge crossing with a span at least 8 m long is recommended.

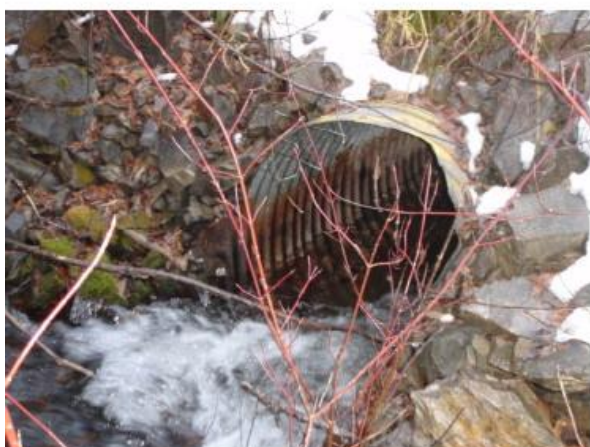
Priority Sites\_BLOO334\_Outlet

- BLOO334  
The crossing is located on Bloom Creek, a major tributary to Caven Creek. It consists of a round culvert with a perched outlet resulting in an impassable barrier. Spawning BT have been recorded in the stream and WCT occur throughout the watershed. Approximately 14.7 km of fish habitat is available upstream of the crossing. Replacement by a 7 m bridge is recommended.

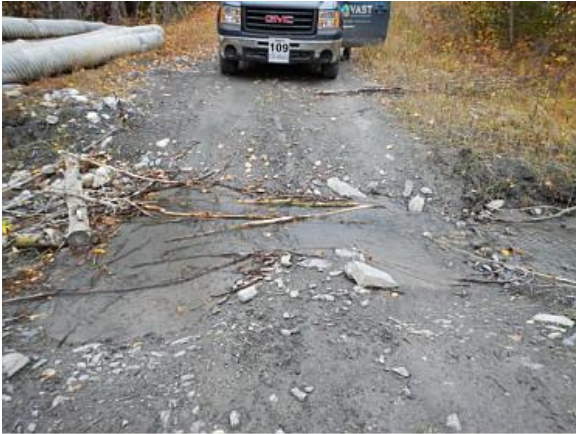
Cochrane Creek Road Damage 02

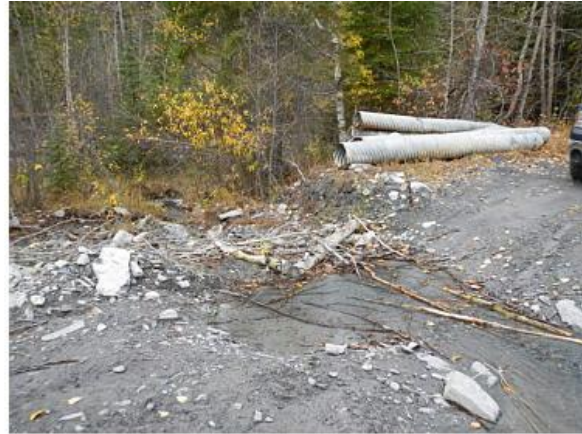
Cochrane Creek Road Damage 01

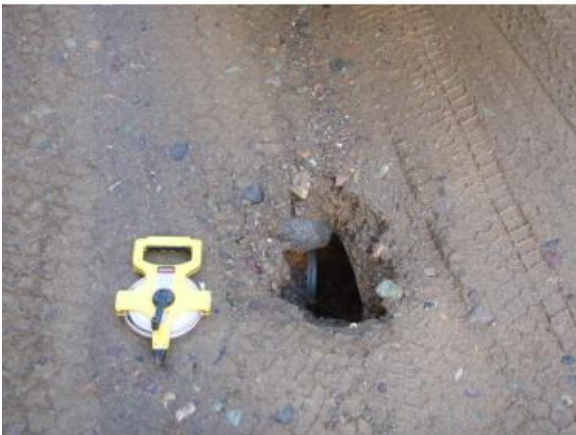
Bull River Road\_culvert damage at BULL017

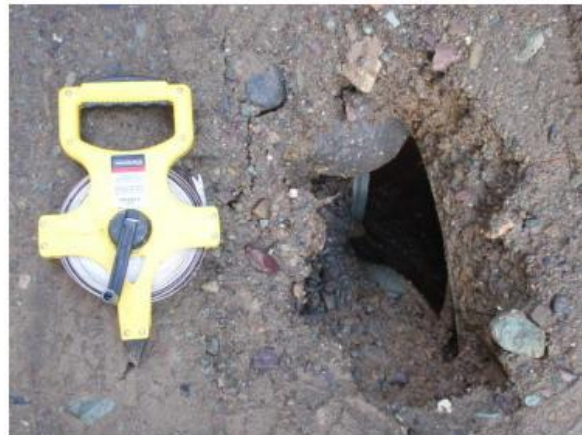
Bull River Road\_collapsed culvert damage at BULL017

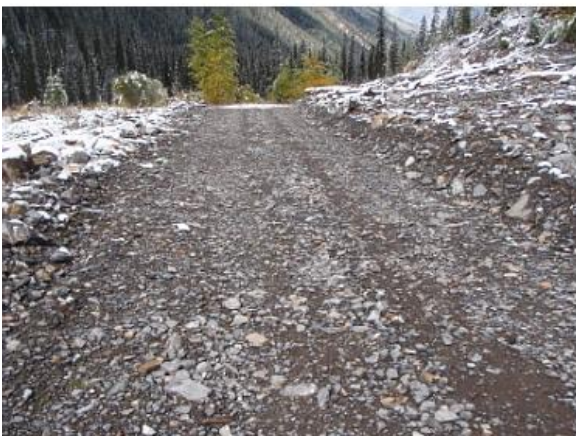
The Blackfoot FSR was in good condition. The road was re-surfaced one year ago. A car has been pushed over the downhill side of the road near the 27 km marker.

Blackfoot Creek Road Damage

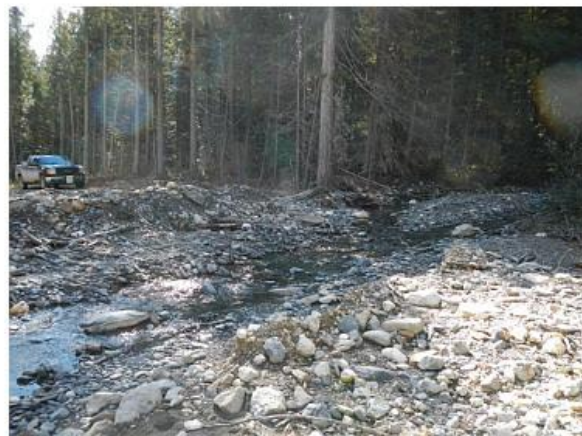
The Albert FSR had a number of culverts that were recently displaced by torrents during the spring freshet. At the 56 km marker, a large failure has made the road impassable by trucks. The other failures occurred beyond this point.

Albert River Road Damage01

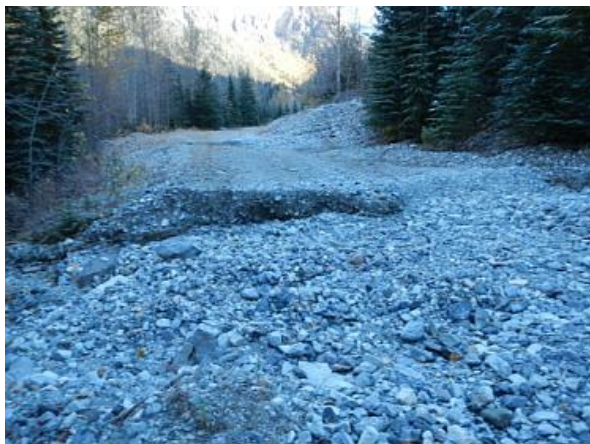
Albert River road damage 02

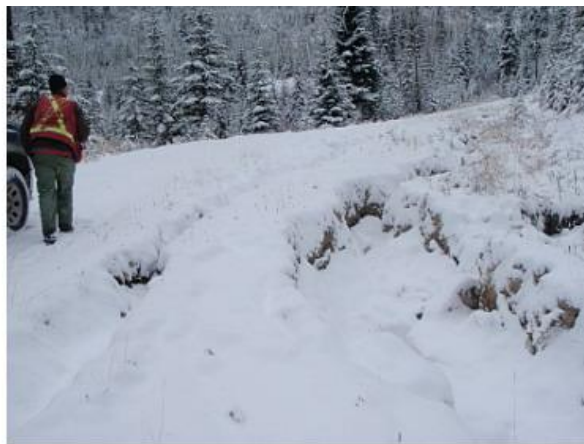
Thunder Creek FSR is in good condition. The material in the road surfacing contains a large amount of gypsum which makes the road very muddy when it rains. It is recommended that more gravel be added to the surface of the road.

Thunder Creek road erosion near THUN 020

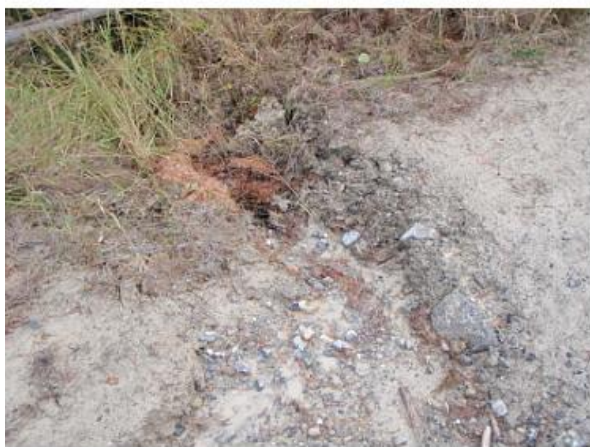
Thunder Creek Road damage near THUN203

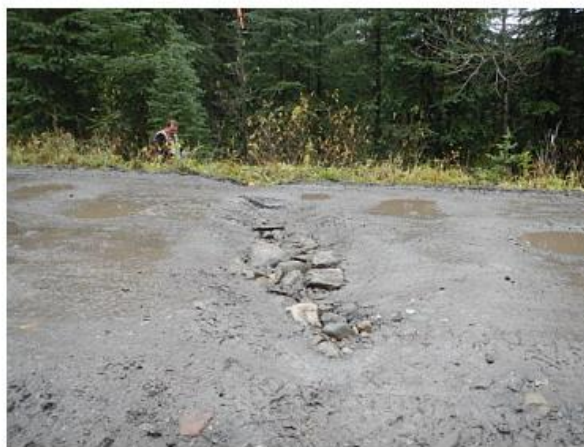
Teepee Creek Road Damage

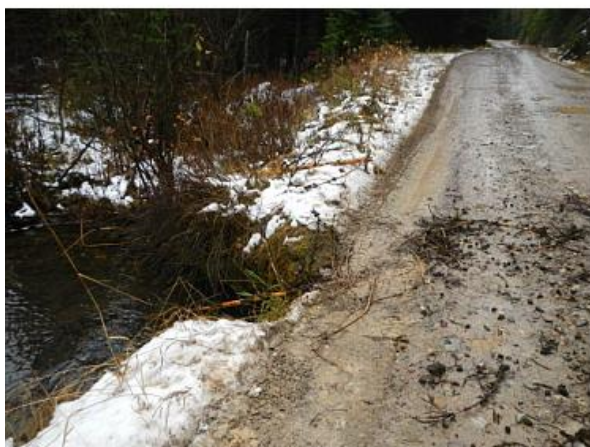
Teepee Creek Road damage near TEEP612

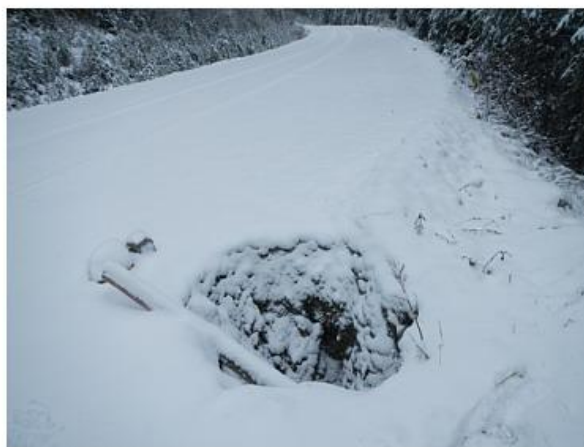
Schofield Creek Road Damage

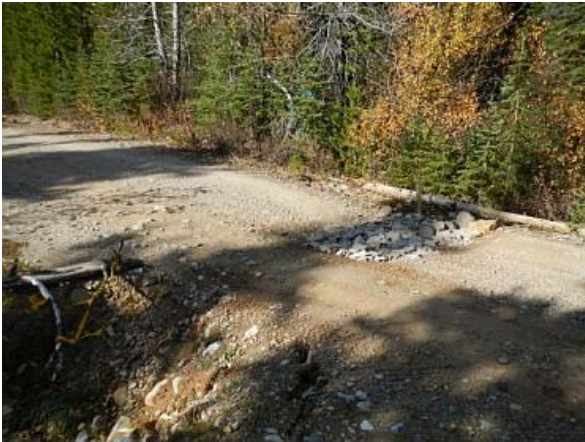
Flathead FSR. Both of these roads have been de-activated. Mclatchie FSR also intersects with Flathead FSR. This road is in poor condition and should be re-surfaced and brushed out.

Flathead River McLatchie Road Damage

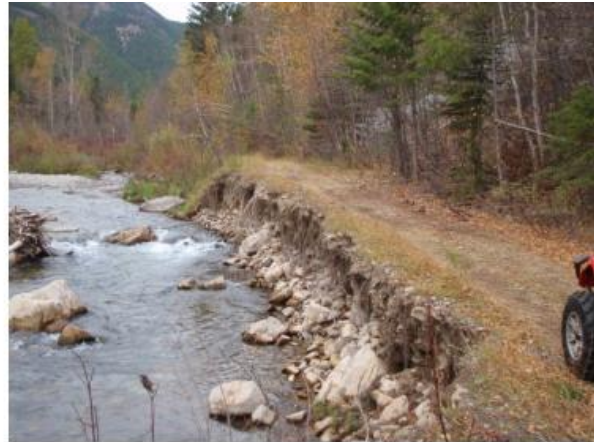
Cummings Creek FSR is extremely degraded. Many makeshift ATV bridges have been constructed. It is recommended that the road be de-activated.

Cummings Creek Road Damage 02

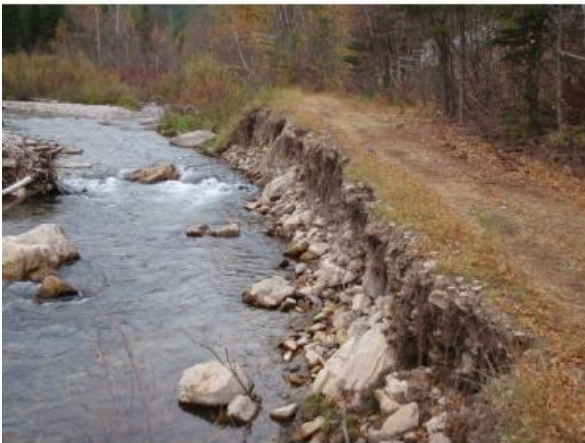
Cummings Creek Road Damage 01

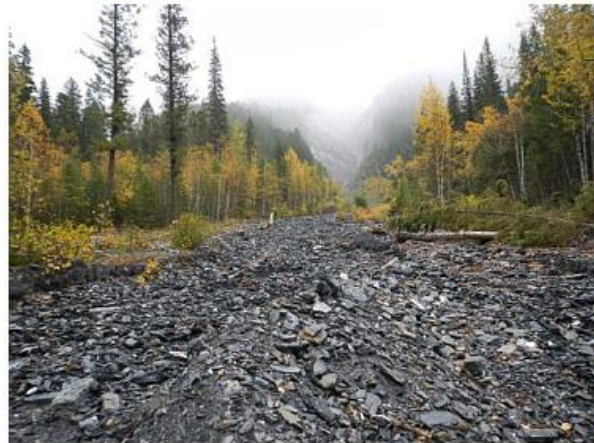
Cochrane Creek Road Damage 05

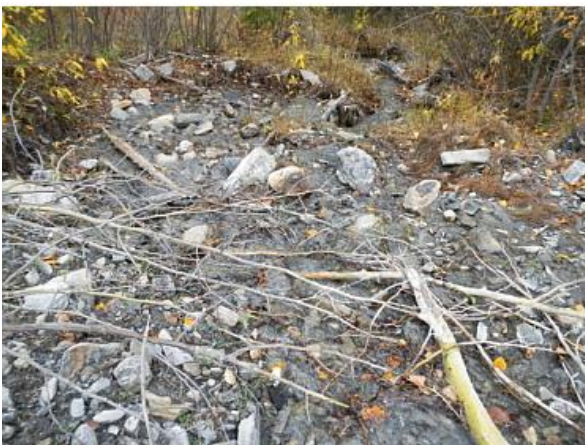
Cochrane Creek Road Damage 04

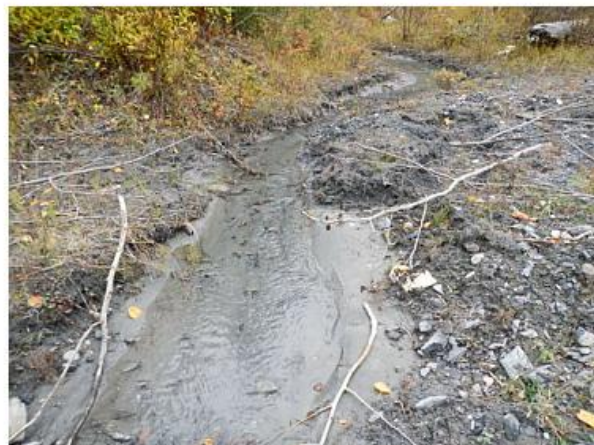
Cochrane Creek Road Damage 03
