MEMORANDUM

SUBJECT W.A. Webster complaint re gravel pit development by
Department of Highways on Metchosin Road at Farhill
Road, Metchosin

TO ACCOMPANY REPORT ON
**GRAVEL PIT DEVELOPMENT
METCHOSIN**

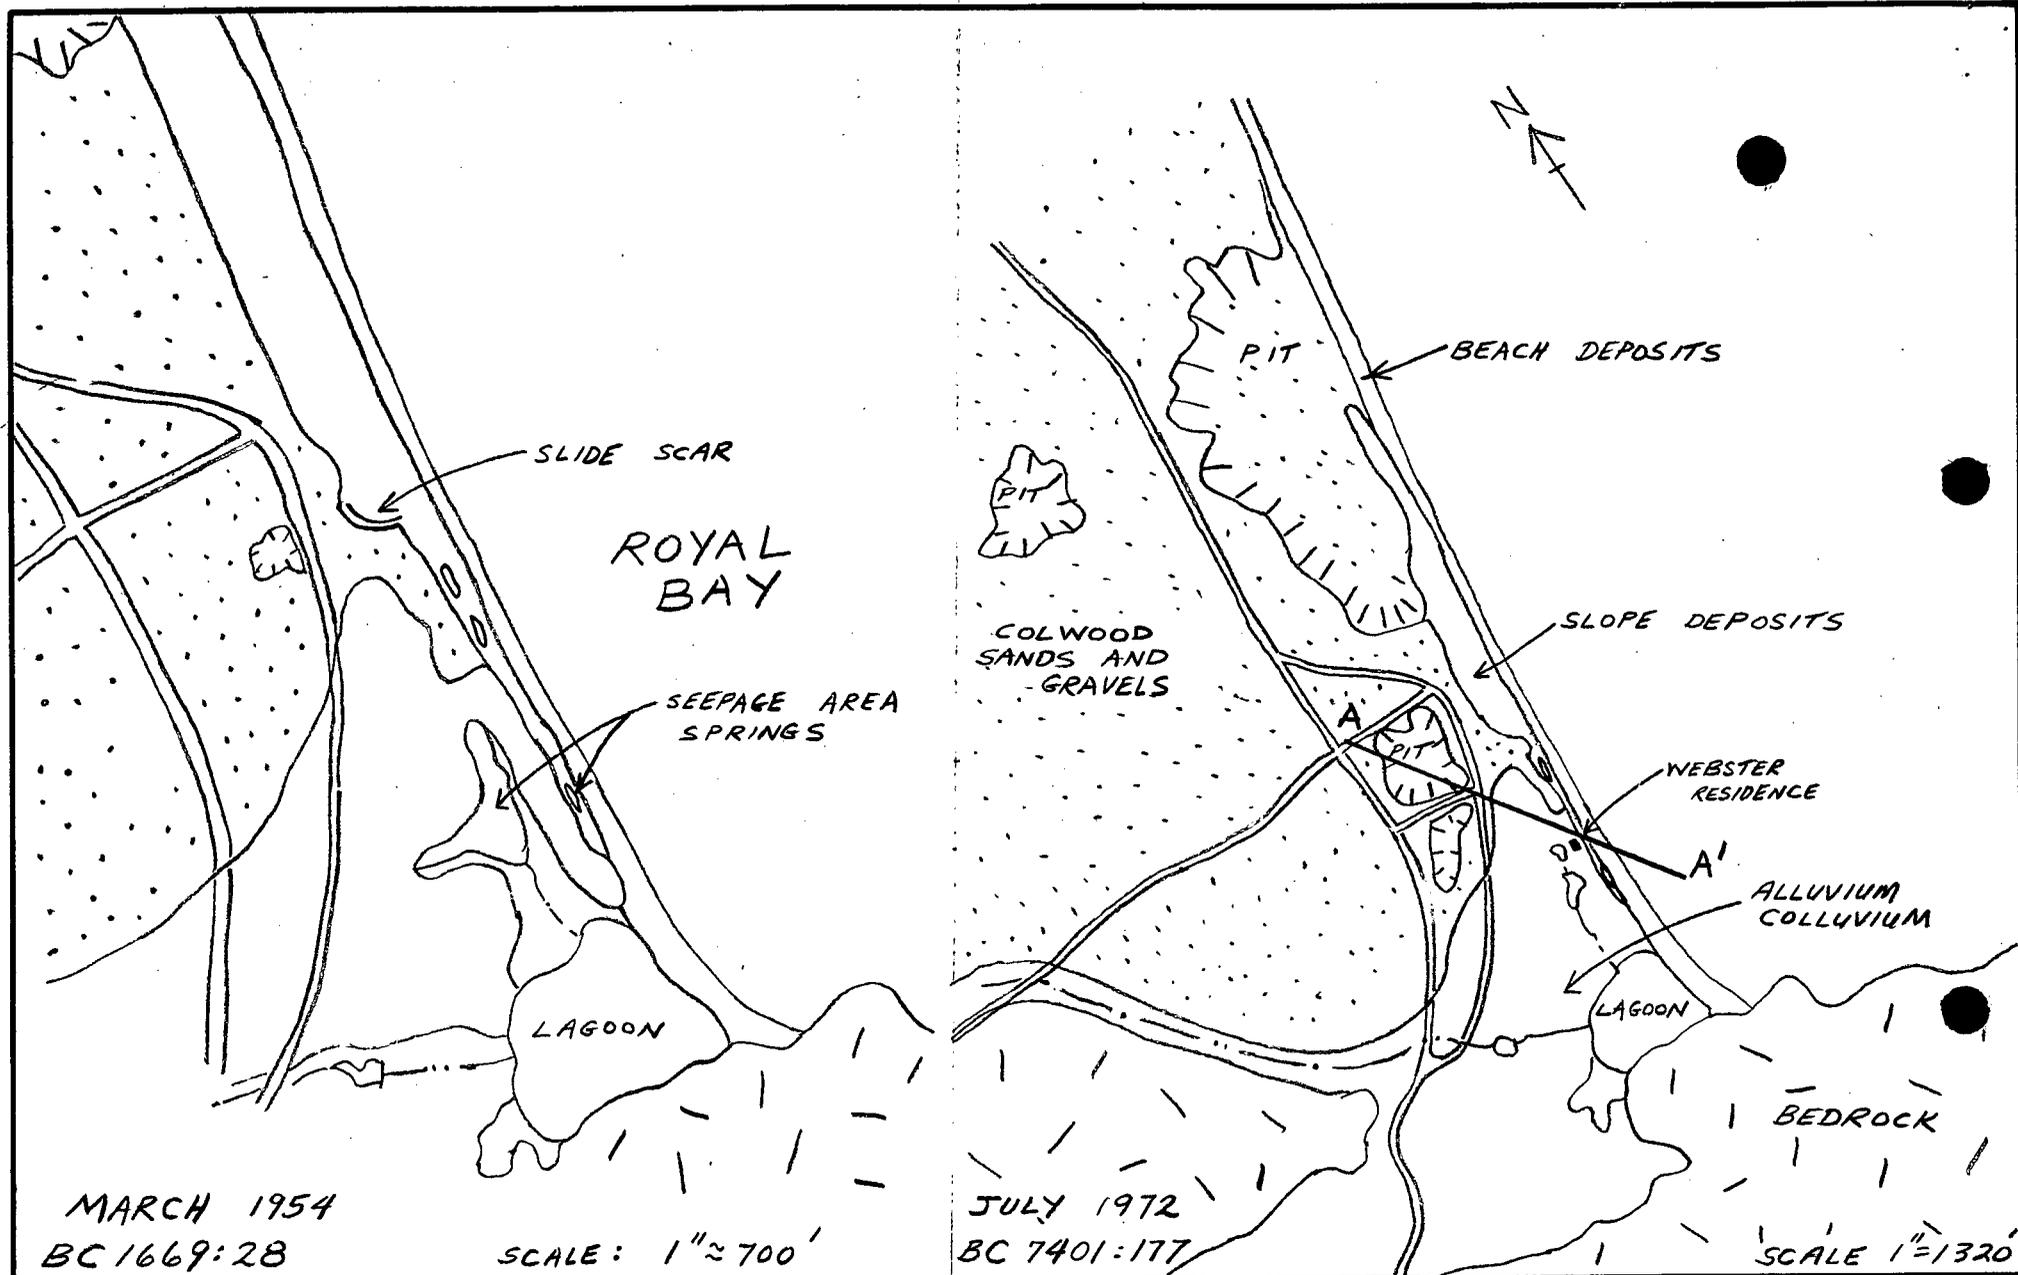
FILE No. 0239013 DWG. No. FIGURE 1

Springs and seepage zones occur at the contact between the sands of unit 2 and underlying stony clay along the sea cliff and also within low areas on the dissected slopes adjacent to the lagoon south of the Webster property (Figure 1). A major spring occurs within a shallow gully on the Burr property south of the Webster residence with the major portion of the spring heading from the toe of the rising upland towards the west. The local wet area on the Webster property appears to be part of the same groundwater discharge area as the Burr spring but being at a slightly higher elevation is not completely inundated. However, fluctuations of the water table and moisture changes in the zone above the water table may be expected to be more pronounced on the Webster property.

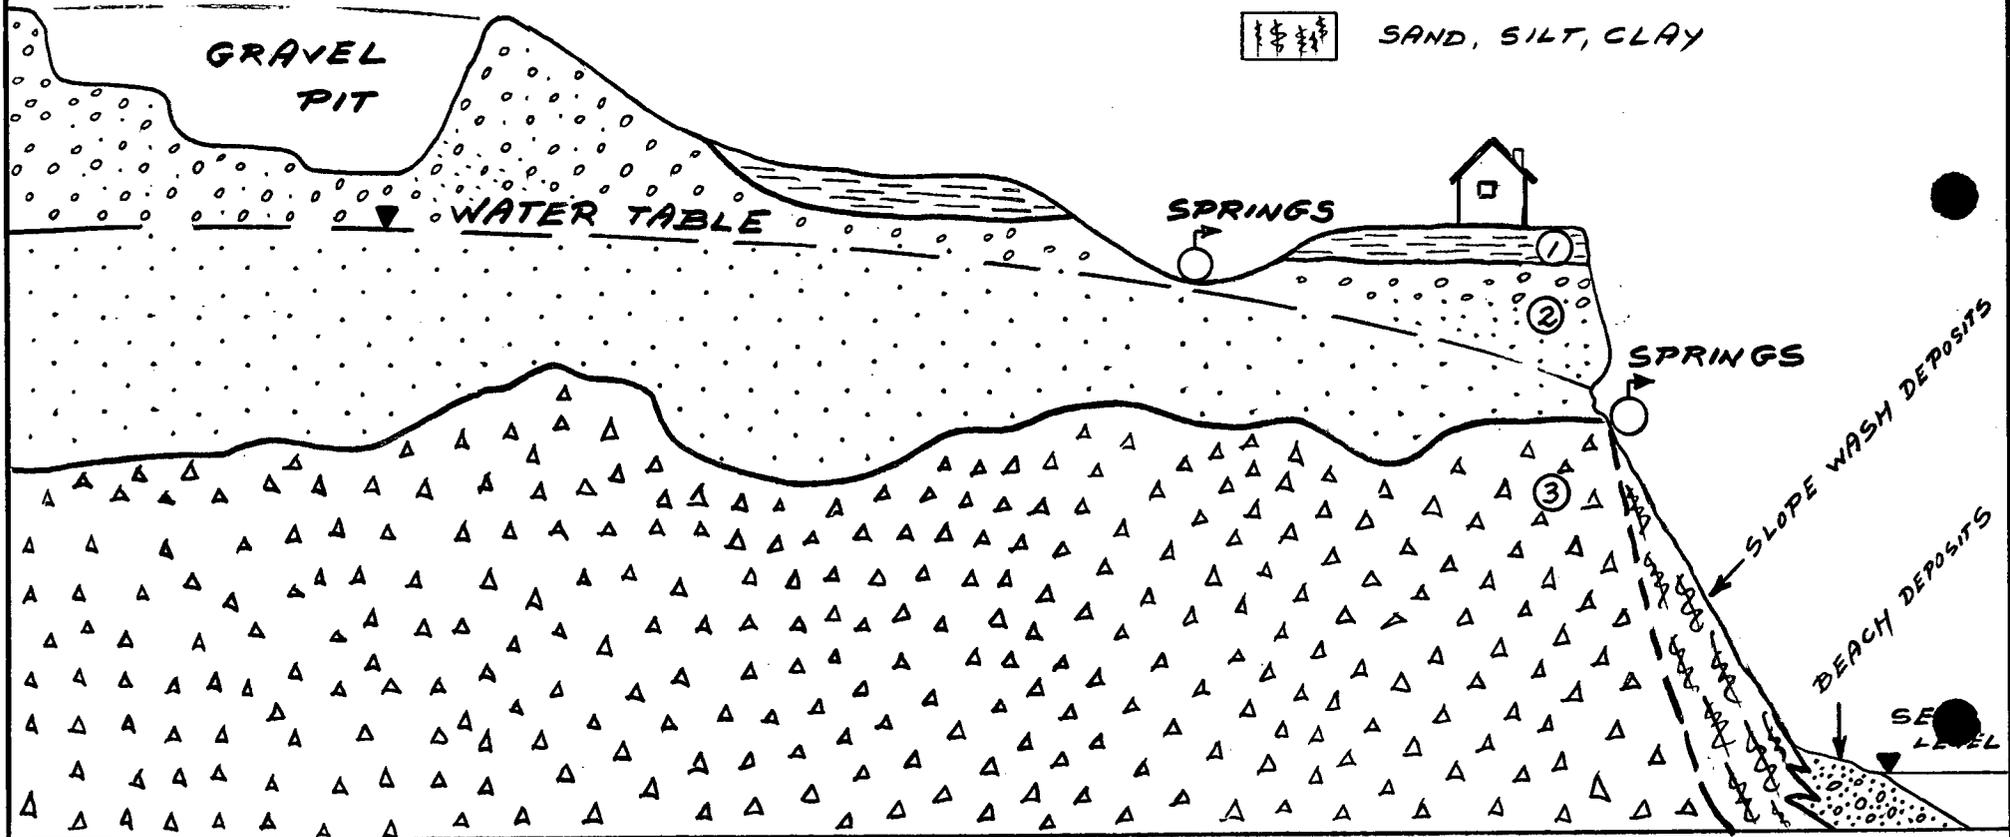
FILE No. 0239013 DWG. No. FIGURE 2

Prior to commenting on the validity of Mr. Webster's contentions a brief discussion of the geology and natural groundwater conditions of the area is warranted. The gravel pits west and north of the Webster property occur within the Colwood plain which represents an extensive glacial deposit (raised delta) of coarse sands and gravels (Figure 1). Towards the southeast the plain terminates abruptly along a steep seaward facing cliff up to 240 feet in height (Clapp, 1913). The deposit named the "Colwood sands and gravels" by Clapp (1913) represents a deltaic-fluvial sequence deposited during wasting of the last major ice sheet that covered the area. The sands and gravels are well stratified with a large part of the deposit comprised of delta fore-set beds dipping 15 to 25 degrees towards the southeast (Clapp, 1913). Examination of the sea cliff at various sites near the Webster property reveals the following general succession of deposits from the top of the bank to sea level (Figure 2). The complete section however is not always present along the sea bank.

- Unit 1. 10 feet of brown buff, blocky clayey till with pebbles and boulders
- Unit 2. 40⁺ feet of sand and gravel (Colwood sands and gravels) grading downwards to fine hard silty sand
- Unit 3. 60⁺ feet of very hard gray stony clay with sand lenses.

GEOLOGICAL CROSS SECTION A A' LOOKING NORTHEAST

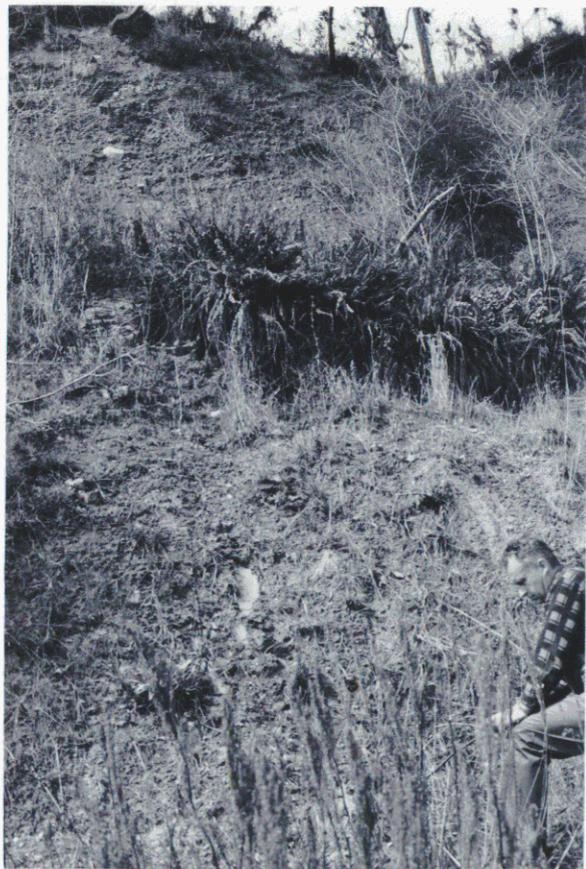
GLACIAL TILL ON BANK
WITH COVERED SECTION
BELOW WEBSTER PROPERTY.

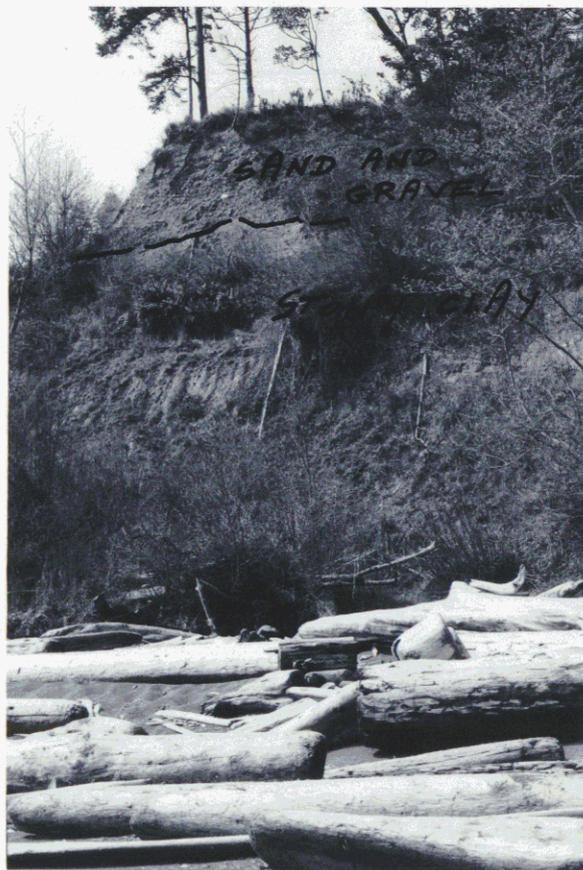
COLWOOD SAND AND GRAVEL
OVERLYING STONY CLAY
BURR PROPERTY.

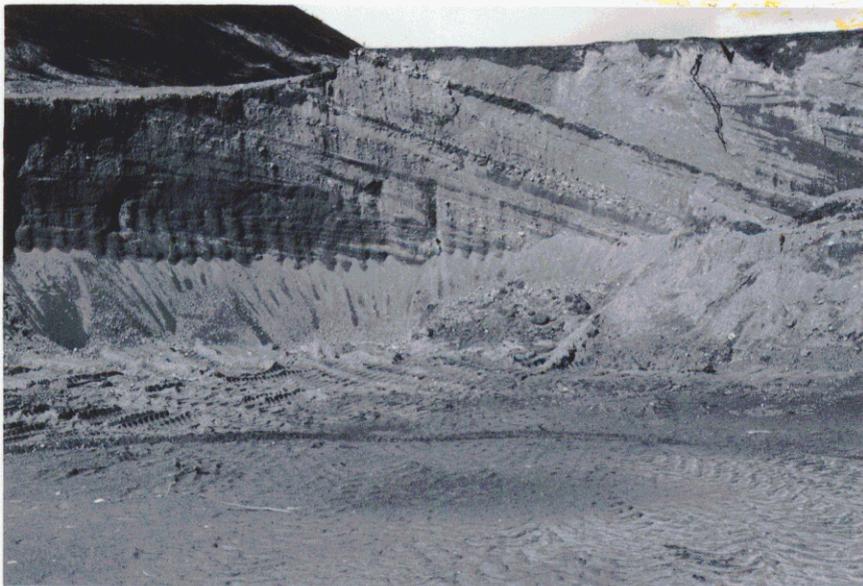
Geologic conditions in the area indicate that probably shallow groundwater movement is directed through the Colwood sands and gravels from the northwest to the southeast. In addition, stratification of the deposits with dips toward the southeast favour a preferred groundwater movement in this direction. It would seem probable therefore that rainfall falling within the pits upslope of the Webster property may contribute to discharge flow of the springs downslope. Considering the relative size of the pits in relationship to the area downslope being approximately equal, any mounding of the water table beneath the pits may result in higher water table conditions downslope. Other factors however could give rise to higher water table conditions on the Webster property. These include:

HIGHWAYS GRAVEL
PIT. COLWOOD SANDS
AND GRAVEL. NOTE
DIP OF SANDS AND
GRAVEL TO S.E.

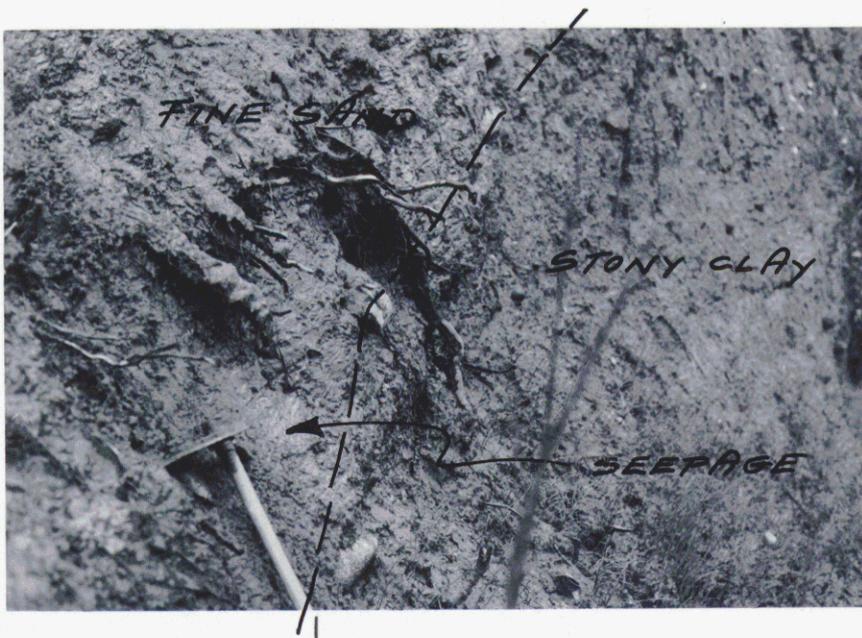
Discharge from the springs located on the sea bank tends to remove much of the fine sand from which the springs originate thereby undermining the cliff. Once undermining proceeds, support of the overlying materials is reduced facilitating large sections of the cliff to slump and slough out to sea. Aerial photographs taken in 1954 (Figure 1) prior to excavation of the Highways pit indicate this type of condition has existed in the past. From these photographs it would appear that this erosion is advancing southeasterly along the bank. (see slide scar, Figure 1). Where erosion has taken place in the past it appears that the bank is relatively stable at these locations possibly because the slide material has covered former discharge areas.

FINE SAND
OVERLYING HARD
STONY CLAY.
NOTE SEEPAGE
FROM SAND AT
CONTACT.

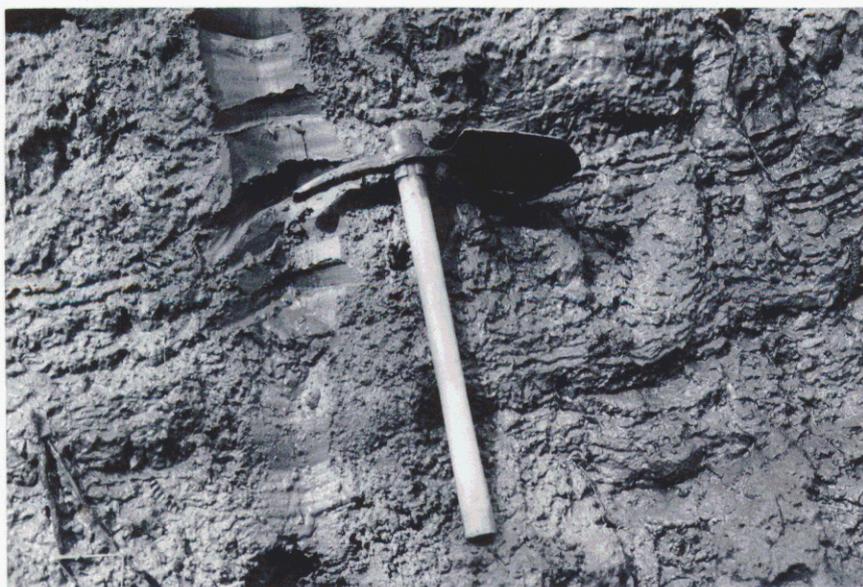
SEEPAGE FROM
FINE SAND.
