# Crawford Creek Hydrogeomorphic Investigation and Identification of Habitat Restoration Opportunities

Apex File HA-15-PL-01

Prepared For: Fish and Wildlife Compensation Program

24-Dec-2015

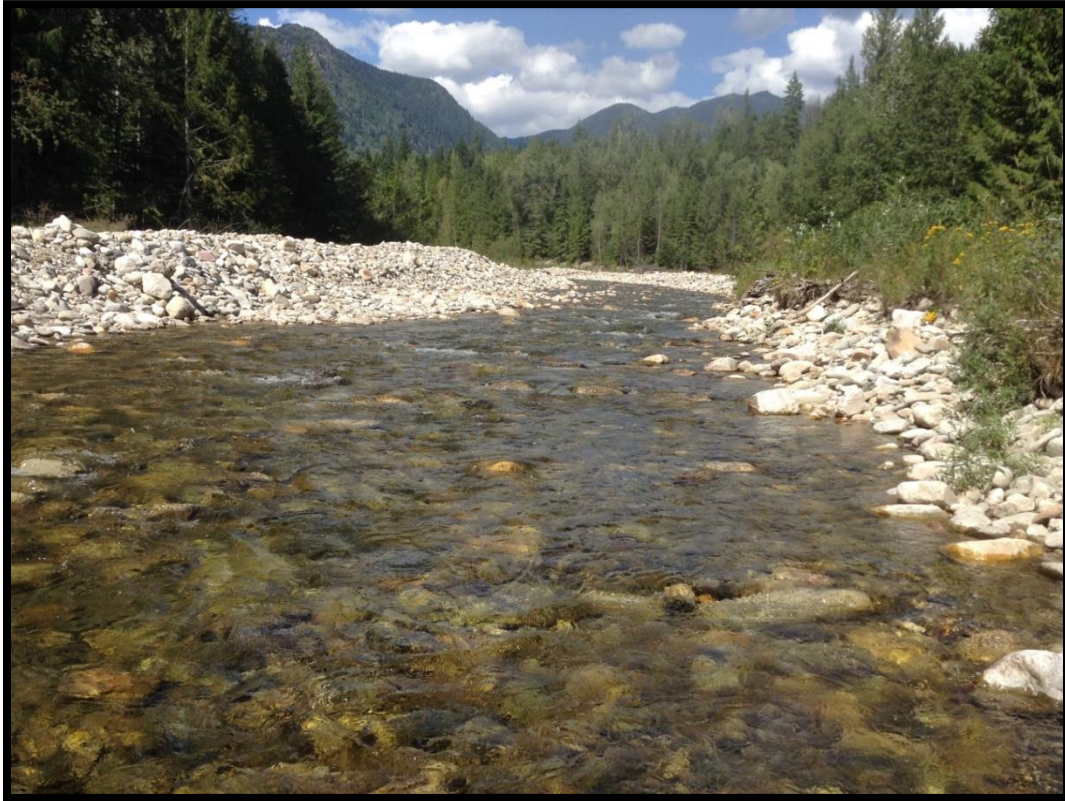
*Looking upstream at top end of constructed flood protection berm (2012) on Crawford Creek*

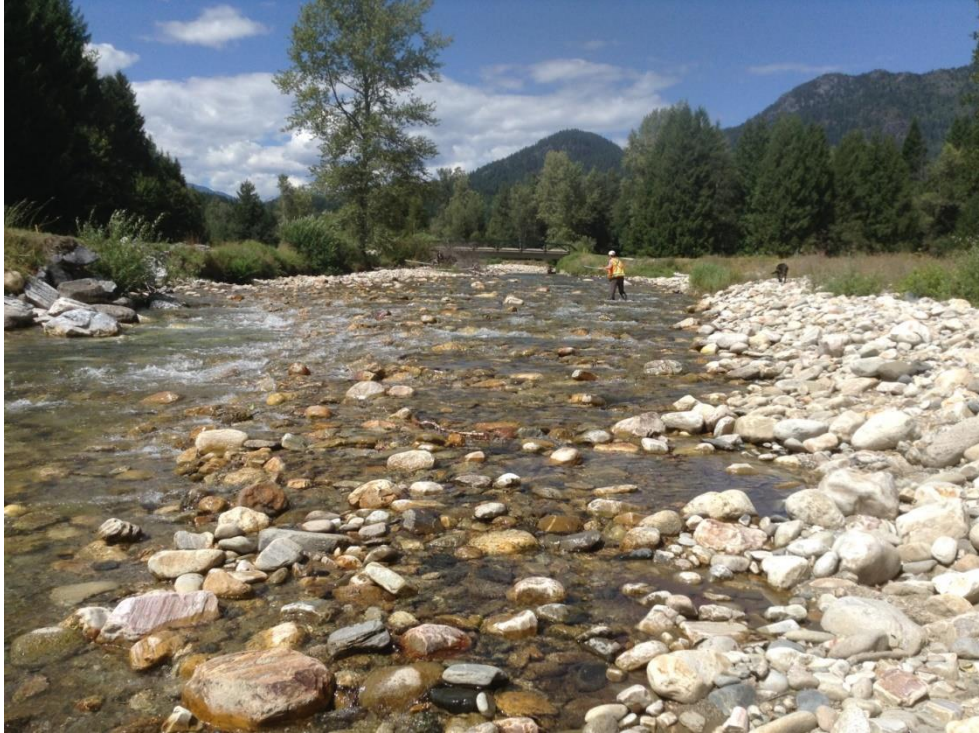
Site CR-01 includes a 100 meter channel length downstream from the golf course bridge and above the Highway 3A bridge. The channel of Crawford Creek at site CR-01 has a riffle-pool morphology with limited development of pools. Channel gradient ranges from 0.5% through the pools to 2.5% across the riffles. Riffles are comprised of cobbles and small boulders. Recent flooding has resulted in the deposit/scour of a large mid-channel cobble bar. Channel banks are eroded and vertical resulting in an increased susceptibility to erosion during seasonal flooding. Where the mature riparian trees remain along the stream bank, channel banks are less disturbed and in places the banks are overhanging and the roots of the trees have protected the banks from extensive erosion.

Photo 1. Looking upstream in at the riffle-pool channel at site CR-01. Bank on right (looking upstream) is extensively eroded. Lack of coniferous vegetation is the result of clearing for the golf course.

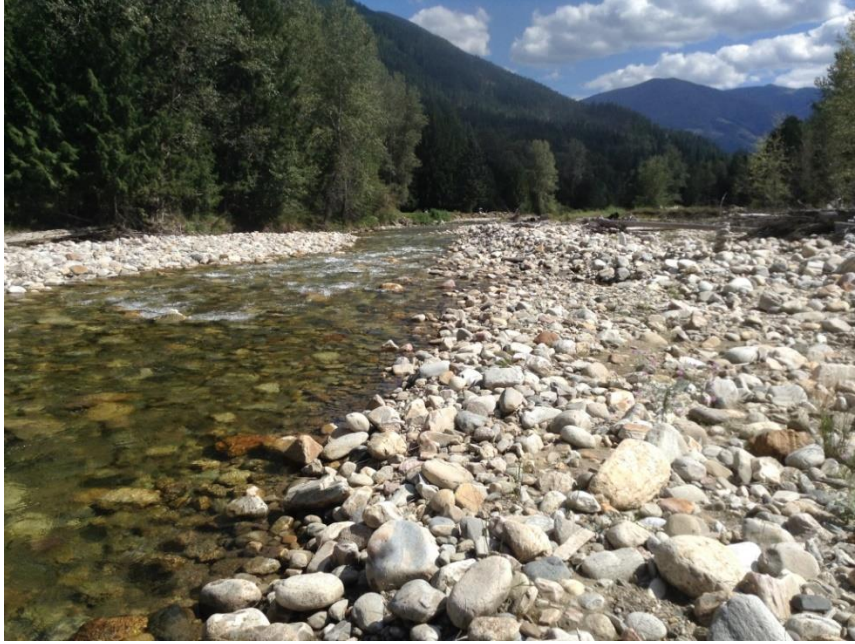
Site CR-02 is located at the bottom end of the wide, disturbed section of channel below the golf course gravel pit. Above this point the channel consists of multiple branches around bright cobble/boulder deposits. At the survey location the channel is contained in a single thread but the right bank and flood plain (looking downstream) have been eroded and scoured of vegetation. The left bank is also eroded but not as extensively where a few mature riparian trees are preserved. The channel appears to have a high degree of lateral and vertical instability through this section due to the presence of cobble and boulder bars and eroded stream banks.

The channel displays a plane-bed to step-pool morphology although the development of pools is limited. The channel gradient through this section ranges from 0.4% in the pools to 4% in the steeper step sections. Upstream from this site for at least 200 meters there is a complete lack mature riparian vegetation. Accumulations of large woody debris are deposited on the tops of the cobble bars and along the channel margins.

Photo 2. Looking downstream at site CR-02. Channel has a step-pool to plane-bed morphology. Lateral cobble bar on left bank (looking downstream) and scour of the right bank and flood-plain is the result of the 2012 and 2013 floods.

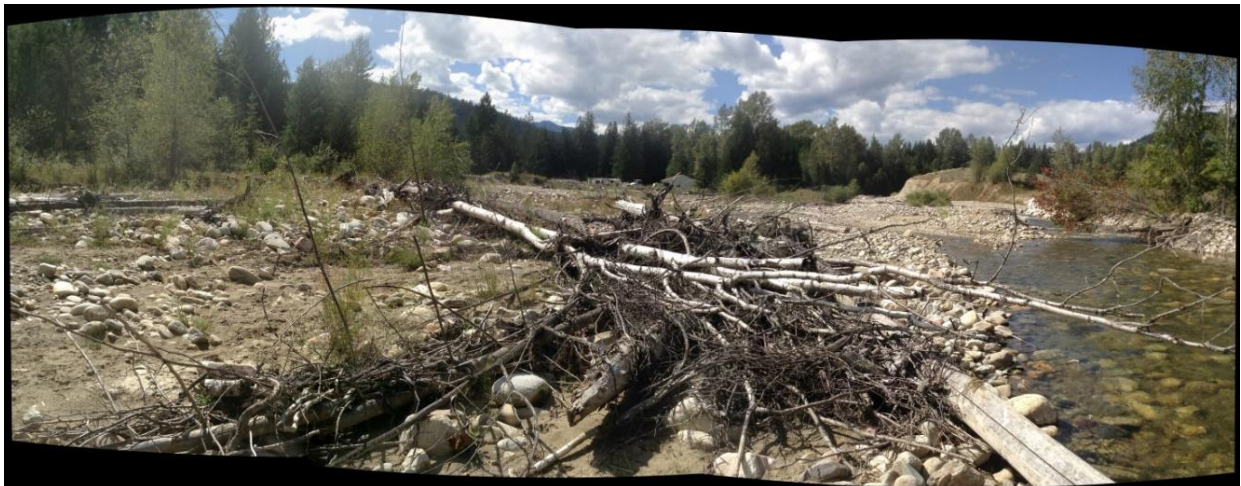
Photo 3. Panorama looking upstream at site 2. Recent flooding has deposited LWD along channel margins and on cobble/boulder bars. Floodplain on left (looking upstream) has been scoured of vegetation.

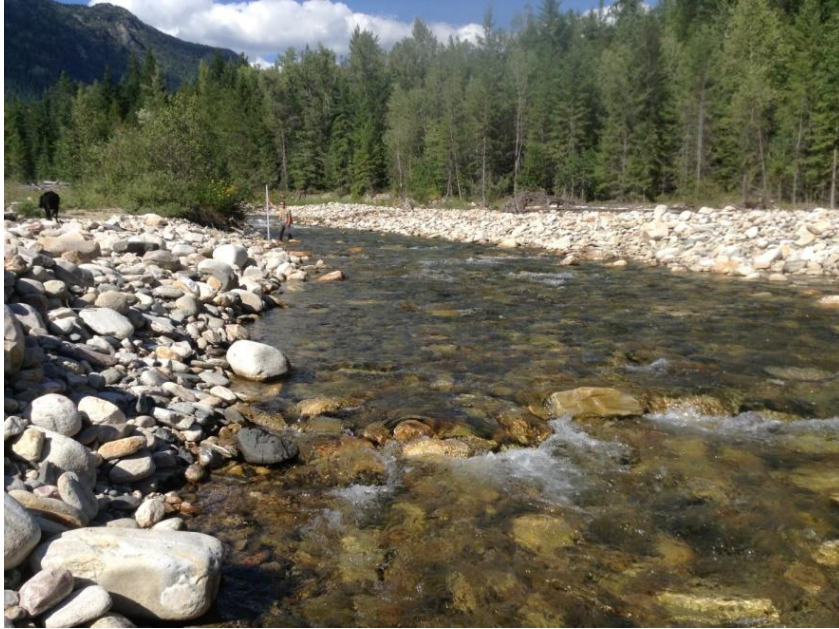
Site CR-04 is situated immediately upstream of the end of the constructed berm. At this site the channel has a stepped-morphology with limited pool development and channel gradient ranges from 1% through the pools to 3.5% through the step segments. The channel is confined by or has become eroded into (incised) an existing cobble/boulder deposit that is over a meter in height along the left bank (looking upstream). A recently deposited cobble/boulder levee is present along the right bank (looking upstream).

Photo 4. Looking upstream at site 4. Channel has a step-pool morphology. Cobble/boulder deposits along both banks cause the channel to be narrower and deeper through this section.

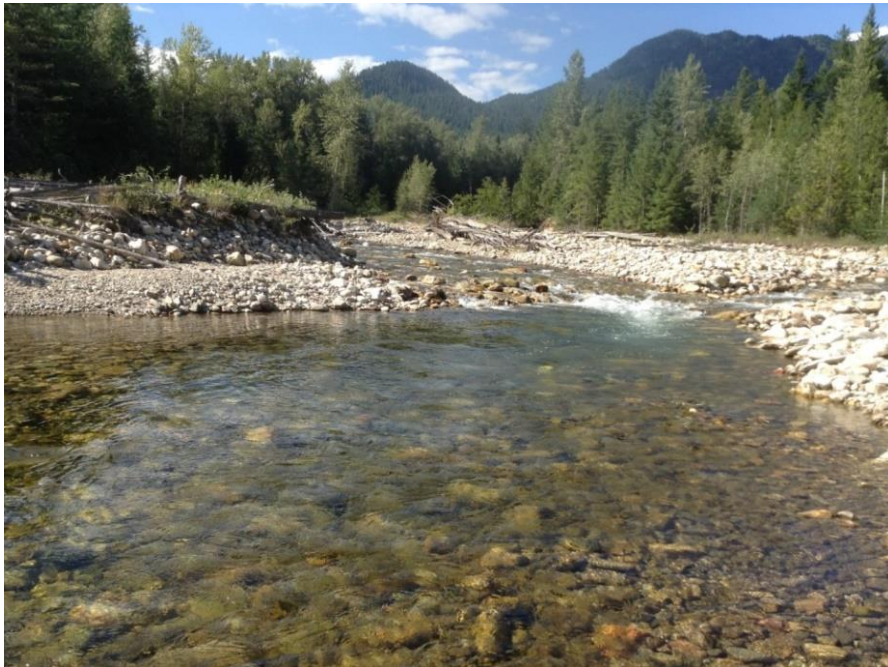
An investigation of the forested floodplain on the east side (right side looking upstream) of the channel shows evidence of a large cobble/boulder flood deposit from roughly 50 to 70 years ago that is approximately half a meter above the current (2012/2013) flood stage. The vegetation on this flood deposit consists of juvenile conifers up to about 20 cm diameter at the butt as well as alder and cottonwood. The location of this deposit is identified as CR-05 on Figure 2.

Photo 5. Looking upstream just above Site CR-04. The channel here appears to have eroded down into an older cobble/boulder deposit that is evident in this photo along the left bank (looking upstream).

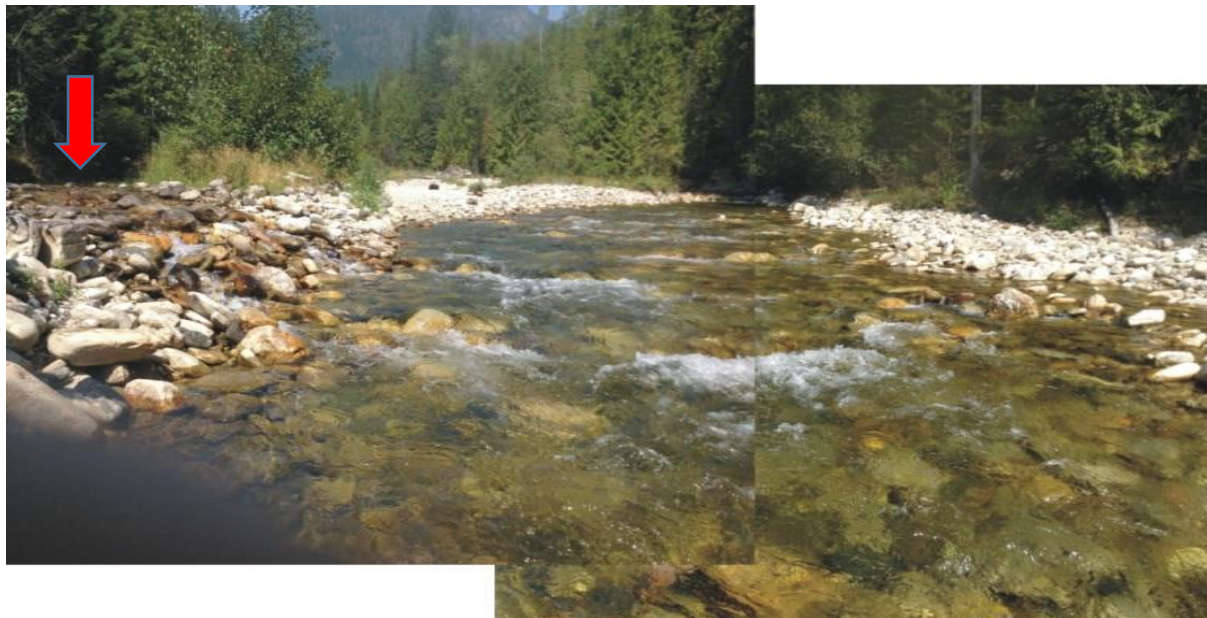
This site is located at the bottom end of the old spawning channel. The confluence of the spawning channel is elevated roughly 1.2 meters above the current elevation of the bed of Crawford Creek which indicates that Crawford Creek has become degraded through this section compared to 30 years ago when the spawning channel was constructed.

The channel at site CR-06 has a step-pool morphology with limited occurrence of pools. Channel gradient ranges from about 1.7% to 3% over the surveyed section. Channel banks are eroded and have been scoured of vegetation in the recent floods. The channel is locally confined by bedrock along the right bank (looking upstream).

Riparian vegetation consists of juvenile coniferous and deciduous trees. Cobble bars and portions of the floodplain have recently been scoured of vegetation. There is a large woody debris jam (mega jam) 50 meters downstream from site CR-06

Photo 6. Looking upstream at site 6 at downstream end of spawning channel (red arrow on left). Channel has a step-pool morphology. Channel of Crawford Creek has degraded over a meter since the spawning channel was constructed in the 1980's.

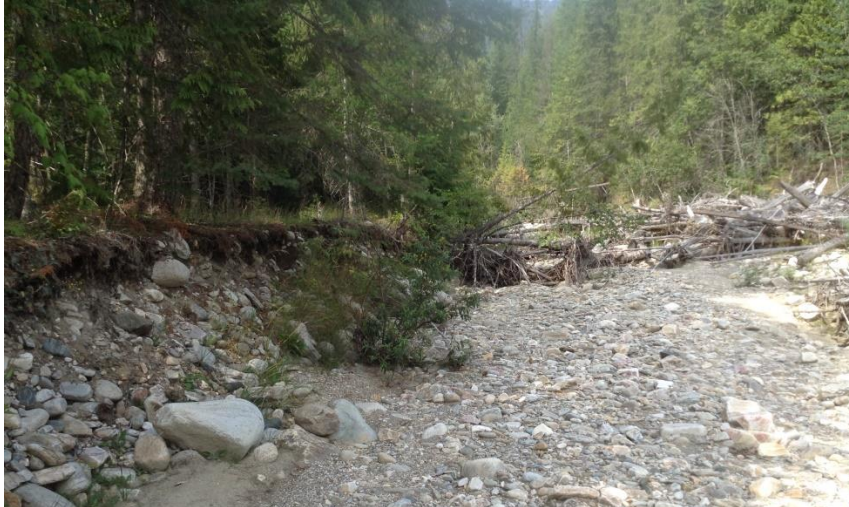
The recent floods have eroded the outer portion of the original berm that protects the spawning channel from overbank floods in Crawford Creek. Flood deposits similar in age to those noted east of site CR-04 are also present along the eastern side of Crawford Creek in this location.

Photo 7. Looking upstream beside upper portion of spawning channel above site CR-06. The recent floods have eroded the bank/berm that separates the spawning channel from overbank floods in Crawford Creek.

The old spawning channel west of Sites 7 and 6 has become de-coupled from the channel of Crawford Creek as a result of degradation of the Crawford stream bed. In addition the 2012/2013 floods have eroded the berm separating the spawning channel from Crawford Creek. Restoring this spawning channel for immediate use will require excavation and re-grading of the outlet of the spawning channel to bring it down to the current elevation of Crawford Creek. The central portion of the spawning channel where the

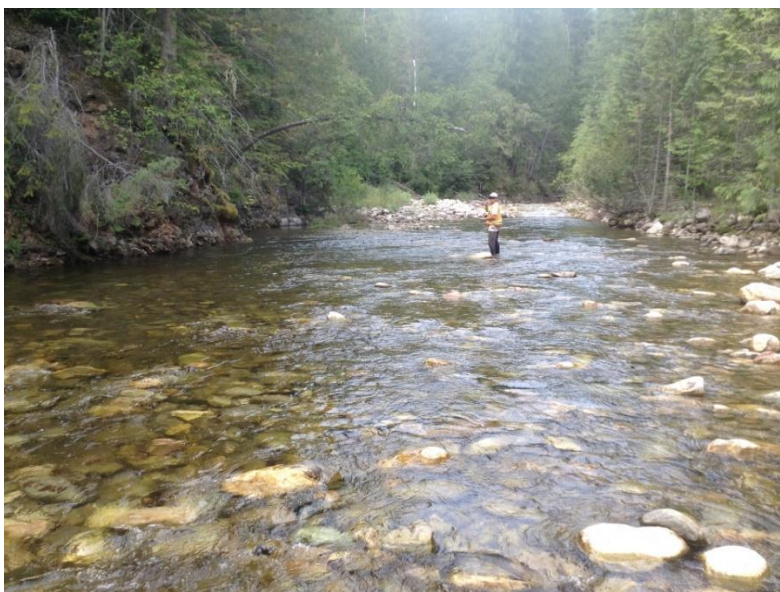
Photo 8. Looking upstream at site CR-07.

The uppermost detailed survey site is located just upstream from the entrance to the old spawning channel. The channel through this reach has a plane-bed to riffle-pool morphology although development of pools is limited to isolated locations along the bedrock cliffs. The channel is confined on the left bank (looking upstream) by bedrock cliffs. Channel gradient is 3% and the bed material is relatively finer cobbles compared to site CR-06. The right channel bank (looking upstream) is eroded and vertical.

Riparian vegetation consists of juvenile conifers and alder. Approximately 50 to 70 year flood deposits including cobbles, boulders, and woody debris including an old bridge timber are deposited along the eastern side of Crawford Creek. The riparian stand appears to date to this old flood event.

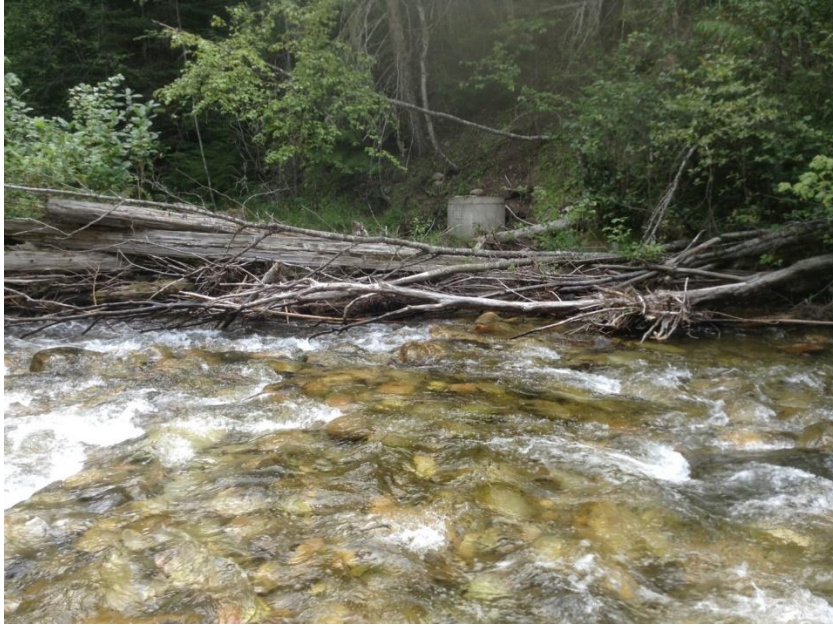
Photo 9. Just below site CR-07. Woody debris from recent flood has blocked Inlet of spawning channel.

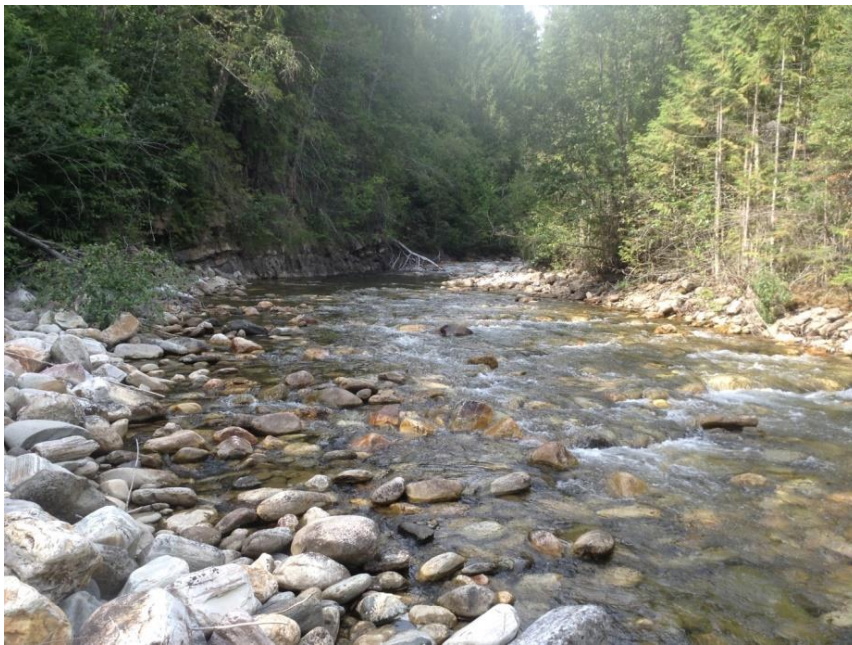
Photo 10. Looking upstream into the canyon beyond site 8

Site CR-08 was not a full survey site location. Photographs taken here, looking upstream, show the downstream end of the bedrock canyon. The boulder bar deposited here reveals the high velocity of the flow at this point. Boulders are imbricated indicating that they have been transported and deposited by the flowing water. Photo 10 also shows the scour along both sides of the channel associated with the recent large flood events.

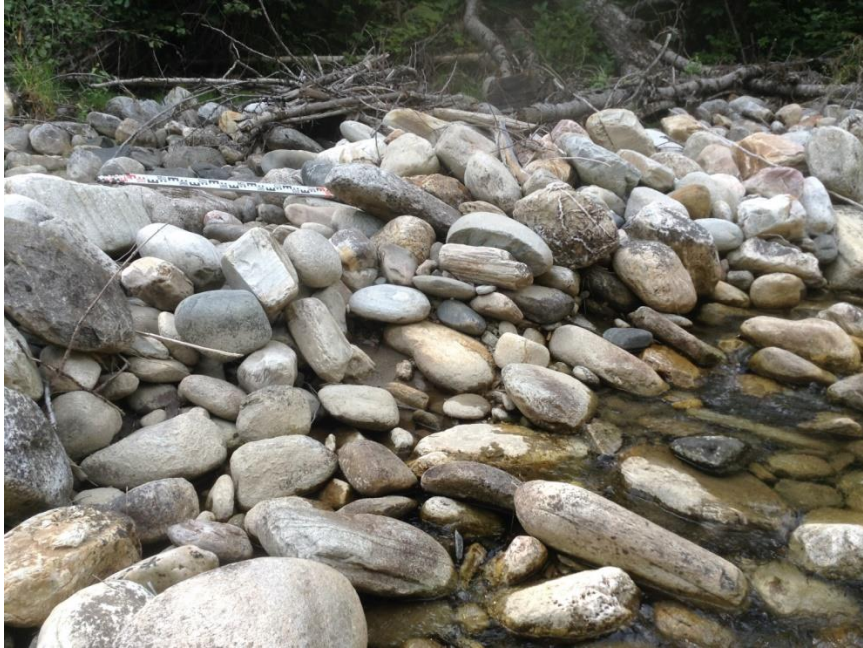
Photo 11. Imbricated boulder bar at Site 8. These boulders are transported through the canyon during flood events and deposited at the canyon outlet in response to the drop in velocity where the channel is unconfined.

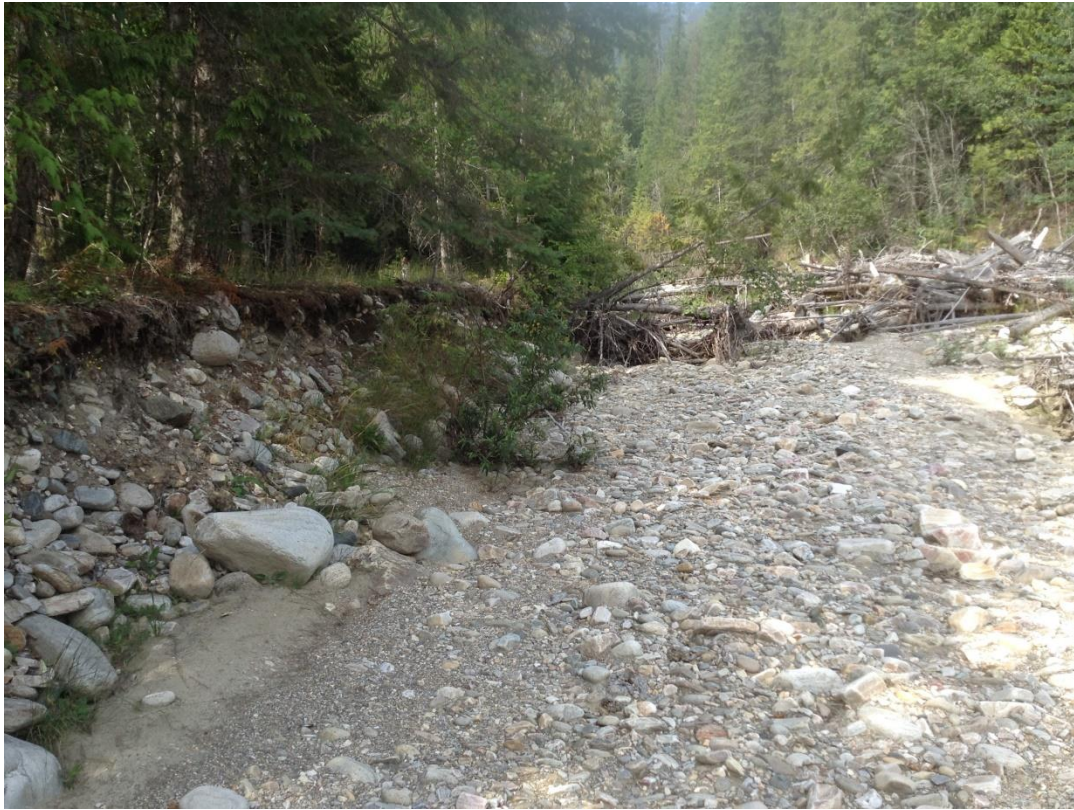
Photo 12. Looking upstream at eroding bank that separates the spawning channel from Crawford Creek

Some of the areas visited during Oct 13 were vegetated directly above short eroded bank, in these locations and where bank is higher, but has conifer canopy directly above it, class I riprap can be placed by keying the toe and placing riprap within the eroded gaps and onto the bank (basically riprap protection with short vegetated spur (vane or groynes) oriented at a determined angle.

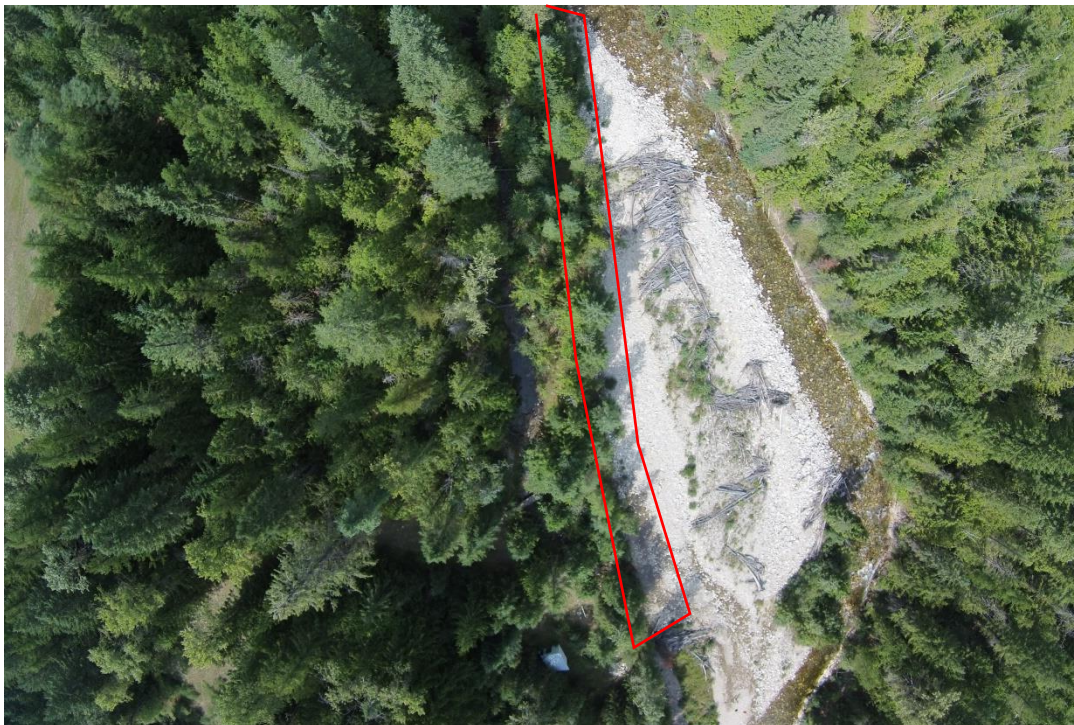
Photo 13. Looking down at approximately 100 meters of raveling bank on channel side of spawning channel.

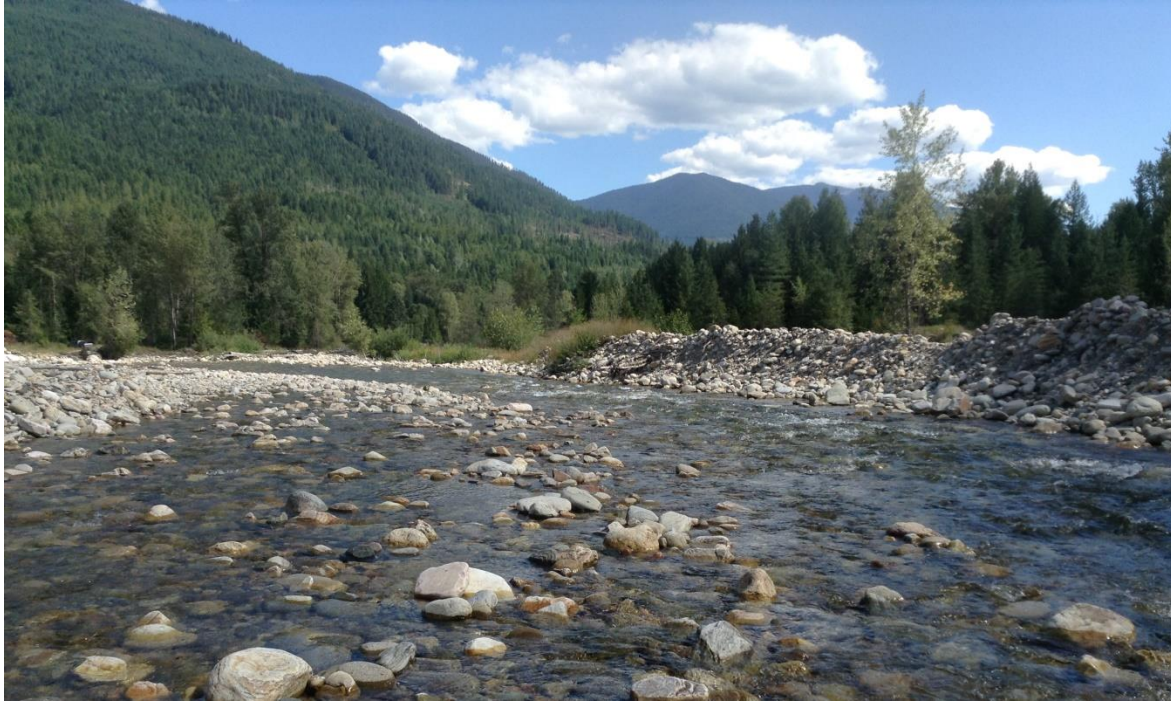
Photo 14. Looking downstream at portion of constructed berm that is contributing sediment and creating scour along opposite bank

Re-position lower 20 meters of berm and re-establish second channel to reduce flow concentration in confined channel segment.

Create vegetated, armored bank along berm to increase flood resistance and reduce ongoing erosion of cobble – gravel berm. Use toe of riprap along existing berm and insert live cutting of willow and balsam poplar species using the insertion planting method (see photo and drawing). Armour and vegetated entire berm and include vegetated riprap application and vegetated spurs (see photos Area 1) along bank

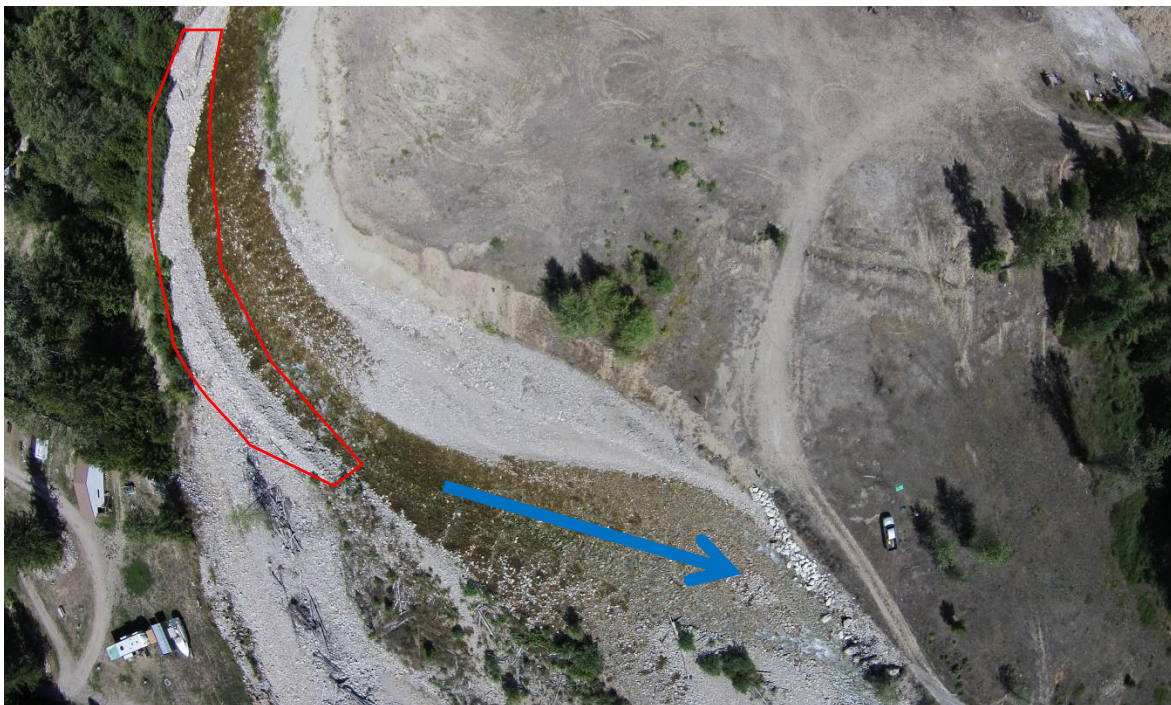
Photo 15. Looking down at approximately 100 meters of berm that is contributing sediment and creating scour along opposite bank. Blue arrow shows location of flow being directed by the berm and the area on the opposite bank that is being eroded.

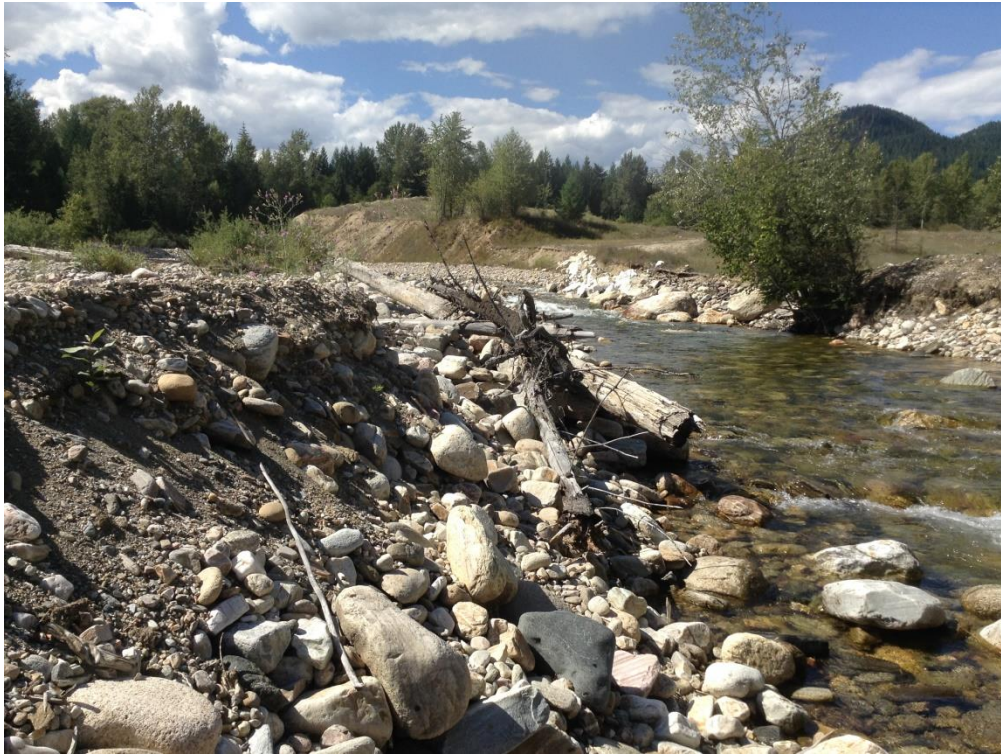
Photo 16. Looking upstream at bank on right where flow from bermed area is eroding bank

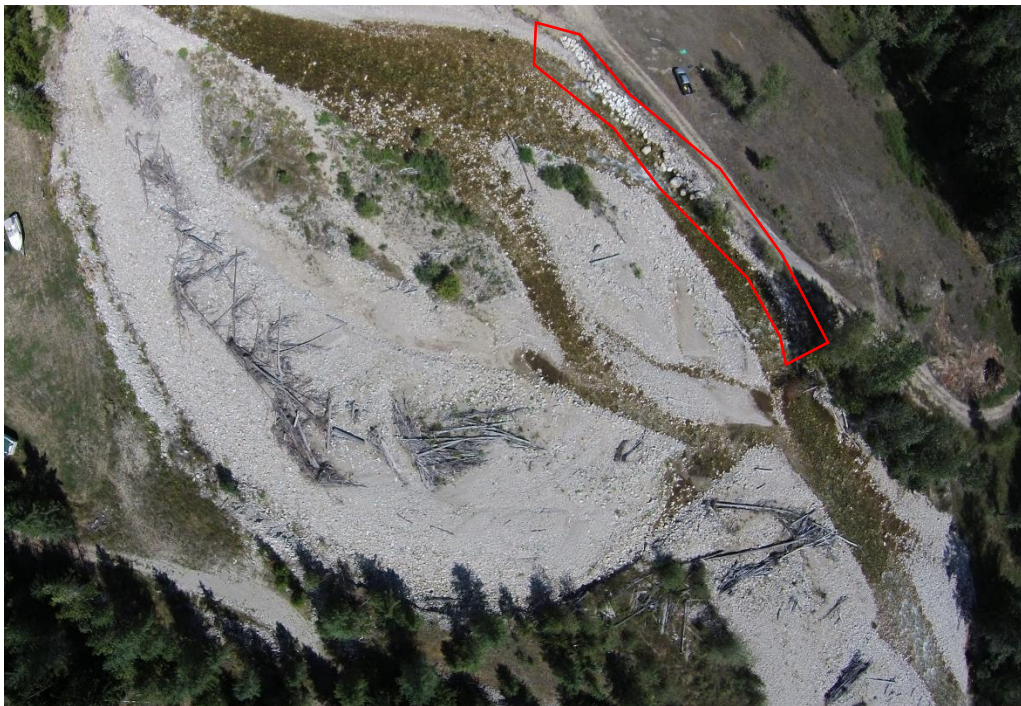
Photo 17. Area of eroding bank from above.

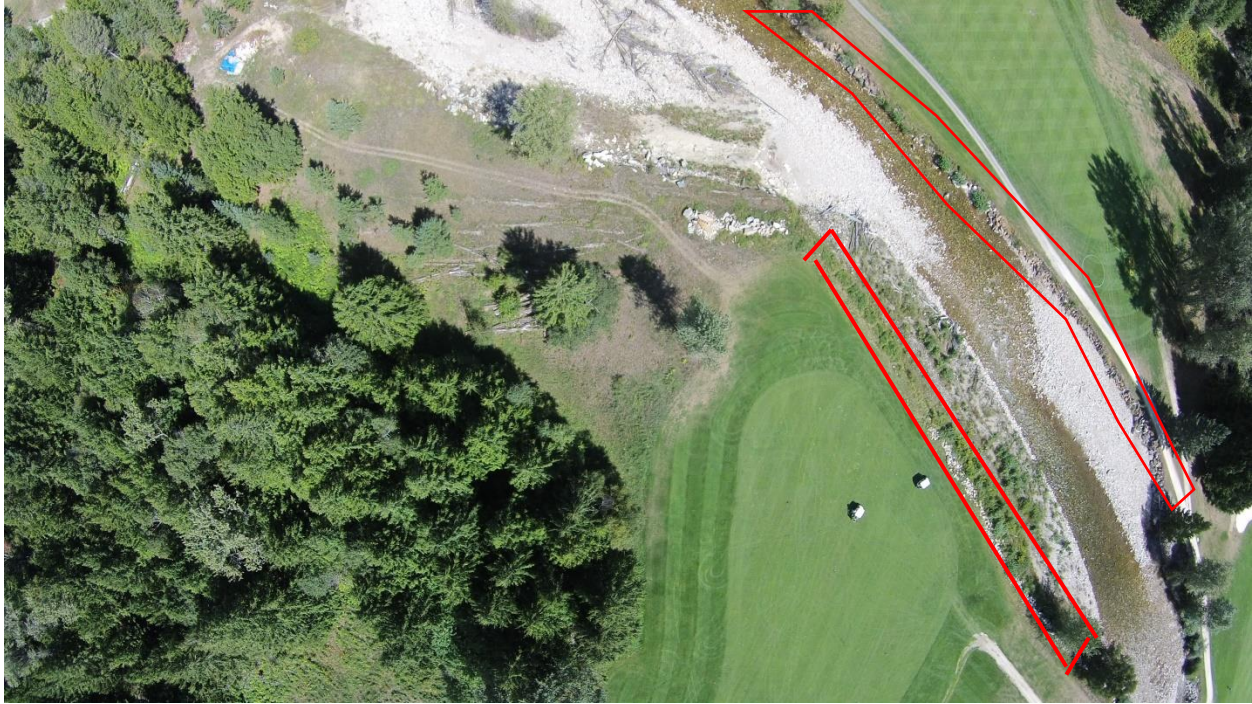
Photo 18. Erosion along fairway channel bank - east side

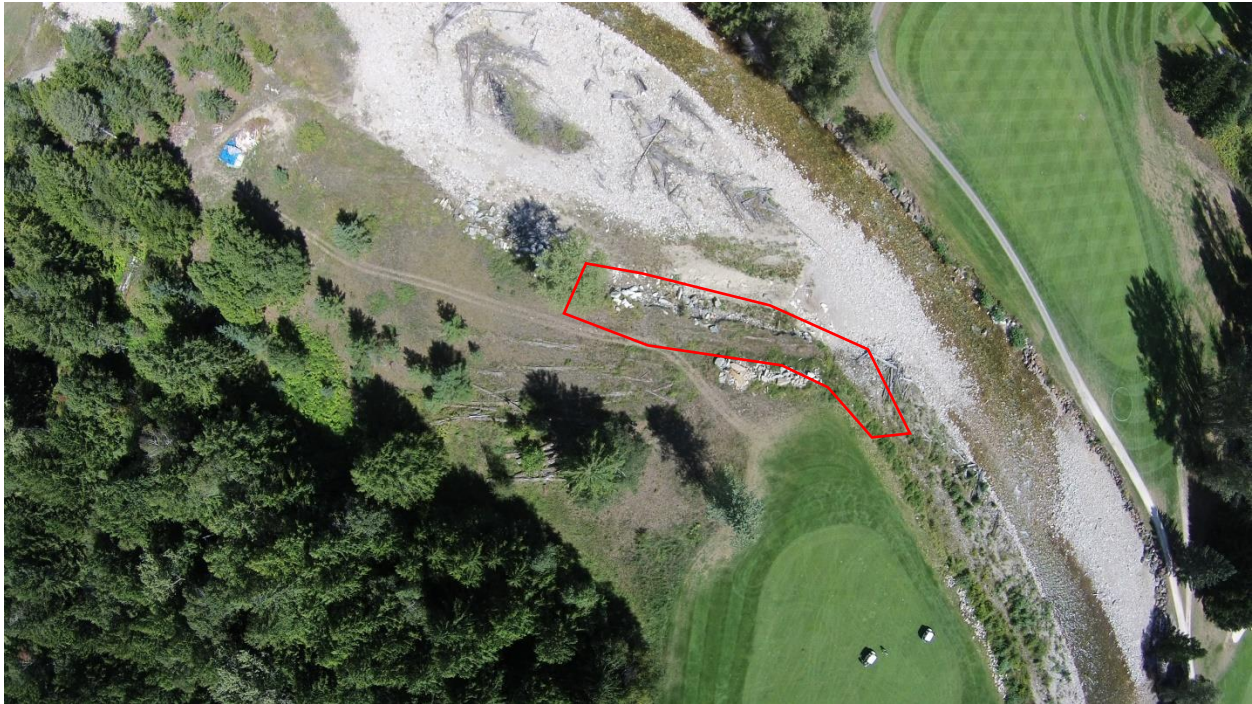
Photo 19. Looking down at eroded channel bank at upstream end of fairway on west side of channel.
