G. Bryden  
Assistant Regional Engineer  
Water Rights Branch  
Ministry of the Environment  
BUILDINGS

Wikkerink Well - Cobble Hill Area

December 30, 1977

WIKKERINK WELL - COBBLE HILL AREA

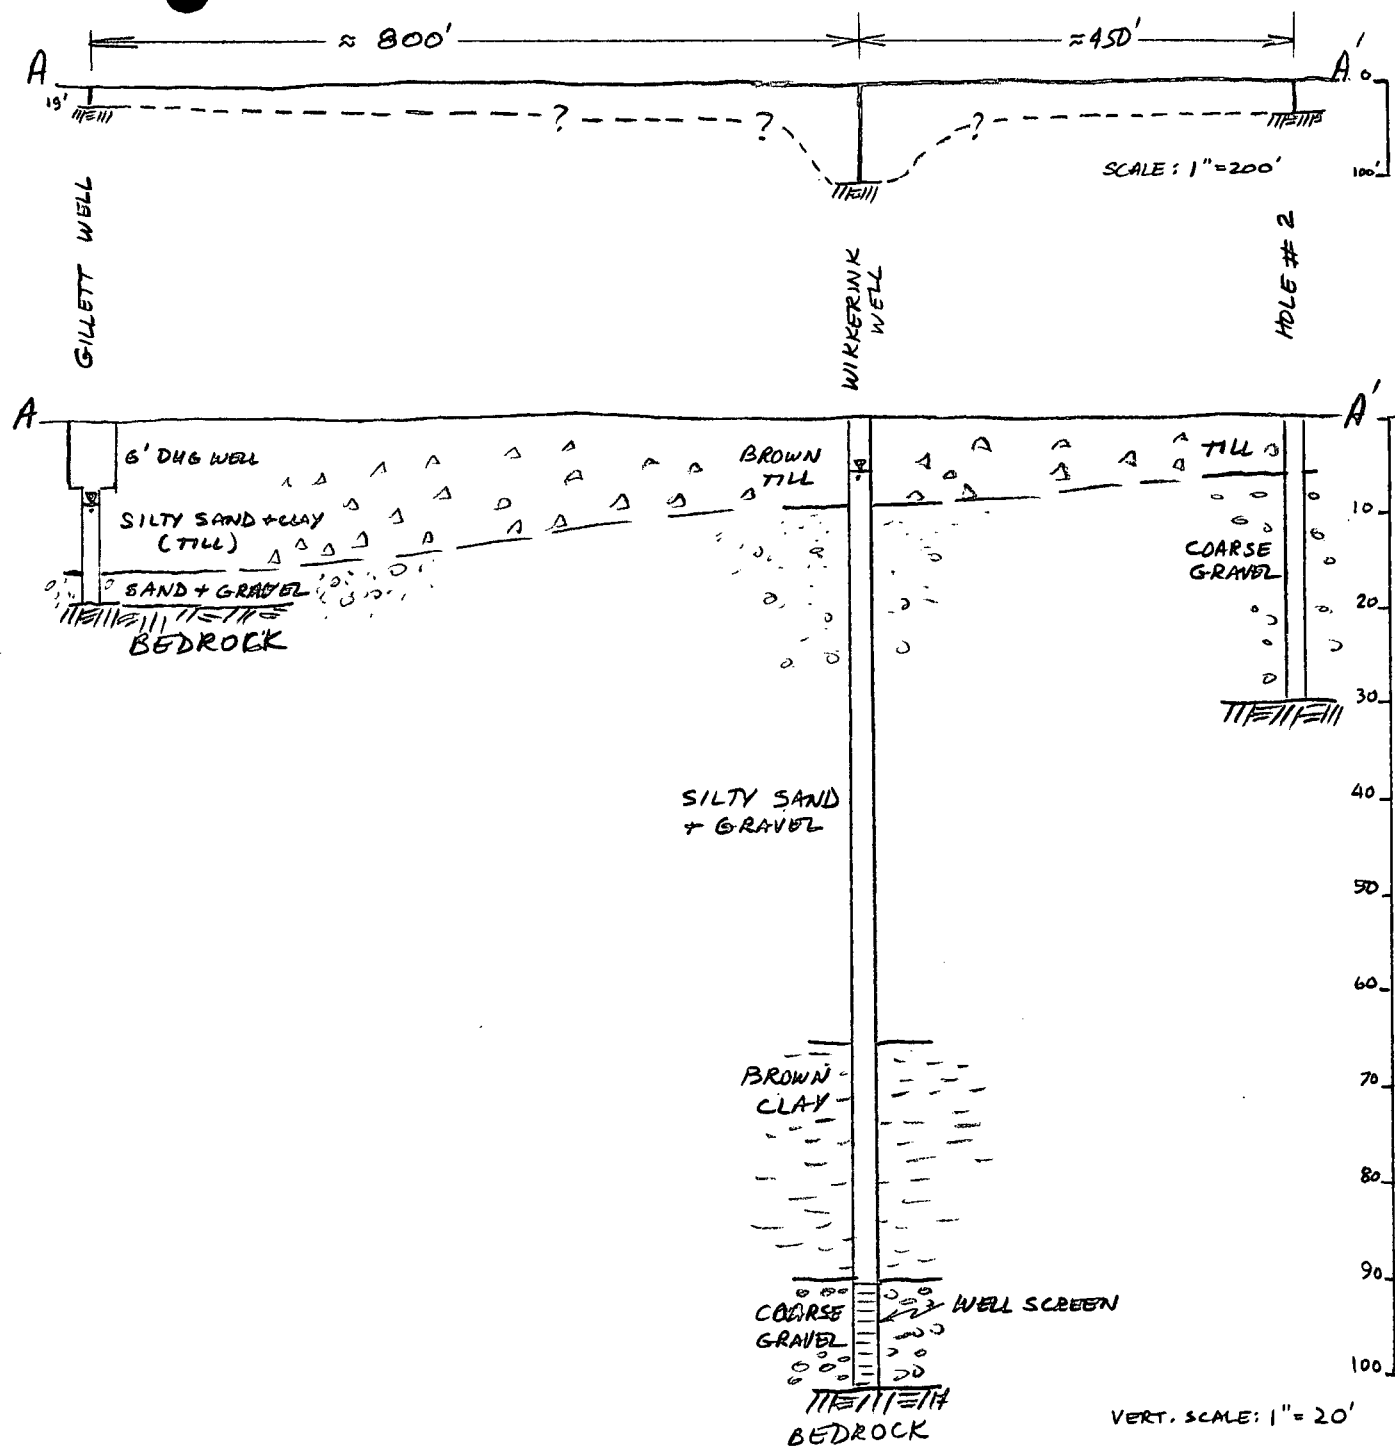
FIG. 2: CROSS-SECTION A-A' SHOWING  
WIKKERINK WELL IN POSSIBLE CHANNEL.

A cross-section (Figure 2) containing the deep Wikkerink well, a shallower well and the Gillett well shows that the deeper Wikkerink well is located in a "trough" or bedrock low which may be a buried channel that controls the groundwater flow by acting as a sink into which the surrounding groundwater moves. Air photographs of the area show scars of several old meltwater channels which may be traced to include the site of the deeper Wikkerink well. These suggest further evidence of a probable buried channel. However, to confirm this, more detailed drilling and/or geophysical testing would be required.
