**ARTIFICIAL NESTING STRUCTURE USE AND MAINTENANCE**  
**PROJECT # PF15 – W16**

**March 2015**

**FISH & WILDLIFE COMPENSATION PROGRAM – PEACE**

**Ecofor Consulting Ltd.**  
1575 2<sup>nd</sup> Ave.  
Prince George, BC  
V2L 3B8  
250-960-1155

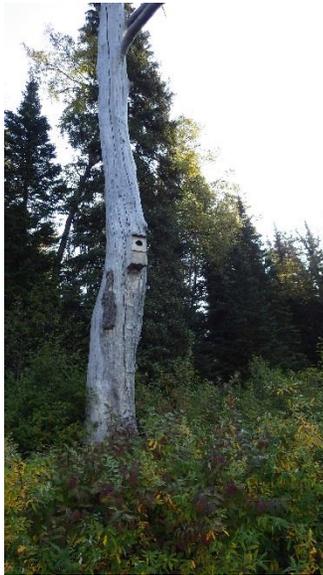
GPS: K5-2014

Kerry Lake: Active Nest Box

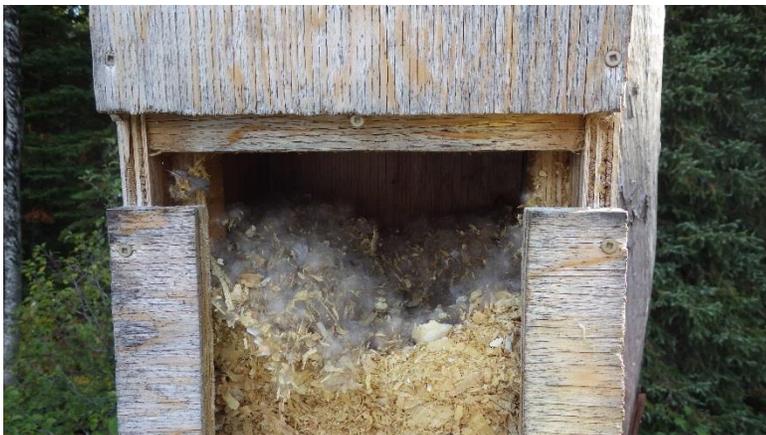
GPS: K5-2014

Kerry Lake: Active Nest Box

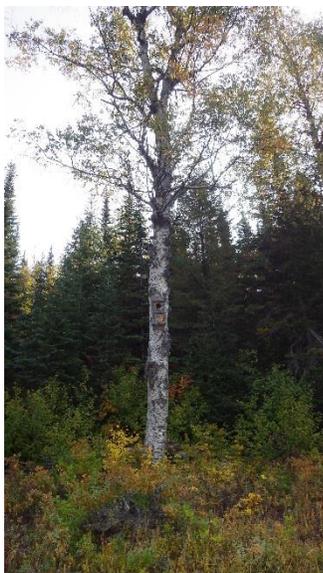
GPS: K2-2014

Kerry Lake: Active nest box

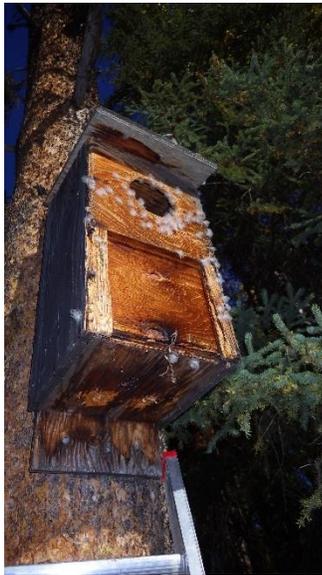
GPS: 60km18-2014

Older nestbox, yet durable due to dry, south exposure.

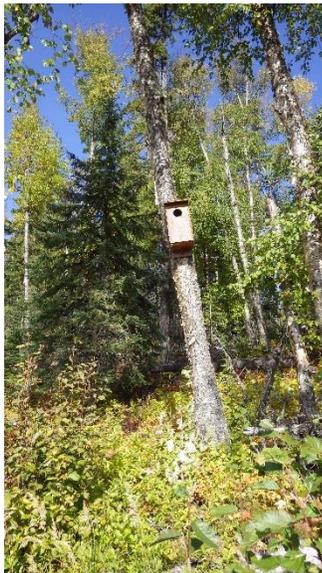
GPS: D8-2014

Dina Lake: Active nestbox.

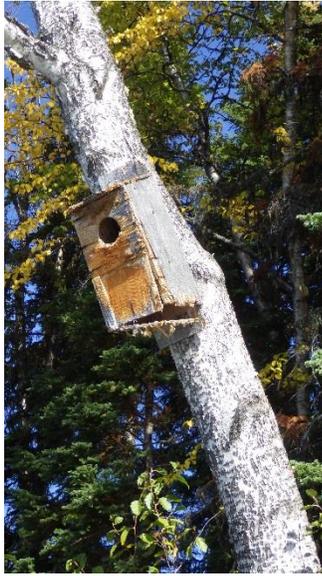
GPS: D2-2014

Dina Lake: non-functioning nestbox damaged by bear. Suspect nesting waterfowl / eggs were present.

Normally, the nestbox would be replaced with a new one. Due to a nearby water license study, it was taken down and not replaced. This box location will require a new one as soon as possible.

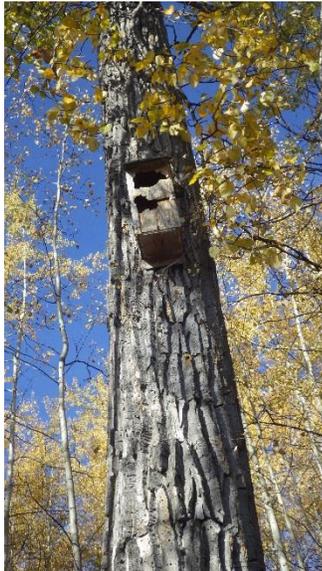
Suspect owl / squirrel use.

Replaced with new box.

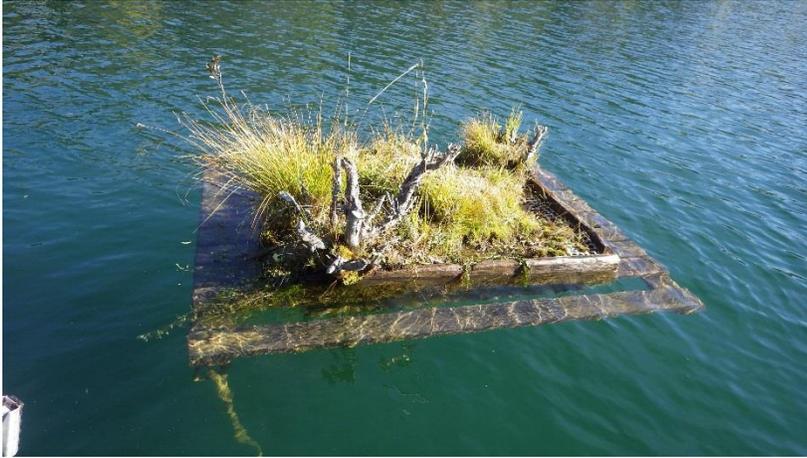
GPS: Disl-2014

Vegetation growth and beaver use of floating island. Boards coming loose on sides and sinking. Styrofoam visible along edge and bottom right corner.

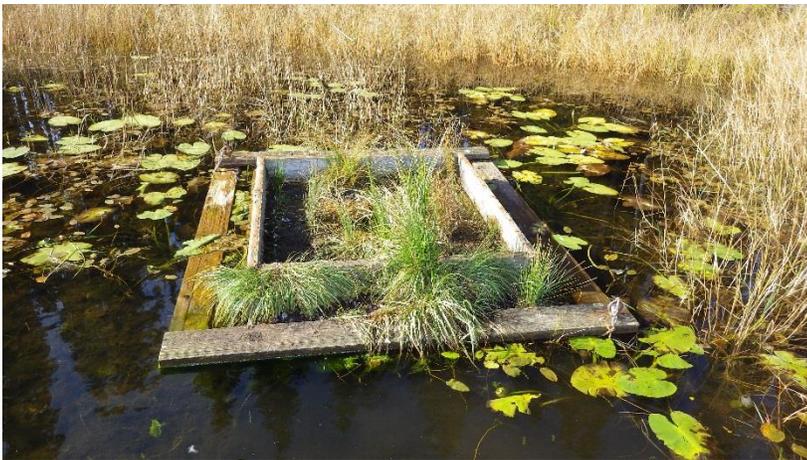
GPS: 60kmi-2014

Non-functional floating island grounded ashore from floating ice. No soil and all styrofoam is not present. Immovable from shallows and slated to be taken apart and removed.

| Location | Feature Type | GPS Description (KML & GPX) | Recommendations for Next Maintenance Period | Year to Complete |
|---|---|---|---|---|
| | Floating Island | 60kmi-2014 | Remove and replace with new island | 2017 |

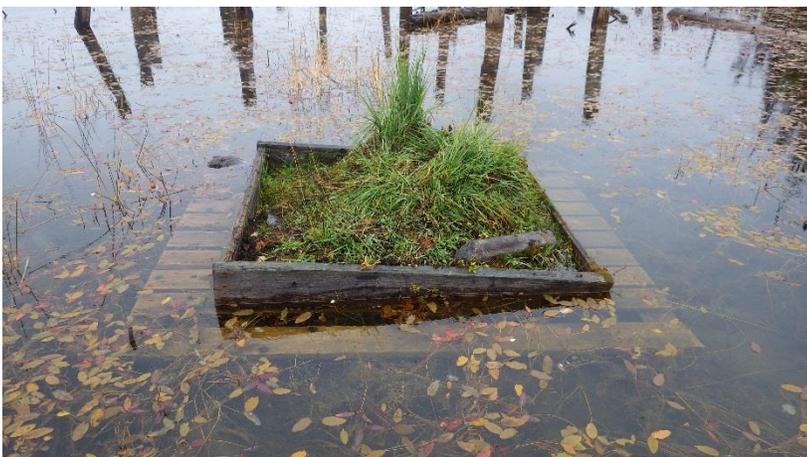
Grounded in shallow water. Boards are rotten and starting to come apart. Slated for removal / replacement during next maintenance period.

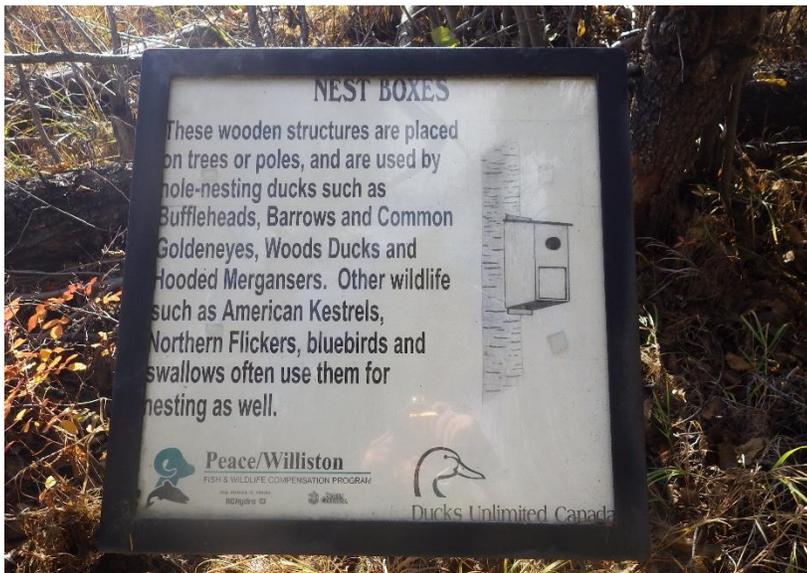
Rocky Marsh interpretive sign along trail. Heavy mountain pine beetle blowdown behind the tree and situated below nestbox in the below photo.

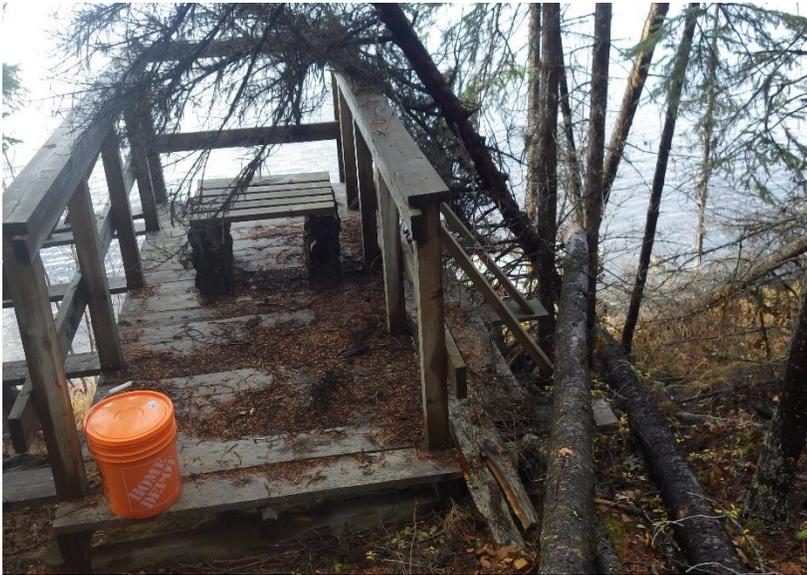
Rocky Marsh observation tower.

Dead mountain pine beetle killed trees against the tower. No evidence of use by public.

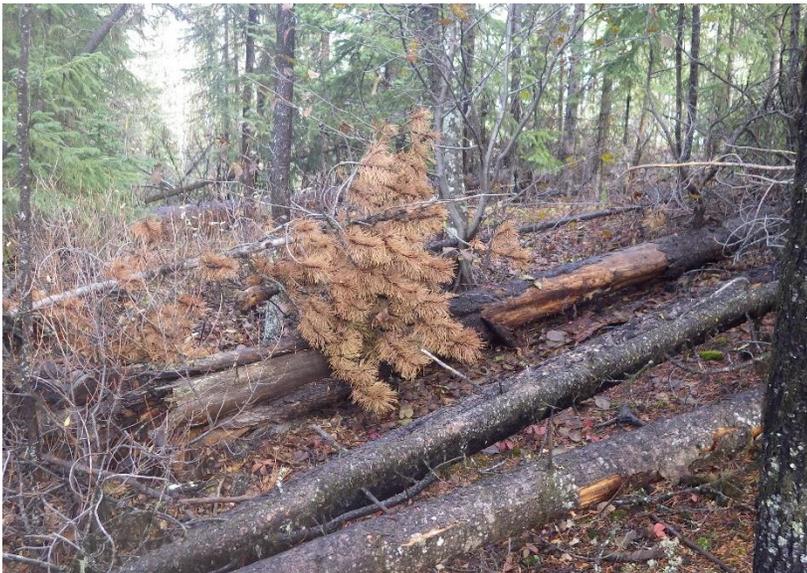
Representative mountain pine beetle killed trees on ground. This is the view from behind the observation tower along what is the access trail.

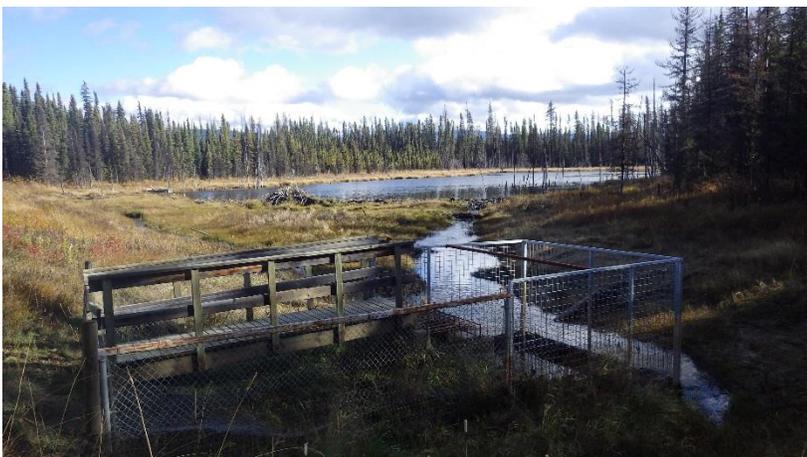
Overview of outlet dam structure at Rocky Marsh. Beaver dam in background holding back water.

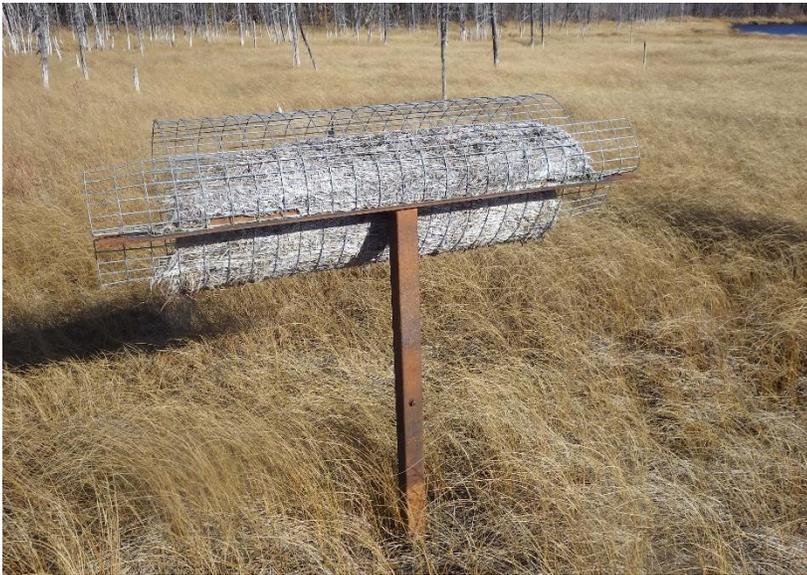
GPS: Rock-T2-2014

- All 3 tunnels at Rocky Marsh have lost structural integrity with the collapse of the wire mesh. In addition, annual straw placement before each nesting period has not occurred and therefore no waterfowl use will occur.
- Removal all three tunnels from Rocky Lake as per recommendation in Juelfs and Corbould 2008.

Requires yearly maintenance and placement of straw prior to the spring nesting period

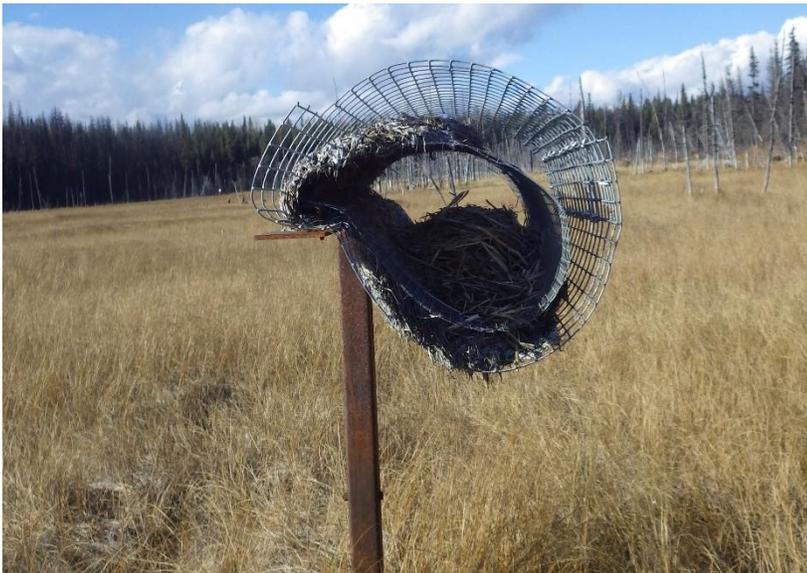
GPS: Rock-T2-2014

Requires yearly maintenance and placement of straw prior to the spring nesting period.
