**Interior Watershed Assessment**  
for the  
**IRISH CREEK WATERSHED**  
*(Vernon Forest District)*

**FINAL REPORT**

Prepared for  
**TOLKO INDUSTRIES LTD.**  
Lavington Division

by  
**DOBSON ENGINEERING LTD.**  
#4, 1960 Springfield Road  
Kelowna, B.C.  
V1Y 5V7

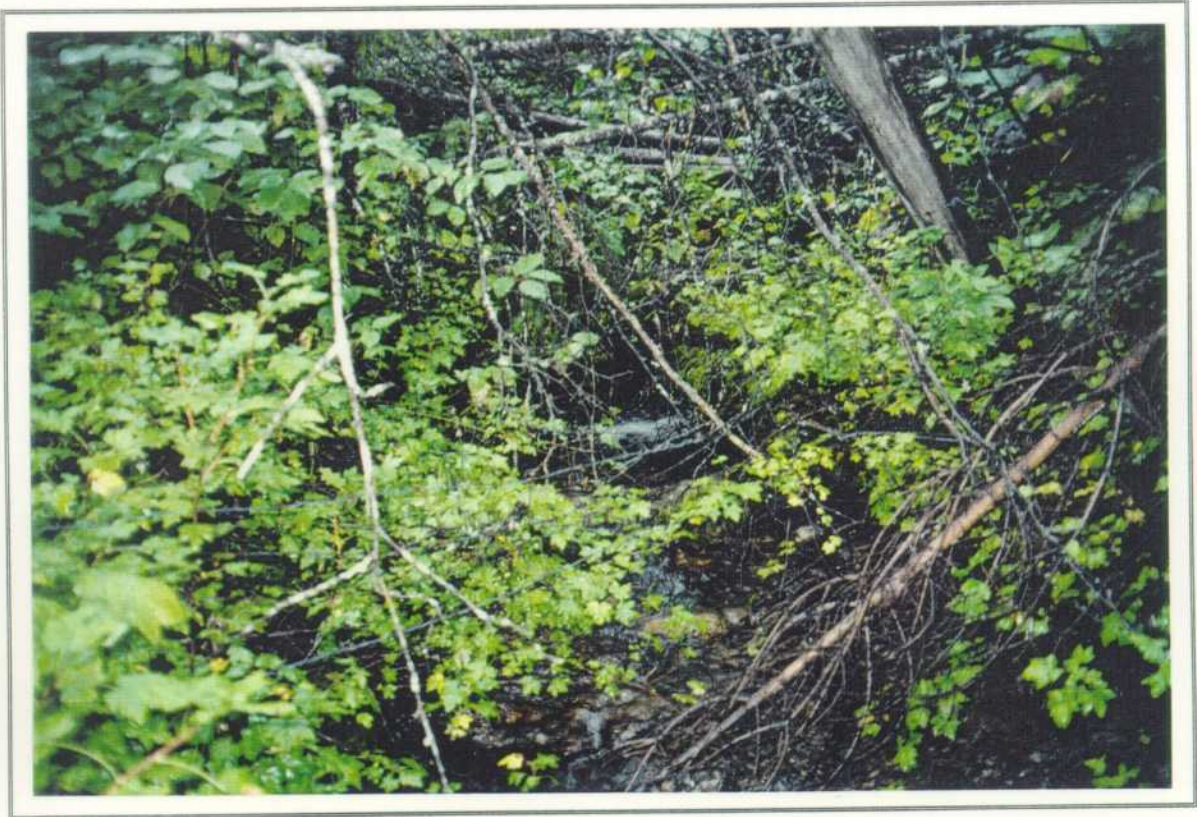
Irish Creek above the POI (Reach F and G) was characterized as having a partially aggraded step-pool morphology with a boulder, cobble, gravel and sand bed and a gradient of 10 to 15% [refer to Appendix A, Photos 1 and 2]. Large woody debris plays a minor role in defining the channel morphology with the majority of woody debris spanning the channel. Numerous small slumps (<5 m<sup>2</sup>) were identified along the creek associated with the Class V terrain that is adjacent to the creek. The sand component on the bed of the creek appears to be higher than what would be expected for most channels with this gradient. The high sand component is a result of limestone seeps that has cemented the sand on the bed of the channel instead of allowing the sand to be transported downstream. These limestone seeps were observed to enter the creek at numerous locations along Reach F and G. It should be mentioned that the amount of sand within the Reaches F and G is not related to past forest development since no

**PHOTO 1.** Irish Creek, approximately 60m above point of interest (POI).

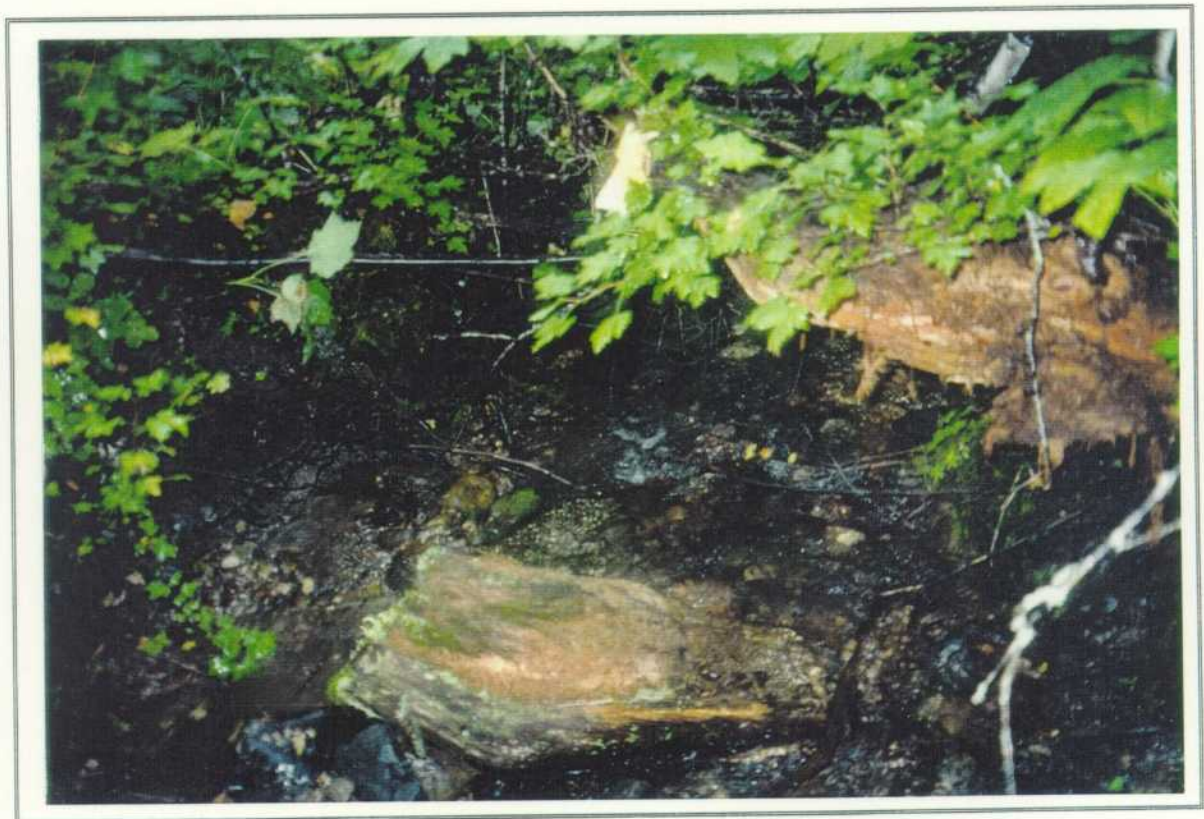
**PHOTO 2.** Channel bed of Irish Creek approximately 60m above POI. Note: mixture of cobbles, gravel & sand on bed of channel.

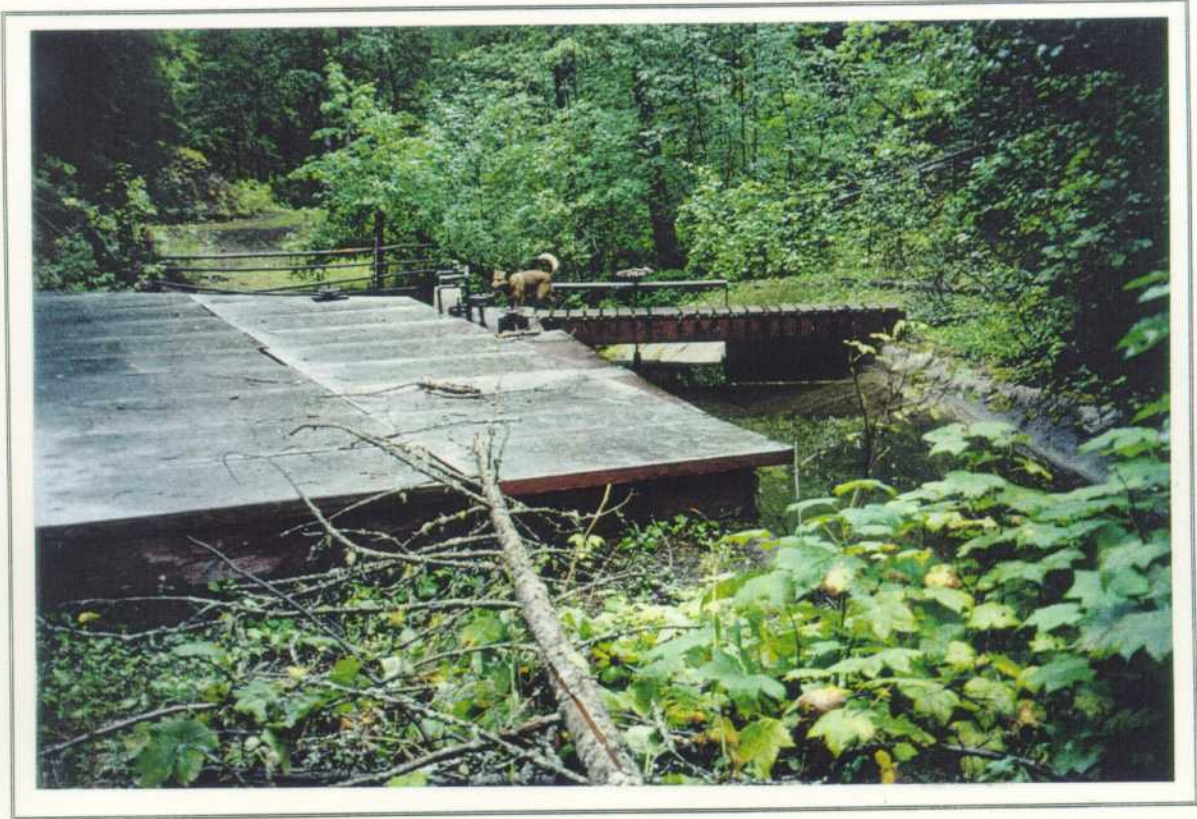
Directly below the POI (Reach E) Irish Creek was characterized as having a partially to moderately degraded step-pool morphology with a cobble, gravel and sand bed and gradient of 7% [refer to Appendix A, Photos 3 to 8]. Evidence of bank erosion and scour were present in this reach and are possibly related to the release of water at the water intake pond.

PHOTO 3. Water intake at POI.

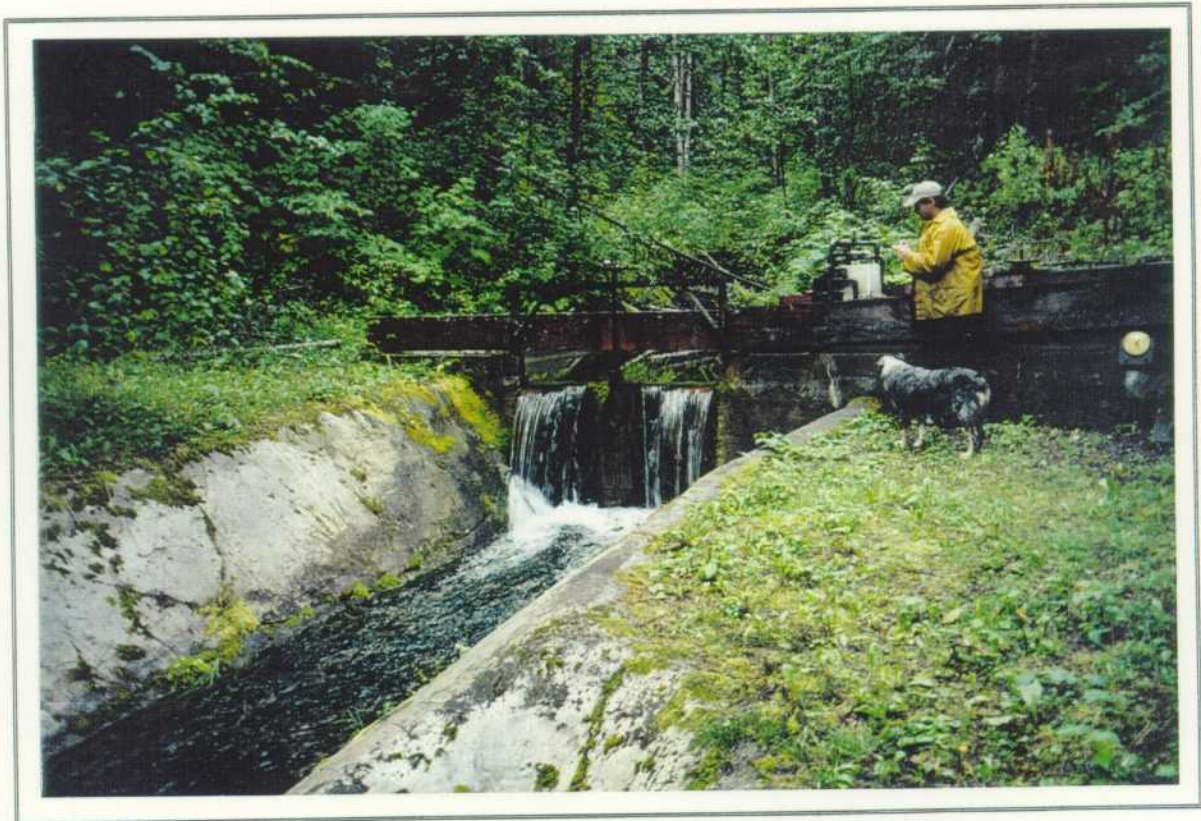
PHOTO 4. Looking upstream toward water intake at POI.

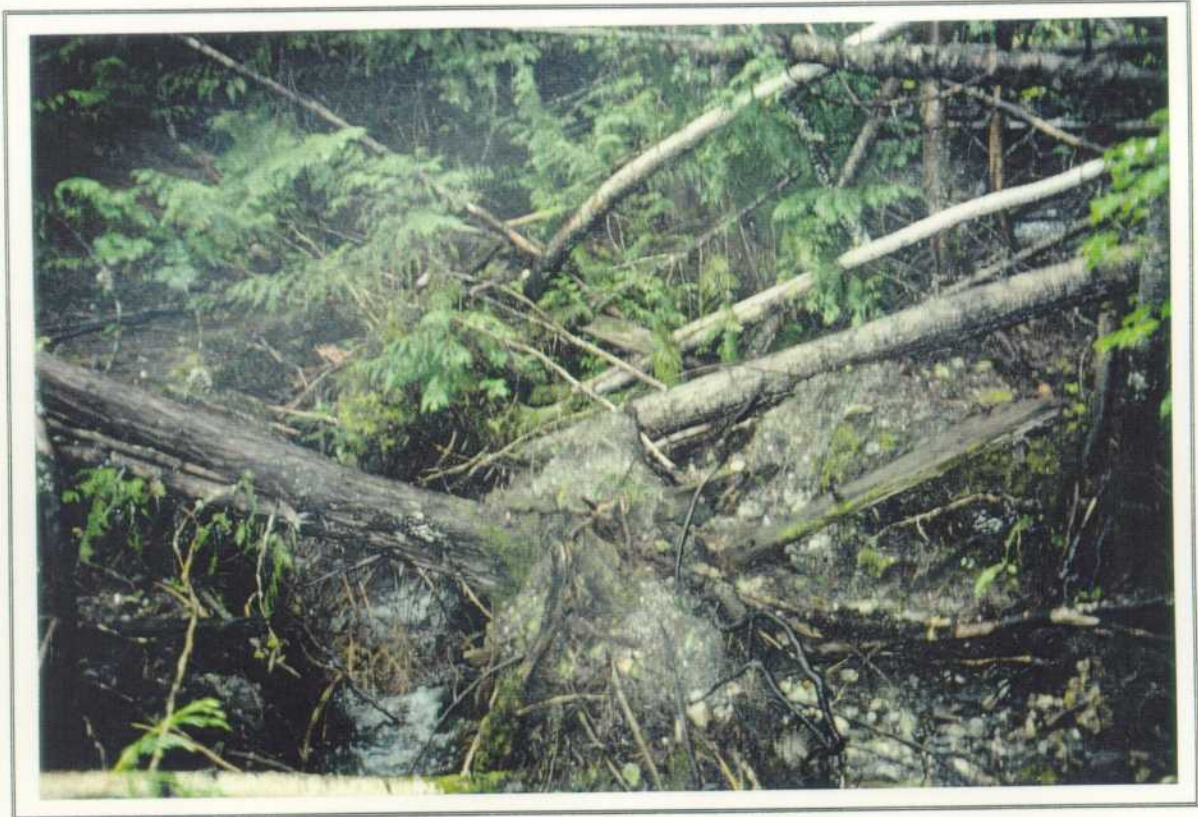
**PHOTO 5.** Blowdown along creek below POI.

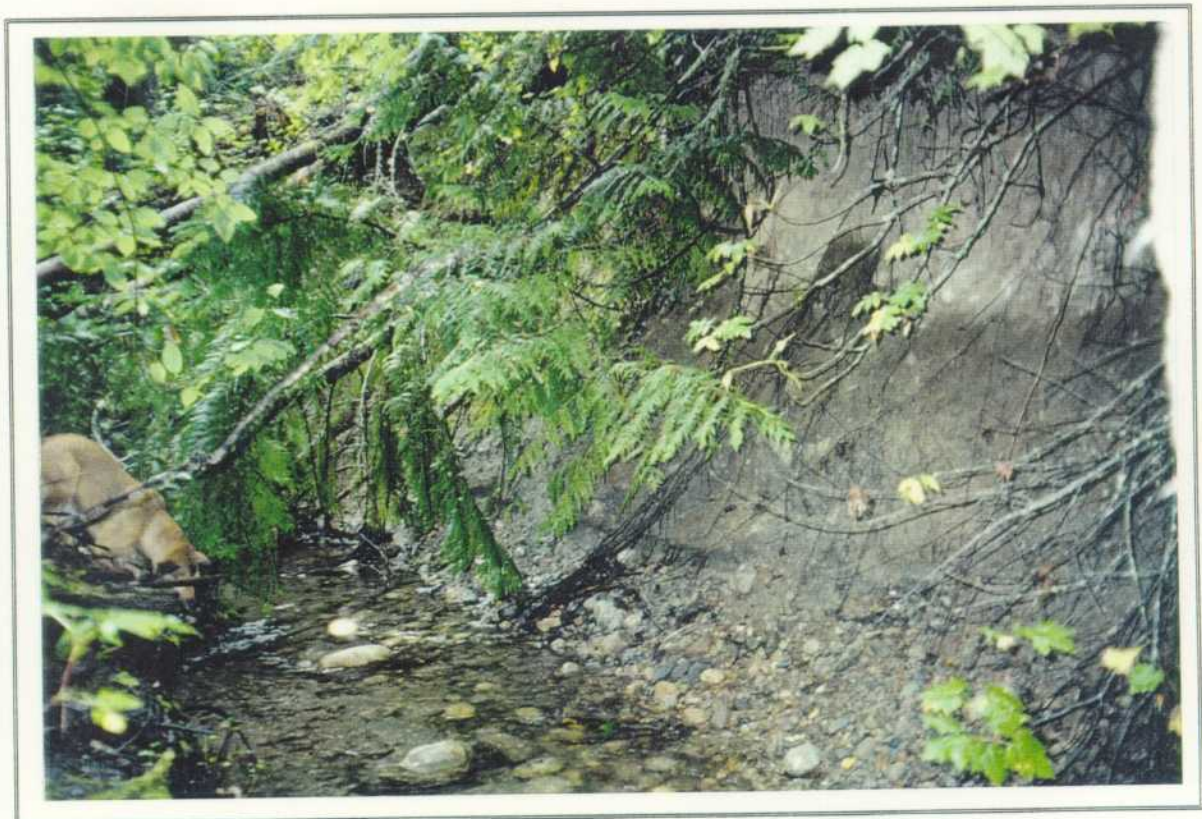
**PHOTO 6.** Bank failure along Irish Creek approximately 100m below POI.

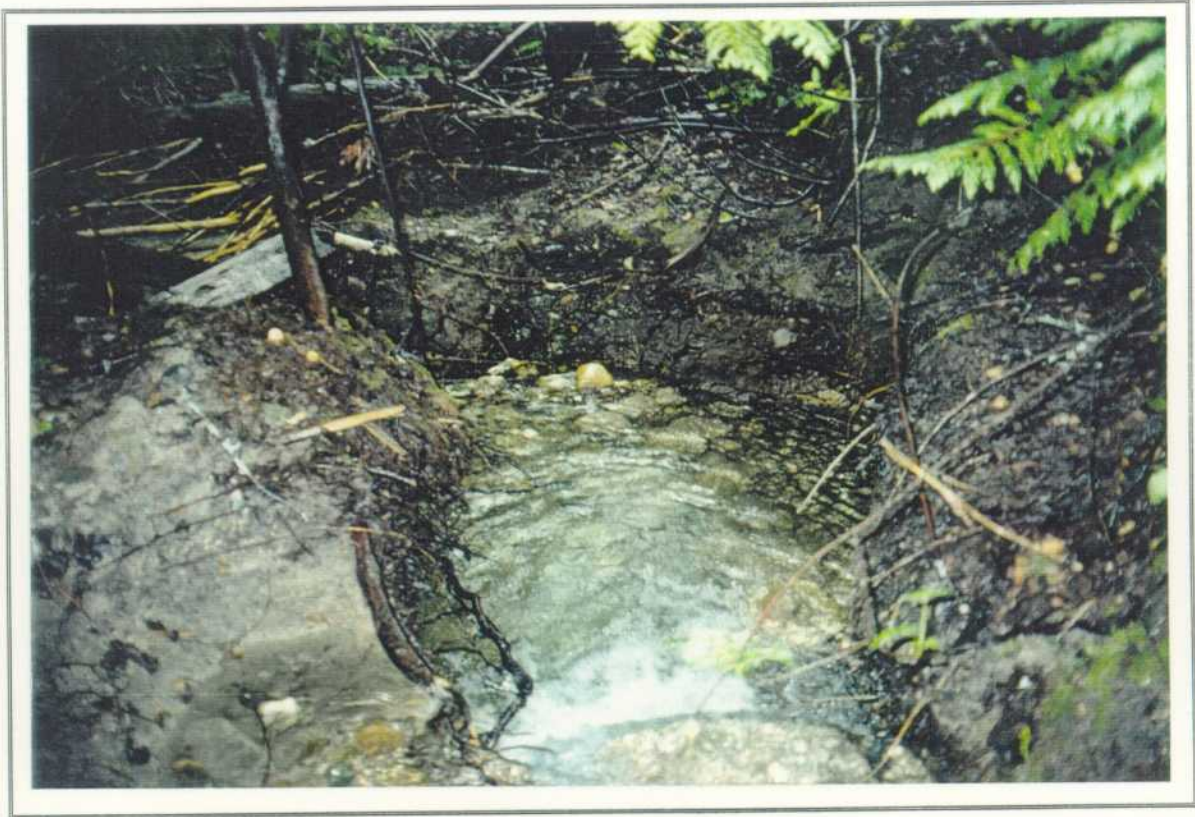
**PHOTO 7.** Evidence of channel bank erosion and scour below POI at lower road crossing location.

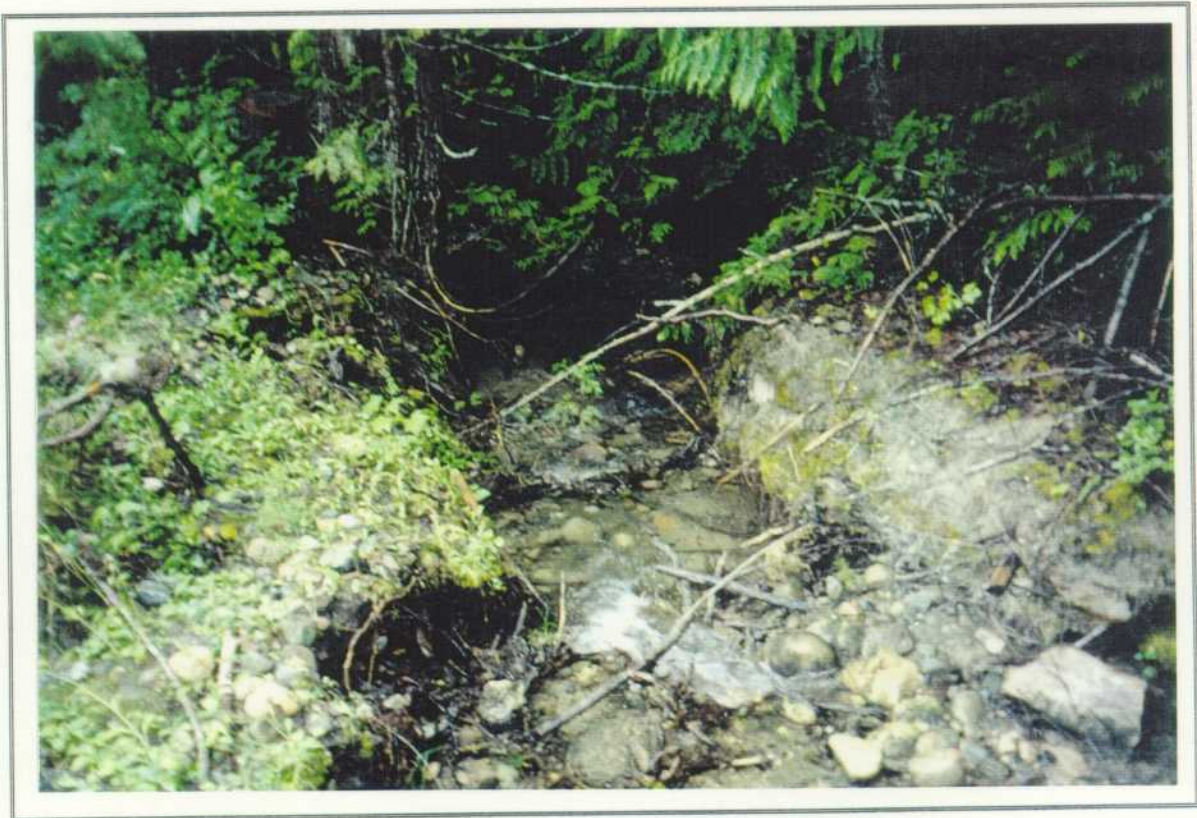
**PHOTO 8.** Characteristic channel condition below POI within Reach E.

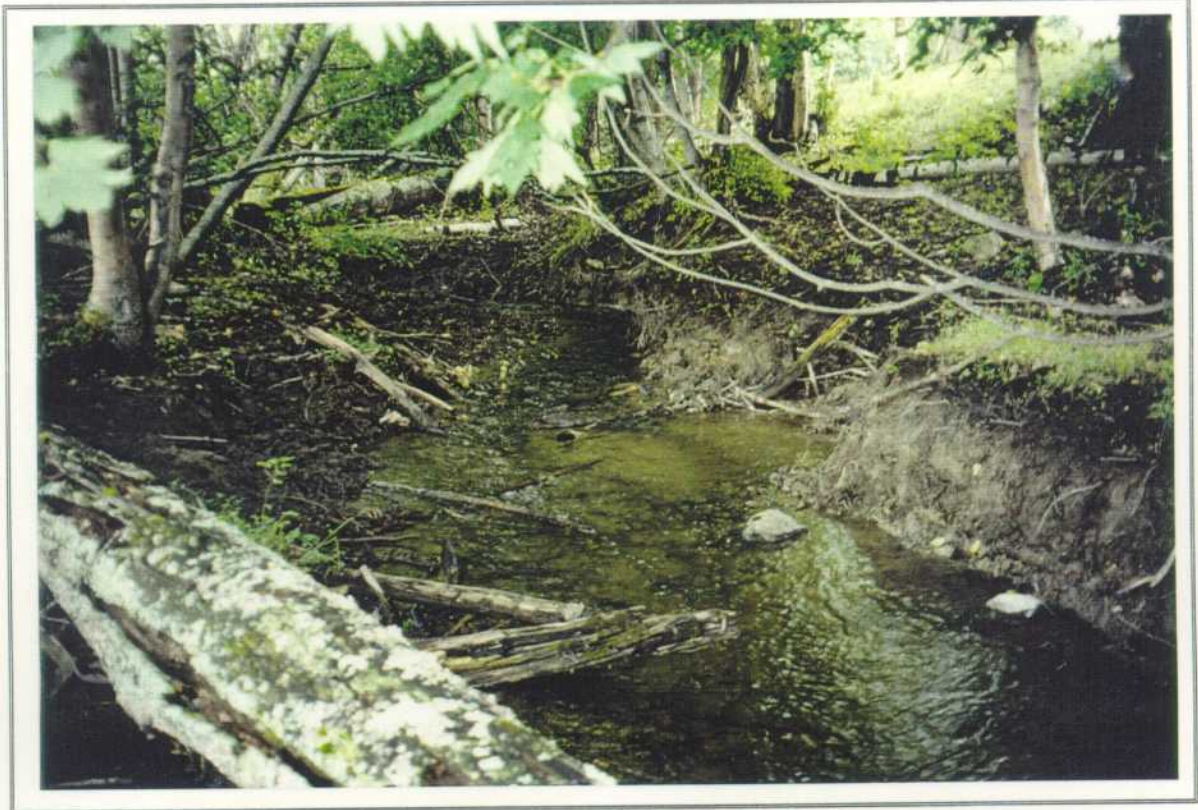
The lower reaches of Irish Creek were assessed at two locations: above Beatrice Road and above Westside Road. Channel conditions above Beatrice Road were characterized as having a moderately to severely aggraded riffle-pool morphology with a sand and silt bed and a 2% gradient [refer to Appendix A, Photos 9 to 12]. Riparian vegetation along this portion channel consisted mainly of birch and cottonwoods approximately sixty years old. Cattle have trampled the banks and bed throughout this area. Below the Beatrice Road crossing the channel is more complex and is less disturbed evidenced by stable banks and a higher frequency of pools.

**PHOTO 9.** Channel conditions approximately 300m above Beatrice Rd. Note: silt banks trampled by cattle.

- BC Environment and the private land owners should give consideration to completing a channel assessment on Irish Creek that flows through private land. The purpose of this work would be to identify rehabilitation works to improve channel conditions, riparian functions and ultimately water quality.

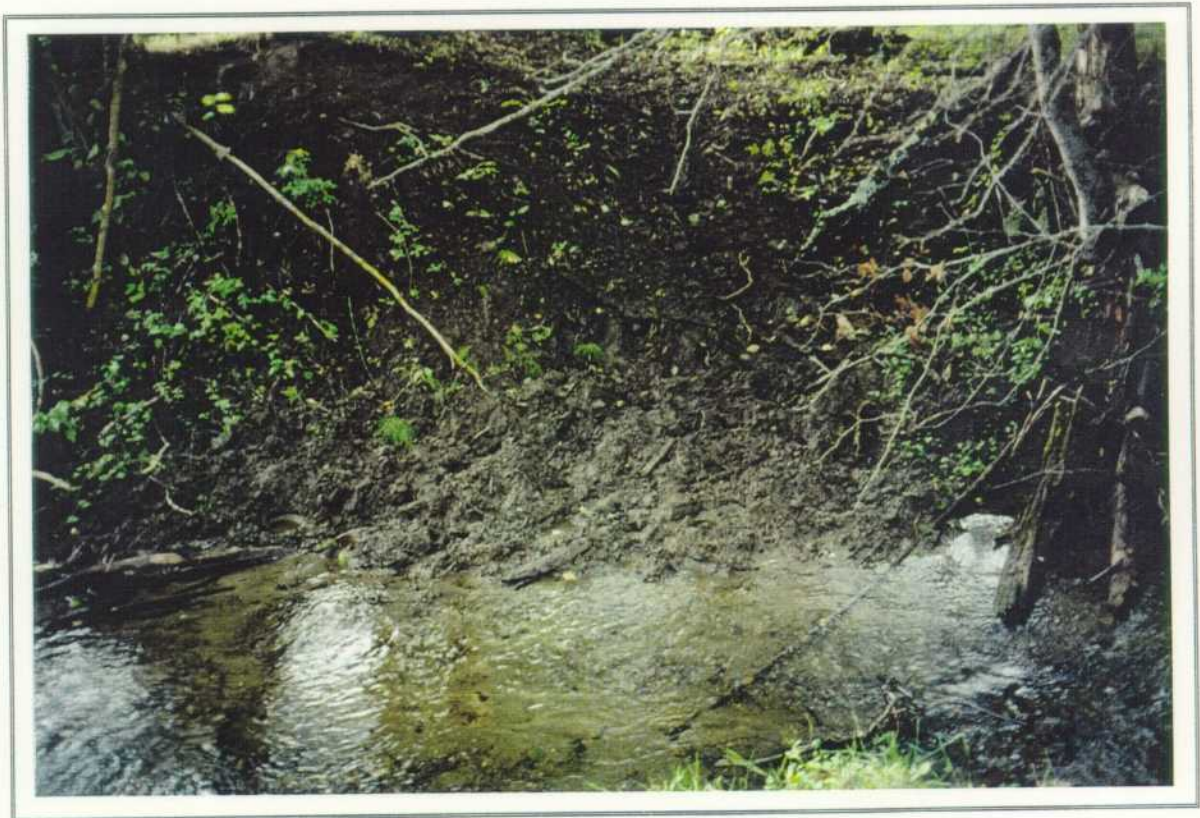
**PHOTO 10.** Cattle crossing location above Beatrice Road.

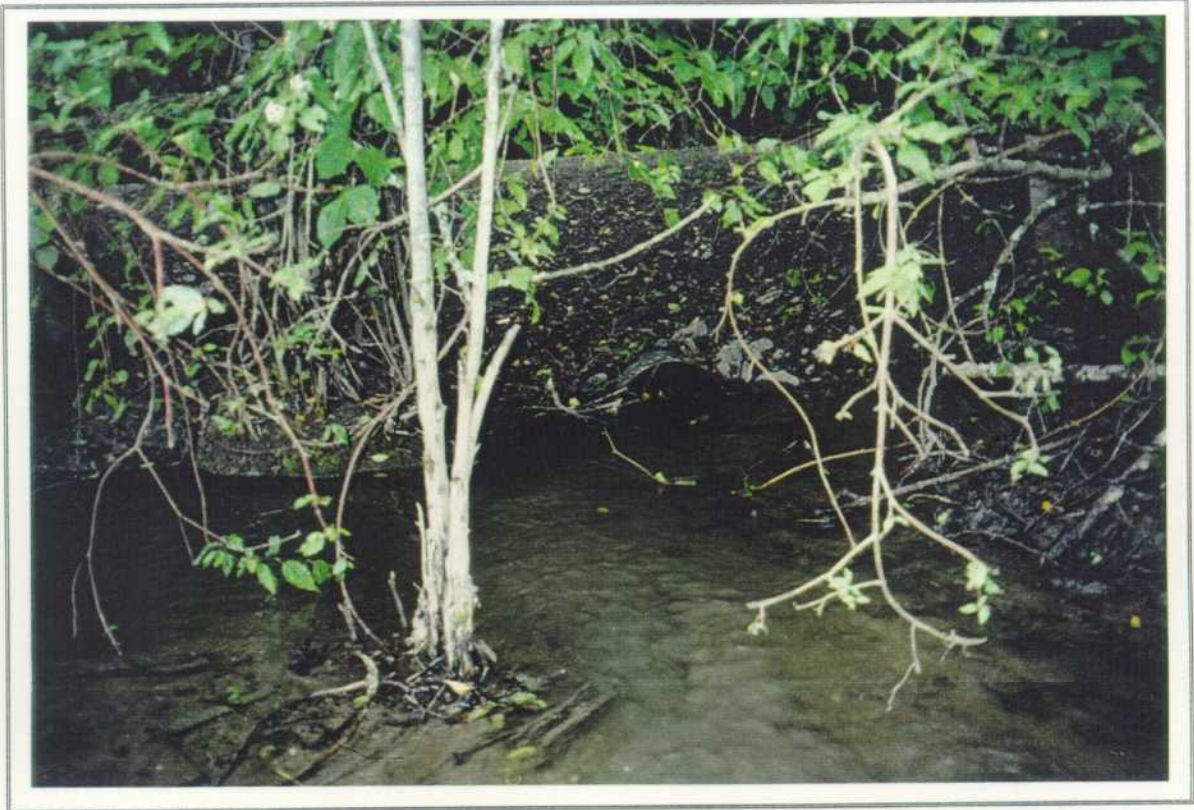
**PHOTO 11.** Culvert inlet at Beatrice Road crossing.

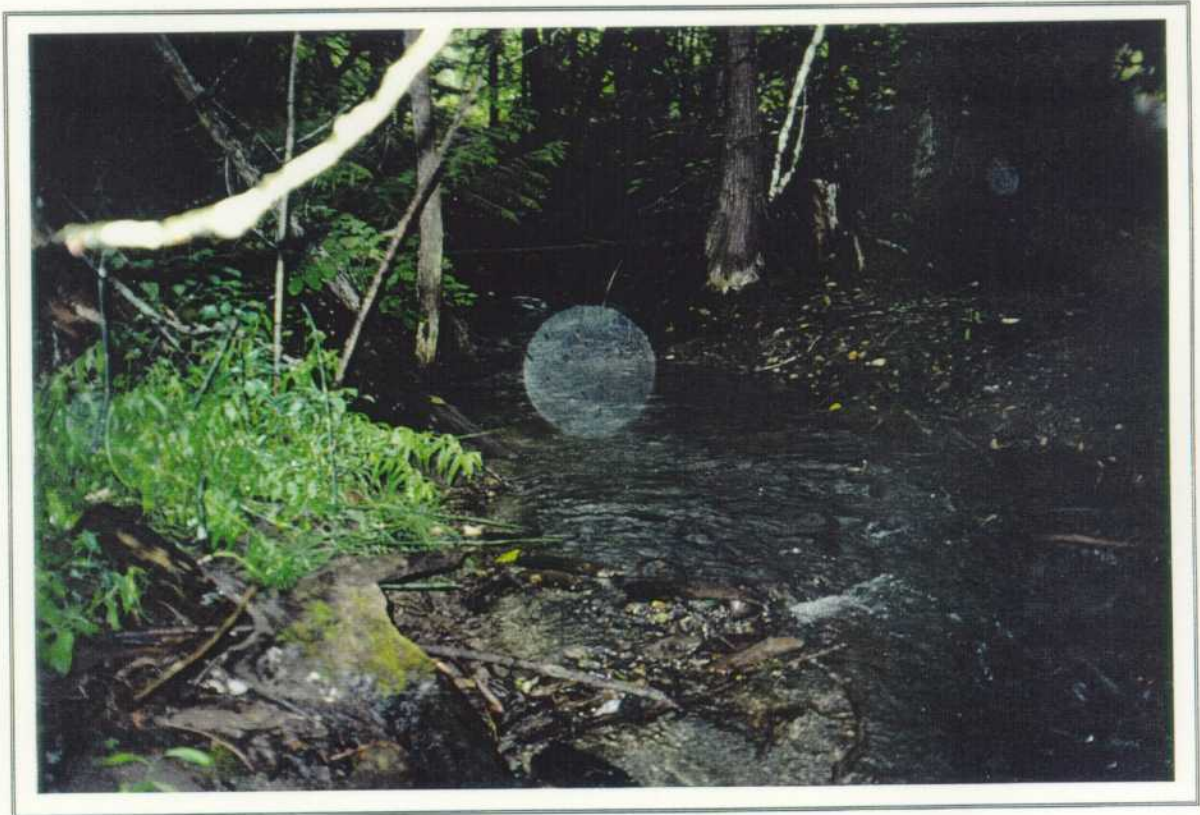
**PHOTO 12.** Irish Creek directly below Beatrice Road crossing.

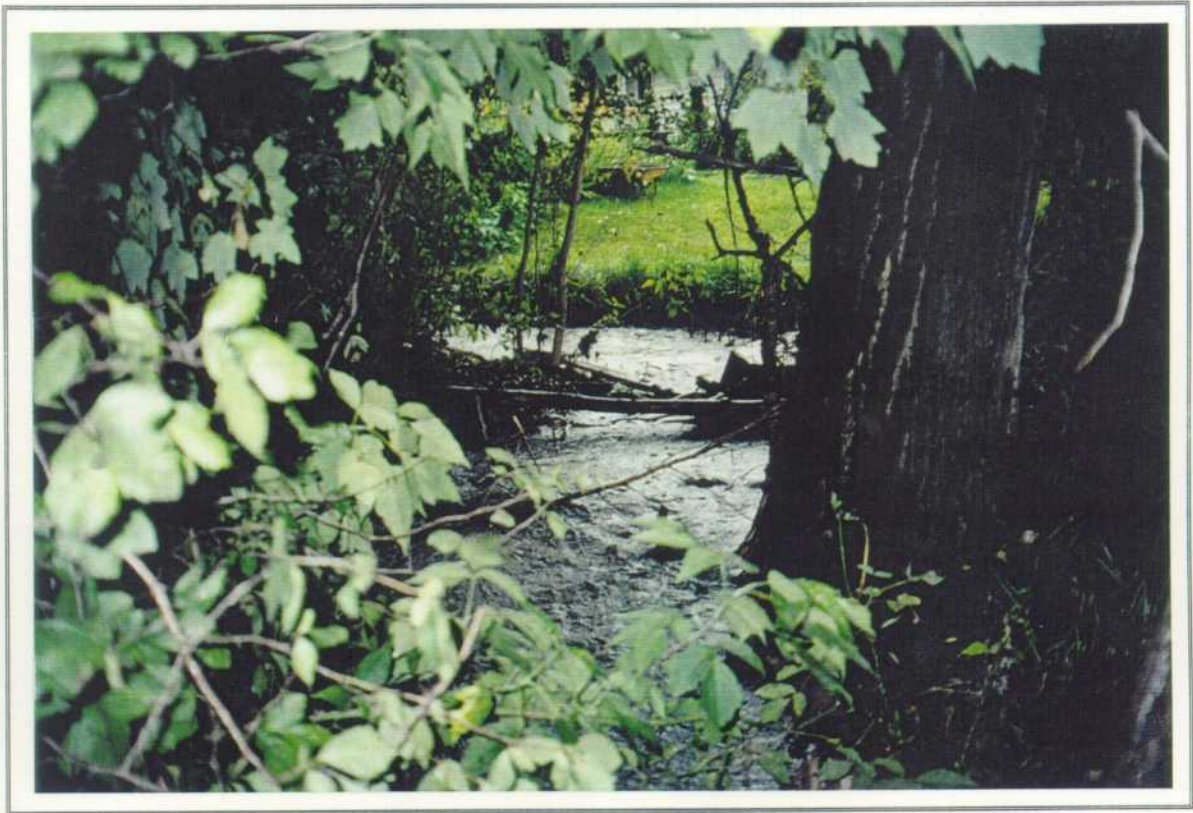
The channel near the Westside Road is characterized as having a moderately aggraded, riffle-pool morphology with a gravel bed and a 2% gradient [refer to Appendix A, Photos 13 and 14]. A limited amount of large woody debris was present in this channel. Riparian vegetation consisted of large cottonwoods (dbh>30 cm) and shrub species (e.g. dwarf rose, Douglas maple and dogwood). Channel banks appeared to be stable.

**PHOTO 13.** Irish Creek directly above Westside Road.

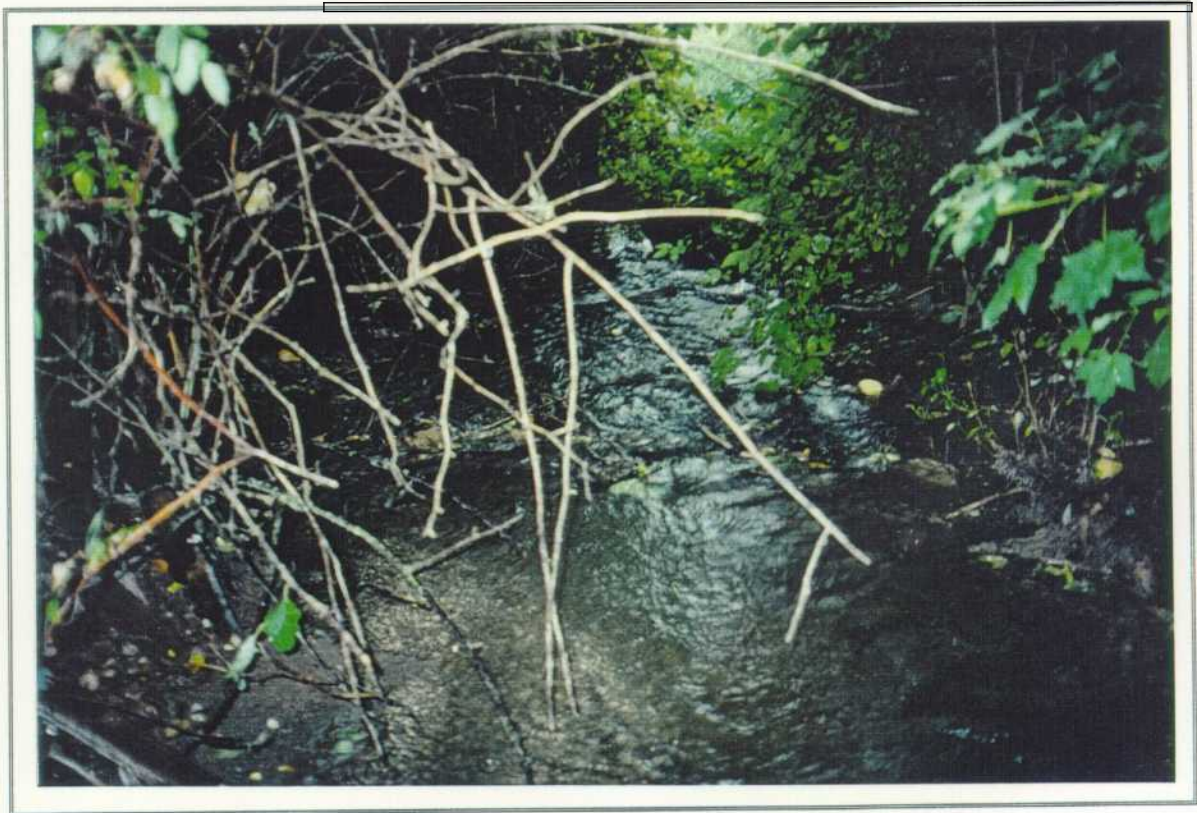
**PHOTO 14.** Irish Creek directly below Westside Road.
