Interior Watershed Assessment
for the
DUTEAU CREEK WATERSHED
(Vernon Forest District)

Prepared for
RIVERSIDE FOREST PRODUCTS LIMITED
Lumby Division

by
DOBSON ENGINEERING LTD.
#4 - 1960 Springfield Road
Kelowna, B.C.
V1Y 5V7

March 1999

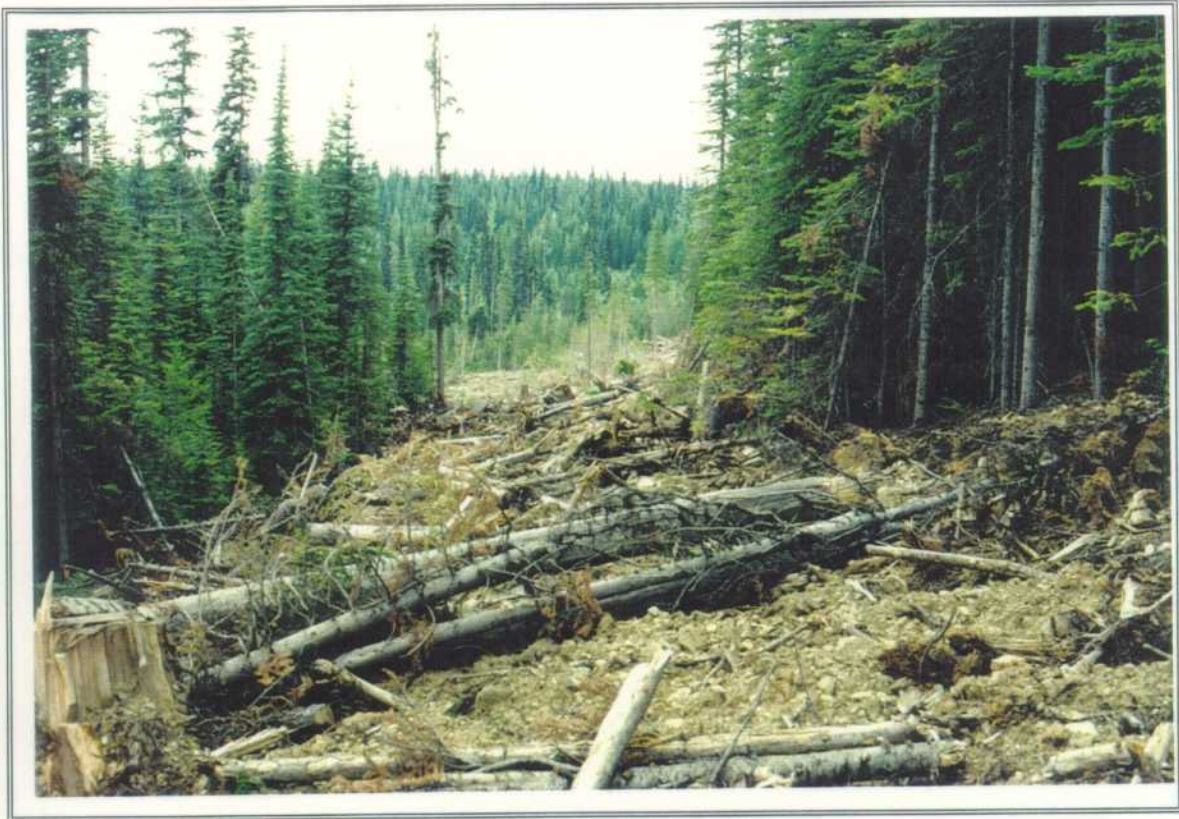
PHOTO 1. Temporary access structure (road) from Aberdeen FSR to recent cutblock upslope of canyon section.

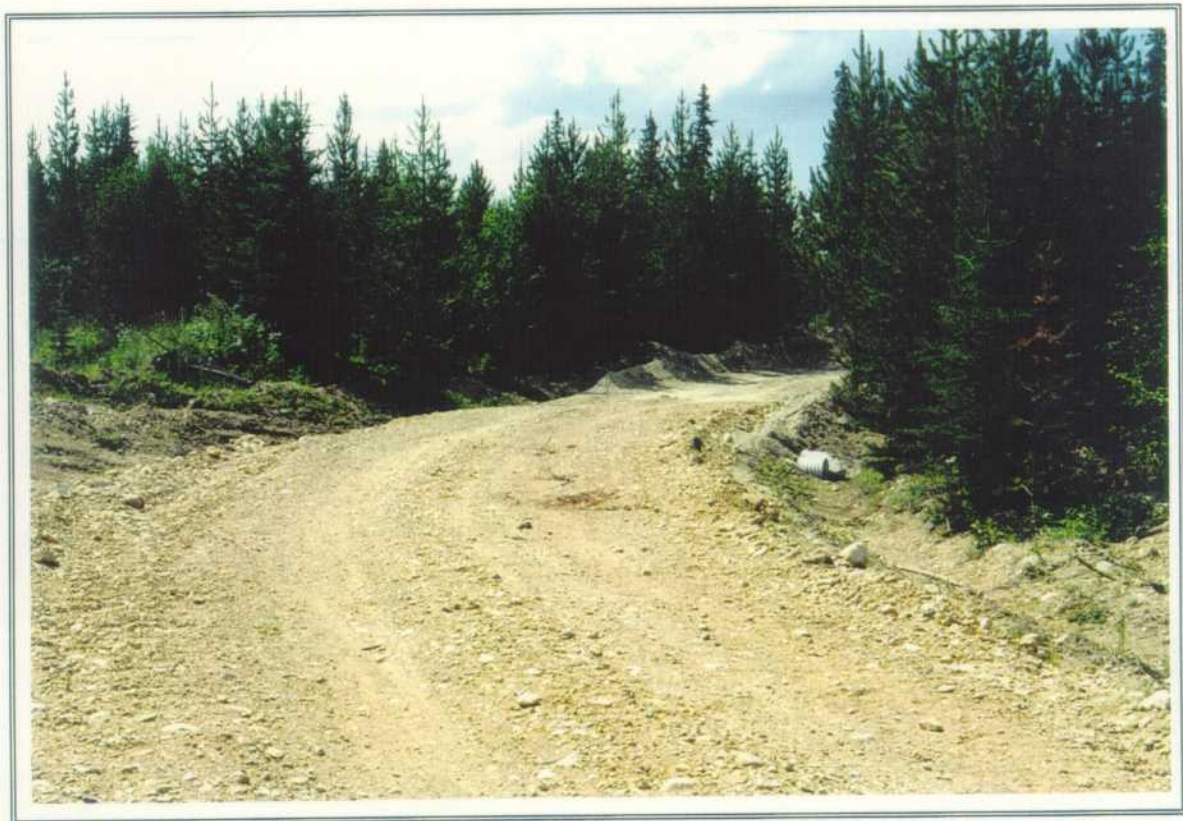
PHOTO 2. New road on the plateau section of the watershed. Coarse surfaced and well drained.

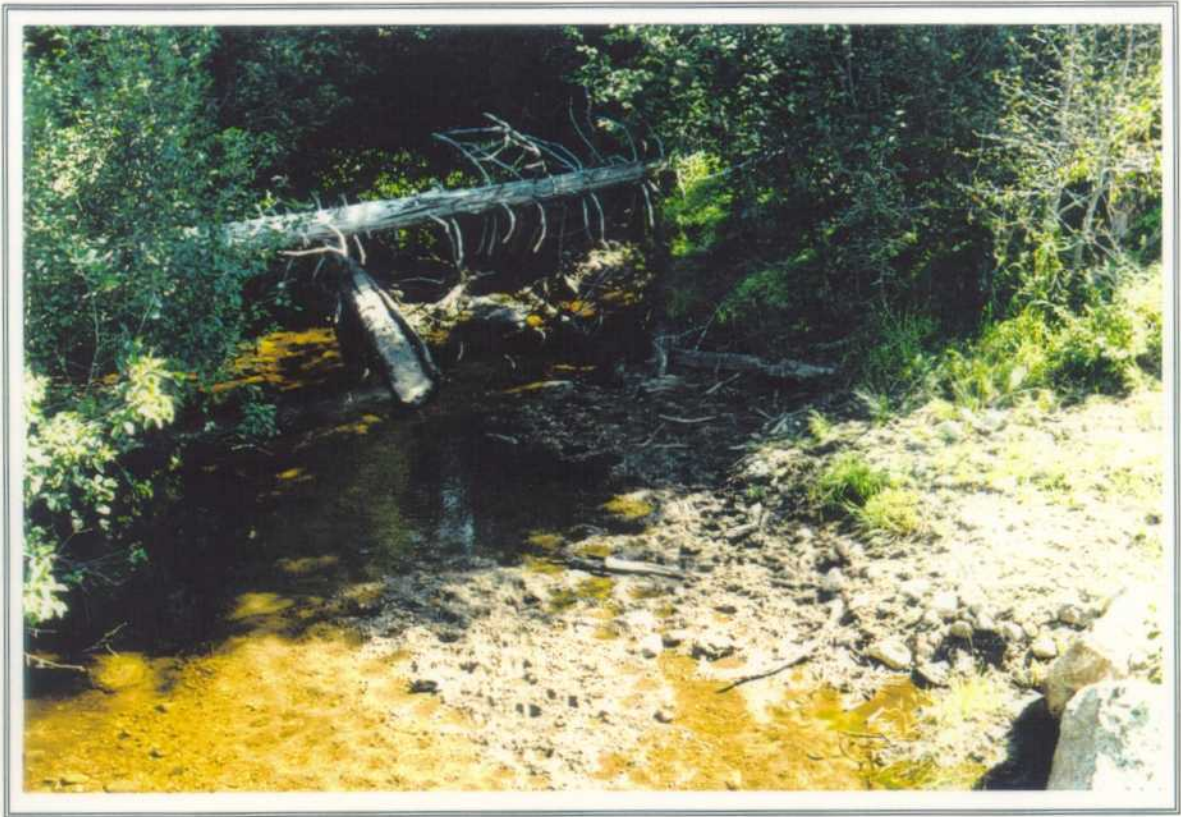
PHOTO 3. Direct cattle access and sedimentation in Duteau Creek at Philpot Road crossing upstream of Grizzly swamp.

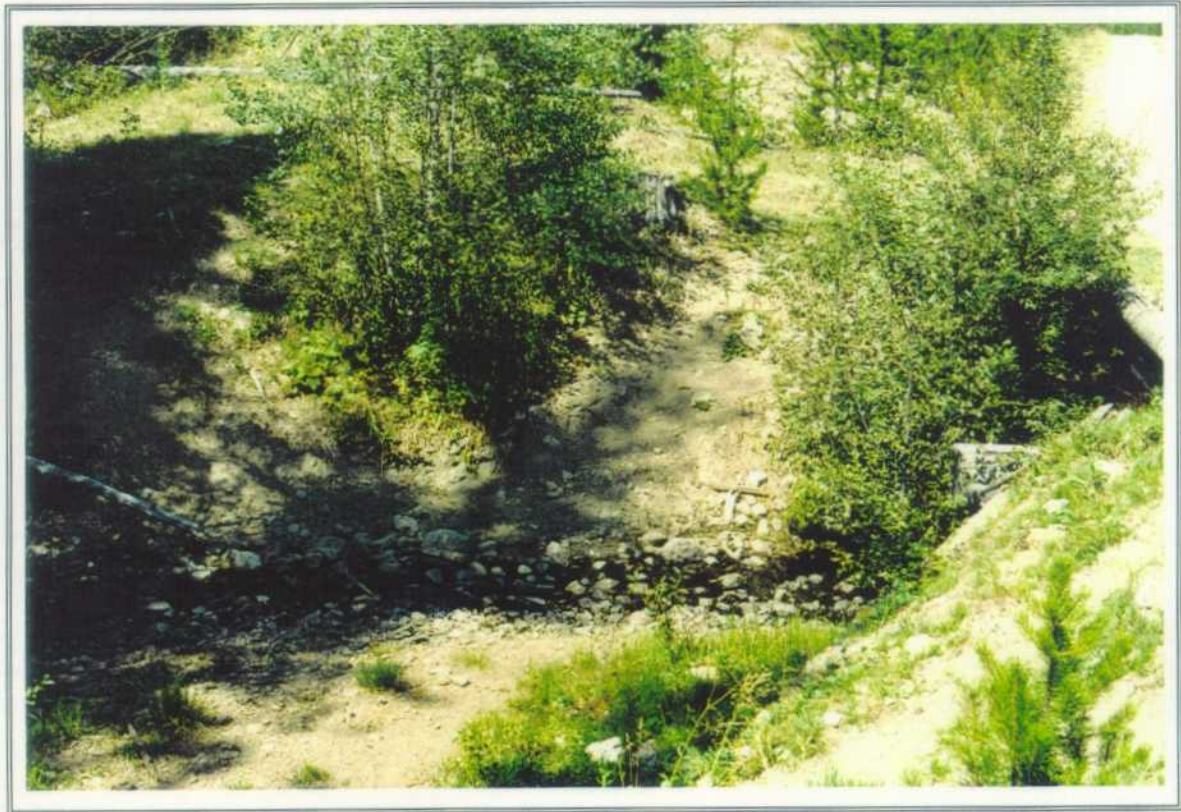
PHOTO 4. Cattle access to lower Curtis Creek at Curtis Mainline crossing.

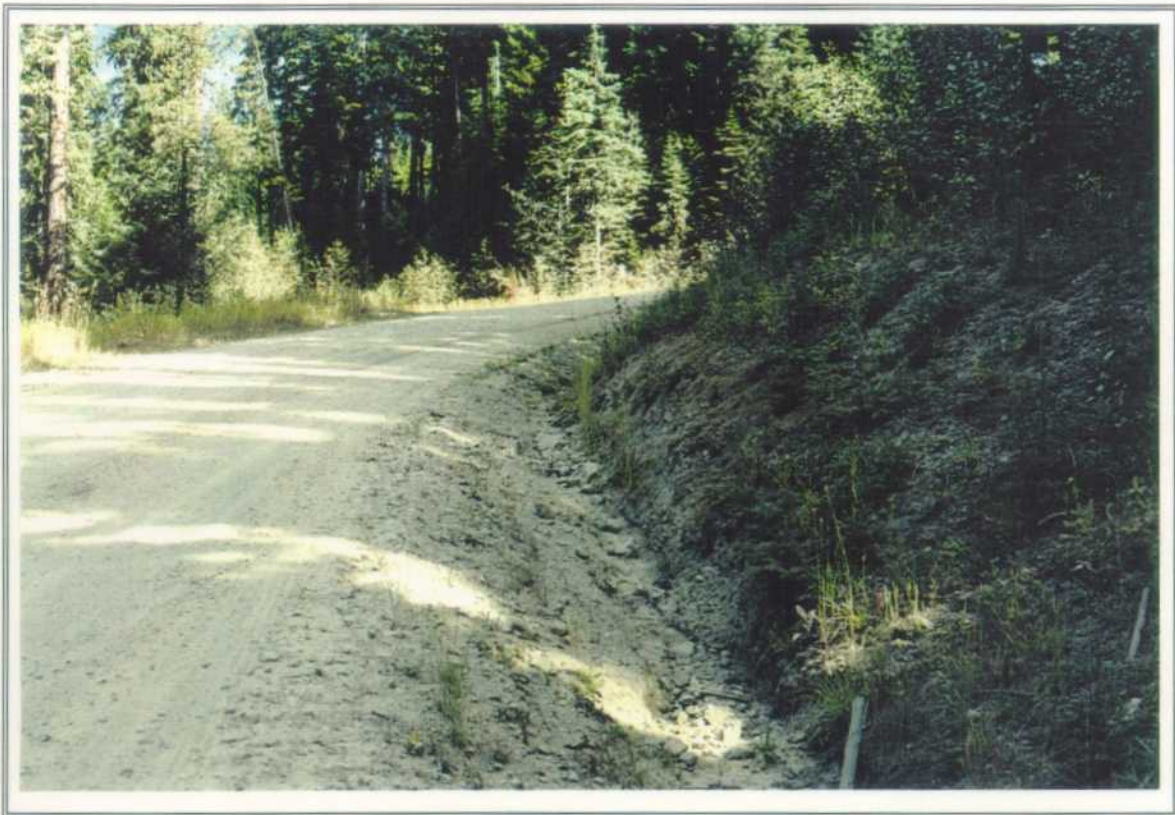
PHOTO 5. Evidence of ditchline scour beyond Duteau Creek crossing on Haddo FSR. Climbing section of road locally known as “throttle hill”.

- Surface erosion controls on “throttle hill” immediately beyond the Duteau mainstem crossing on the Haddo FSR.
- Removal of old cattle bridge from reach D upstream of Headgates.
- Improvement or deactivation of the access road through the canyon above Headgates.
- Joint review of the 533.1 road failures with Dobson Engineering Ltd., Riverside Forest Products Limited and NOWA to determine remediation alternatives.

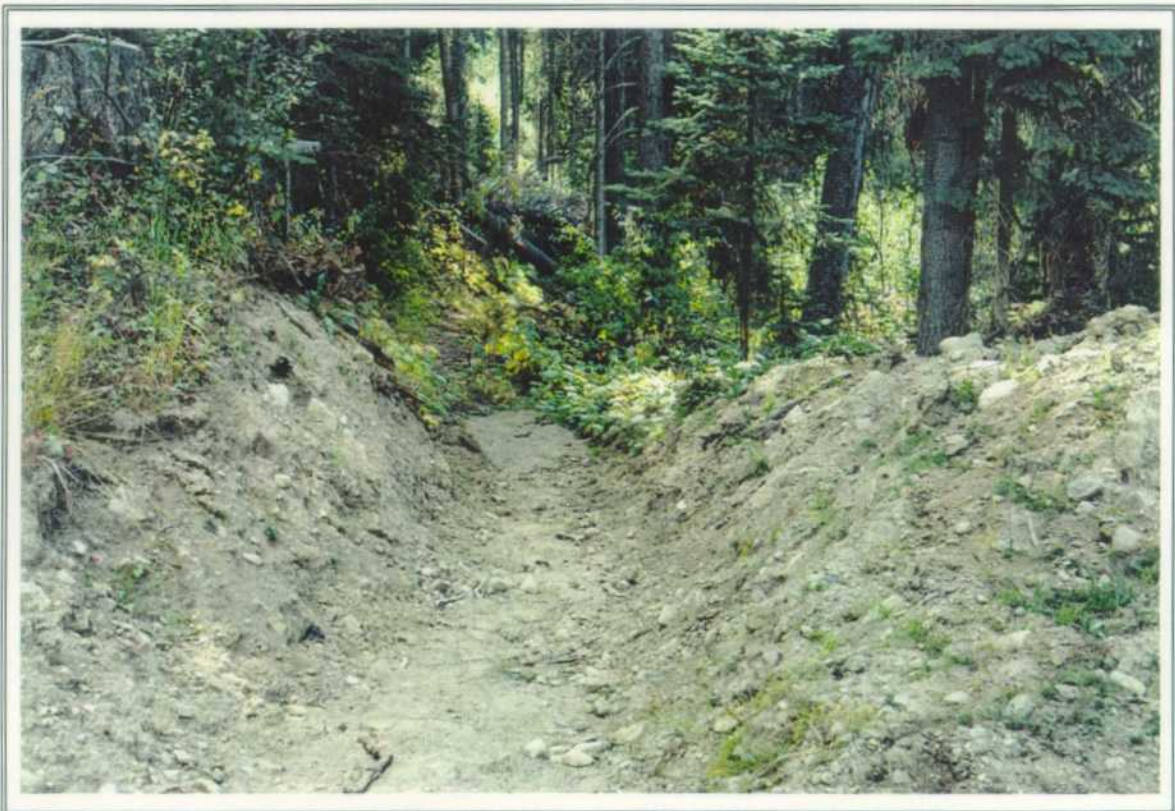
PHOTO 6. Recent (1998) ditchline cleaning and sump construction downslope of “throttle hill”. Fine sediment (sand and silt) still reaching Duteau Creek.

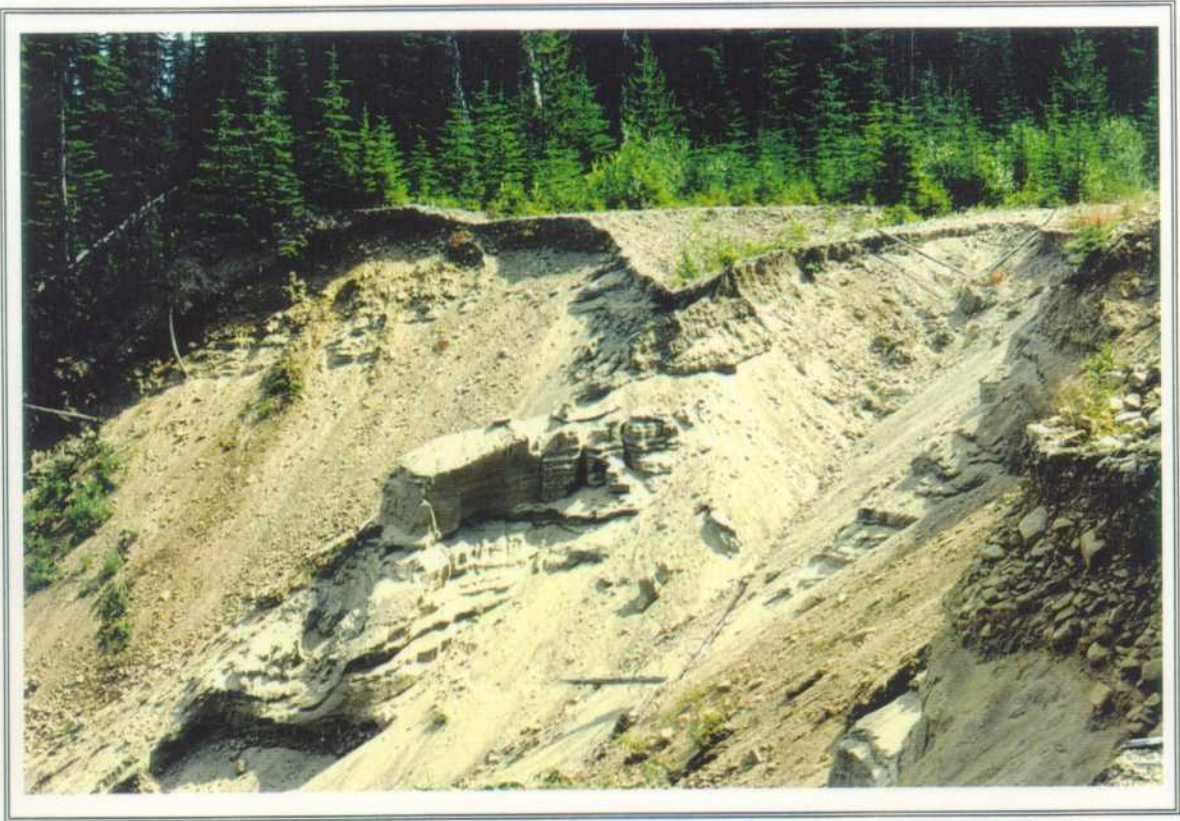
The road was constructed in glacio-fluvial and glacio-lacustrine deposits, and the failure was caused by road drainage saturation of fine sediment overlying an impermeable clay layer. Deactivation of the road was recommended with bank protection along Duteau Creek.

The high sediment source section is the failure on road 533.1 and the road running surface beyond the slide in the Duteau U/S of Grizzly sub-basin [*Photo 7*]. Secondary erosion of sand, silt and clay is occurring. A field review of this site with Riverside Forest Products Limited, NOWA and Dobson Engineering Ltd. is planned for 1999 to determine remediation alternatives.

PHOTO 7. Failure from the 533.1 road in the upper Duteau Creek sub-basin.

In the fall of 1998, Riverside Forest Products Limited pulled back the headscarp of the failure to minimize further raveling and sediment input to the channel. A joint review of the site with Dobson Engineering Ltd., NOWA and Riverside Forest Products Limited is planned in 1999 to discuss further rehabilitation options.

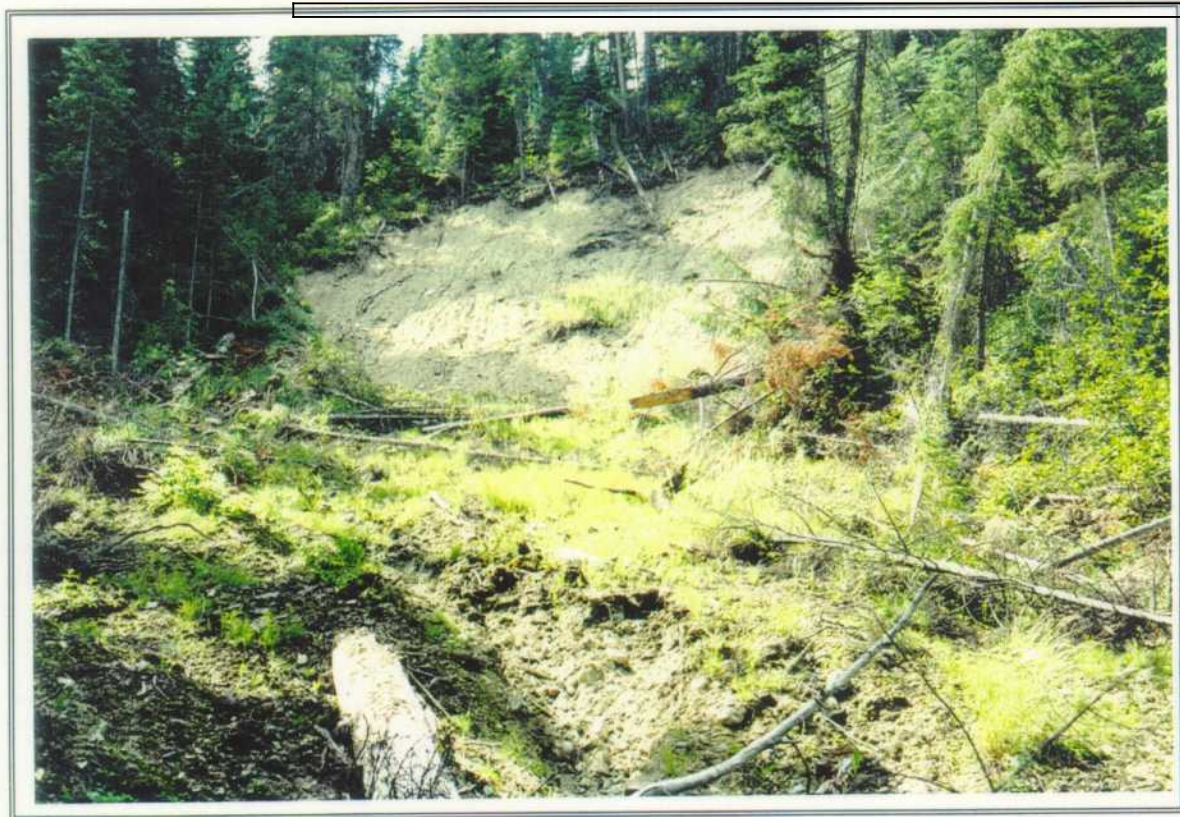
Also in July of 1997, a landslide occurred on the west bank of Duteau Creek approximately 0.5 km downstream of the Haddo FSR crossing near Edwin Lakes. The slide occurred on an undisturbed slope as a result of saturated soil conditions and possibly localized blowdown. An older slide scar was observed immediately upstream of the recent slide site. Bioengineering prescriptions were completed by Dobson Engineering Ltd. and the work was completed by Bar-Ten Springs Enterprises and NOWA in the fall of 1998.

PHOTO 8. 1997 slide into Duteau Creek from canyon wall approximately 0.5 km downstream of the Haddo FSR road crossing. This site was bioengineered in the fall of 1998.

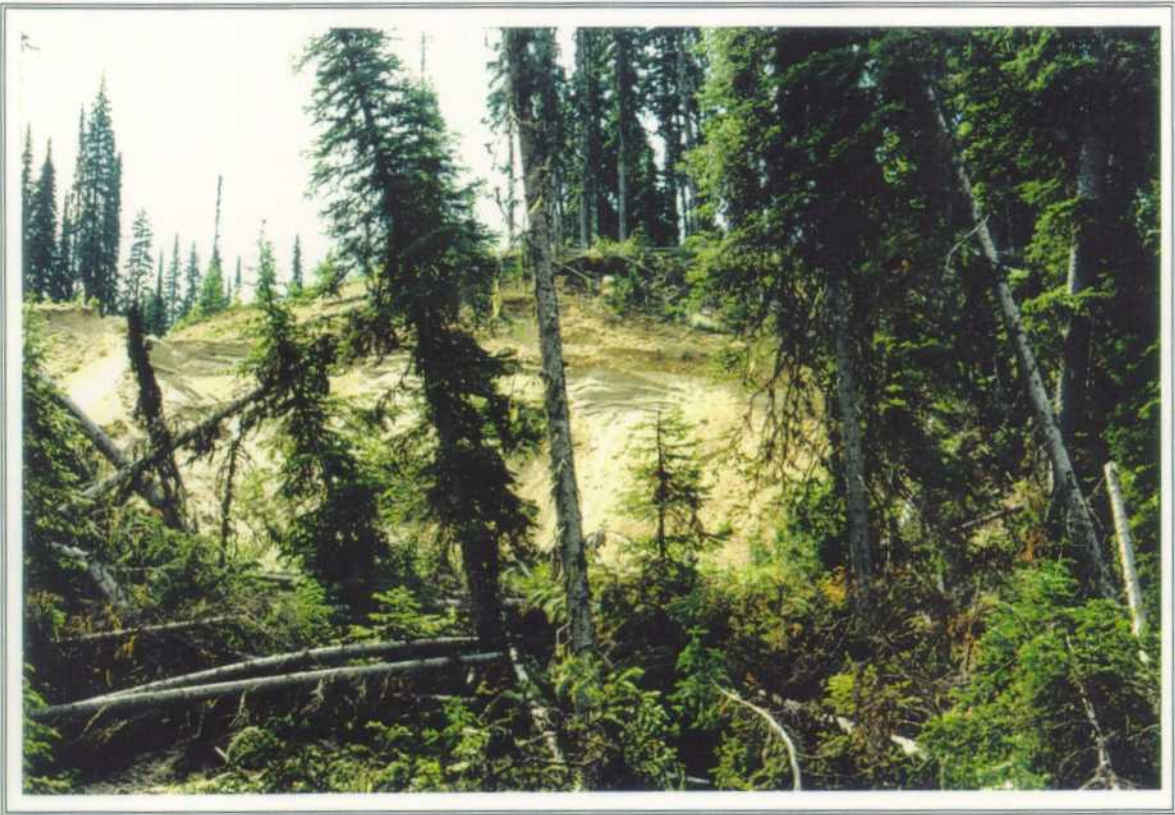
The landslides from the 533.1 road occurred in an isolated glacio-fluvial sand and silt deposit along the Duteau U/S of Grizzly mainstem channel in the upper watershed [Photos 9 and 10]. Other similar surficial deposits have been mapped as Class IV or V terrain along the Duteau Creek downstream of Haddo Lake and Crescent Creek mainstem channels. The completion of terrain stability field assessments and surface soil erosion hazard assessments where required for proposed roads and cutblocks in these areas should identify any terrain or surface erosion concerns prior to development.

PHOTO 9. Failure from the 533.1 road showing cross-bedding in isolated glacio-fluvial gravel, sand and silt deposits in the upper watershed.

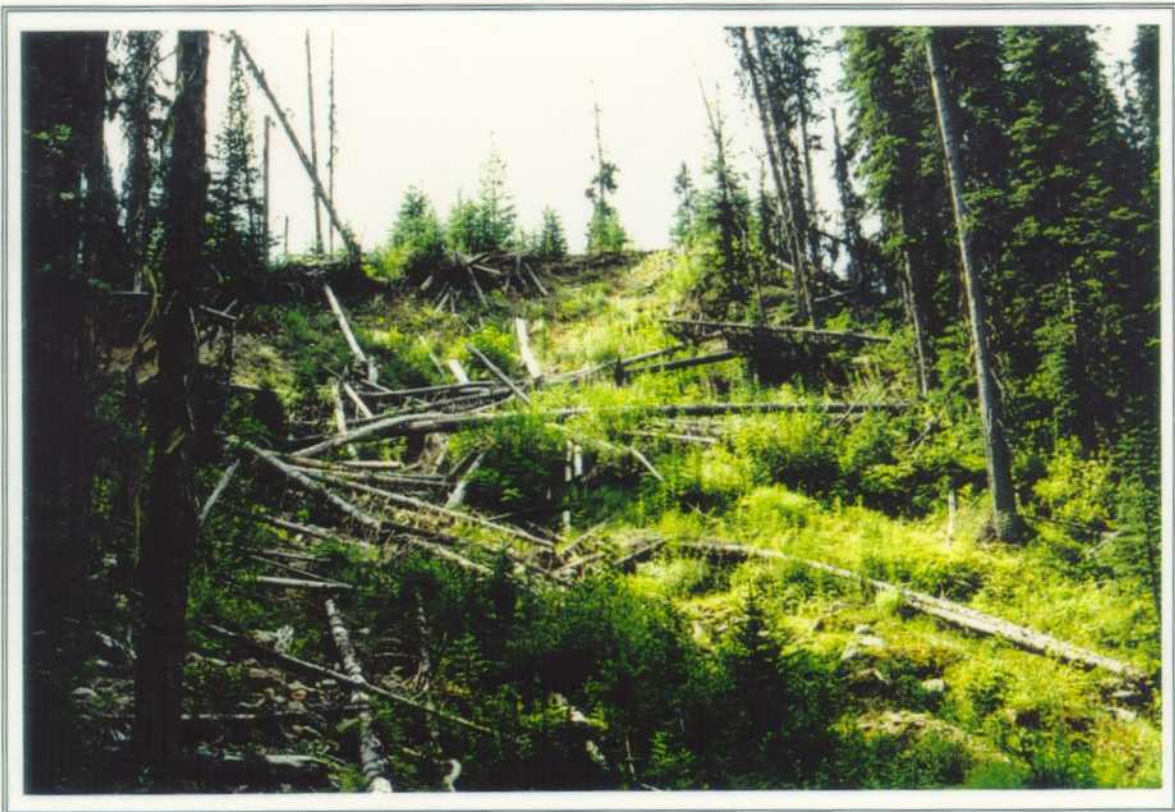
PHOTO 10. Older failure immediately upstream of the 533.1 road slide. This event is assumed to be between 10 and 15 years old.

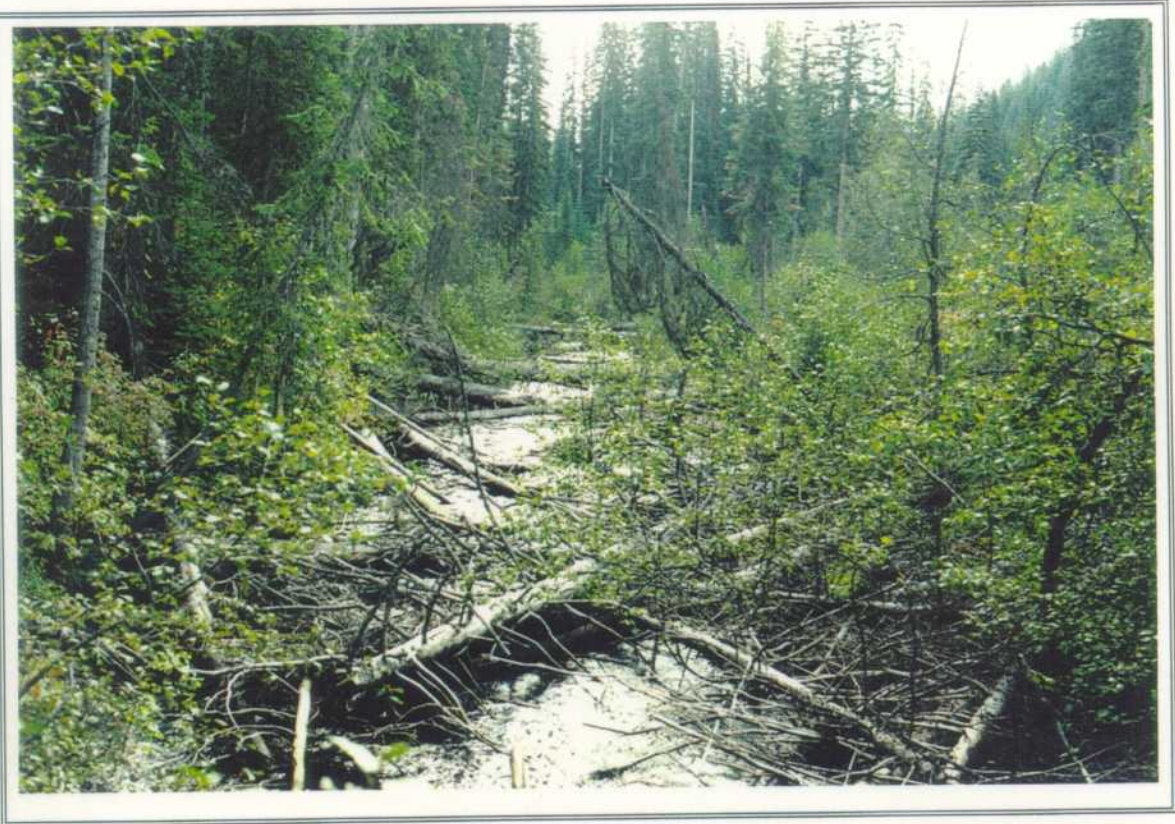
Both natural and cutblock boundary blowdown has occurred in the riparian zone between Haddo Lake and the upper canyon [Photo 11]. Partial salvage of accessible timber was completed in 1997 (CP 599). These reaches appear to be susceptible to blowdown and are sensitive to disturbance from increased woody debris input and possible avulsions. A Riparian Management Area (RMA) strategy should be developed for these reaches – one that reduces the risk of blowdown in the RMA and recommends possible salvage methods where blowdown occurs to be implemented on a site specific basis.

PHOTO 11. Blowdown along the Duteau Creek mainstem adjacent to opening CP 599. This woody debris will eventually rot and may lead to dams in the channel with avulsions and downstream sedimentation at the water intake.

No blocks are currently proposed along the Duteau Creek mainstem between Haddo Lake and the canyon. Blowdown has occurred along this reach in the past and further salvage activity may be required. A Riparian Management Area (RMA) strategy should be developed for these reaches – one that reduces the risk of blowdown in the RMA and recommends possible salvage methods where blowdown occurs to be implemented on a site specific basis.

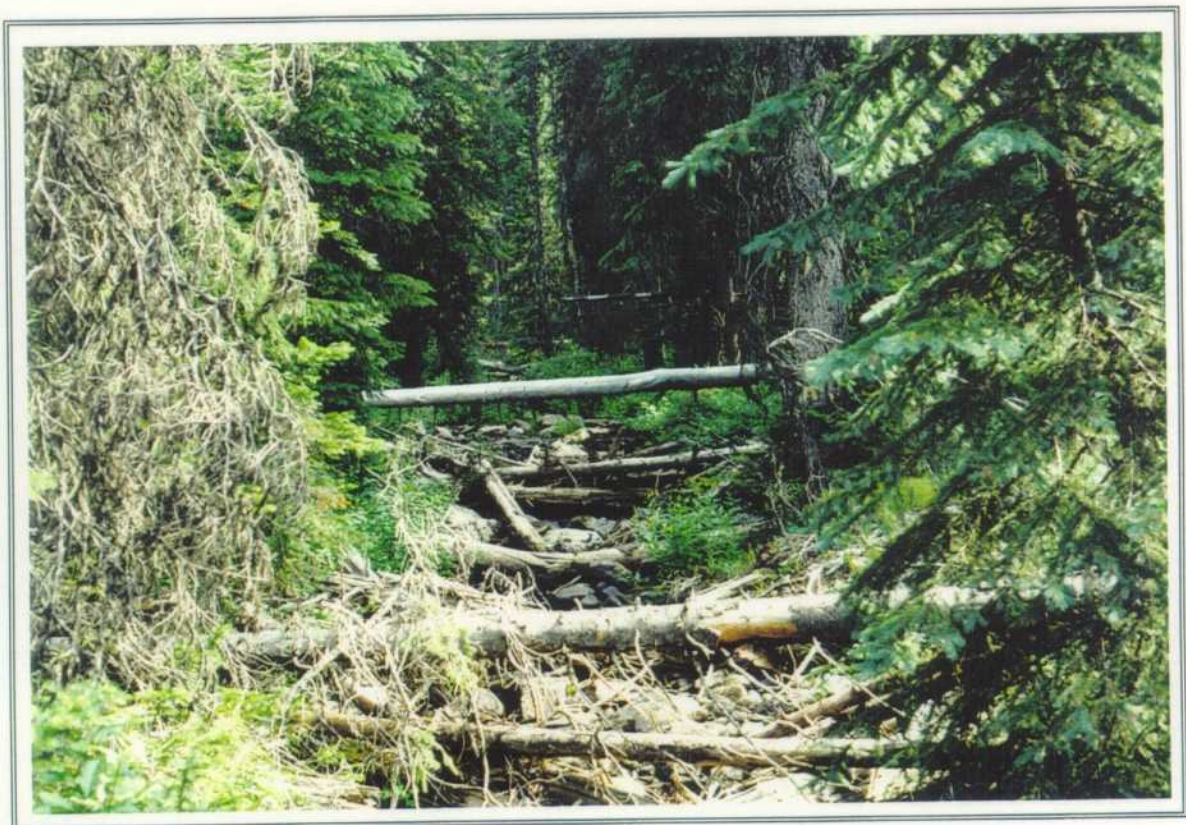
PHOTO 12. Reach L upstream of the 533.1 road failure. Stable cascade-pool morphology with large woody debris control.

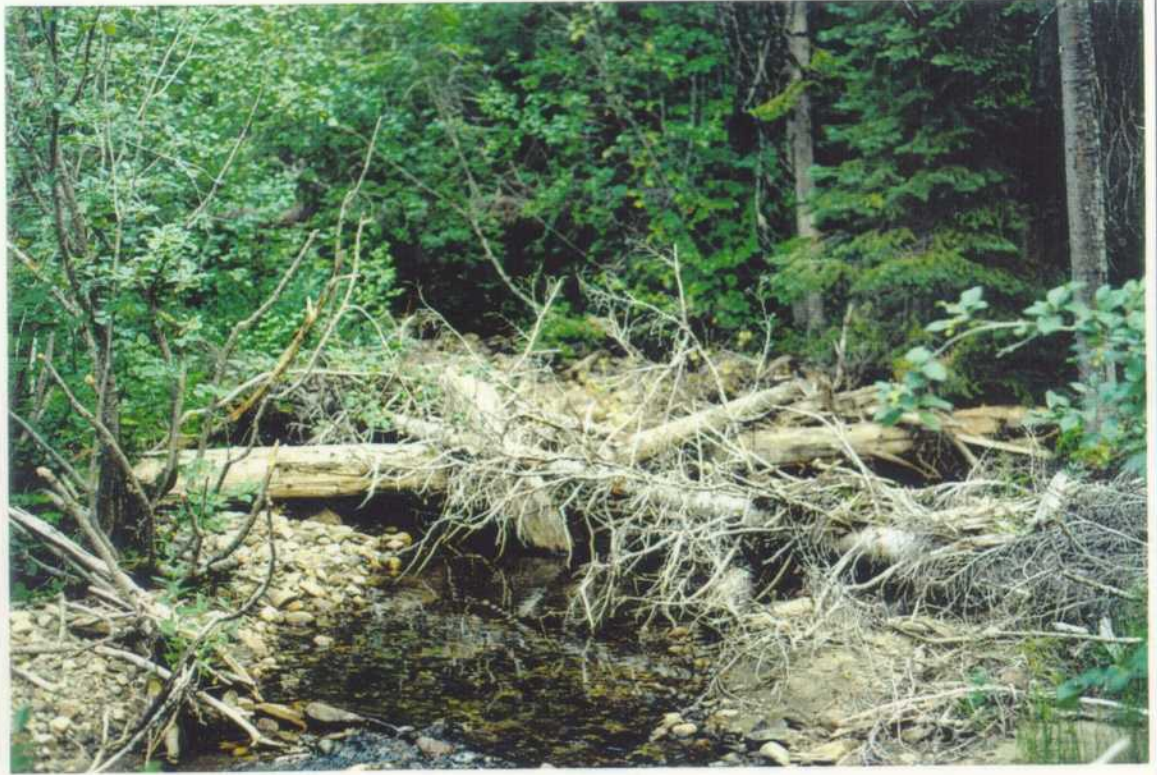
PHOTO 13. Reach K downstream of the 533.1 road failure. Channel is aggraded from sand and gravel input.

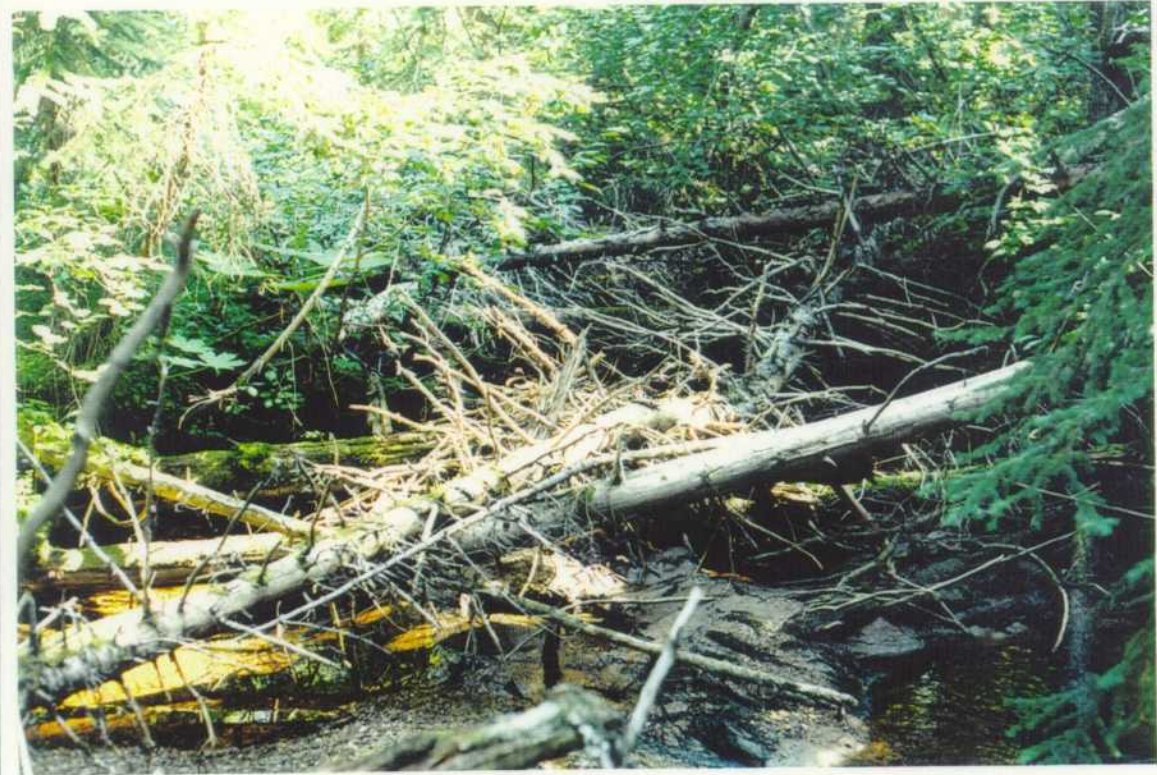
PHOTO 14. Reach J upstream of Grizzly swamp showing sand and small gravel bars transported downstream from slides on the 533.1 road. The sand and small gravel aggregate is mobile in the system.

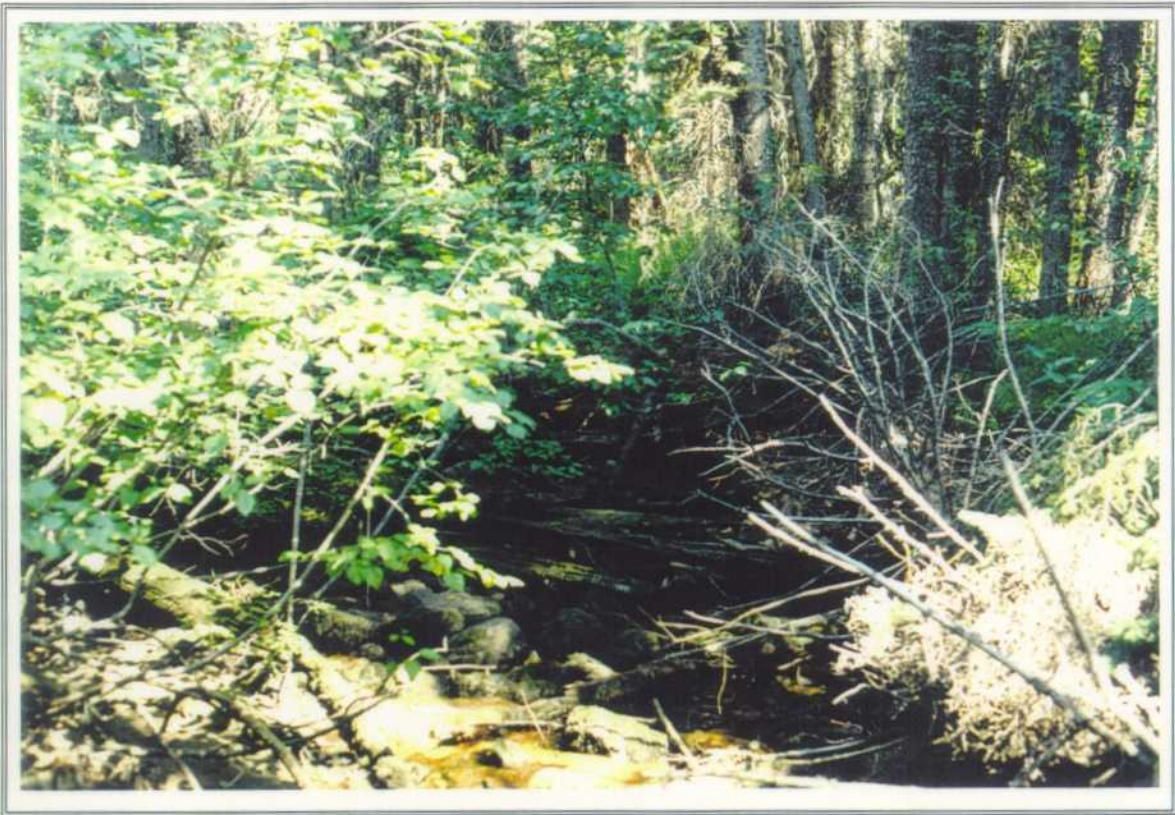
No reaches were delineated on Heart Creek. The mainstem channel has a low gradient stable riffle-pool morphology with large woody debris control [Photo 15]. Localized natural blowdown in the riparian zone is providing some sand and gravel input. No channel concerns were noted.

PHOTO 15. Heart Creek upstream of the Curtis mainline crossing. Stable cascade-pool and riffle-pool morphologies throughout with minor sand input from localized natural blowdown in the riparian zone.

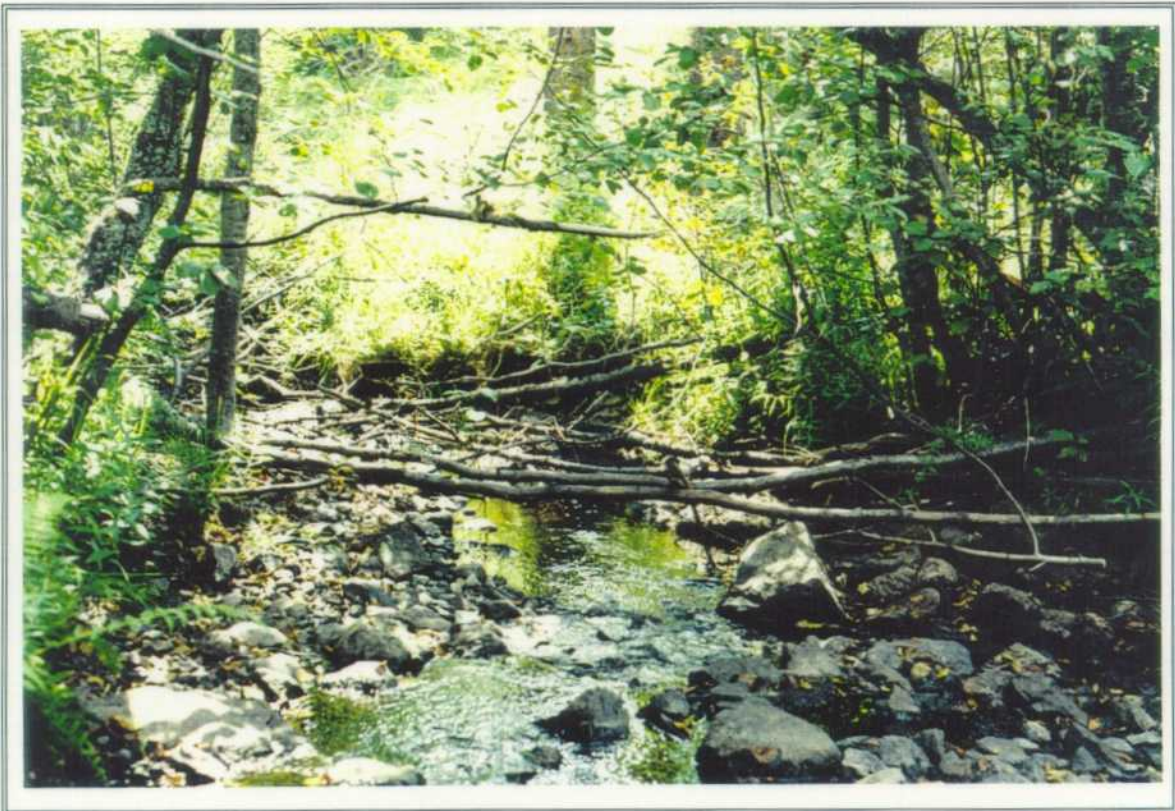
PHOTO 16. Alder and willow regeneration on the banks of Curtis Creek. The channel was logged to the banks in the mid-1980s. Direct cattle access to the channel was observed upstream and downstream of this location.

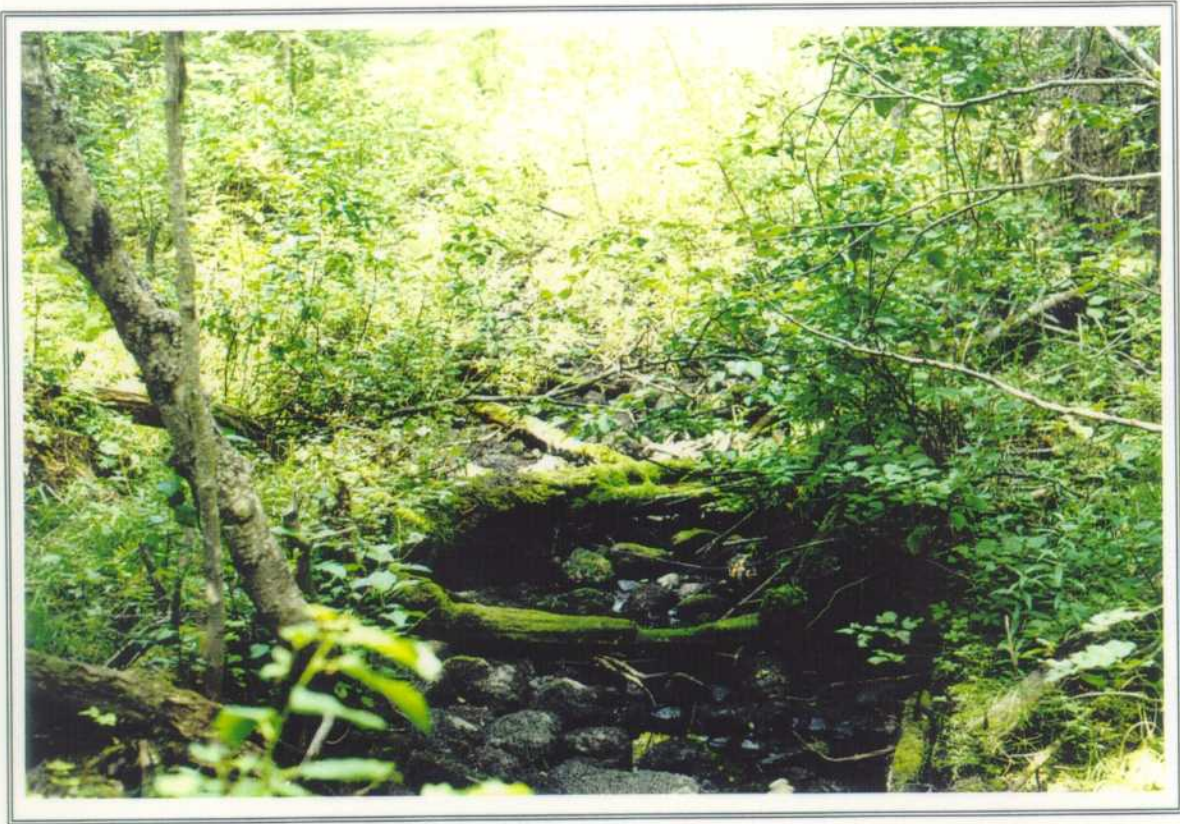
PHOTO 17. Lower Flyfish Creek with a stable cascade-pool morphology and regenerated alder, willow and conifer riparian zone.

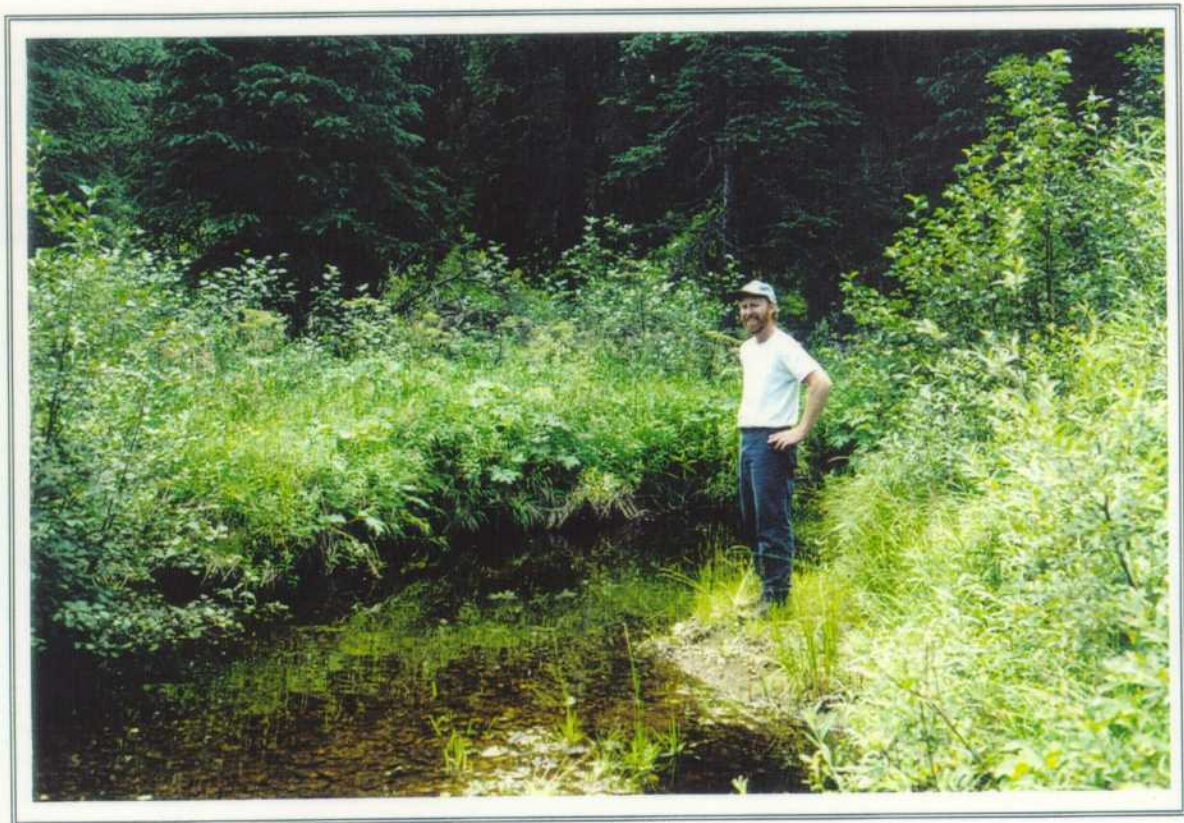
PHOTO 18. Flyfish Creek at the confluence with Duteau Creek. No evidence of peak flow related disturbance or increased sediment load.

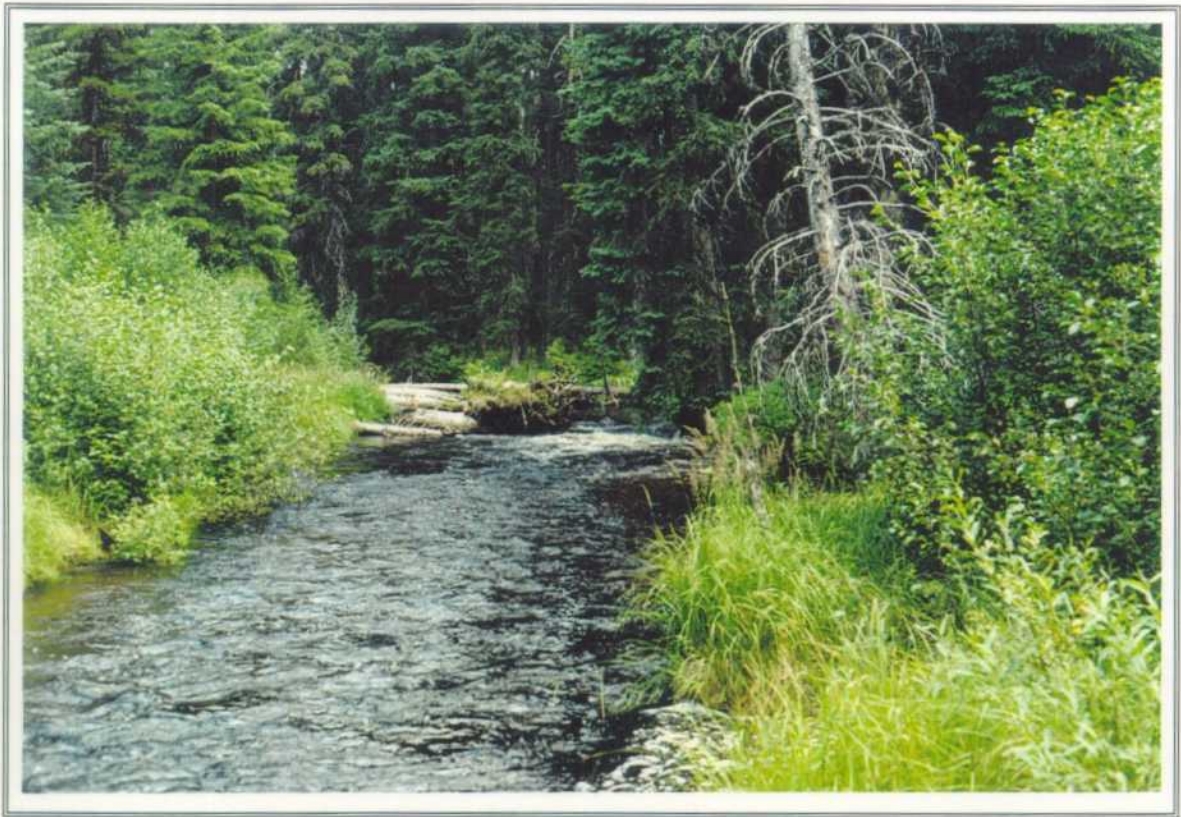
PHOTO 19. Duteau Creek downstream of Haddo Lake (reach H). Stable riffle-pool morphology with large woody debris control.

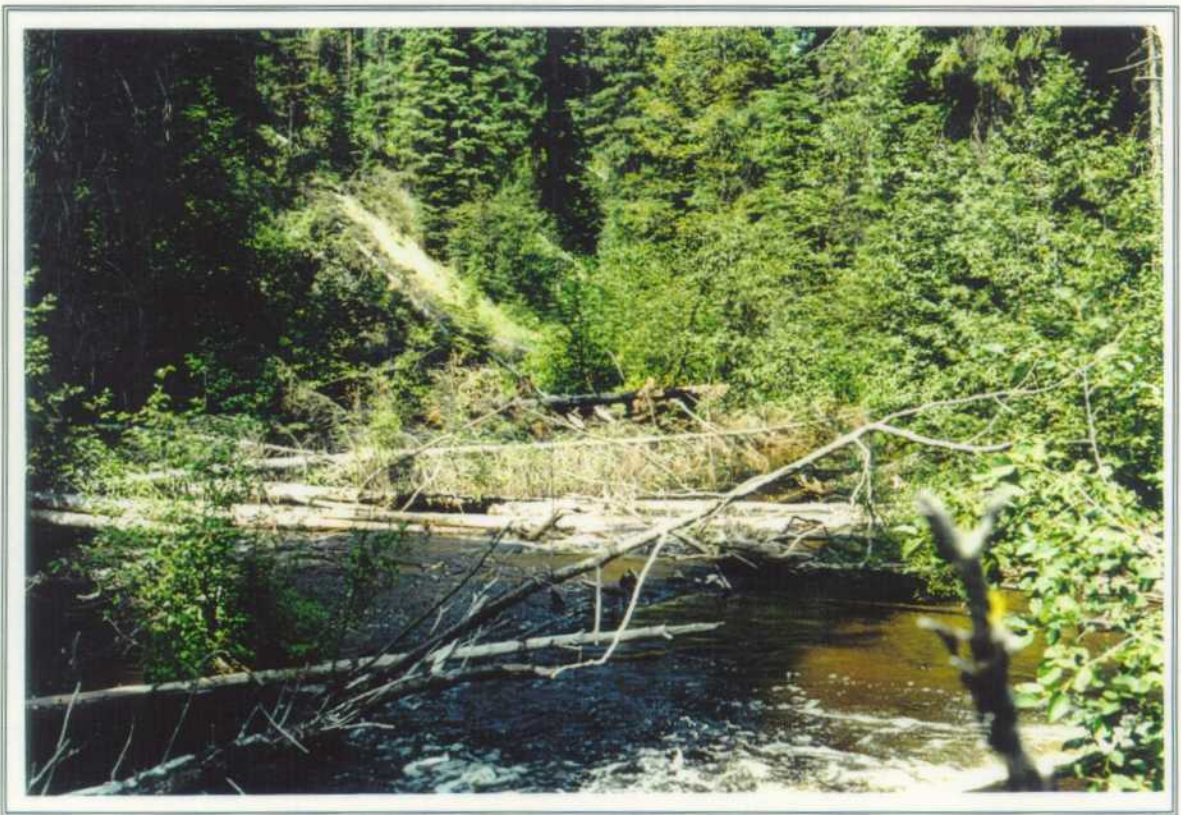
PHOTO 20. Duteau Creek downstream of the Flyfish Creek confluence (reach G). Large woody debris is abundant in the channel from natural blowdown in the riparian zone. The channel bed and banks are stable at this location.

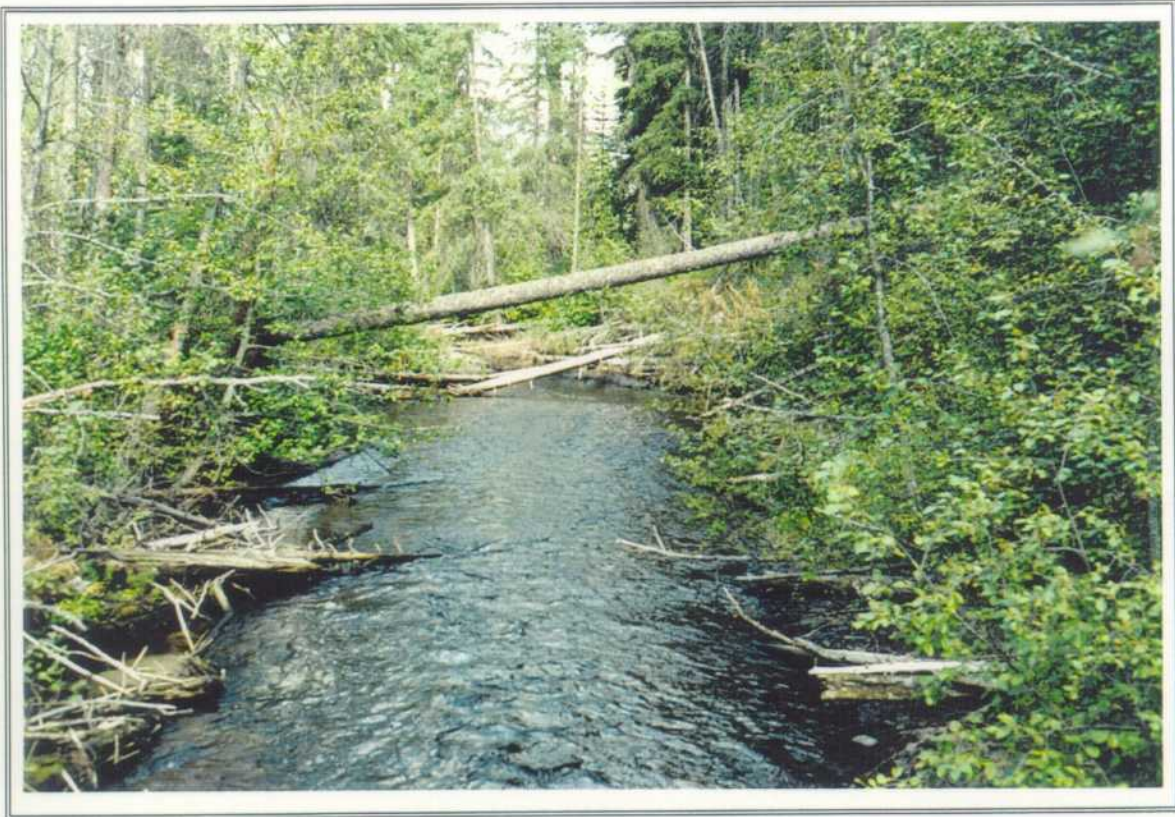
Reach F is also a low gradient riffle-pool channel extending to the head of the canyon. Large woody debris is abundant from localized blowdown, particularly along old block boundaries [Photos 11 and 21]. The majority of blowdown was observed to be spanning the channel at the assessment location and partial salvage had already been undertaken in the adjacent block (CP 599).

PHOTO 21. Stable riffle-pool channel (reach F) with abundant large woody debris from blowdown in adjacent opening CP 599.

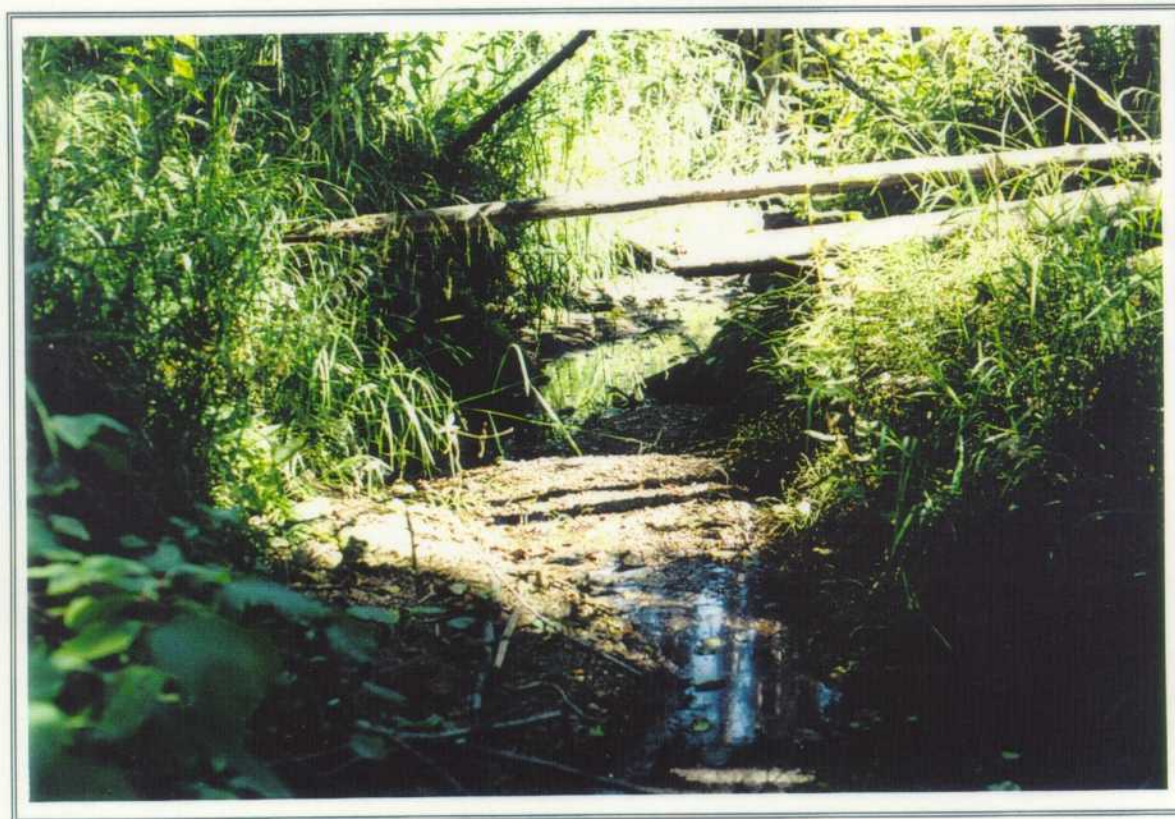
PHOTO 22. Crescent Creek upstream of the Aberdeen FSR road crossing. Sand and gravel bar deposits are present from early 1990s beaver dam release in the headwaters, and minor sediment input from direct cattle access to the channel.
