Interior Watershed Assessment
for the
DUTEAU CREEK WATERSHED
(Vernon Forest District)

Prepared for
RIVERSIDE FOREST PRODUCTS LIMITED
Lumby Division

by
DOBSON ENGINEERING LTD.
#4 - 1960 Springfield Road
Kelowna, B.C.
V1Y 5V7

March 1999

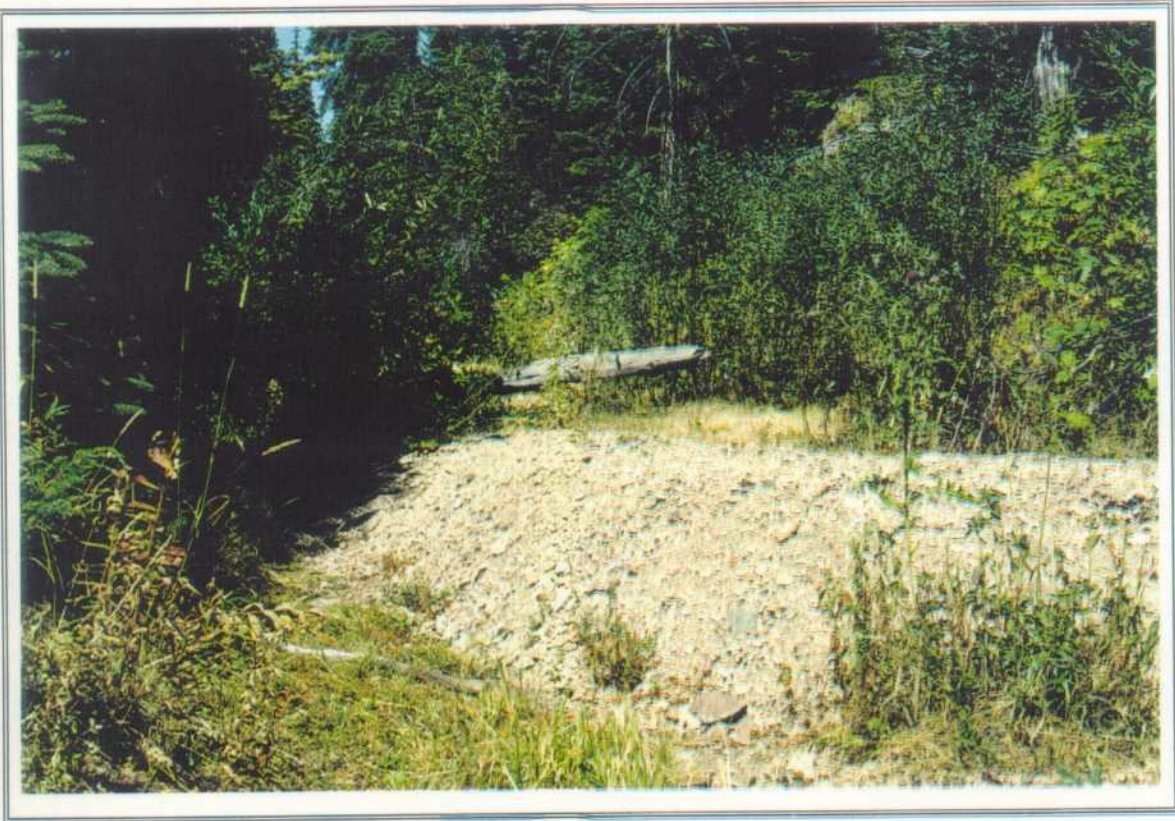
PHOTO 23. PHOTO 23. Upper Crescent Creek showing large mid-channel gravel and sand wedge formed during flood following beaver dam release.

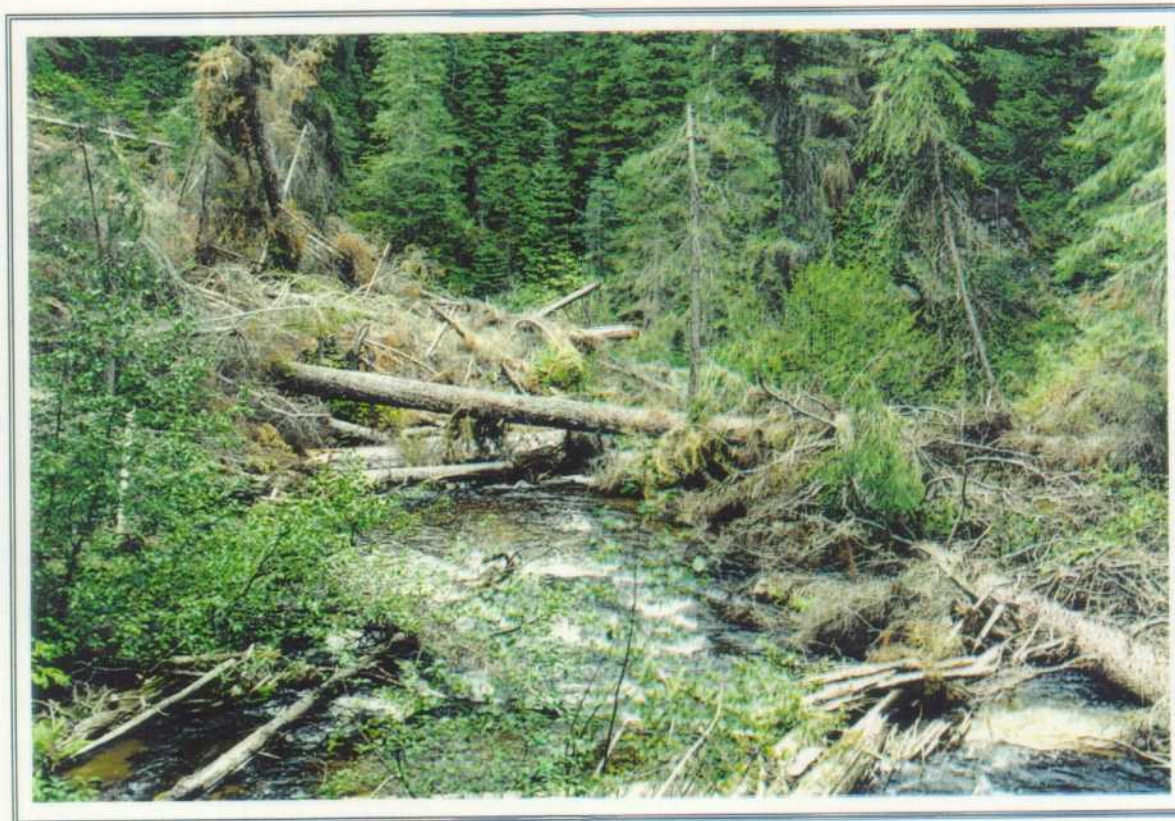
PHOTO 24. Woody debris introduced to reach D from the slide approximately 0.5 km downstream of the Haddo FSR crossing.

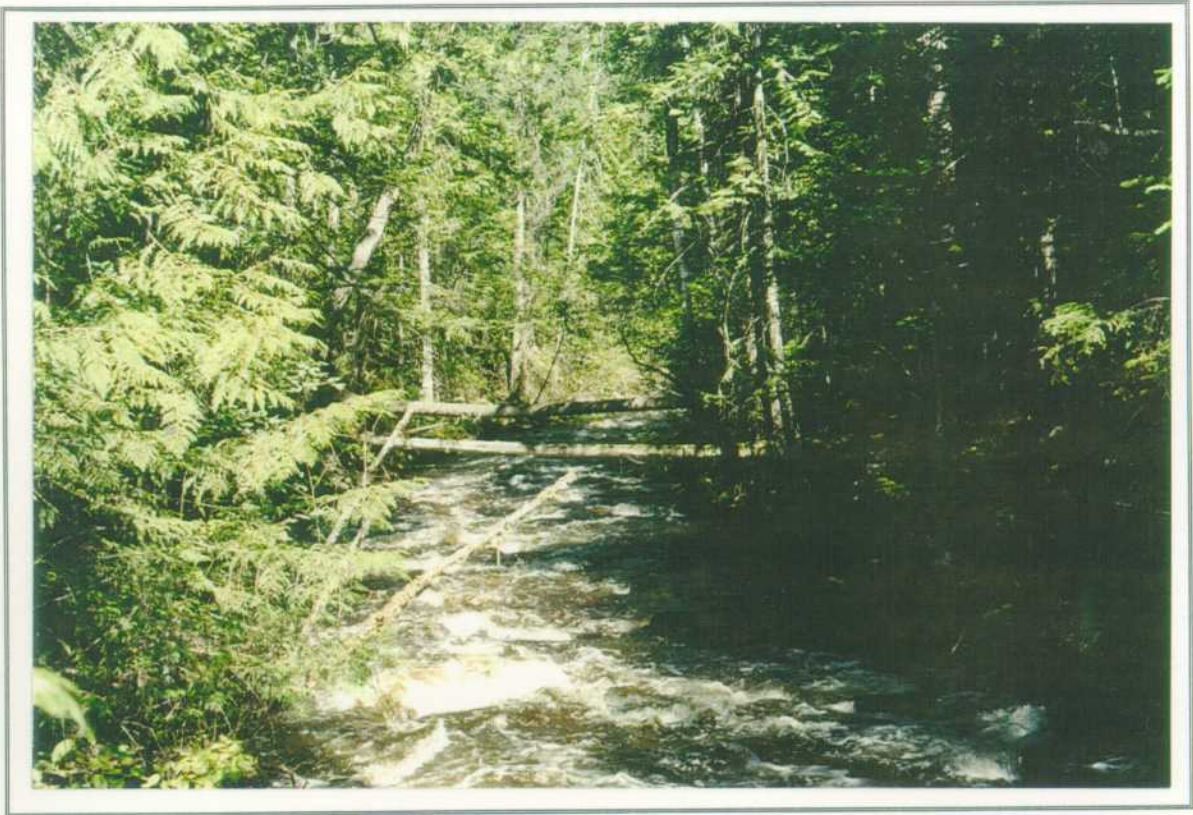
PHOTO 25. Duteau mainstem upstream of the Headgates reservoir (reach D). The channel bed and banks are stable through this reach and disturbance from high 1996 and 1997 flow events is not evident.

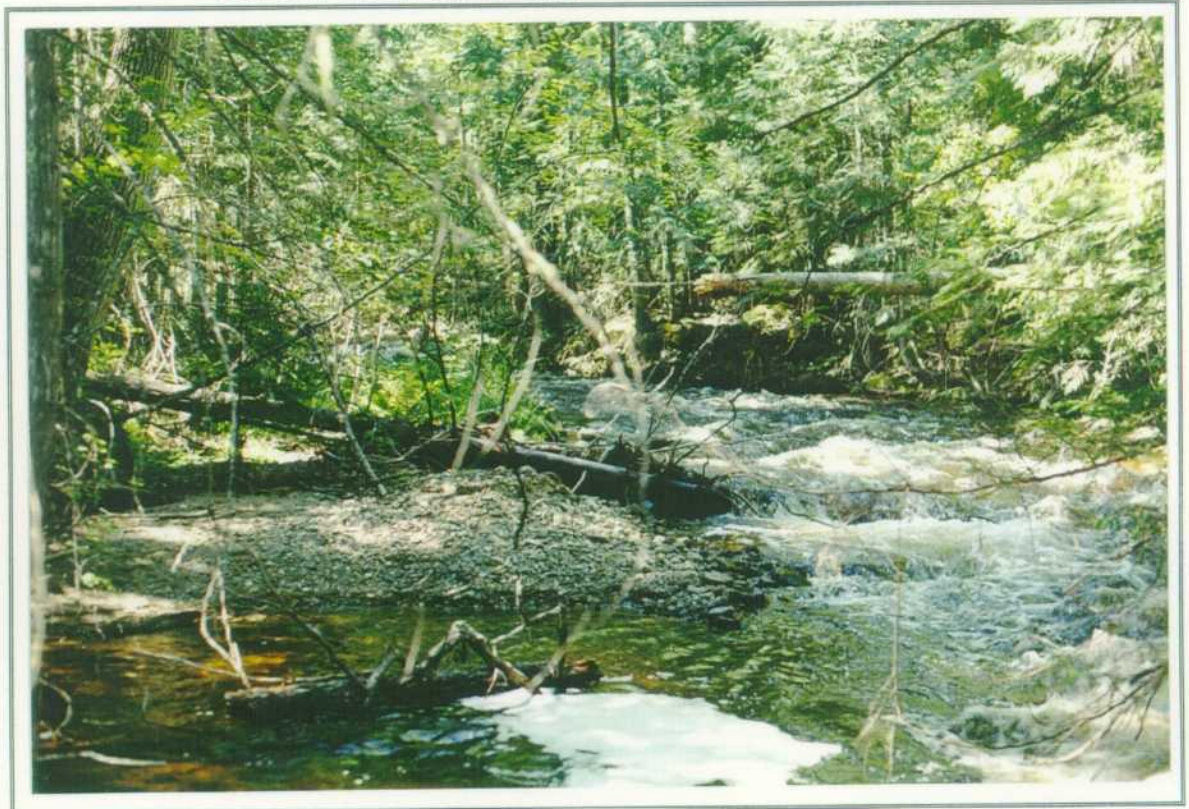
PHOTO 26. Sand and gravel bar accumulations from upstream slide input in reach D upstream of the Headgates reservoir. Elevated sedimentation levels in the reservoir can be anticipated until stored bar deposits are transported through the system.

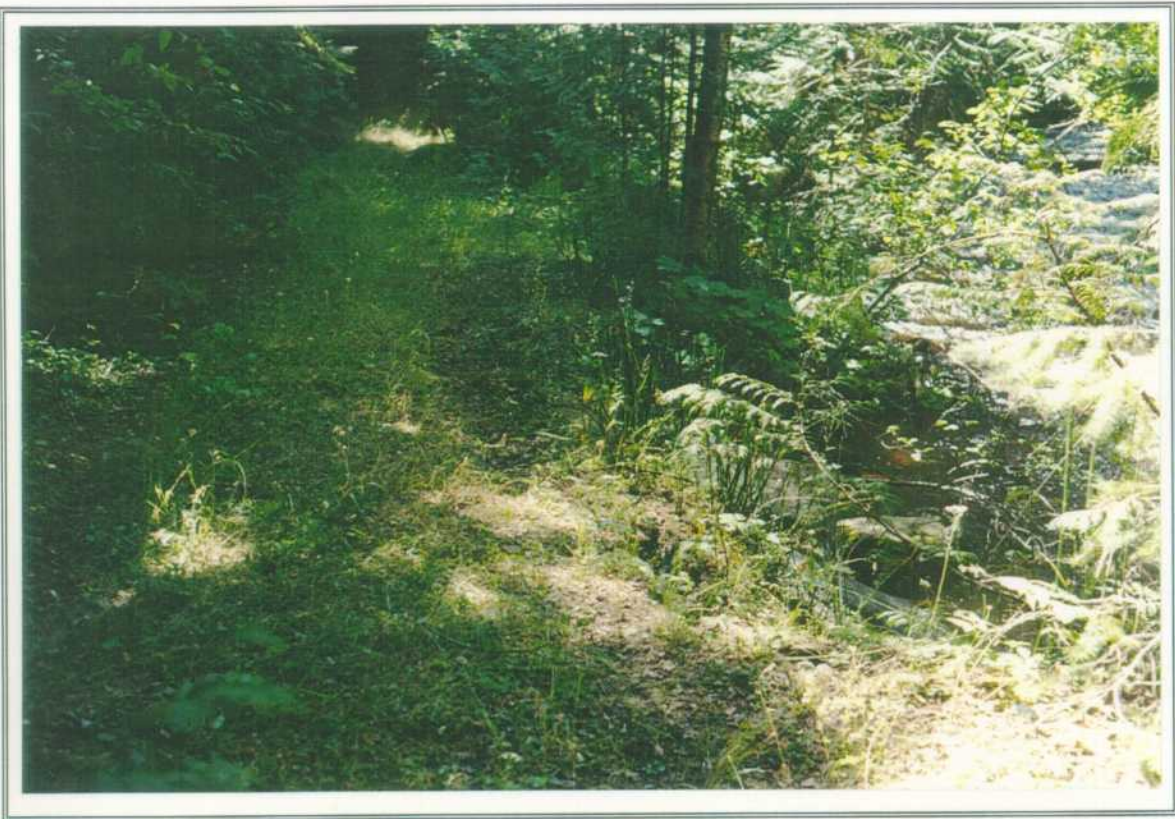
An old trail paralleling the mainstem channel with a cattle bridge approximately 2,000 m upstream of the Headgates intake was noted. Minor channel bank erosion and road fill failure was observed on the road [Photo 27], and the bridge is rotting and will soon collapse into the channel [Photo 28]. According to the range permit holder for the area, the bridge and access trail is no longer required. The bridge should be removed as soon as possible and eroding fill locations along the trail should be pulled back and either bioengineered or armoured.

PHOTO 27. Minor channel bank erosion and road fill input to the channel on old trail upstream of Headgates reservoir.

- Remove the cattle bridge from lower reach D and upgrade or deactivate the trail adjacent to the channel to reduce erosion and sedimentation.
- Continue proactive cattle management in conjunction with range permit holders and the MoF Range and Recreation Branches, particularly between Haddo Lake and the canyon and area around the upper reservoirs.
- Consider spawning substrate input to the Duteau Creek mainstem channel downstream of the Headgates intake.
- Complete the planned MELP/NOWA and SBFEP review of stream channels potentially affected by the Aberdeen fire, and rehabilitate disturbed stream channels and riparian areas where required.
- Assess observed bank shearing and channel sedimentation concerns in the Crescent, Flyfish and Curtis drainages and Aberdeen Residual area through the range use plan process.

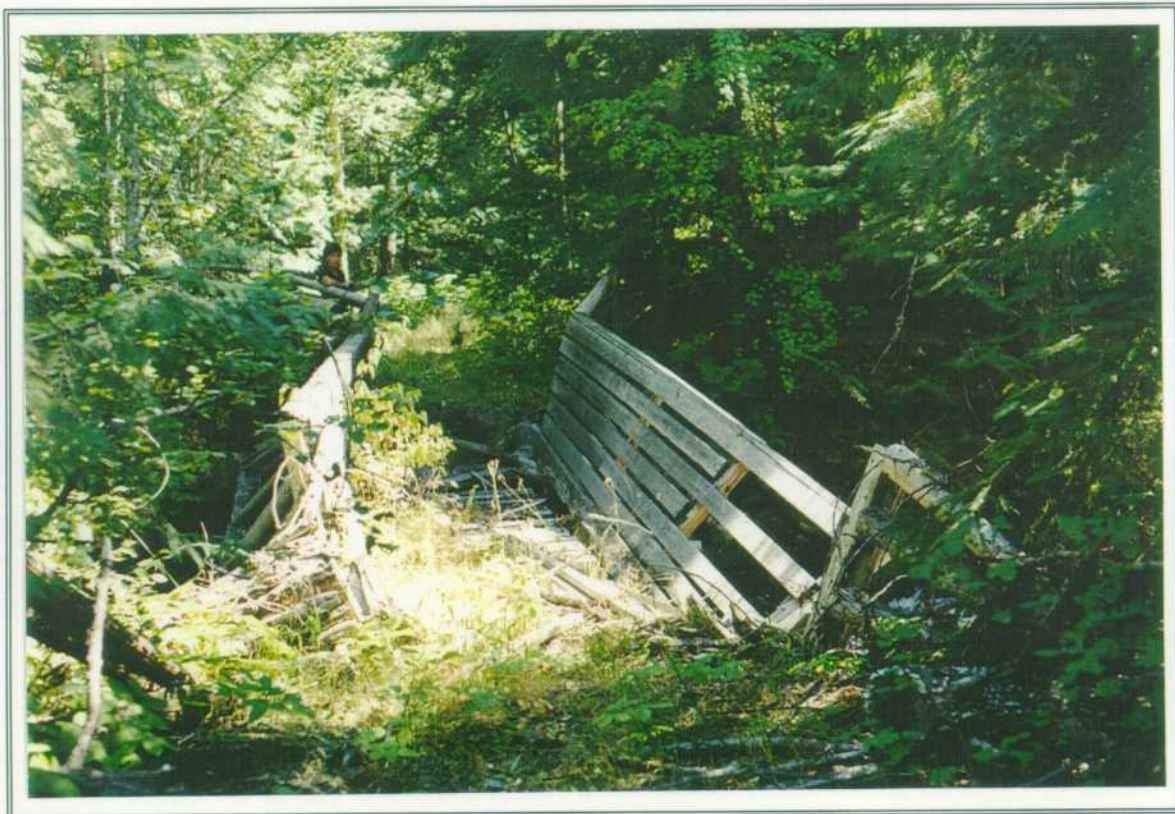
- An old cattle bridge and eroding access trail upstream of Headgates was noted in the field assessment. The bridge is rotting and will eventually collapse into the channel. Bridge removal and trail upgrading or deactivation would address these concerns.

PHOTO 28. Old cattle bridge over mainstem channel (reach D) above Headgates reservoir.

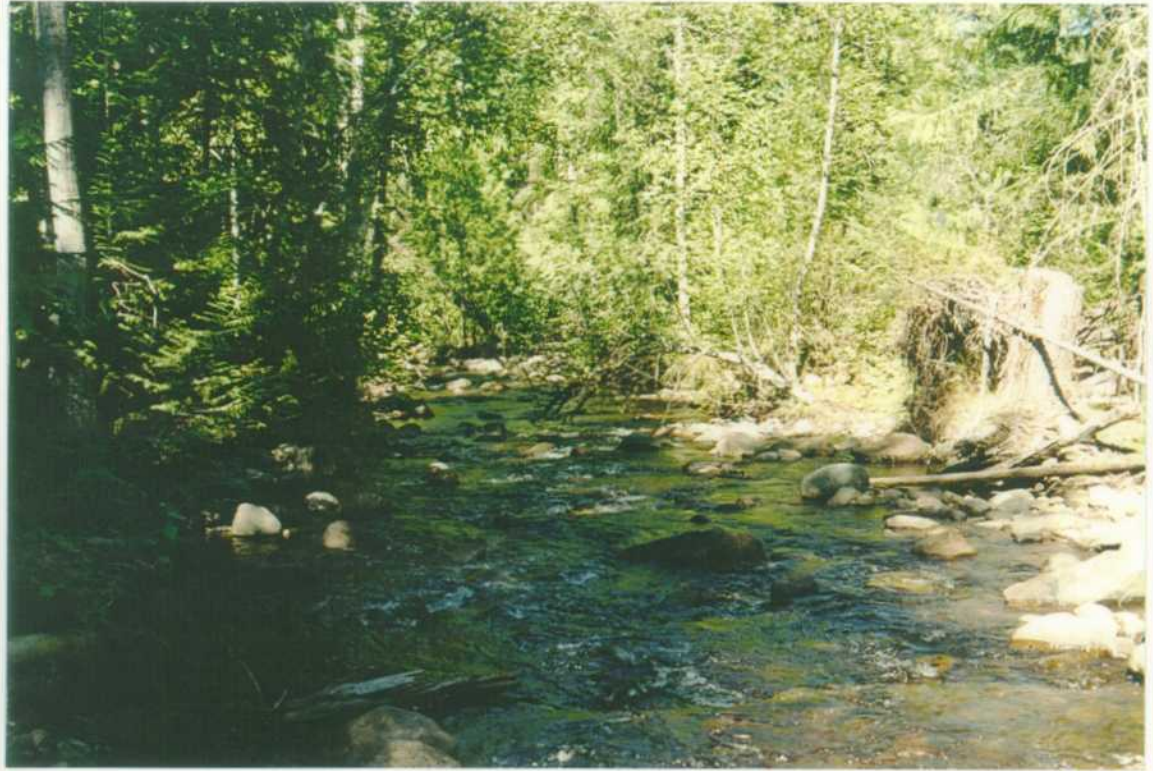
Downstream of Headgates (reaches B and C), the channel has a moderately degraded cascade-pool morphology as a result of bedload capture in the intake pond [Photo 29]. No bank disturbance or recent bedload movement was observed from the 1996 and 1997 spring freshet flows.

PHOTO 29. Duteau Creek mainstem channel downstream of Headgates reservoir (reaches B and C). The channel is armoured (degraded) and lacks sand and gravel bedload which is being captured in the reservoir upstream.

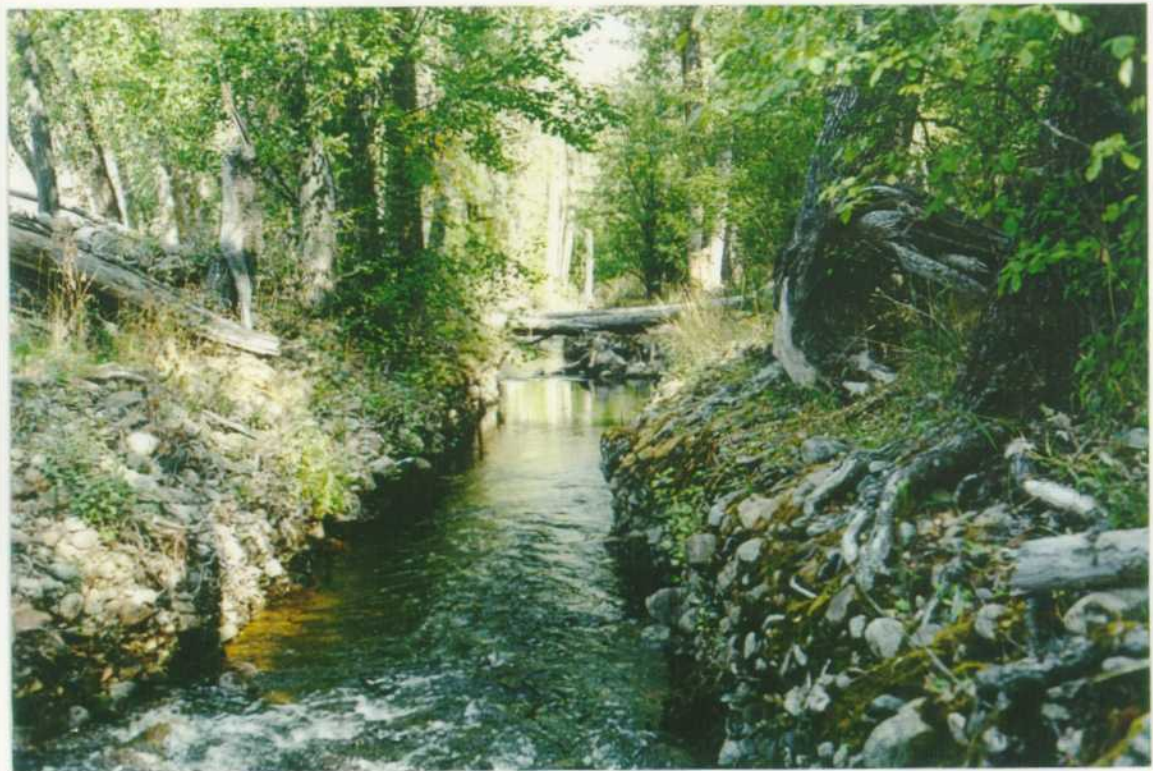
On the fan (reach A), the channel is also moderately degraded downstream of the Whitevale road crossing [Photos 30 and 31]. All of reach A is a riffle-pool channel flowing through alluvial deposits which are easily eroded if bedload supply or flow regimes are altered. The channel on the fan is valuable salmonid and resident trout spawning and rearing habitat and should be considered for enhancement. The re-introduction of spawning sized substrate below Headgates may be a possible mitigation alternative.

PHOTO 30. Scoured mainstem channel of Duteau Creek on the alluvial fan downstream of the Whitevale road crossing.

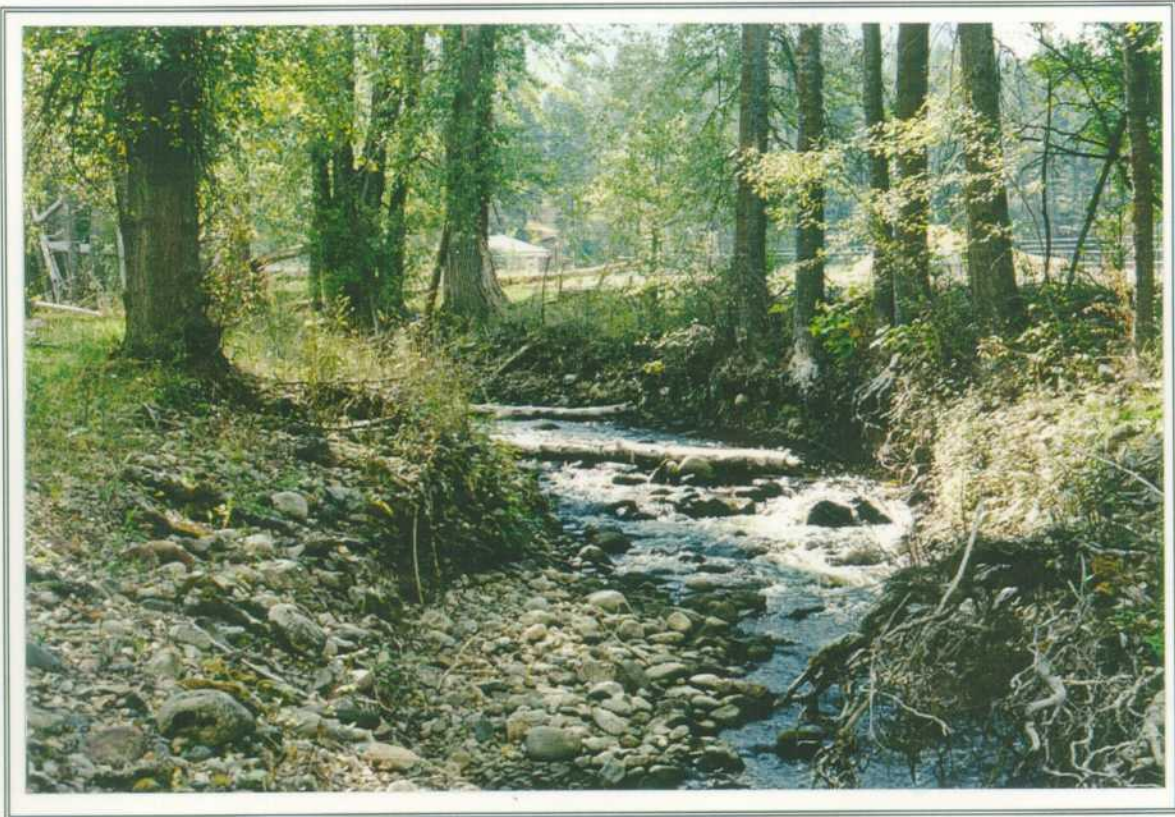
PHOTO 31. Mature poplar trees stabilizing bank materials in scoured section of Duteau Creek downstream of Whitevale road.
