# Executive Summary

In the spring of 1997, the Nadina Community Futures Development Corporation (NCFDC) was designated as a proponent for FRBC funding in a Watershed Restoration Program (WRP) project in the Mid-Bulkley Watershed (see figure 1). The NCFDC is a non-profit community economic development corporation based in Houston, British Columbia. The implementing partner in this endeavor was the Ministry of Environment, Lands, and Parks, Skeena Region BC Environment office (MELP).

The British Columbia Conservation Foundation (BCCF) was contracted by NCFDC to carry out a WRP Detailed Level 1 Fish, Fish Habitat and Riparian Assessment in the summer of 1998.

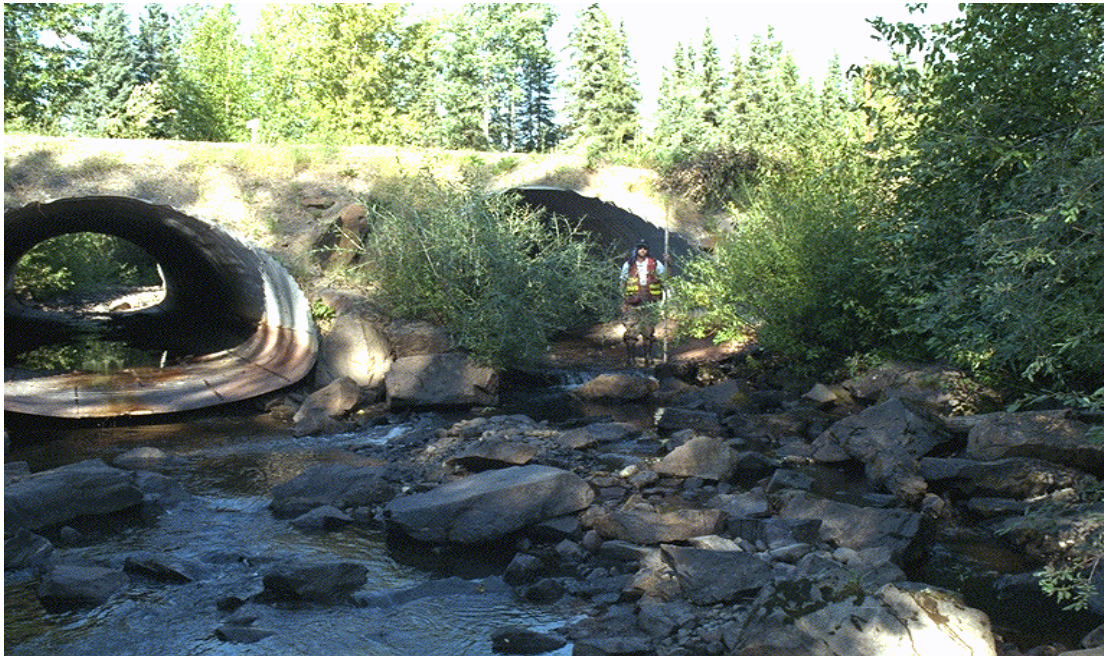
**Impact Description:** Channelizing on both banks with rip-rap to bankfull height, two pipe-arch culverts, one impassable at most flows, both impassable at low flows.

**Prescription Photo:** Representative shot of impacted area showing culverts with summer low flow water levels.

**Goal(s):** To complex habitat and dissipate hydraulic energy. To provide access upstream to juvenile salmonids during the summer low-flow period.

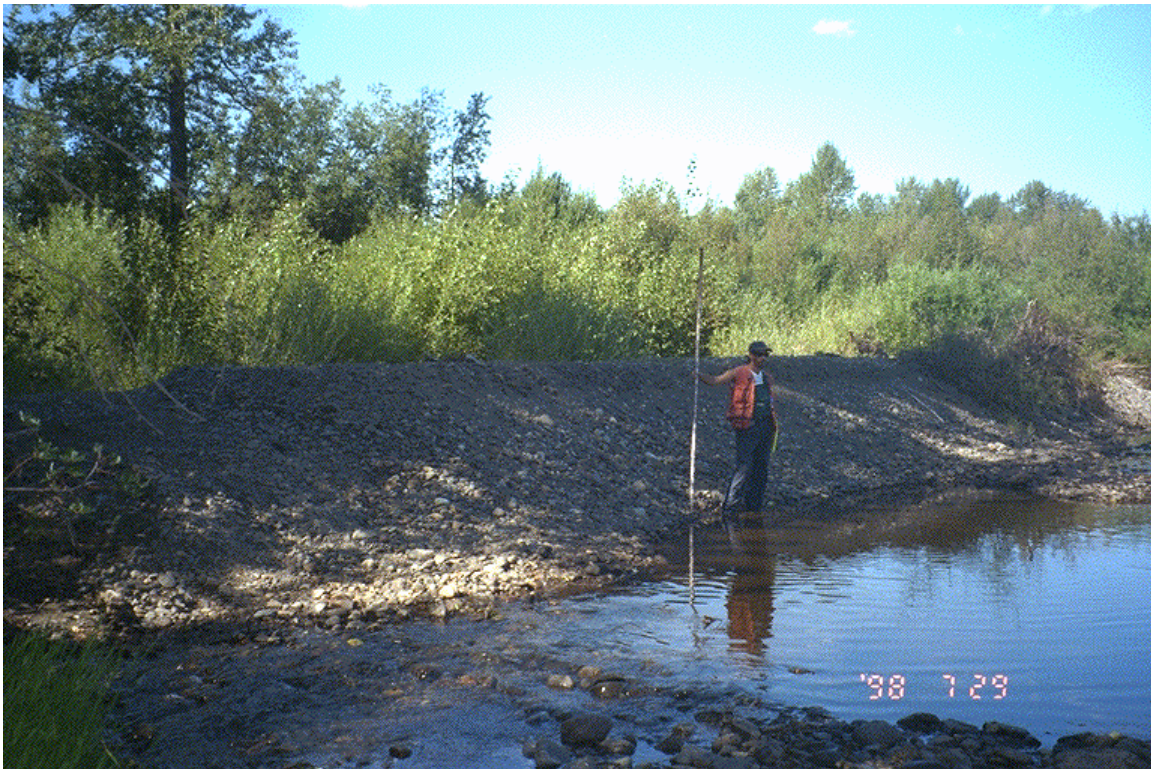
**Impact Description:** Extensive point and mid-channel bars due to upstream sources of sediment and bedload.

**Prescription Photo:** Representative photo of extensive aggradation, showing elevated lateral bar at 0+160 metres upstream.

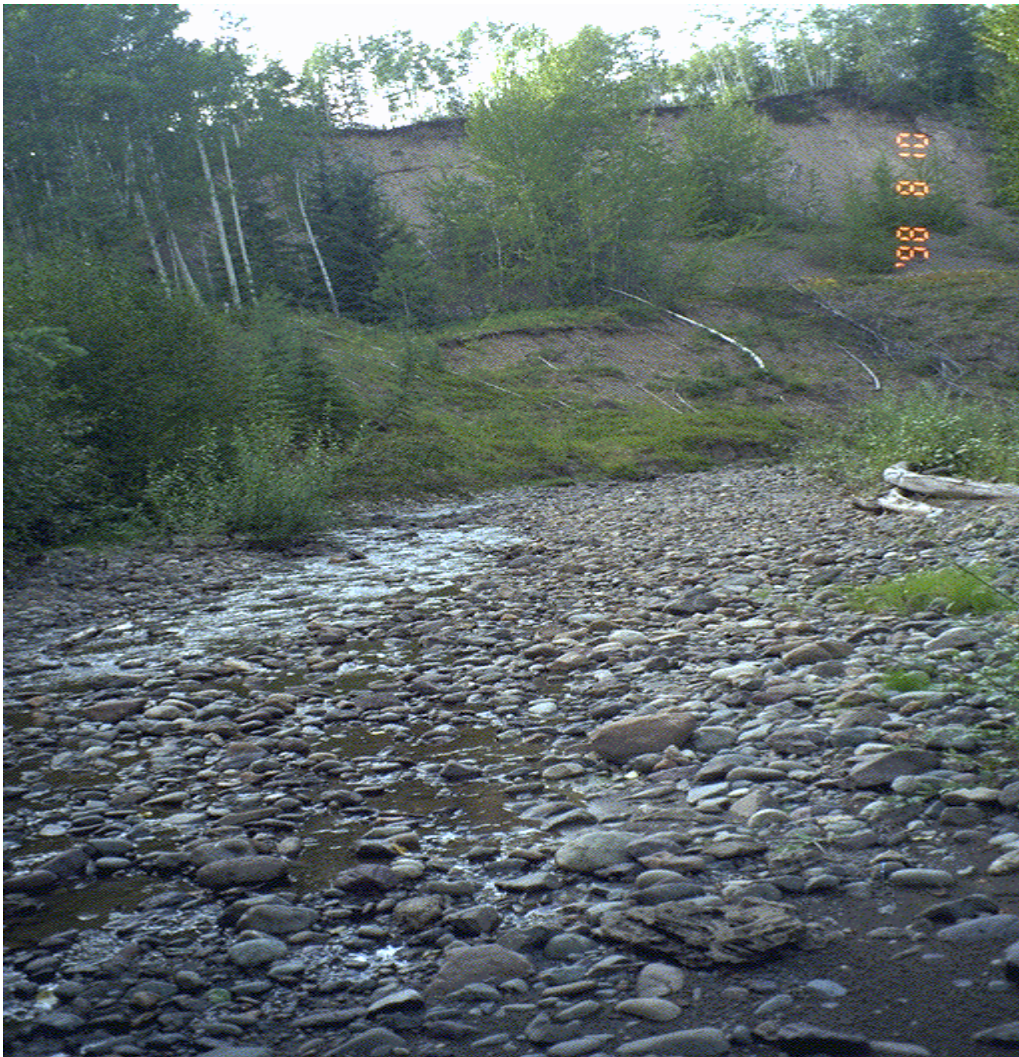
**Impact Description:** Rotational slump on right valley wall, sand and clay slump block sliding on a sandy stratum. Below cleared and grazed land. Cattle use of several benches on the face is probably exacerbating the problem.

**Prescription Photo:** Showing slump in background and extensive aggradation downstream. Note the many small areas of slumping on the slump block face.

**Goal(s):**To mitigate downstream sediment delivery from this site. Channel disturbance and land use is minimal in reach 2 upstream.

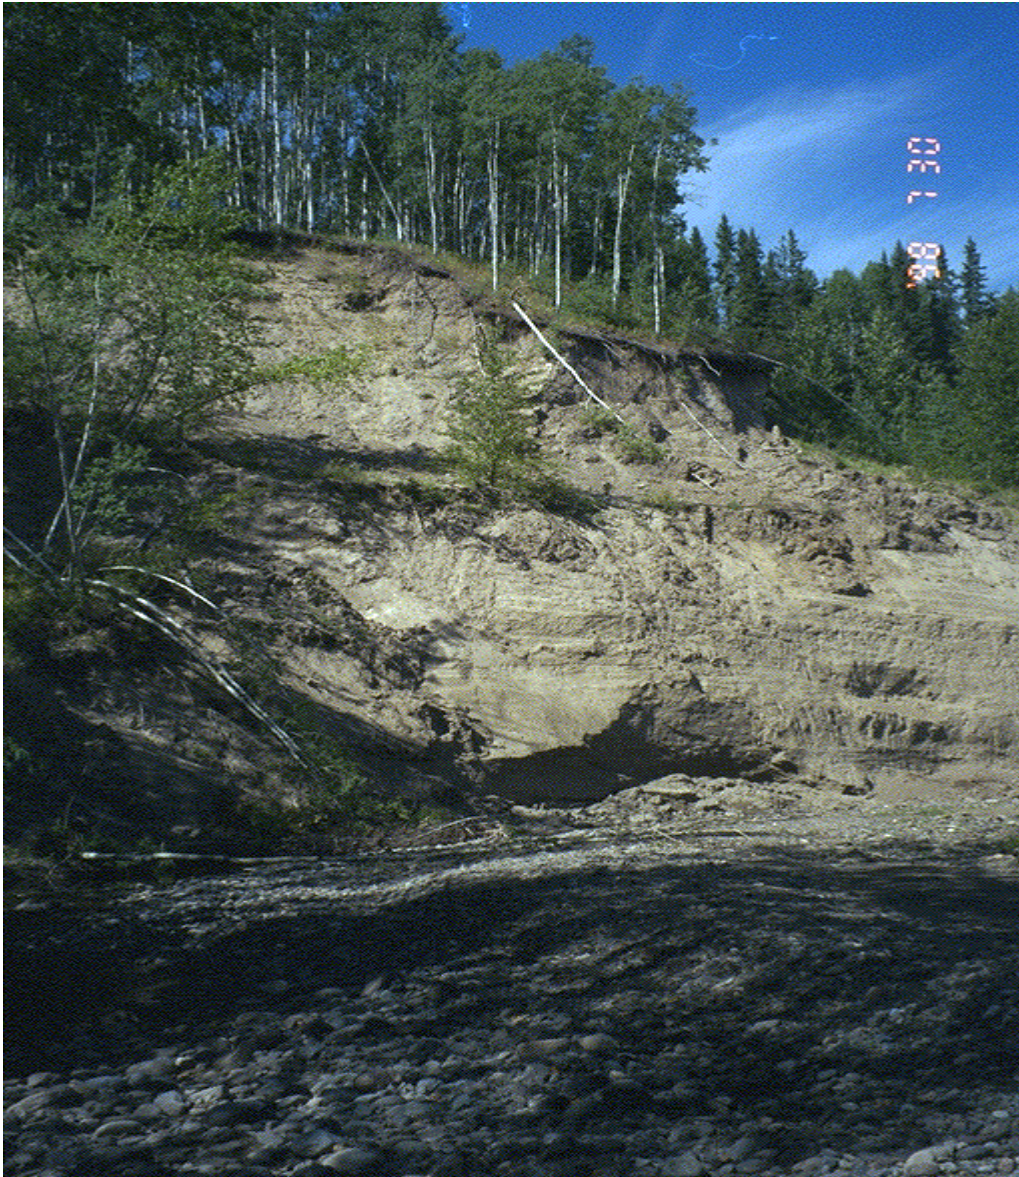
**Prescription Photo:** One of two large slides on the right valley wall in the reach (location = 2+045m). Photo taken looking upstream.

**Impact Description:** Constant diverting of the creek away from the alluvial fan and confining it to the valley upstream has led to significant slope instability in two areas.

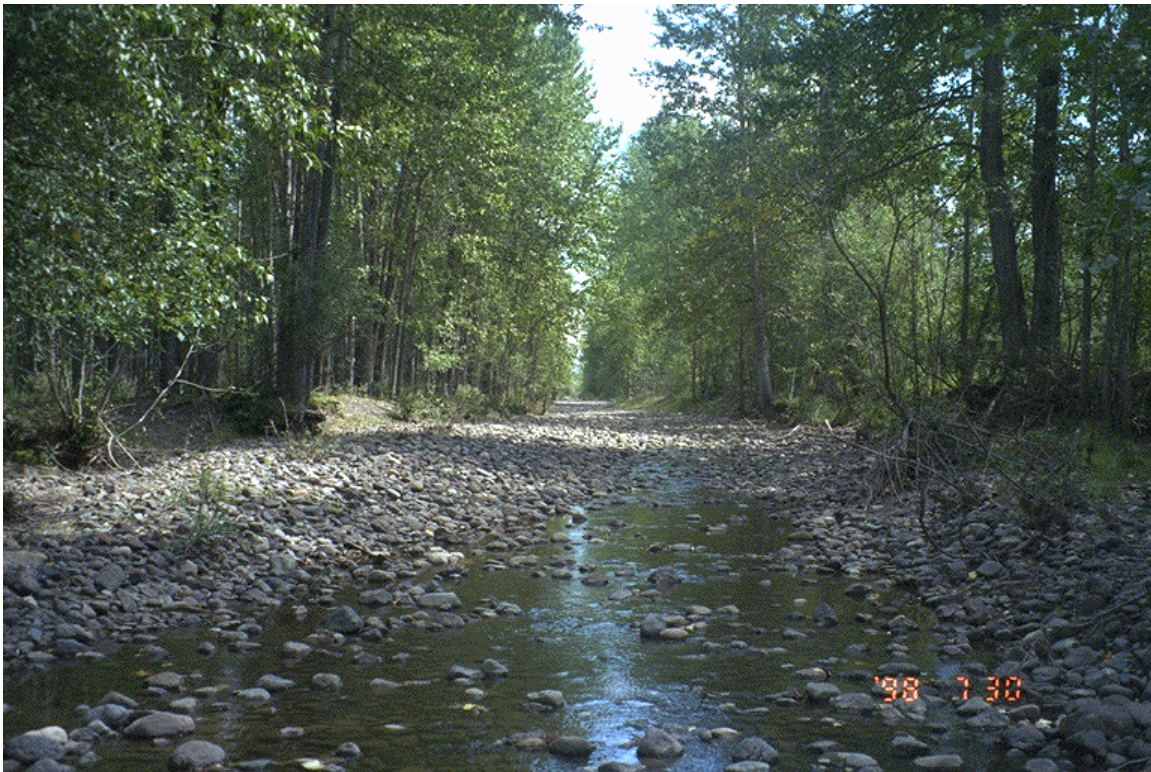
**Impact Description:** Diversion of the creek using a long straight dyke (circa 1948) away from the Bulkley River floodplain and West to connect with Perow Creek. This has caused extensive degradation and channel feature homogenization. Combined with extensive cattle grazing and the removal of upstream LWD, this has severely damaged fish habitat in this section.

**Prescription Photo:** Long, straight diverted section below the highway, Habitat characterized as long shallow glides and riffles with almost no pool habitat. Picture taken at low flows looking upstream.

**Goal(s):** To complex habitat and dissipate hydraulic energy. To provide increased quantity and quality of summer rearing habitat for juvenile salmonids, particularly coho and chinook salmon.

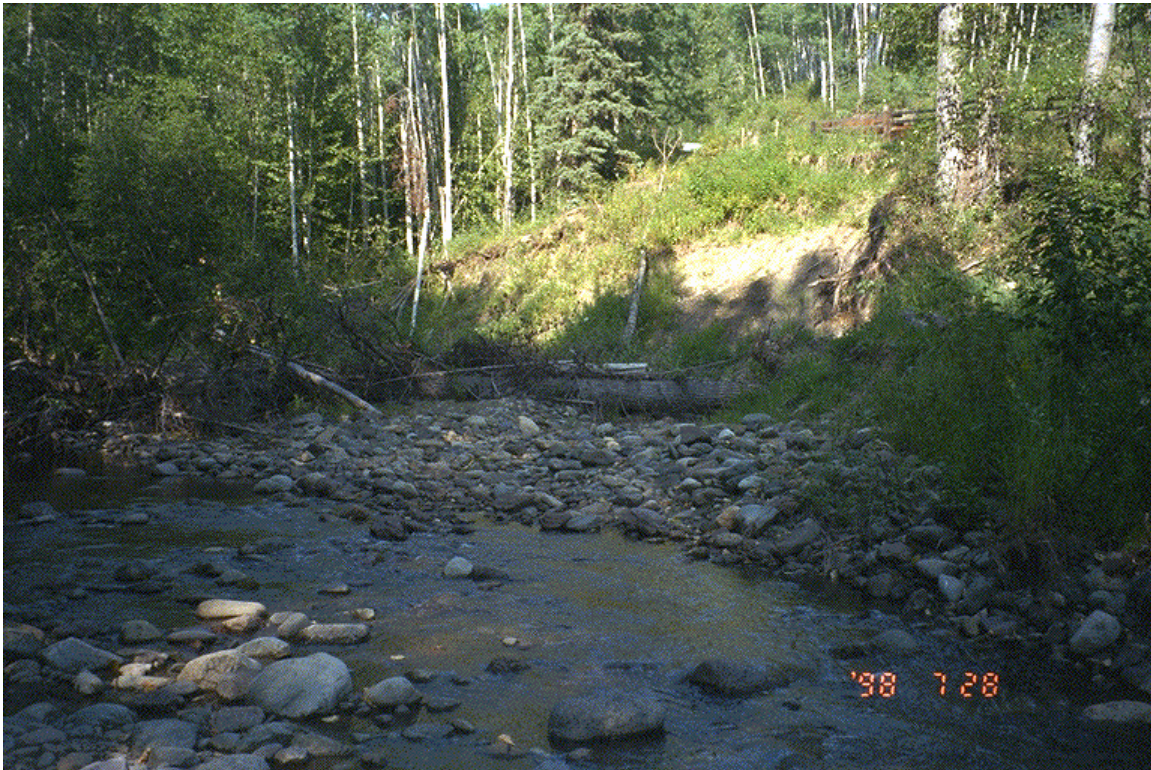
**Impact Description:** Sediment delivery from a rotational slump of fine-textured materials. Impact vectors are thought to be cattle trampling/grazing and removal of overstory/shrub vegetation at the top of the slope altering surface and subsurface drainage patterns in the slope, and removing the stabilizing and strengthening effect of plant roots.

**Prescription Photo:** Representative shot of impact site. There is a cattle corral and path for cattle at the lip of the slope which is not shown in the picture.

**Goal(s):** To mitigate the delivery of sediment downstream by continued mass movement of this slope.

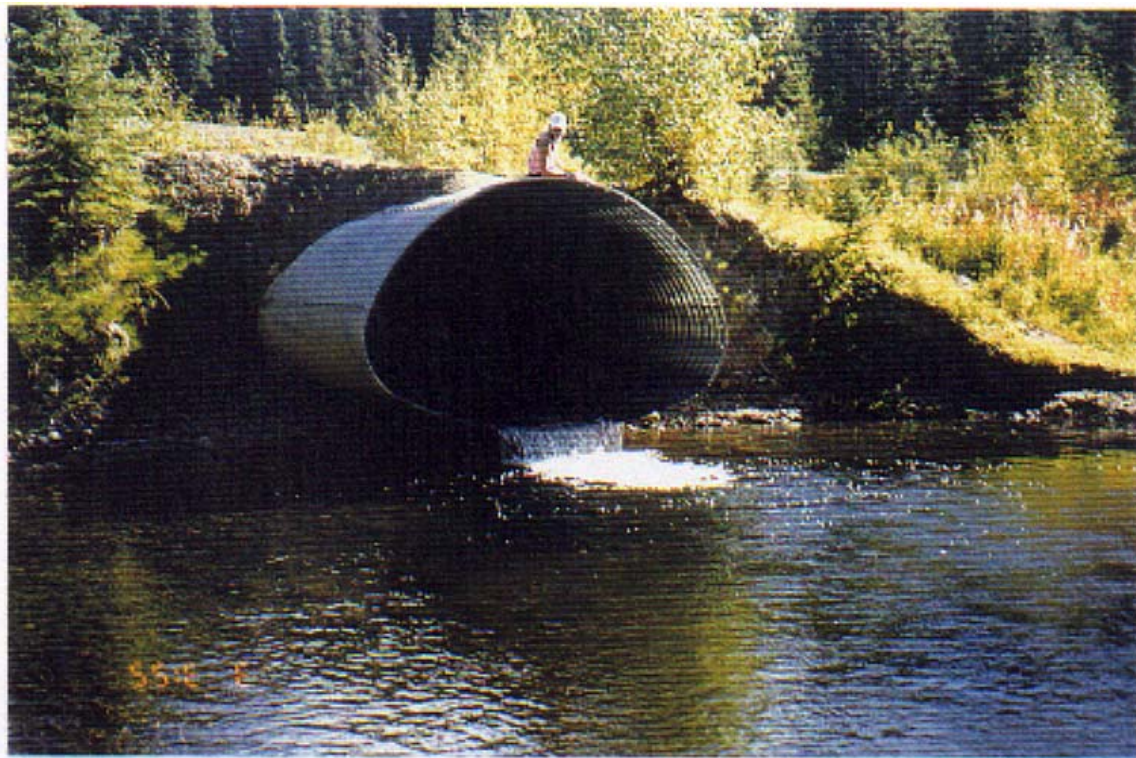
**Impact Description:** Undersized culvert is a barrier to upstream fish passage at low flows, and is undersized for flood flows in the reach, causing fill slope erosion at the road crossing, and channel disturbance downstream.

**Prescription Photo: Culvert on McQuarrie Creek at Michelle Bay FSR. Note extensive erosion of fill and size of culvert versus bankfull width.**

**Goal(s):** To reestablish upstream fish access during summer low-flow periods, and to mitigate downstream sources of channel disturbance due to flow concentration and subsequent velocity increase.

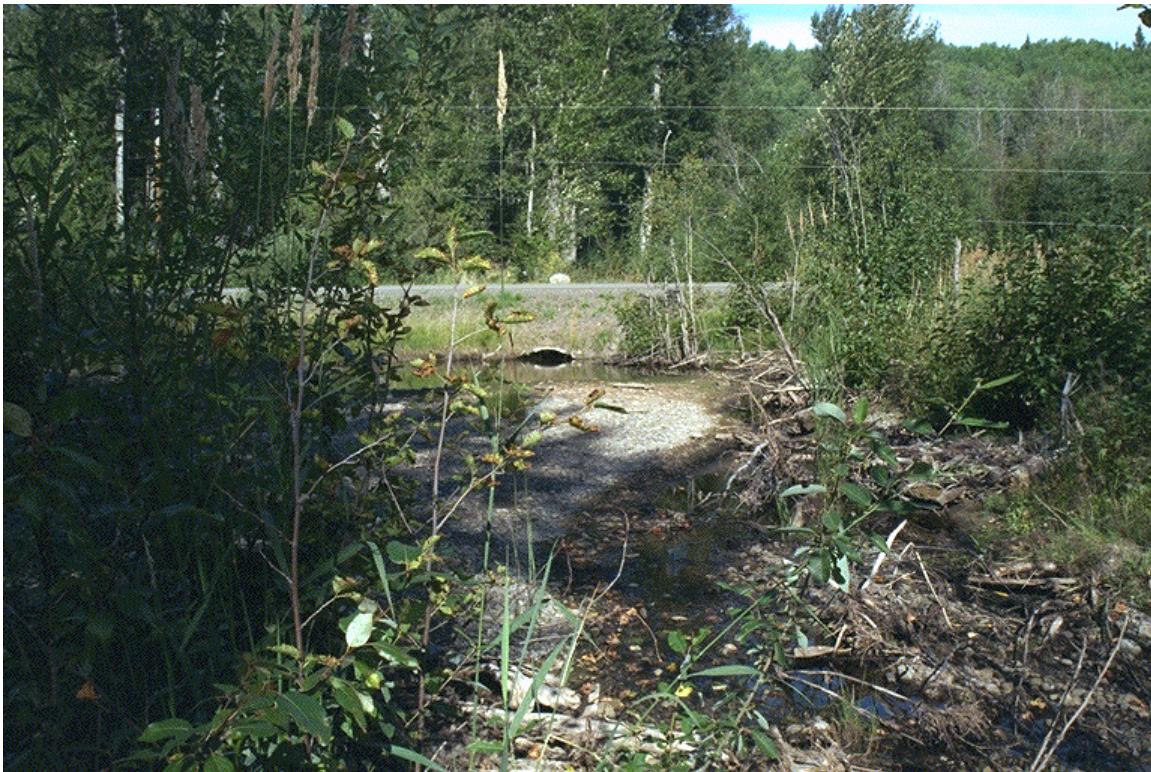
**Impact Description:** Upstream sediment sources causing extensive aggradation of fine sandy materials in this area, coupled with extensive cattle grazing and bank compaction.

**Prescription Photo:** Representative shot of impact site. Channel is highly aggraded (as indicated by bars and height of highway culvert above water surface at low flows versus likely height at installation), and wanders with no cohesive banks.

**Goal(s):** Reestablish a single channel thread and provide access to oxbow pond adjacent to the channel.

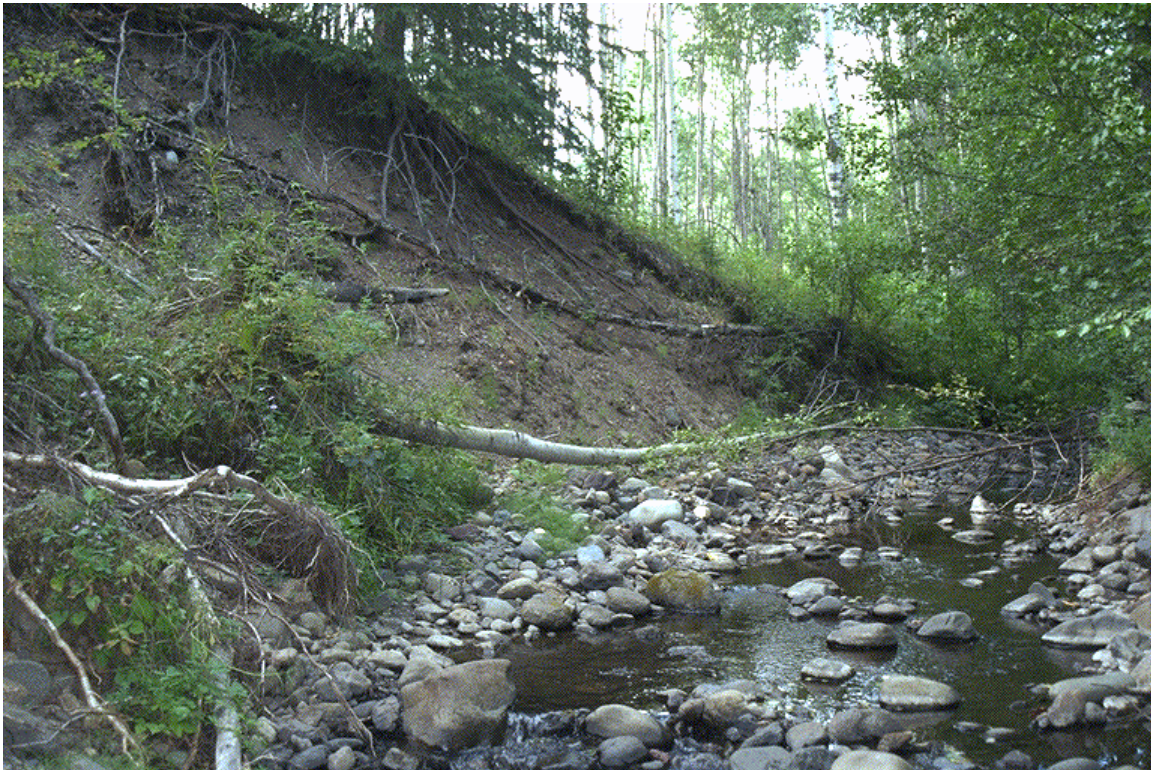
**Impact Description:** Slumping hillside below land clearing combined with toe erosion caused by a log jam (lateral movement of thalweg)

**Prescription Photo:** Slide at 0+274 metres. Note how slide is beginning to restore naturally by reaching a new planform that does not result in further slumping. The toe is naturally armoured by debris until the forces of erosion remove it. However, surface erosion is still a major problem here.

**Goal(s):**Add lifespan to natural toe armoring and restore ground and vegetation cover to mitigate surface erosion.

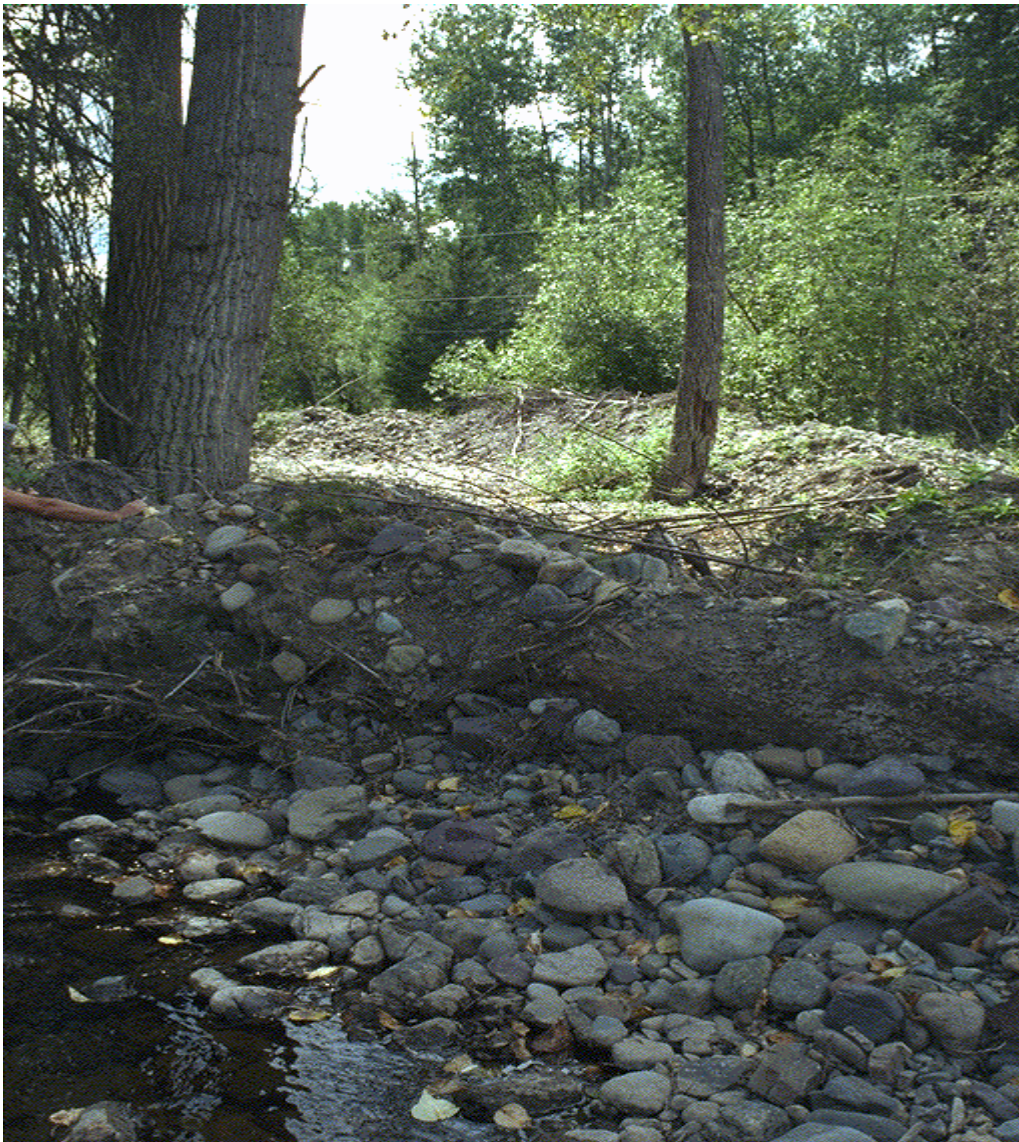
**Impact Description:**Landowner has diverted creek away from their powerline (from which all riparian vegetation was removed), and straight into the forest. This diversion is a huge source of sediment as indicated by field observations. This is only one of several diversions by the landowner to straighten the channel in the vicinity.

**Prescription Photo:** Site of diversion. Abandoned channel is in the distance. Powerline poles are visible in photo to right.

**Goal(s):**To restore channel morphology, mitigate bank erosion problems in old channel, and block off new channel and baffle with LWD.

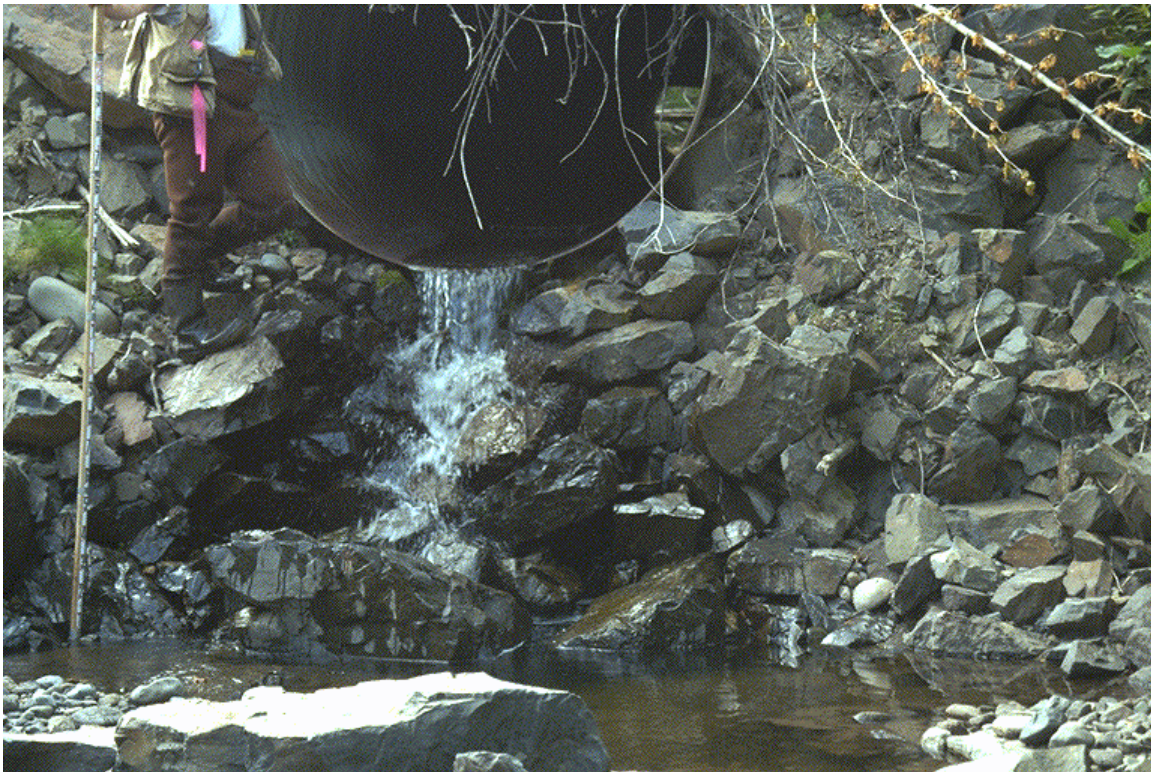
**Impact Description:**Poor culvert installation at Michelle Bay FSR is a barrier to upstream fish passage by salmonids. It is also highly undersized, and has caused a great deal of channel disturbance above it. Backwatering during floods has led to scouring of unvegetated banks at the powerline and increased toe erosion of a slope upstream. This sediment is aggrading upstream and being delivered downstream.

**Prescription Photo:** Culvert at impact site. Note drop of approximately 1 metre over angular boulders. This rubble pile is also 1 metre long, and there is no plunge pool below it or at the end of it, as the rubble is dissipating stream energy, and upstream sediment has infilled any pool created at higher discharges.

**Goal(s):**To restore access to juvenile and adult salmonids, particularly coho salmon and steelhead trout and to restore channel damage once the culvert has been replaced.

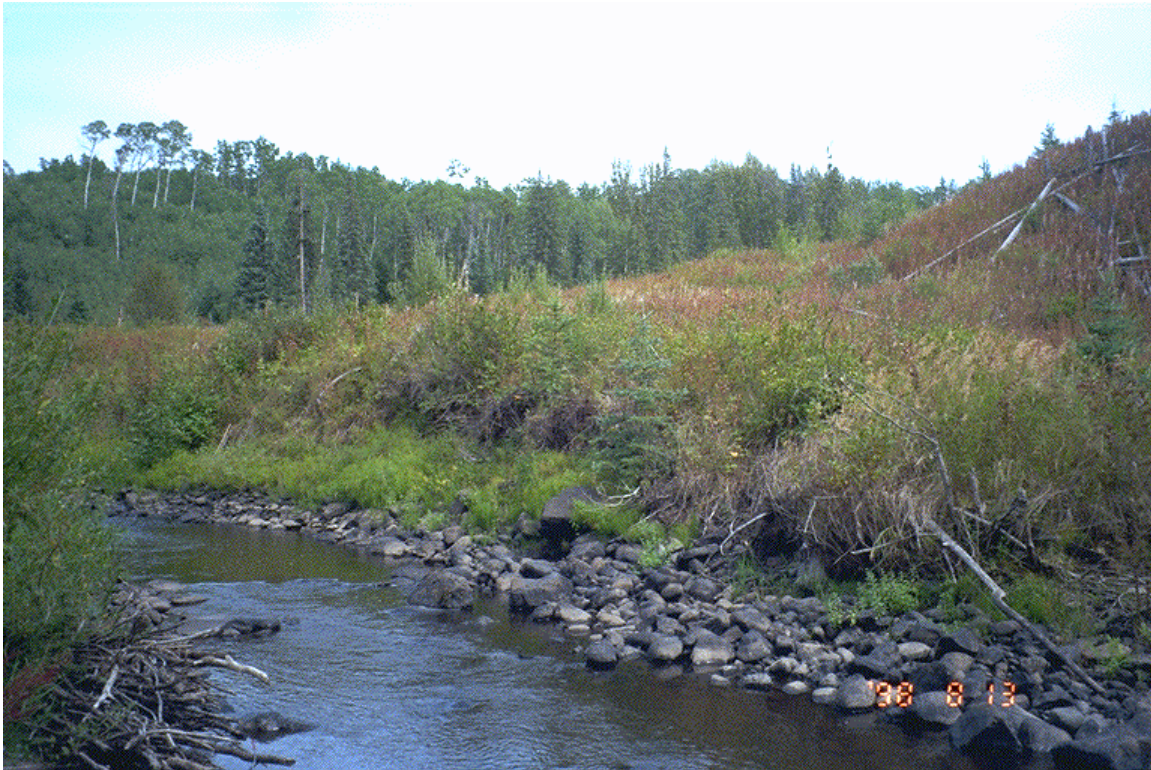
**Impact Description:**Riparian forest had undergone extensive clearcutting in the 1970's to the streambanks and is not naturally regenerating, floodplain function is poor, and has high rates of lateral movement.

**Prescription Photo:** One of several areas of extensive clearcutting to the streambank that was carried out on private land in the 1970's. 1+560 metres, looking upstream.

**Goal(s):** To restore forest cover in the riparian zone and thus aid in restoring bank stability, LWD sources, and stream shading.

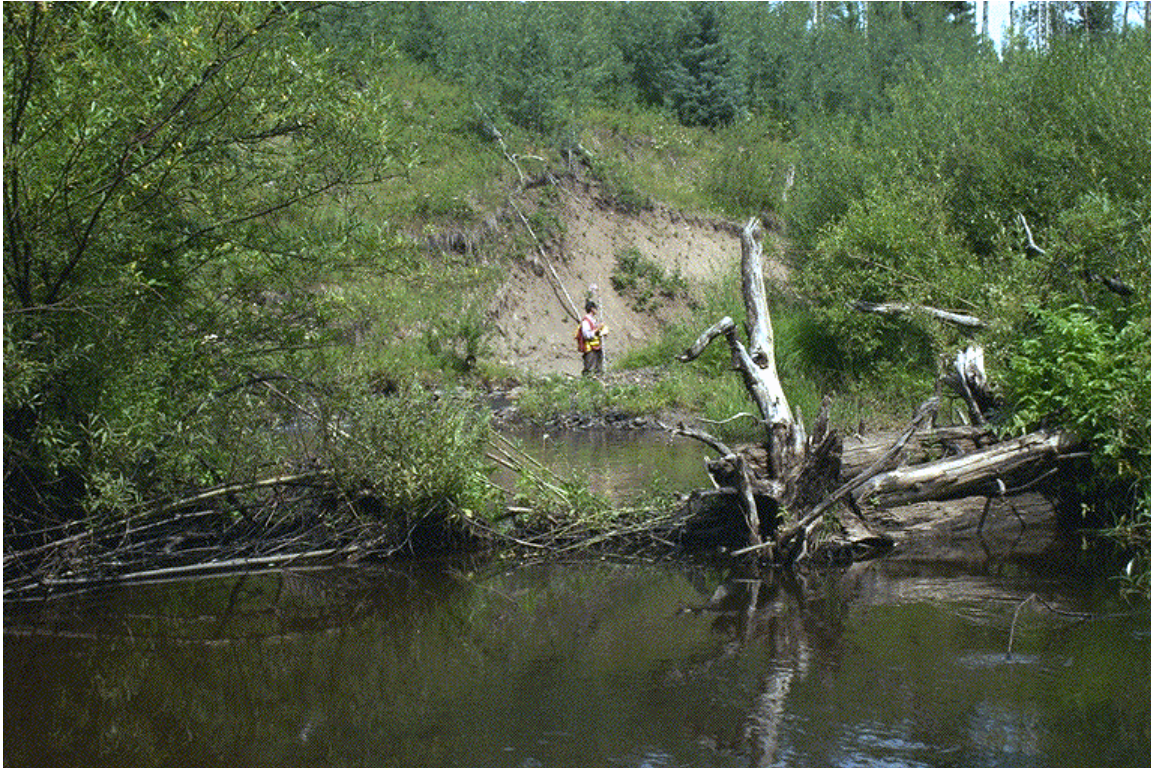
**Impact Description:** Slope failure related to concentration of surface water onto unstable slope above creek.

**Prescription Photo:** Impact site in background, note point of water concentration in centre of face above slide.

**Goal(s):**To divert and slow surface drainage from this area, and to rehabilitate the slide surface to mitigate surface erosion and sediment delivery to the creek.

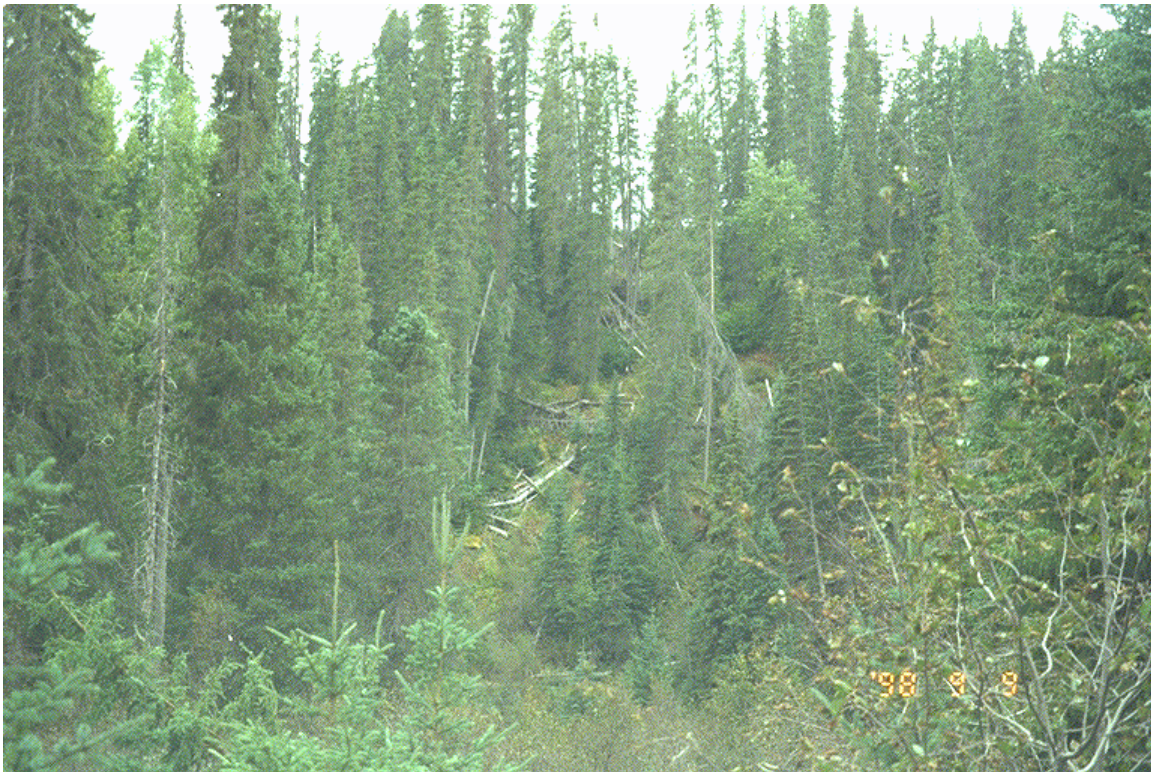
**Impact Description:** Forest harvesting to lip of slope and gully headwalls decreasing wind resistance and causing increased water load in gullies. A great deal of windthrow at block boundaries is suspected to have been responsible for several small gully failures and partial gully failures. The effects of this problem will likely worsen as root networks continue to decay after harvesting.

**Prescription Photo:** One of several small gully failures initiated along the lip of the offending cutblock.

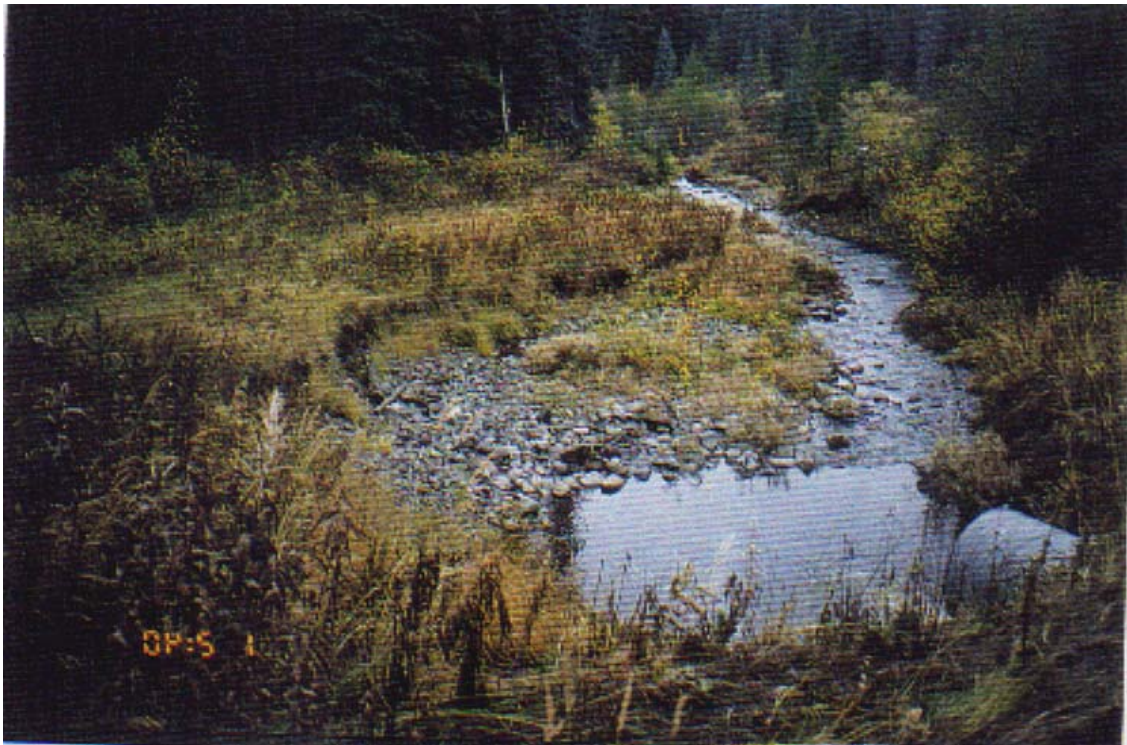
**Impact Description:** Undesized and perched culvert is blocking upstream access to rainbow trout, and causing bank erosion and aggradation downstream by increasing water velocities and stream power.

**Prescription Photo:** FSR-2417 Crossing of Unnamed Creek, with perched culvert in foreground and disturbed channel in background. Note: Extensive bank erosion to left of photo.

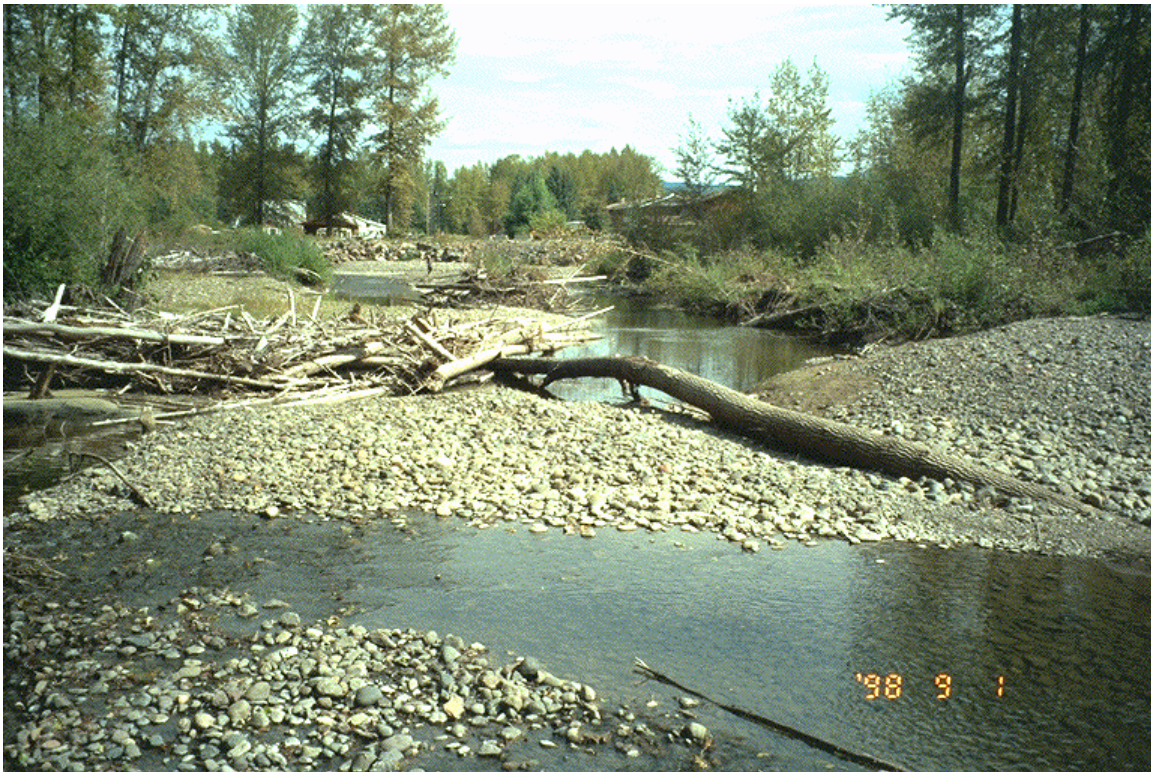
**Impact Description:** Channelizing of both banks and diversion of creek away from townsite. Has lead to major habitat simplification, downstream sedimentation and erosion, and aggradation upstream and downstream, as well as loss of floodplain and riparian function within the channelized section.

**Prescription Photo:** Extensive aggradation, log jams, and lateral movement below channelized section of reach 1, Buck Creek.

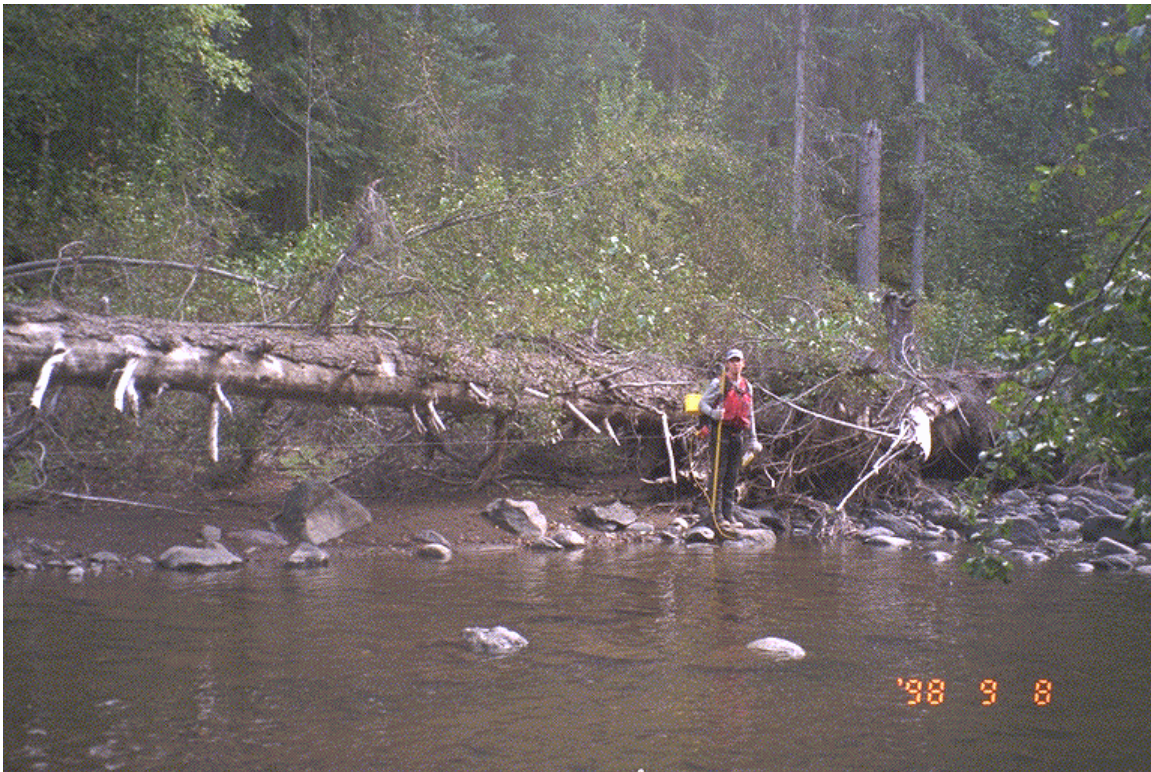
**Impact Description:** Loss of sediment storage function at geomorphic notch point (log jams at canyon mouth) due to decreasing upstream LWD supply and an altered basin runoff regime. This is leading to cumulative sediment impacts propogating downstream and exacerbating impacts there.

**Prescription Photo:** 60 cm dbh cottonwood stem parallel to flow within first canyon on Buck Creek (downstream of impact prescription site). Indicative of general loss of LWD and sediment storage function within this part of the reach.

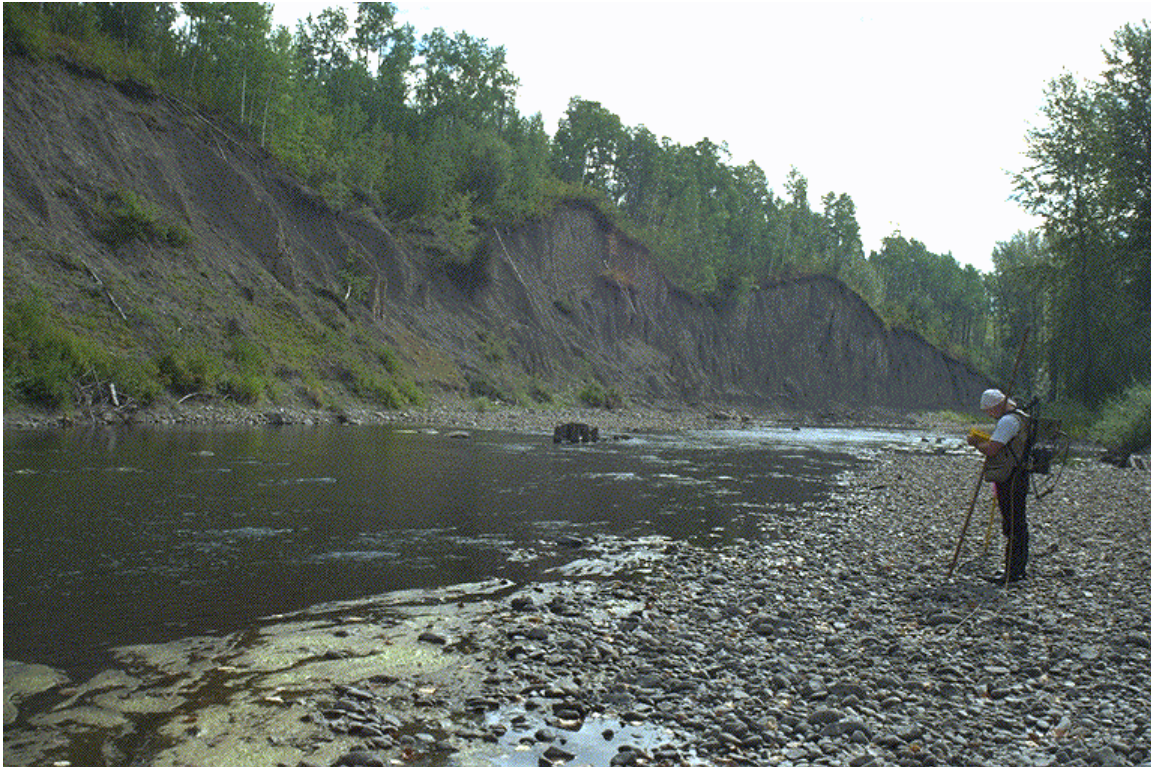
**Impact Description:** Subsurface and surface runoff diversion and concentration downslope by the Michelle Bay FSR (both sites) and a section of the old highway (site 1) are causing extensive surface erosion and slumping of the valley walls. These sites are large sources of fine sediment in runoff and mass movements to the Bulkley River.

**Prescription Photo:** Representative shot of site #1 looking upstream. Note old bridge pilings in background where old highway crossing existed. The old roadbed which used to go up the slope to the left has now been completely eradicated by slumping and erosion.

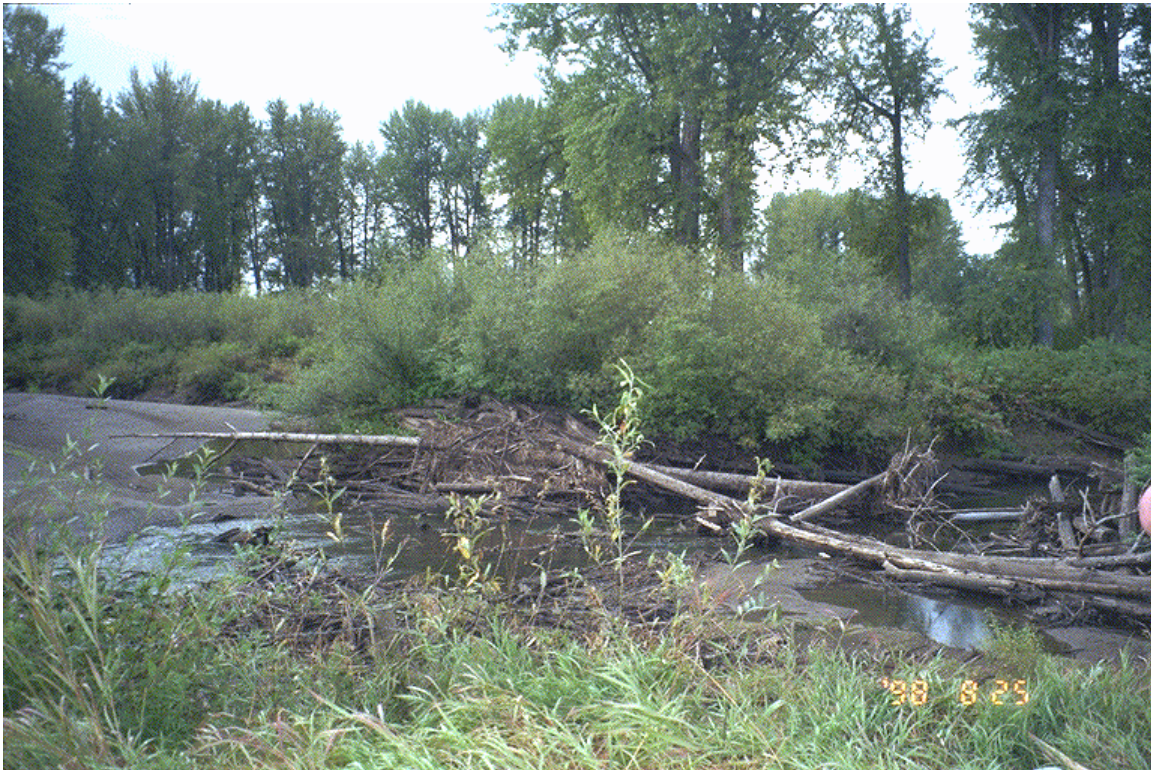
**Impact Description:** Removal of riparian forest for hay farming upstream of a meander neck led to extensive bank erosion. The bank erosion caused a change in the angle of attack of the main flow (thalweg) on the outside bank of the meander downstream. The increased shear stress on the meander neck lead to an avulsion in the spring, 1997 flood.

**Prescription Photo:** Upstream end of avulsion showing avulsion channel (foreground) and abandoned channel (background). Flow is left to right. Photo taken from hay field (note grasses in extreme foreground).

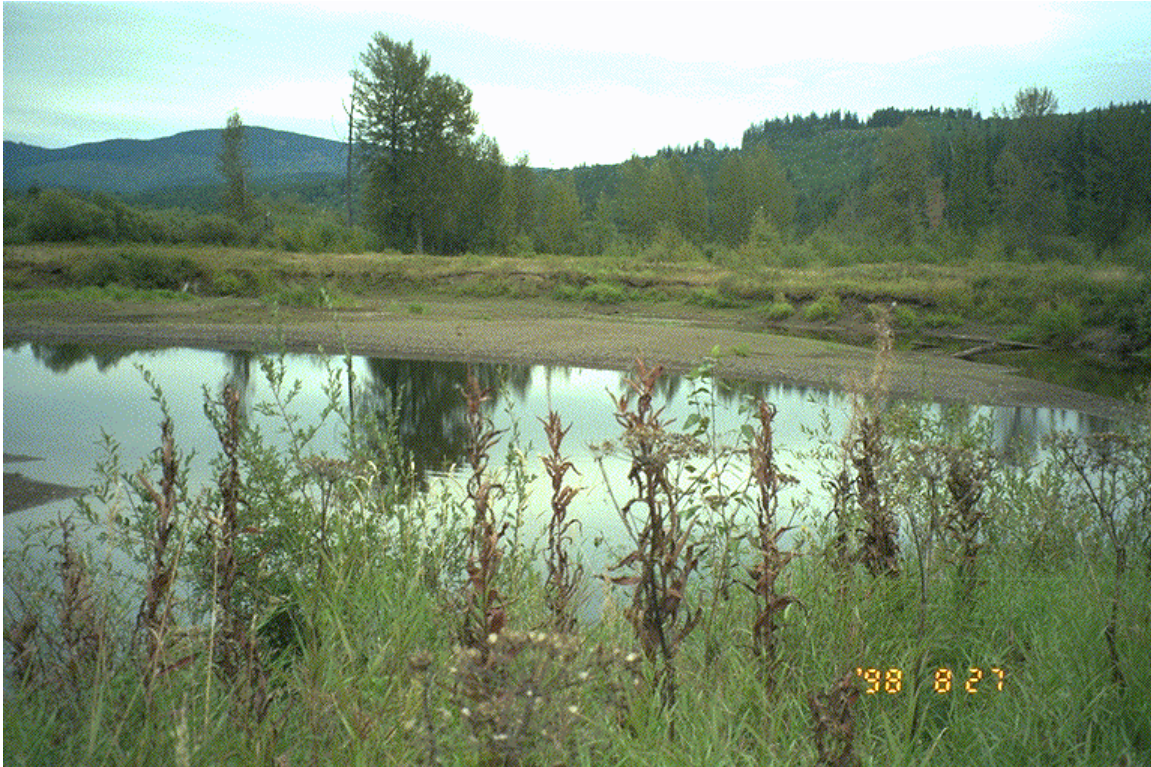
**Impact Description:** Severe bank erosion of fine-textured soils and aggradation at agricultural (hay) land due to channel constriction at the Knockholt Bridge and removal of riparian forest/soil compaction by agricultural machinery. The channel constriction by the bridge downstream of the impact site is causing bank scouring and erosion as a large eddy is formed above. The circular motion of the eddy is undercutting the bank toe.

**Prescription Photo:** Extensive bank erosion just upstream of the Knockholt Bridge, reach 2, Bulkley River. Note the large lateral bar. Photo taken at low water (August), indicating the potential for installing works as presented in the conceptual drawing. Upstream view.
