Hartley Creek Restoration Project- 2007 As-built Report

Prepared for:
Ministry of Transportation
231 - 447 Columbia St.
Kamloops, BC
V2C 2T3

Prepared by:
Interior Reforestation Co Ltd
4142 McPhee Road
Cranbrook, BC V1C 4J6

RE: Hartley Creek Restoration 2007 As-built Report

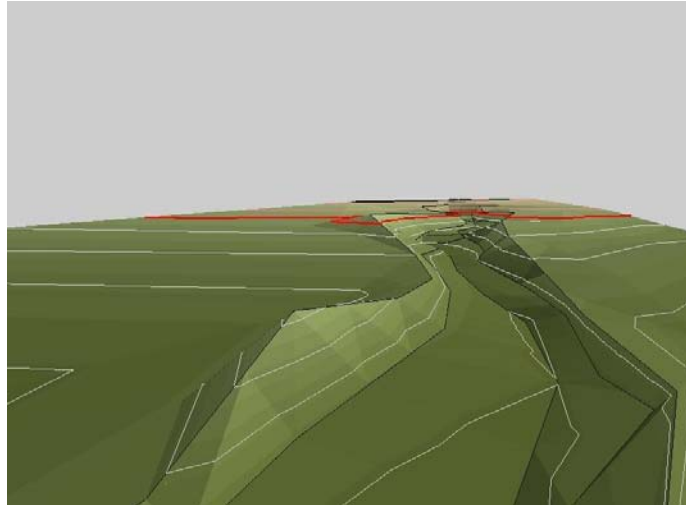
In April/May 2007, Interior completed a topographical survey of the channel and riparian area. This survey provided detailed descriptions of the channel and planting areas as they existed prior to spring freshet (Figure 2). The detailed channel profile obtained by the survey will serve as a baseline for monitoring channel development, including tracking changes in channel substrate aggradation and/or degradation over time. The topographical survey also aided Interior staff in preparing 2007 construction prescriptions in the following areas: identifying areas requiring riparian planting, estimating the volume of topsoil needed to prepare the planting areas, and defining the perimeter to be fenced following planting (Figure 3).

Figure 2: Contour map created from topographic survey completed on April 24, 2007. View looking upstream towards culvert from approximately 250 m downstream.

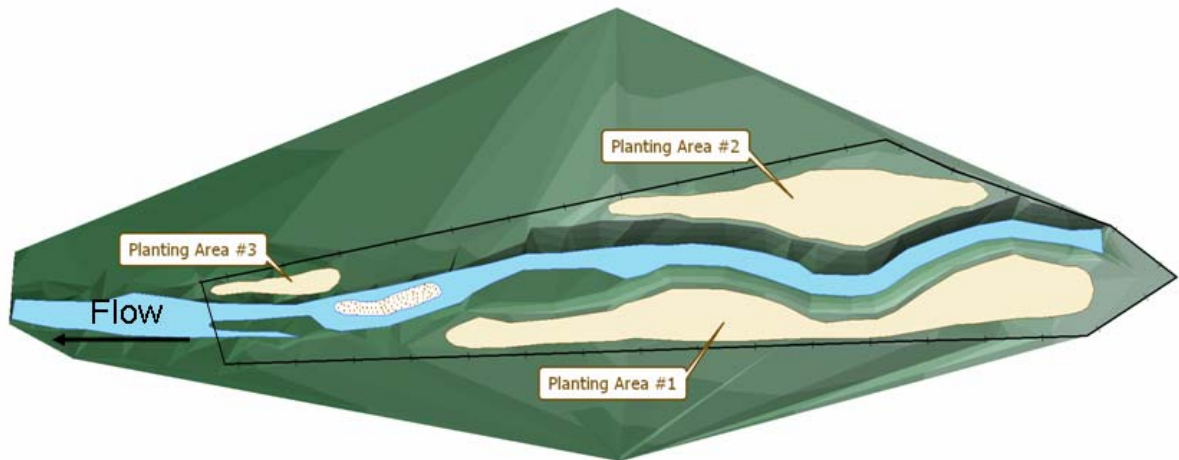
Figure 3: Estimated Planting Areas identified during April 24, 2007 survey and as-built fence line.

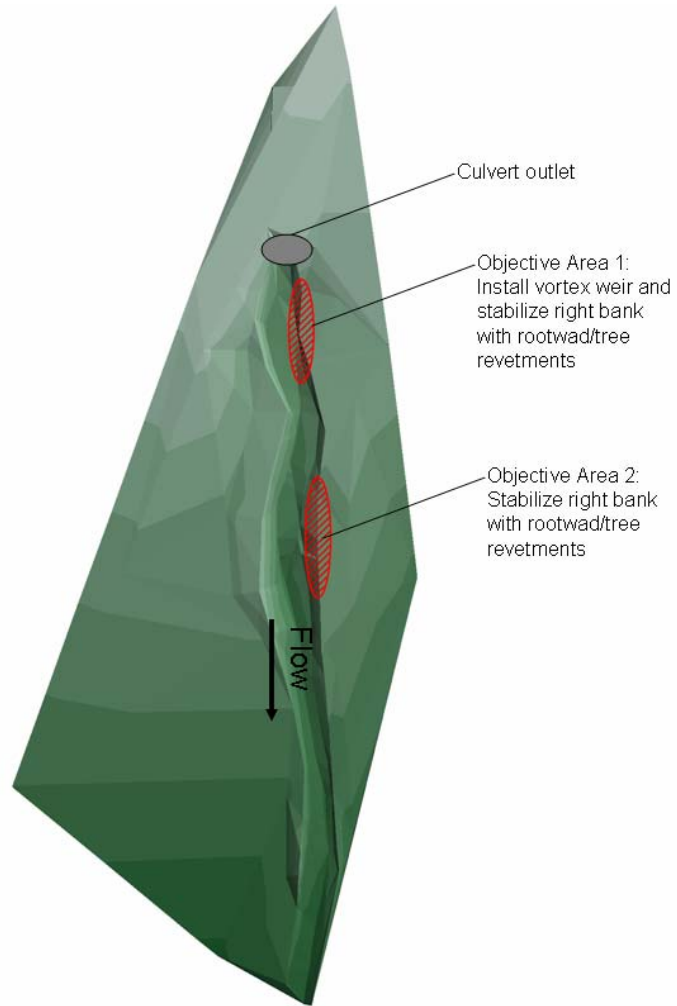
The first 100 m section downstream of the culvert, which was left unimproved in 2006, was one of the two areas targeted for the 2007 restoration (Figure 5). In this area, a vortex weir was installed approximately 40 m downstream of the culvert outlet (Figure 6). The weir was installed with an alignment designed to direct the thalweg from the center of the channel into the armoured right bank (river right). This is predicted to effectively move the majority of flows towards the eroding bank (outside corner). However, at high flows the vortex weir will likely be unable to redirect all of the discharge resulting in some of the hydraulic energy being directed at the deposition bank (i.e. point bar, inside corner). During freshet of 2007, flows similar to this were observed sheering off unprotected point bars as the bank material of Hartley Creek is highly erodable. This erosion resulted in the loss of the beneficial meander. To help prevent point bar erosion, a series of six rootwads were installed on the deposition bank to prevent major erosion and maintain the stream meander until riparian vegetation is established (Figure 7).

Figure 5: Two objective areas for the 2007 instream works.

The second objective area for 2007 restoration efforts (Figure 5) was a depositional corner that experienced considerable erosion during the 2007 freshet. The objective in this area was primarily maintenance, as structures had been placed both upstream and downstream in 2006. Visual inspections deemed it necessary to armour the corner with rootwads and tree revetments as described above to re-establish a functional meander and w/d ratio (Figure 8). Prior to backfilling the rootwads, two alder bushes and one hawthorn, with roots attached, were placed to the depth of the water table. These plantings were conducted in order to help accelerate the re-establishment of functional riparian vegetation, as alder possess symbiotic mycorrhiza capable of fixing nitrogen and ultimately increasing soil nutrients.

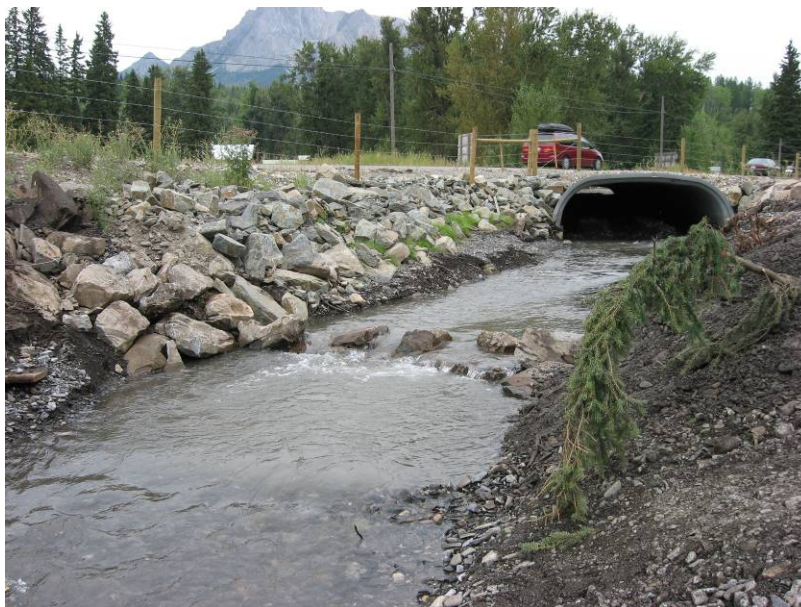
Figure 6: Vortex weir installed approximately 40 m downstream of culvert outlet.

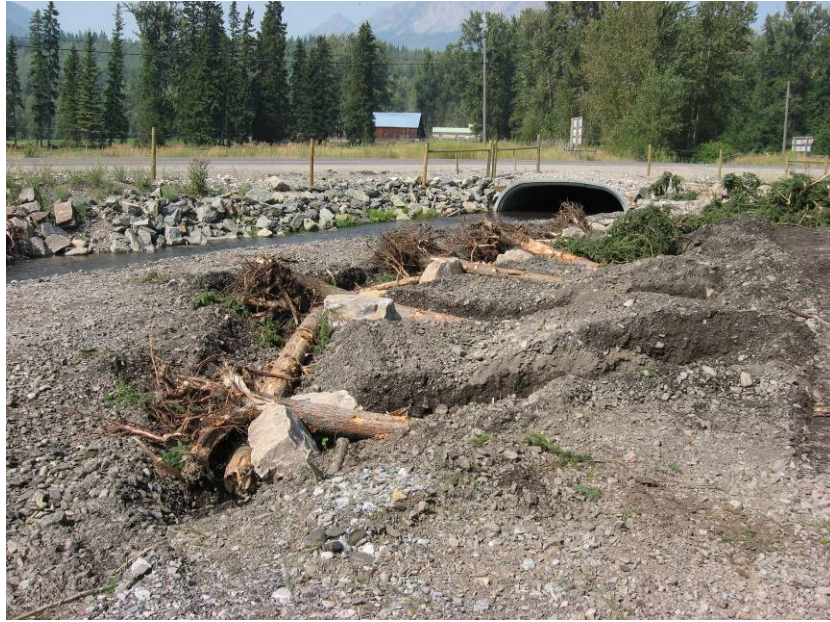
Figure 7: Series of six rootwads installed on deposition bank immediately downstream of the Highway 3 crossing.

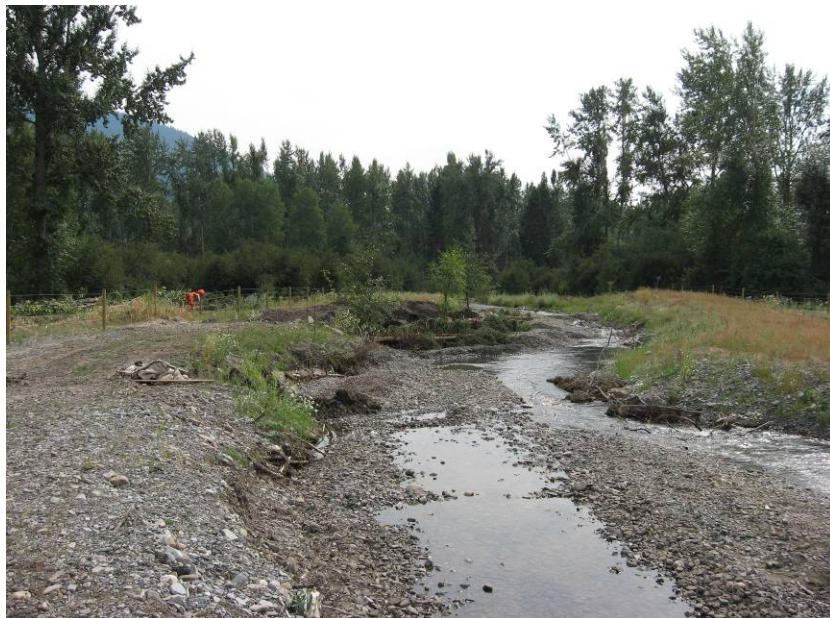
Figure 8: Downstream view of second area targeted in 2007 works. Note transplanted alder and hawthorn shrubs.

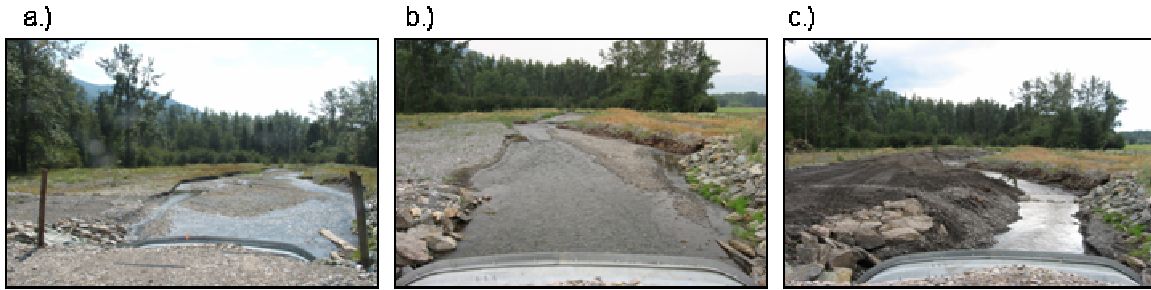
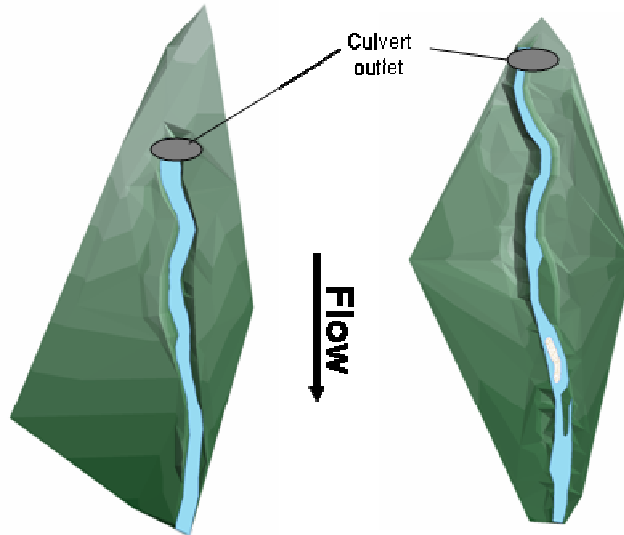
On November 16, 2007, Interior staff completed an as-built topographical survey of the Hartley Creek site. The survey focused specifically on the 2007 instream works. This data provided a means of identifying changes in the w/d ratio, channel sinuosity and channel slope, from the 2004 pre-construction conditions through the 2006 and 2007 restoration works (Figure 10). A comparison between the years showed a measurable decrease in the w/d ratio with time. Cross-sectional data collected in 2004 and 2007 was used to calculate the w/d ratio at twelve locations within the site (Figure 11). The w/d ratio of the reconstructed channel is presently more comparable to that of the undisturbed section upstream of the Highway 3 crossing (upstream w/d = 4.82). Although the photos and topographical surface appear to show an improved sinuosity (meander morphology), the current position of the thalweg does not yet fully conform to the restored banks, therefore yielding only a minor increase in sinuosity (Figure 10). Sinuosity is expected to improve (i.e. increase) with each spring freshet as the channel morphology develops in response to the new bank structures. The thalweg is expected to more accurately reflect the bank meander pattern as high flows create areas of erosion and deposition.

2004 Pre-construction	2007 As-built
Width: Depth	11.78	8.4
Sinuosity	1	1.04
Thalweg slope (%)	1.16	0.75

Figure 10: a.) Photo of 2004 Preconstruction state b.) Photo and topographical survey of 2006 as-built state showing incomplete sinuosity along the left bank and c.) Photo and topographical survey of 2007 as-built state showing restored sinuosity. Table included to provide width:depth ratios and sinuosity.
