Fish Habitat Assessments for Fish Passage Restoration in the Kootenay Business Area

Project Number PD13TFE005

Prepared For: **Ministry of Forests, Lands and Natural Resource Operations**
British Columbia Timber Sales
907 Ridgewood Road
Nelson, British Columbia
V1L 6K1

Prepared By: **Vast Resource Solutions Inc.**
PO Box 538
Cranbrook, BC
V1C 4J1

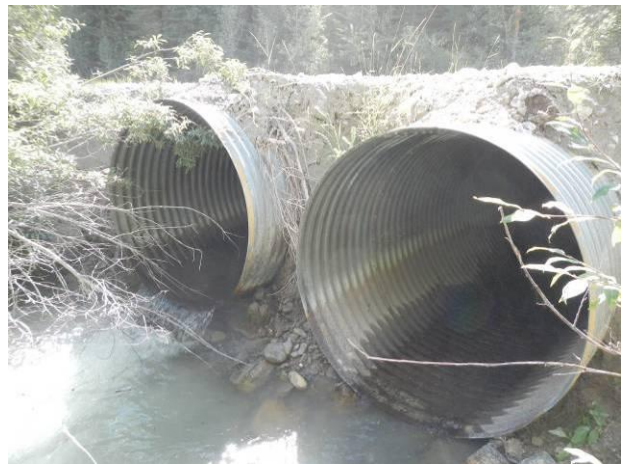
Outlet of culvert. Note that right downstream culvert is perched.

Although it is not clear whether Plumbob Creek provides spawning habitat to Kooconusa BT, the Plumbob04 stream crossing should be replaced in order to restore fish access to the upper reach of the creek. A low profile arch structure would likely be more suitable than a bridge at this location as it will not restrict the effective width of the road. Based on the measured channel width, the diameter of the structure should be at least 5.00 m.

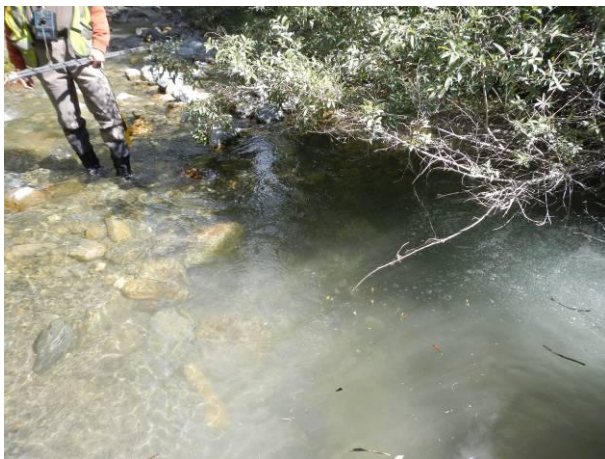
Downstream view from culvert. Pooling at outlet.

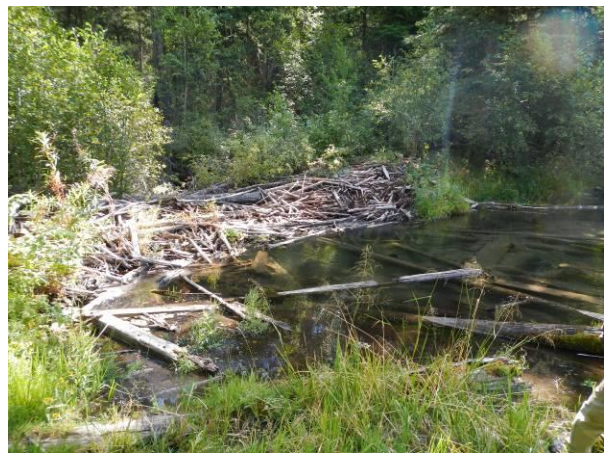
Permanent beaver dam upstream of culvert.

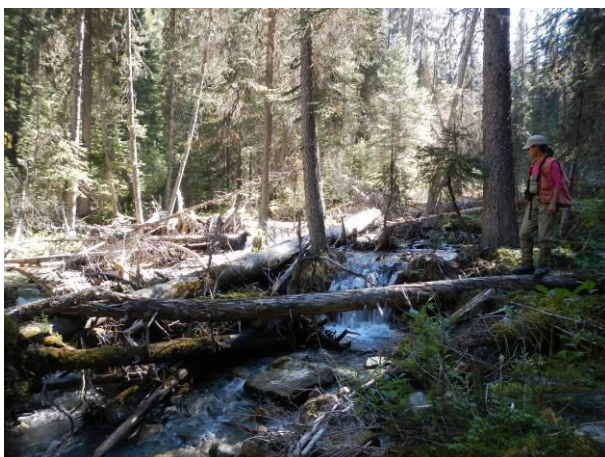
Channel is highly disturbed upstream of culvert with abundant large woody debris. Disturbance was caused by upstream cable logging.

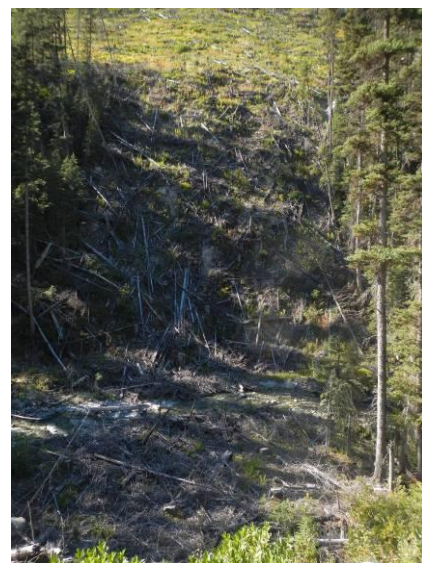
Cable logging across creek near upstream road crossing at Stork Creek.

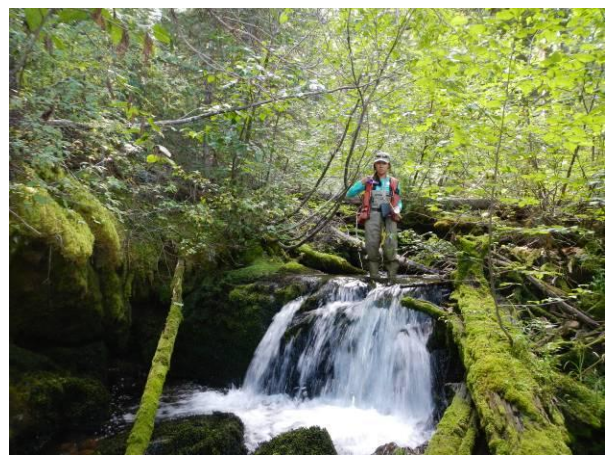
Cascade (1.3 m high) upstream of culvert.
Numerous cascades are present along the stream.

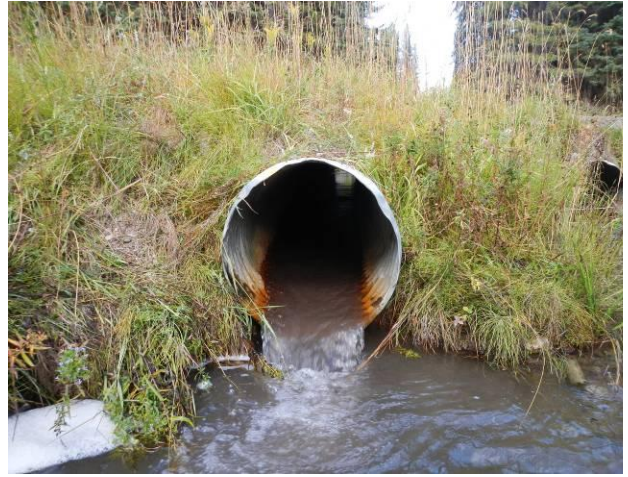
Outlet of right downstream culvert. This culvert is perched but the left downstream culvert is not perched.

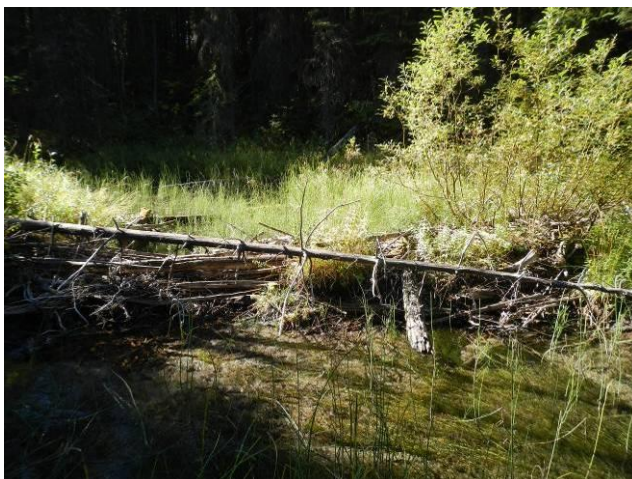
Numerous beaver dams were observed, which might limit the effectiveness of restoration work.

We recommend assigning a low-medium replacement priority to this crossing. Although the stream provides some rearing habitat and is connected to the Flathead River, the lack of overwintering or spawning habitat, and the high level of beaver activity in the area would significantly limit the effectiveness of the restoration work. Replacement with an arch structure is recommended (greater than 5.00 m).

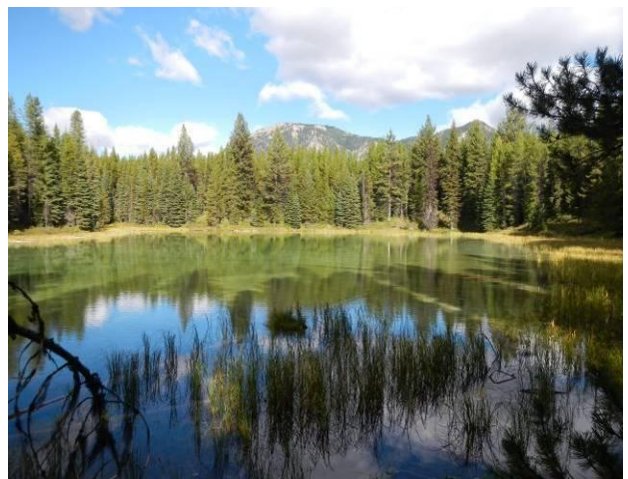
Beryl Lake is a shallow lake with limited overwintering habitat.

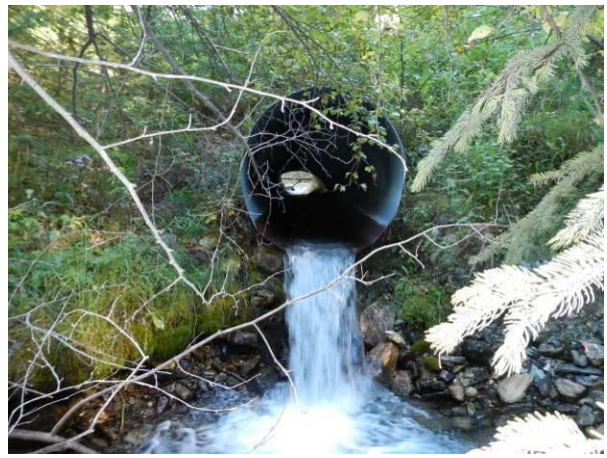
Perched culvert barrel at outlet.

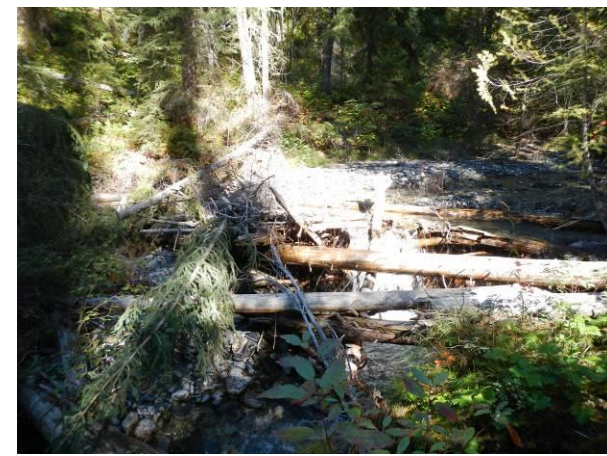
Barrier to fish passage (1.20 m high) created by persistent debris downstream of culvert.

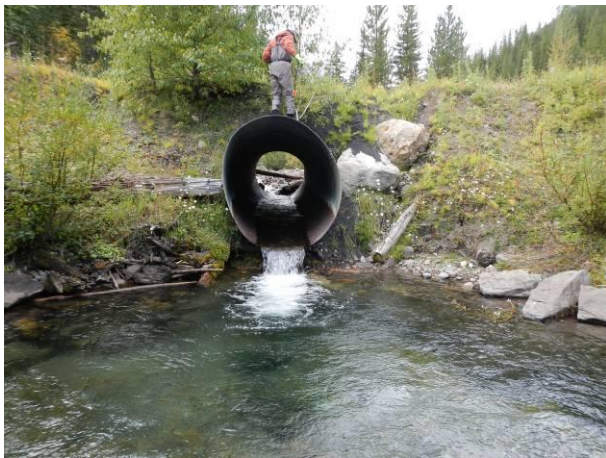
Perched culvert at outlet.

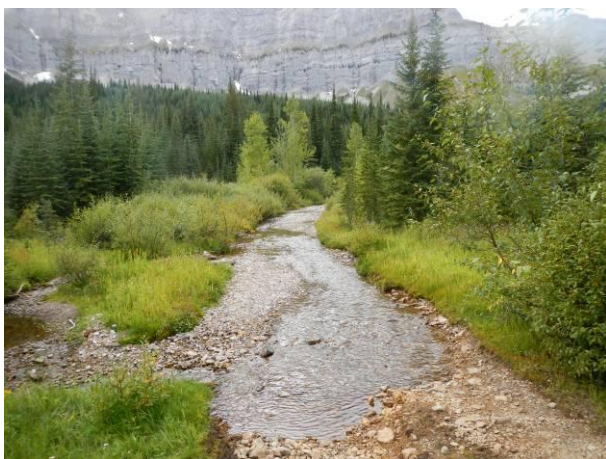
Upstream Habitat: The substrate is dominated by bedrock and numerous small cascades (approximately 0.7-1.0 m high) were observed. The stream washes out the road at approximately 1.93 km upstream from the culvert. A 2.00 m high waterfall (>20% gradient) was also located at the washout area. The upstream slope increases significantly as the stream transitions from bedrock-riffle-pool (long riffle, shallow pool stretches) to step-pool (with shallow pools) and cascade-pool areas. Overwintering habitat is fair to poor. Spawning habitat is poor due to the presence of bedrock. Rearing habitat is fair. No fish were observed.

The stream washes out the road at approximately 1.93 km upstream from culvert. A 2.00 m high waterfall (>20% gradient) was also located at the washout area.

A low priority should be given to the replacement of this crossing due the presence of bedrock, which would impede embeddedment of the new structure. Multiple impassable barriers were also observed. Replacement with a bridge structure (with a span of at least 5.00 m) is recommended.

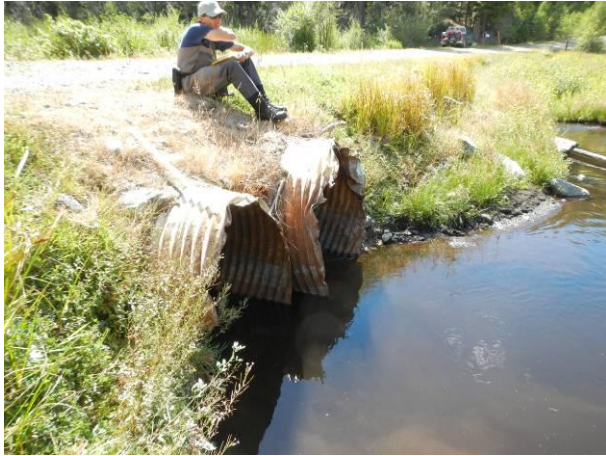
Inlet of culverts. Scour on the road surface indicates that the culverts are undersized and cannot accommodate spring high flows.

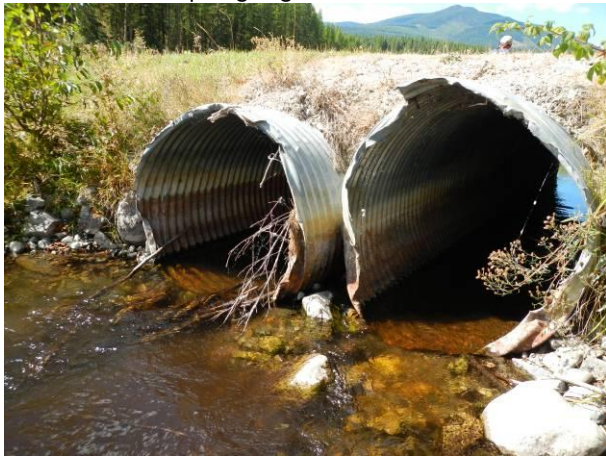
The culvert is only partly embedded but is not a significant barrier to fish since it has low velocity. The road fill material was observed to be spilling over the culvert and is slowly covering the outlet.

Outlet of culverts. The culverts are not embedded but they are not barriers to fish due to the low water velocity.

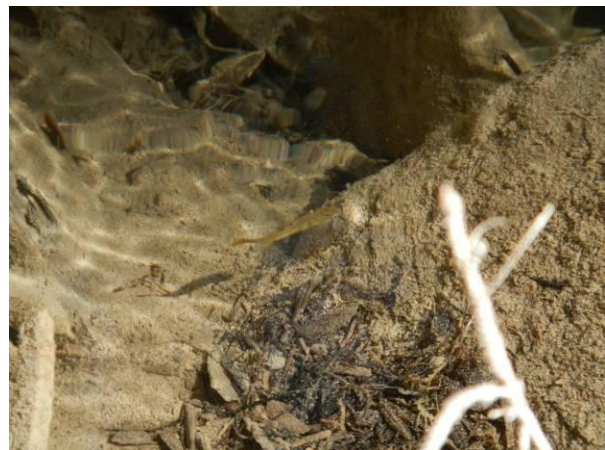
WCT fry observed upstream of culvert.

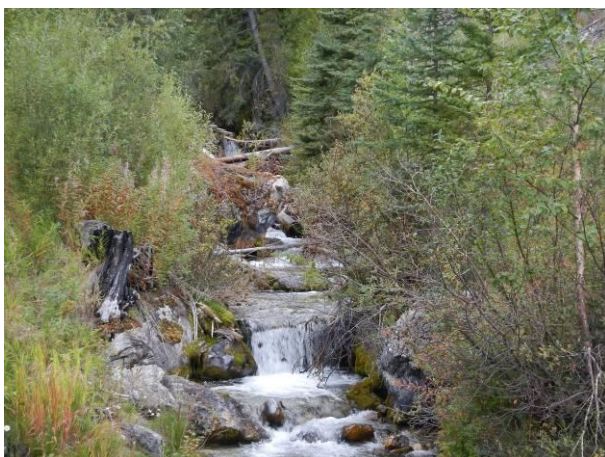
Waterfalls and large woody debris upstream of culvert.
