Channel and Debris Flow Risk Assessment

Ross Creek

M.J. Milne & Associates Ltd.

June 2002

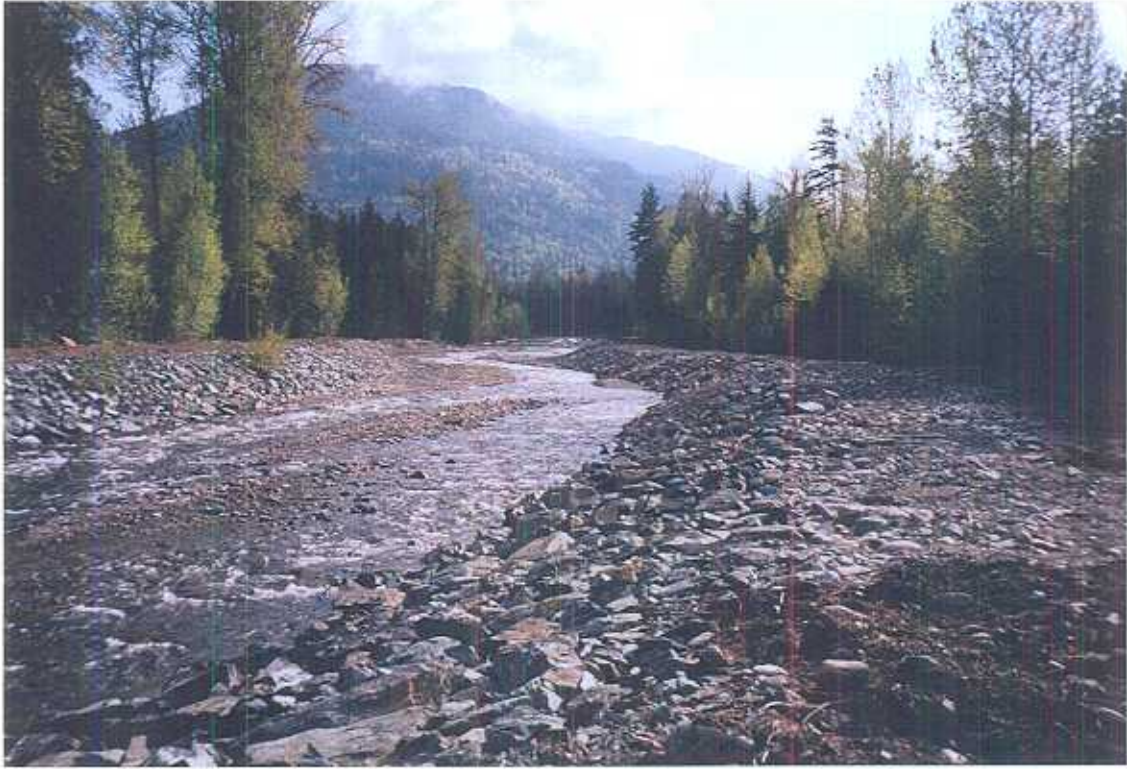
Reach R1 on the lower Ross fan is confined to approximately 15 m bankfull width by artificially constructed riprap levees [*Photo 1 - Appendix C*]. The channel has a braided pattern within the riprapped margin and is aggrading in this location. The average gradient of reach R1 is approximately 2.3 % [*Appendix B*], well below any threshold required for debris flow initiation. There is no evidence of recent or historic debris flow deposition on reach R1.

Photo 1. Reach R1 approximately 50 m upstream of Squilax-Anglemont Bridge. Note braided channel pattern within riprap banks.

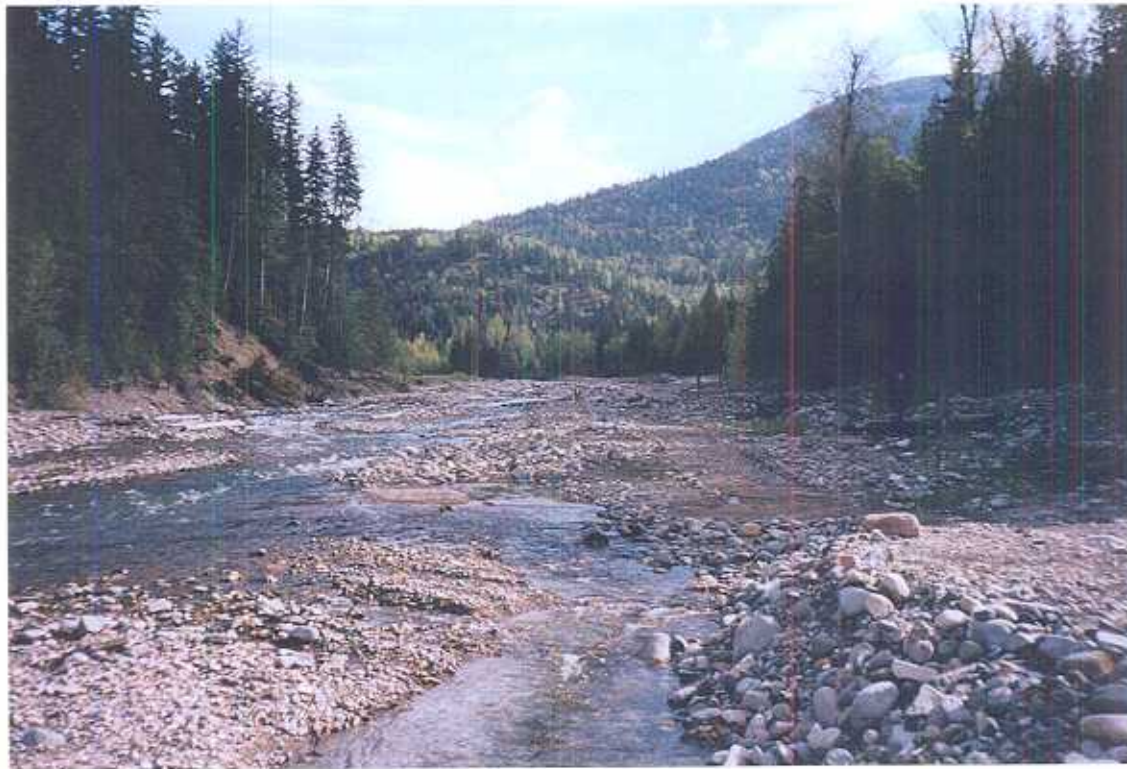
equipment is visible throughout reach R2 [Photo 2]. Approximately 90% of the reach is confined along its right (west) bank by a relic fan deposit composed of fluvial sand, gravel and cobble overlying lacustrine silt and clay deposits [Photo 3]. The left (east) bank is unconfined and has experienced significant erosion. The entire riparian zone along the left bank of reach R2 has been harvested and now consists of second growth vegetation ranging in seral stage from shrub-herb to young cedar dominated forest. Woody debris has been removed from reach R2, likely to prevent accumulation at the Squilax-Anglemont Bridge. Harvesting in riparian areas and removal of in-stream woody debris reduces natural bank protection and in-stream complexity, and can increase streamflow velocity. Increased velocity following debris removal would likely have been short-term, decreasing to natural levels or less as channel width increased with ongoing aggradation and bank erosion. While the role of natural bank protection and sediment regulation processes is small compared with the high level of sediment delivery to the Ross fan, their impairment has exacerbated long-term bank erosion, sediment transport, and deposition problems.

Photo 2. Reach R2 showing unconfined fan channel, bankfull width ranging from 40 to 100 m, and gravel reworked by heavy equipment. Note absence of woody debris and young regenerating forest on both banks.

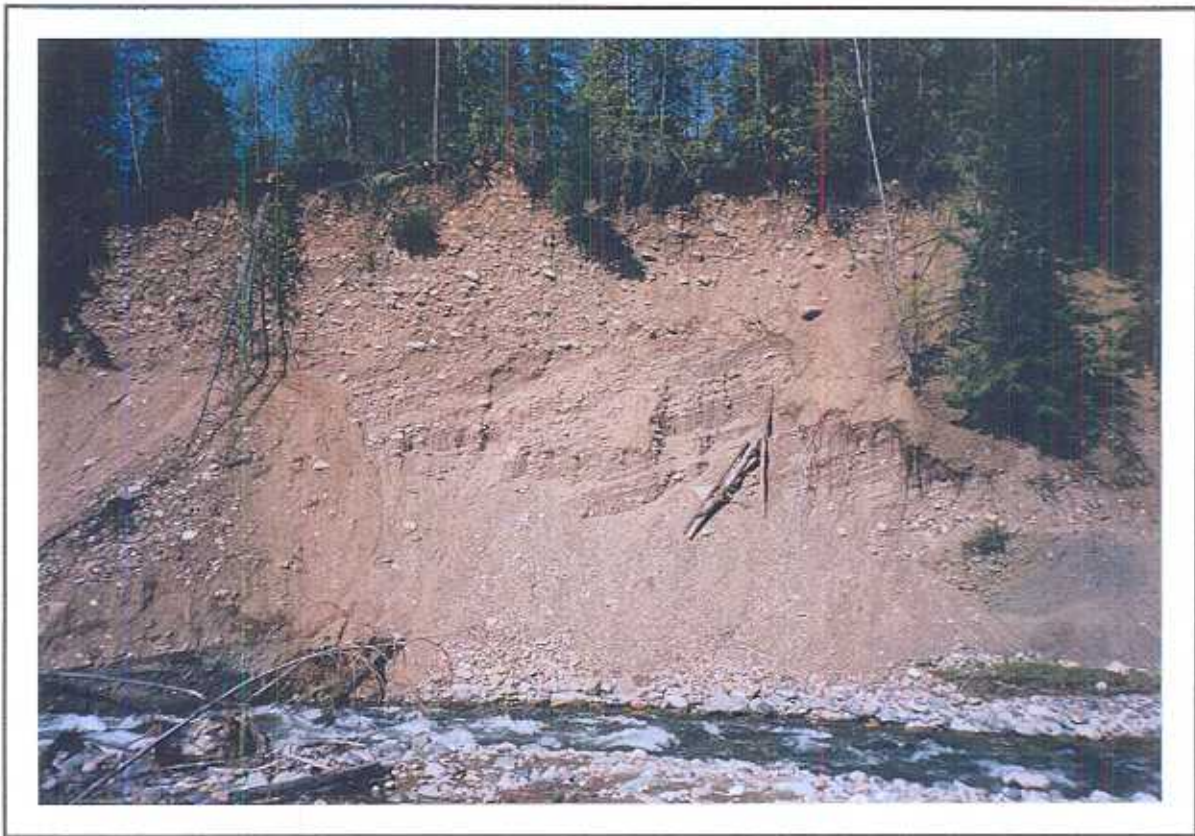
Photo 3. Historic delta and alluvial fan deposits on along right bank of reach R2. Note fluvial sand, gravel and cobble materials, overlying lacustrine silt and clay deposits at lower right of photo.

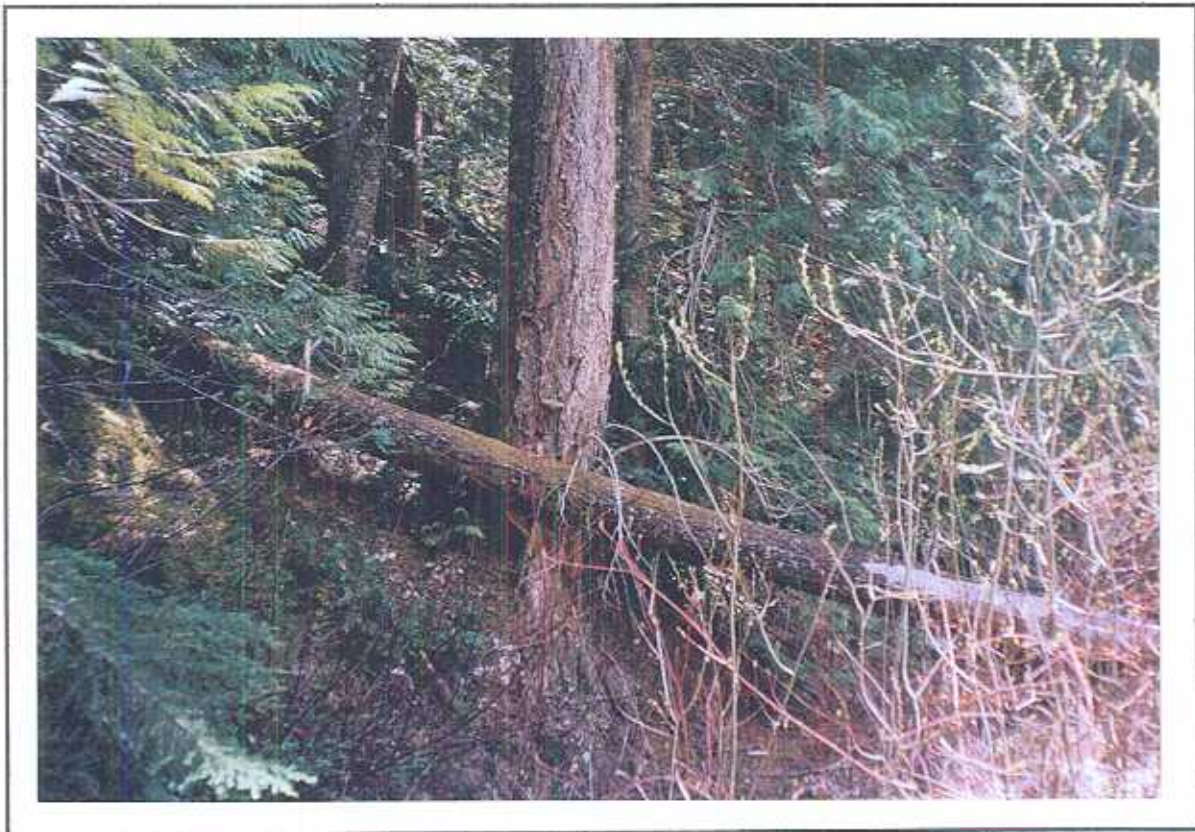
Steep glacio-fluvial terrace and bedrock slopes bound reach R4 over its entire length (3,400 m). Average channel gradient on reach R4 is 4.6%, mature vegetation is present to the water's edge [Photo 4], and no debris flow trim line is visible. Some scarring was noted on the upstream side of riparian vegetation, attributable to large woody debris movement following debris jam release in upstream areas. Debris flow initiation potential on reach R4 is low. Numerous historic and active valley sidewall slides are present along reach R4, as noted in the overview. Several large debris jams with associated sediment deposits are present throughout the reach [Photos 5 & 6] derived from both valley sidewall slides and upstream post-fire related mass wasting. The channel has recently (last two to five years) eroded around the lowermost and largest jam releasing a significant volume of sediment, and re-activating an adjacent valley sidewall slide [Photo 5]. It is likely that the bulk of sediment released from this jam occurred during relatively high flows experienced in the spring of 1997. The volume of sediment released into the lower channel and onto the Ross Creek fan during this event would account for much of the aggradation and erosion problems experienced at that time. Monitoring of this jam during high flows may provide an early warning mechanism for future high bedload transport and delivery events. There is a high risk of flooding and channel avulsion on the Ross Creek fan from the future release of sediment and debris from the lowermost jam. It is unlikely that this jam will fail in a catastrophic manner based on its size, but future sediment release episodes are inevitable. Removal of this jam is not advisable as numerous others are acting in a similar manner upstream, and the complete removal of all jams on the system would release an unmanageable volume of sediment.

Photo 4. Mature vegetation present at water's edge on reach R4 with no debris flow related scarring.

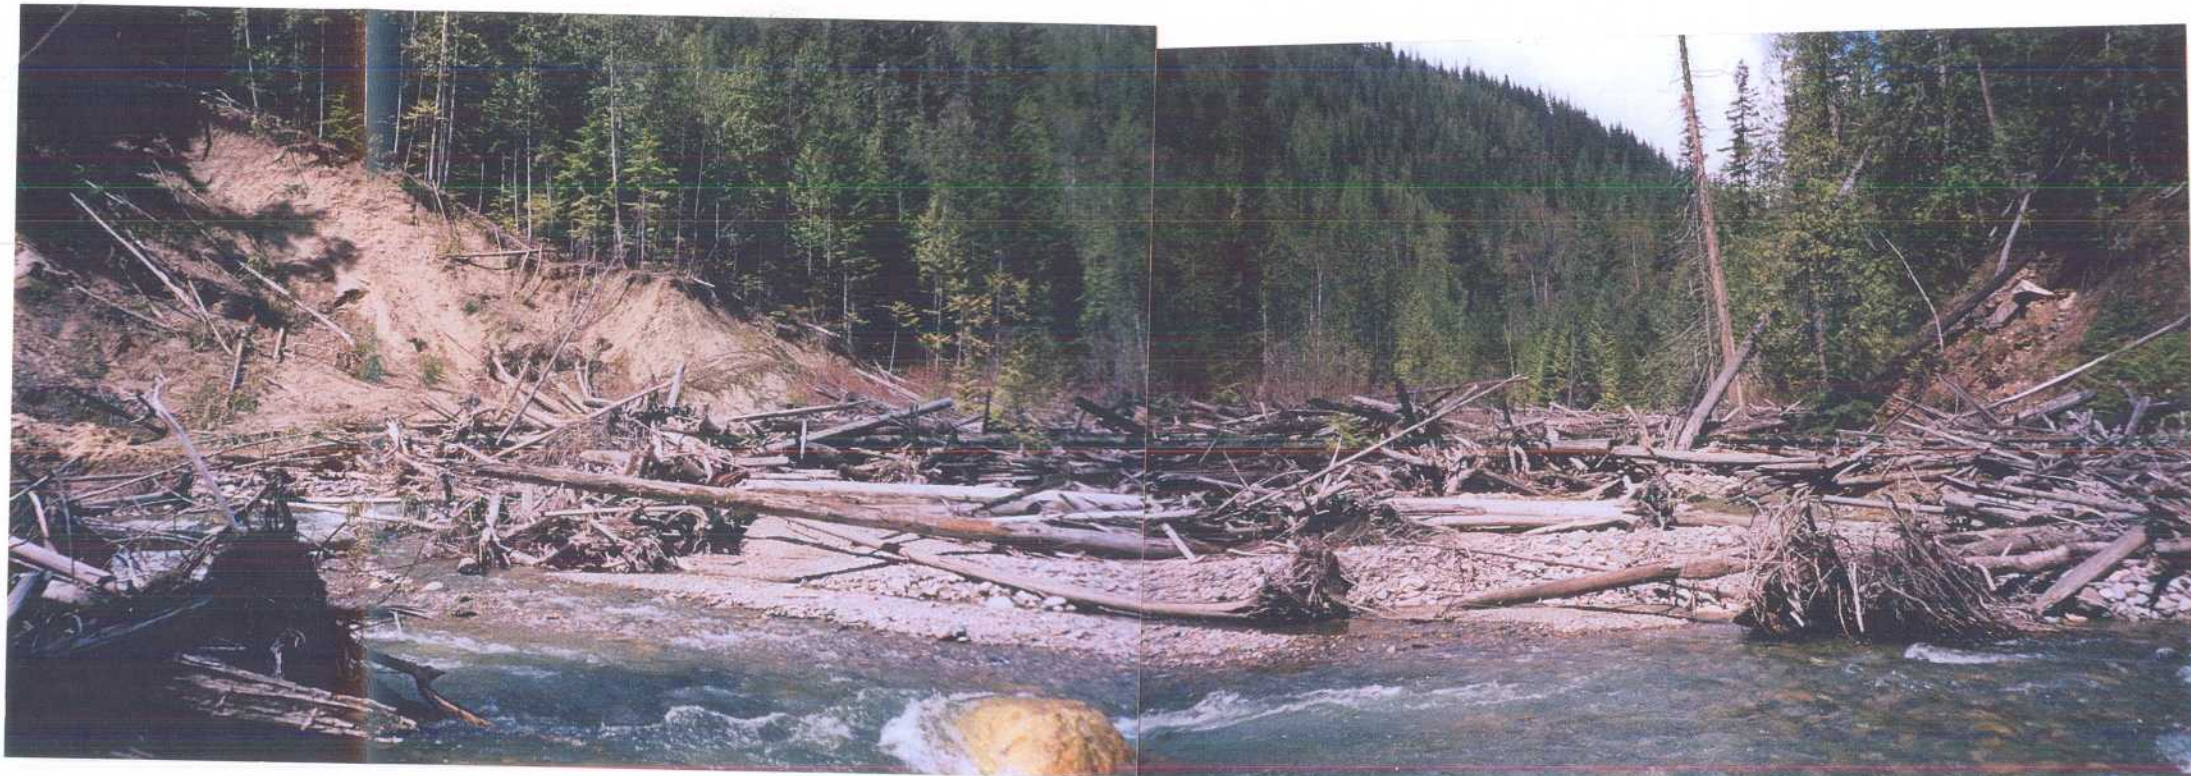
There is a high risk of flooding and channel avulsion on the Ross Creek fan from the future release of sediment and debris from the lowermost jam on reach R4. Monitoring of this jam during high flows may provide an early warning mechanism for future high bedload transport and delivery events on the fan. It is unlikely that this jam will fail in a catastrophic manner based on its size, but future sediment release episodes are inevitable. Removal of this jam is not advisable as numerous others are acting in a similar manner upstream, and the complete removal of all jams on the system would release an unmanageable volume of sediment.

Photo 5. Lowermost debris jam on reach R4. The channel has eroded around the jam on the left side of the photo re-activating a large slope failure in glacio-fluvial and lacustrine terrace deposits. This jam is approximately 75 m width and 3 m high.

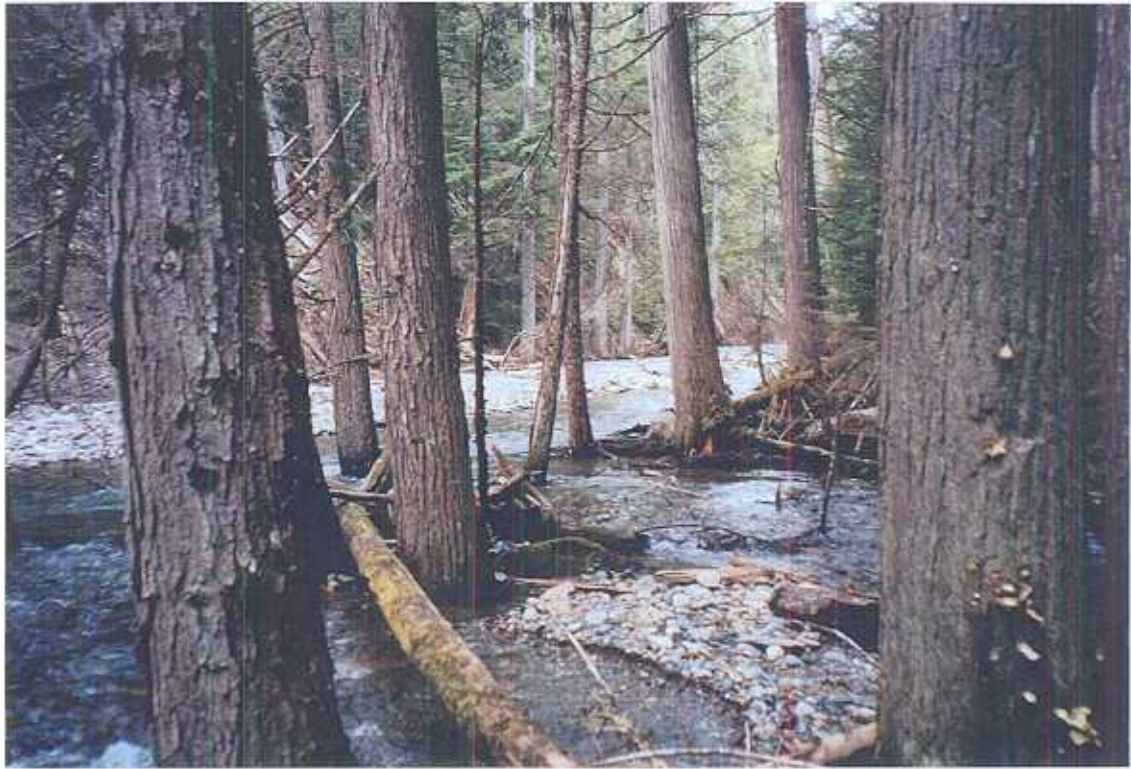
Photo 6. Heavily aggraded section on upper reach R5. The entire floodplain is inundated in this location under approximately 3 m of gravel and cobble material. A downstream debris jam is the likely cause of sediment accumulation.

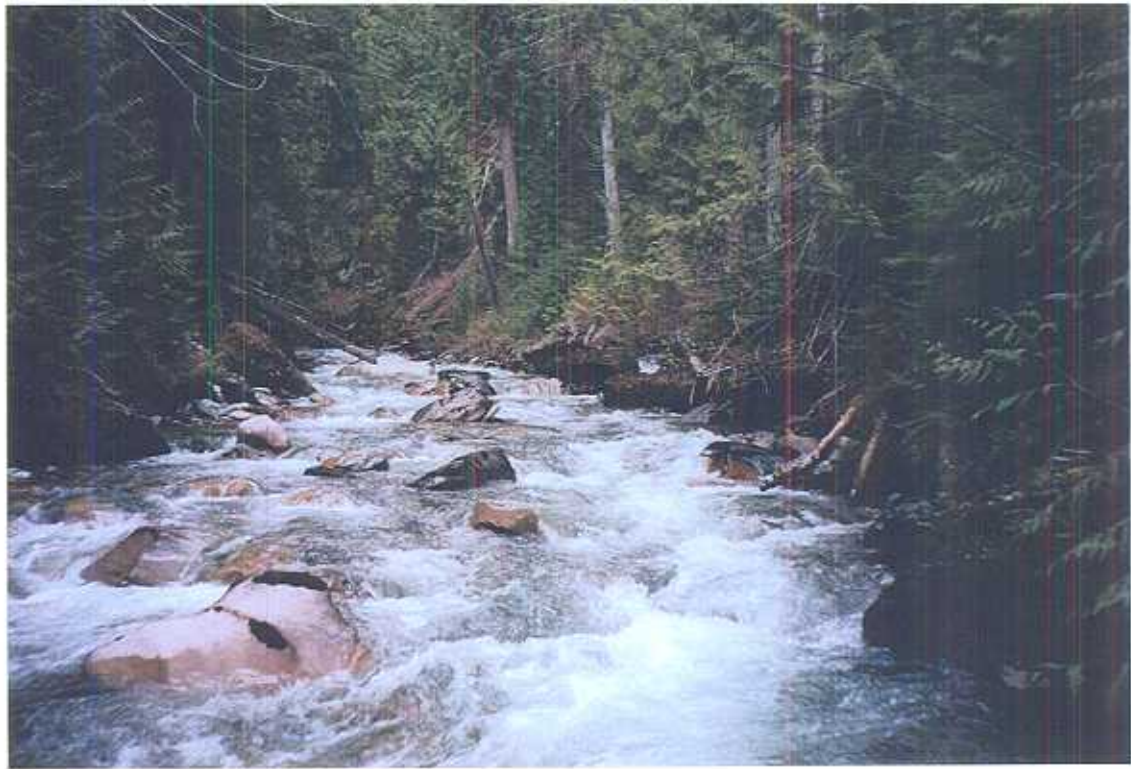
Photo 7. Reach R5 immediately upstream of the East Tributary confluence. Note mature timber to the water's edge and no evidence of a debris flow trim line.

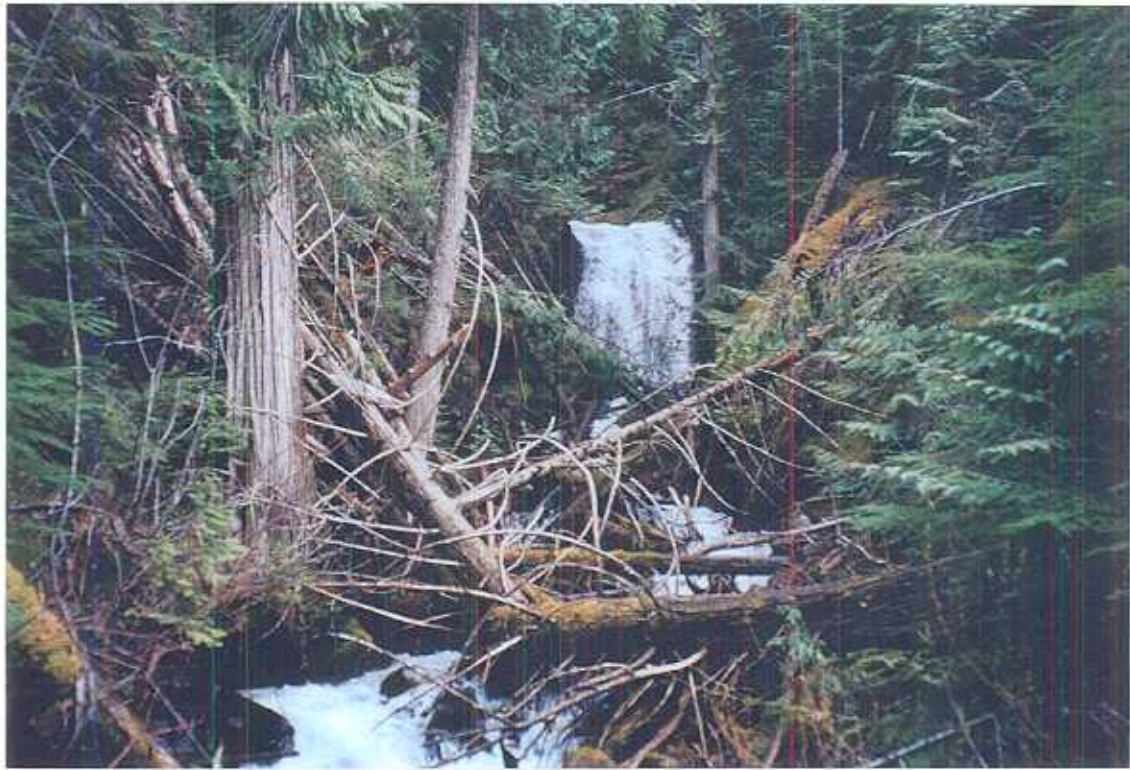
The lowermost reach on the East Tributary (ET1) is 350 m long and has an average gradient of 25.7% [Photo 8]. Steep bedrock and colluvial slopes bound the channel, with glacio-fluvial sand and gravel deposits in upper slope areas. Several valley sidewall slides, initiated by upslope road and trail related drainage diversions [refer to section 4.2.4] have impacted on ET1, but debris flows have not occurred. Based on this, and the gradient and channel confinement, debris flow initiation potential from a valley sidewall landslide is considered moderate on ET1. Additional road drainage diversion related slides into ET1 should be expected until drainage issues have been addressed through restoration or road deactivation (refer to section 4.4). Mature vegetation is present to the water's edge on lower ET1 and no trim line or scarring is present [Photo 9]. If a debris flow were initiated in ET1 it would impact on Ross Creek but deposit in the channel a short distance downstream of the confluence. Such an event would increase sediment and debris accumulation in jams on lower Ross Creek, and likely impair water quality and fish habitat for a short period of time until fine sediment is washed through the system, but would not increase the low risk of debris flow run out or deposition on the fan.

Photo 8. Reach ET1 immediately upstream of confluence with Ross Creek. Note mature cedar vegetation to water's edge and no evidence of a debris flow trim line.

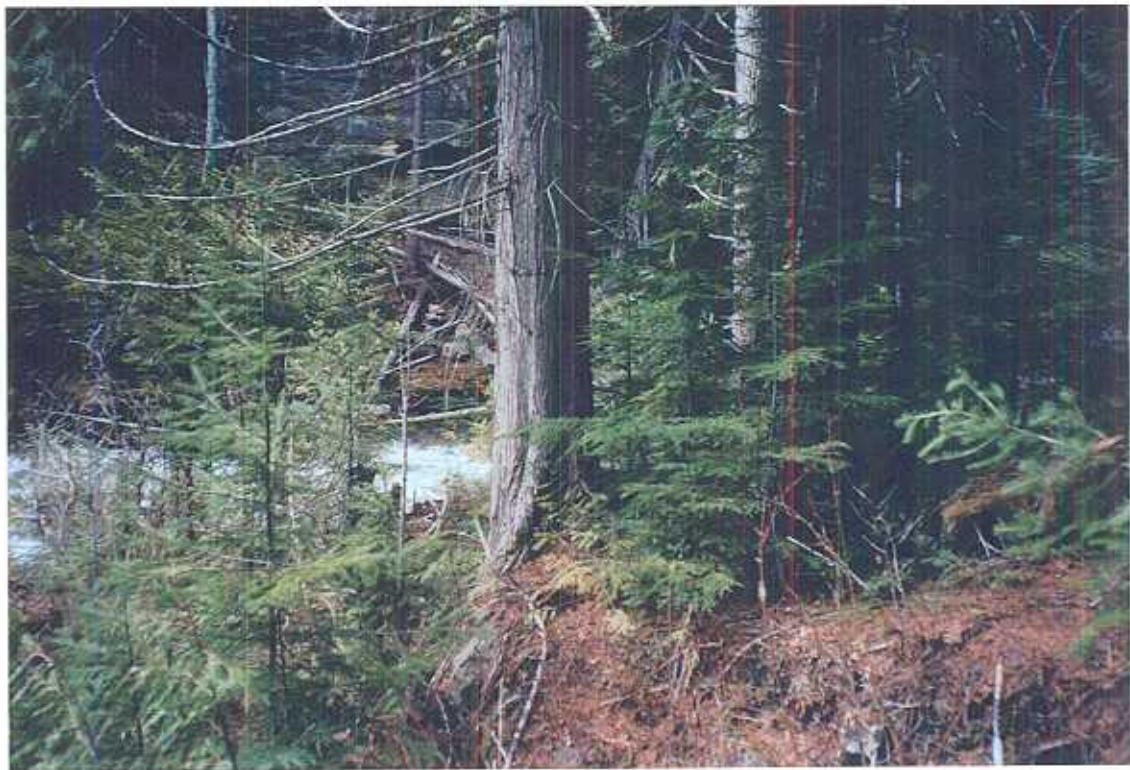
Photo 9. Mature cedar tree on right bank of reach ET1 at confluence with Ross Creek. No debris flow related scarring visible.

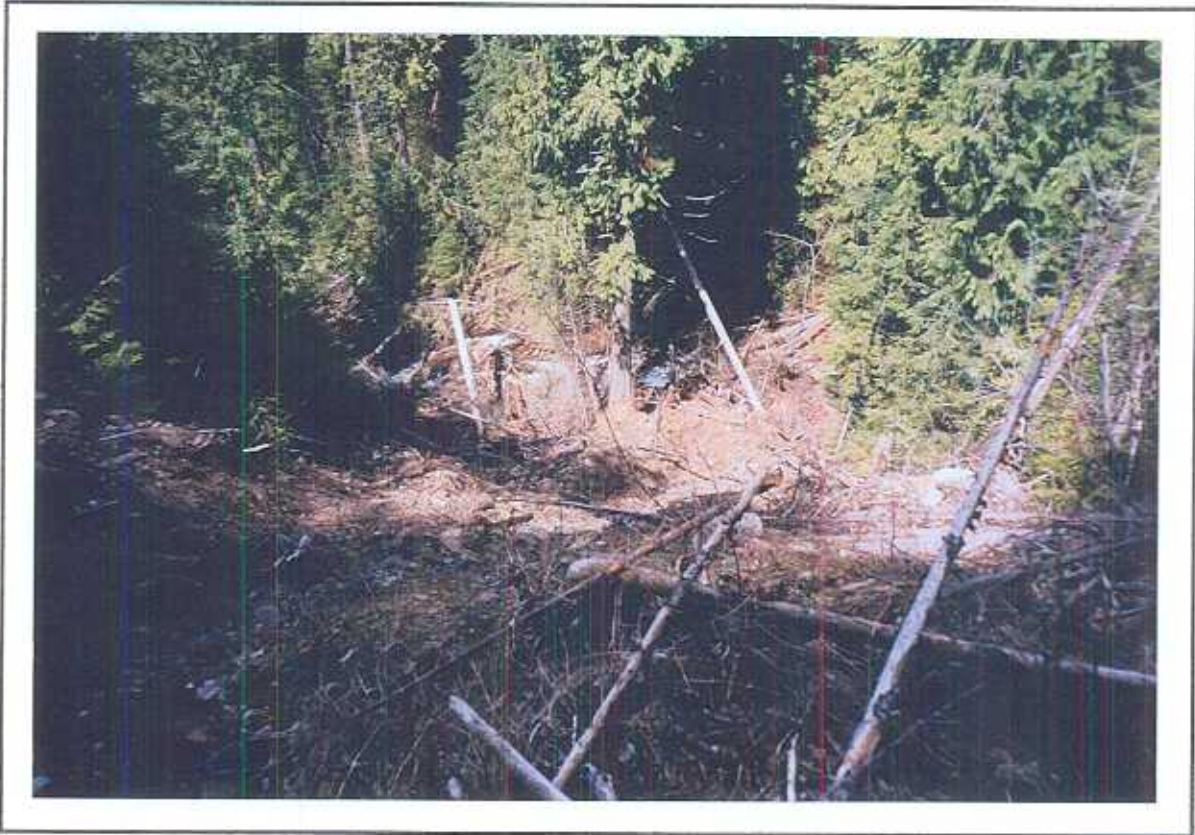
Reach ET2 is 2,780 m long has an average gradient of 18.0% and has also been impacted by valley sidewall slides [Photos 10 & 11]. Debris flows were not initiated by the slides, but the potential for debris flow initiation from a valley sidewall landslide is considered moderate, based on stream gradient and confinement. If a debris flow were initiated in ET2 it would carry through ET1 and impact on the Ross mainstem. An event initiated in

Additional landslides have also occurred from fillslope failure along Trails 2 and 3 within the East Tributary valley [Photos 10, 11, 12]. There is a high existing landslide hazard associated with portions of these trails that lie within the East Tributary valley. Upslope areas where SBFEP forest development is planned do not drain onto these sites and should not affect the current hazard level. There is a moderate risk of increased sediment input, and water quality and fish habitat impairment on lower Ross Creek from additional slides in this area. The existing hazard and risk on these roads could be reduced by deactivation.

Photo 10. Recent (2001) road fillslope related landslide into reach ET2. Landslide material deposited within 50 m of the impact location and no debris flow was initiated.

- There is a high existing landslide hazard and moderate risk of downstream water quality and fish habitat impairment associated with portions of Trail 2 and 3 that lie within the East Tributary valley. Existing conditions should not be affected by development planned in upslope areas. If funding were available, the landslide hazard and associated risk in this area could be reduced by deactivation.

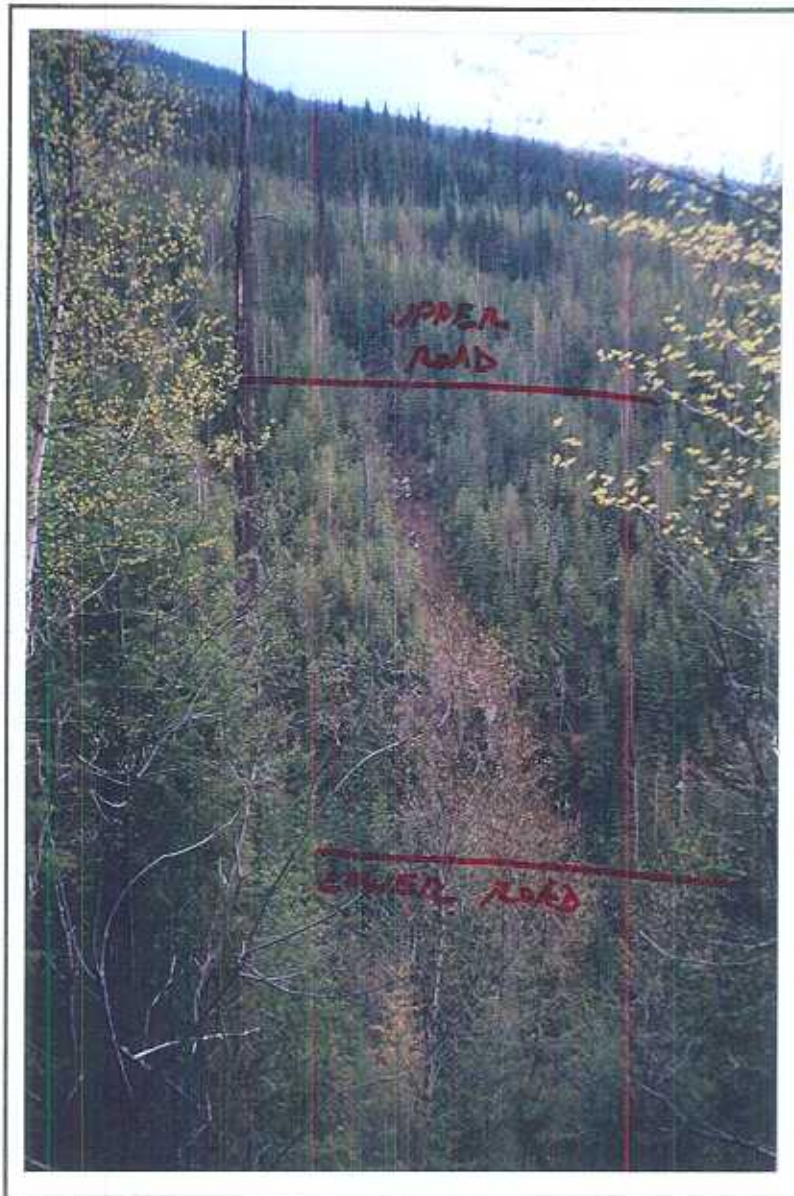
Photo 11. View across East Tributary valley at slide shown in photo 10. The slide initiated at an old road at the break in slope and carried through a lower slope road before impacting on the channel. Slope gradient ranges from 70 to 100% in the vicinity of the slide and lower slope road.

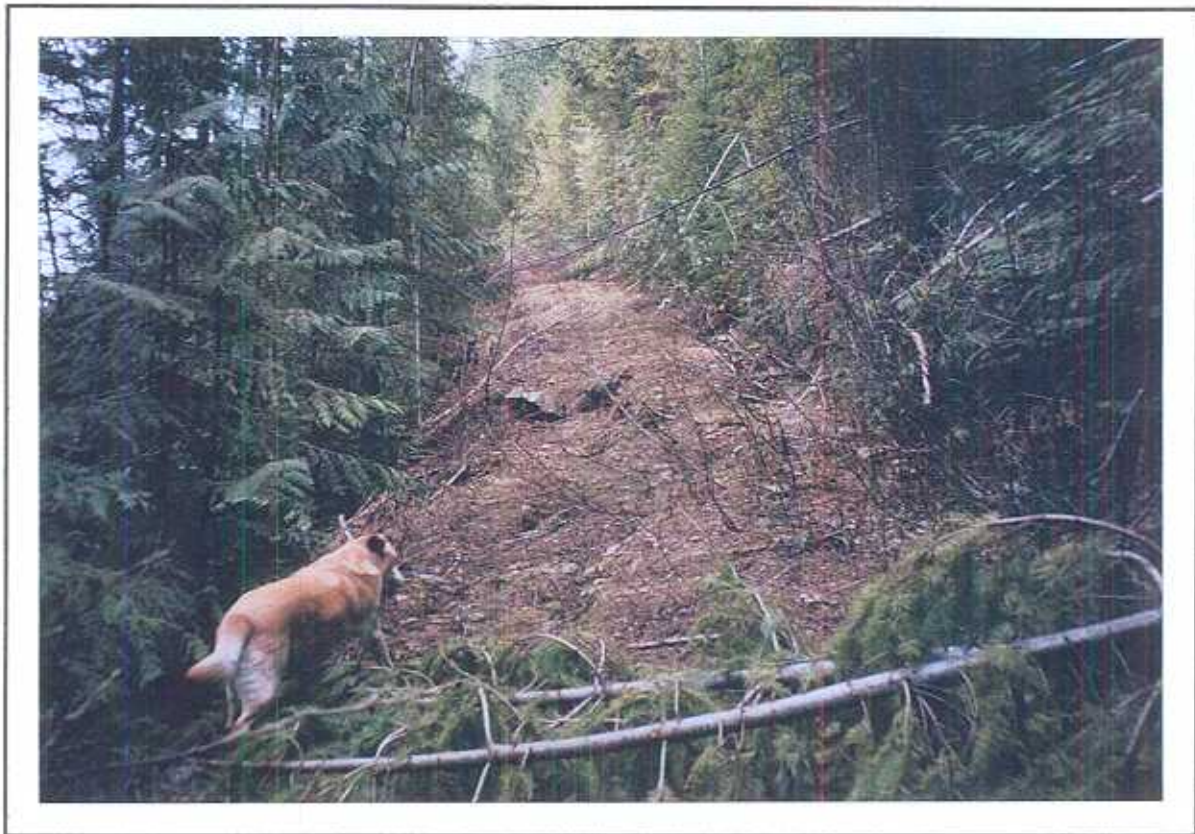
ET2 would likely carry farther down the mainstem than an event initiated in ET1, but deposition would occur and the low risk of debris flow run out or deposition on the fan would not be affected. Sediment and debris from an event initiated in ET2 would also accumulate in jams on the mainstem and water quality and fish habitat would likely be impaired until fine sediment was washed through the system. Many of the slides that impacted on ET2 likely resulted from root strength deterioration following Mag Fire occurrence, but several have been initiated by road fillslope failure on steep slopes adjacent to the channel. Future fillslope slides should be anticipated along ET2 based on old road construction methods and evidence of road instability [Photo 12](refer to section 4.4).

Photo 12. Old tension cracks with fillslope displacement on lower slope road shown in photo 11. Slope gradient is 90% in this location. Similar conditions exist along most of the lower slope road on both side of the East Tributary valley.
