## **Fish Passage Culvert Inspection - City of Prince George**

Prepared for:  
**City of Prince George**  
505-4<sup>th</sup> Avenue  
Prince George, British Columbia  
V2L 3H2

EDI Project No.: 04-BC-0104

February 2005

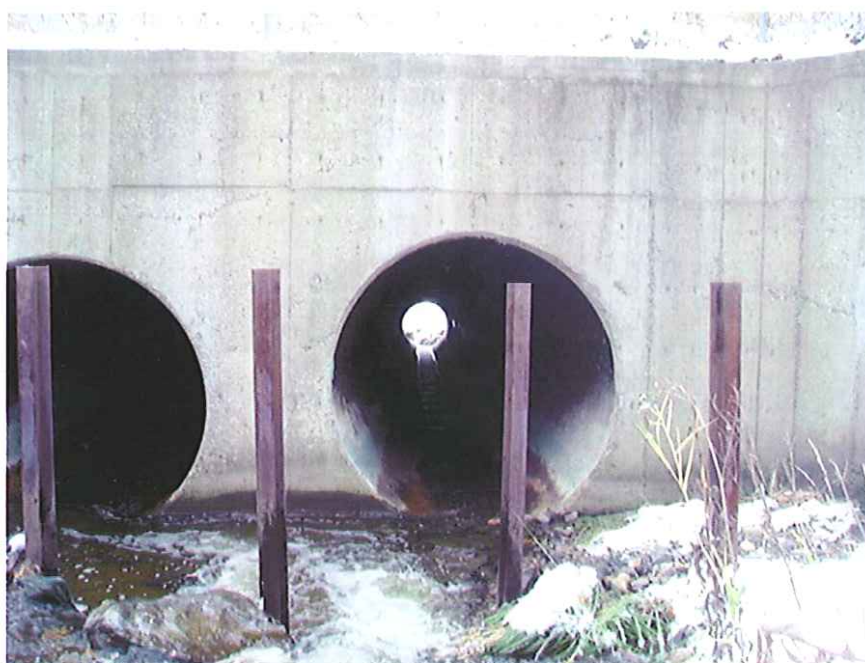
**Site 1 - McMillan Creek (Prince George Pulp Mill Road): Full Seasonal Barrier, High Priority**

The two non-embedded side-by-side culverts at Site 1 were determined to be a full barrier based on the FPCI assessment criteria. Since this site is located 20 m upstream from the Nechako River, it experiences backflooding during springtime high water volumes. The increased water depth would likely provide more suitable conditions for fish passage thereby permitting the upstream migration of

View of left bank inlet.

View of right bank inlet.

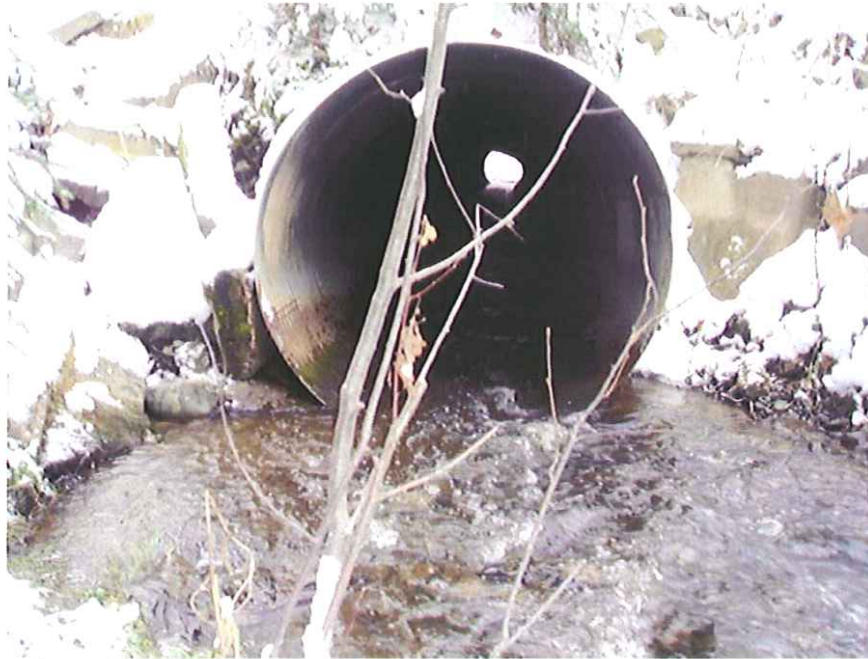
**Site 2 – McMillan Creek (Hoferkamp Road): Full Barrier, High Priority**

View of inlet.

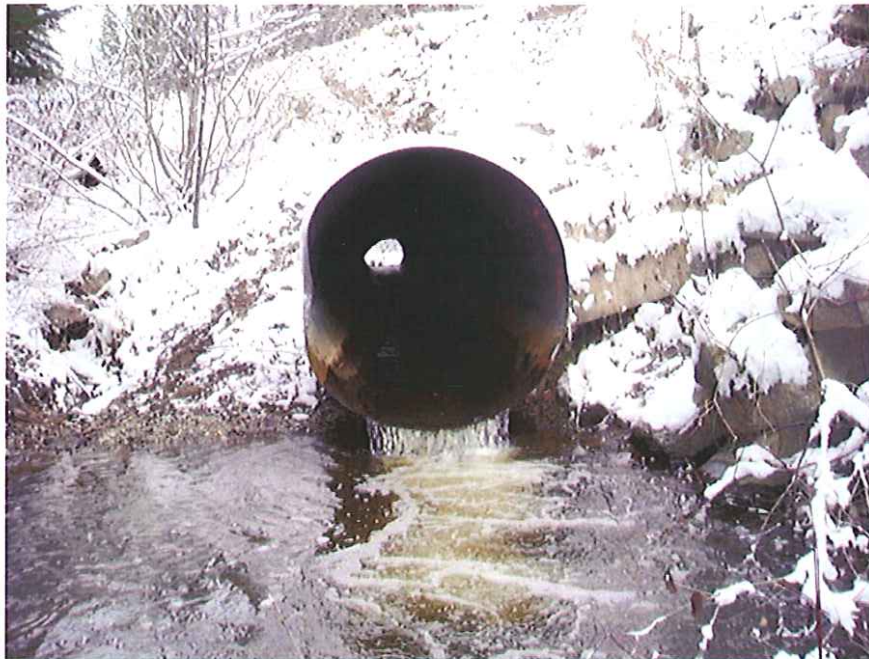
View of outlet.

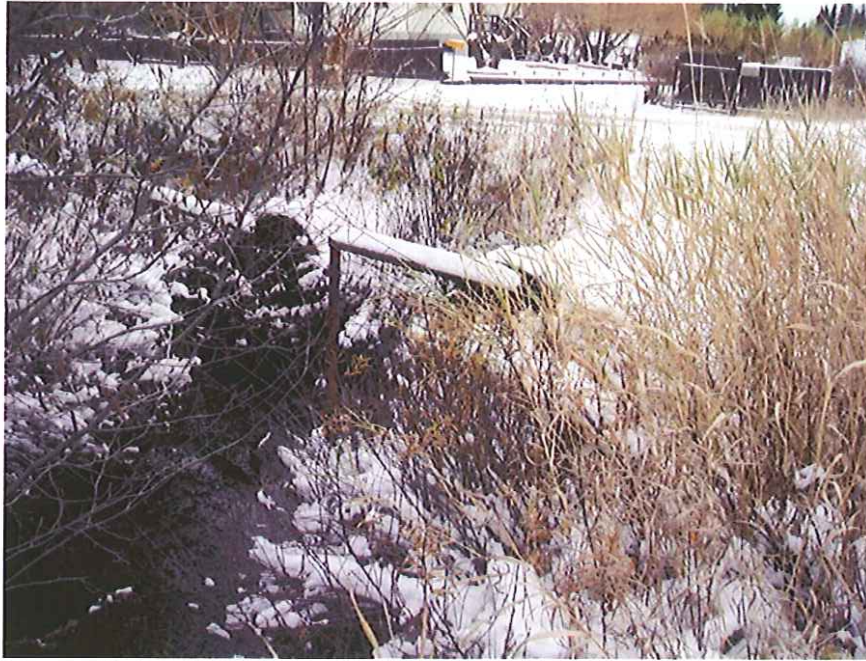
**Site 4 – McMillan Creek (McMillan Ave): Full Seasonal Barrier, High Priority**

The two non-embedded corrugated metal culverts (1200 mm diameter) at Site 4 were determined to be a **seasonal full** barrier to fish passage. The site is located approximately 2 km from the confluence of the stream and may be obstructing access to almost 13 km of McMillan Creek. However, many rainbow trout have been captured upstream from the crossing. This suggests that fish are capable of passing through these culverts under certain conditions. Given that the average channel width was 3.01 m, this crossing was undersized. The average culvert water velocity was 0.80 m/s. The gradient of this culvert was 1.6%. There was no outfall drop.

View of inlet. Note the anti-beaver devices.

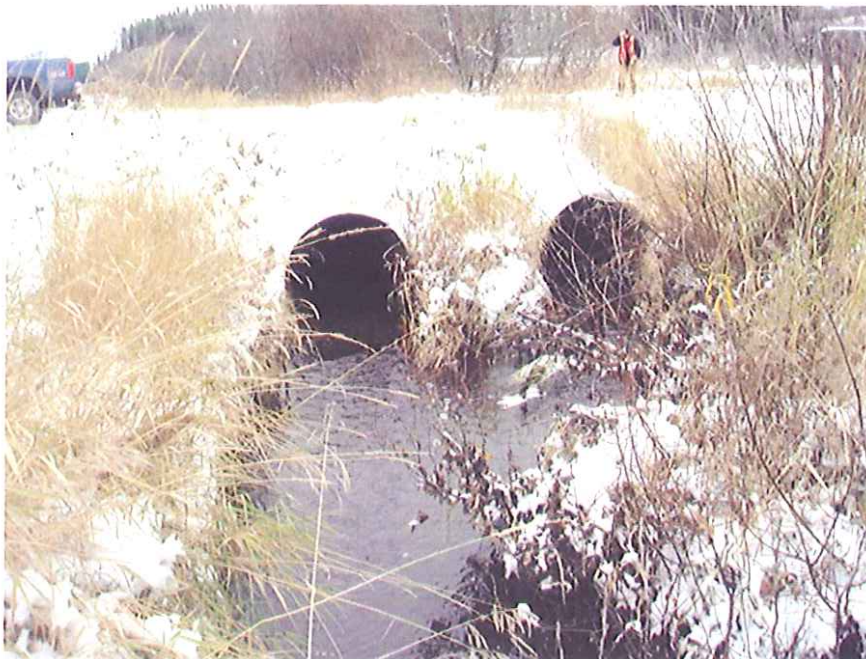
View of outlet.

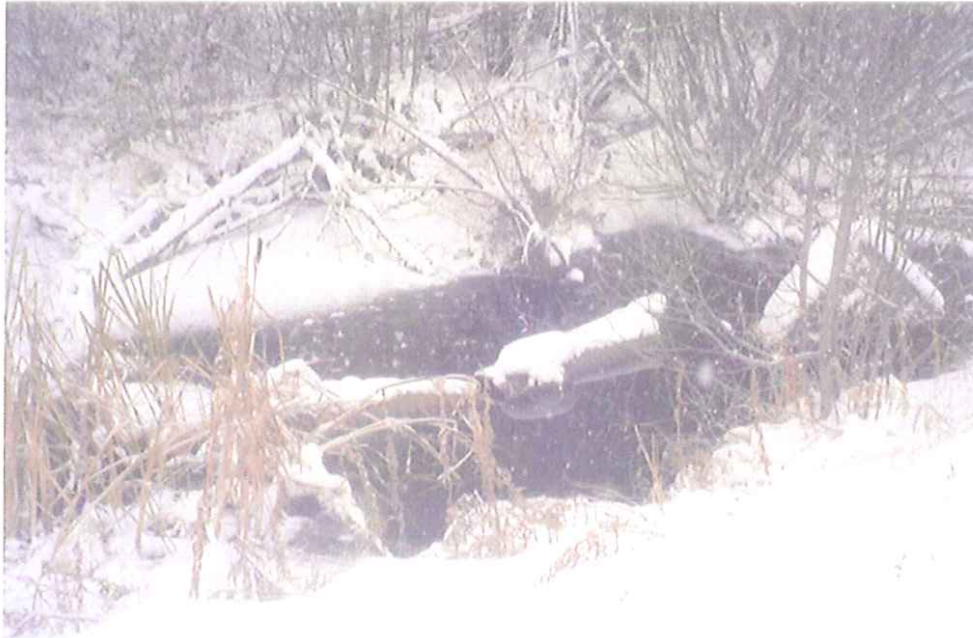
**Site 8 – McMillan Creek (Old Summit Lake Road): No Barrier, No Maintenance Issues**

View of old culvert within the stream channel upstream of inlet.

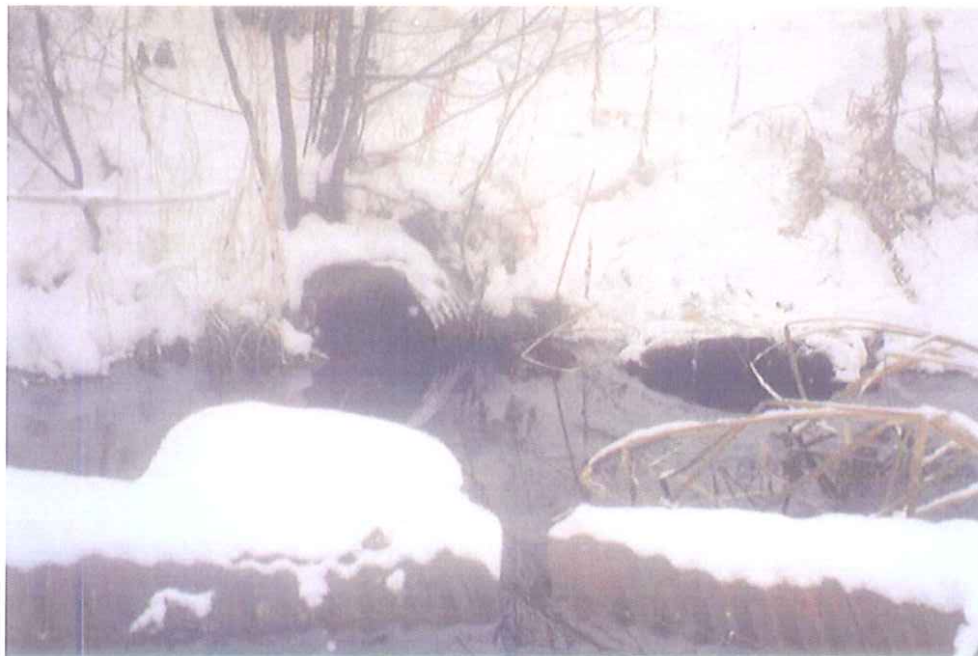
View of old culvert within the stream channel facing inlet.

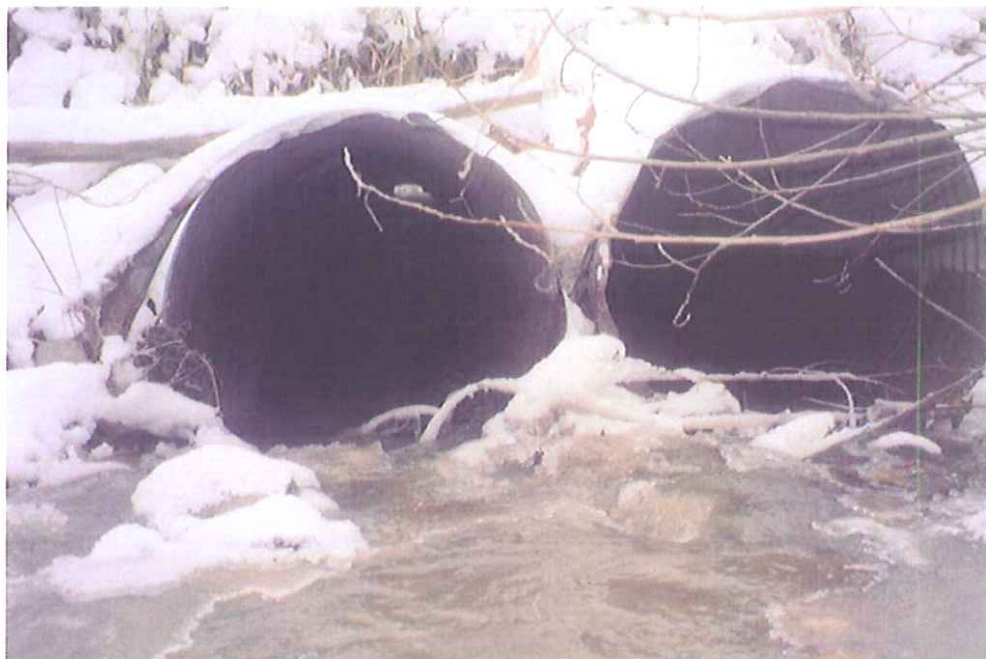
**Site 12 - Unnamed Stream (Indian Reserve Road): Full Seasonal Barrier, High Priority**

Site 12 is considered a **full seasonal** barrier. It is located approximately 150 m from the Fraser River and consequently would likely experience backflooding conditions. However, during the remainder of the year this crossing is potentially alienating nearly 4 km of high quality habitat. There are two non-embedded 1200 mm circular corrugated metal culverts at this railway crossing. Given that the average channel width was 3.06 m, these culverts are undersized. The average culvert water velocity was 0.88 m/s. The average gradient of these culverts was 3.6%. The average outfall drop height was 47.5 cm.

View of inlets

Two crossings were assessed on an unnamed stream intersecting Indian Reserve Road. Site 13 (Indian Reserve Road) is the road crossing and Site 12 (Indian Reserve Road) is the railway crossing. Both crossings were considered to be undersized and do not meet the recommended Q100 flood frequency estimate. Both crossings were considered full seasonal barriers and high priority crossings. However, electrofishing upstream of these crossings yielded juvenile rainbow trout presence above the barrier crossings. These fish are likely present due to seasonal backflooding events from the Fraser River. It is not currently known whether rainbow trout populations are self-sustaining above the crossings.

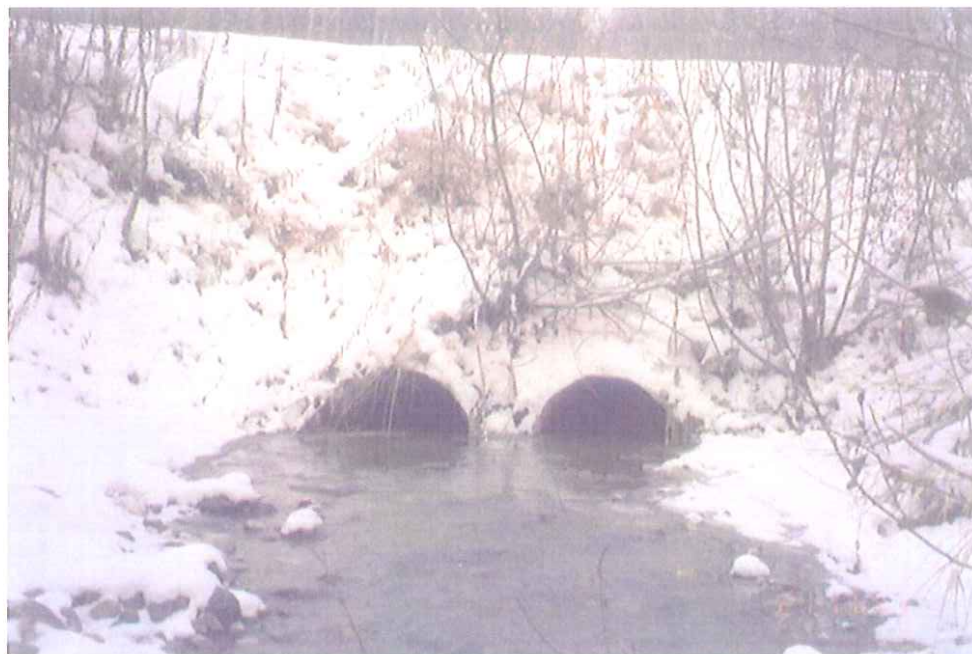
View of outlets.

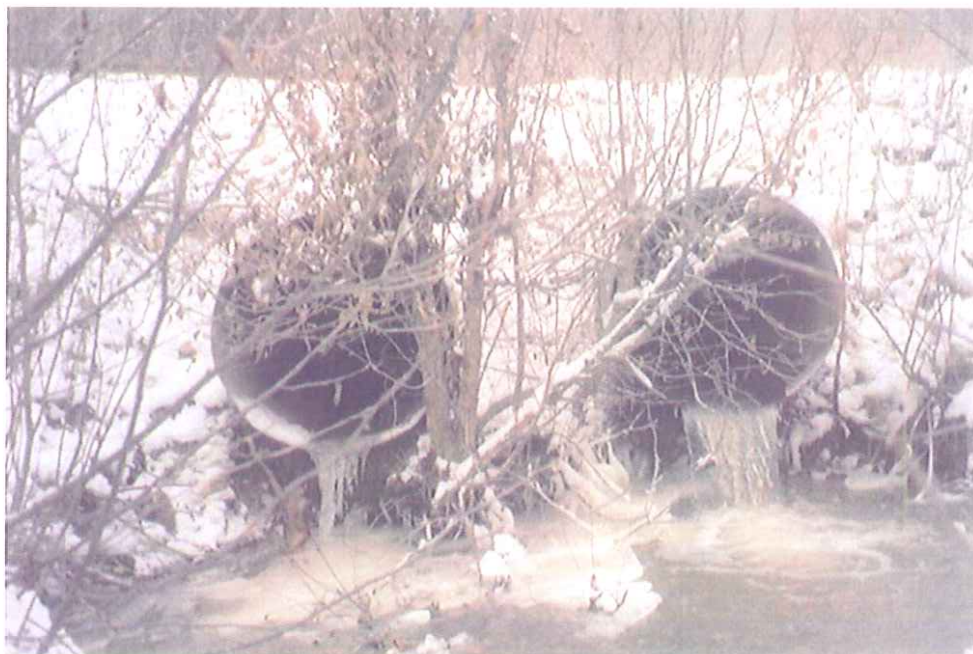
**Site 13 – Unnamed Stream (Indian Reserve Road): Full Seasonal Barrier, High Priority**

**Site 13 is considered a full seasonal barrier. It is located approximately 130 m from the Fraser River and would experience backflooding conditions. There were two non-embedded 900 mm round corrugated metal culverts at this crossing. Given that the channel width was 3.4 m these culverts are undersized. The average culvert water velocity was 1.19 m/s. The average gradient of these culverts was 3.2%. There was no outfall drop at this crossing.**

View of outlets.

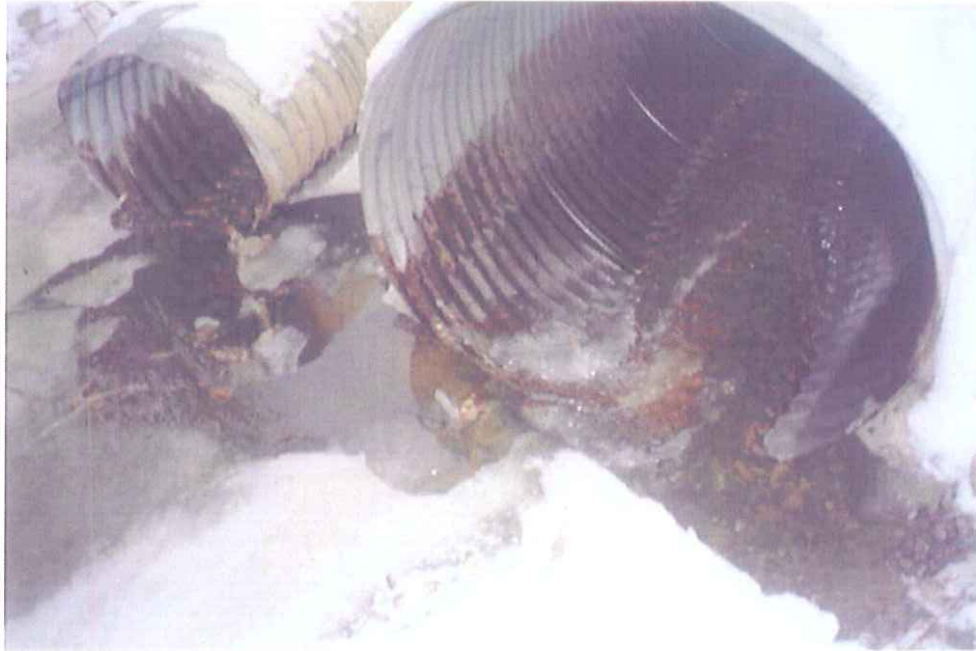
**Site 14 - Parkridge Creek (Domano Road): Full Barrier, High Priority**

View of inlets.

One crossing (Site 14) was assessed on Parkridge Creek and was rated as a full barrier. The two culverts at this crossing are undersized for this stream. Using the Fish Passage Culvert Inspection Scoring Matrix, this site was rated as a high priority. Although rainbow trout and chinook salmon have been documented downstream from Domano Road, fish have never actually been captured immediately below the crossing. Before replacing this culvert, additional investigations are recommended to ensure fish passage in Parkridge Creek is obstructed by the culvert, instead of a natural barrier farther downstream.

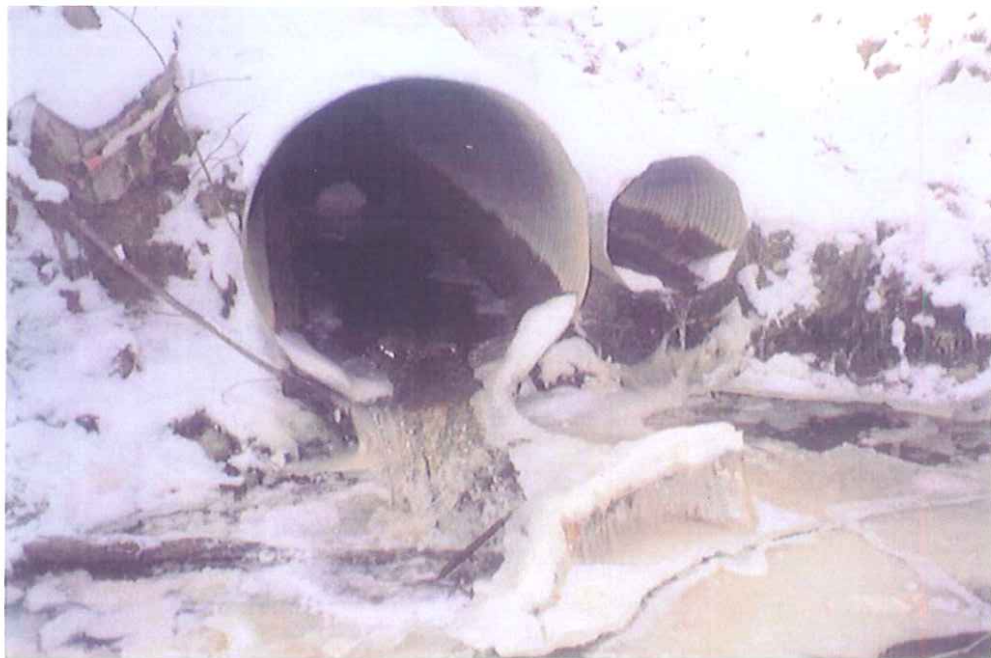
View of outlets.

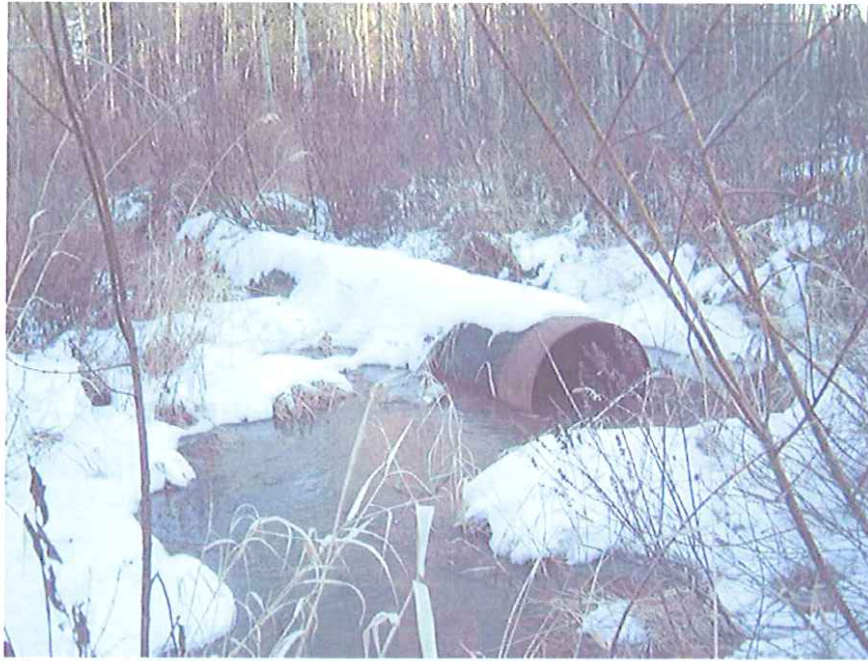
**Site 15 – Unnamed Stream (North Blackburn Road): No Barrier,  
Moderate Maintenance Issues**

View of old corrugated metal pipe within stream channel.

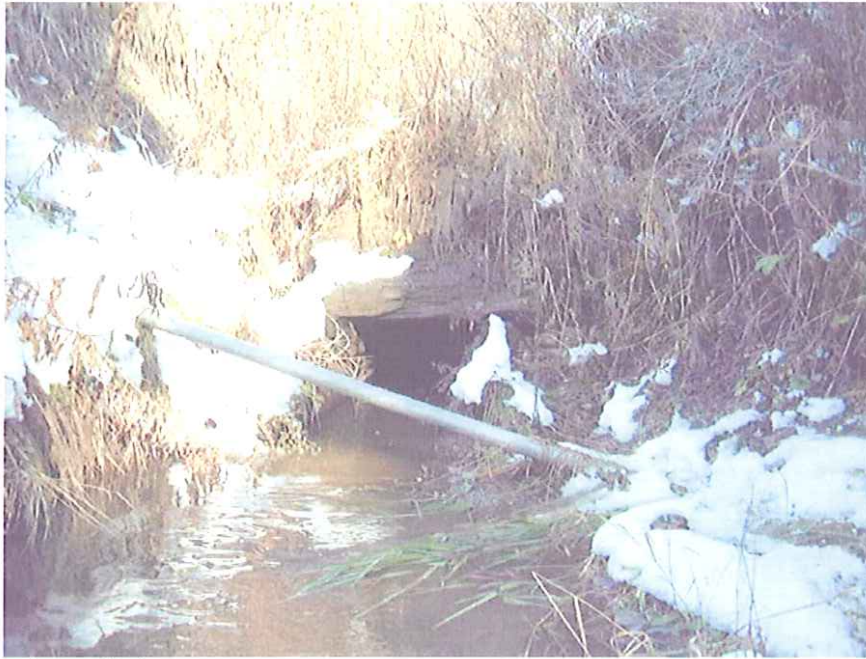
**Site 17 - Unnamed Stream (Giscome Road): Partial Barrier, High Priority**

Site 17 was considered a **partial** barrier, **high** priority crossing. It is located on an unnamed first order stream approximately 1 km from its confluence with Bittner Creek. Given that the conditions within the culvert were very close to the fish passage criteria (3.2.1) this crossing was considered a partial barrier. This crossing has potentially alienated approximately 1 km of habitable stream length. Within the culvert there is a transition between a wooden box culvert inlet and a circular cement culvert outlet. The cement culvert outlet is dated 1941. The culvert diameters were 550 and 600 mm respectively. Given that the average channel width was 2.02 m, this crossing was undersized. The average culvert velocity was 0.49 m/s. The culvert gradient of this culvert was 1%. There was no outfall drop at this crossing.

View of inlet

Site 17 was considered a partial fish passage barrier. The crossing was considered to be undersized for the site conditions. The conditions at the site were close to the fish passage criteria outlined in Section 3.2.1 of this document, resulting in the rating of partial barrier. The structure was dated 1941 and consists of a wooden box culvert inlet and a cement culvert outlet with a transition in the middle of the crossing. Replacing this crossing with a structure suitably sized for the stream would restore full fish passage to a headwater segment of Bittner Creek that is presumably fish-bearing but that likely contributes marginally to overall fish production. Significant temporary disruption to traffic would have to occur during construction, since Giscome Road is a relatively busy corridor.

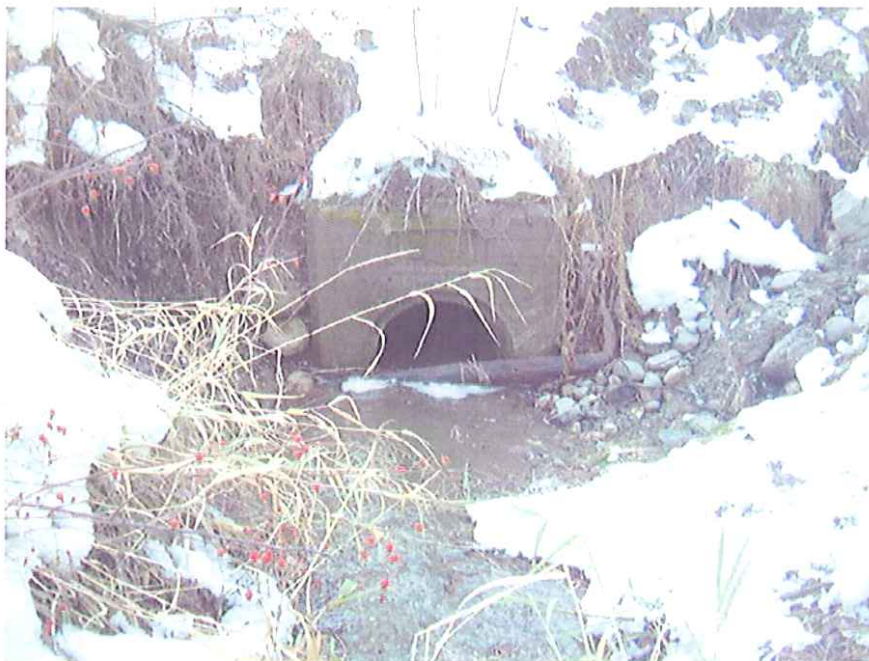
View of outlet.

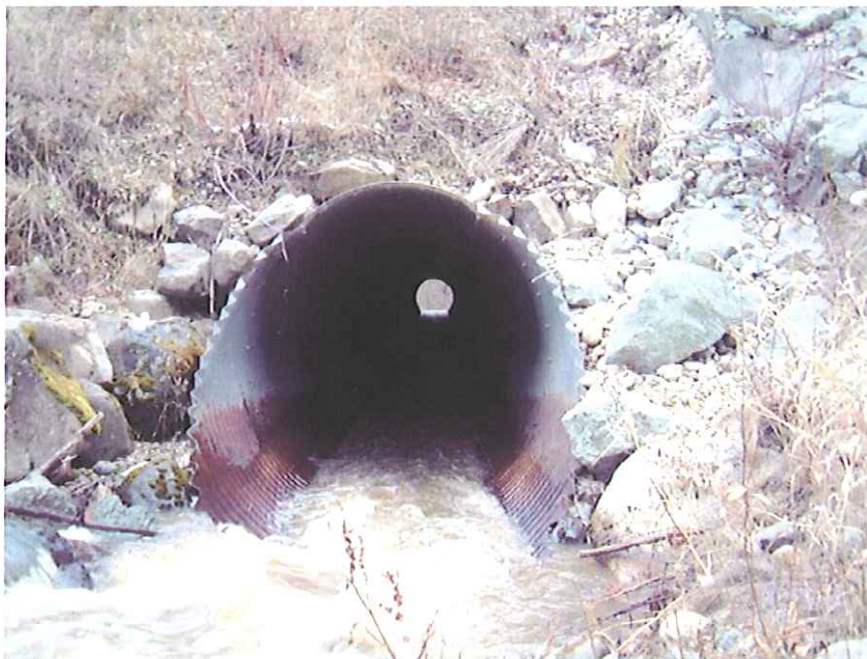
**Site 18 - Haggith Creek (Willow-Cale Road): Full Barrier, High Priority**

Site 18 was considered a **full** barrier, **high** priority crossing. The crossing was located 200 m from the Fraser River. Although this crossing is in close proximity to the Fraser it was not considered to have the conditions even seasonally to allow fish passage. The excessive outfall drop and water velocity were evaluated to be far beyond the fish passage criteria (3.2.1). Thus, backflooding events from the Fraser River would likely not alter the conditions at the crossing enough to allow fish passage. This crossing is alienating approximately 7.5 km of potential habitat. There is one non-embedded 2000 mm round corrugated metal culvert present at this site. Given that the average channel width is 6.87 m, this culvert is undersized. The average water velocity was 2.15 m/s. The outfall drop height was 125 cm.

View of inlet.

One crossing (site 18) was assessed on Haggith Creek and was rated as a full barrier. Using the Fish Passage Culvert Inspection Scoring Matrix this site was rated as a high priority. The culvert at this site was undersized and was a definite barrier. This crossing is a barrier to approximately 7.5 km of potential fish habitat. The crossing was starting to fail with water piping underneath the culvert. The major constraint for replacing this crossing is the large amount of fill over the existing culvert.

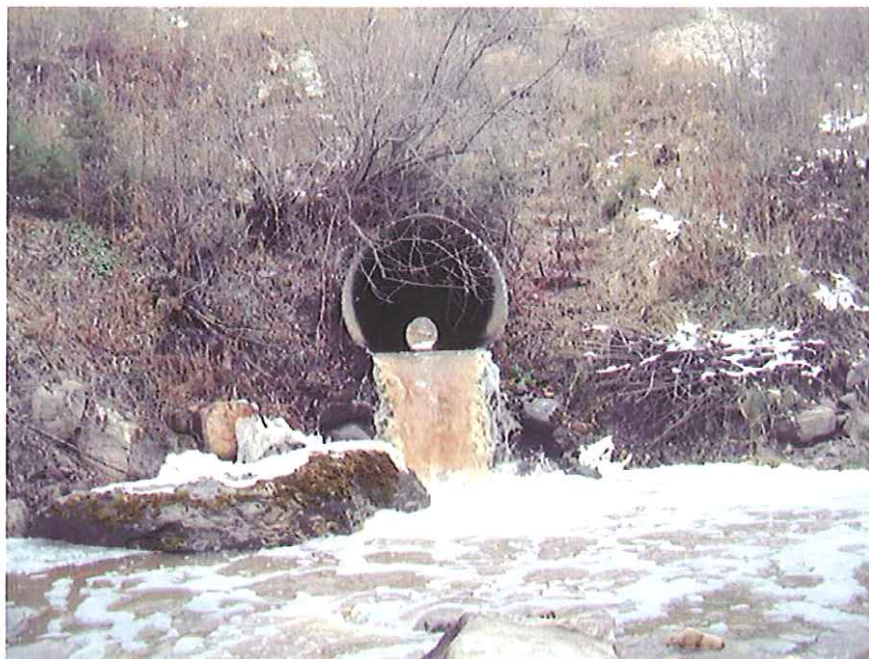
View of outlet.

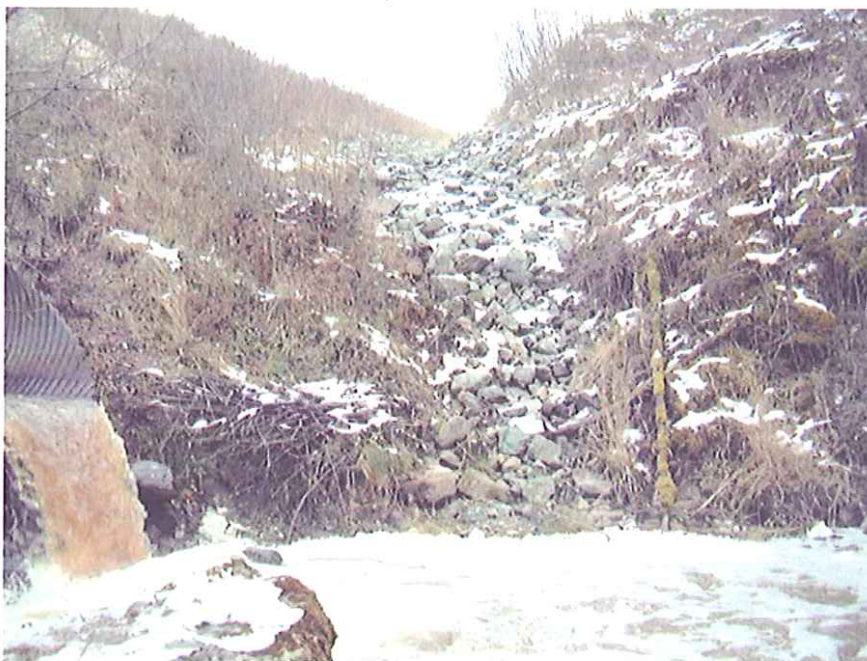
**Site 18 – Haggith Creek (Willow-Cale Road): Full Barrier, High Priority**

This culvert was starting to fail as water was piping underneath the culvert. The water flowing underneath could potentially mobilize the soil and carry sediment into the stream channel.

View of outlet and right bank slope.
