**TERRAIN CLASSIFICATION AND
TERRAIN STABILITY MAPPING
ALBREDA AND MESSITER PROJECT AREAS**

**BC Timber Sales
Kamloops Business Area**

**MADRONE ENVIRONMENTAL SERVICES LTD.
1081 Canada Avenue, Duncan, BC V9L 1V2**

March 19, 2007

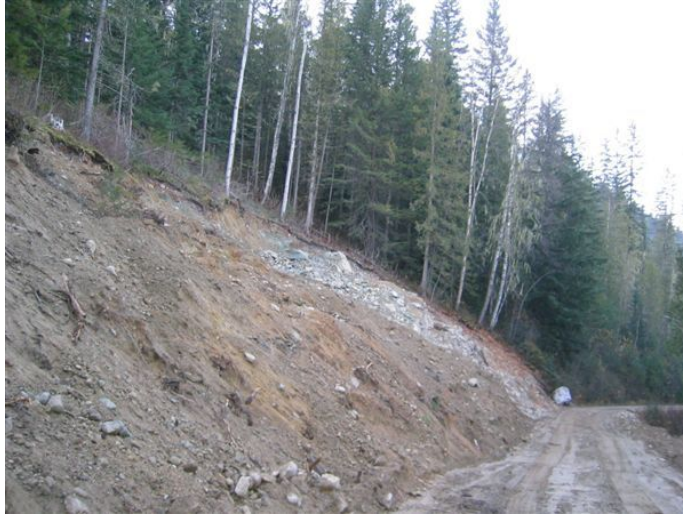
Photo 1. Road cuts are a valuable resource for observing the material below the surface.

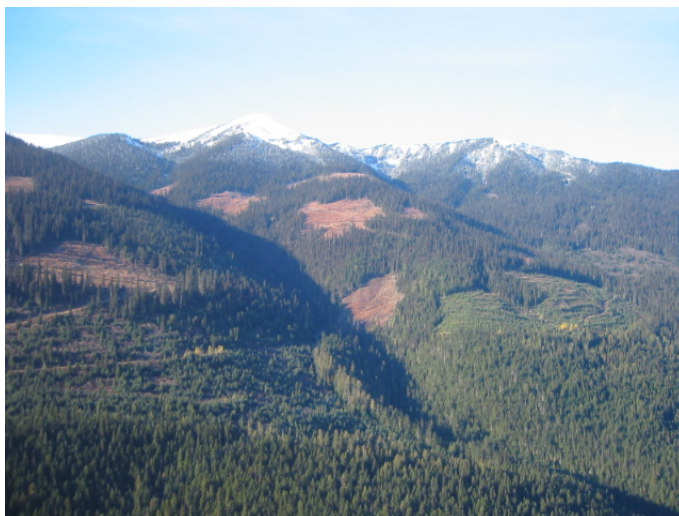
Photo 2. West side of Albreda project area, where valley sidewalls are dissected by deep gullies.

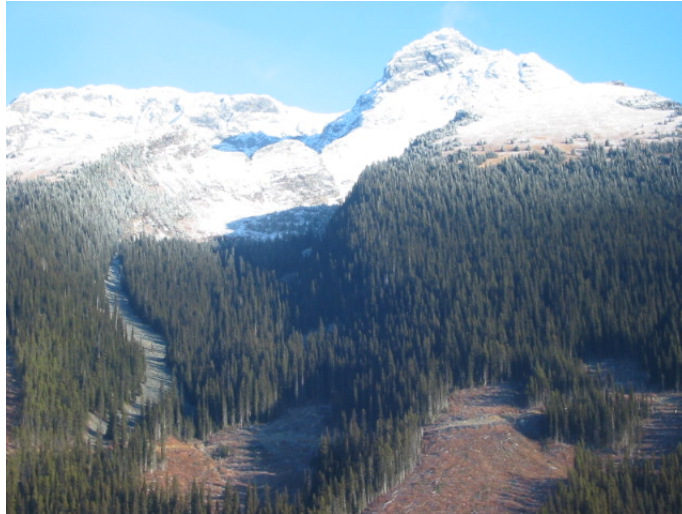
Photo 3. Significant peak of the Malton Range in the northeast portion of the Albreda project area.

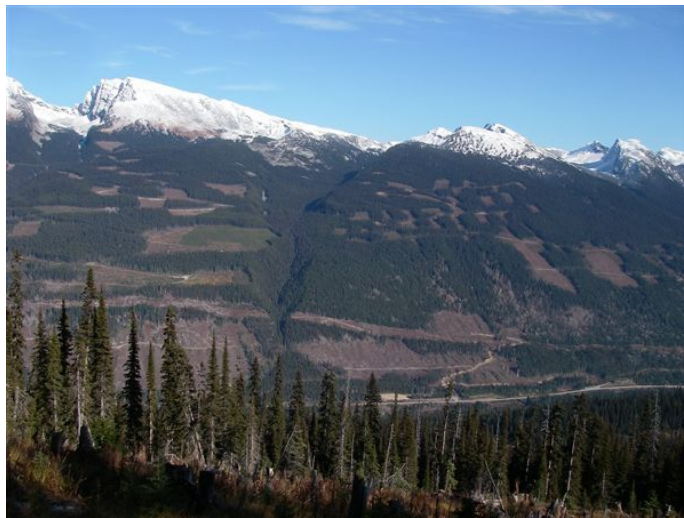
Photo 4. Malton Range and east side of Albreda project area.

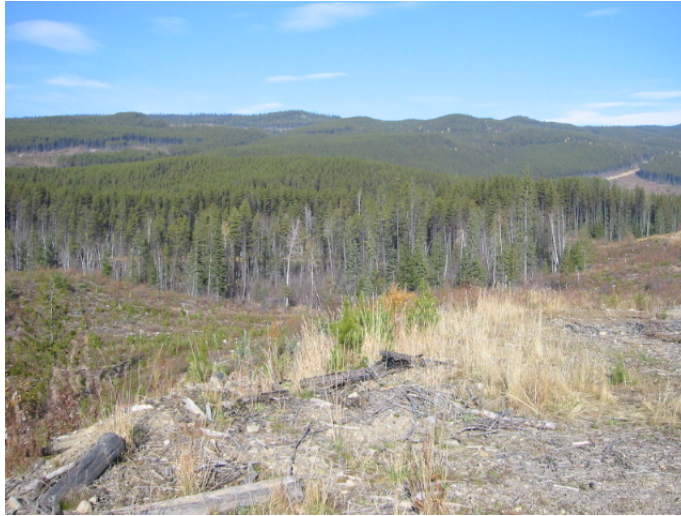
Photo 5. Moderate sloping, undulating terrain typical of the southern portion of Messiter project area.

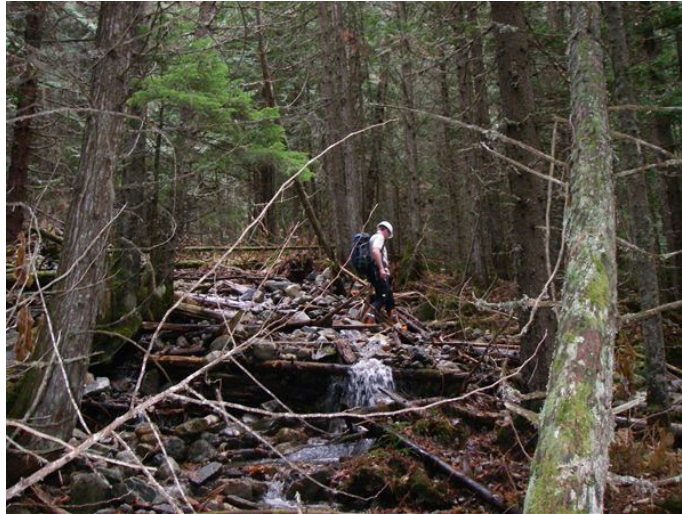
Both Albreda and Messiter project areas include large creeks and rivers draining the surrounding terrain. As a consequence of scattered mountainous topography and heavy annual snowpack, the hydrologic regime of these watercourses is snowmelt dominated. The maximum daily and instantaneous flows typically occur in late spring or early summer, particularly in the larger rivers and creeks. The range of elevation in the Albreda project area is such that a significant snowpack likely persists into July, and this ensures that flows are maintained throughout the summer in the larger creeks and rivers. Peak instantaneous flows are usually associated with the sudden onset of high temperatures that accelerate melting of the snowpack and are typically combined with spring or summer rainstorms falling on the melting snowpack. Flows are more seasonally varied in some smaller creeks lacking the high elevation snowmelt contribution (but still experience a snowmelt peak flow). In some years, a smaller peak flow may occur during late October or early November as a result of rain-on-snow events. These short-term flood flows are significant in entraining sediment. The first large flows of the year entrain much of the sediment stored in tributary creeks and gullies (Photo 6). Sediment load usually peaks following this.

Photo 6. Stream clogged with woody debris and sediment wedges in Messiter project area.

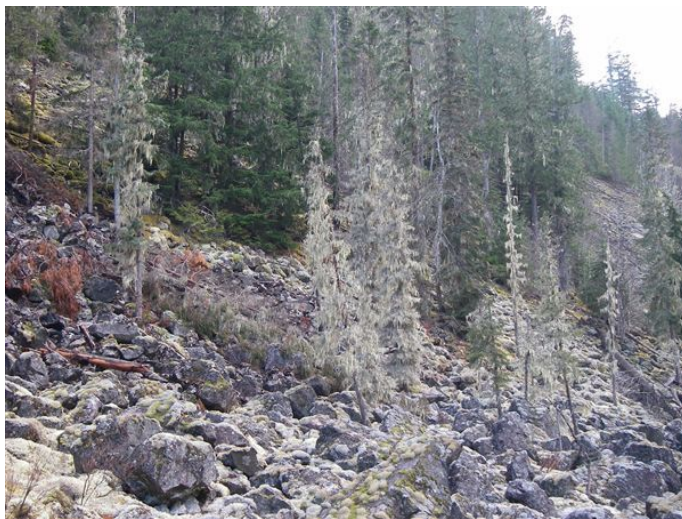
Photo 7. Stable talus slope in Albreda project area.

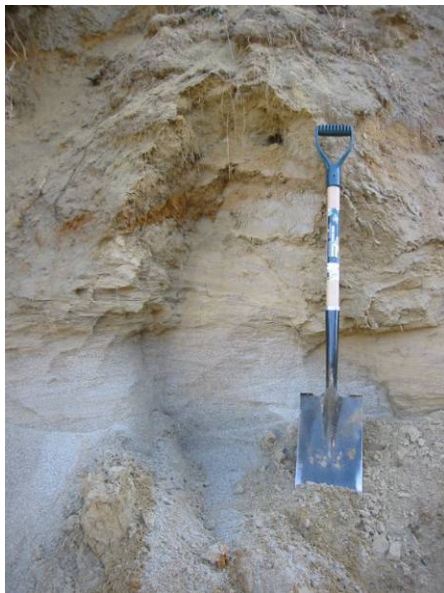
Photo 8. Bedding planes of silt and sand in a massive glaciofluvial deposit in the Albreda project area.

In places, post-glacial incision and gullying through the deposits has resulted in oversteepened banks (*FGks/Mks-V*) that are susceptible to failure, chronic ravelling, and erosion.

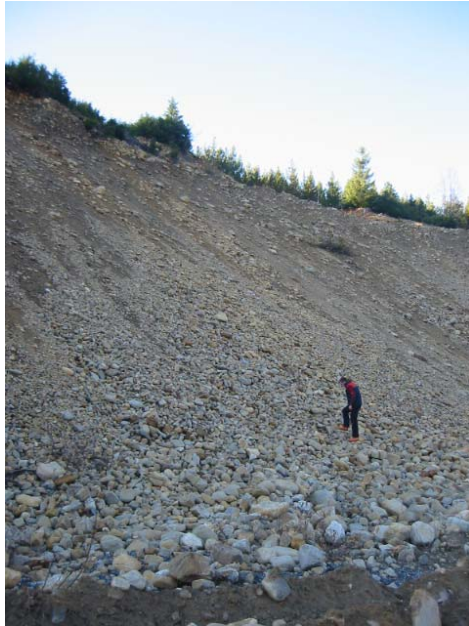
Photo 9. Glaciofluvial gravel deposit more than 20 m deep. Located in southeast corner of Albreda project area.

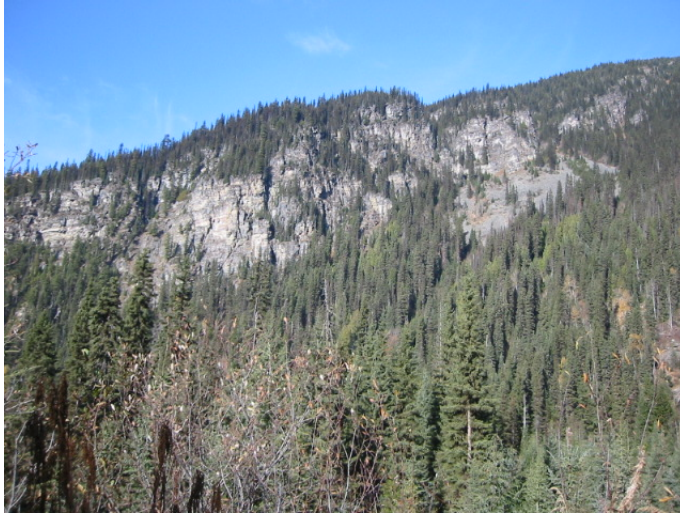
Photo 10. Bedrock exposure typical of Messiter project area.

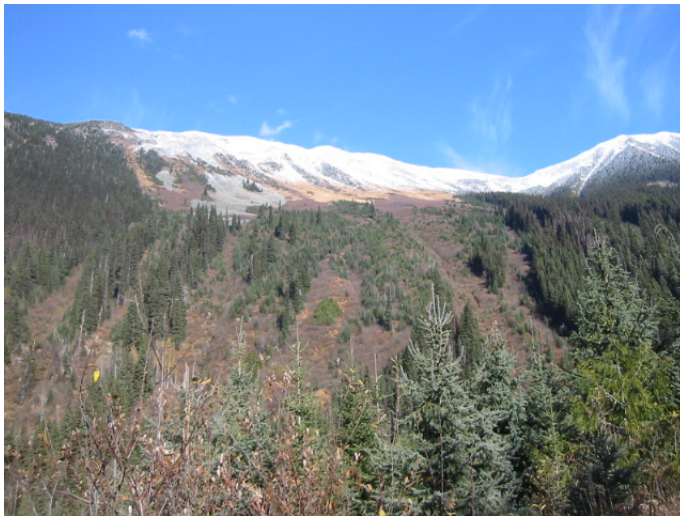
Photo 11. Avalanche tracks originating in alpine area of northeastern portion of Albreda project area.

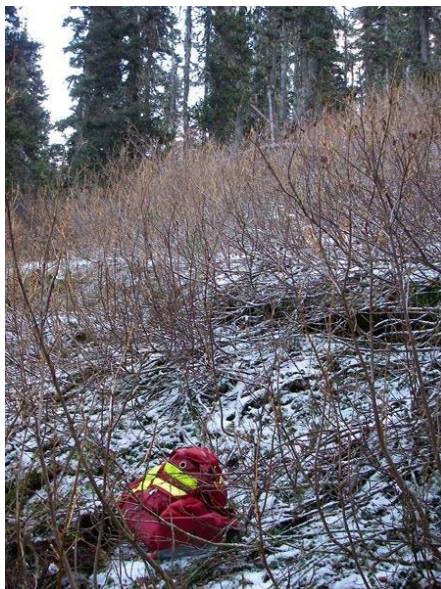
Photo 12. Seepage area characterized by dense shrubs.

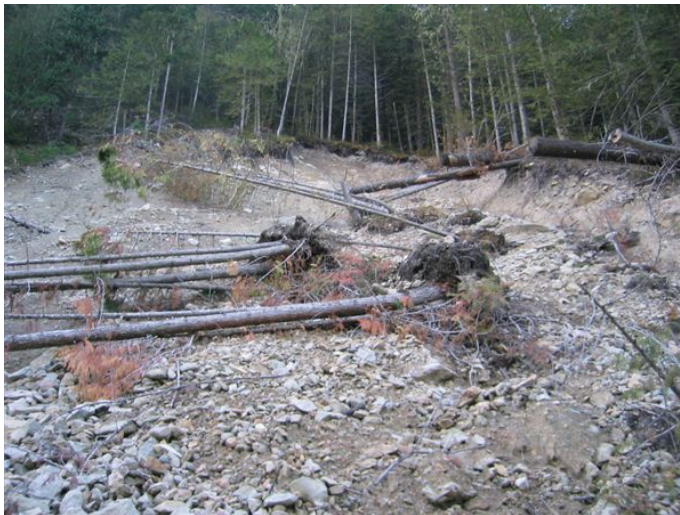
For both debris slides and debris flows, the geomorphic process label is included in the polygons where the slope failure was triggered (e.g., -R"s) (Photo 13), as well as the downslope polygons that were affected by the event (e.g., -Rs). In most places, an on-site symbol on the map is used to delineate the extent of the failure.

Photo 13. Initiation zone of debris slide that initiated in deep surficial material.

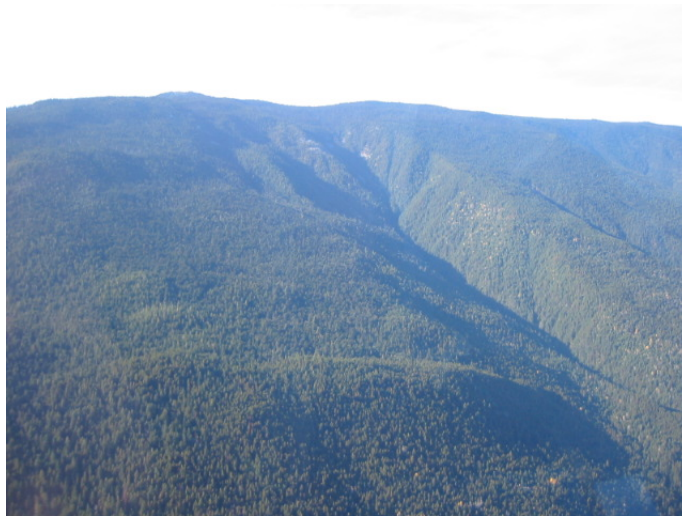
Photo 14. Large gully system in Messiter project area.

Along these reaches the sidewalls are composed of steep surficial material that is susceptible to debris slides. Many of the larger gullies are deep bedrock ravines that are incised more than 50 m and are located along fault lines.

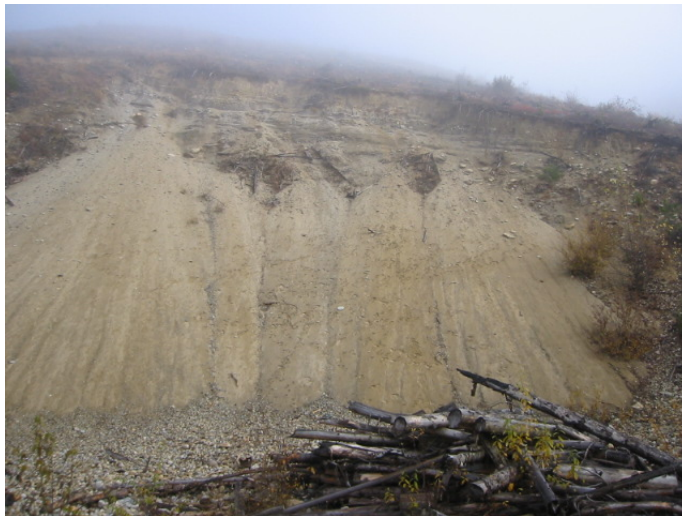
- Road construction can increase landsliding by diverting and concentrating water flows.
- Ground-based harvesting can lead to diverted flows and the saturation of areas of a hillslope that do not otherwise receive as much water. This in turn can lead to landslides.
- Where cut-and-fill road construction crosses steep slopes, roads can create unstable fillslopes subject to failure when they saturate or when incorporated stumps and logs collapse.
- Cutslopes can undercut soil mantles above the slope, leading to debris slides (Photo 15).

Photo 15. Large cutslope failure in deep glaciofluvial deposits, located in the northeastern portion of the Albreda project area.

- Proper planning, construction (including supervision), and deactivation of logging roads and skid roads can minimize water diversion or concentration problems. Planning includes the placement, spacing, and sizing of culverts.
- Full-bench construction, coupled with appropriate sidecast treatment, such as full or partial end-haul, will reduce the hazard of fillslope failures on roads built on hillslopes greater than 60% to 70% (depending on terrain and material).
- Cutslope instability can be prevented by avoiding road construction across steep slopes with deep deposits.
- Proper watershed management measures in road construction and maintenance will minimize the amount of sediment produced along roads. Careful water management is especially necessary during construction, when the potential for generating sediment is greatest.
