MURRAY CREEK AREA
DETAILED TERRAIN MAPPING
WITH EVALUATIONS FOR SLOPE STABILITY
AND EROSION POTENTIAL

Sid Tsang, B.Sc., G.I.T.

B.C. Ministry of Forests
Lillooet Forest District

October 1995 *a*

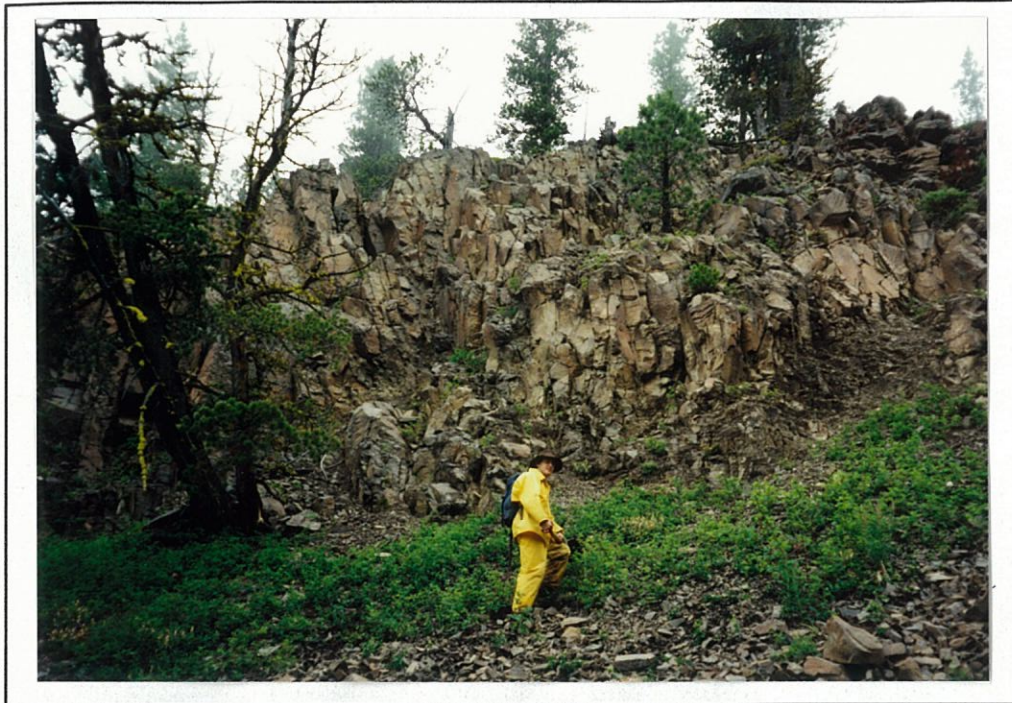
Rock slides (-R"r) and rock fall (-R"b) are less extensive than debris slides and are mapped in the central part of the study area and east of cutblock 52. At site B73, highly fractured volcanic rocks are exposed at the top of a large rock slide with rubbly talus accumulating at the base of outcrops (Photo 1). At site S56, rock fall occurs at the headscarp of a deep-seated slump block in basalts.

Photo 1. Site B73. Highly fractured basalts at headscarp of old landslide.

The volcanic bedrock fractures readily along planes of weakness (joints) that function as slip planes. Deep-seated slumping and sliding was identified on this rock type (sites S56 and B73). A rock stability specialist should be consulted prior to forest activities (i.e., road construction or logging) through steep outcrops of this rock type.

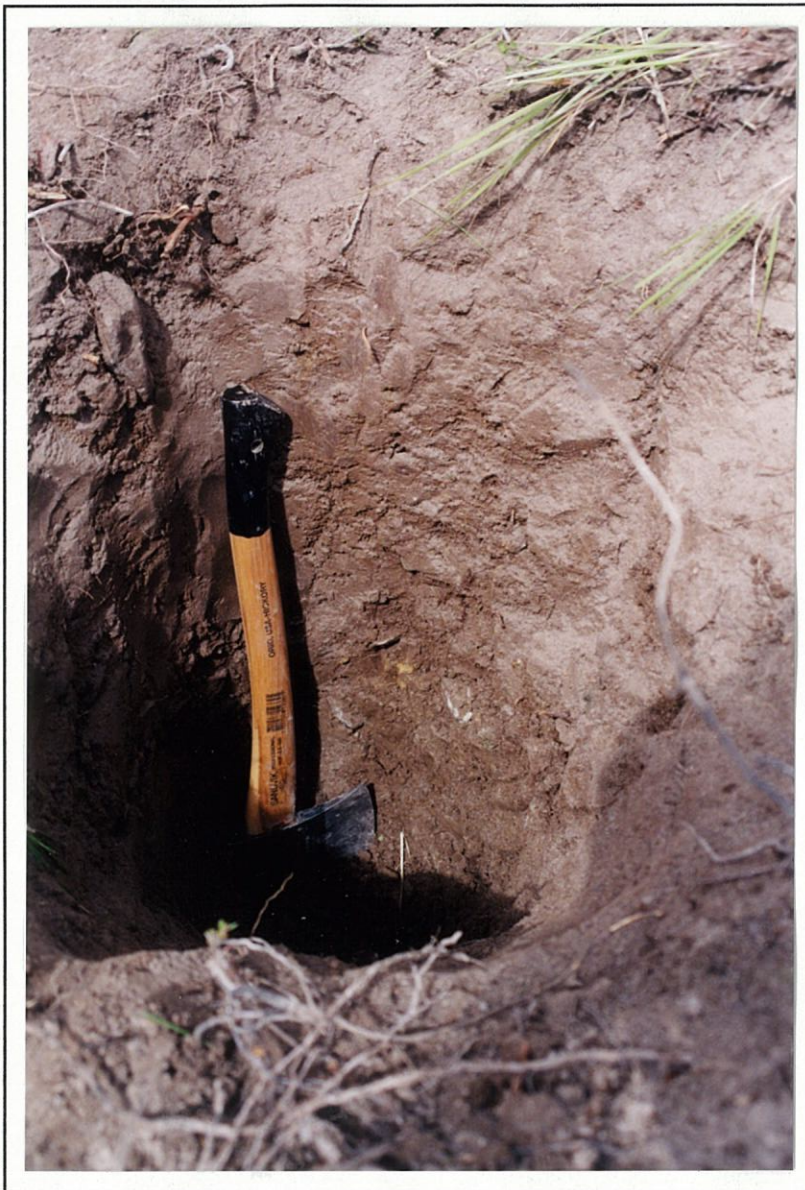
Highly consolidated and cohesive basal (subglacial) till is widespread in the study area (e.g., site S72, Photo 2). Particle size analysis indicates that the matrix texture is a sandy mud with a high clay content (30-49%). Clast content ranges from 20 to 40% by volume, and pebbles (2-64 mm), cobbles (64-256 mm) and boulders (> 256 mm) are predominantly subangular to subrounded. Clasts consist of mainly volcanic rocks, with minor sedimentary and metamorphic types. The Munsell colour of till is dark brown (10YR4/3).

Photo 2. Fine textured till in 1 metre deep soil pit at site S72. Note the low clast content.

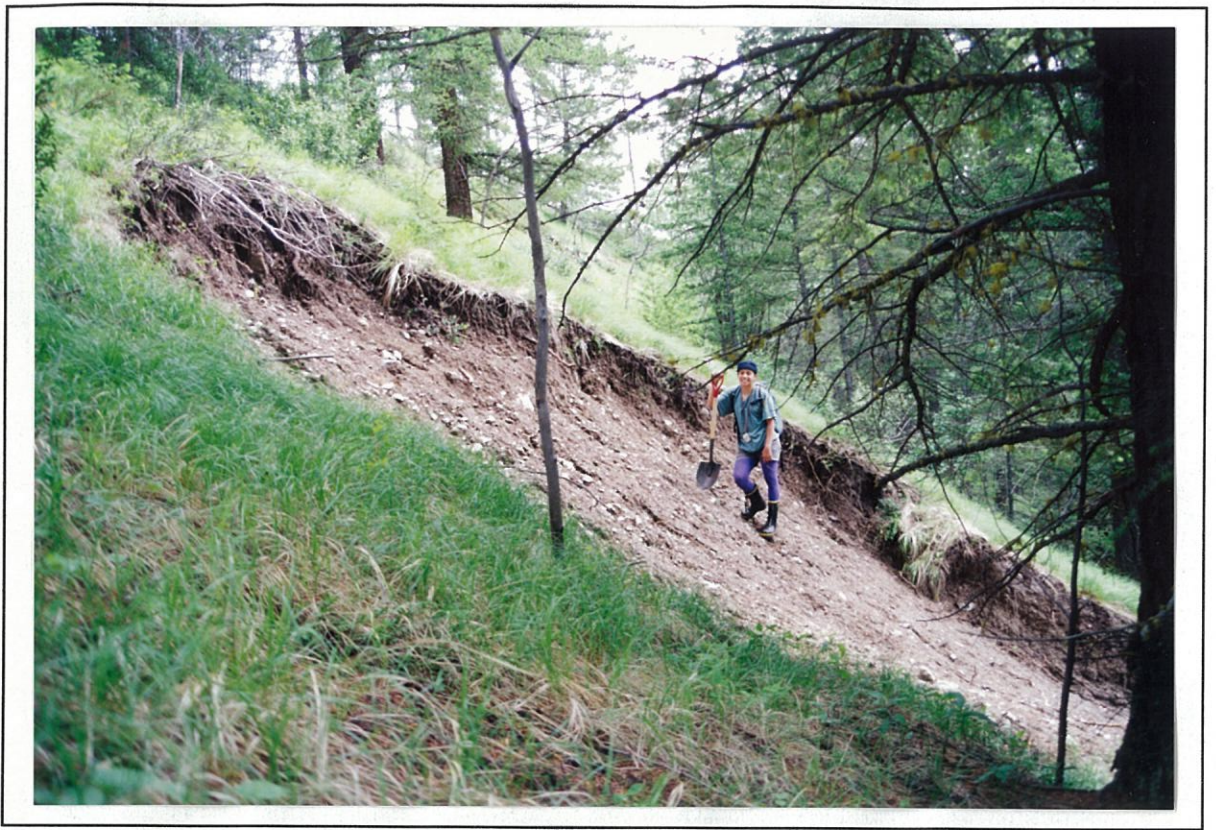
These basal tills are typically dense, and have very low permeability, although they contain water. Till overlying moderately steep (> 65° (33°)) bedrock may slide during and following wet weather and snowmelt (Photos 3 and 4). Where roadcuts intersect the contact between till and bedrock, seepage may cause sloughing and recession of cut banks.

Photo 3. Recent slide at site S74 in thin till, below recent cutblock east of Murray Creek.

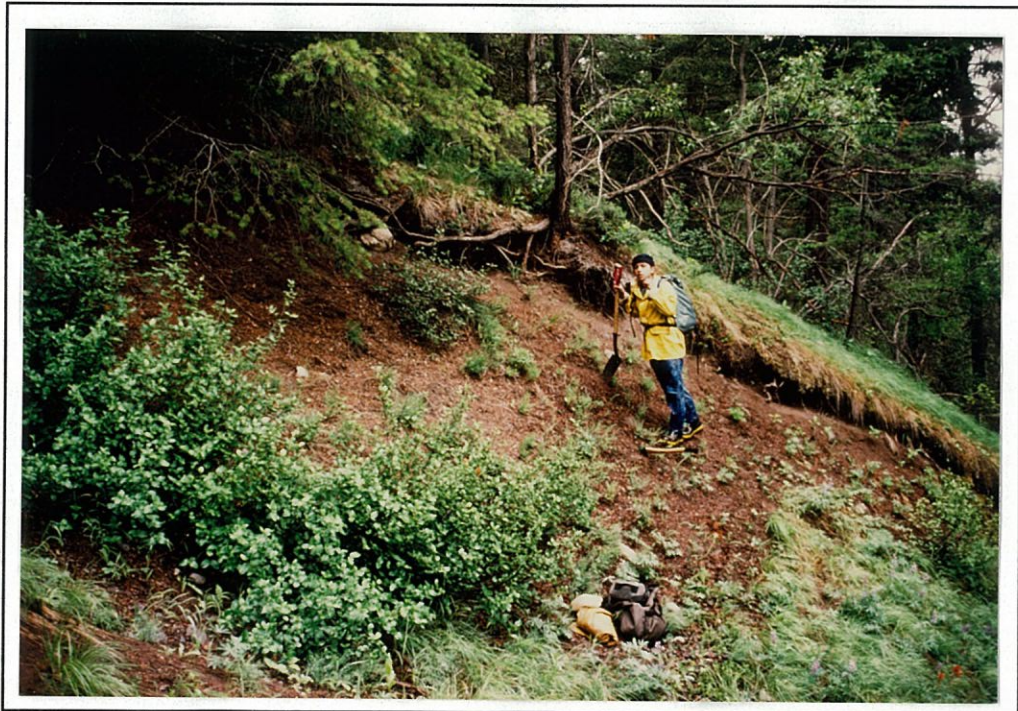
Photo 4. Slide in thin till below site S70. Slope above headscarp is approximately 65%.

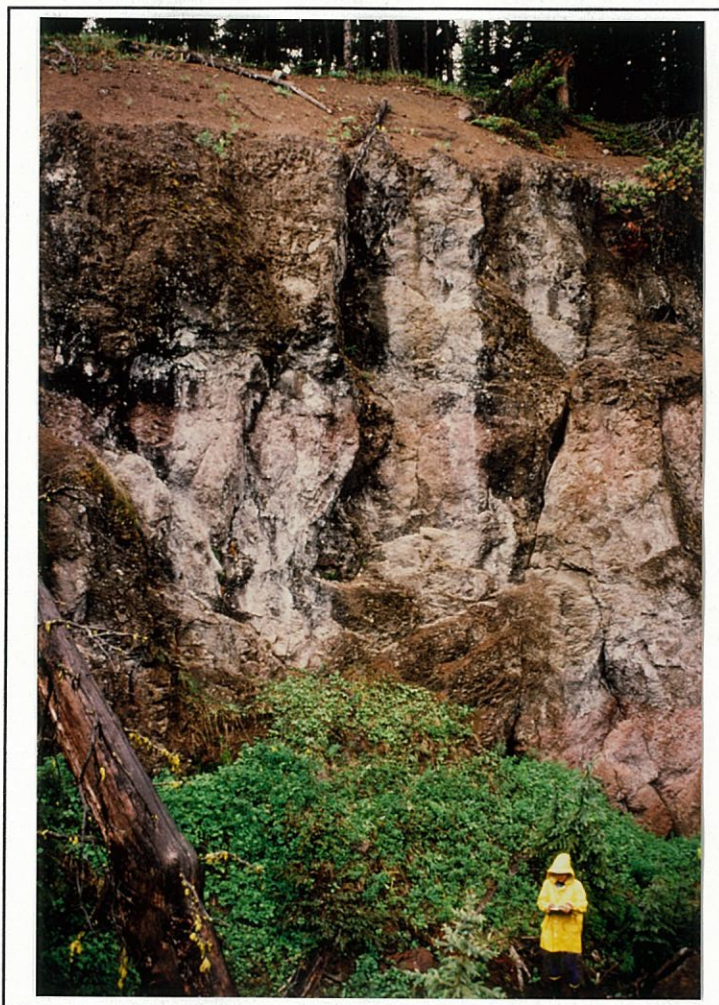
Photo 6. Site S56, 1-2 metres of till overlying basalt plateau.

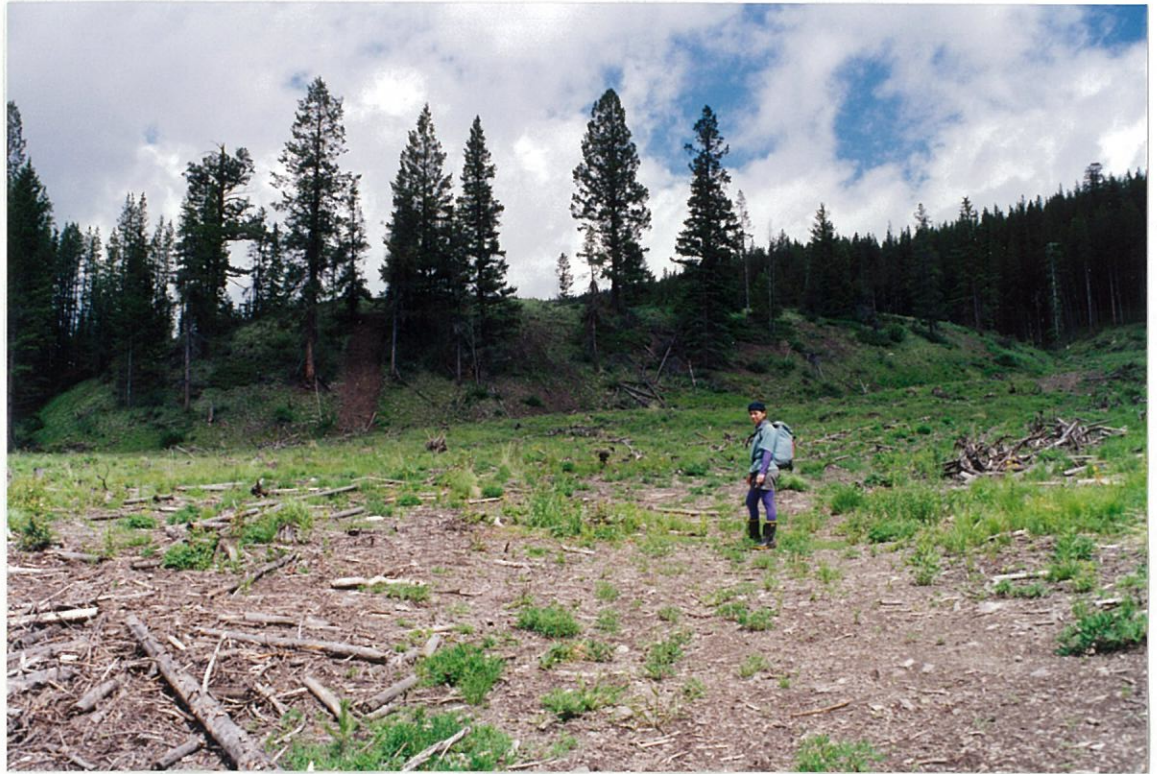
Slumping in surficial materials (-Fx, -Fu) was mapped at sites S72 and B75 in the central part of the study area. Here, hummocks and lobes consisting of reworked till were formed as this material was transported slowly downslope by a sliding or flowing action (Photo 7).

Photo 7. Toe of slump in recent clearcut by site S72. Note the sharp break in slope between the lobe and flat till blanket.

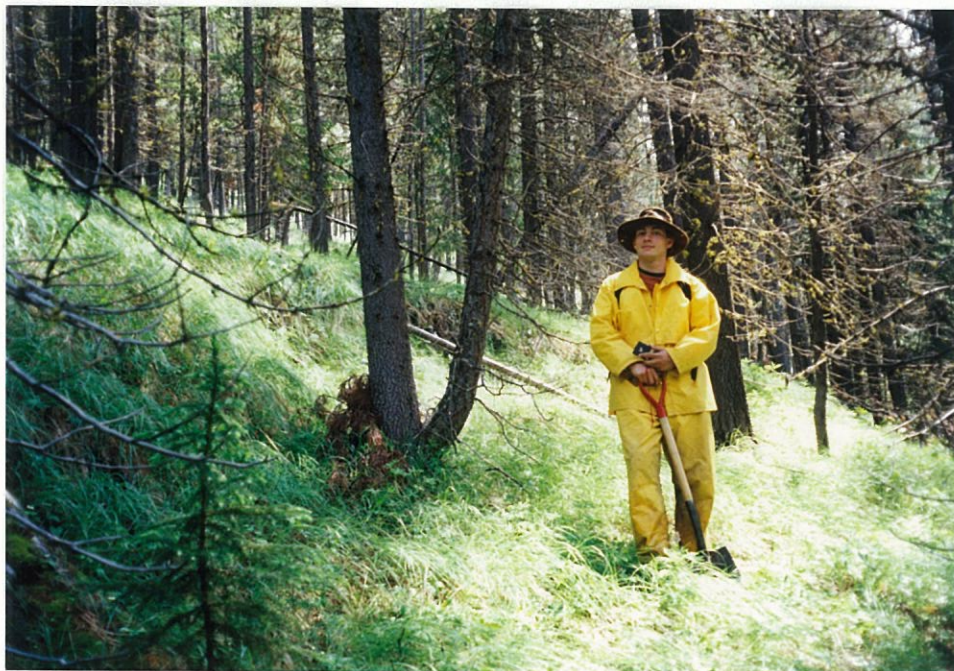
Photo 8. Headscarp of a recent slump at site B77 in till. Under appropriate conditions this material will slide as in Photos 3 and 4.
