SPRUCE CREEK COMMUNITY WATERSHED

Detailed Terrain and Slope Stability Mapping

**Prepared for
Squamish Forest District
Small Business Program**

September 1996

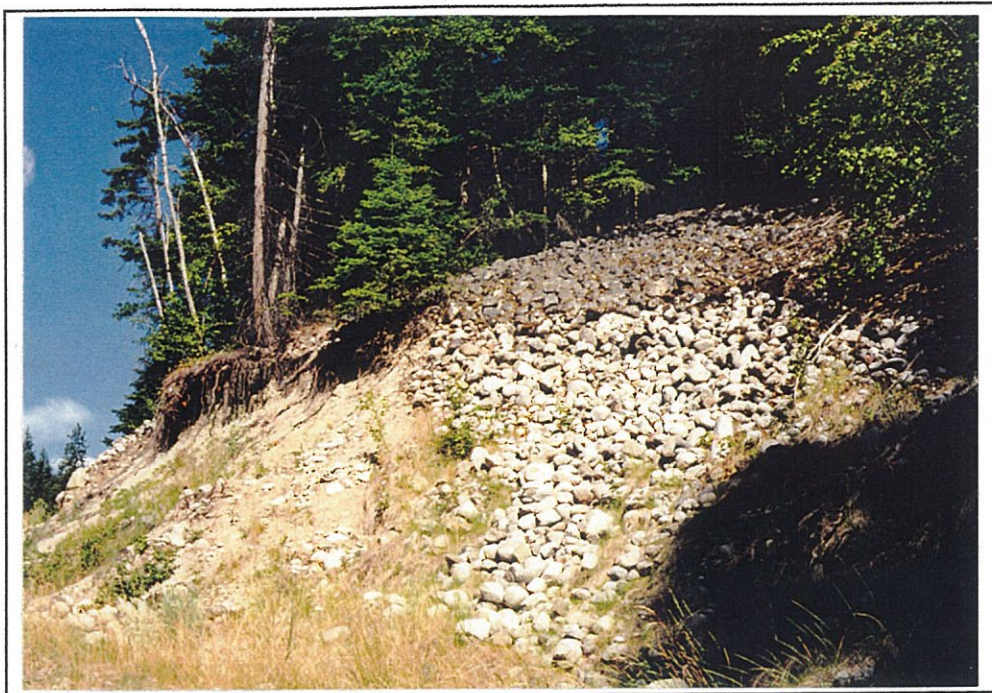
Talus slopes are abundant in upper Spruce Creek at the base of steep rock outcrops. Colluvium in talus slopes is generally rubbly, with very few fines. At the base of avalanche tracks and debris flow gullies is colluvium derived from till and rock upslope. This consists of angular to sub-rounded clasts with interstitial silty sand. Along the lower reaches of Spruce Creek, colluvium has been derived from glaciofluvial terraces, and consists of rounded boulders (Photo 1).

Photo 1. Bouldery colluvium overlying glaciofluvial sediments near site C25.

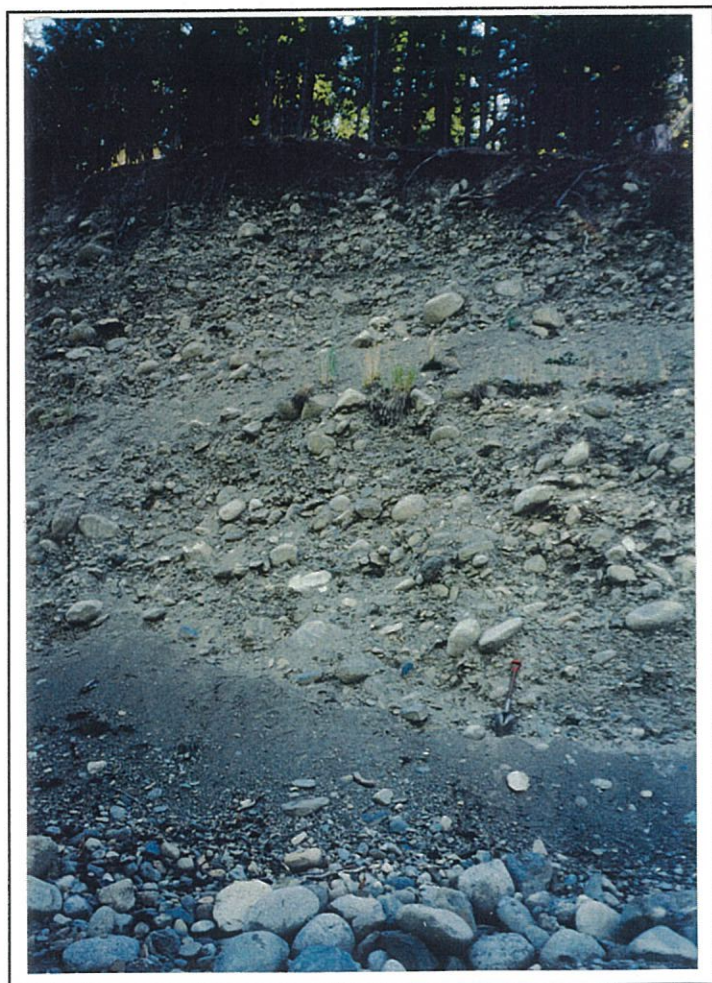
Photo 2. Site S1 -- very thick glaciofluvial sediments. This is the edge of an old fan.

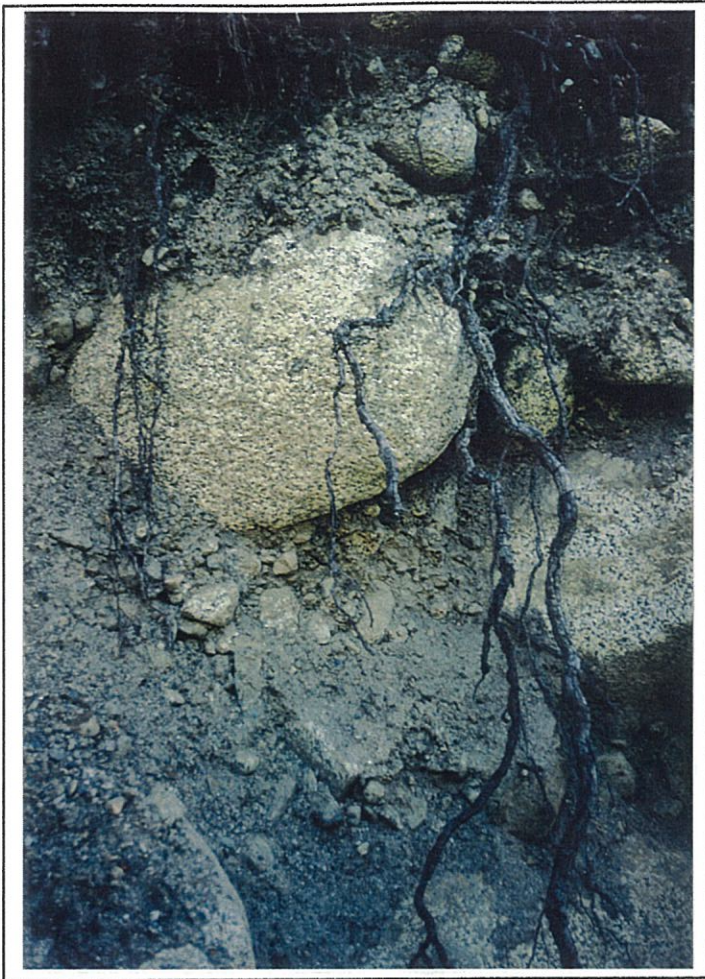
Photo 3. Close-up of glaciofluvial material in a road cut at site C24.

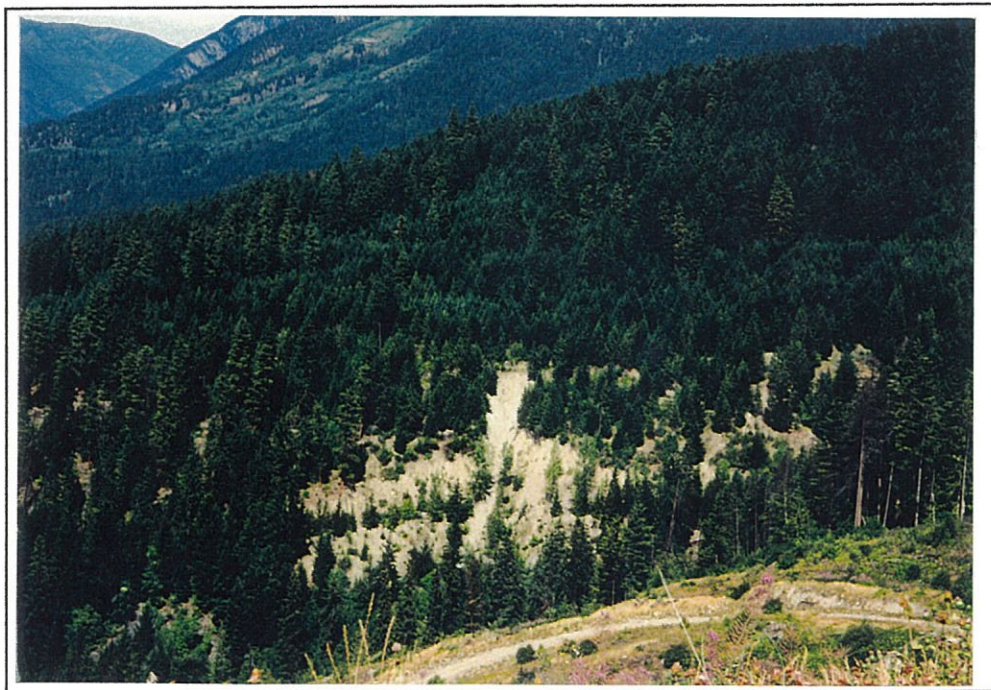
Debris slides occur when a mass of sediment or weathered bedrock becomes detached from a slope and slides downslope along a shear plane. Failure occurs when water tables are high and the soil is saturated. In the study area, debris slides occur in areas where thin colluvium overlies rock, and on steep glaciofluvial scarps undercut by creeks. Photo 4 shows a debris slide on a glaciofluvial scarp beside Spruce Creek.

Photo 4. Failure in glaciofluvial terrace on the north side of Spruce Creek. This is possibly related to an old road.

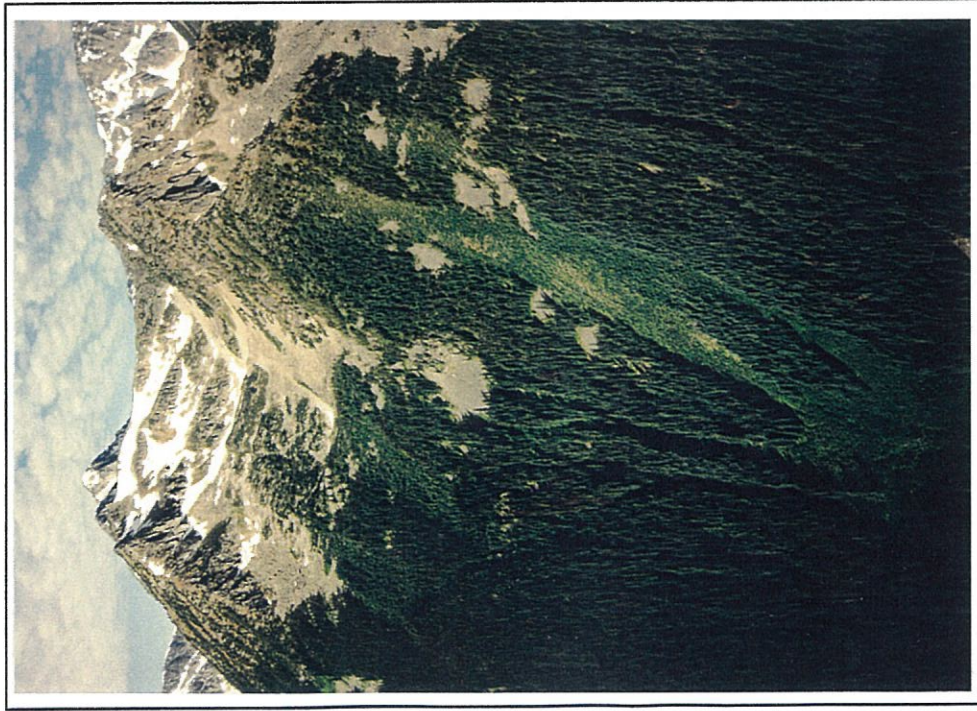
Avalanches are common in upper and middle Spruce Creek valley, as indicated by the presence of numerous, clearly defined (treeless) avalanche tracks. Snow starts to slide on steep treeless areas below the ridge crests, and most avalanches travel all the way down to Spruce Creek. Removal of trees from steep, high elevation slopes that receive heavy snowfall could result in the extension of initiation and runout zones. Although snow avalanches are not a factor in the assessment of slope stability, they are a hazard to winter activities. Photo 5 shows a typical avalanche track.

Photo 5. Large avalanche track in upper Spruce Creek.

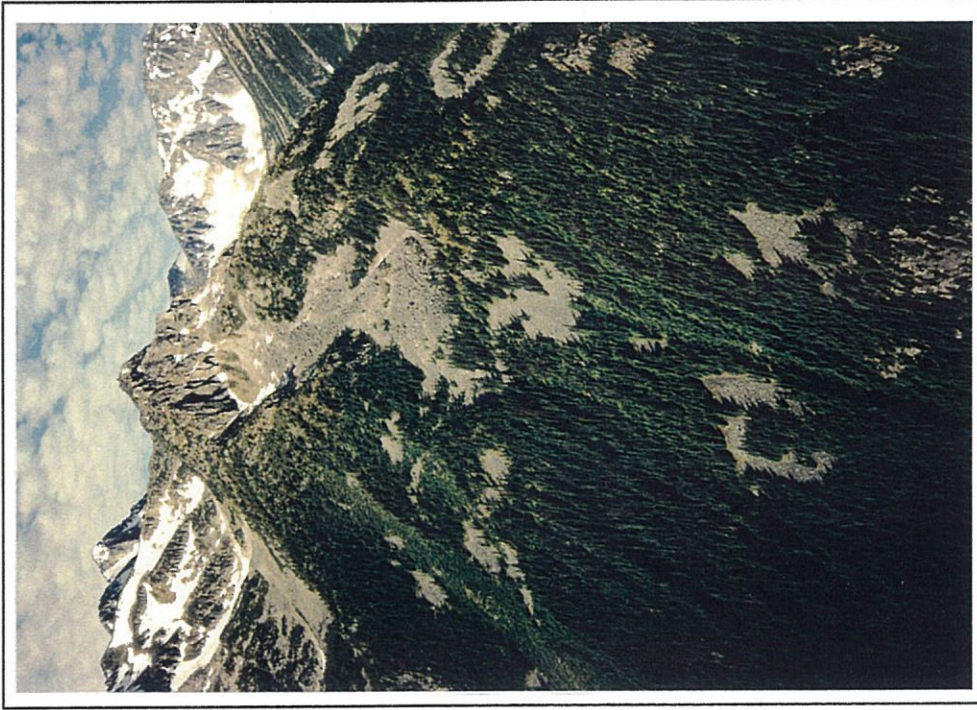
In the upper part of the area, a rock glacier was identified (Cmb-F["]g) (Photo 6). Rock glaciers are slow-moving, glacier-like tongues of blocks and rubble with interstitial ice, extending out from cirques in alpine areas. They are not usually a hazard to forestry activities.

Photo 6. View of rock glacier in upper Spruce Creek

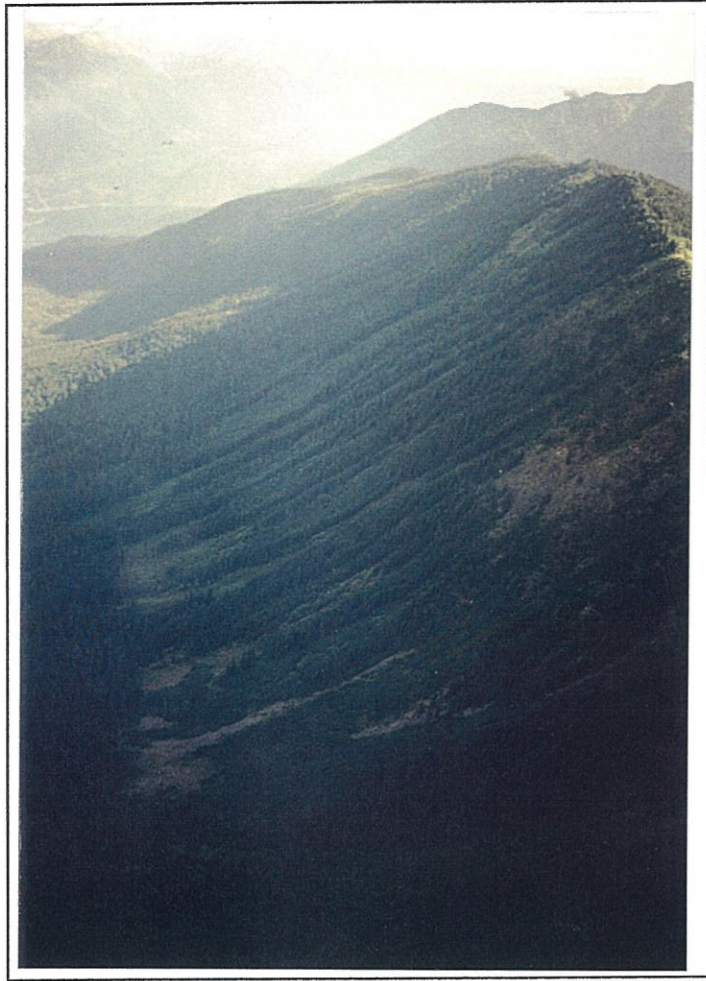
Photo 7. East side of upper Spruce Creek. Note numerous avalanche and debris flow tracks
