STRATHCONA DAM & RESERVOIR
ELK RIVER
CHANNEL STABILITY
AND MITIGATIVE MEASURES

JANUARY, 1992

STRATHCONA DAM AND RESERVOIR ELK RIVER CHANNEL STABILITY, MITIGATIVE MEASURES

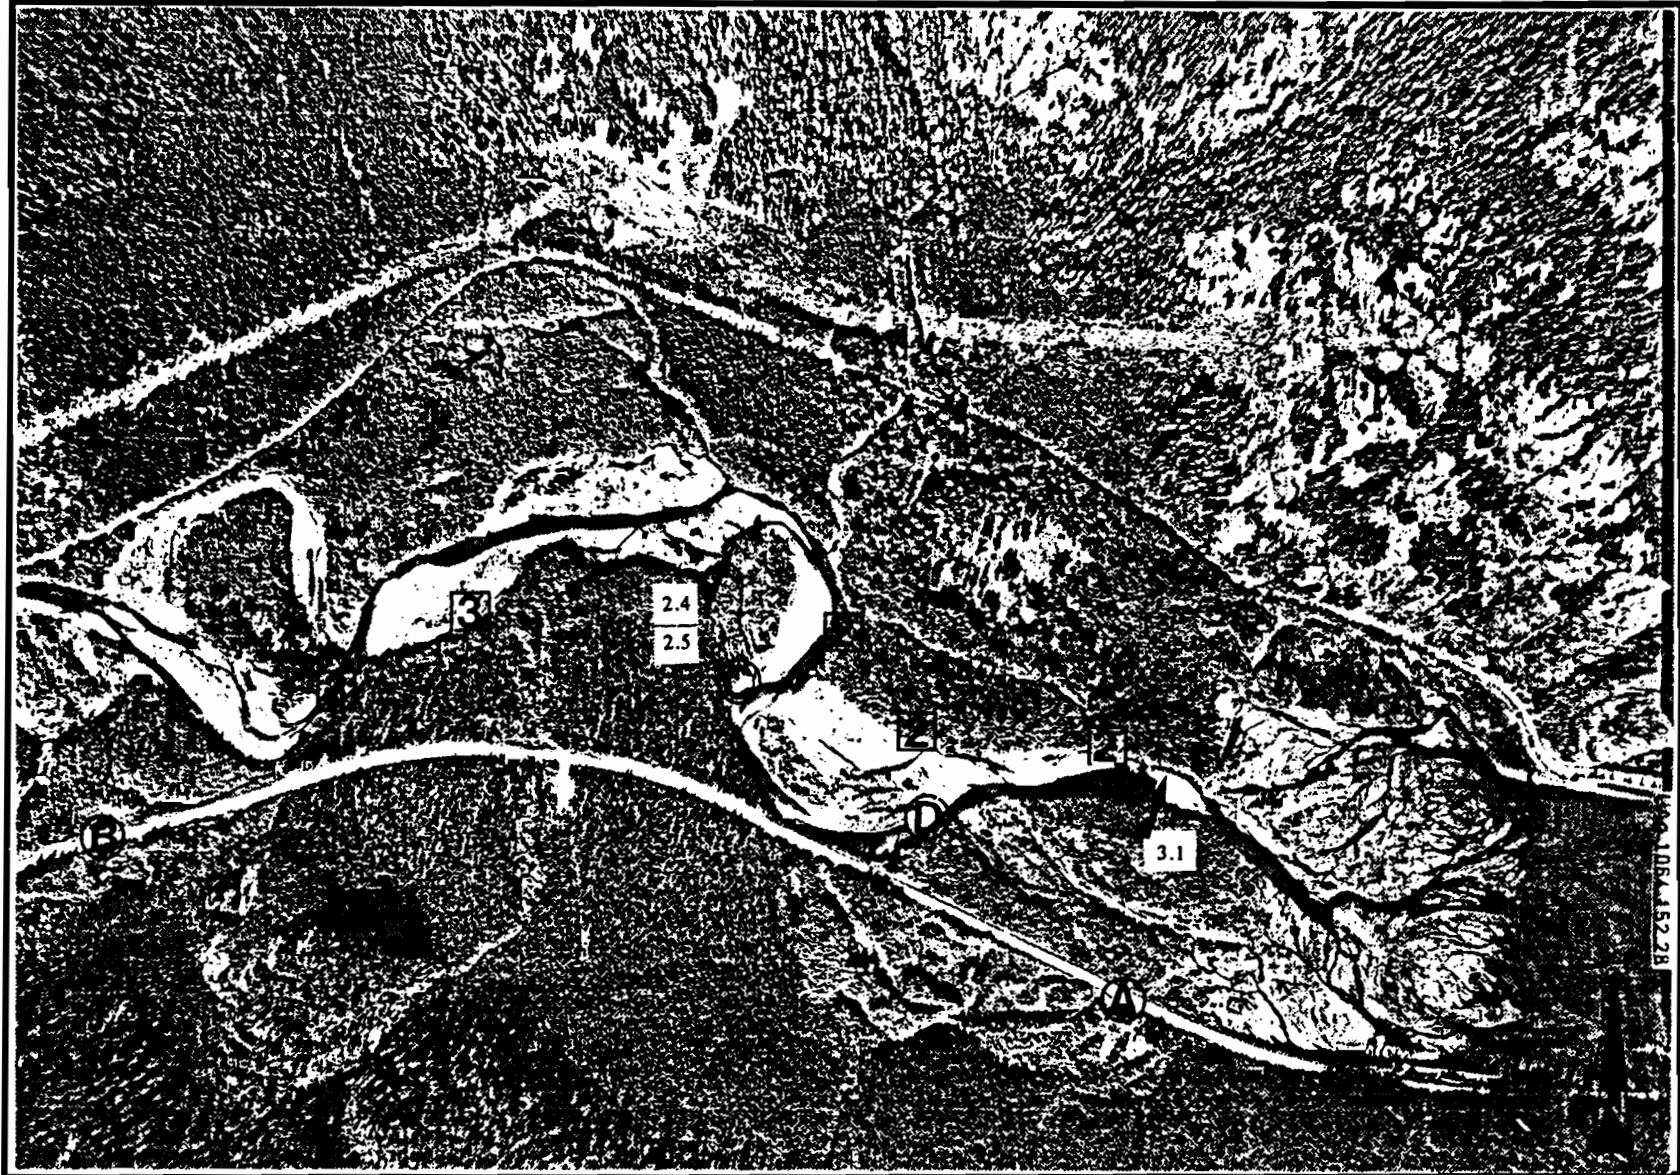
Figure 4.1: Elk River downstream end of Reach 1.
Note: Numbers in boxes correspond to sites used in Karanka and Kellerhals, 1980. Lettered sites are new. Two digit #'s show Plate locations in this report.

An excellent reach for a first trial application would be the lowermost 2 km of the Elk River north bank, from the Elk River Timber (ERT) road to the mouth of the river, including all of the Tlools Creek fan (*Plate 3.2*). This site is marked as "Site 2" on *Figure 4.1*. There are also other, shorter, reaches that could be used for an initial study such as "Site 3", upstream of Filberg Creek or "Site D", across the river from "Site 2".

There is some potential for adding to the amount of fish rearing habitat in back channels and wetlands by excavating some new, small backchannels or by deepening existing drainage courses or off-channel ponds. Sites "A", "B" and "C" (*Figure 4.1*) would appear to be particularly suitable, if the culverts at Sites "A" and "B" were to be improved simultaneously. Some work of this nature was carried out along the Coldwater River (near Merritt, B.C.) in connection with the Coquihalla Highway (see Beniston *et al.*, 1987 and 1988) and has generally been effective in providing Coho rearing habitat.

Due to inadequate culverts, the Highway 28 and the ERT road embankments interfere with fish access into tributary streams and into some cut-off wetland areas (*Plate 4.3*). Five culverts have been identified as needing upgrading from a fisheries point of view near Sites "A" and "B" (*Figure 4.1 and 4.2*). Generally the work would call for the replacement of the existing culvert with a larger one, set at a lower elevation.

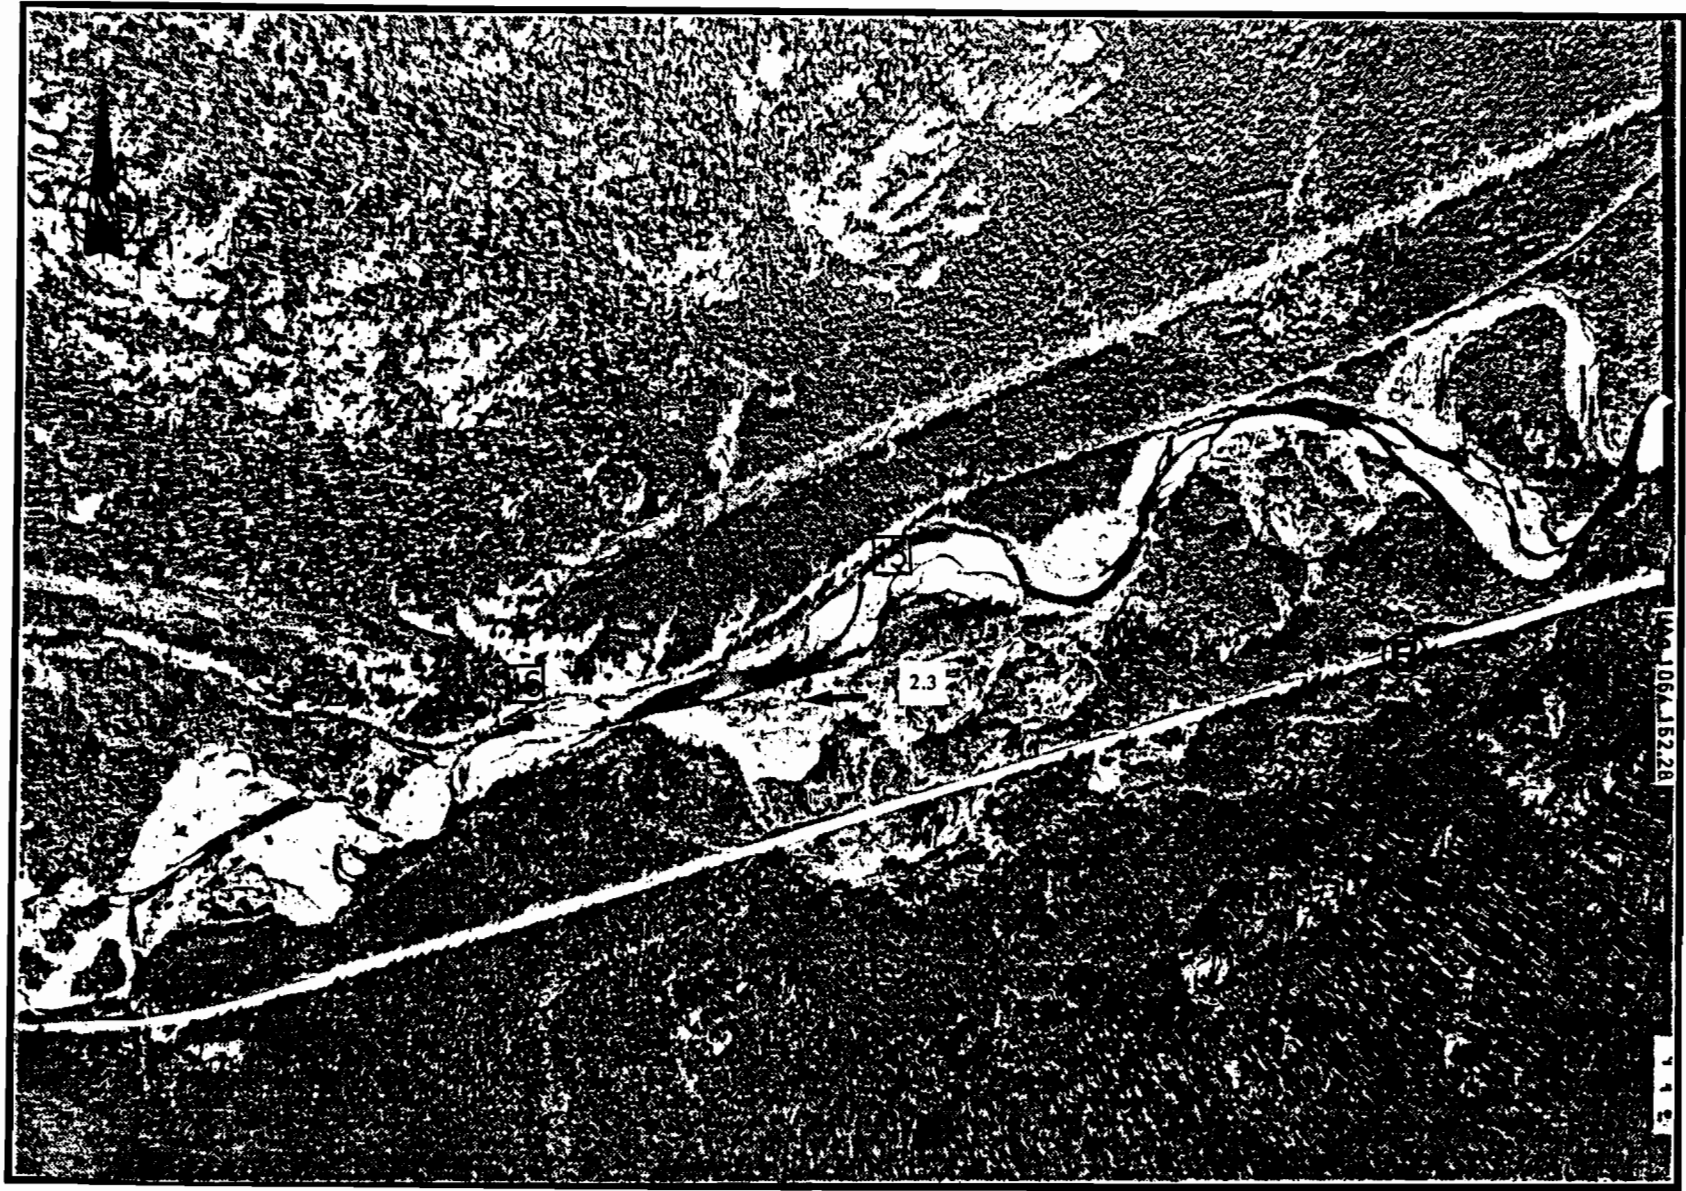
Figure 4.2:

Elk River central part of Reach 1.

In order to be effective, a quarry capable of producing very large rock (1,500 mm and up or 8 tonnes and up) would have to be found or opened up. Depending on the desired degree of protection, and on the state of the existing rip-rap, these very large rocks could be placed as a continuous single or double row over top of the existing rip-rap or as single rocks, one every 10 to 15 m along the toe of the existing embankments. Both schemes would add to the security of the embankments while improving the fish habitat diversity and stability. Good sites for an initial try-out of the scheme are Site 19 on Highway 28 (*Figure 4.3*) or Sites 15 and 16 along the ERT road (*Figure 4.2*).

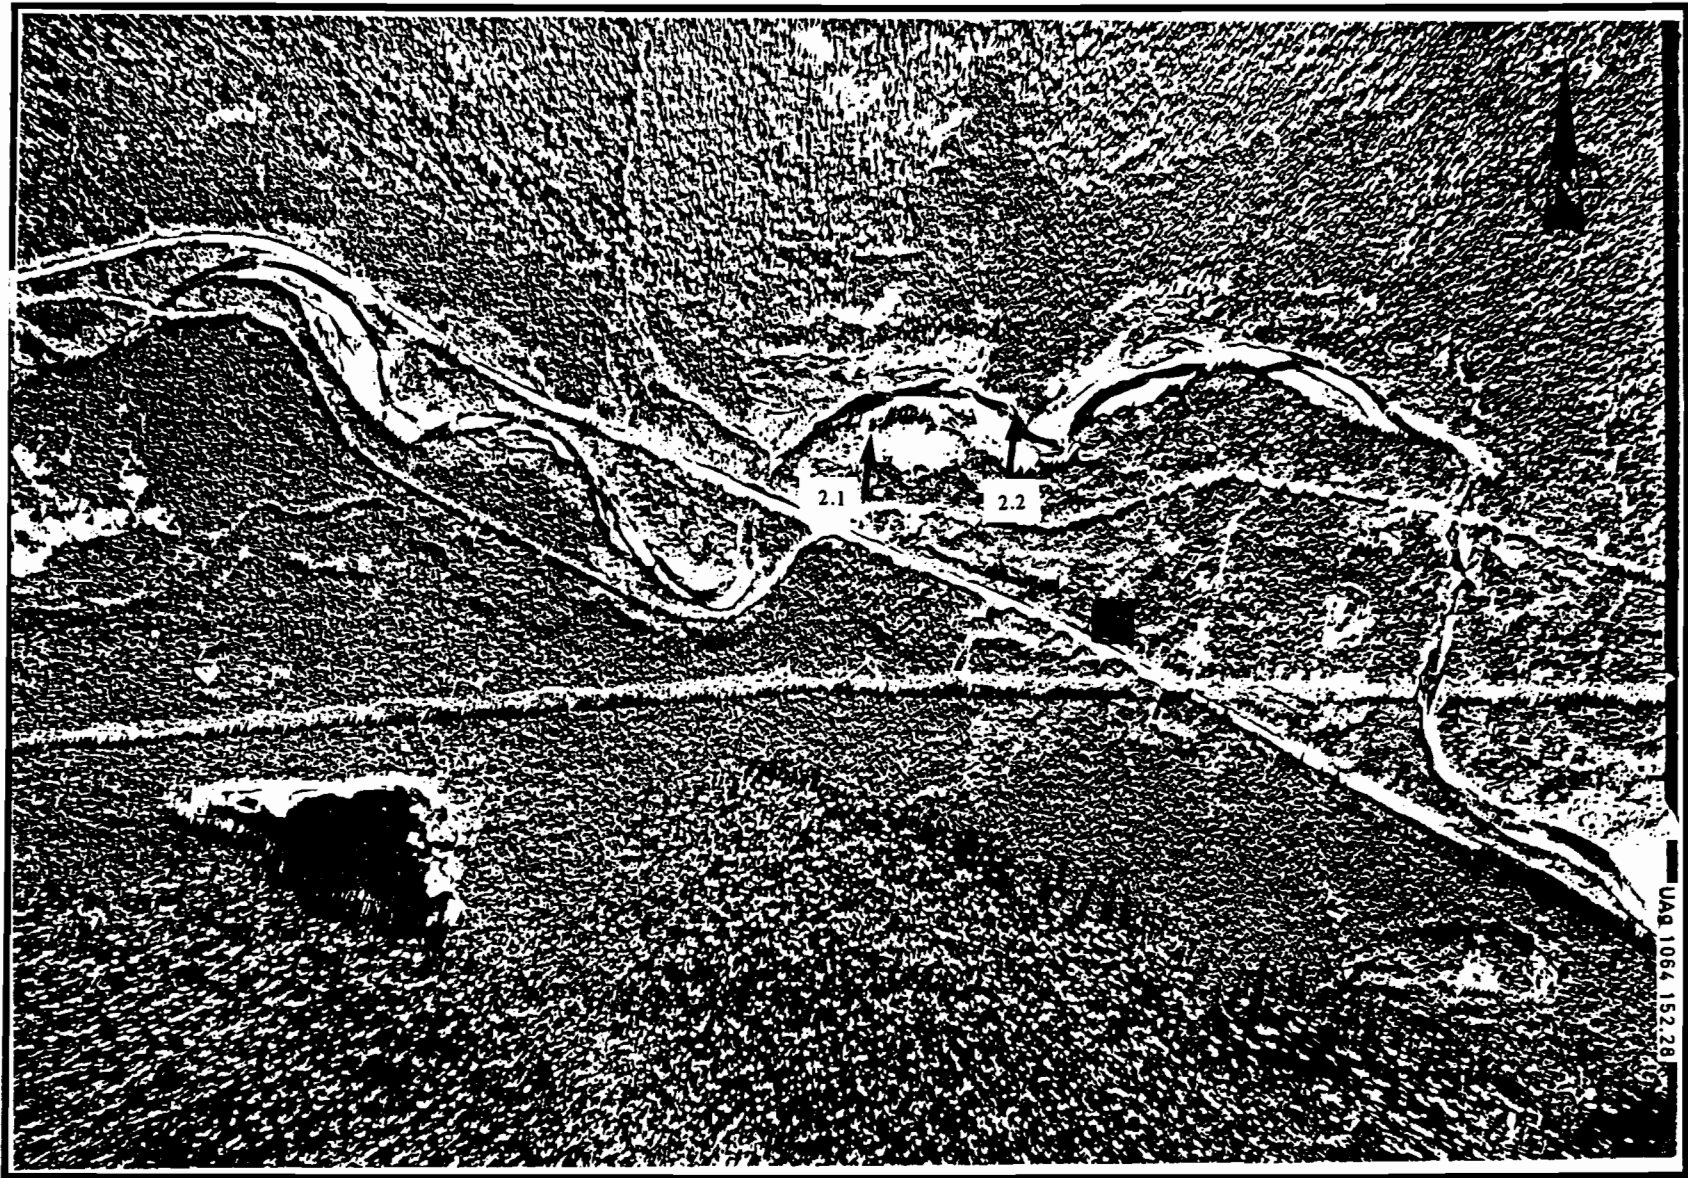
Figure 4.4: Elk River, lower section of Reach 2 and the gorge (on right).

Two of the sites also require some channel excavation on one or both sides of the new culvert. At Site 20 (*Figure 4.4*), where an unnamed creek crosses Highway 28 in two large culverts (*Plate 4.4*), the drop-off at the culvert outlet is an obstacle to fish passage which could be eliminated with a rip-rap weir downstream.
