Final Report

WATERSHED RESTORATION PROGRAM

MISSION CREEK WATERSHED STREAM ASSESSMENT

Project 511.01

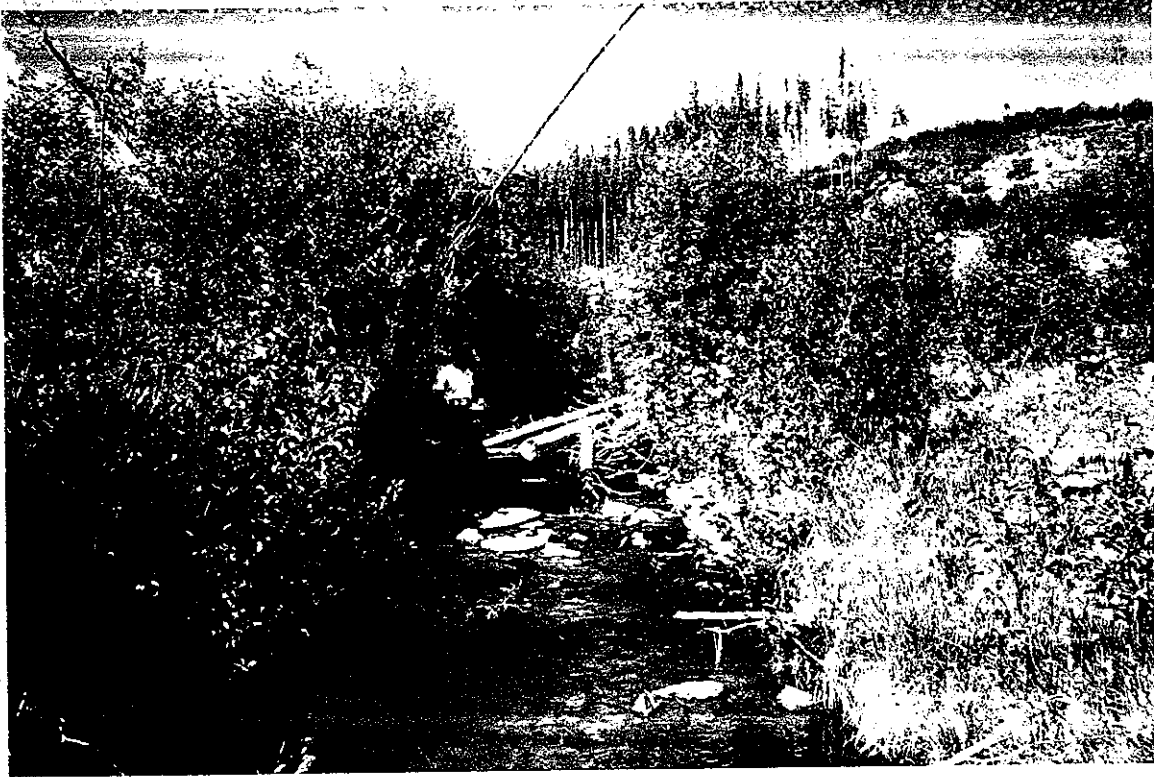
There are several logging-related debris jams and substantial LWD is present in the channel (Photograph 1). The LWD is causing some localized accumulation of sediment and undercutting of the channel banks. The majority of the debris jams are not barriers to fish migration. However one jam was noted that is definitely a barrier to fish migration during low flows. There is excellent rearing and spawning habitat at this site that has been impacted by the presence of logging debris.

Photograph 1. Debris jam at Hilda Creek Site #2. Note lack of riparian buffer.

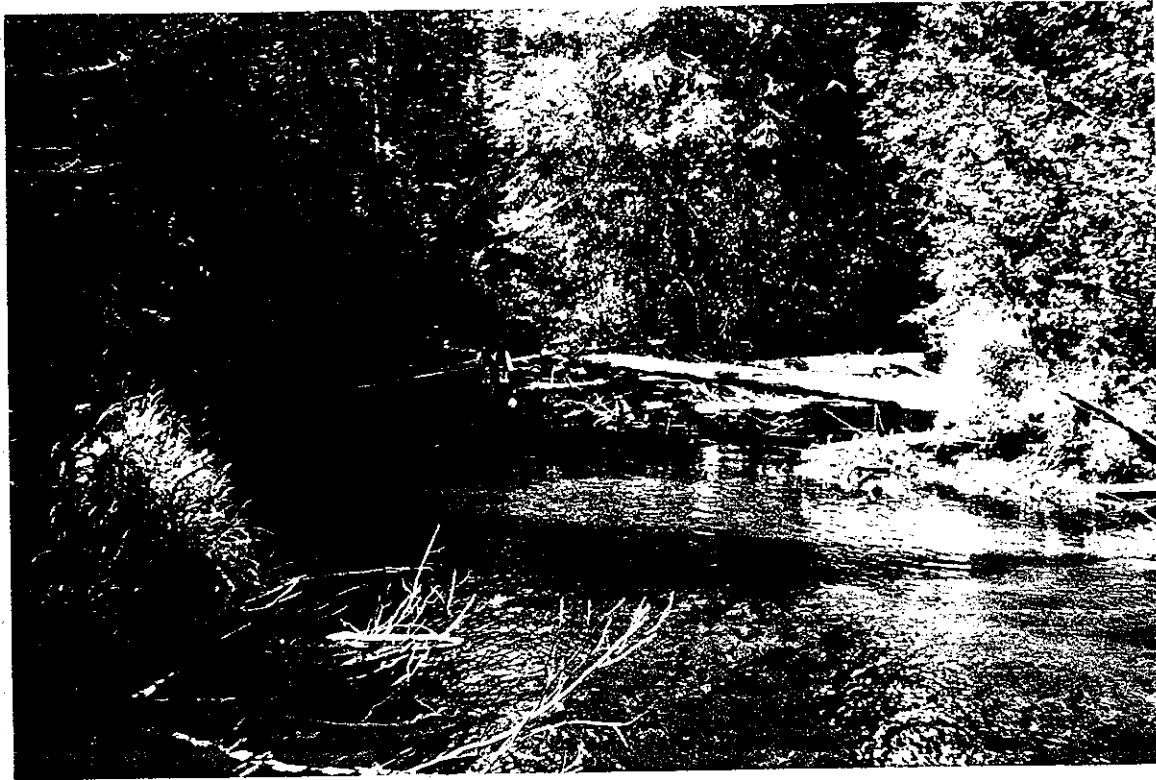
Photograph 1. Debris jam at Belgo Creek Site #2 (downstream view).

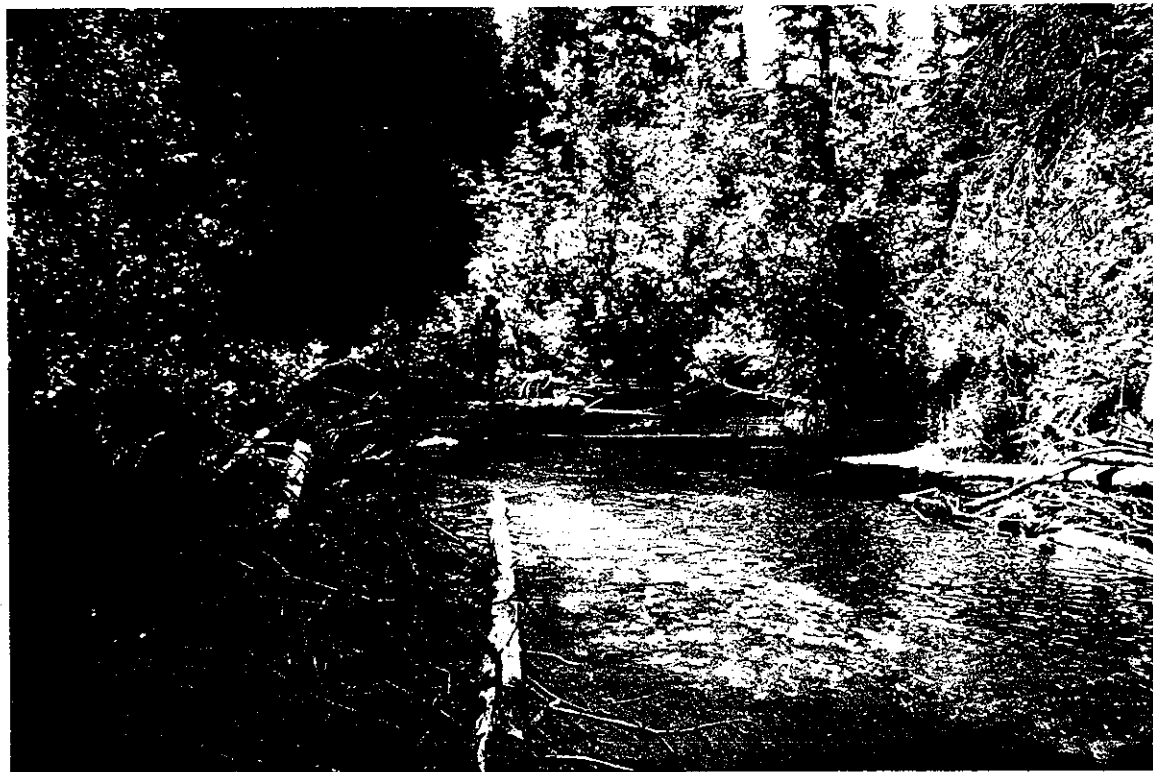
Photograph 2. Debris jam with 1 m deep pool on upstream side at Belgo Creek Site #16. Note scattered LWD on banks.

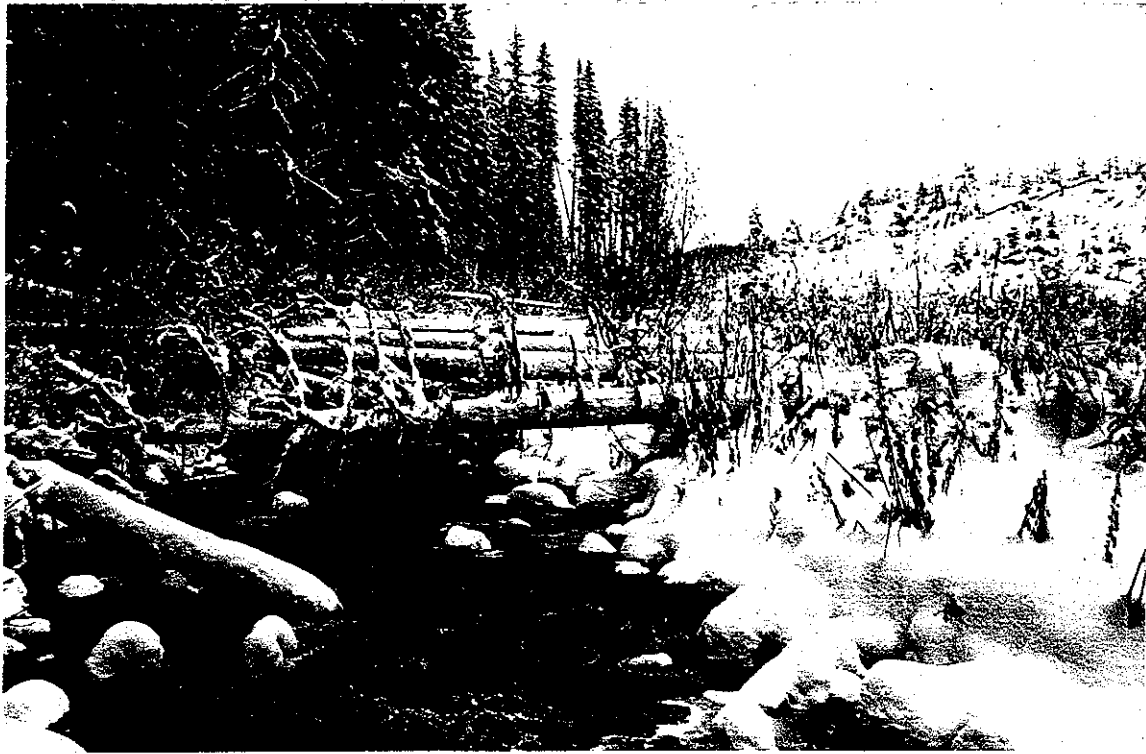
Site #15 No buffer strip; substantial windfall and other debris in creek; road crossing over ephemeral tributaries. Debris removal and road maintenance recommended.

Photograph 1. Windfall across stream adjacent to cutblock at Hydraulic Creek Site #15.

Site #15 is a strong candidate for a restoration. Possible steps include debris removal, riparian zone planting, and road repair.

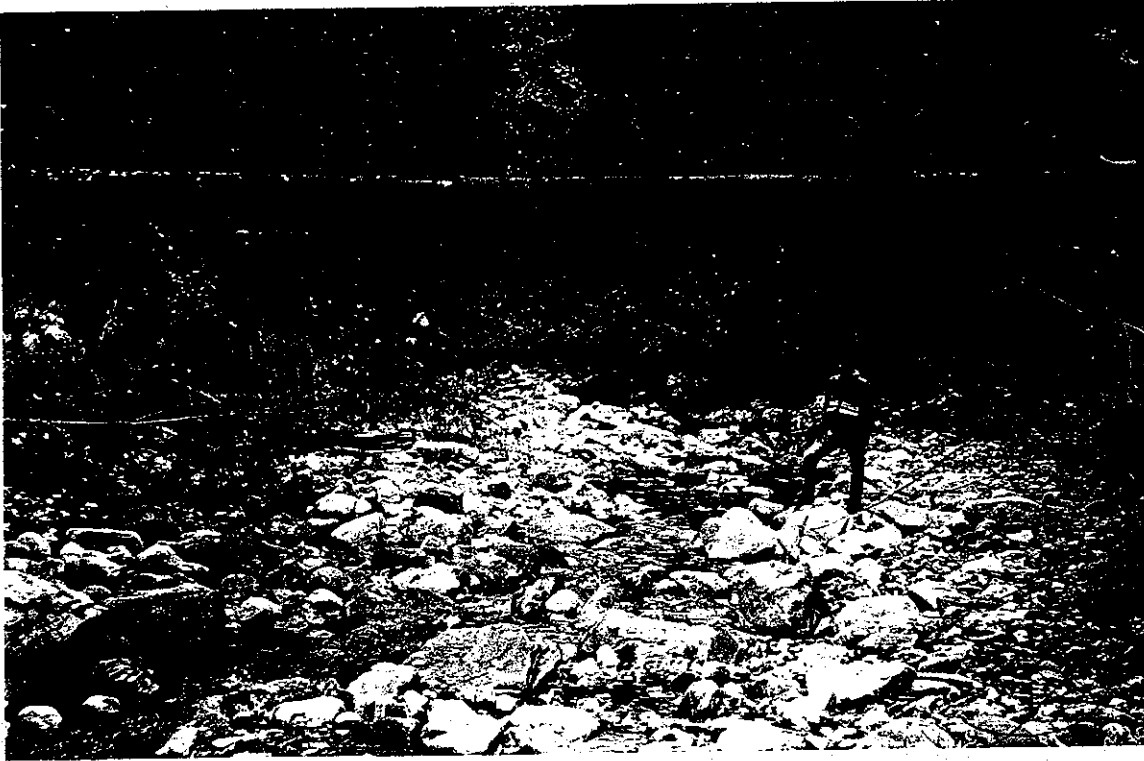
Photograph 1. Water pipeline crossing KLO Creek at Site #4.

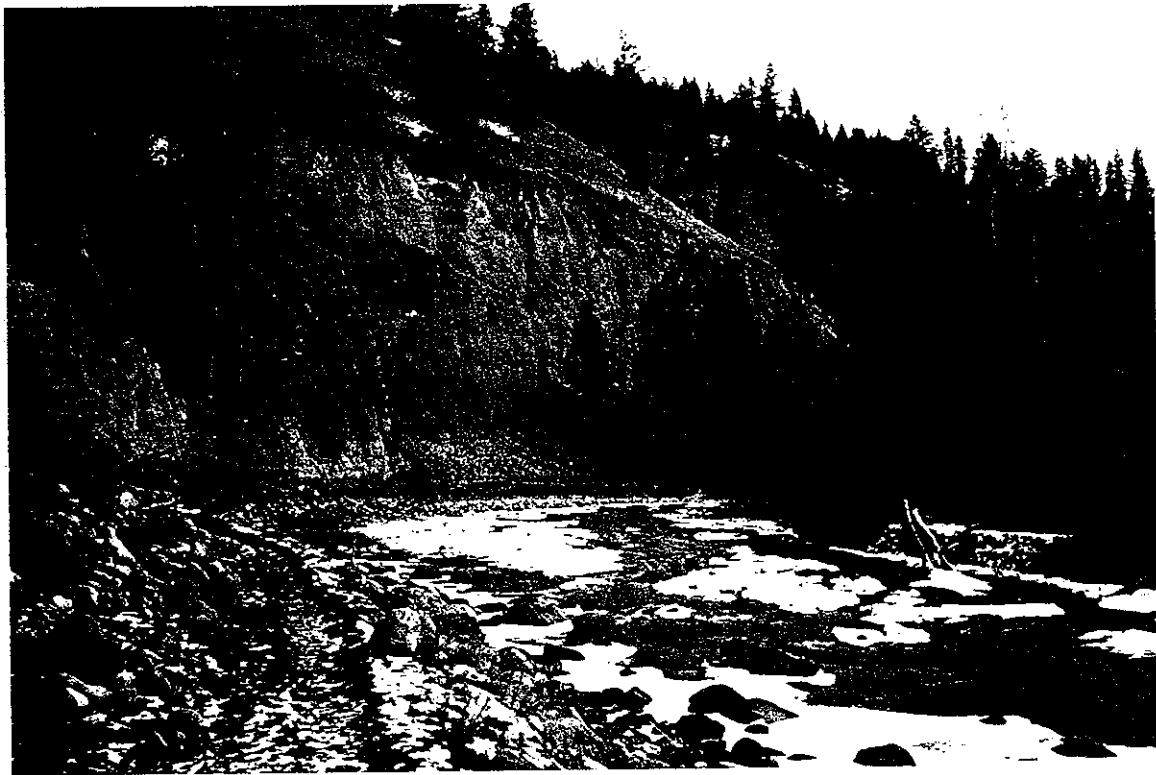
Photograph 2. Naturally eroding bank at Mission Creek Site #27 (view looking upstream).

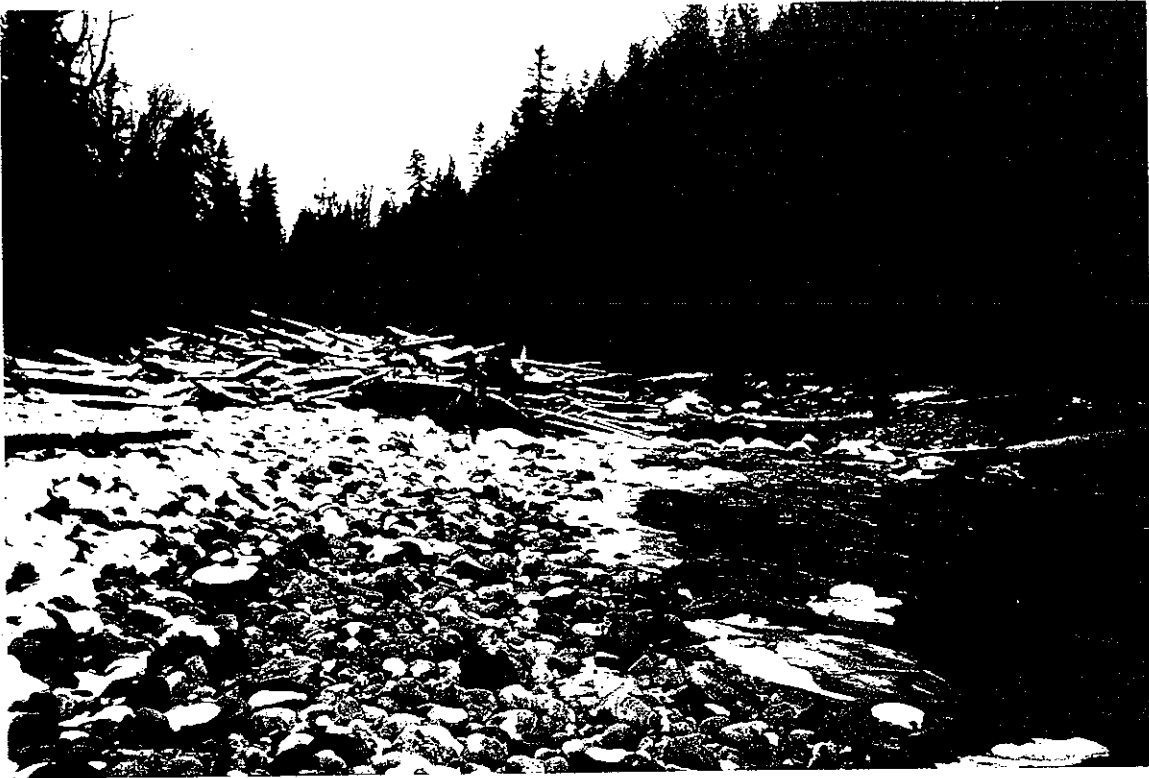
Photograph 3. Large debris jam at Mission Creek Sites #29.

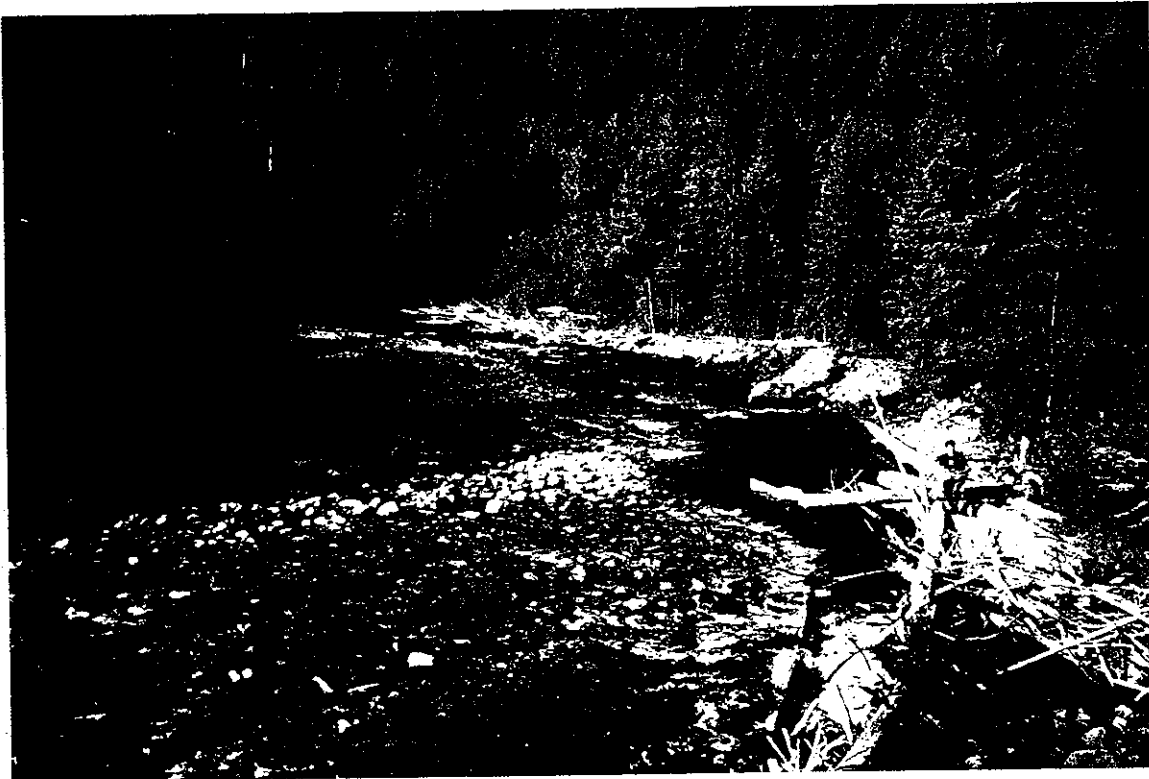
Photograph 4. Debris jams blocking access to side channels at Mission Creek Site #31.
