**MIDDLE FORK OF THE WHITE RIVER, MAIYUK, KLOOKUH, AND WINDERMERE  
CREEKS – ROUTINE MONITORING NEAR CANAL FLATS, BRITISH COLUMBIA**

**Slocan Forest Products Ltd.**  
P.O. Box 39  
Radium Hot Springs, British Columbia  
VOA 1M0  
(250) 347-6407

**Applied Aquatic Research Ltd.**  
Calgary, Alberta

March 2001  
File: AAR00-4

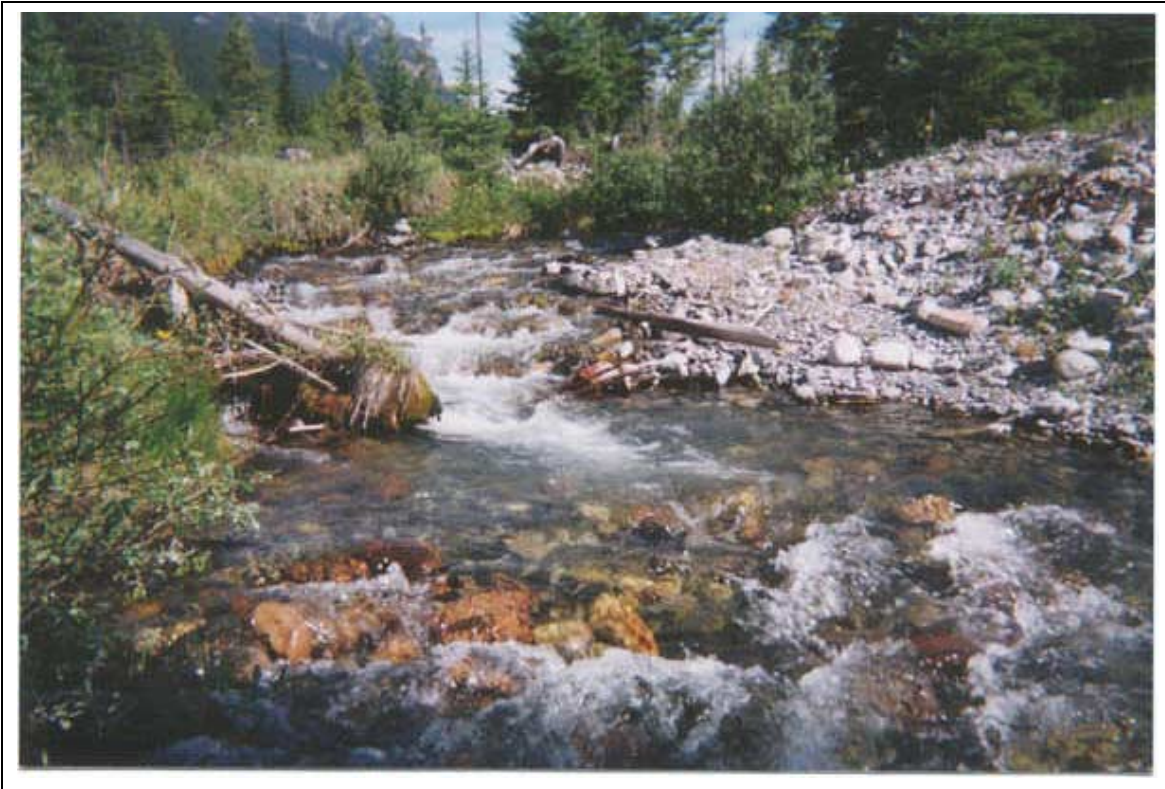
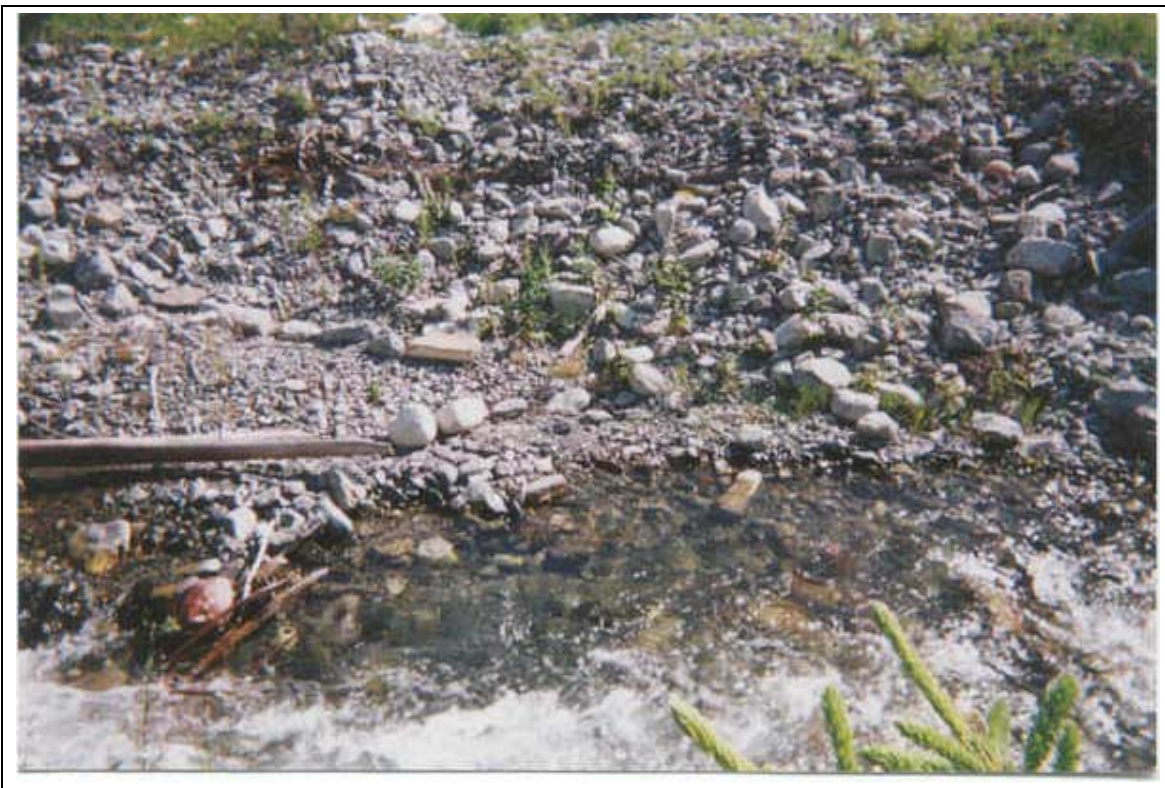
The prescription at this location consisted of a combination of bank revetment, slope re-contouring and LWD placement. Representative photographs are provided in Plates 9 and 10. The pool adjacent to the restoration prescription was 36 cm deep along the left bank. Some larches have been planted along the top of bank. No additional riprap is required along the toe of the slope. Recommended maintenance at this site includes planting of willows along the toe of the slope- note there is abundant source material on site.

Plate 9 View upstream at site KK-05, Klookuh Creek (July 22, 2000). Tree revetment is located in left of photo (right downstream bank).

Plate 10 View across and downstream at pool formation; site KK-05, Klookuh Creek (July 22, 2000).

Recommendations: - Plant additional willows @ the top of slope; some larch has been replanted already; there is abundant source material.  
 - don't need to re-armour or add additional riprap;  
 R (F25 - View of pool 36cm deep on LB);  
 Roll 3, Frames 147 - Panorama facing d/s.

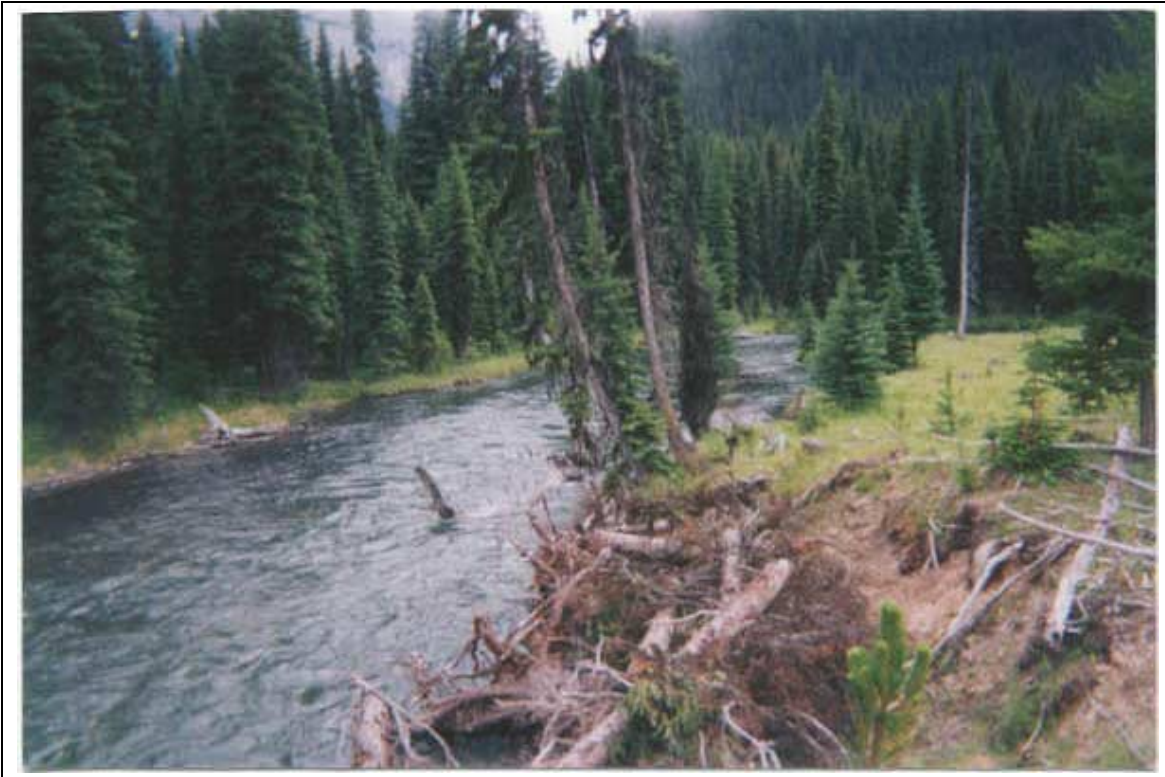
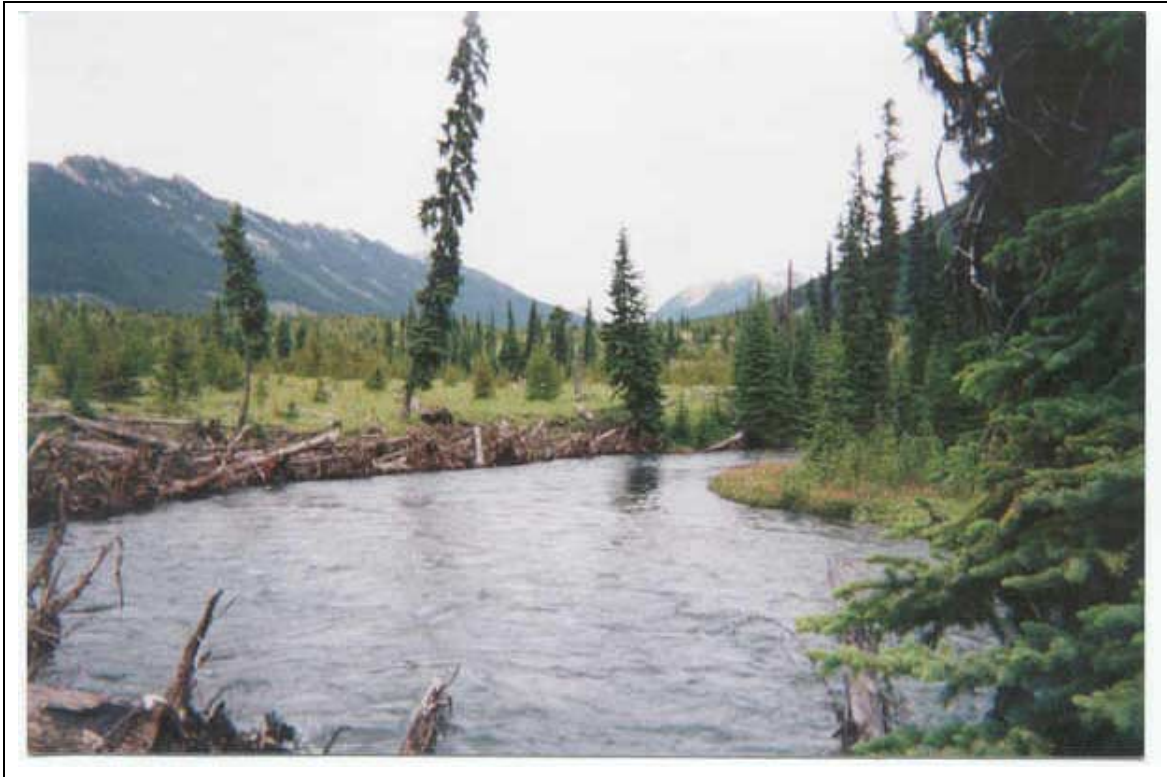
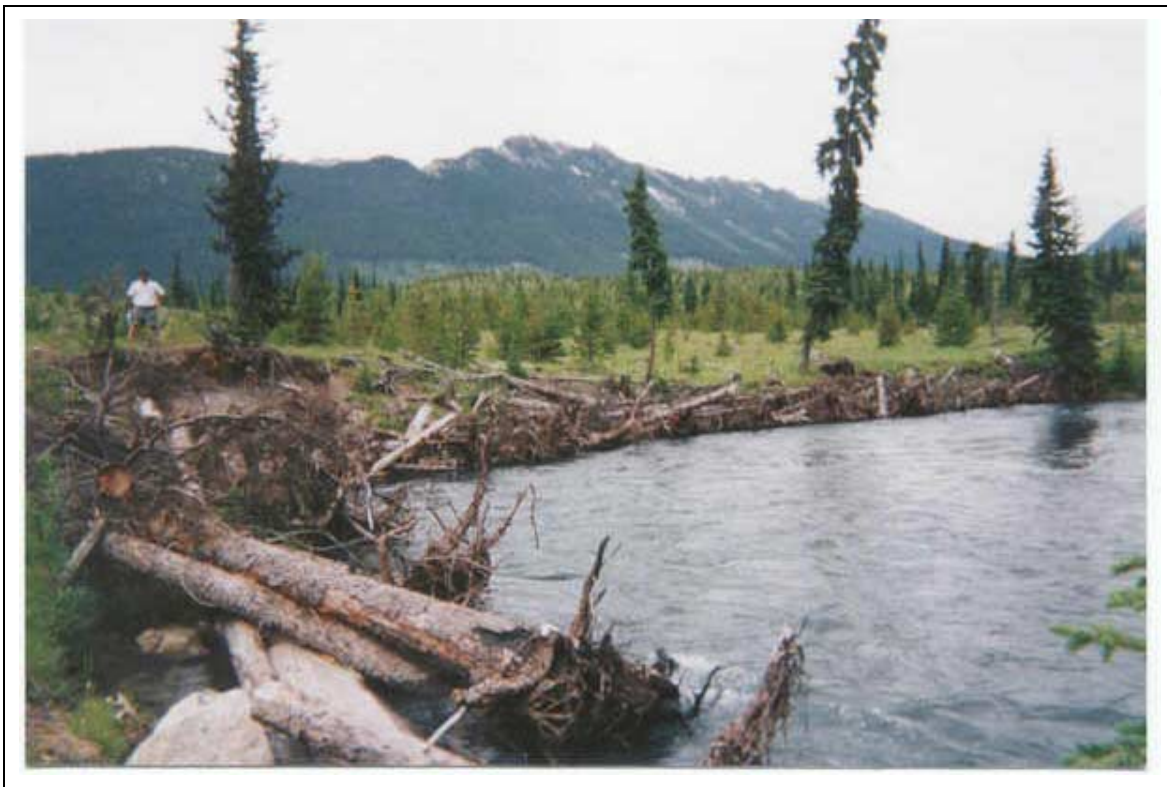
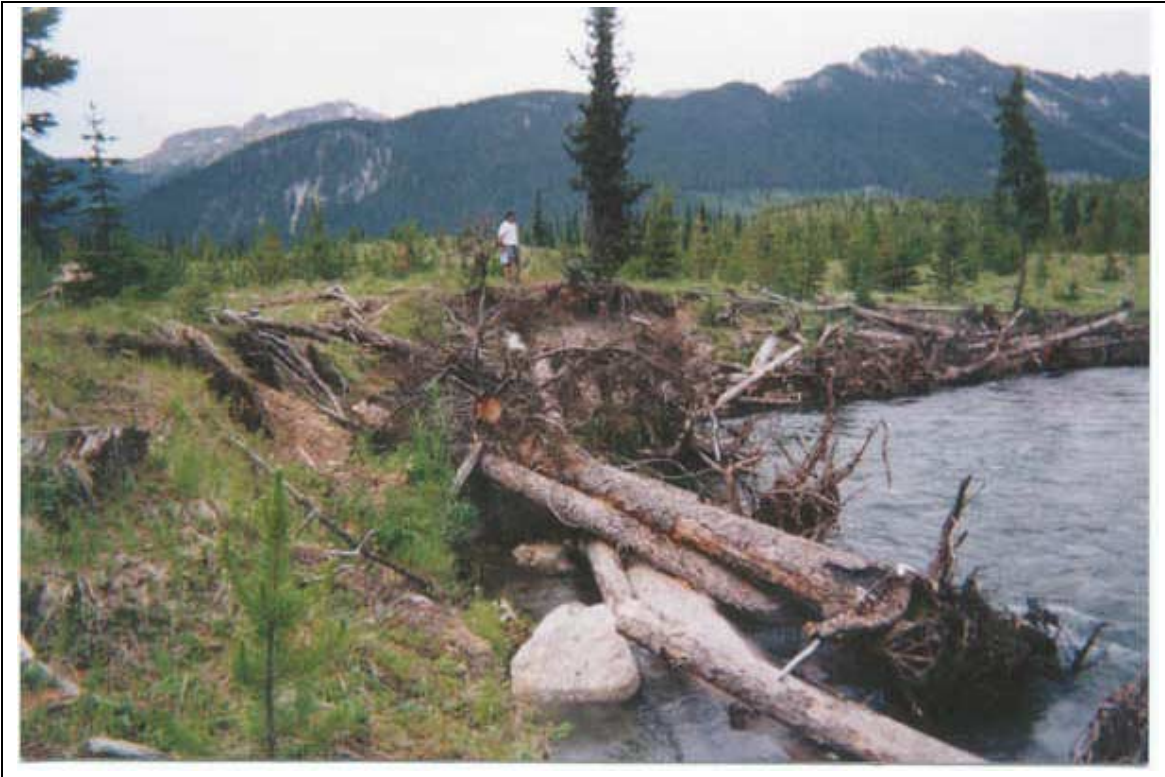
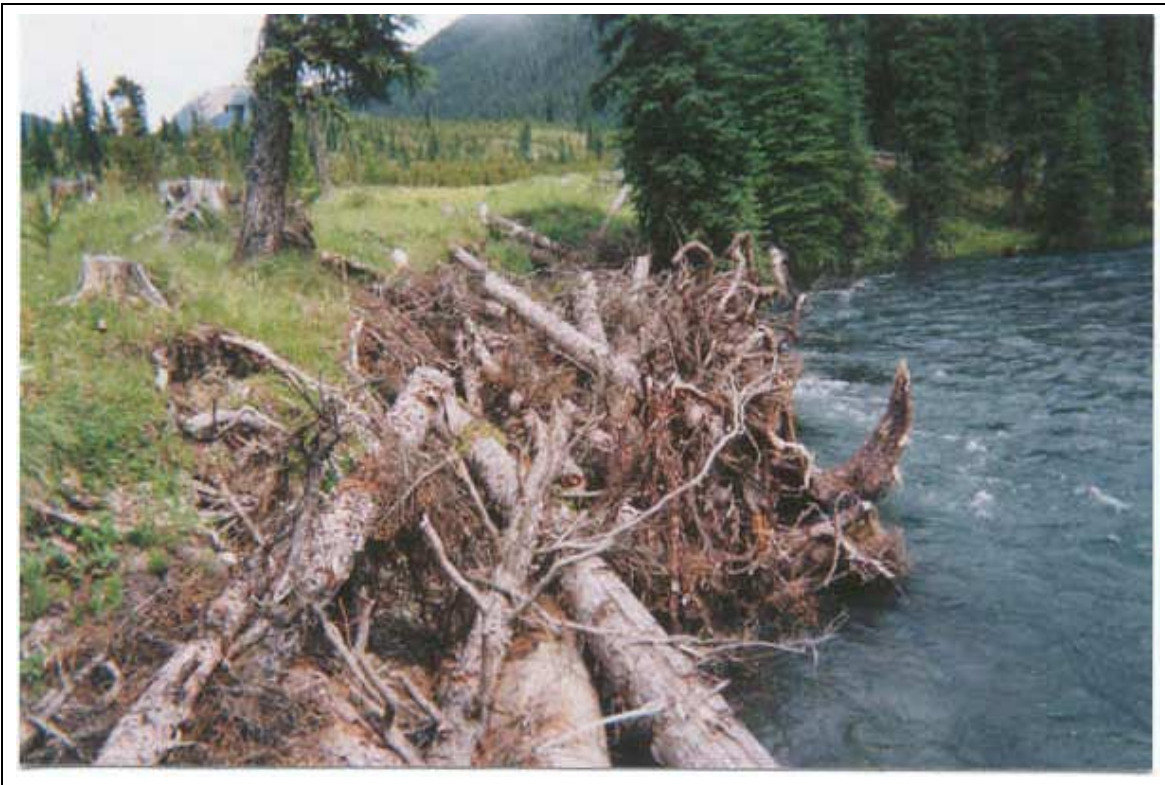
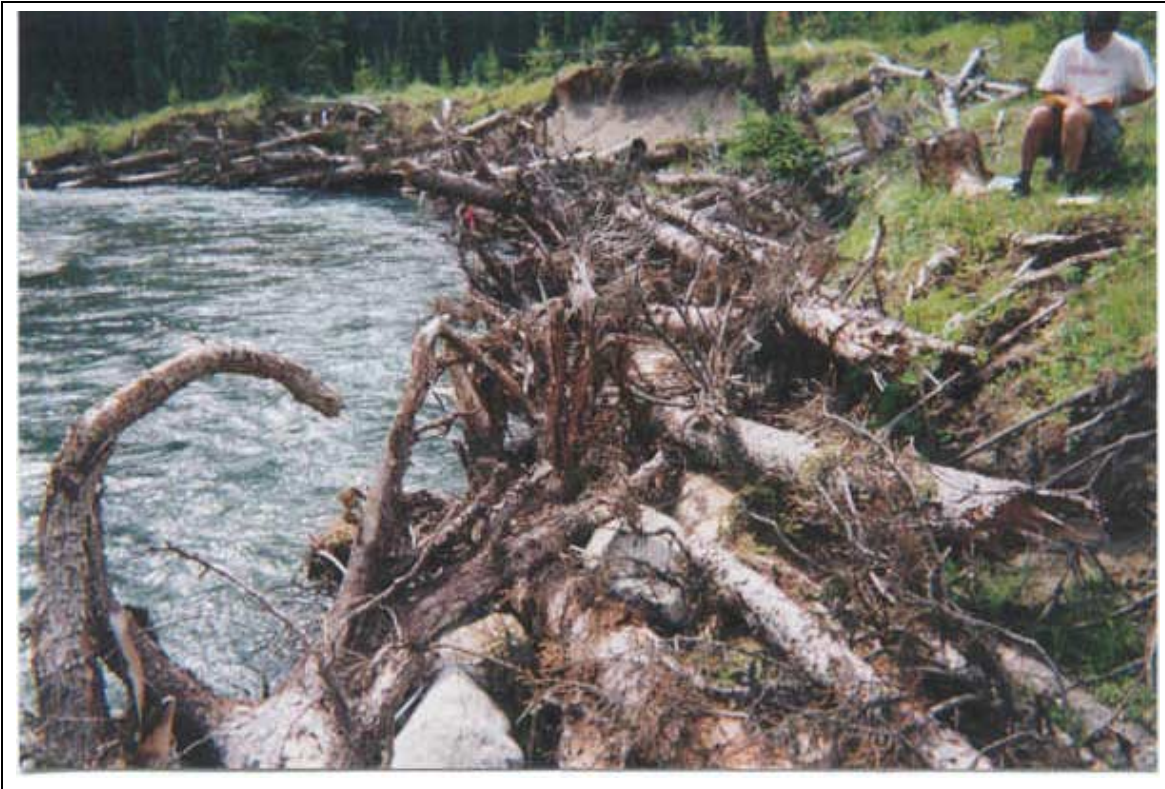
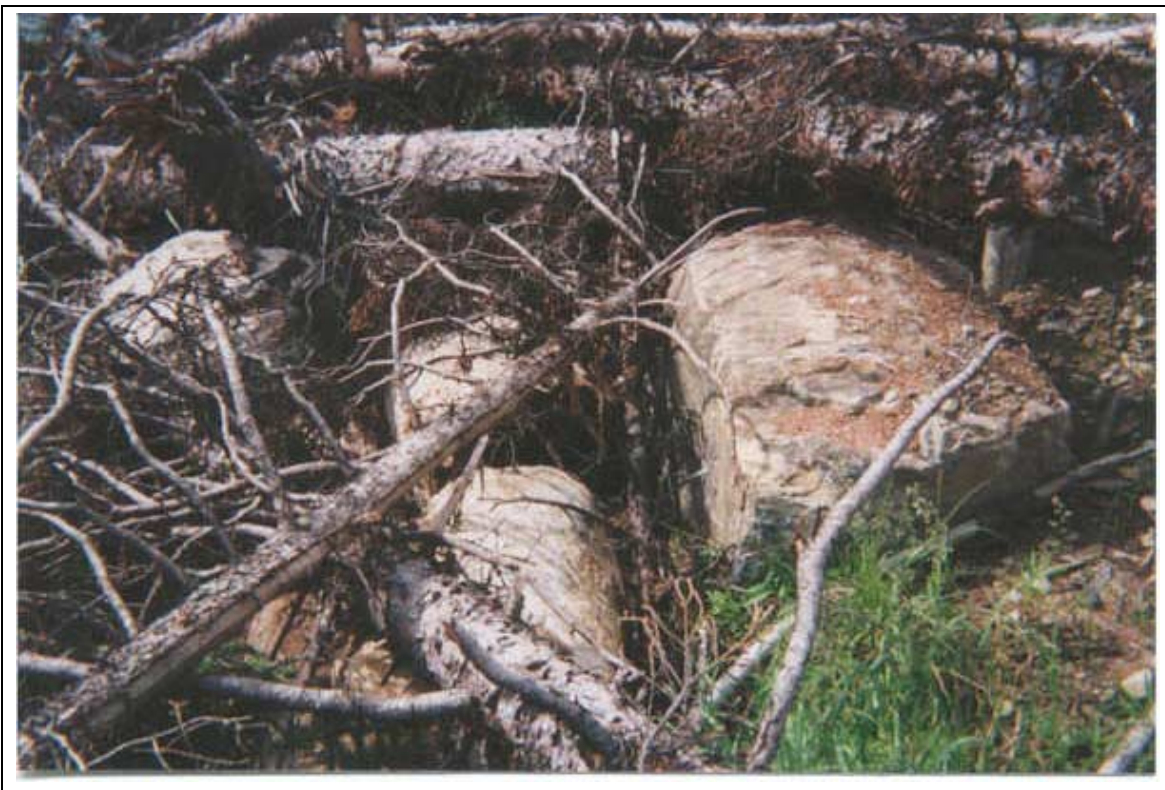
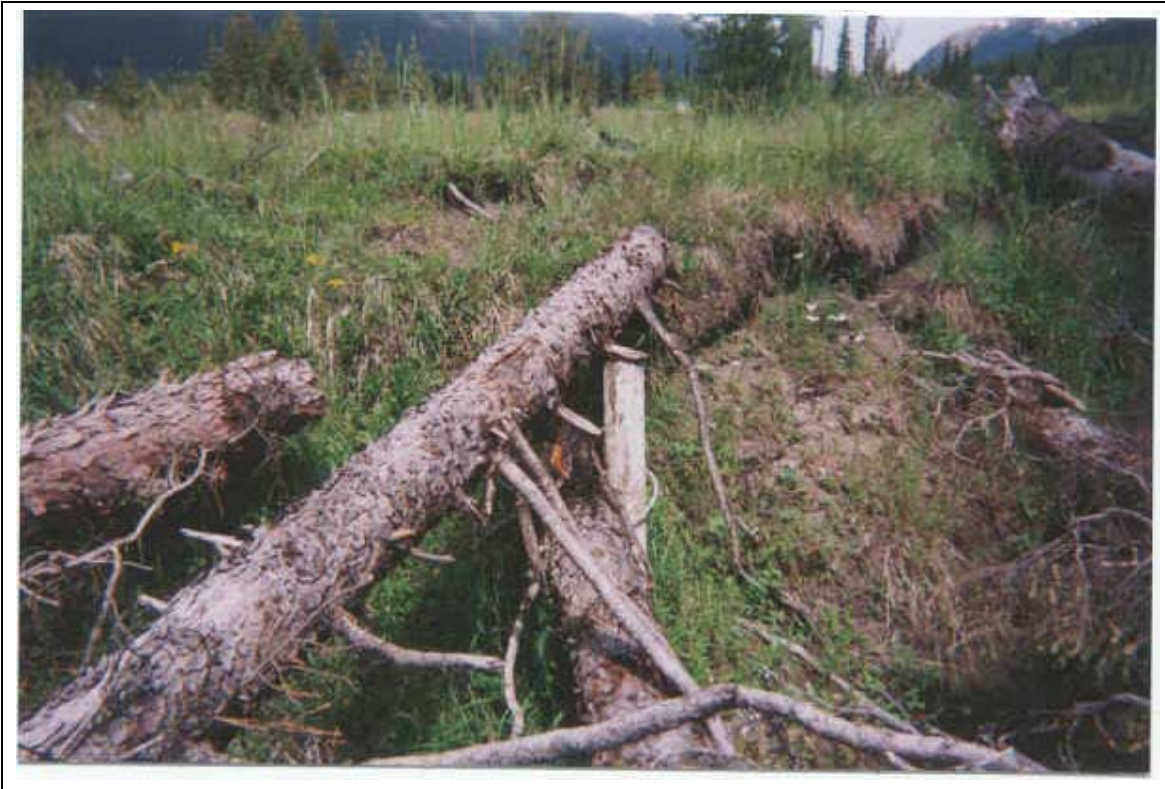
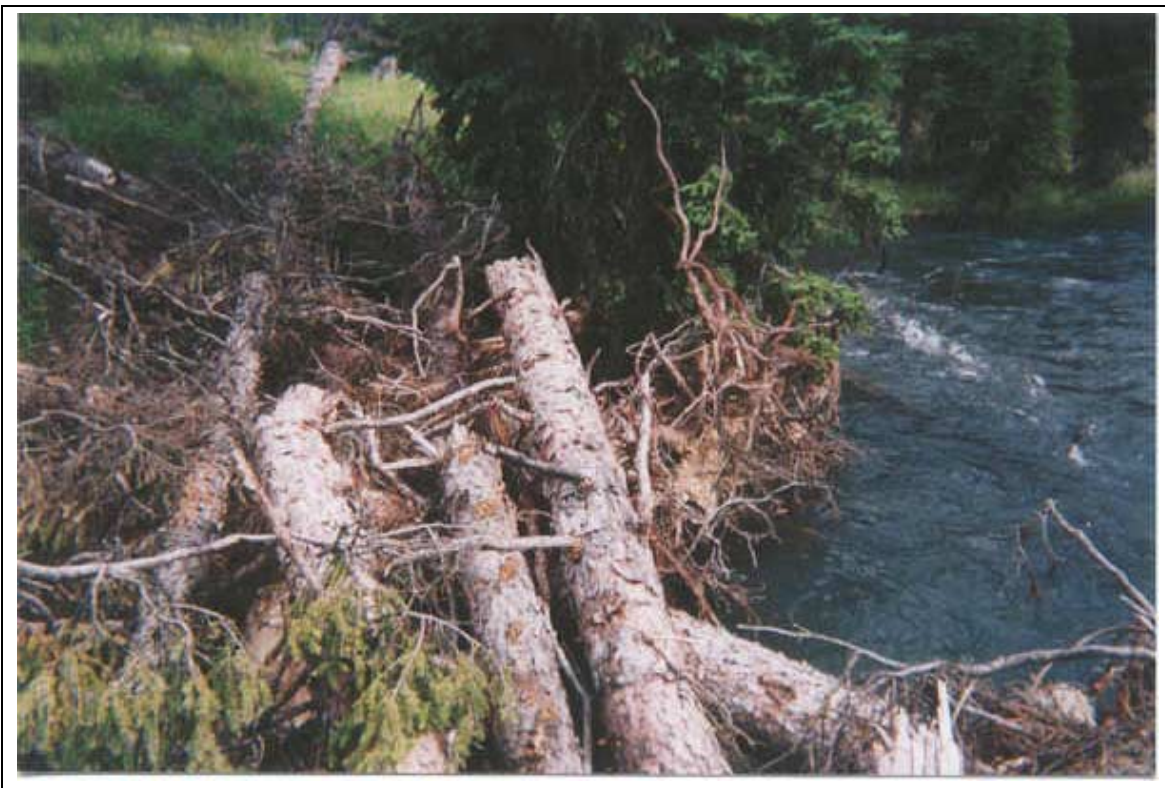
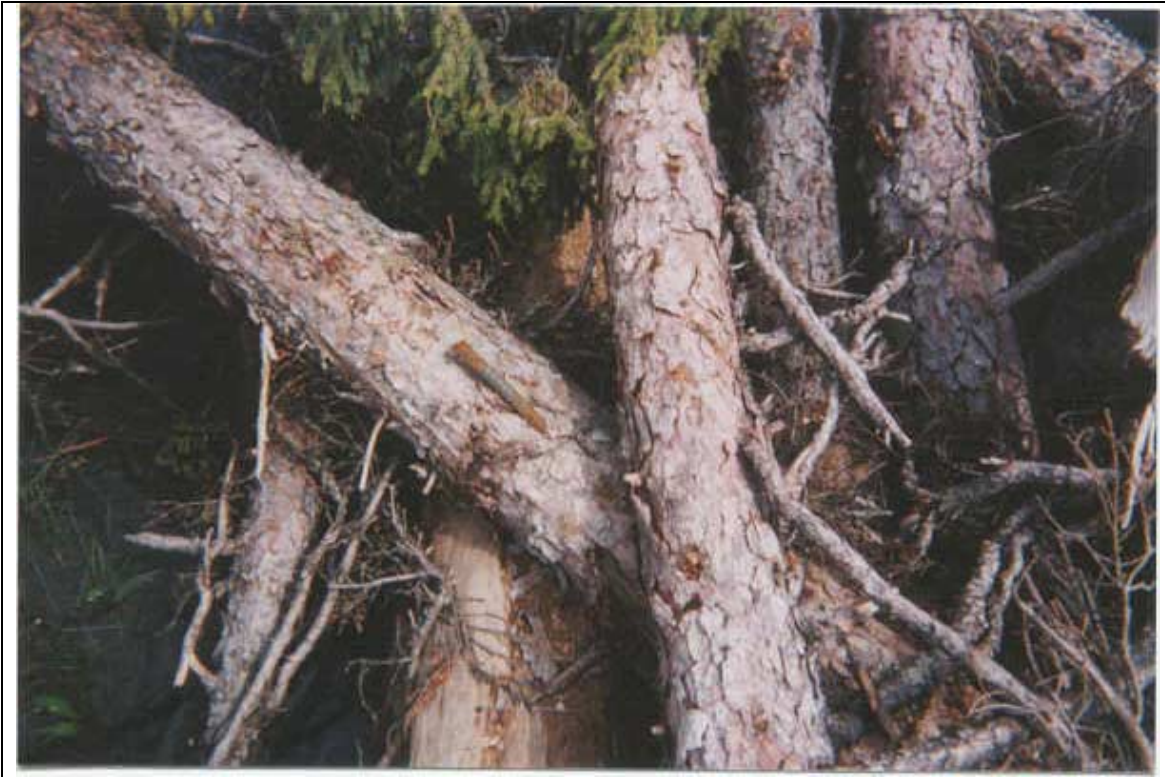
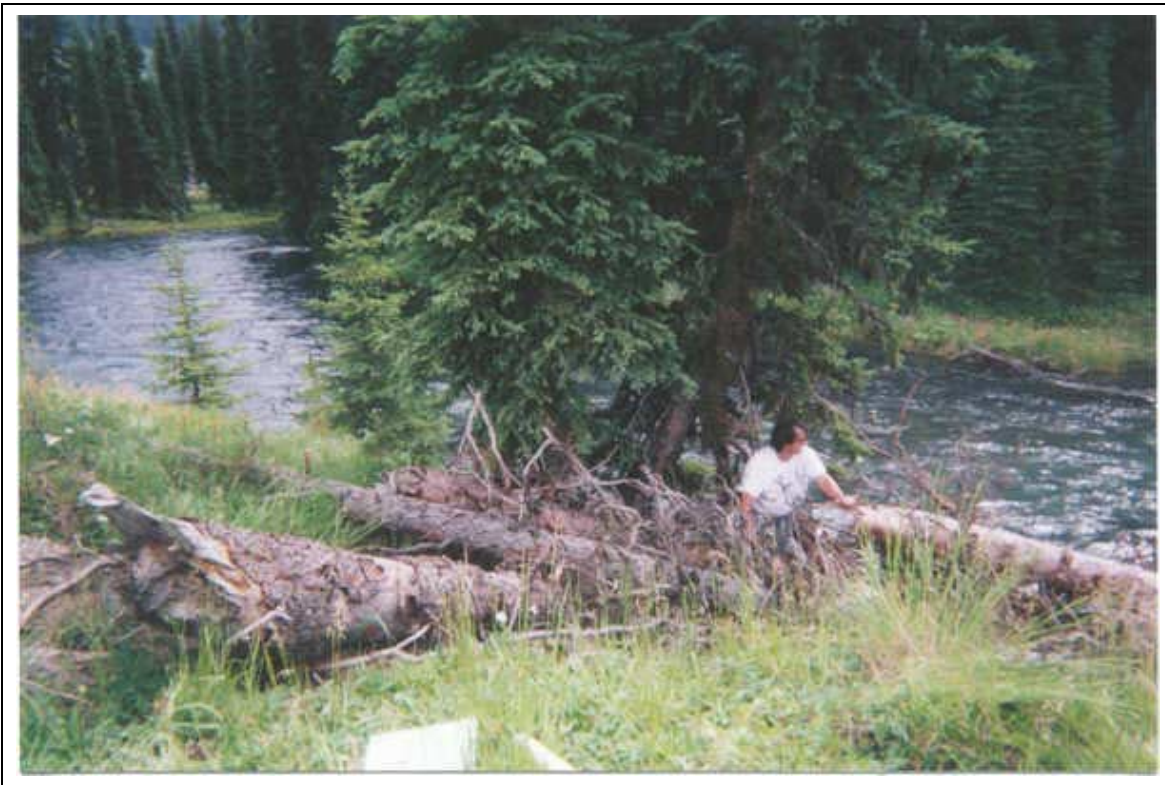
The restoration prescription at this site consists of a bankside logjam and tree revetment approximately 35 m long constructed in August 1999. (Plates 11 to 22). The upstream end of structure is well protected with lots of rock at its upstream end. There is a section of cable at the upstream end of the site that has about 8" of play and needs to be tightened. The footer logs throughout the length of the structure average 60 cm in diameter. There is a loose log 5 m long with its stump attached under an overhanging spruce that is also under ballasted (Plate 12). The log should be cabled in series with the existing rock and adjacent structures. Also, some cables have frayed ends that should be cut off and braided neatly. There is some evidence of slumping along the top of bank in the middle of the structure, and a fracture line has formed. It is anticipated that this material will slump onto woody debris at the rear of the logjam, and a stable angle of repose will form at the bank's edge. The area slumping should be monitored and planted with willows once the bank has stabilized.

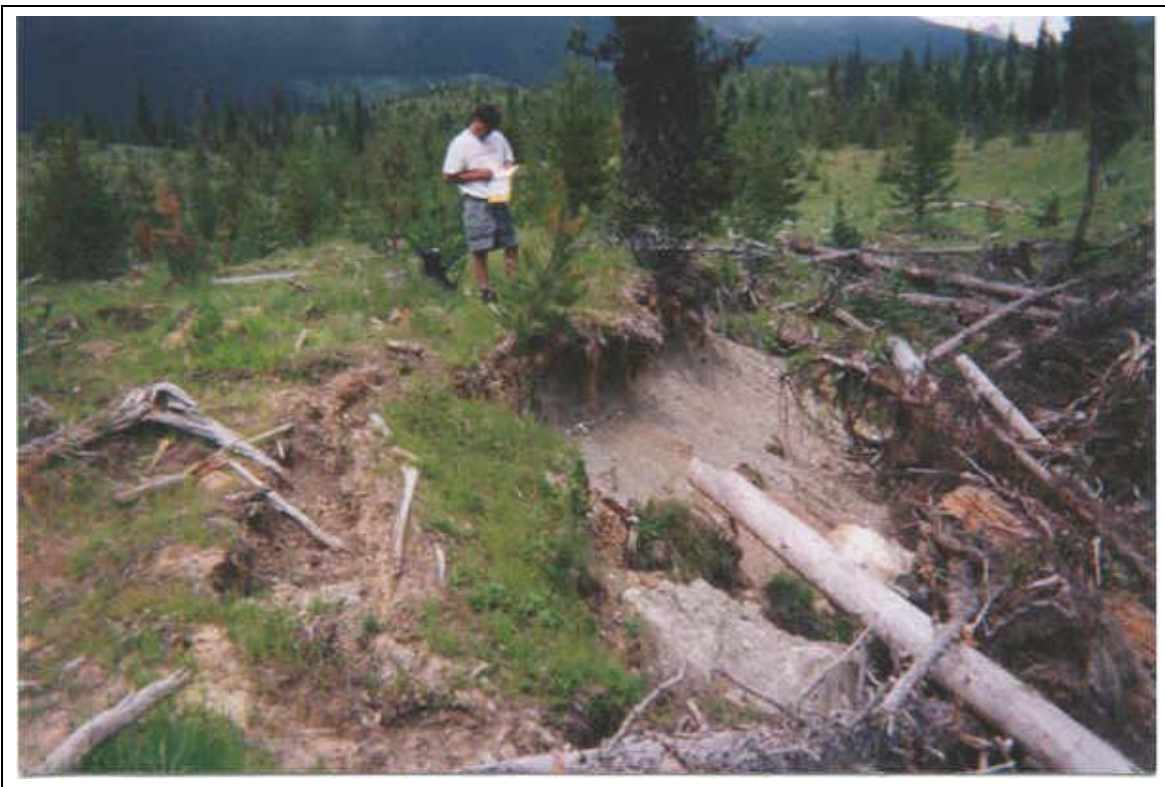
Plate 12 View upstream from lower end of site MY-01, Mayuik Creek (July 22, 2000). Note fracture line along top-of-bank and associated slumping.

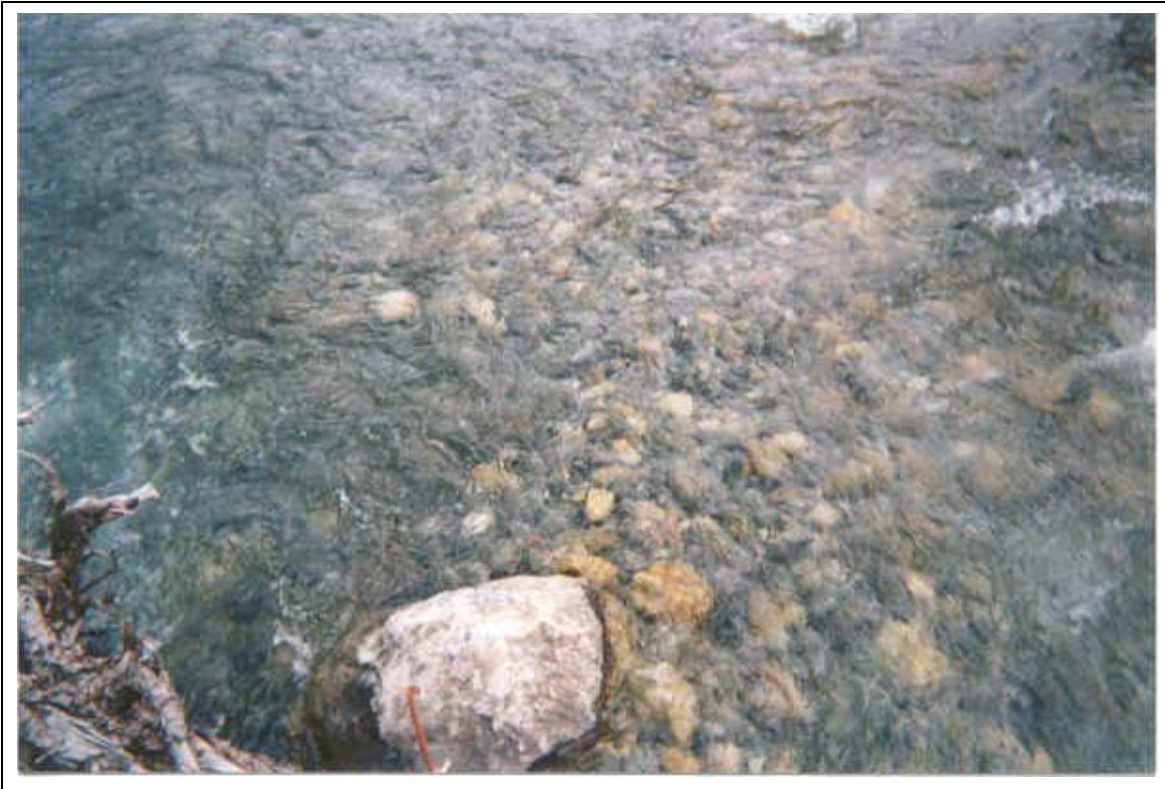
Plate 25 View downstream of sediment wedge formed at tip of triangular logjam; site MF-01, Middle Fork of the White River (July 22, 2000).

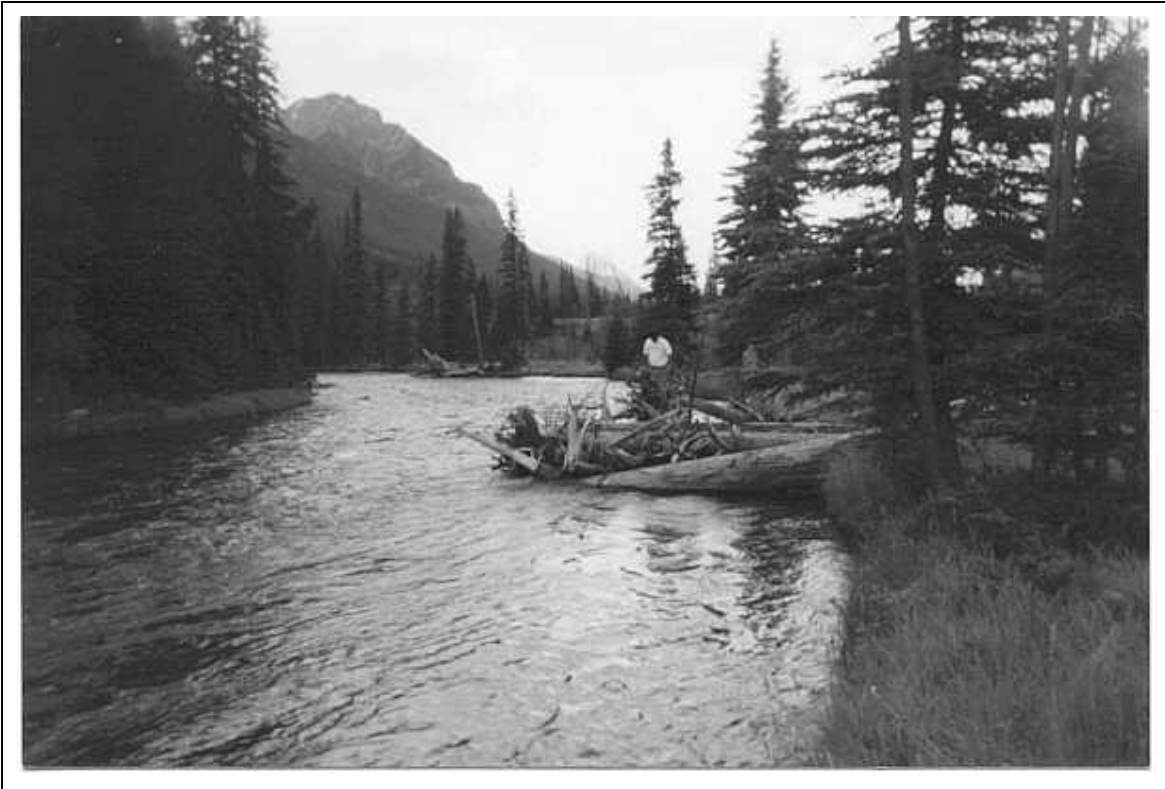
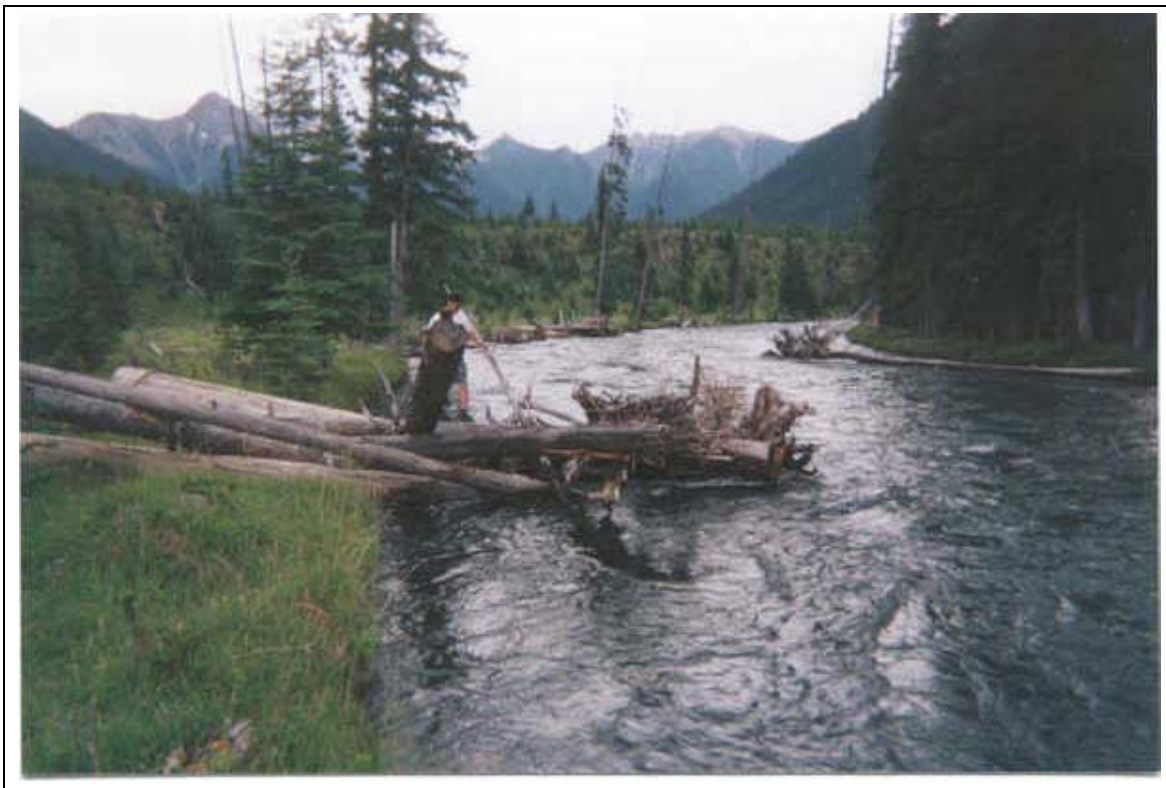
The restoration prescription at this site was a lateral triangular logjam (Plates 27 and 28). There is a loose log (no cables attached) on the upstream side of the structure, which should be attached. There are several loose cables (Jim holding cable end – Plate 29), which should be tightened or removed. Components of the structure may porpoise during freshet and weaken cables. The amount of slack/play in the cables should be monitored.

Plate 27 View upstream at triangular logjam; site MF-02, Middle Fork of the White River (July 22, 2000).

Plate 28 View downstream at triangular log jam, site MF-02, Middle Fork of the White River (July 22, 2000)

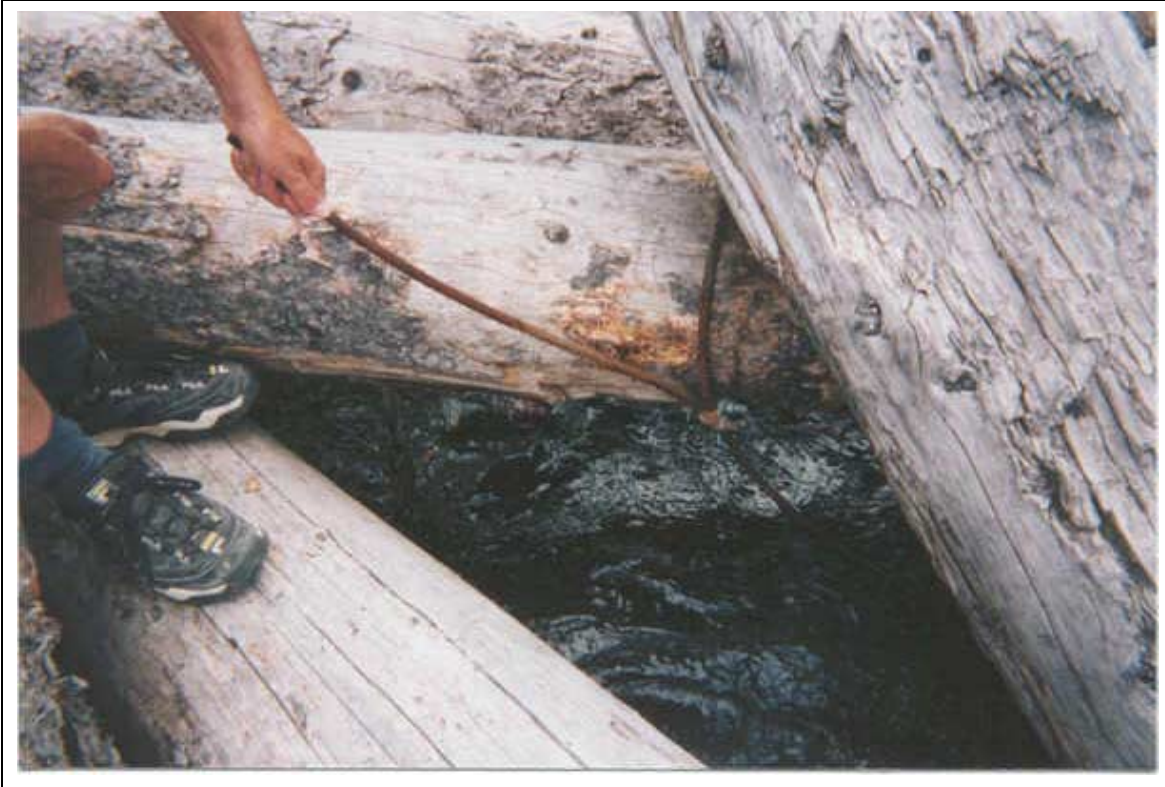
Plate 29 Jim King holding loose cable end at triangular log jam, site MF-02, Middle Fork of the White River (July 22, 2000).

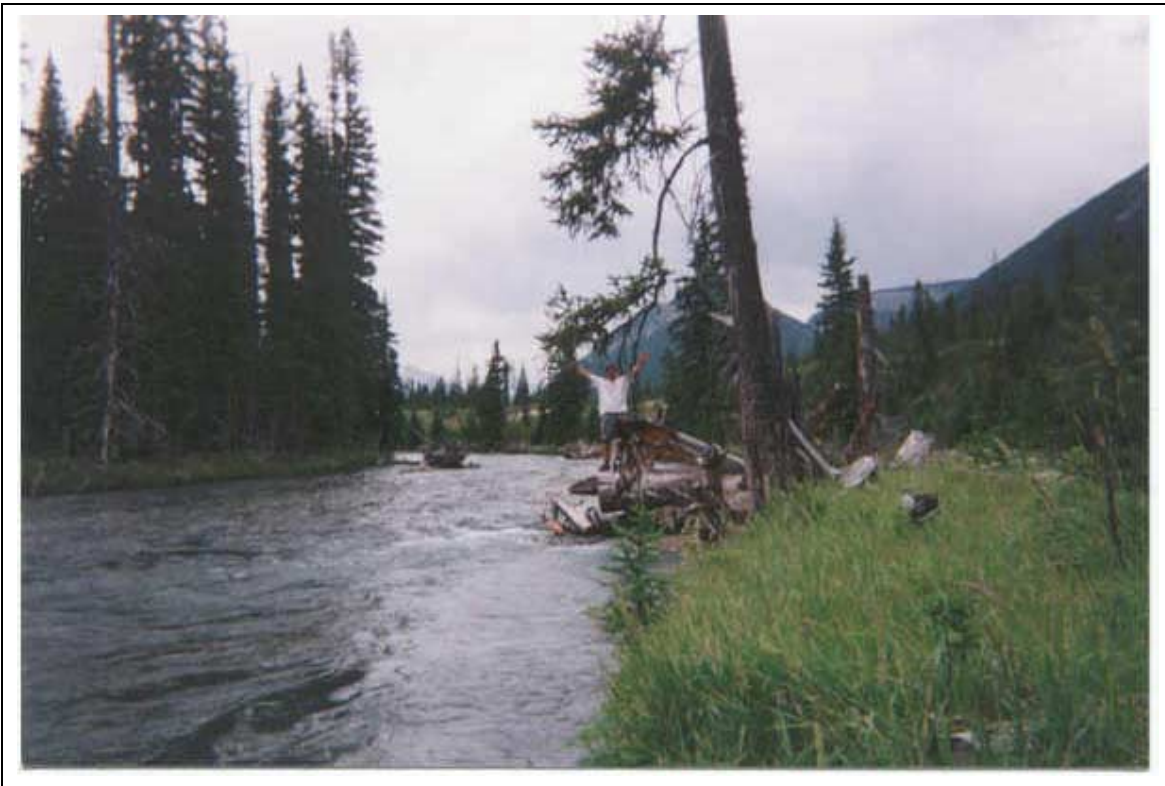
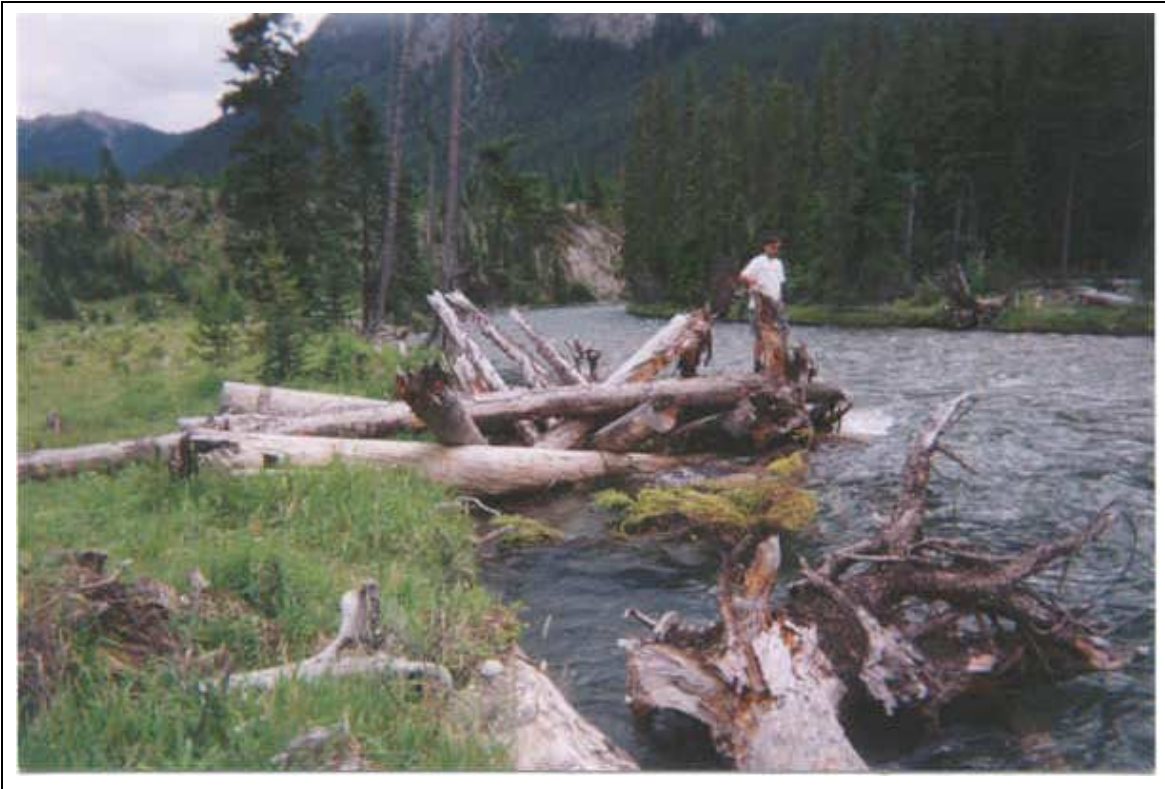
The restoration prescription constructed at this site was a triangular logjam (Plates 30 and 31). There are loose cables in the structure, although it may be difficult to tighten them given their location. Components of the structure are connected in series, which reduces the risk of an individual component swinging free because of a loose cable. Cables may tighten as the structure settles over time, and should be monitored occasionally (every 2-3 years). No additional maintenance is required.

Plate 30 View upstream at triangular log jam, site MF-03, Middle Fork of the White River (July 22, 2000)

Plate 31 View downstream at triangular logjam; site MF-03, Middle Fork of the White River (July 22, 2000).

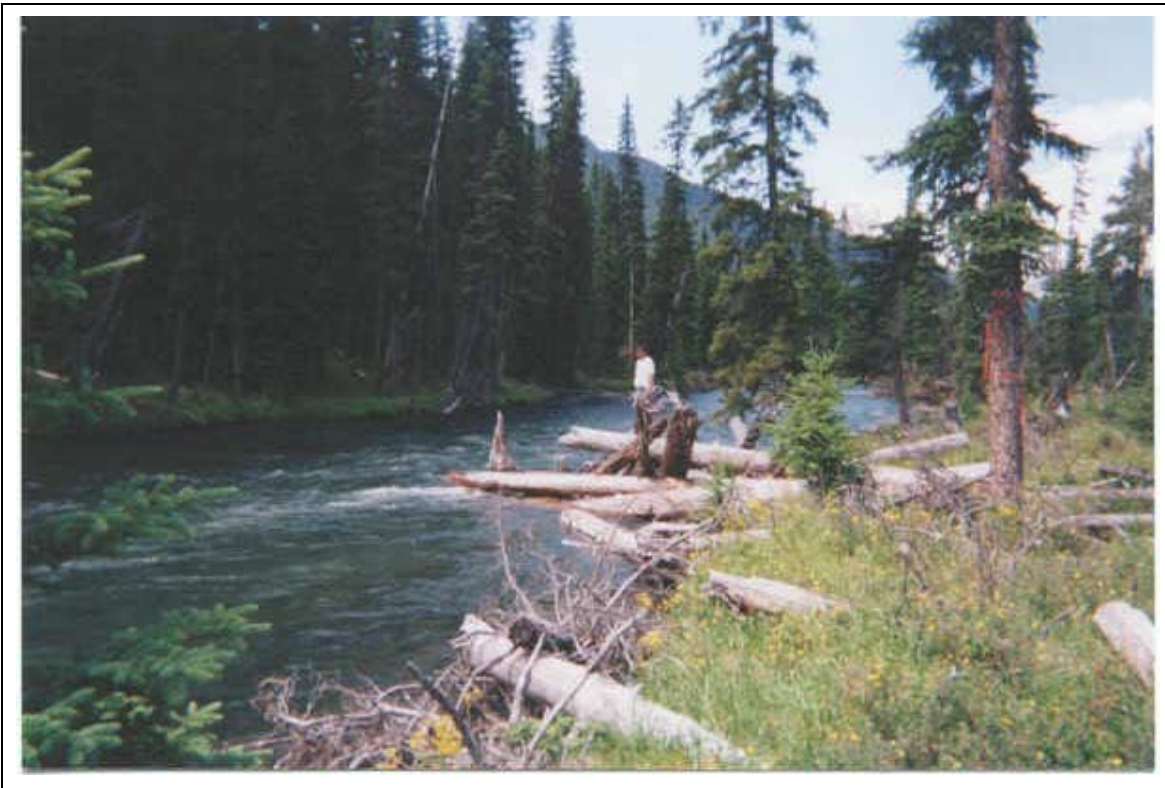
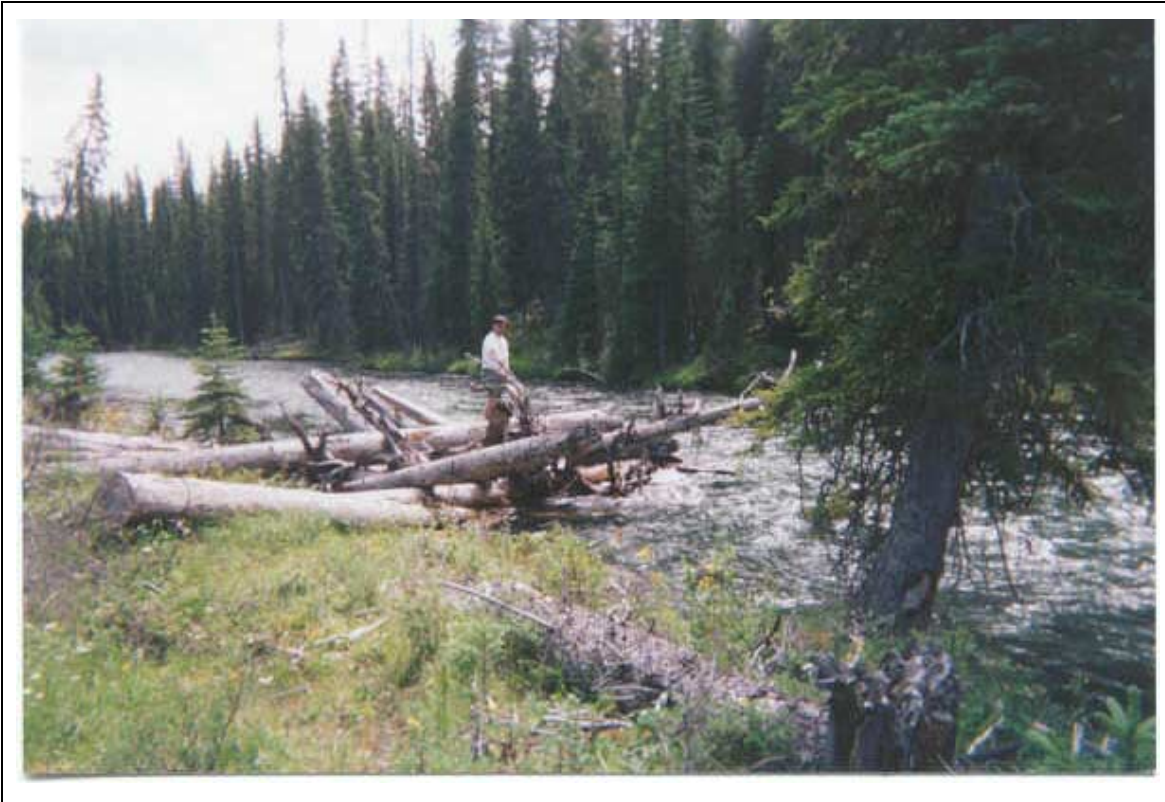
A lateral logjam was constructed at this site (Plates 32 and 33). All components appear to be attached and connected (poor site conditions may have restricted visibility during completion of the fall 1999 monitoring). There is a log extending into the stream which previous reports recommended for removal; however, the log is providing instream cover and does not appear to be affecting the integrity of the structure. The log extending downstream should be left intact. No additional maintenance is required.

Plate 32 View upstream at triangular logjam; site MF-04, Middle Fork of the White River (July 22, 2000).

Plate 33 View downstream at triangular logjam; site MF-04, Middle Fork of the White River (July 22, 2000).
