**MIDDLE FORK OF THE WHITE RIVER, MAIYUK, KLOOKUH, AND WINDERMERE  
CREEKS – ROUTINE MONITORING NEAR CANAL FLATS, BRITISH COLUMBIA**

**Slocan Forest Products Ltd.**  
P.O. Box 39  
Radium Hot Springs, British Columbia  
VOA 1M0  
(250) 347-6407

**Applied Aquatic Research Ltd.**  
Calgary, Alberta

March 2001  
File: AAR00-4

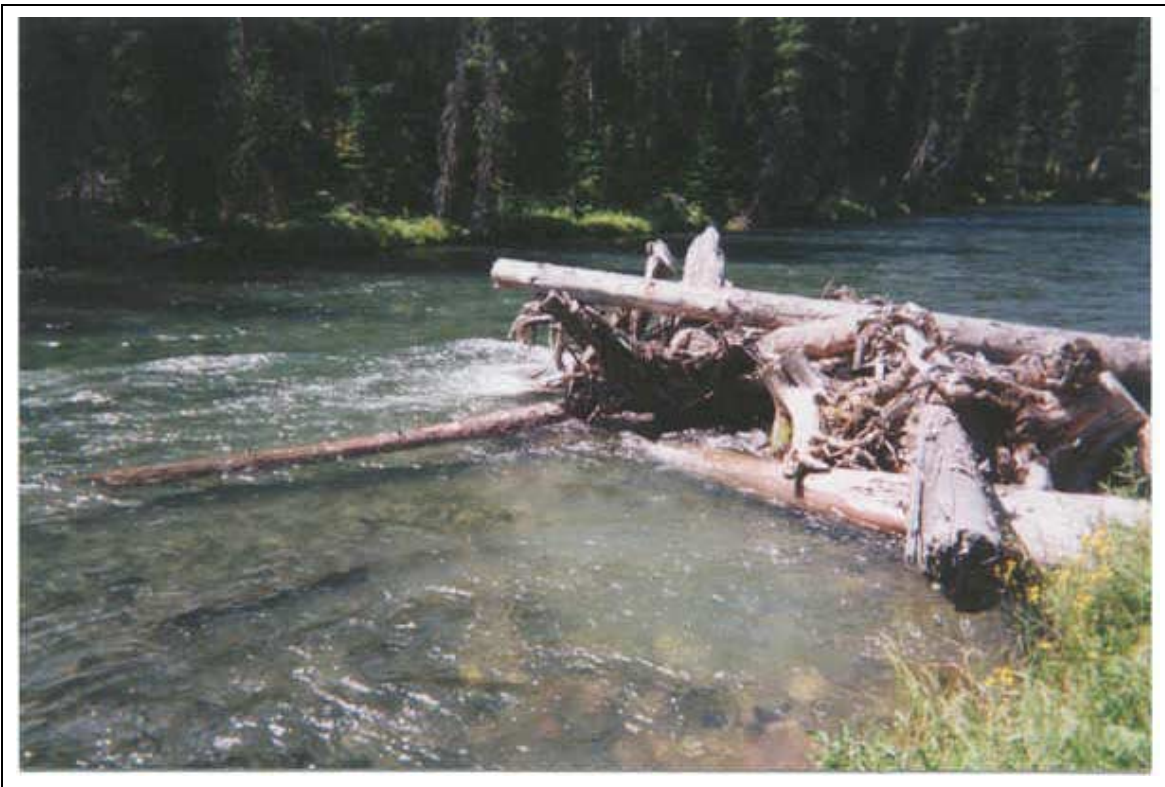
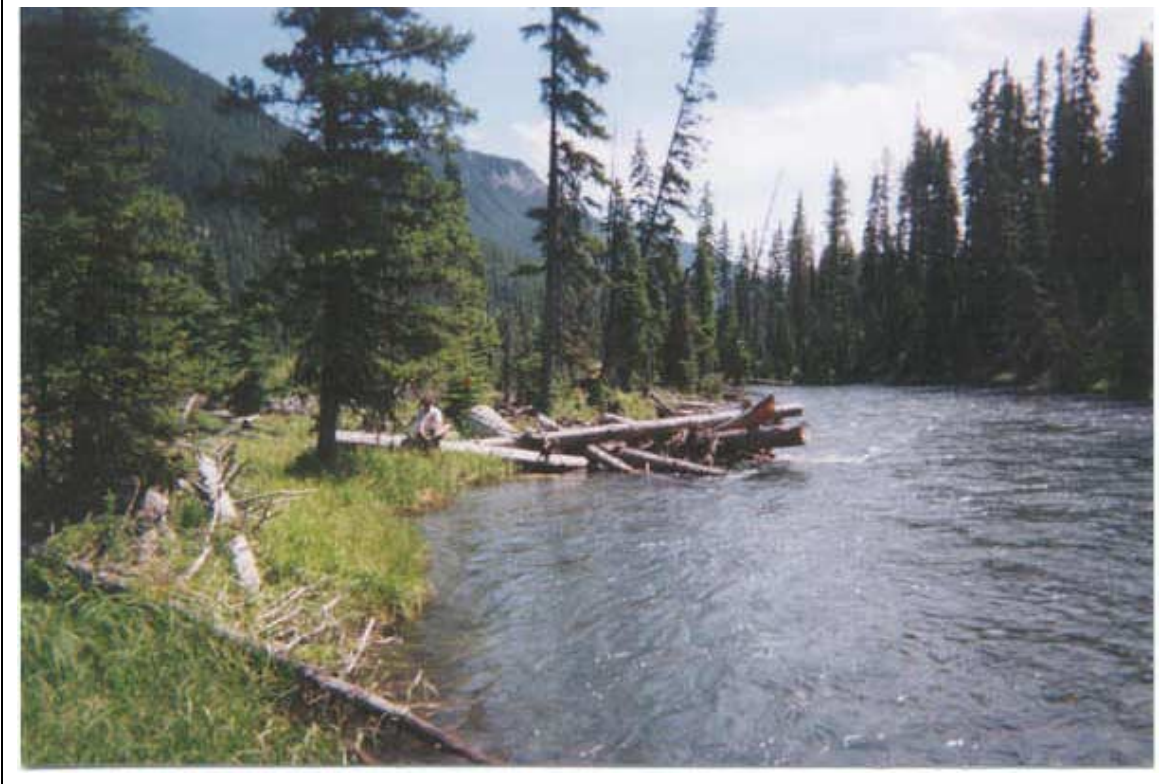
The restoration prescription at this site is a lateral triangular logjam (Plates 34 and 35). Maintenance requirements at this site include tightening loose cables and attaching loose components. No additional ballast needs to be added at this time.

Plate 34 View across triangular log jam, site MF-05, Middle Fork of the White River (July 22, 2000)

Plate 35 View downstream at triangular log jam, site MF-05, Middle Fork of the White River k (July 22, 2000)

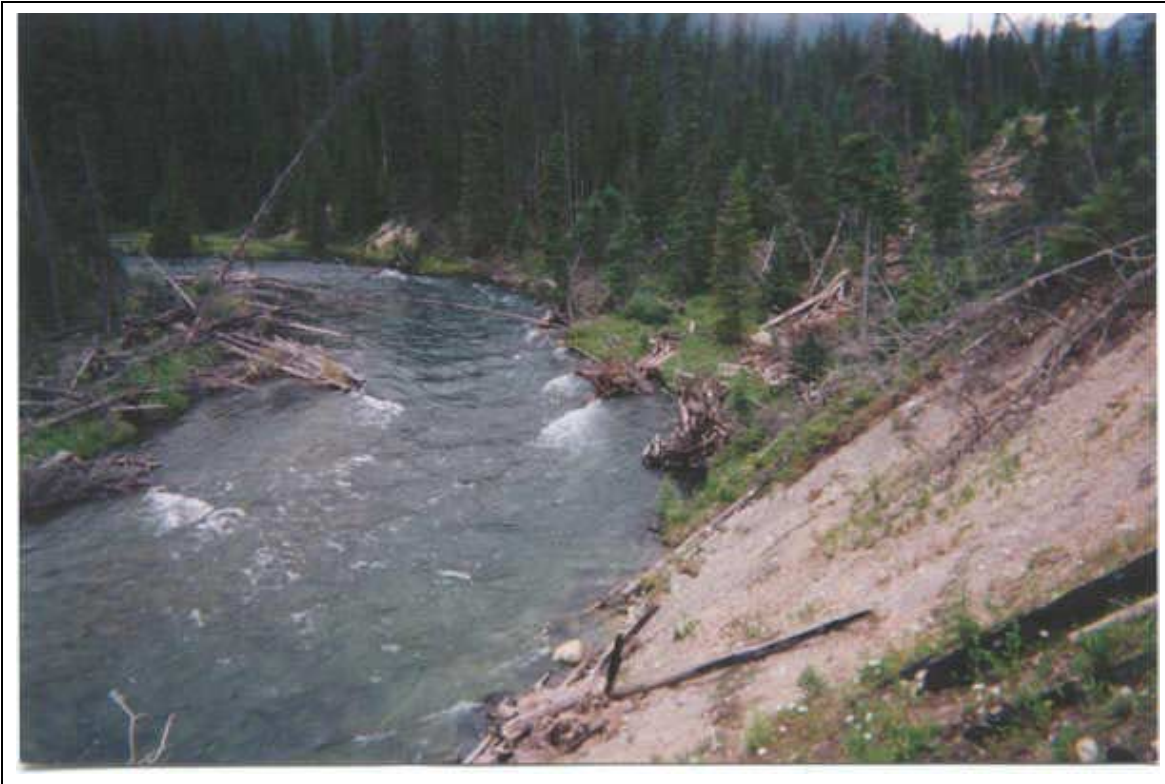
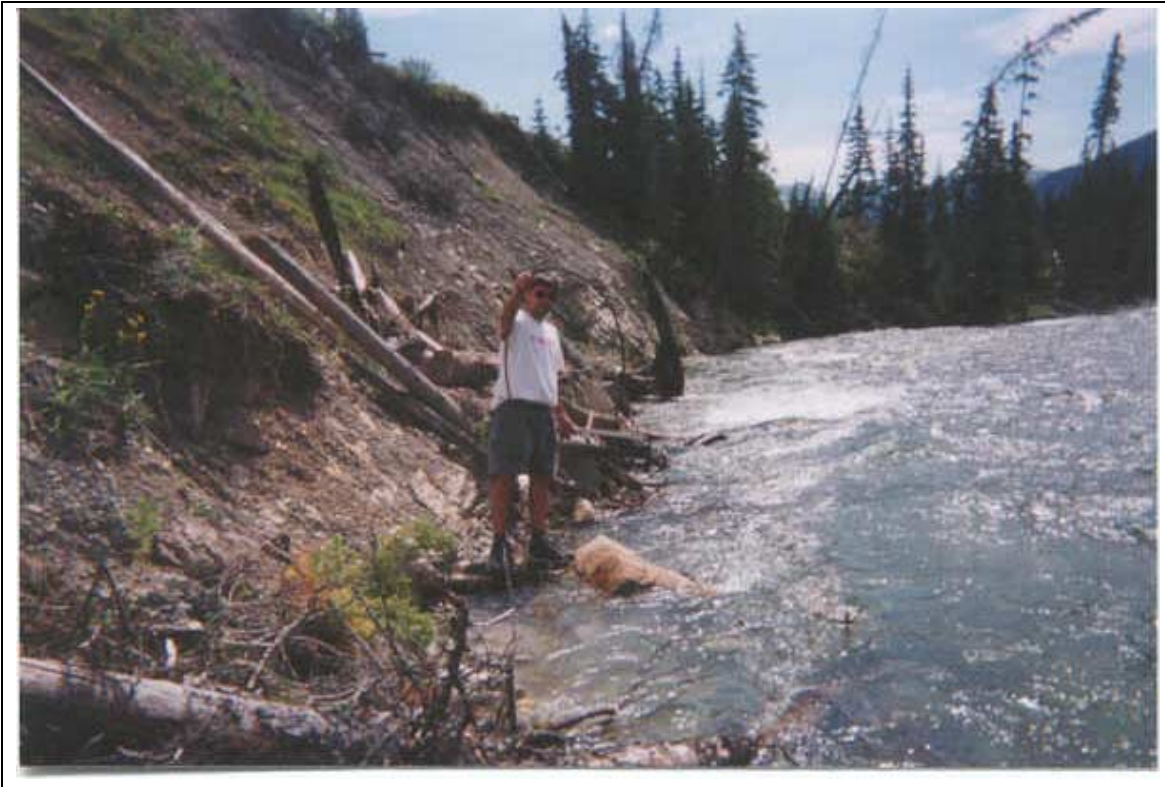
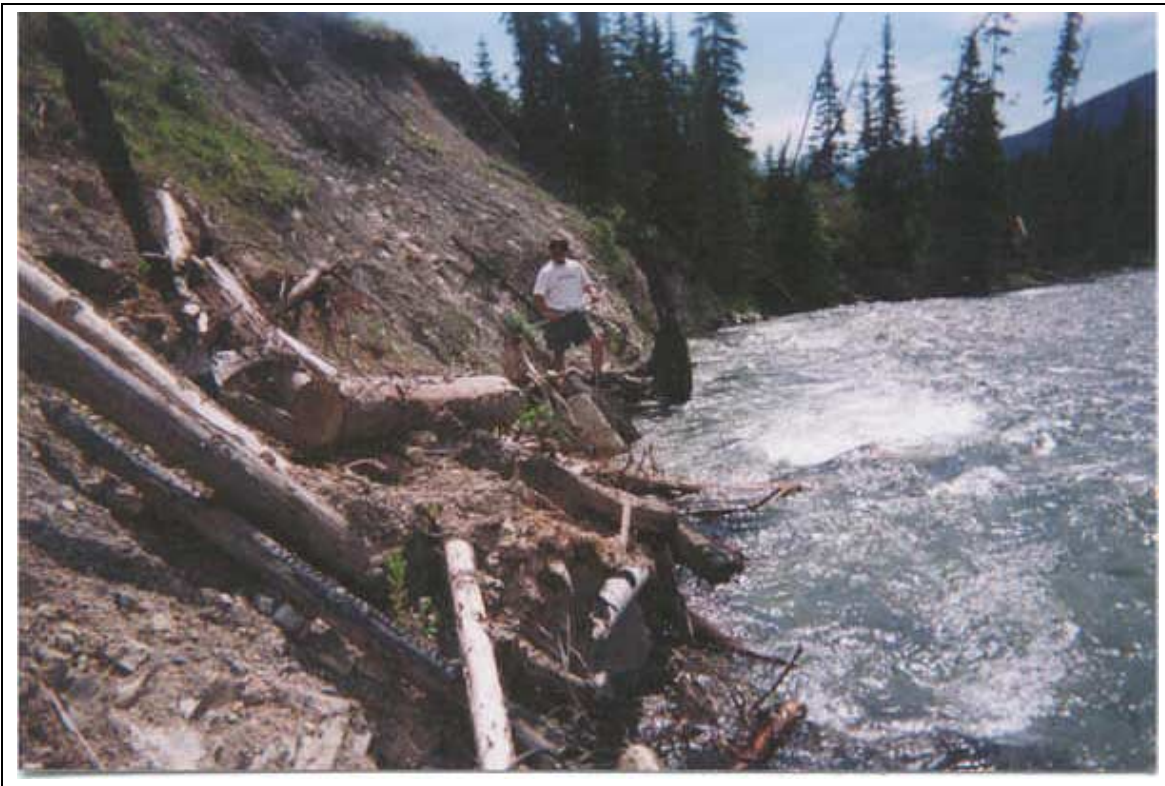
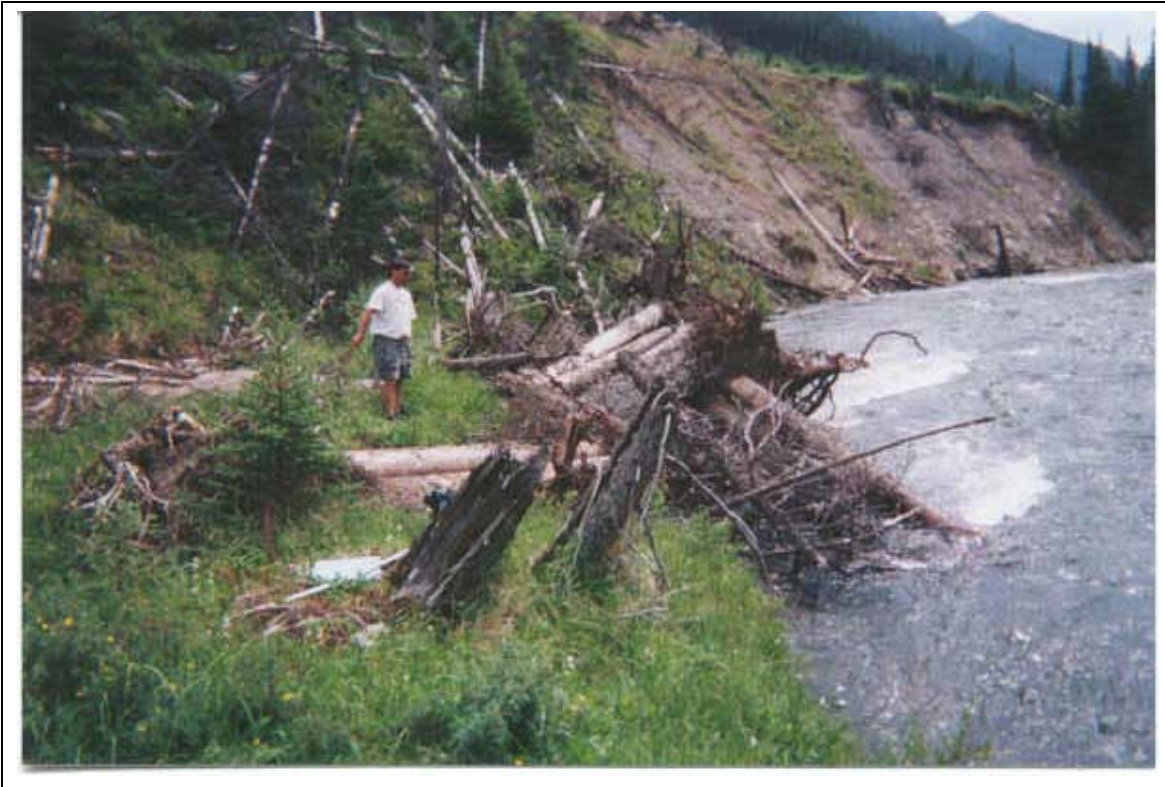
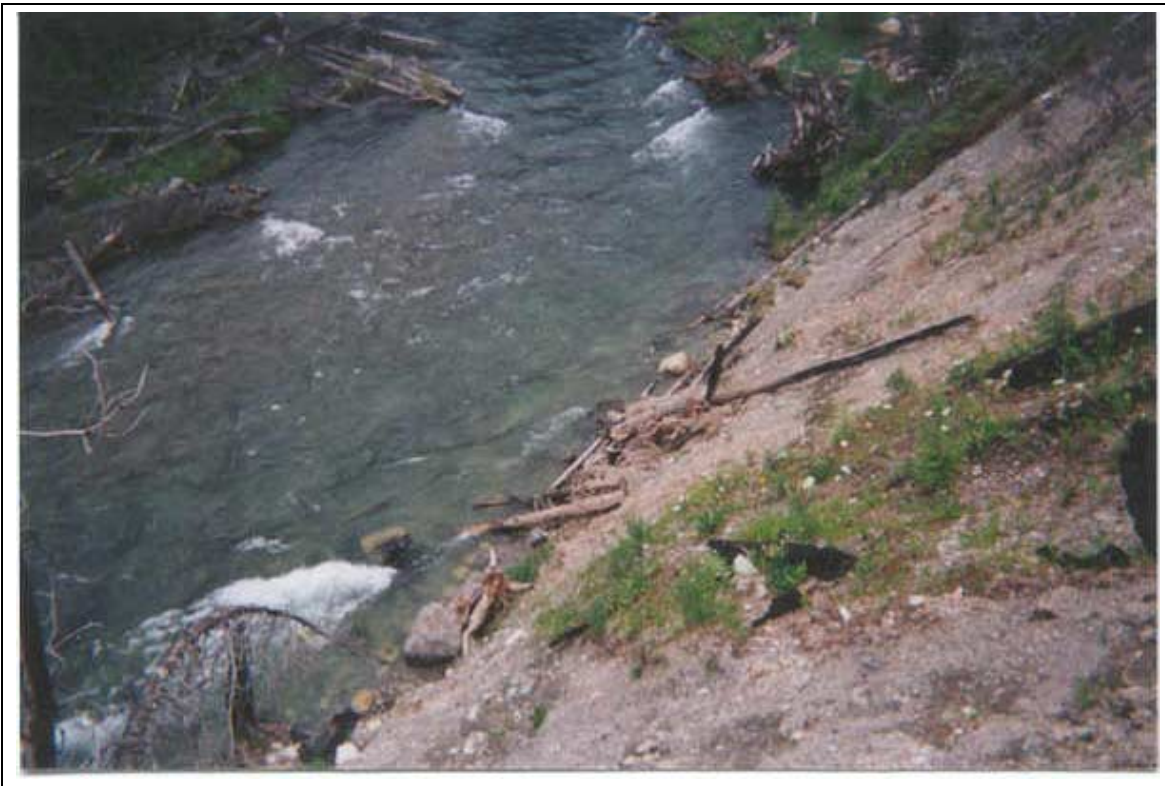
The restoration prescription initially proposed at this site consisted of a tree revetment at the toe of the slope, along with woody debris placed on the slope face. The initial design for the restoration prescription was modified because of safety concerns for hoe operation at the top of the slope (Oliver 1999). The logjam initially proposed was not constructed, and was replaced with boulders placed at the toe of the slope to dissipate energy (Plates 46 to 50). The hill slope was planted with immature shrubs to establish rooted vegetation. The upper section of the slope was re-contoured to a more stable angle (Oliver 1999, Plate 14).

Plate 46 View upstream from top of steep bank, MF-06, Middle Fork of the White River (July 22, 2000).

Middle Fork White River		MF-06	Stabilize steep slope			3					2	2	2	BT, WCT	All			2			2	2	2	2	Maintenance required - redirect surface flows using trench/fascines, continue conifer planting/bioengineering
Windermere Creek	Stn 815, Reach 2	P2-B	Debris Removal/LWD placement			3	4		4				4	WCT, BT, KO, EB	All, All, Ad. All			4			4	3	3	3	No maintenance required
Windermere Creek	Stn. 150, Reach 3	P3-A	V-log weirs	4					4				4	WCT, KO, BT	All, Ad. All			4			4	4	3	3	Monitor degradation around V-log weir; see report text
Windermere Creek	Stn. 700-710, Reach 9	P9-C	Tree Revetment			3	3				3		3	WCT	All			3			3	2	3	2	Maintenance required. See report text - replace/add additional cobble and boulder to fill voids and stabilize structure
Windermere Creek	Stn. 960-980, Reach 11	P11-D	Tree Revetment				3				3		3	WCT	All			3			3	3	3	3	No maintenance required
Windermere Creek	Stn. 0-100, Reach 12	P12-A	Boulder clusters				2				3		3	WCT	All			3			3	3	3	3	No maintenance required; complete routine monitoring;
