# **Watershed Risk Analysis**

## **Tranquille River**

Prepared for:

**March 10, 2009**

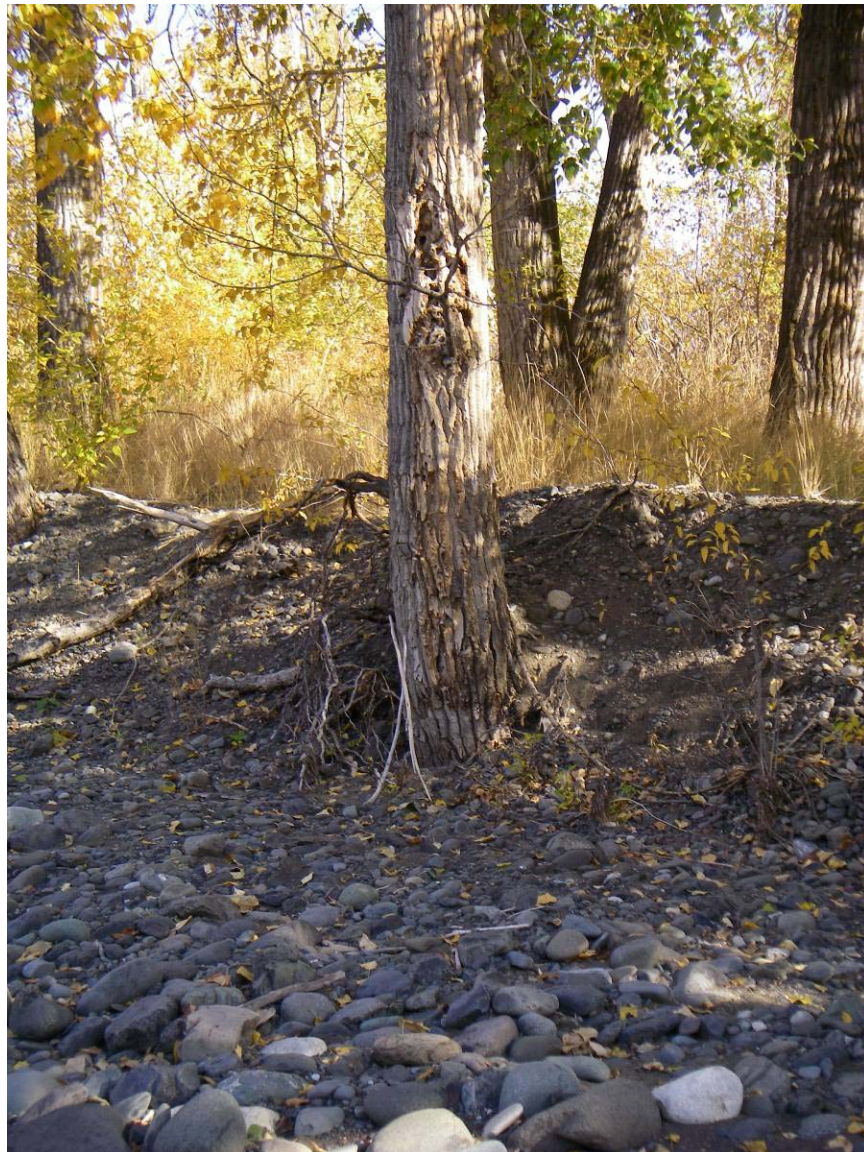
Photo 1. Tranquille River fan downstream of CPR and public/private road crossing. Note adventitious root on cottonwood indicating burial during last disturbance event – likely freshet 2002. Approximately 1.5 m of scour has occurred since.

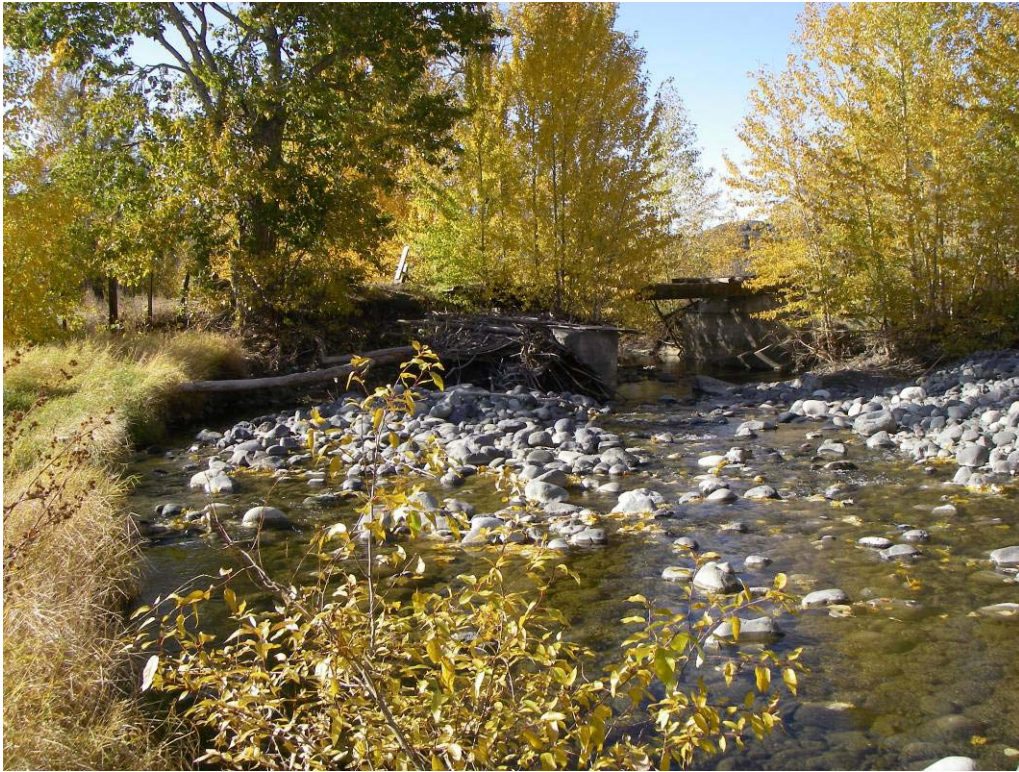
Photo 2. Abandoned public or private road crossing with approaches in active fan area downstream of CPR crossing. Washout likely during high flow periods with sediment input to fish bearing waters.

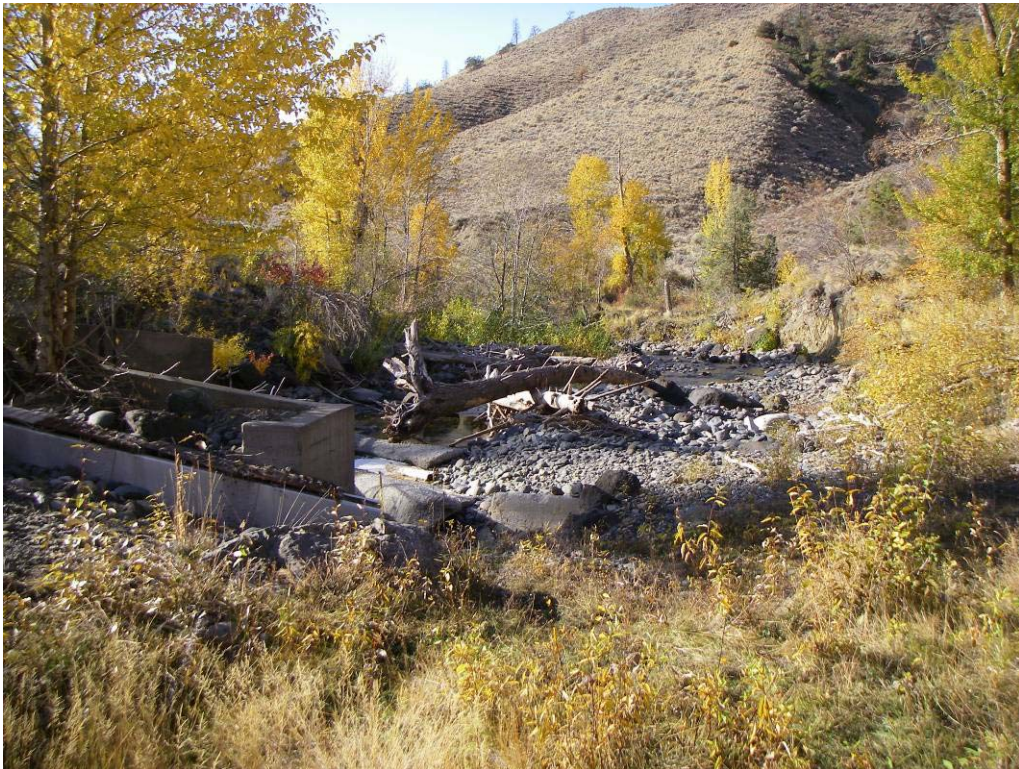
Old water intake infrastructure on lower Tranquille mainstem. The structure is a likely barrier to fish passage. Some water is still diverted from this site though existing infrastructure.

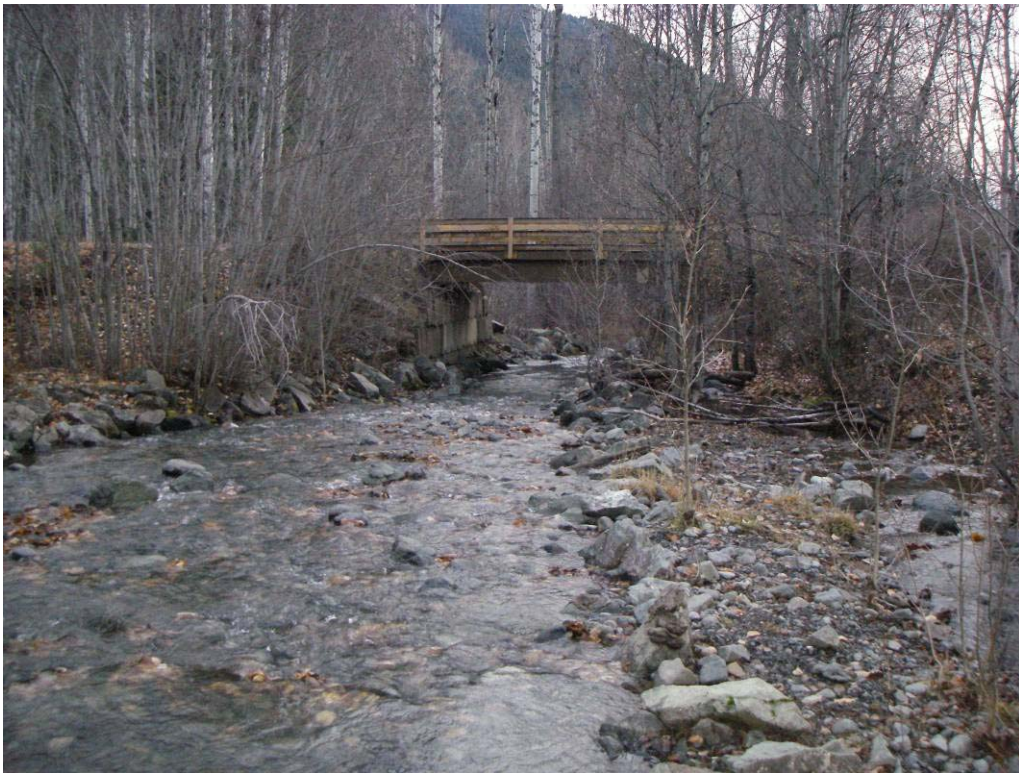
The Sawmill FSR crossing can be affected by debris jam formation at the structure during high flow periods that results from channel bank erosion on the floodplain upstream of the structure. The existing structure is considered undersized in this regard [*Photo 4*]. Failure could result in loss of life, access restrictions, and measurable input of sediment to Watching Creek.

Photo 4. Sawmill FSR crossing on Watching Creek floodplain. The active floodplain is constricted by the structure – sediment and debris accumulation at the inlet is likely during high flow periods. A washout could affect public safety, public infrastructure, access, and water quality.

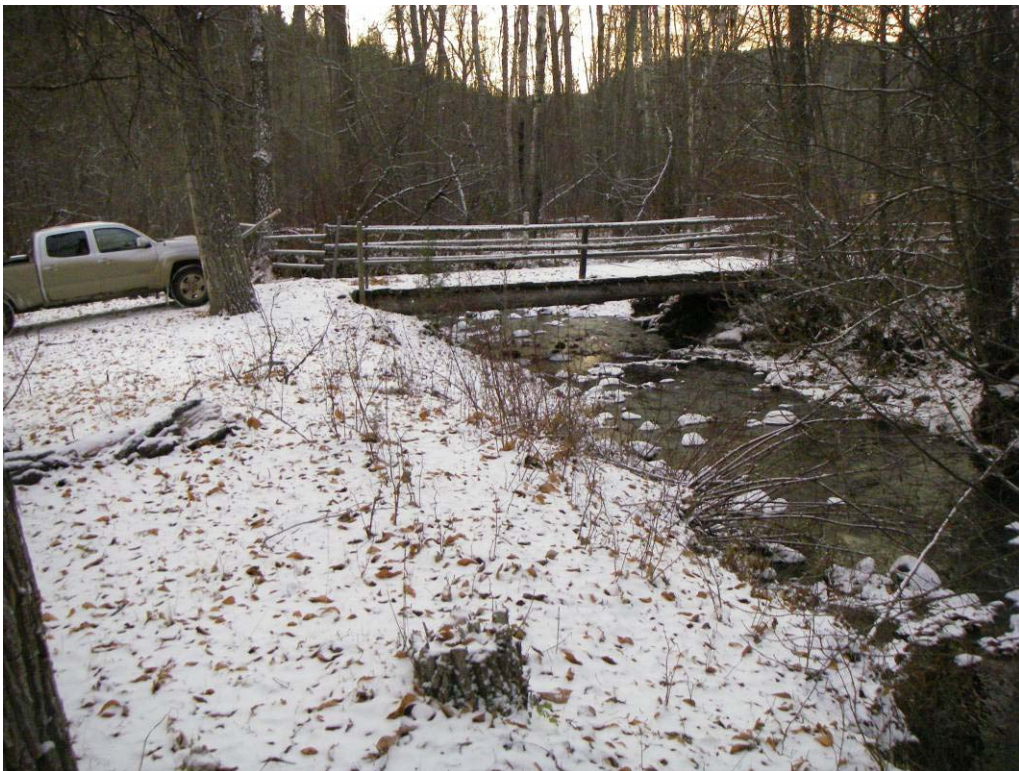
Photo 5. Non-status road crossing on Watching Creek downstream of Sawmill FSR. The structure is on the active floodplain and will likely fail during high flow events that mobilize upstream sediment and debris.

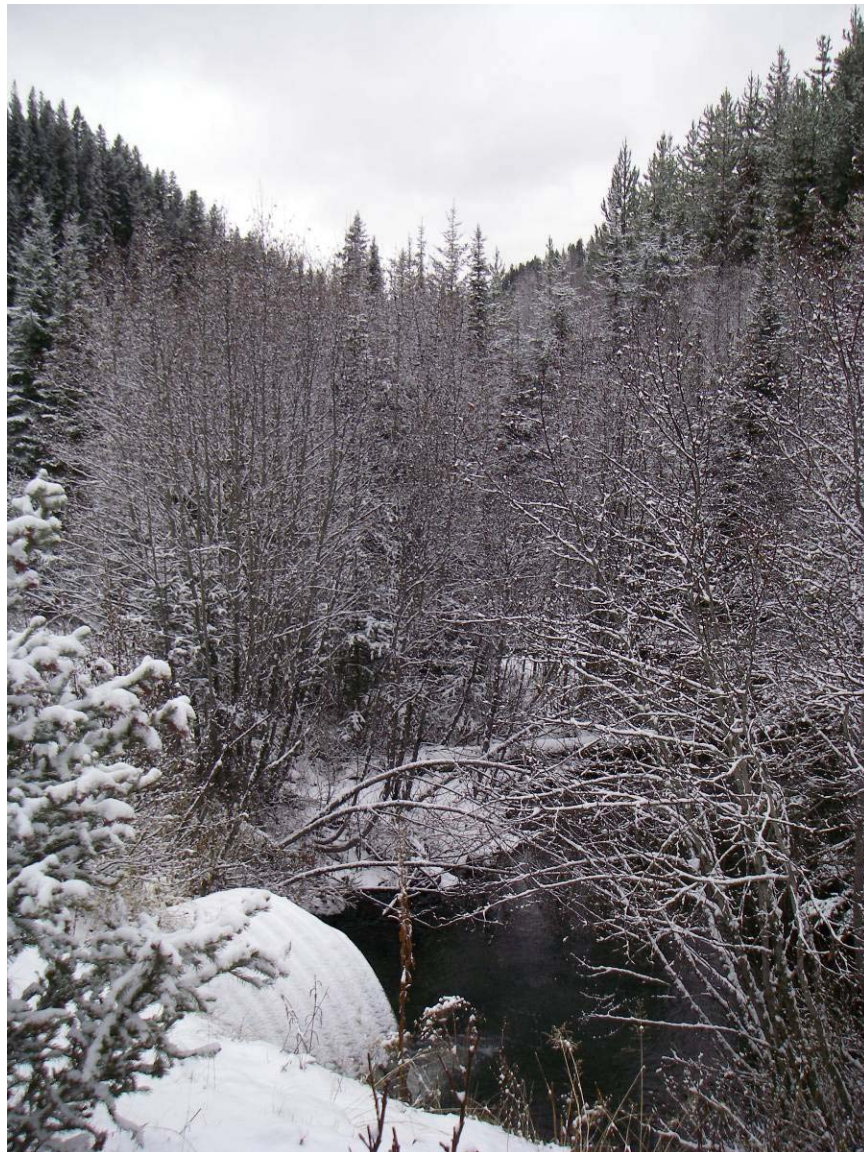
Photo 6. Watching Creek mainstem channel upstream of Tranquille East FSR crossing. Recovery is occurring in riparian areas logged in the 1970's and early 1980's.

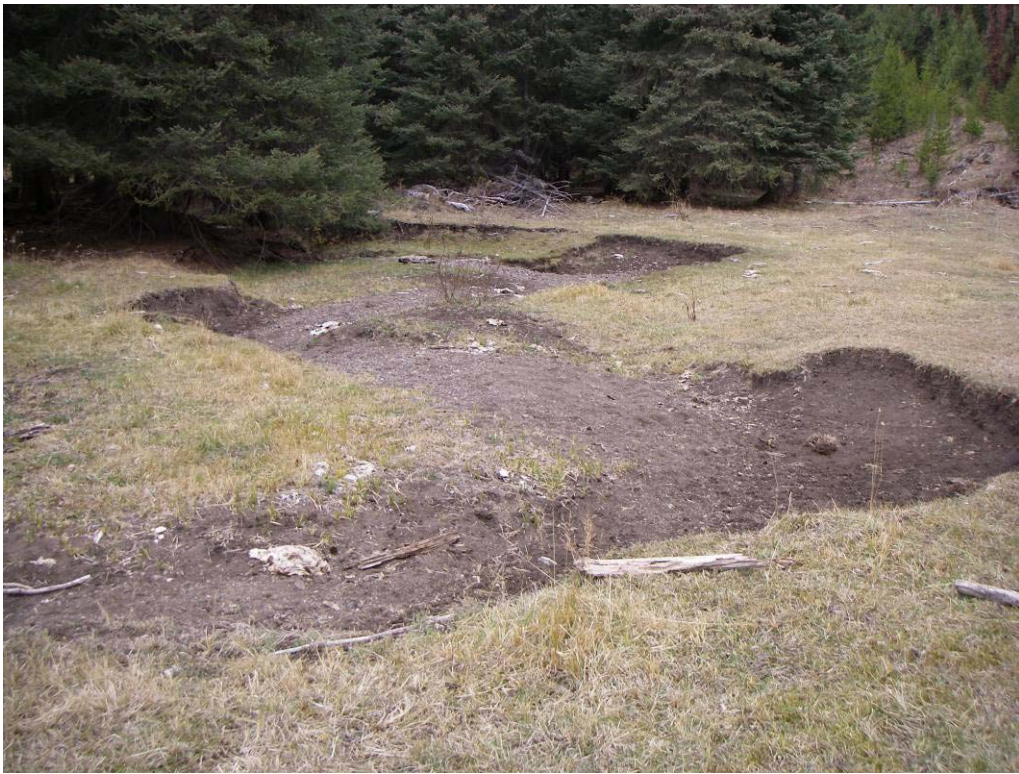
Photo 7. Stream and riparian damage by cattle in Sylvestre Creek sub-basin.

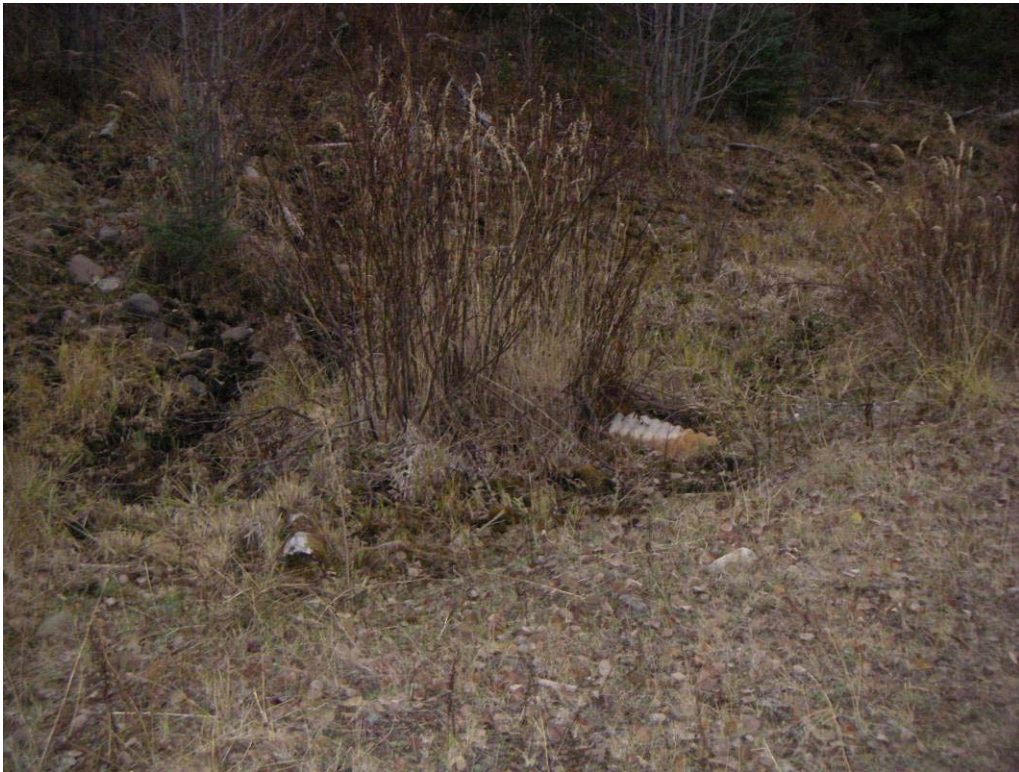
Photo 8. Example of cattle related damage to drainage infrastructure in Tranquille basin. Diversion of flow from this site has scoured an erodable ditchline with input to Tranquille River.

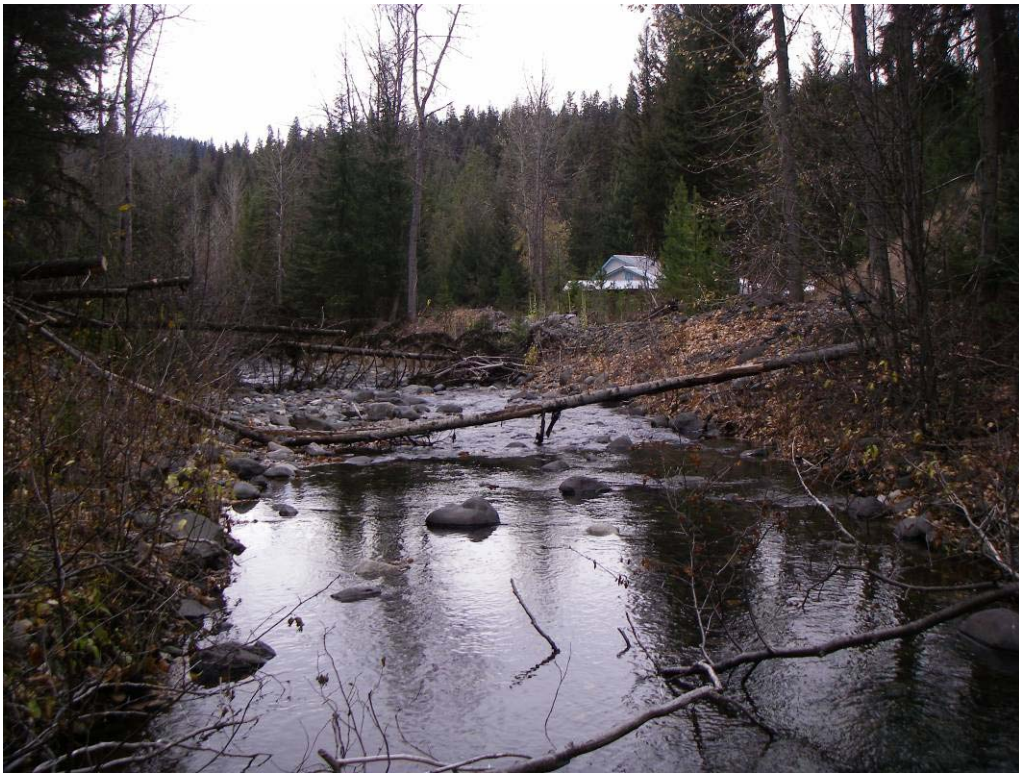
Public safety, private property and public infrastructure on the fan at the upper Red Lake road crossing can be affected by sediment and debris accumulation at the fan apex during high flow periods resulting in channel avulsion [Photos 9, 10]. The private residence on the fan in this location has been undermined at least once necessitating evacuation and significant repairs. Future avulsions could result in loss of life, damage to private property, washout of the Red Lake road, and effects on access.

Photo 9. Private residence on fan upstream of upper Red Lake road crossing on Tranquille mainstem. Sediment and debris input to the canyon above results in accumulations on the fan during high flow periods with avulsion. The house was undermined in the spring of 1990.

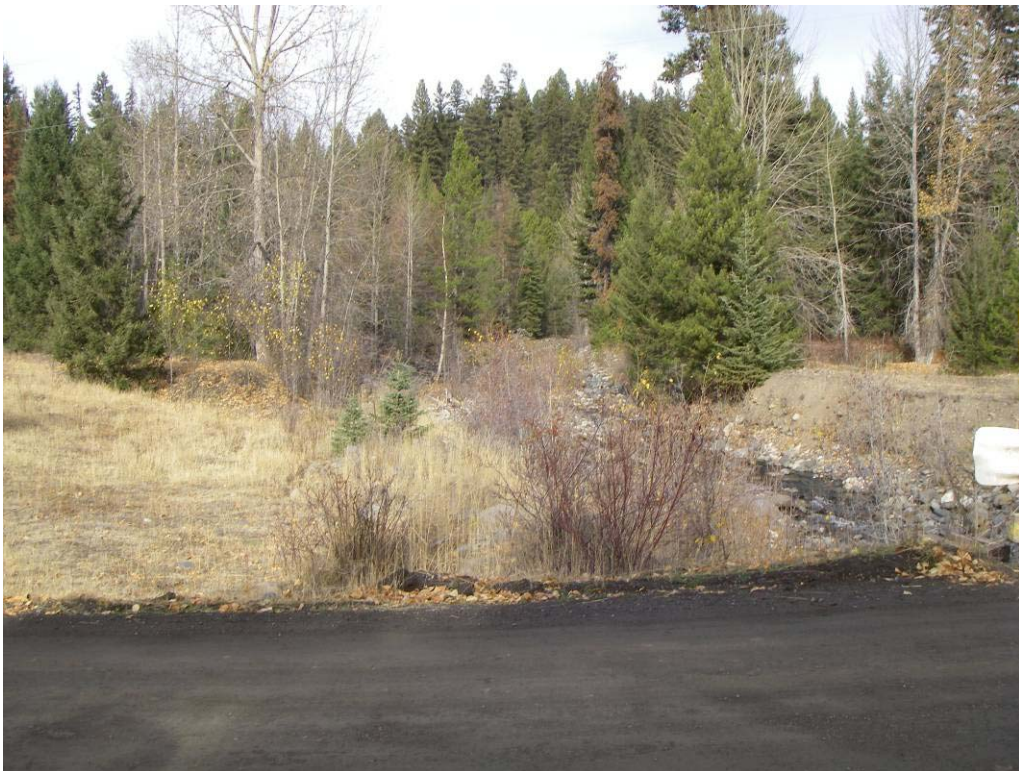
Photo 10. Red Lake road crossing near toe of fan shown in photo above. The structure is undersized and will fail during high flow events that result in sediment and debris accumulation on the upstream side.

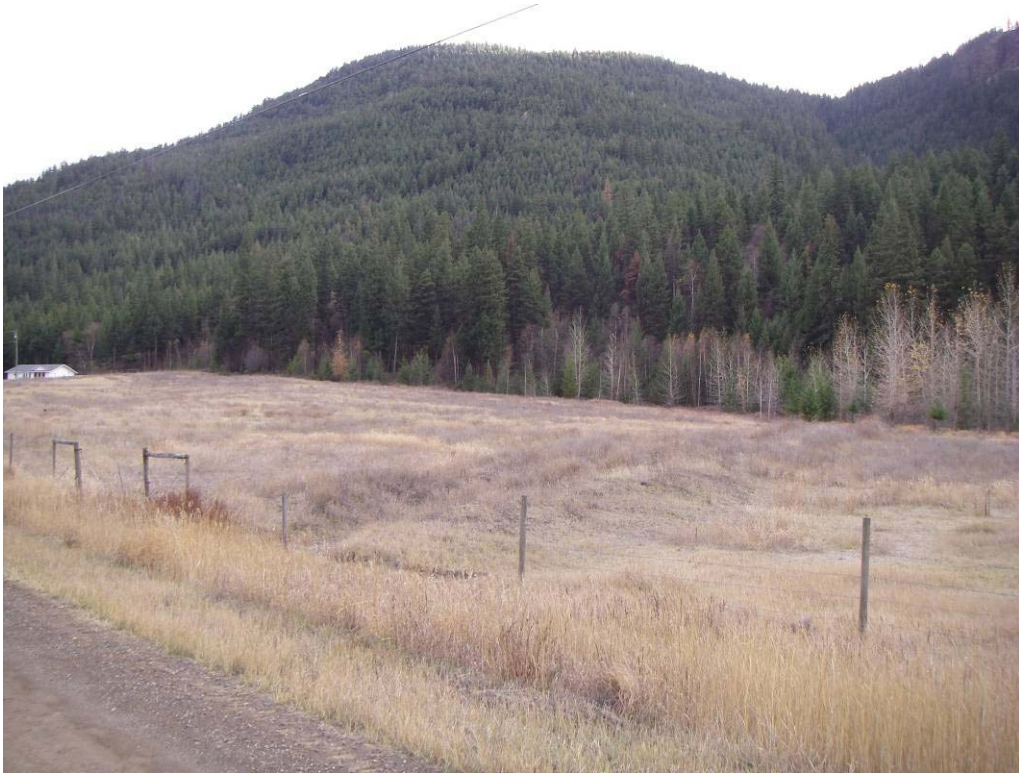
Public safety and private property on the ASD 21 fan can be affected by debris flow or debris flood occurrence during high flow periods that results in channel avulsion and re-direction toward the private residence on this feature [Photo 11, 12]. Loss of life, damage to private property, and effects on access within the sub-division could occur with an event on this system.

Photo 11. ASD 21 fan with residence near apex. Evidence of debris flood activity was noted – an avulsion during such an event could result in loss of life and damage to private property.

Risk to public safety and private property on the ASD 21 fan is high and expected to increase with recent MPB salvage in upstream areas. Risk can be mitigated by minimizing any additional forest development and salvage related effects on runoff in upstream areas and notifying private landowners of the hazards and risk in this location. Preventative measures could be taken to protect the private residence near the apex of the fan, reducing exposure to an event and mitigating risk in this regard.

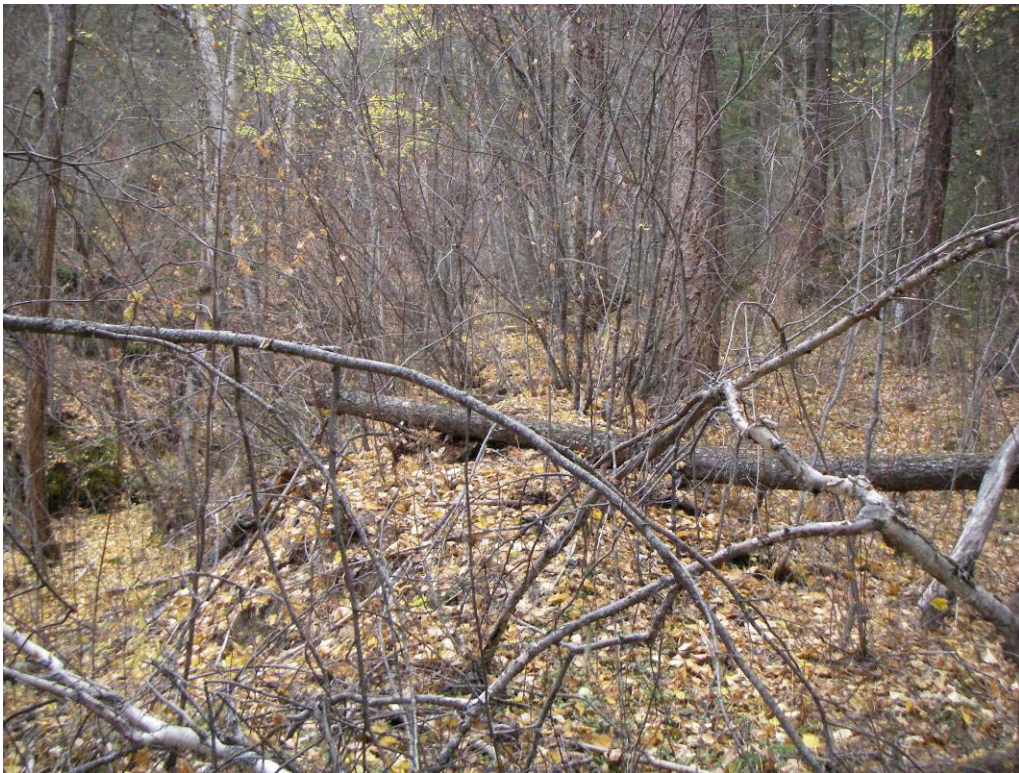
Photo 12. Old debris flood, possibly debris flow deposits on ASD 21 fan upstream of private residence shown above.

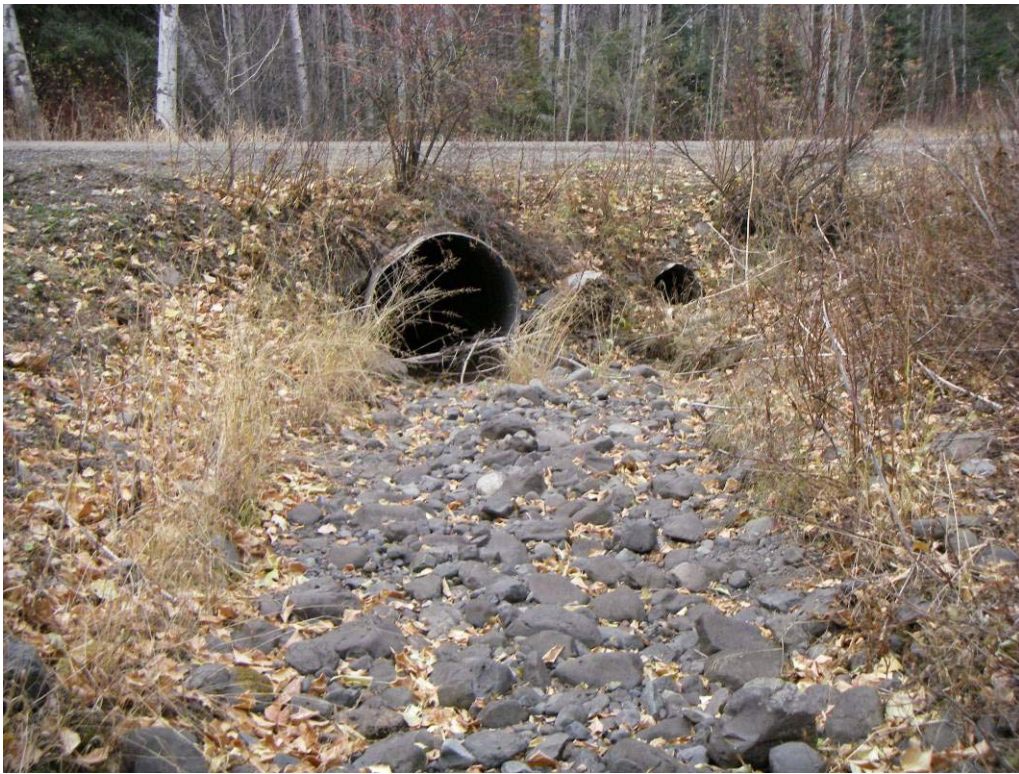
Public safety and infrastructure on the Red Lake road at the Sylvestre Creek crossing can be affected by sediment and debris accumulation at the structure inlet resulting in erosion with sediment input to the channel. The existing culverts are considered undersized with respect to natural fan processes in this area [Photo 13] and the channel is scouring its bed and banks as a result of a suspected increase in streamflow from MPB infestation and salvage throughout the sub-basin. Failure of the structure(s) could result in loss of life, damage to public infrastructure, and effects on access.

Photo 13. Undersized culverts on Red Lake road at Sylvestre Creek crossing. The channel is active on the fan; structures have failed at least once already causing diversion down the ditchline with flow over the road. This site was identified as a problem by Summit in 2003.

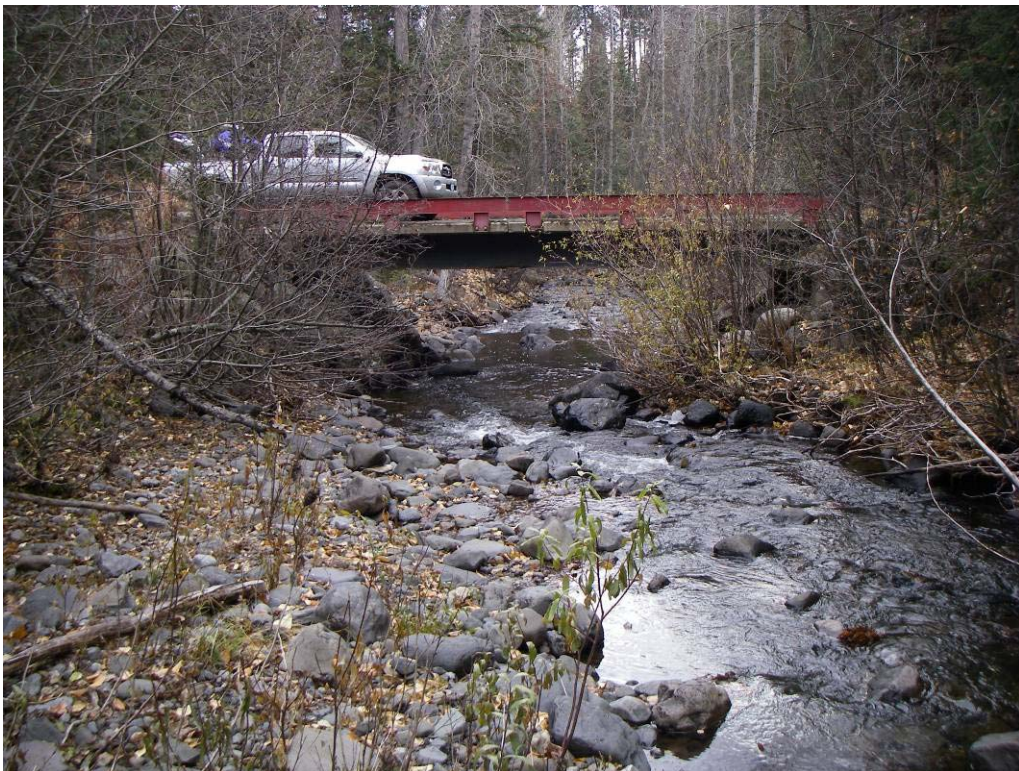
Photo 14. Road 4020.05 crossing on upper Tranquille River floodplain. The floodplain is constricted by up to 50% by the structure in this location. High flows that mobilize upstream sediment and debris may cause failure in this location.

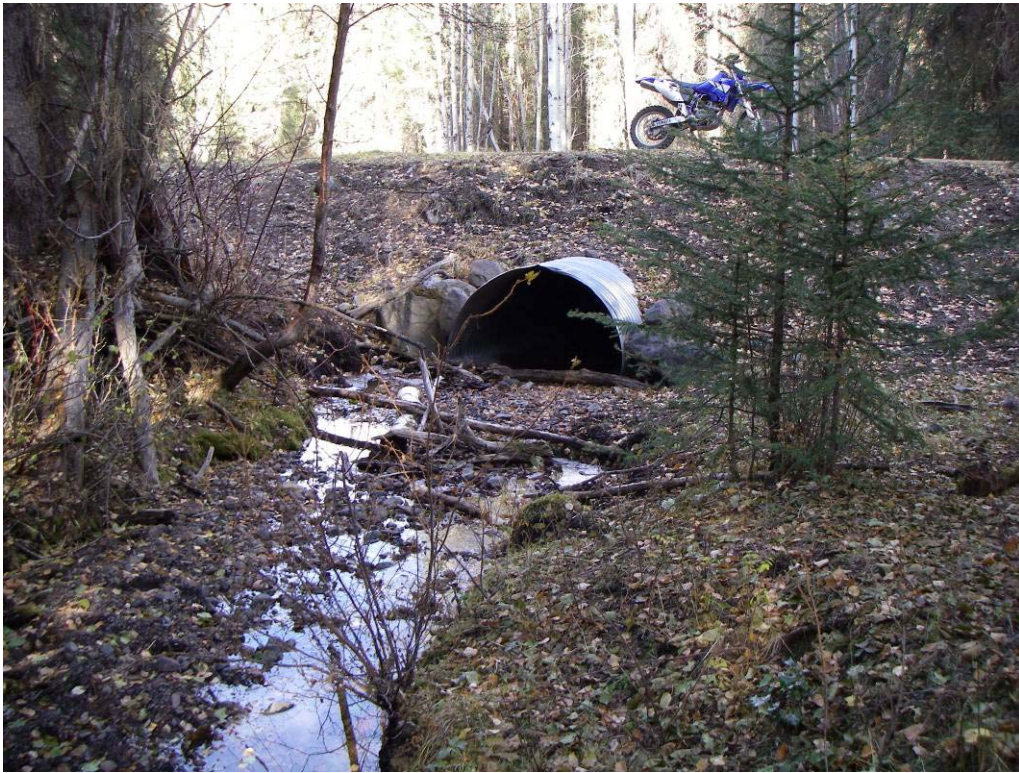
Photo 15. Mobile sediment and debris accumulation at road 4030.25 crossing on alluvial fan.

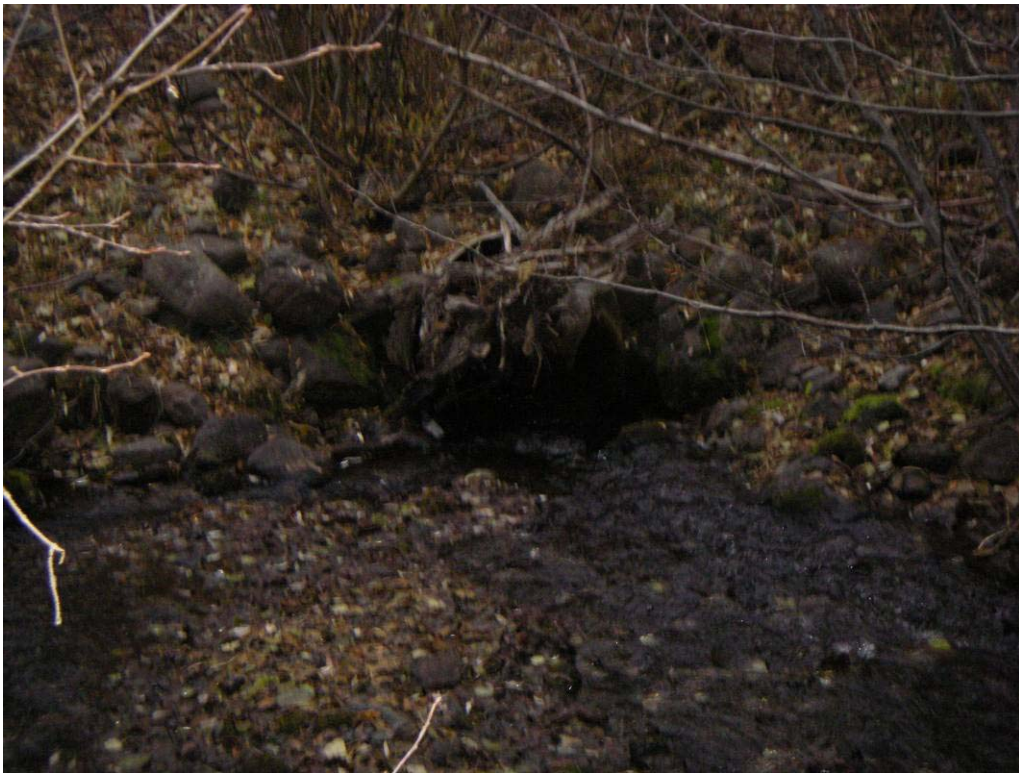
Photo 16. Mobile debris (log with rootball) at inlet of structure on Saul Creek at road K1100.35. Flows were overtopping the road in this location, resulting in diversion onto steep coupled slopes and erosion with input to Tranquille River.

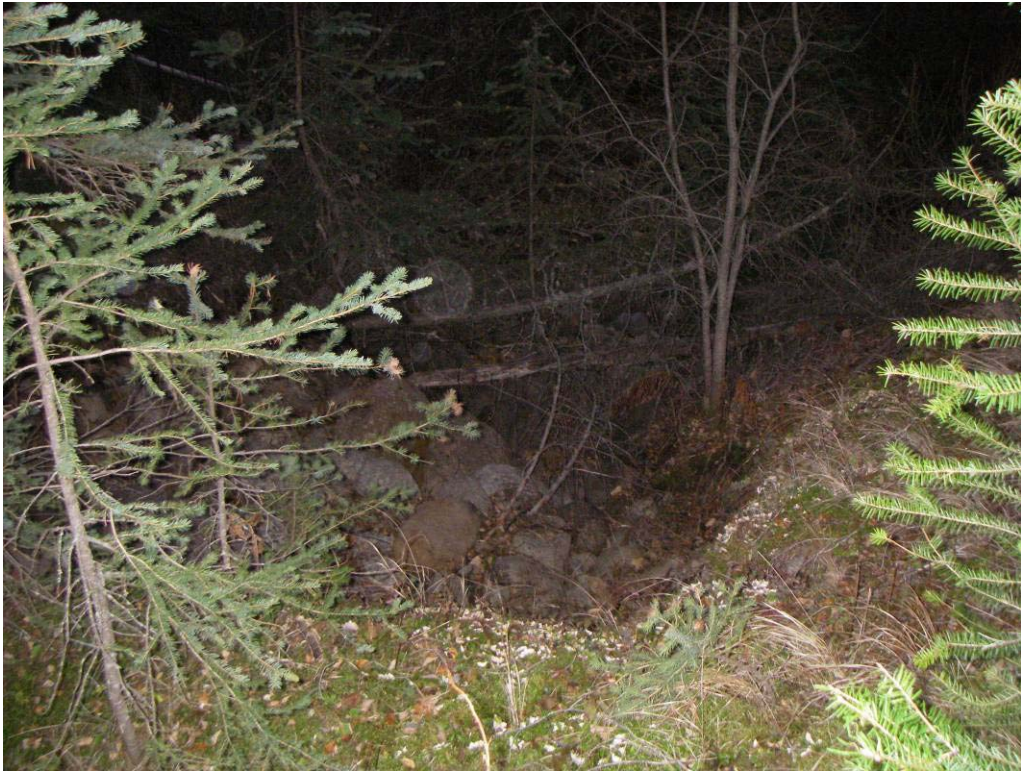
Photo 17. Erosion on steep coupled slope downstream of culvert shown above. The site is connected to Tranquille River.
