Watershed Risk Assessment

Harris Creek

**M.J. Milne & Associates Ltd.
2603 23rd Street
Vernon, BC
V1T 4J7**

March 5, 2010

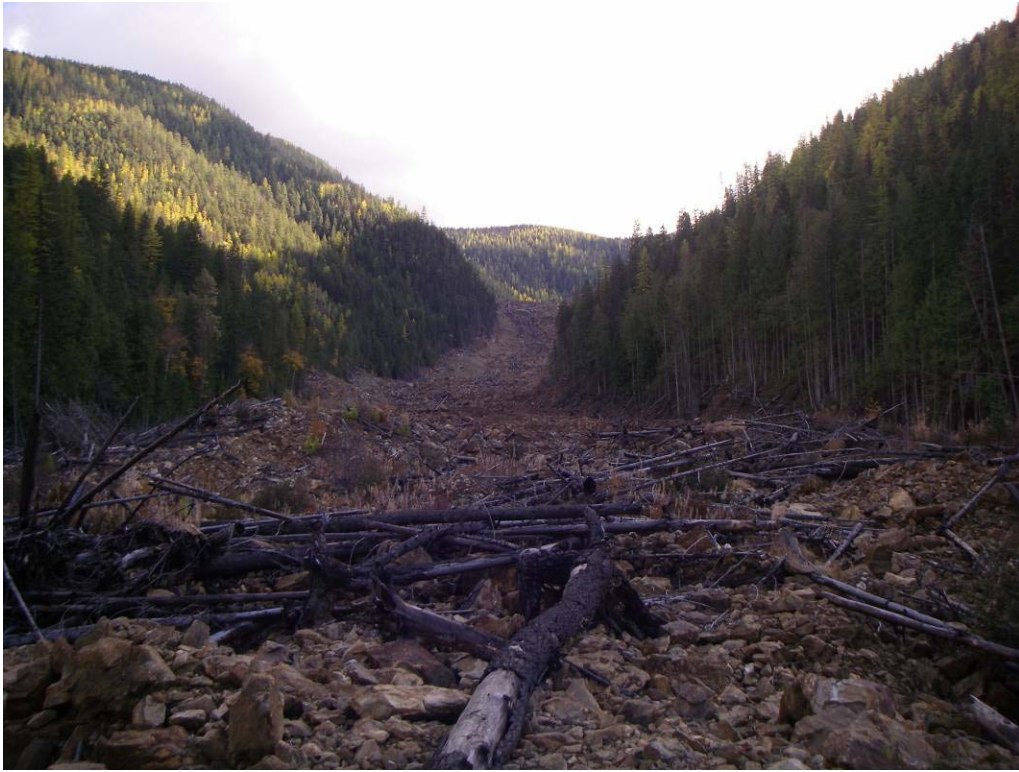
Sediment input to McAuley Creek from one of the largest natural landslides recorded in the BC Southern Interior is negligible at this time. The event involved approximately 20 ha of steep hillslope in the mid-basin area that failed into the mainstem and continued as a debris flow for approximately 1 km. Deposits are very coarse in texture – sediment production is negligible and not expected to worsen over time [*Photo 1 – Appendix D*].

Photo 1. Large natural landslide and debris flow deposit in McAuley basin. Sediment input to McAuley Creek may have been significant at the time of occurrence but ongoing sediment production is negligible.

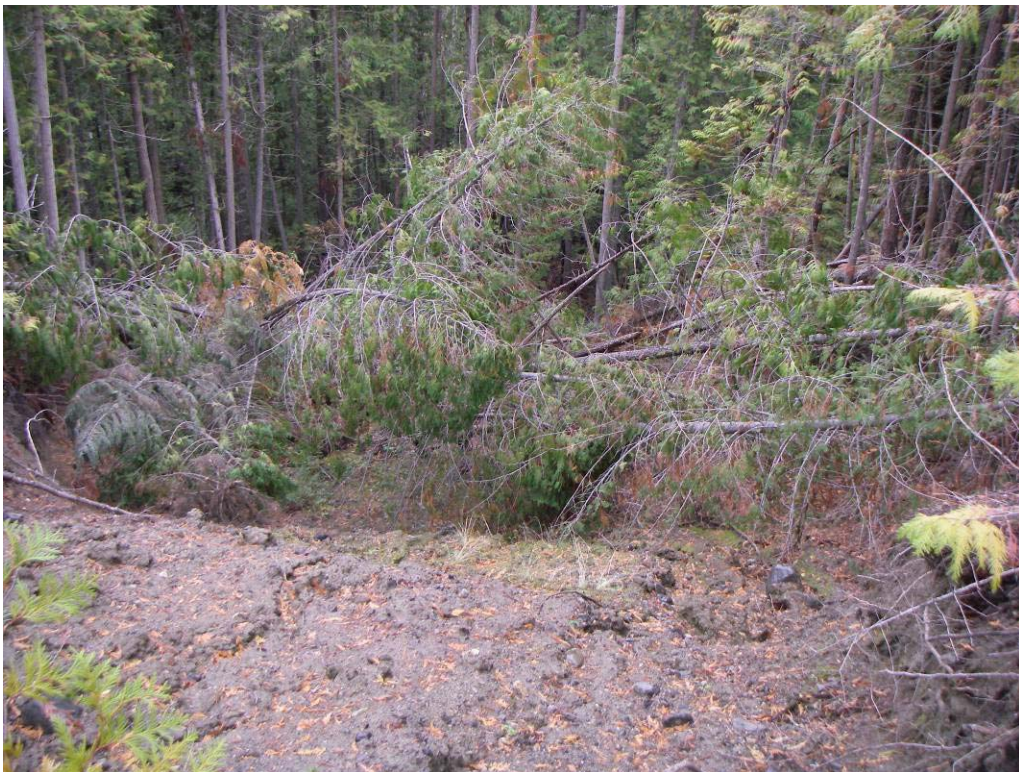
Photo 2. Recent landslide off of Harris Southwest non-status road from culvert discharge on Dustin Road above.

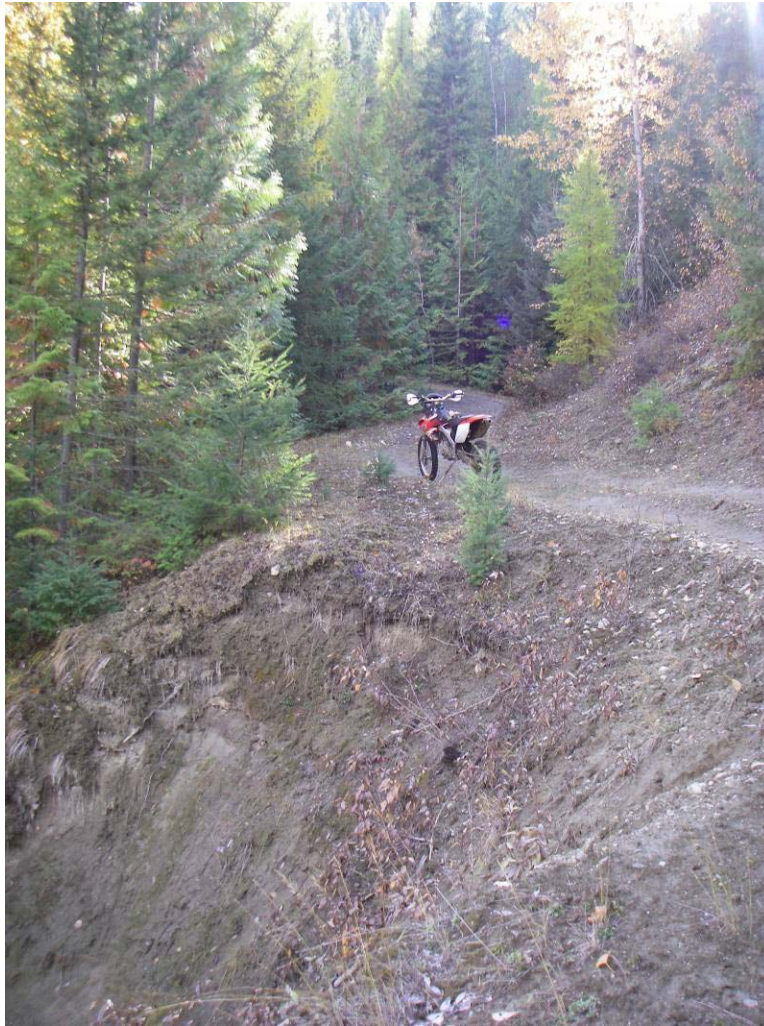
Photo 3. One of several landslides into Harris Creek or tributaries from non-status roads built in or on glacio-fluvial and glacio-lacustrine terraces in the residual area. In this case South Harris non-status road. Drainage infrastructure is failing resulting in diversions into unconditioned areas connected to channels. In other areas oversteepened or supported fill is failing resulting in landslides into channels and onto the Harris Creek floodplain.

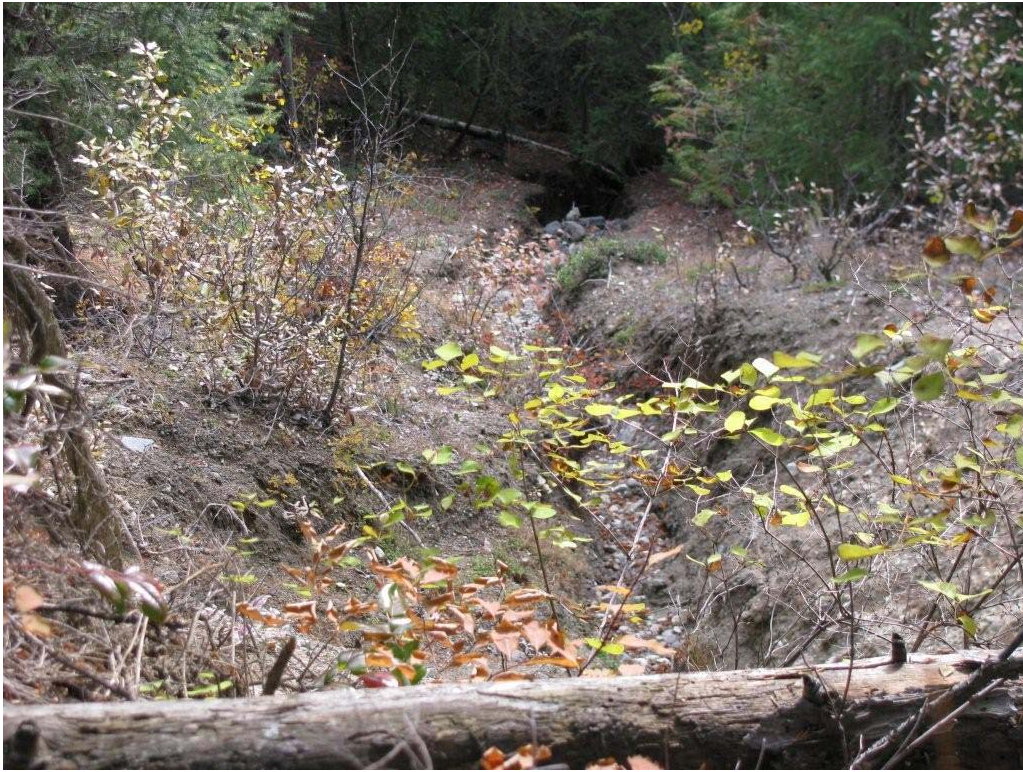
Photo 4. Erosion in glacio-fluvial terrace materials below culverts on Jeffery and South Jeffery Roads. Drainage is diverted and concentrated on these sites from roads leading down to or built on the terrace.

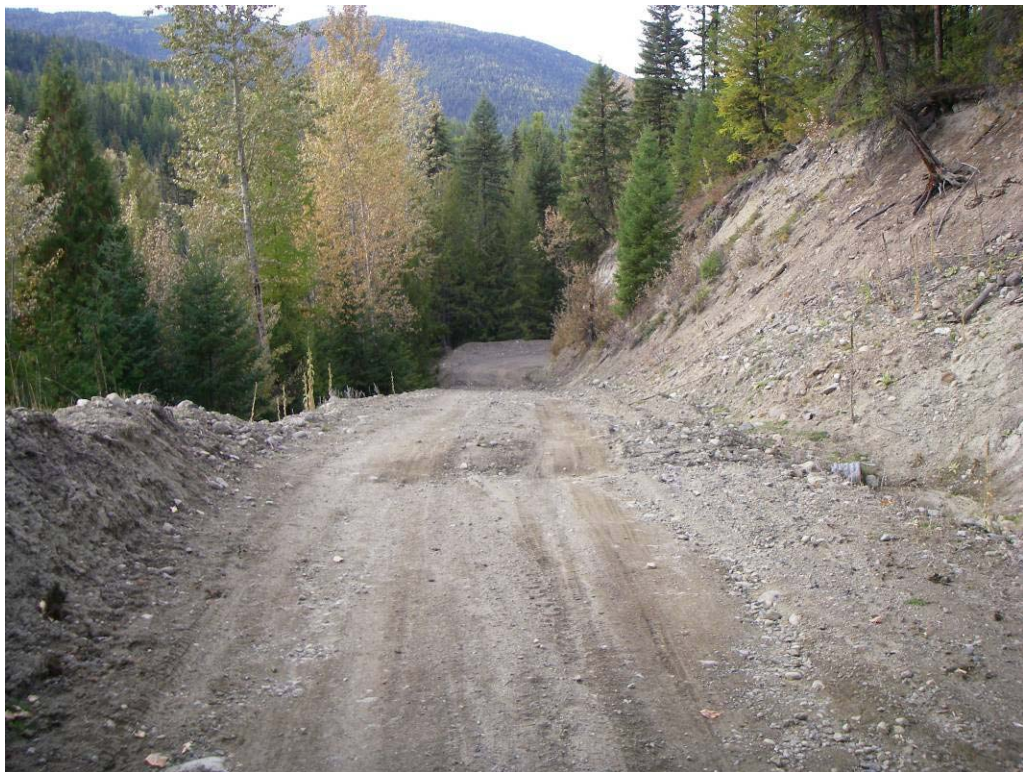
Photo 5. Section of the Jeffery and South Jeffery roads showing fine textured glacio-fluvial deposits, erosion, and headscarp of slide at left. Maintenance of infrastructure is very difficult in this material type without significant armour or bioengineering application. Alternate locations are preferred with restoration of natural drainage on and above and re-contouring.

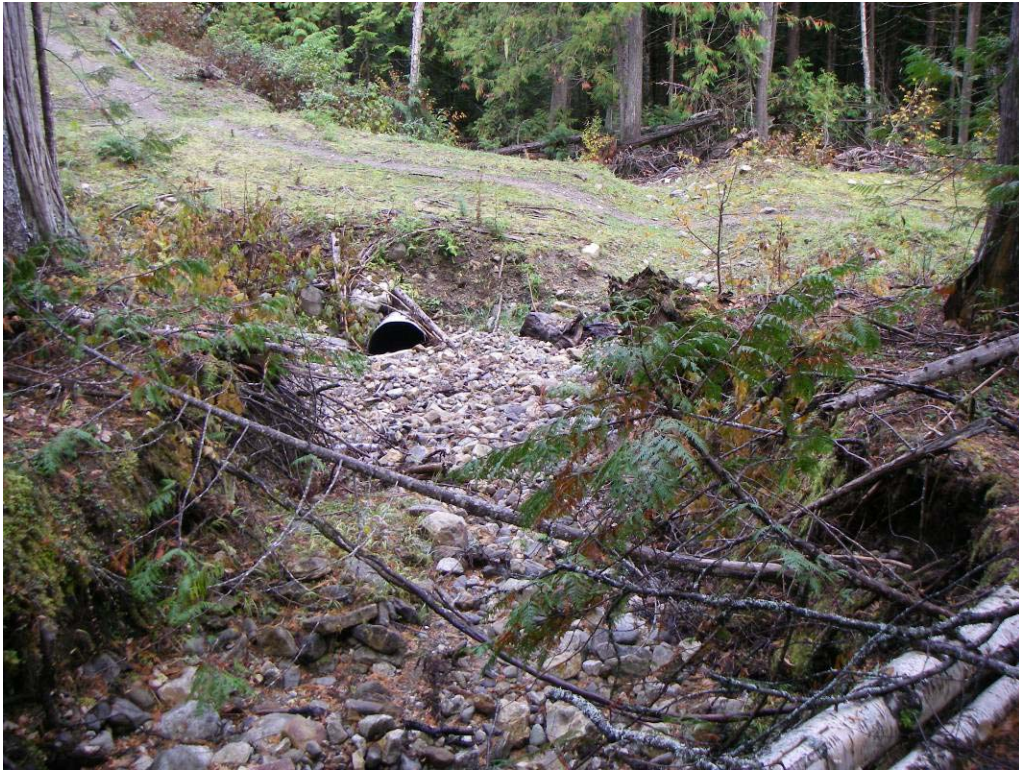
Photo 6. Scoured fan channel and infilled culvert on Dustin F road. The structure is backed up with a water bar but not armoured. The road prism will washout when the structure fails and flow may escape down the road to the southwest. Downstream of the crossing the stream has diverted down the Harris Southwest non-status road resulting in significant scour and sediment input to Harris Creek. Situation typical of road crossings on fan.

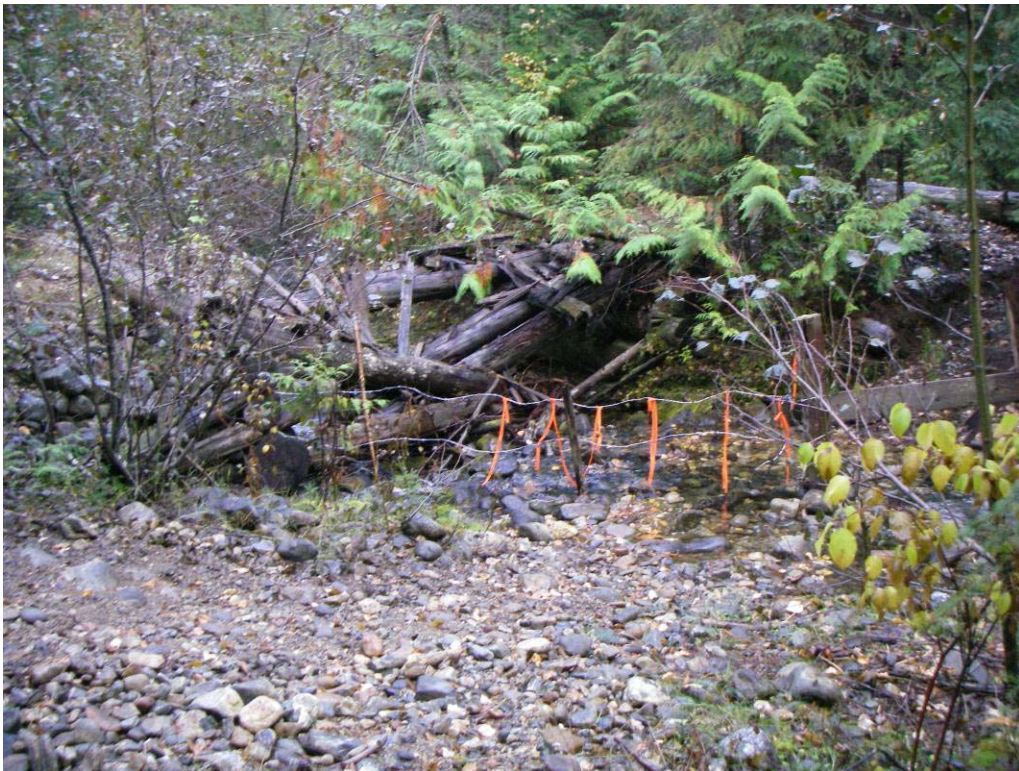
Photo 7. Failed Denis non-status road crossing on McAuley Creek floodplain. Approaches are built from alluvial material, are restricting floodplain processes, and will continue to erode over time with input to the channel.

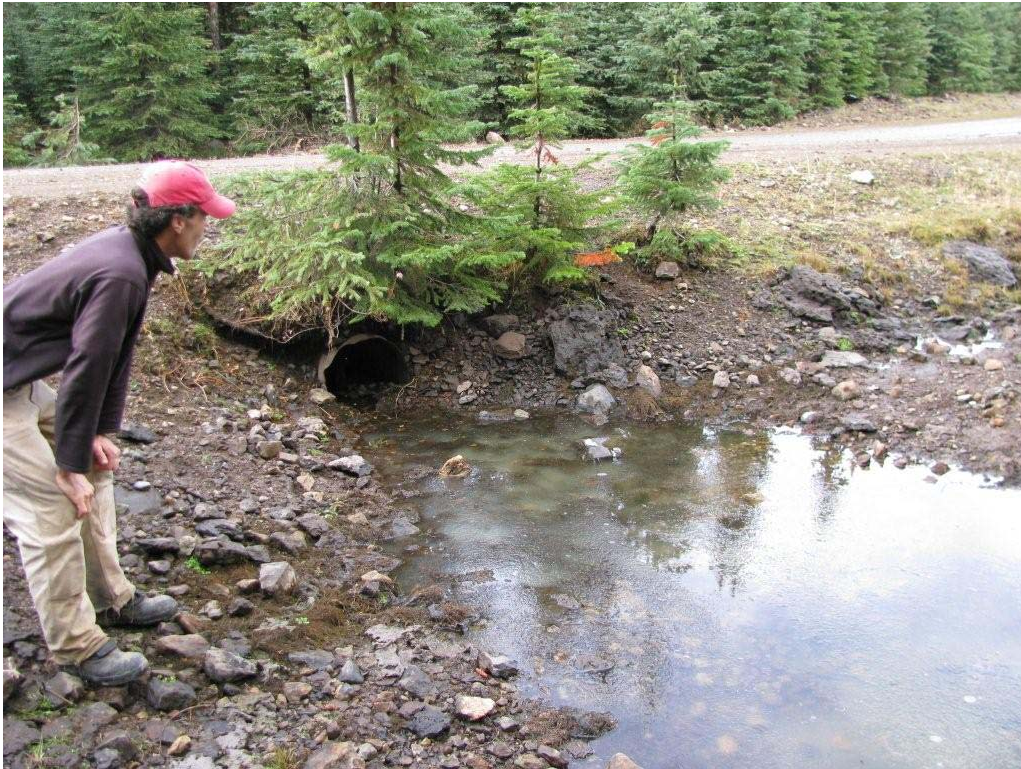
channel (known as site H10). The culvert was crushed in that location resulting in flow over the road and down the ditchline. As of October 2009 no work had been done by either Tolko or BCTS at any of the culvert replacement or maintenance related priority sites.

Photo 8. Blocked culvert at Home FSR crossing on Home Creek. Flow is diverted down the ditch from this site and into the Mosquito basin where increased discharge is scouring channels, increasing sedimentation levels, and stressing downstream road infrastructure.

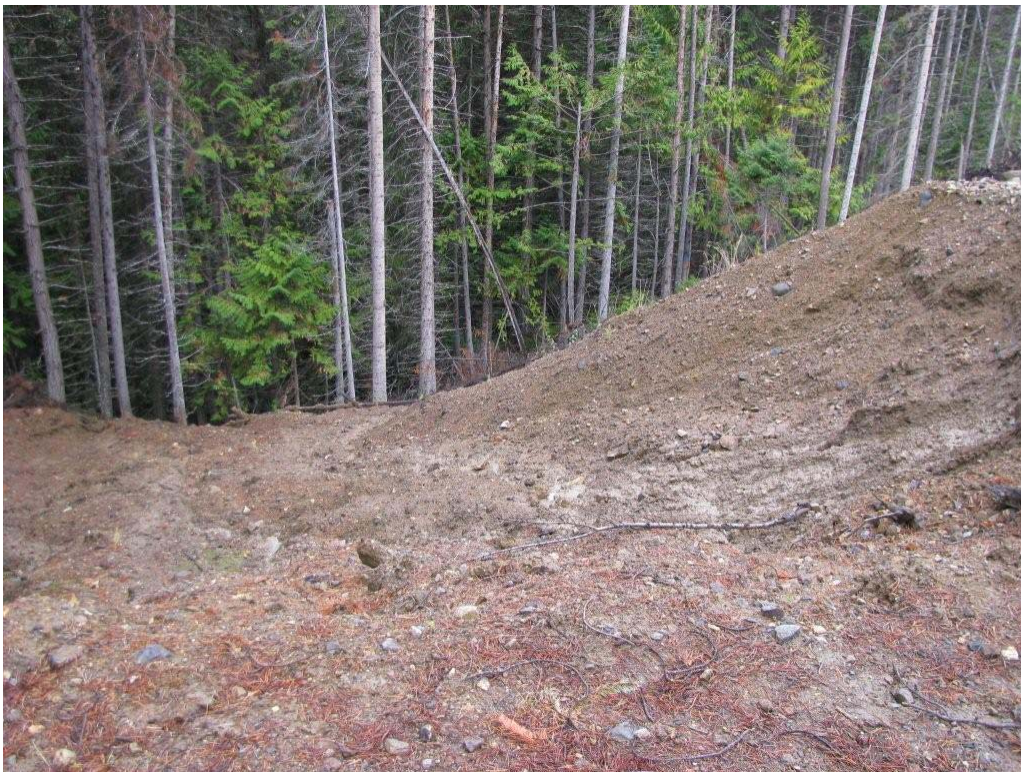
Photo 9. Recent slump off of upper switchback on Dustin Road above West Harris Creek. Cutslopes and drainage infrastructure are failing in this area resulting in drainage diversion onto Class IV terrain.

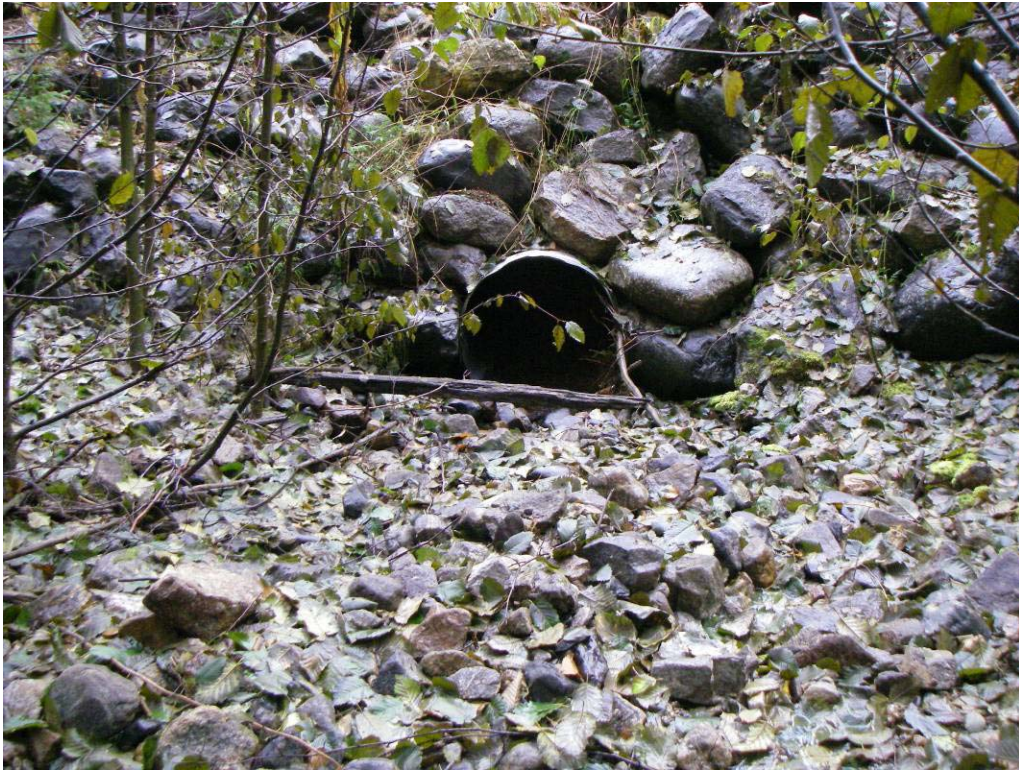
Photo 10. Brendan Road crossing on large S6 channel in residual with mobile sediment and debris. Culverts on channels like this are prone to failure as a result of sediment and debris accumulations at the inlet. Oversized culverts or open bottom structures are more appropriate in these cases.

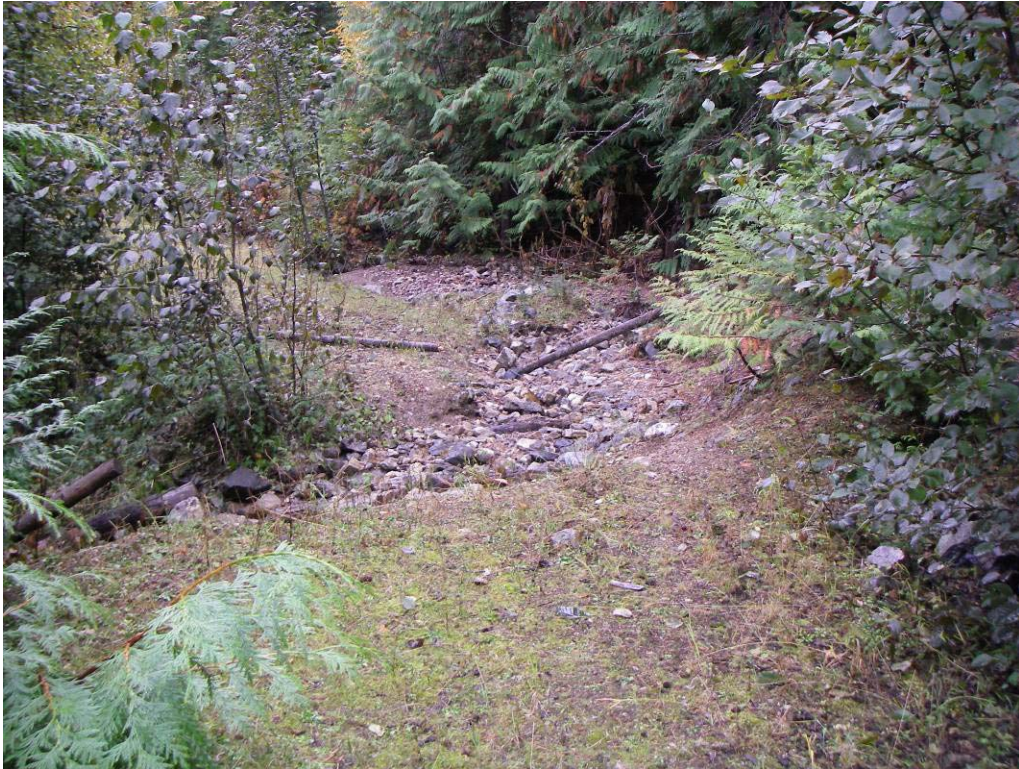
Photo 11. Failed culvert at Upper Amy non-status road crossing on tributary in residual. Flow is moving through waterbar but diversion down the road is likely with ongoing erosion and both range and recreational use.

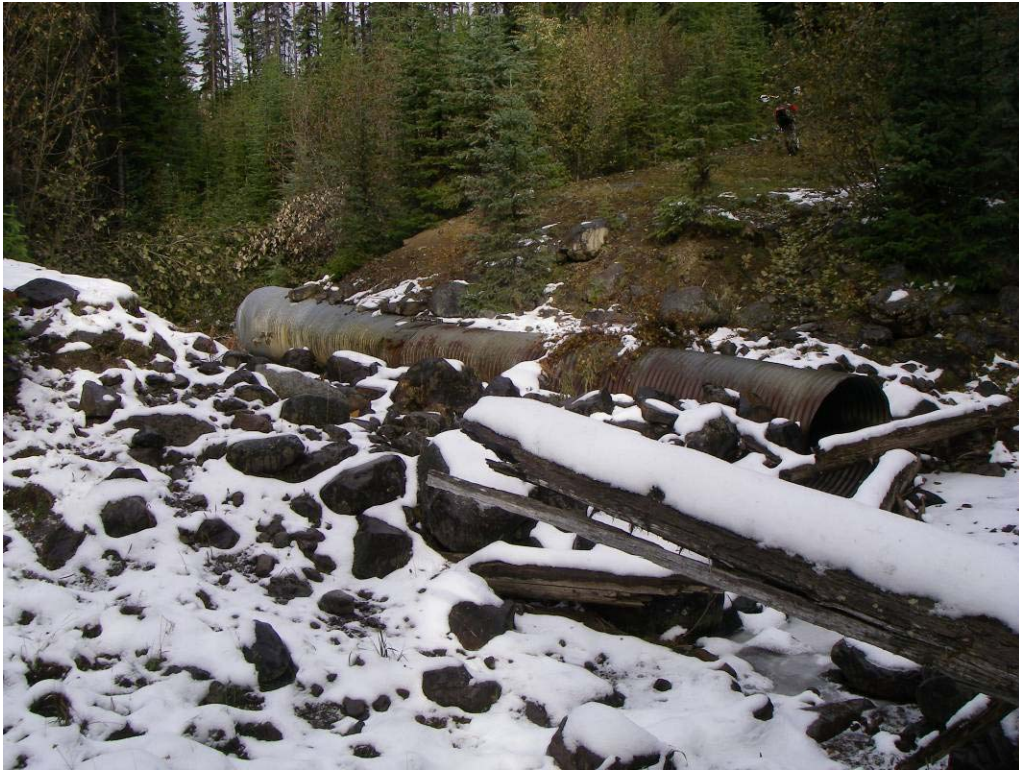
The H100 structure was ineligible for replacement using Forest Investment Account (FIA) funds based on road status, but issues could have been addressed using FIA eligible permanent deactivation methods. One other maintenance related issue was noted at the Home Creek FSR crossing on a non-fish bearing portion of the Home Creek mainstem

Photo 12. Washed out H100 non-status road crossing on Upper Harris tributary. The site is a source of sediment to fish bearing waters, a barrier to fish passage, and eligible for deactivation using FIA funds.

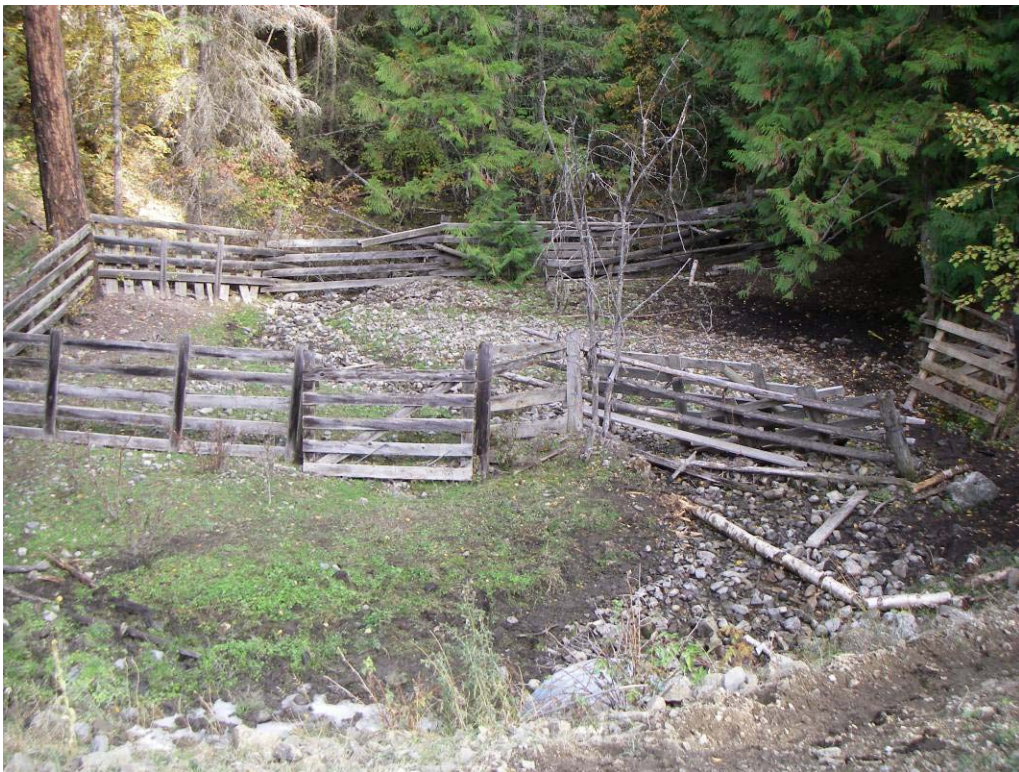
Photo 13. Old or abandoned corral situated on Vidler Creek upstream of resident and anadromous fish and fish habitat. Evidence of recent cattle access to the channel.
