**Fish Passage Culvert Assessments: South West Vancouver Island, B.C.  
Completed in TSA 38 of the Alberni Watershed Group, South Island Forest District**

**Investment Schedule:** COTSA386811

**Project Number:** 6811001

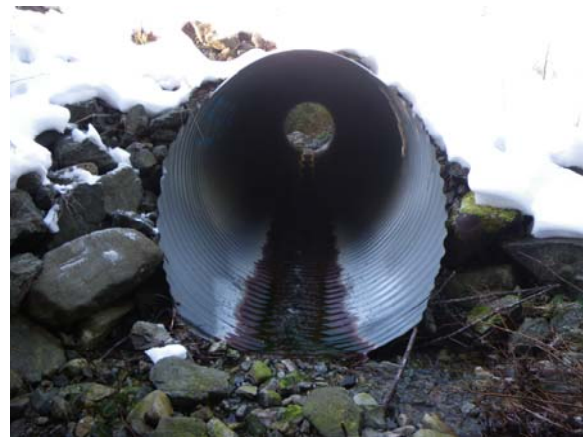
**Photo 1.** View of 2140 mm CSP at crossing 1335 in the Toquart River Watershed, January 2009.

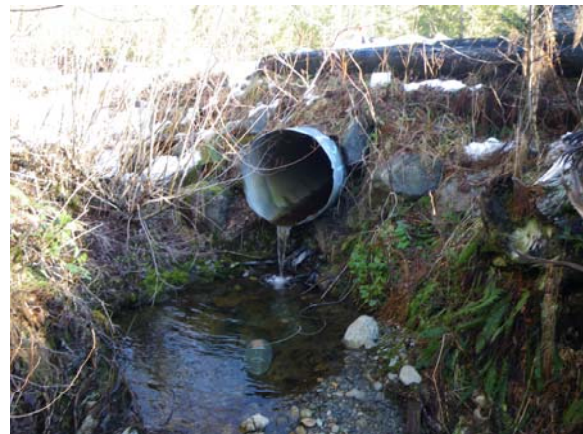
**Photo 2.** View of the hanging 1000 mm culvert at crossing 2557 in the Toquart River Watershed, February 2009.
