Gitanyow Fisheries Authority

**Kitwanga River South
Fish Passage-Culvert Inspection &
Water Quality Effectiveness Evaluation Project 2007**

**Kitwanga Mills Limited
Kitwanga, BC**

February 5, 2008

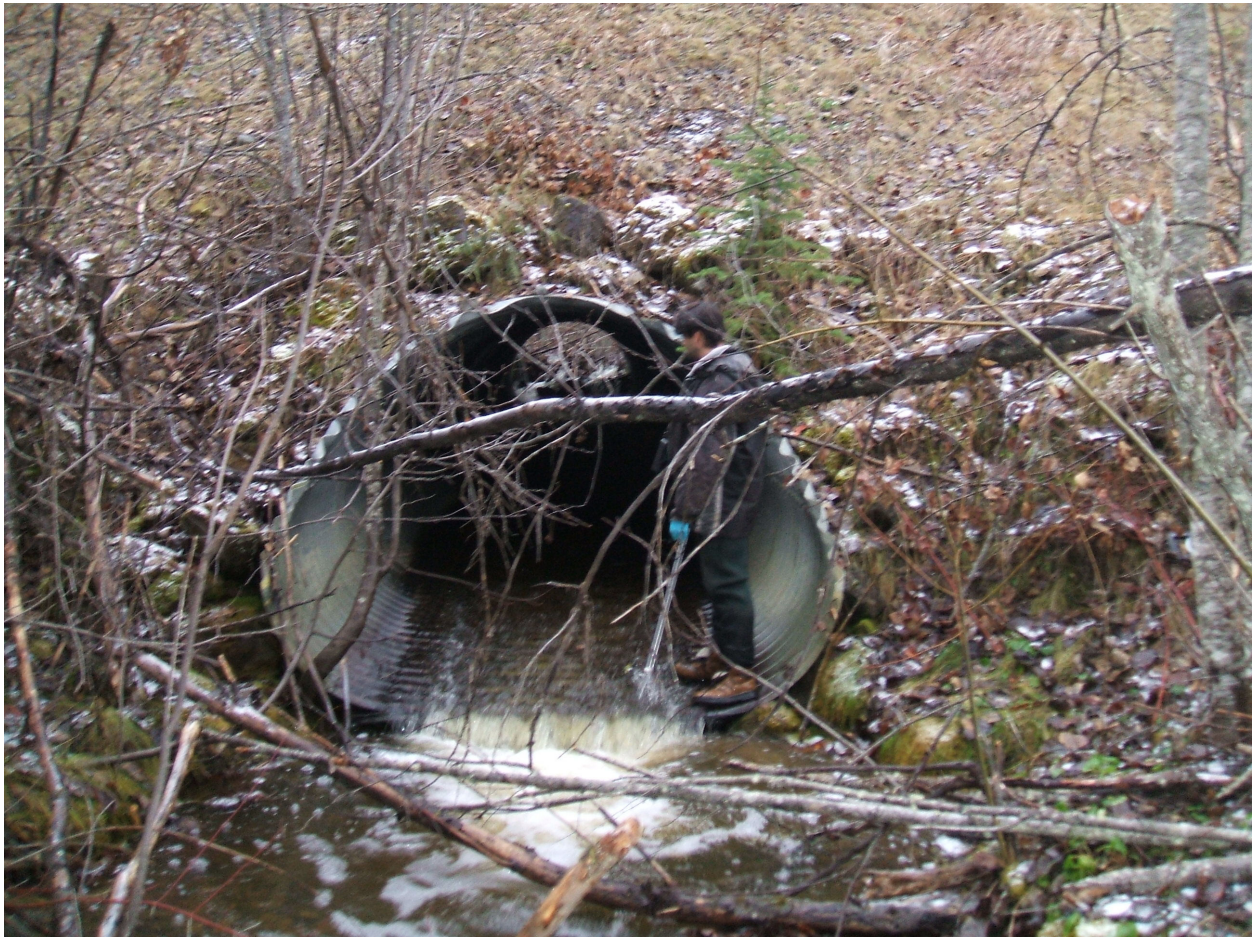
Site 346 was classified as a partial barrier and ranked as a high priority crossing (FPCI Score = 42). The unnamed FSR crosses the mainstem of trib 14 approximately 20 m upstream from the highway 37 crossing. No fish sampling was conducted during this survey but Johnston and Saimoto (2002) captured bull, rainbow and cutthroat trout at the highway 37N crossing below the site, therefore it is highly recommended that site 346 be re-sampled to confirm the presence or absence of fish (Photo 1).

Photo 1: Site 346 - Looking upstream at culvert outlet.

This round metal culvert was considered a partial barrier for several reasons. First, velocity was measured at 1.57 m/s at relatively low flows (5 cm culvert water depth compared to 23 cm high water mark in culvert). Therefore, at low flows the velocity is too high for juvenile salmonids, and at high flows it may be too high for adults (Parker 2000). Second, the culvert gradient was measured at 5% which, for a culvert of this length (23.5 m), Parker (2000) states gradients should not be higher than 0.5%. Finally, the existing culvert diameter was 1400mm and the

Q100 culvert diameter was calculated to be 1970mm for a round culvert, therefore this culvert is undersized. The Q100 for an elliptical culvert was calculated at 2440 by 1750mm.

From 1:20,000 TRIM data, it is estimated that 4.7 km of habitat would be made available upstream if this culvert were replaced, before gradients became too steep for fish passage. A more detailed fish habitat assessment, along with fish sampling, is recommended for this stream.

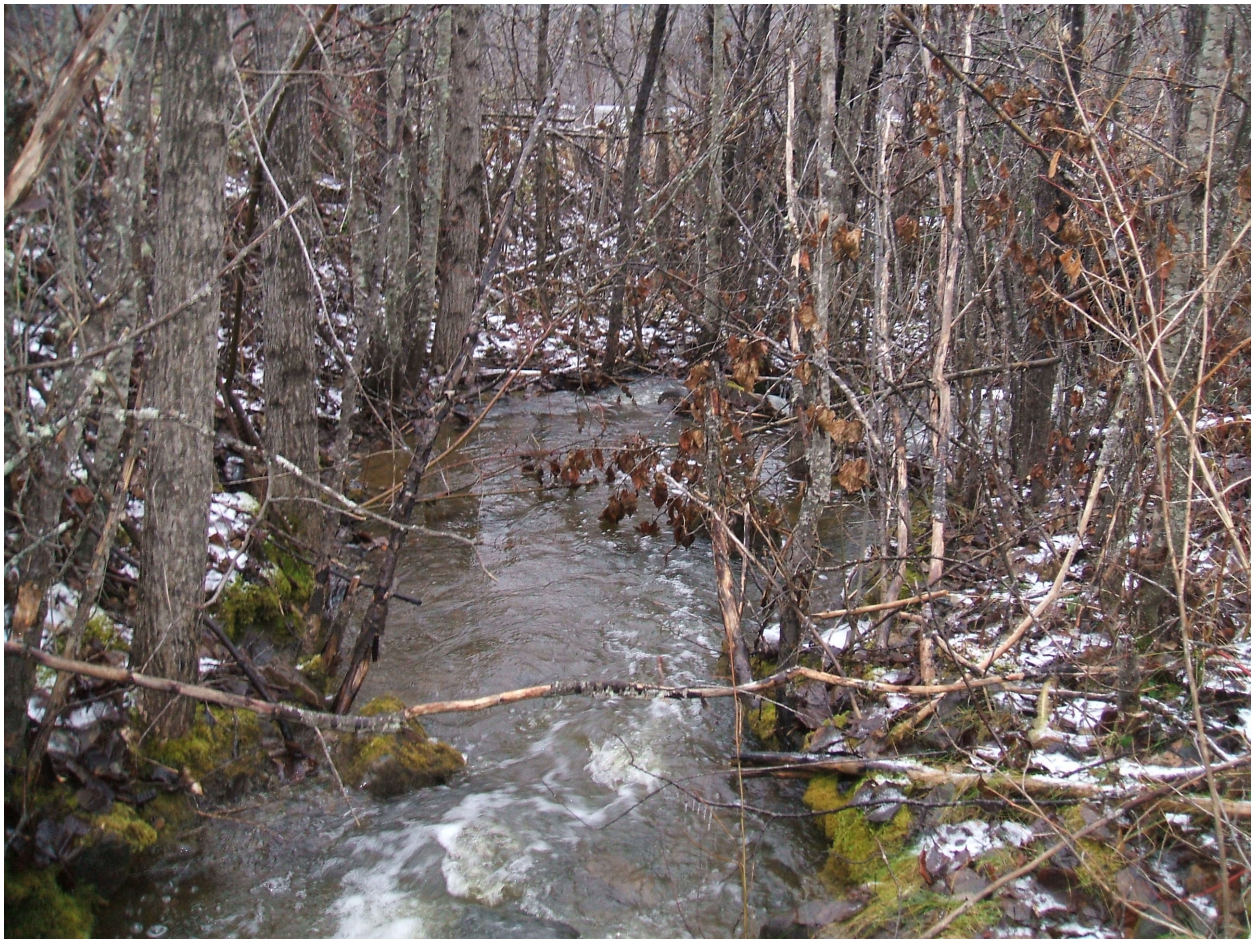
The stream habitat downstream of the culvert was considered moderate for rearing and spawning, with riffle-pool morphology and a gradient of 5% (Photo 2). The average wetted and bankfull widths were 1.4 m and 2.6 m respectively (average of upstream and downstream measurements). Biolith (1998) described the stream as seasonal, however with a bankfull width of 2.6 m measured at site 346, this stream clearly has substantial flow for a portion of the year, and could provide valuable fish habitat during that time. As well, Biolith (1998) described habitat in reach 2, which extends up to 6.1 km upstream of the confluence with the Kitwanga River, as providing potential spawning habitat, with gravel and cobbles and cover provided by LWD, SWD and undercut banks. As well, Biolith (1998) found no barriers in the lower reaches of this stream.

Photo 2: Site 346 - Looking downstream at riffle-pool/glide habitat.

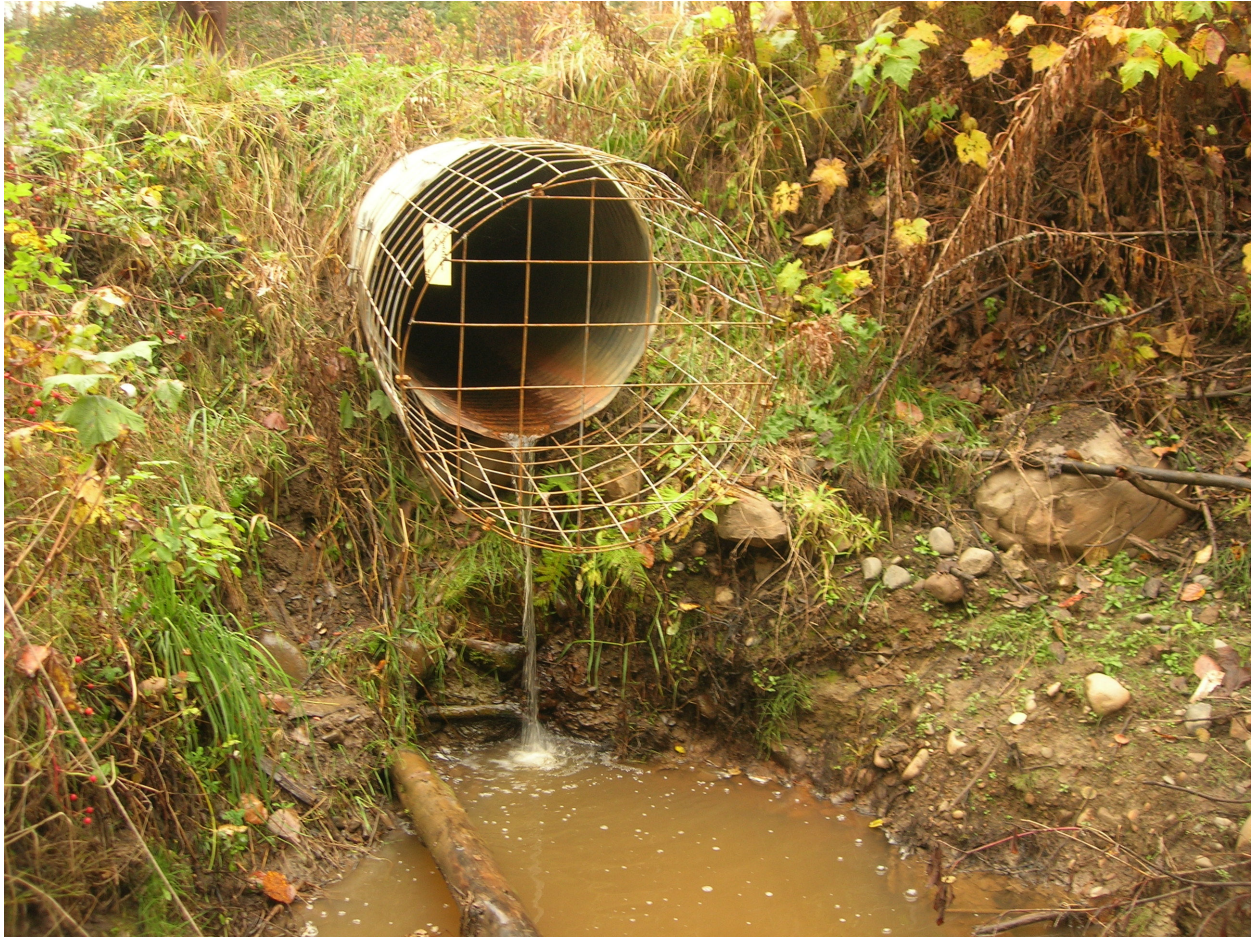
Site 270 was classified as a full barrier and ranked as a moderate priority crossing (FPCI Score = 42; Photo 3). The Tea Lake FSR crosses a tributary to Tea Creek approximately 200 m upstream from the confluence of Tea Creek, and 3 kilometers upstream of the Tea Creek/Kitwanga River confluence. No fish were caught with gee trapping at this site, however it connects directly to Tea Creek with no permanent barriers. Tea Creek is known to support coho and chinook salmon, and cutthroat and rainbow trout (Biolith 1998). There is a non-permanent barrier ~50 m downstream of the culvert caused by small woody debris that could be removed (Photo 4).

This round metal culvert was considered a full barrier for several reasons. First, it has a culvert outfall drop of 96 cm and a plunge pool of only 80 cm depth. This culvert drop is higher than the maximum jump heights for juveniles listed in Parker (2000) of 0.5 m (coho and chinook) and 0.6 (cutthroat and rainbow trout). Second, the culvert gradient is steep at 3.5% for its length of 12.1 m. Parker (2000) recommends slopes no greater than 1% for culverts less than 24 m in length. The water velocity at the time of survey was only 0.16 m/s however the water depth in the culvert was only 2 cm. The measured high water mark was 15 cm inside the culvert, therefore velocities would be much greater at peak water levels. Third, the Q100 culvert diameter was calculated to be 1600 mm for a round culvert, compared to 900 mm of the existing culvert, therefore this culvert is undersized. The Q100 for an elliptical culvert was calculated at 2130 by 1400 mm. In addition, in the event the upstream beaver dam dislodges, the existing culvert would not handle the flow, and a large-scale sediment transfer to Tea Creek would be expected. Finally, the beaver stop would block access to adult fish.

Photo 3: Site 270 - Looking upstream at culvert. Large culvert outfall drop evident, as well as beaver stop that would prevent adult fish passage. Turbid water from exposed banks visible.

The extent of fish habitat upstream of the culvert was not assessed beyond the beaver dam complex during this project. Stream length gained by removing the culvert barrier was estimated at 700 m from 1:20,000 TRIM data. The stream should be assessed upstream of the culvert to verify the length and quality of upstream habitat. As well, fish sampling throughout the beaver dam complex and upstream is recommended.

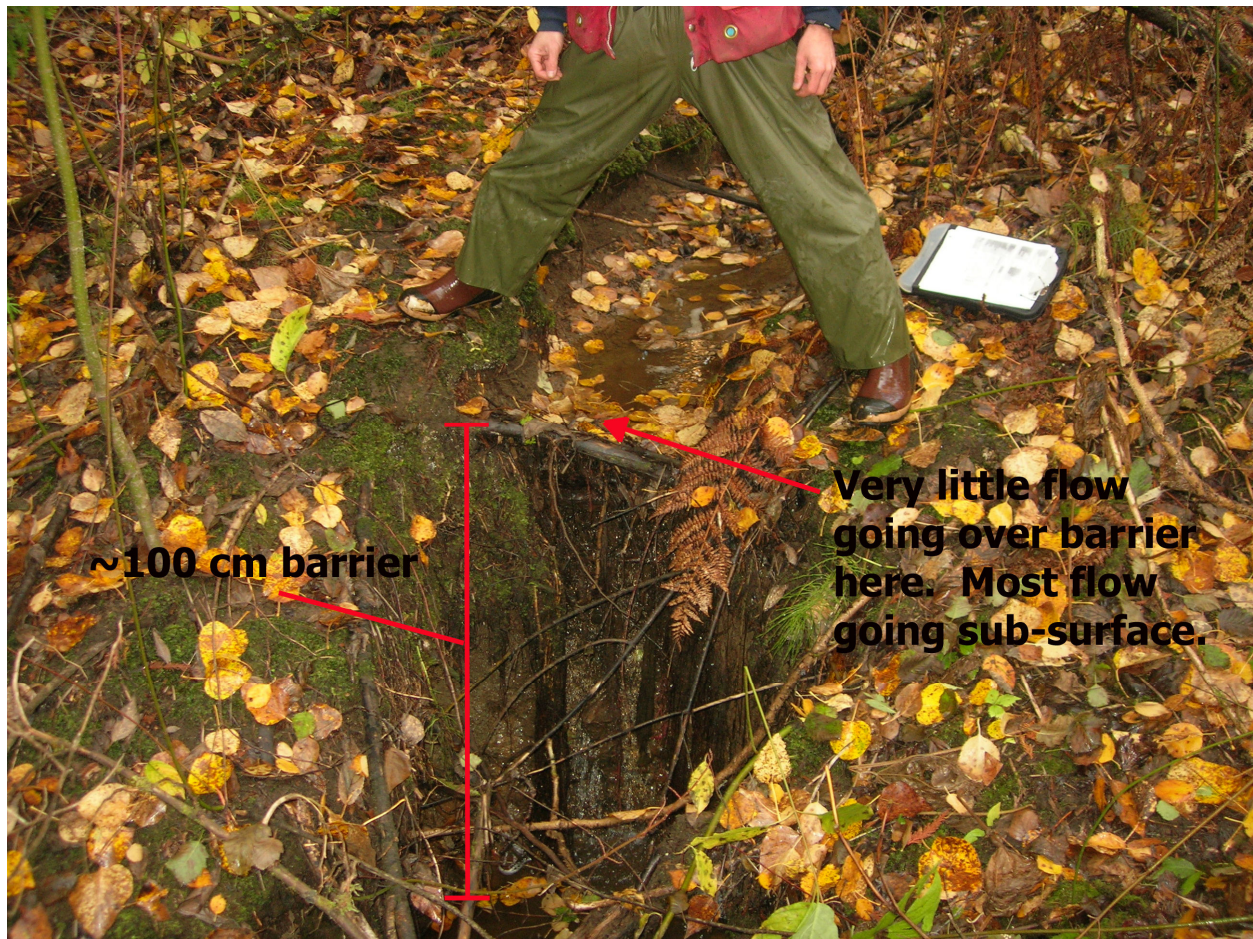
Photo 4: Looking upstream at non-permanent barrier to upstream migration, ~ 50m downstream of site 270 culvert. Note small amount of flow going over barrier at time of survey.

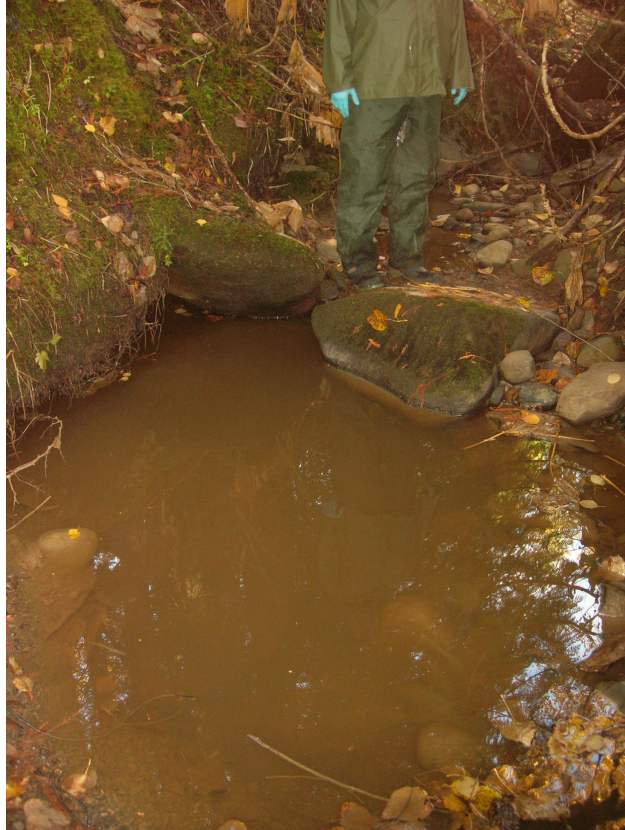
Photo 5: Looking upstream at pool ~75m downstream of site 270 culvert. Low flow conditions and high amounts of suspended sediment evident.

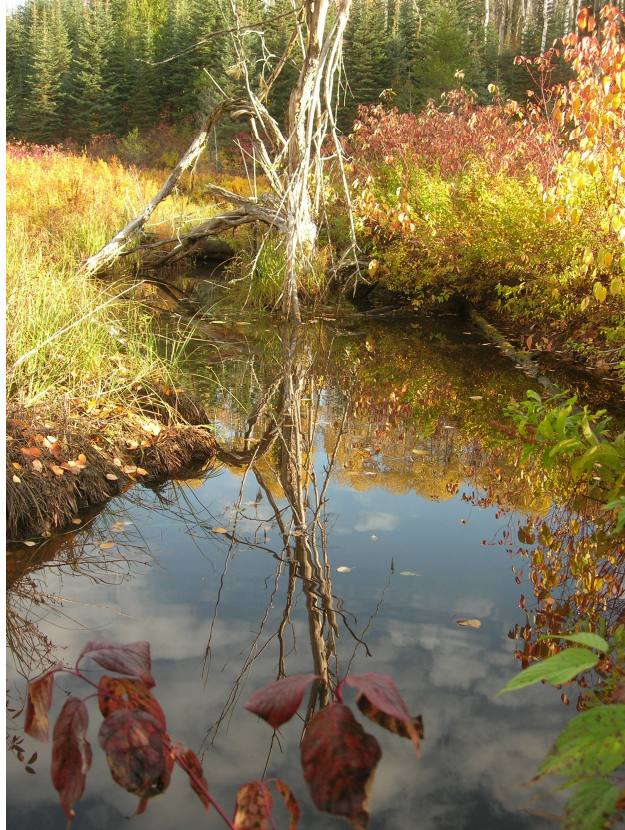
The stream habitat value downstream of the culvert was considered moderate for rearing and spawning, with riffle-pool gravel morphology, some deep pools, and a gradient of 2.5% (Photo 5). The average wetted and bankfull widths were 1.2 m and 1.5 m respectively, downstream of the culvert, and were not measured upstream because it is a beaver pond. Upstream of the culvert is a well-established beaver dam complex that if accessible to juvenile fish, could provide excellent rearing habitat (Photo 6).

Photo 6: Looking upstream at beaver pond just upstream of site 270 crossing. Good potential for rearing here if it was accessible to fish.

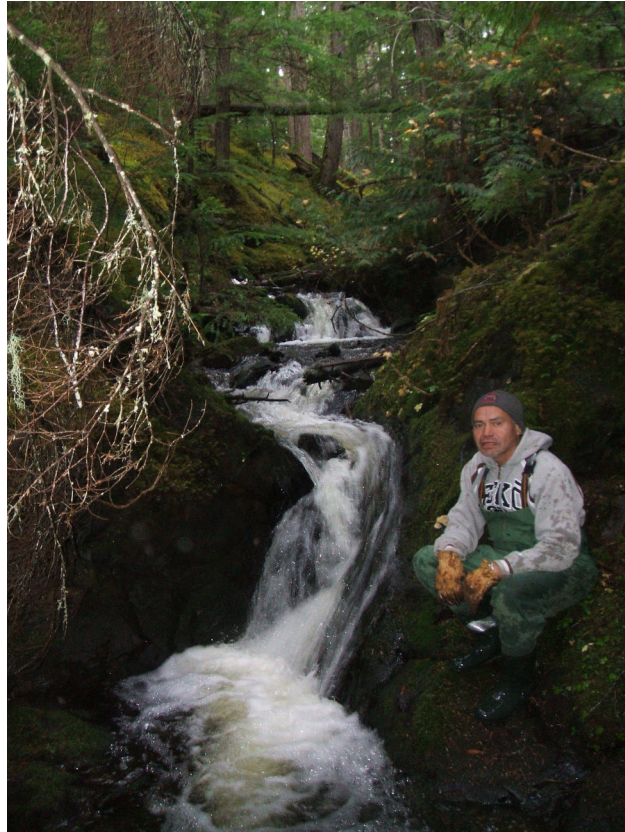
Site 252 (18 Mile Branch Rd): This crossing is approximately half way between the confluence of this stream with the Kitwanga River and its headwaters. Biolith determined the Gitanyow Access Road (crossing located downstream) to be a barrier to fish passage on this stream. GFA crews caught no fish near this culvert. A section of bedrock cascades approximately 100 m long were found, starting ~50m downstream from the crossing. Cascade in Photo 7 is representative of that 100 m stretch. This cascade section is suspected as a barrier to fish passage; however, electro-shocking is recommended upstream to confirm fish presence/absence.

Photo 7: Site 252 - Looking upstream at cascade barrier ~ 50m downstream from crossing.

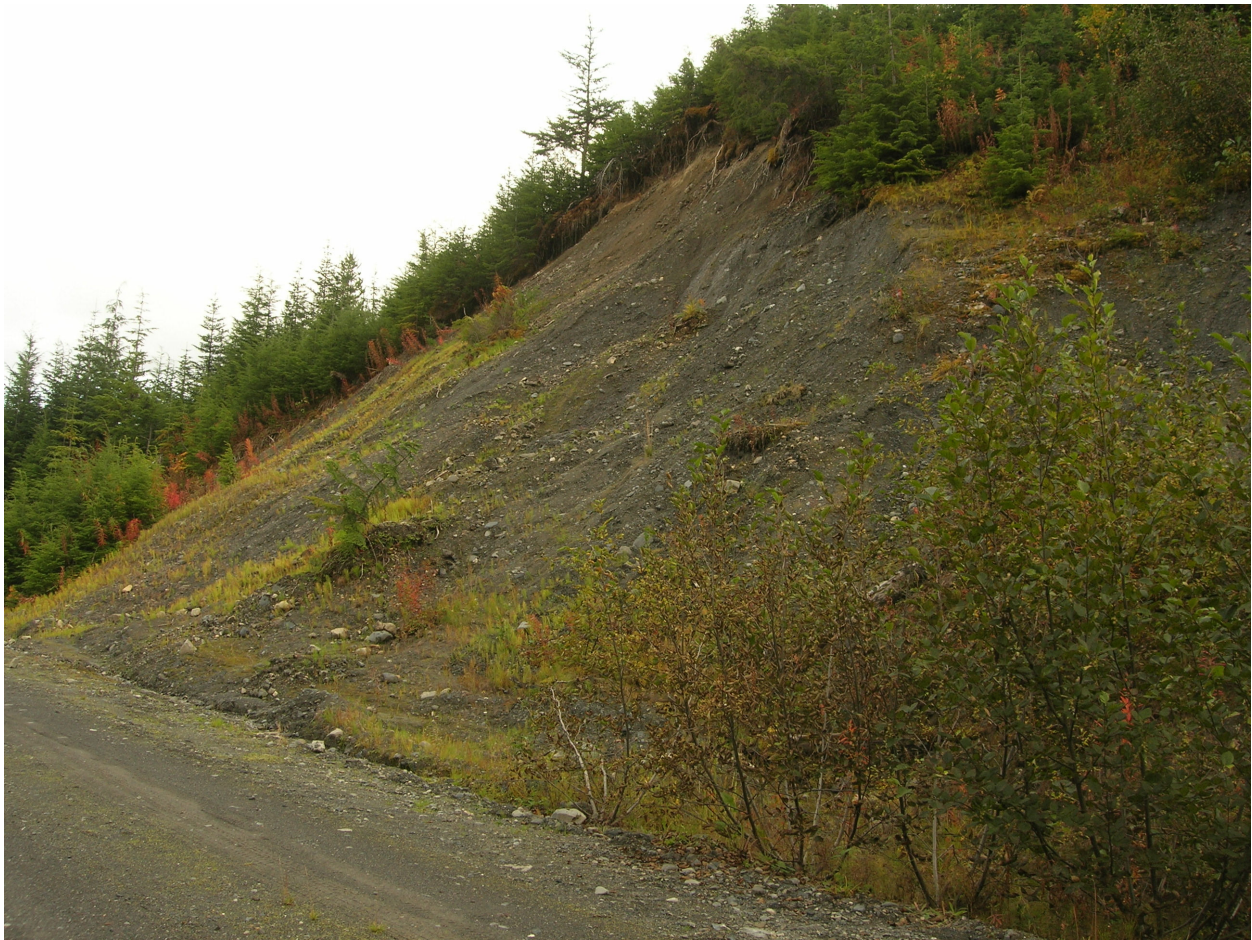
Photo 8: Site 186 - Looking at exposed RR cutbank needing revegetation. This was the largest of 4 areas of mass wasting near this crossing.

Recommendations are for grass-seeding the area of mass wasting and using bioengineering techniques, such as modified brush layers, if necessary. The beaver(s) and associated dam in the ditchline should be removed and regular maintenance conducted in order to keep the area free of standing water and allow the ditchline to re-seed.

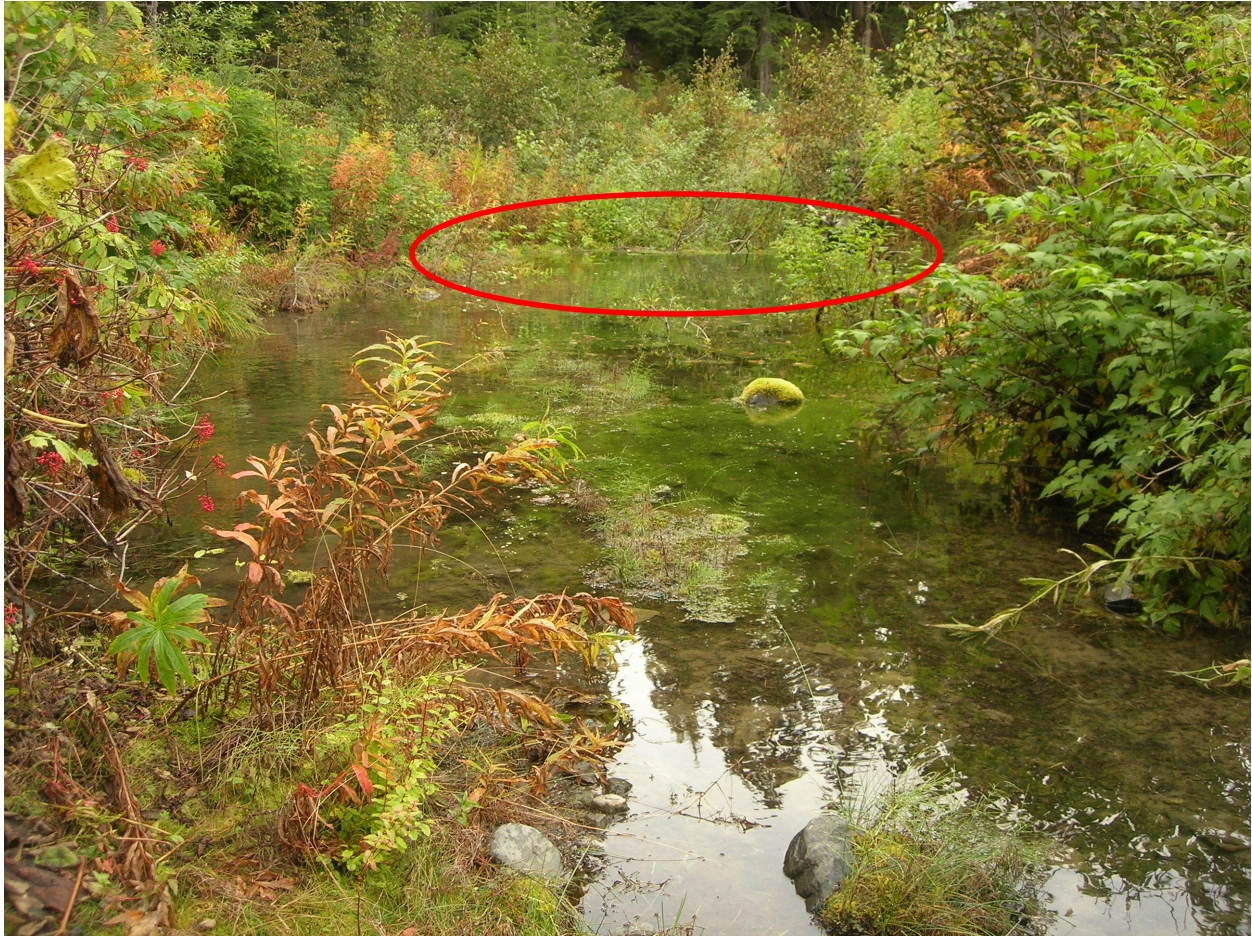
Another sediment issue at this site is a beaver dam constructed in a retention pool in the RRDU (Photo 9). Because this dam is retaining water, it is preventing a portion of the ditchline from re-vegetating. As well, there is a risk of sediment input if the dam dislodges.

Photo 9: Site 186 - Looking downstream at beaver ponded water in RRDU. High sediment accumulation in pond poses risk to water quality if dam dislodges. Dam is at the far end of photo, highlighted in red.

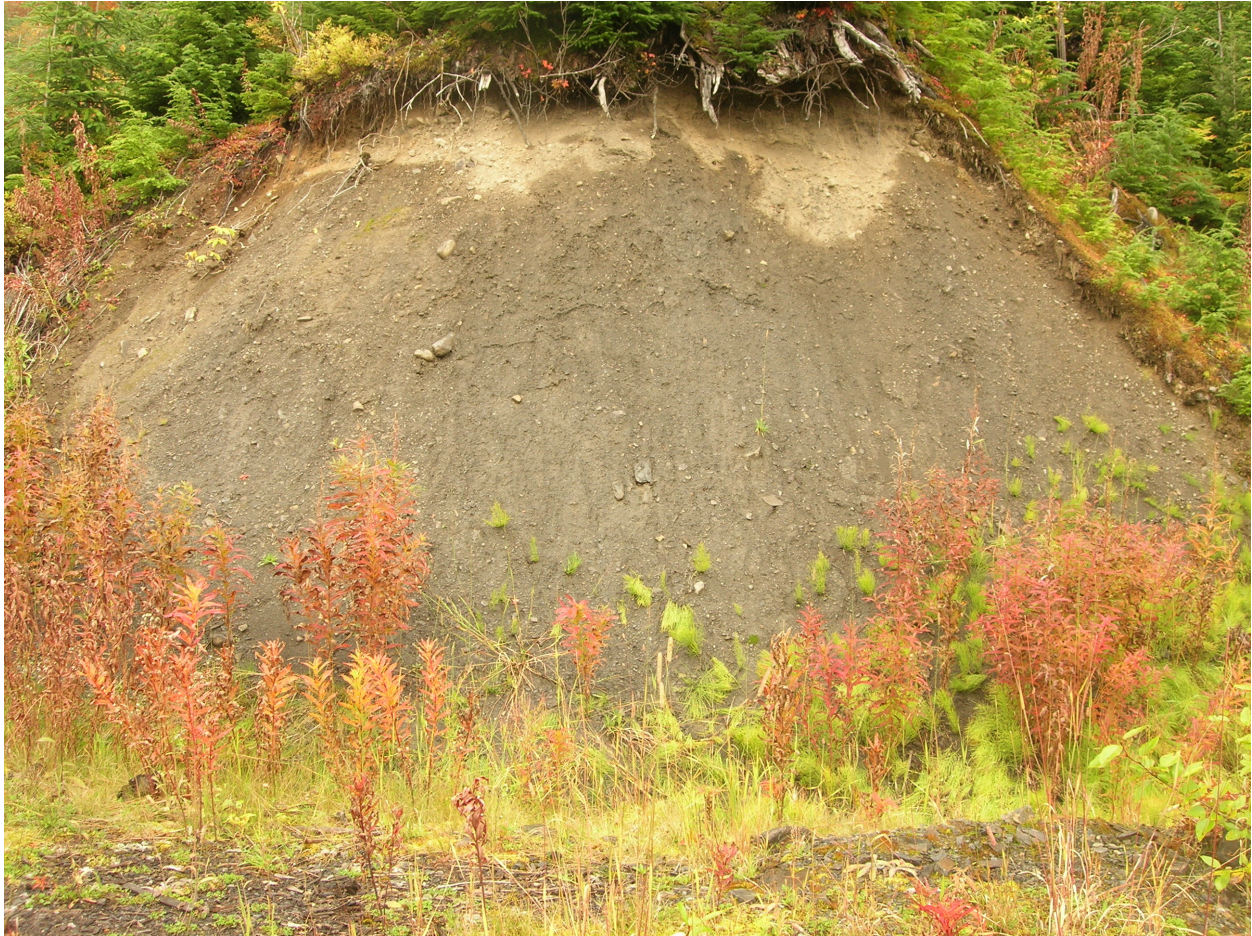
This site is well vegetated except for an area of mass wasting on the RRC, with a net erodible area of 24m² (Photo 10). Grass seeding and construction of a few modified brush layers is recommended.

Photo 10: Site 313 - Looking at exposed RR cutbank needing re-vegetation.

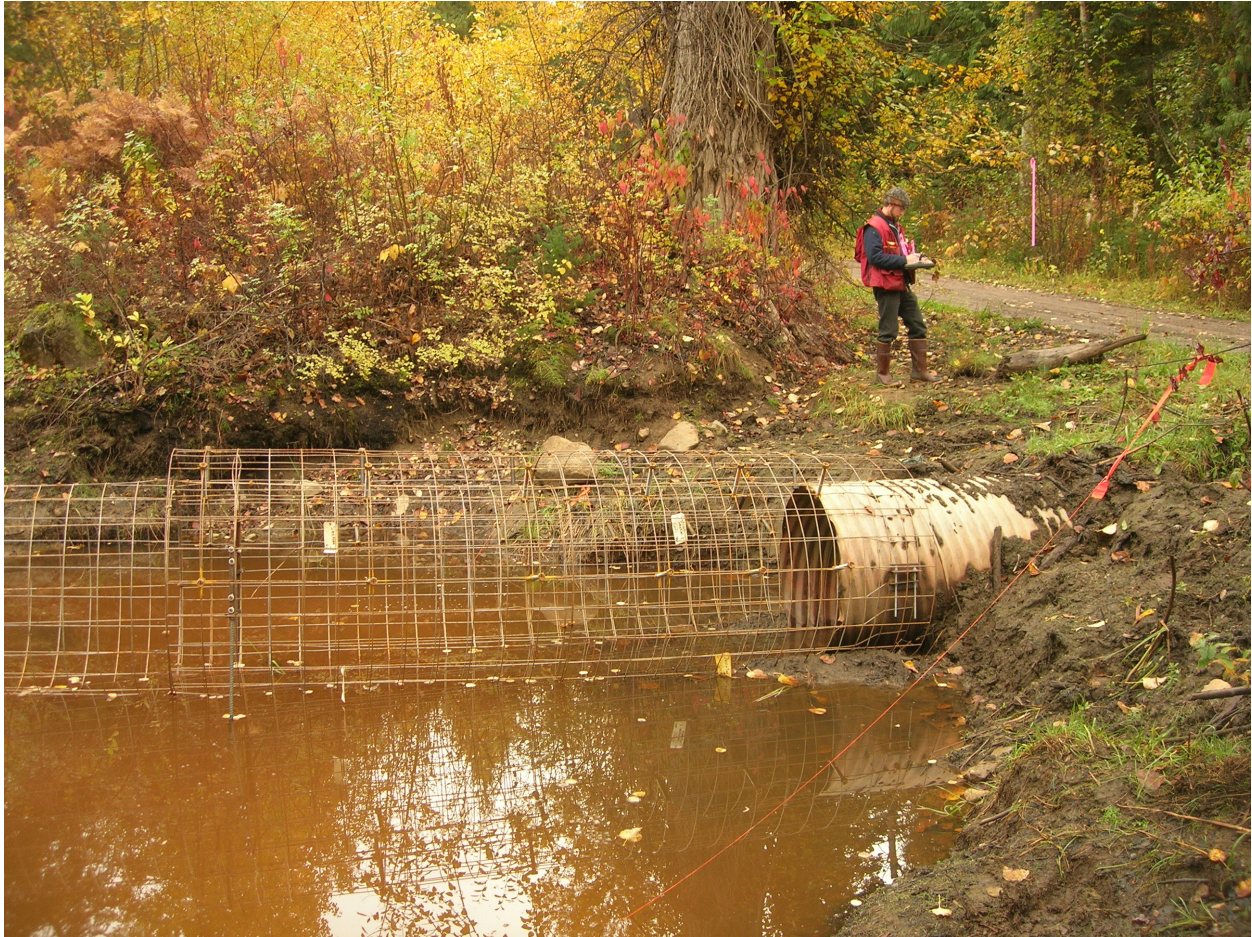
Work was recently done on this crossing and there were exposed areas that were not re-vegetating at the time this survey was performed (Photo 11). Grass seeding should occur immediately in the spring to avoid further sedimentation downstream. The WQEE score of 2 (moderate) is believed to under-represent the sediment contribution at this site. It is clear from observation of the substrate downstream of the crossing that a considerable amount of

Photo 11: Site 270 - Looking across from right to left at culvert inlet. Silty water and exposed soil are evident.

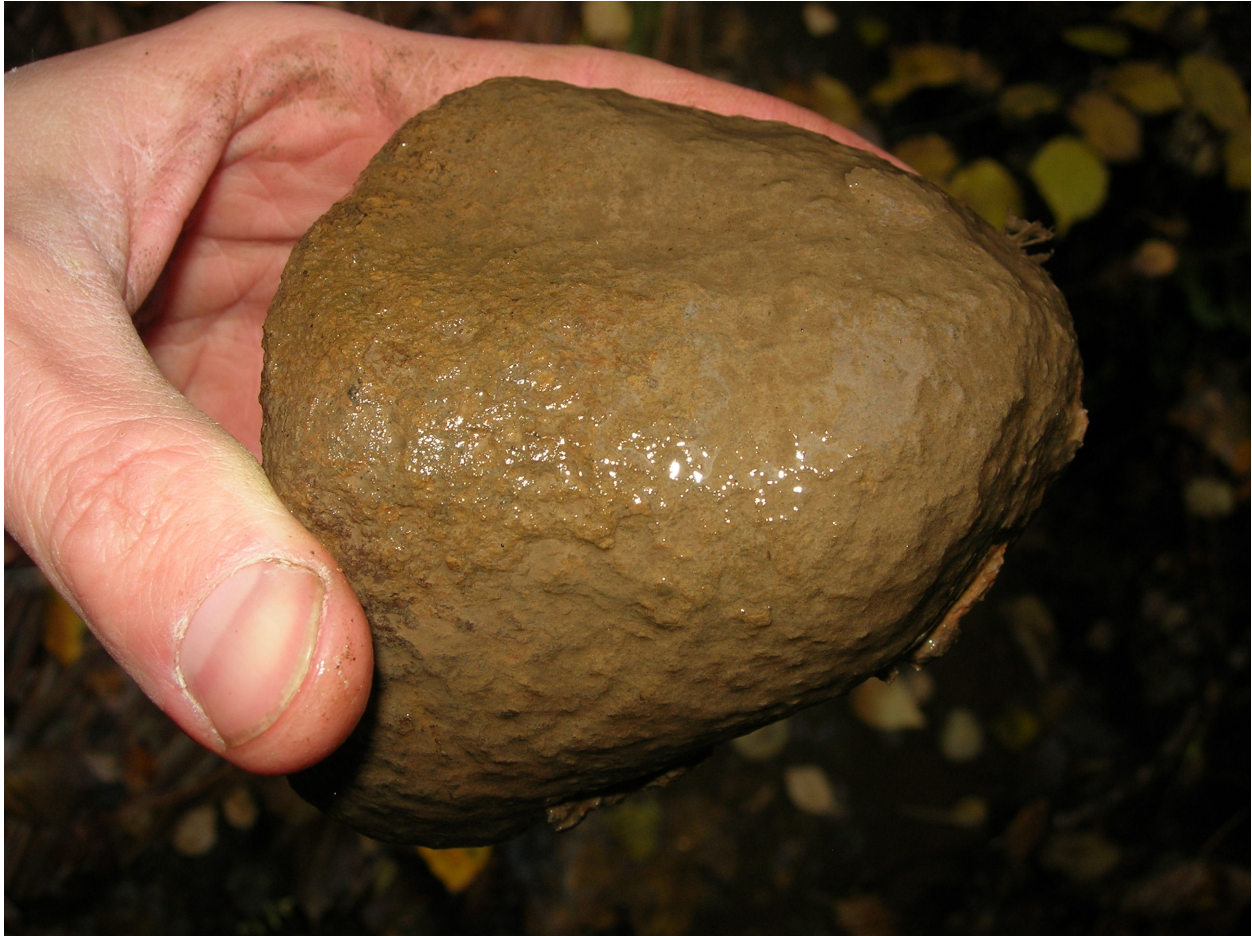
sediment has been deposited into this stream (Photo 12), and into Tea Creek (confluence <100m from crossing).

Photo 12: Site 270 - Looking at silt covered cobble downstream of culvert as evidence of high levels of past sedimentation.

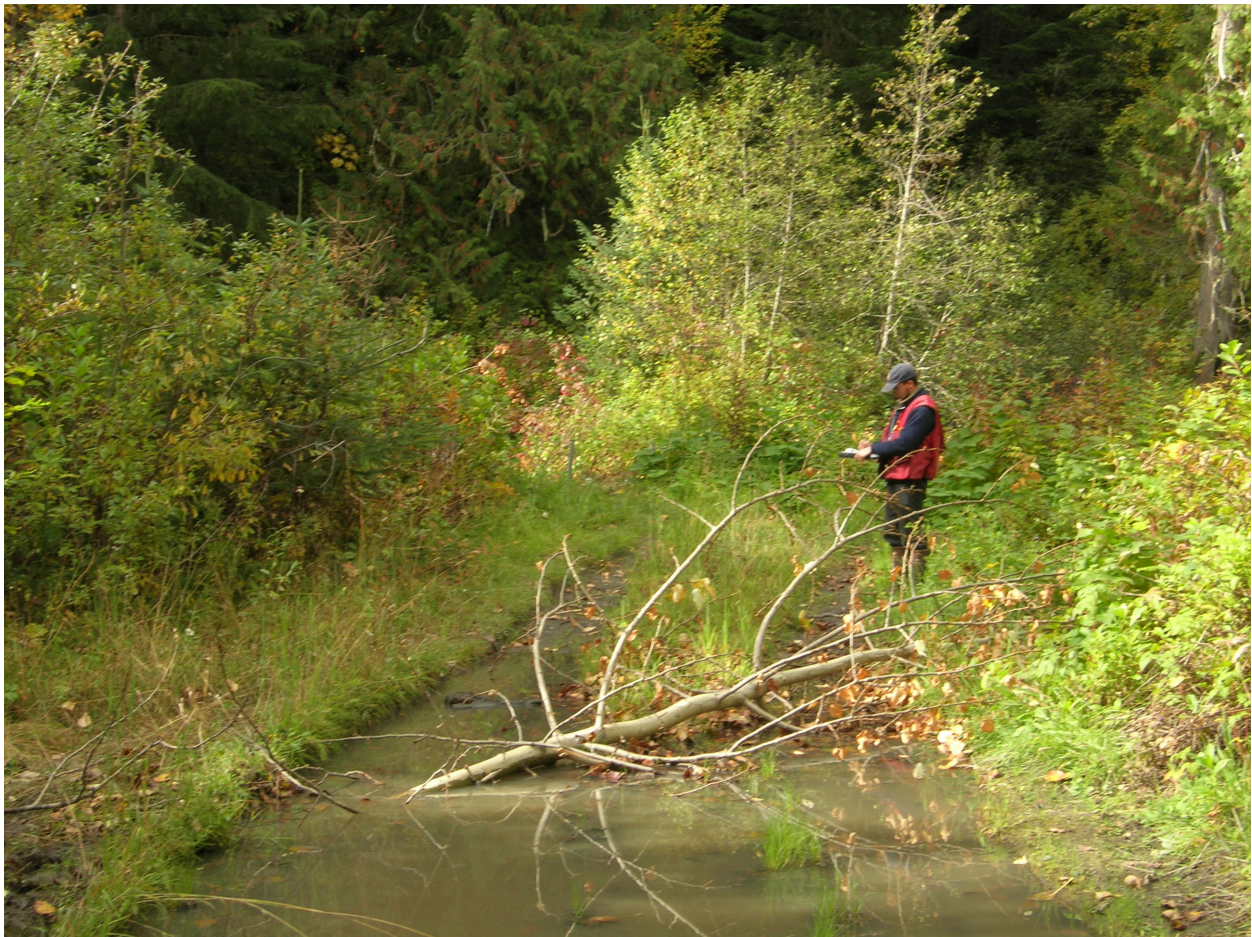
This site scored low (0.08 m^3) because sediment does not currently have an entry point into the river. The old bridge abutment is still in place on the right bank, and diverts water towards the left bank causing erosion. The LRS is very silty and muddy most of the year, but a berm on the left bank of the river prevents silty water from entering the stream (Photo 13). This bank will likely erode away allowing a major entry of silt directly into a known salmon spawning bed.

Photo 13: Site 115 - Looking at silty puddle on LRS. Kitwanga River is in the background but not visible in photo.

It is recommended that the right bank abutment be removed and the left bank armoured with rip rap. The combination of these two actions should minimize further unnatural streambank erosion. In addition, roadbed material (sandy-gravel) should be added to the LRS and it should be grass-seeded.
