Project Completion Abstract for Fish Passage Restoration Projects (engineering activities)

[3000 Road, Site 19/1759, Fulton River Watershed, Northern Interior Forest Region]

Watershed: Harold Price Creek
Watershed Code: 460-081700-43900-51100-1190
Stream Name: Unnamed
1:20,000 Mapsheet: 093M.016
Location: 3000 Road, ~34.0 km
Site Number: Site 19/1759
UTM Coordinates: E 637557 N 6111059

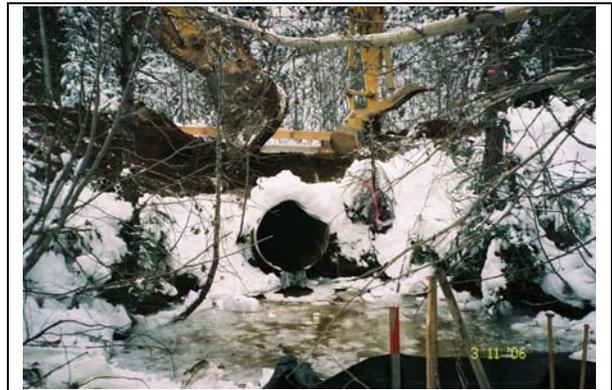
Photo 1. U/s view of outlet, culvert partially excavated.

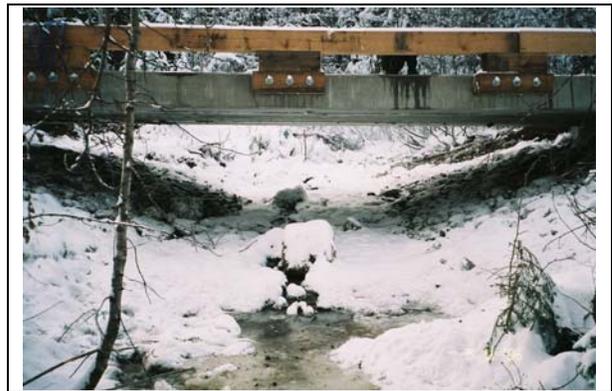
Photo 2. U/s view of completed new channel with bridge in place.

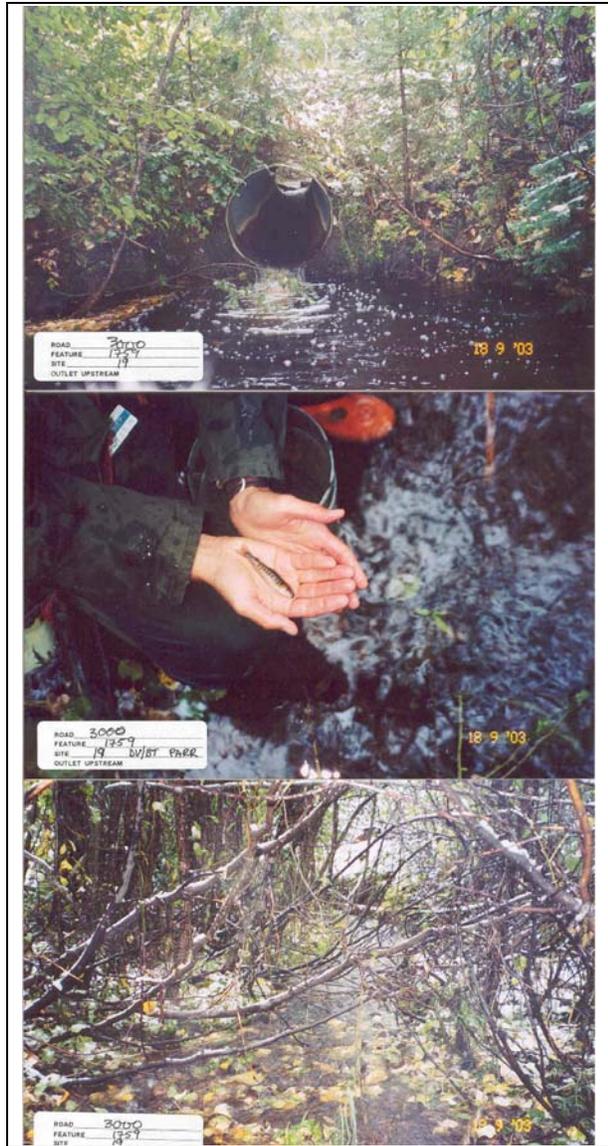
Fish Passage Culvert Inspection – Sept. 18/03
Barriers – Partial; Culvert slope (5.1%) and culvert water velocity (1.1m/s) are barriers to juvenile fish passage upstream
Priority rank score – 40 (H)
Fish Species (DV/BT) – 10 Habitat Value (M) – 7
Barrier (Partial) – 7 Habitat (>1km) – 6
% Stream Barred (>70%) – 10
Upstream Barriers (Yes) – 0

Photo 3. 3000 Road-Site 19/1759 culvert outlet conditions. Culvert slope and H₂O velocity are barriers to juveniles.
