**Project Completion Abstract for Fish Passage Restoration Projects**  
(Engineering Activities)

**3000 ROAD, SITE 8/1666, FULTON RIVER WATERSHED**  
**NORTHERN INTERIOR FOREST REGION**

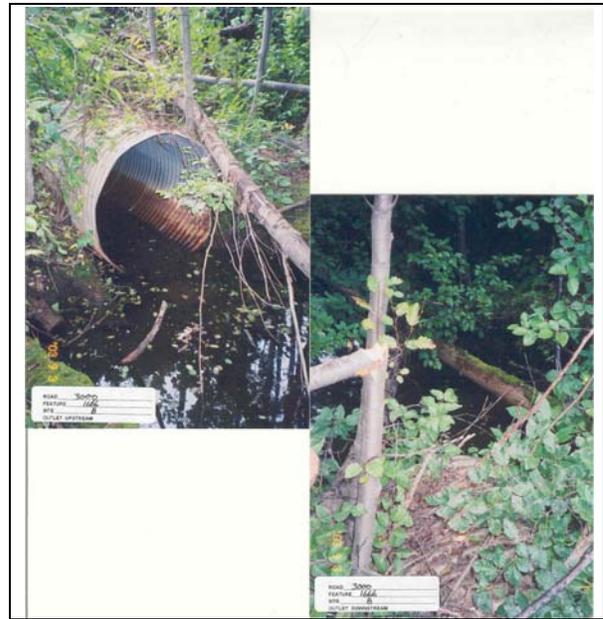
Fish Passage Culvert Inspection – Sept. 3/03  
Barriers – Partial; Culvert slope (6.5%) and culvert water velocity at high flows are barriers to juvenile fish passage upstream  
Priority rank score – 44 (H)  
Fish Species (DV) – 10 Habitat Value (M) – 7  
Barrier (Partial) – 7 Habitat (>1km) – 5  
% Stream Barred (>70%) – 10  
Upstream Barriers (Yes) – 5

**Photo 1.** 3000 Road-Site 8/1666 culvert outlet conditions. No outfall drop but steep culvert gradient (6.5%).

The stream in question is fish bearing and the existing culvert, although large enough to accommodate  $Q_{100}$  flows, is a partial barrier to upstream fish passage. Since restoration of fish passage was the objective of the project, an open bottom structure that would span the reconstructed stream channel was chosen. A pre-cast concrete

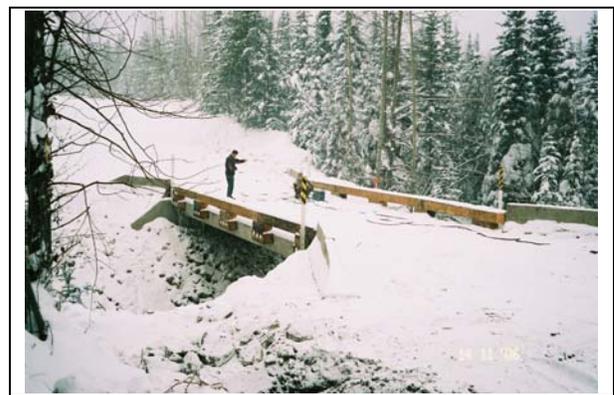
**Photo 2.** Engineer inspecting shear plate welding.

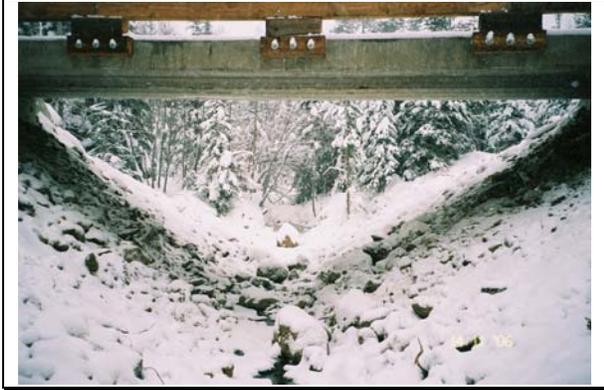
**Photo 3.** 3000 Road-Site 8/1666, d/s view of reconstructed stream channel (Nov.14/06).
