February 17, 2010

Reference: 091-02075

***Slope Stability Review
Broadway Run, Cowichan River, B.C.***

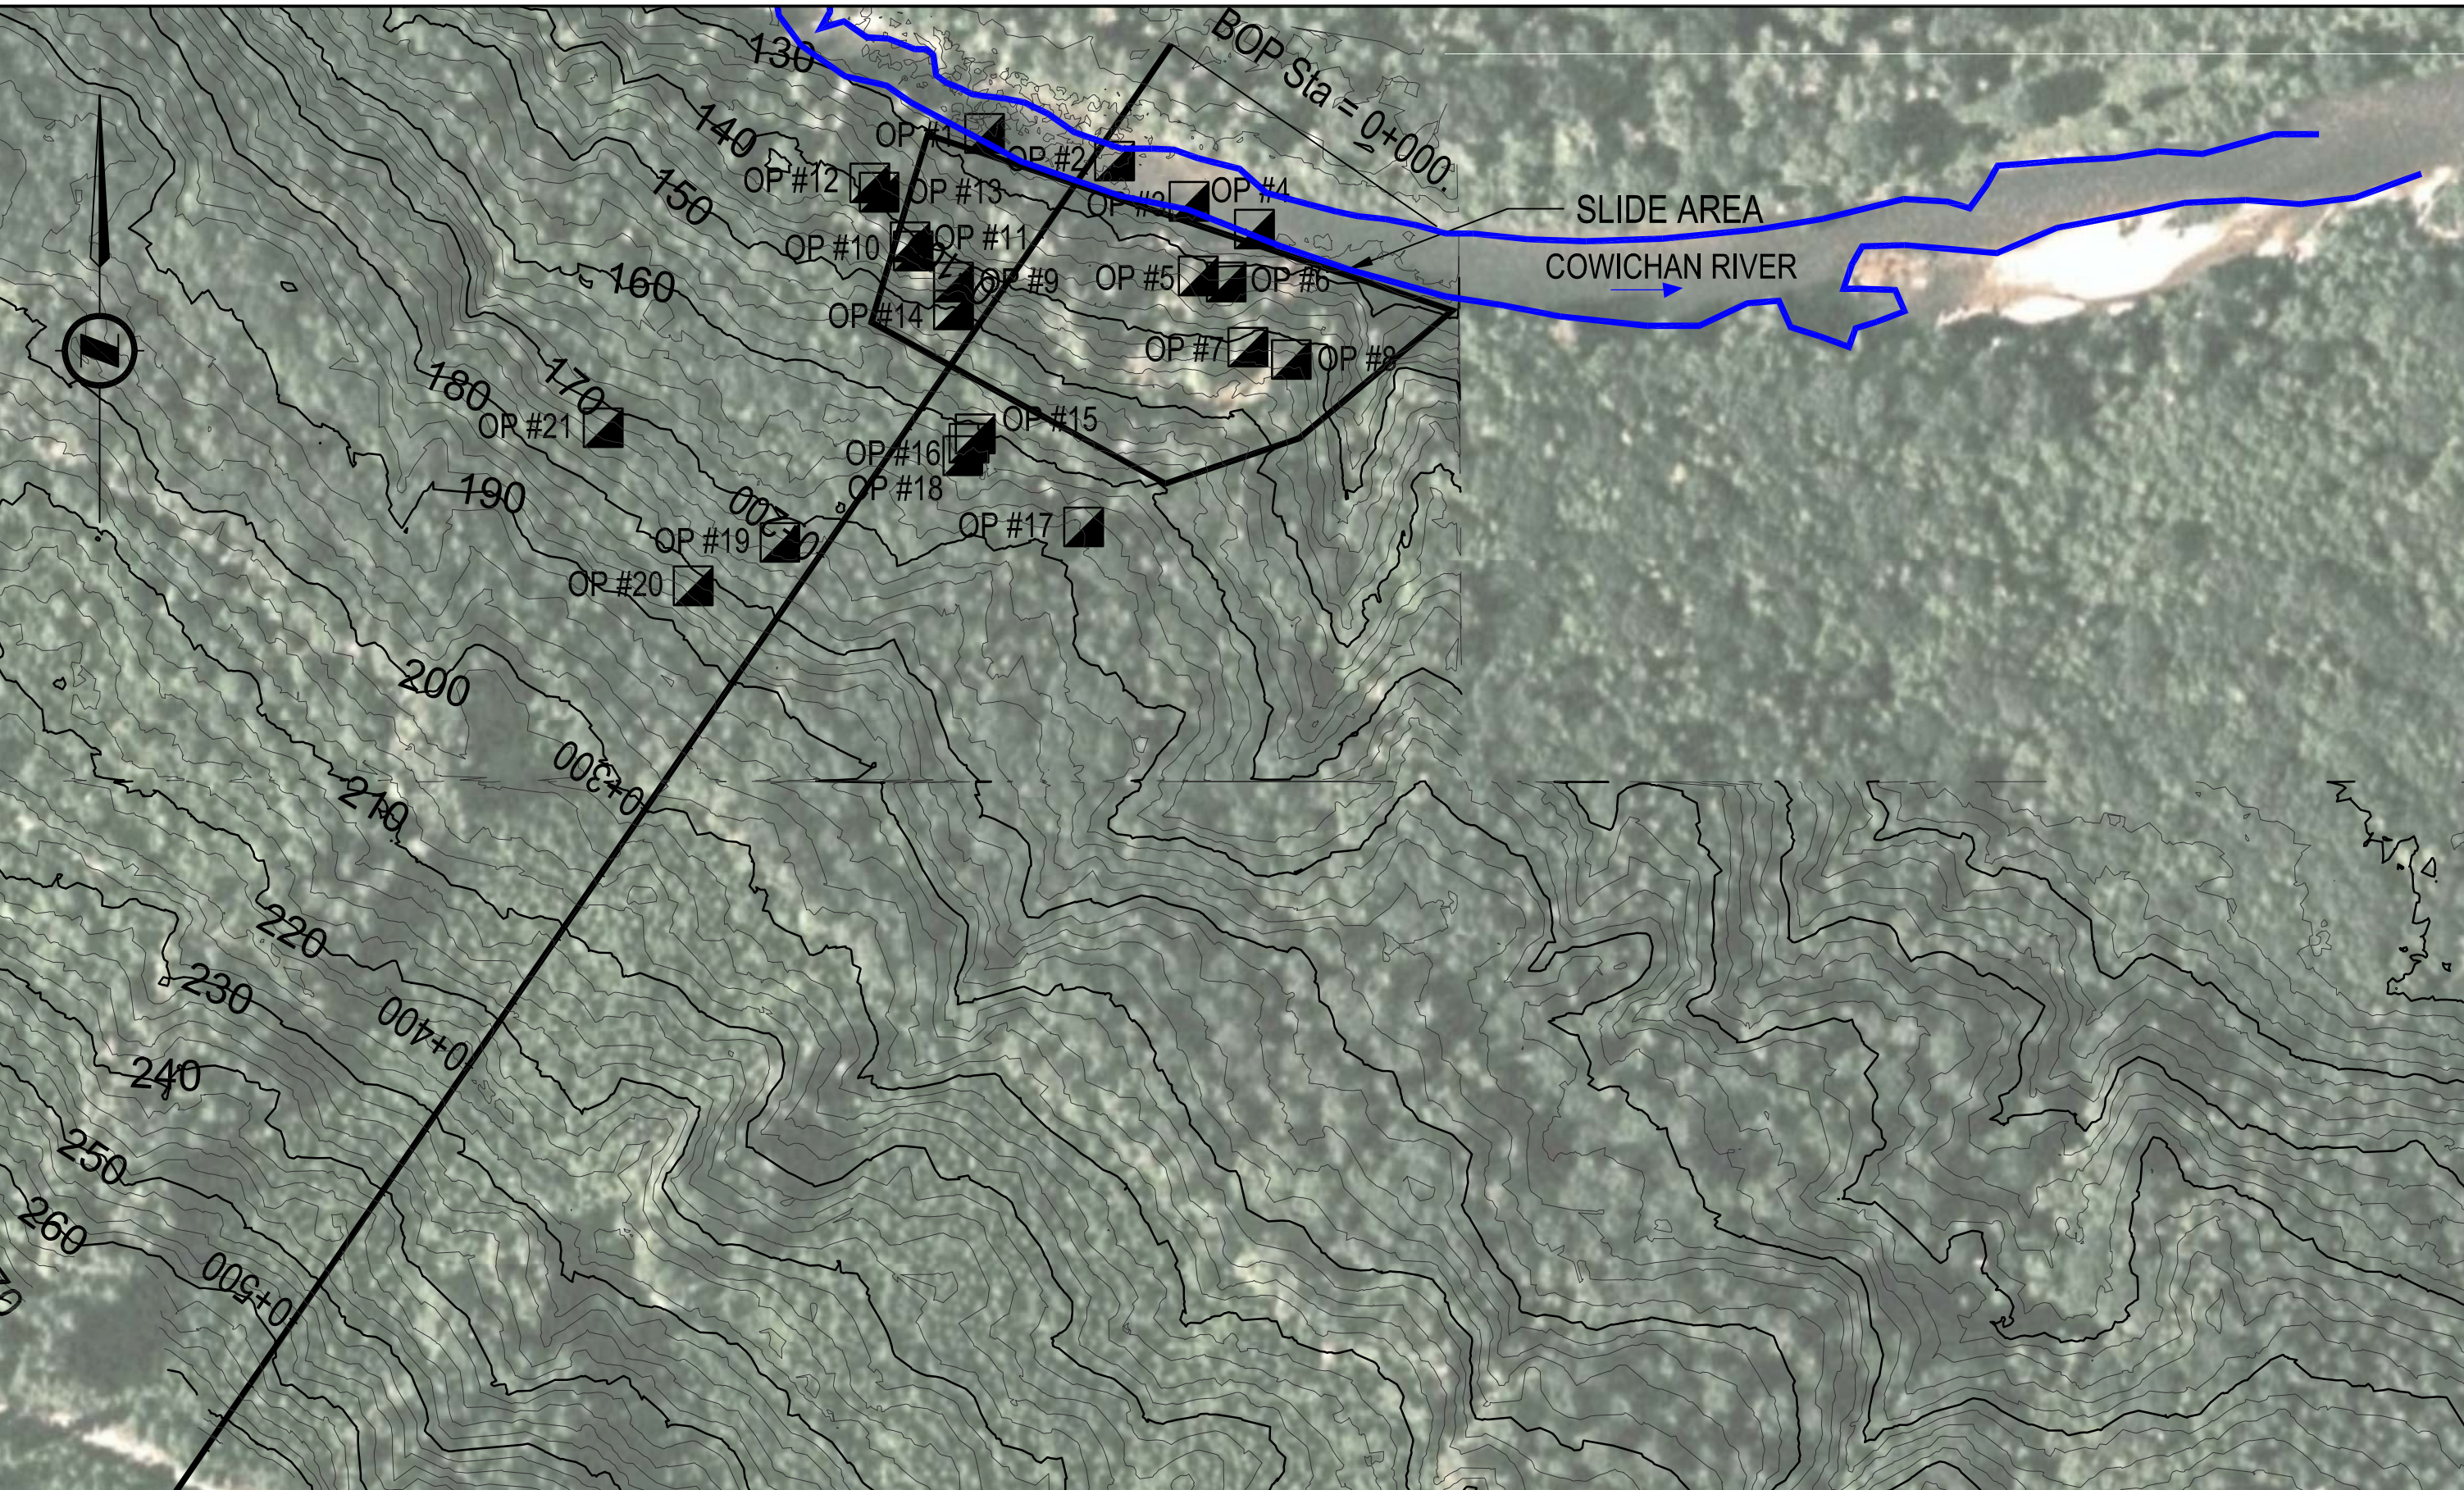
TITLE: SITE PLAN LIDAR SURFACE		
DATE	SCALE:	DWG NO.
JAN., 2010	1:2000	091-02075-02

- Recent reports related to sediment loads in the river;
- Surficial geology plan maps;
- Topographic plan maps;
- Aerial photographs;
- An aerial photograph mosaic of the river showing changes in channel alignment over the period 1968 to 2005;
- A LIDAR survey conducted over the lower portions of the slope in the summer of 2009;
- Site reconnaissance during both dry and wet times of the year with significant features photographed and located with hand-held GPS (See Drawing 091-02075-02)

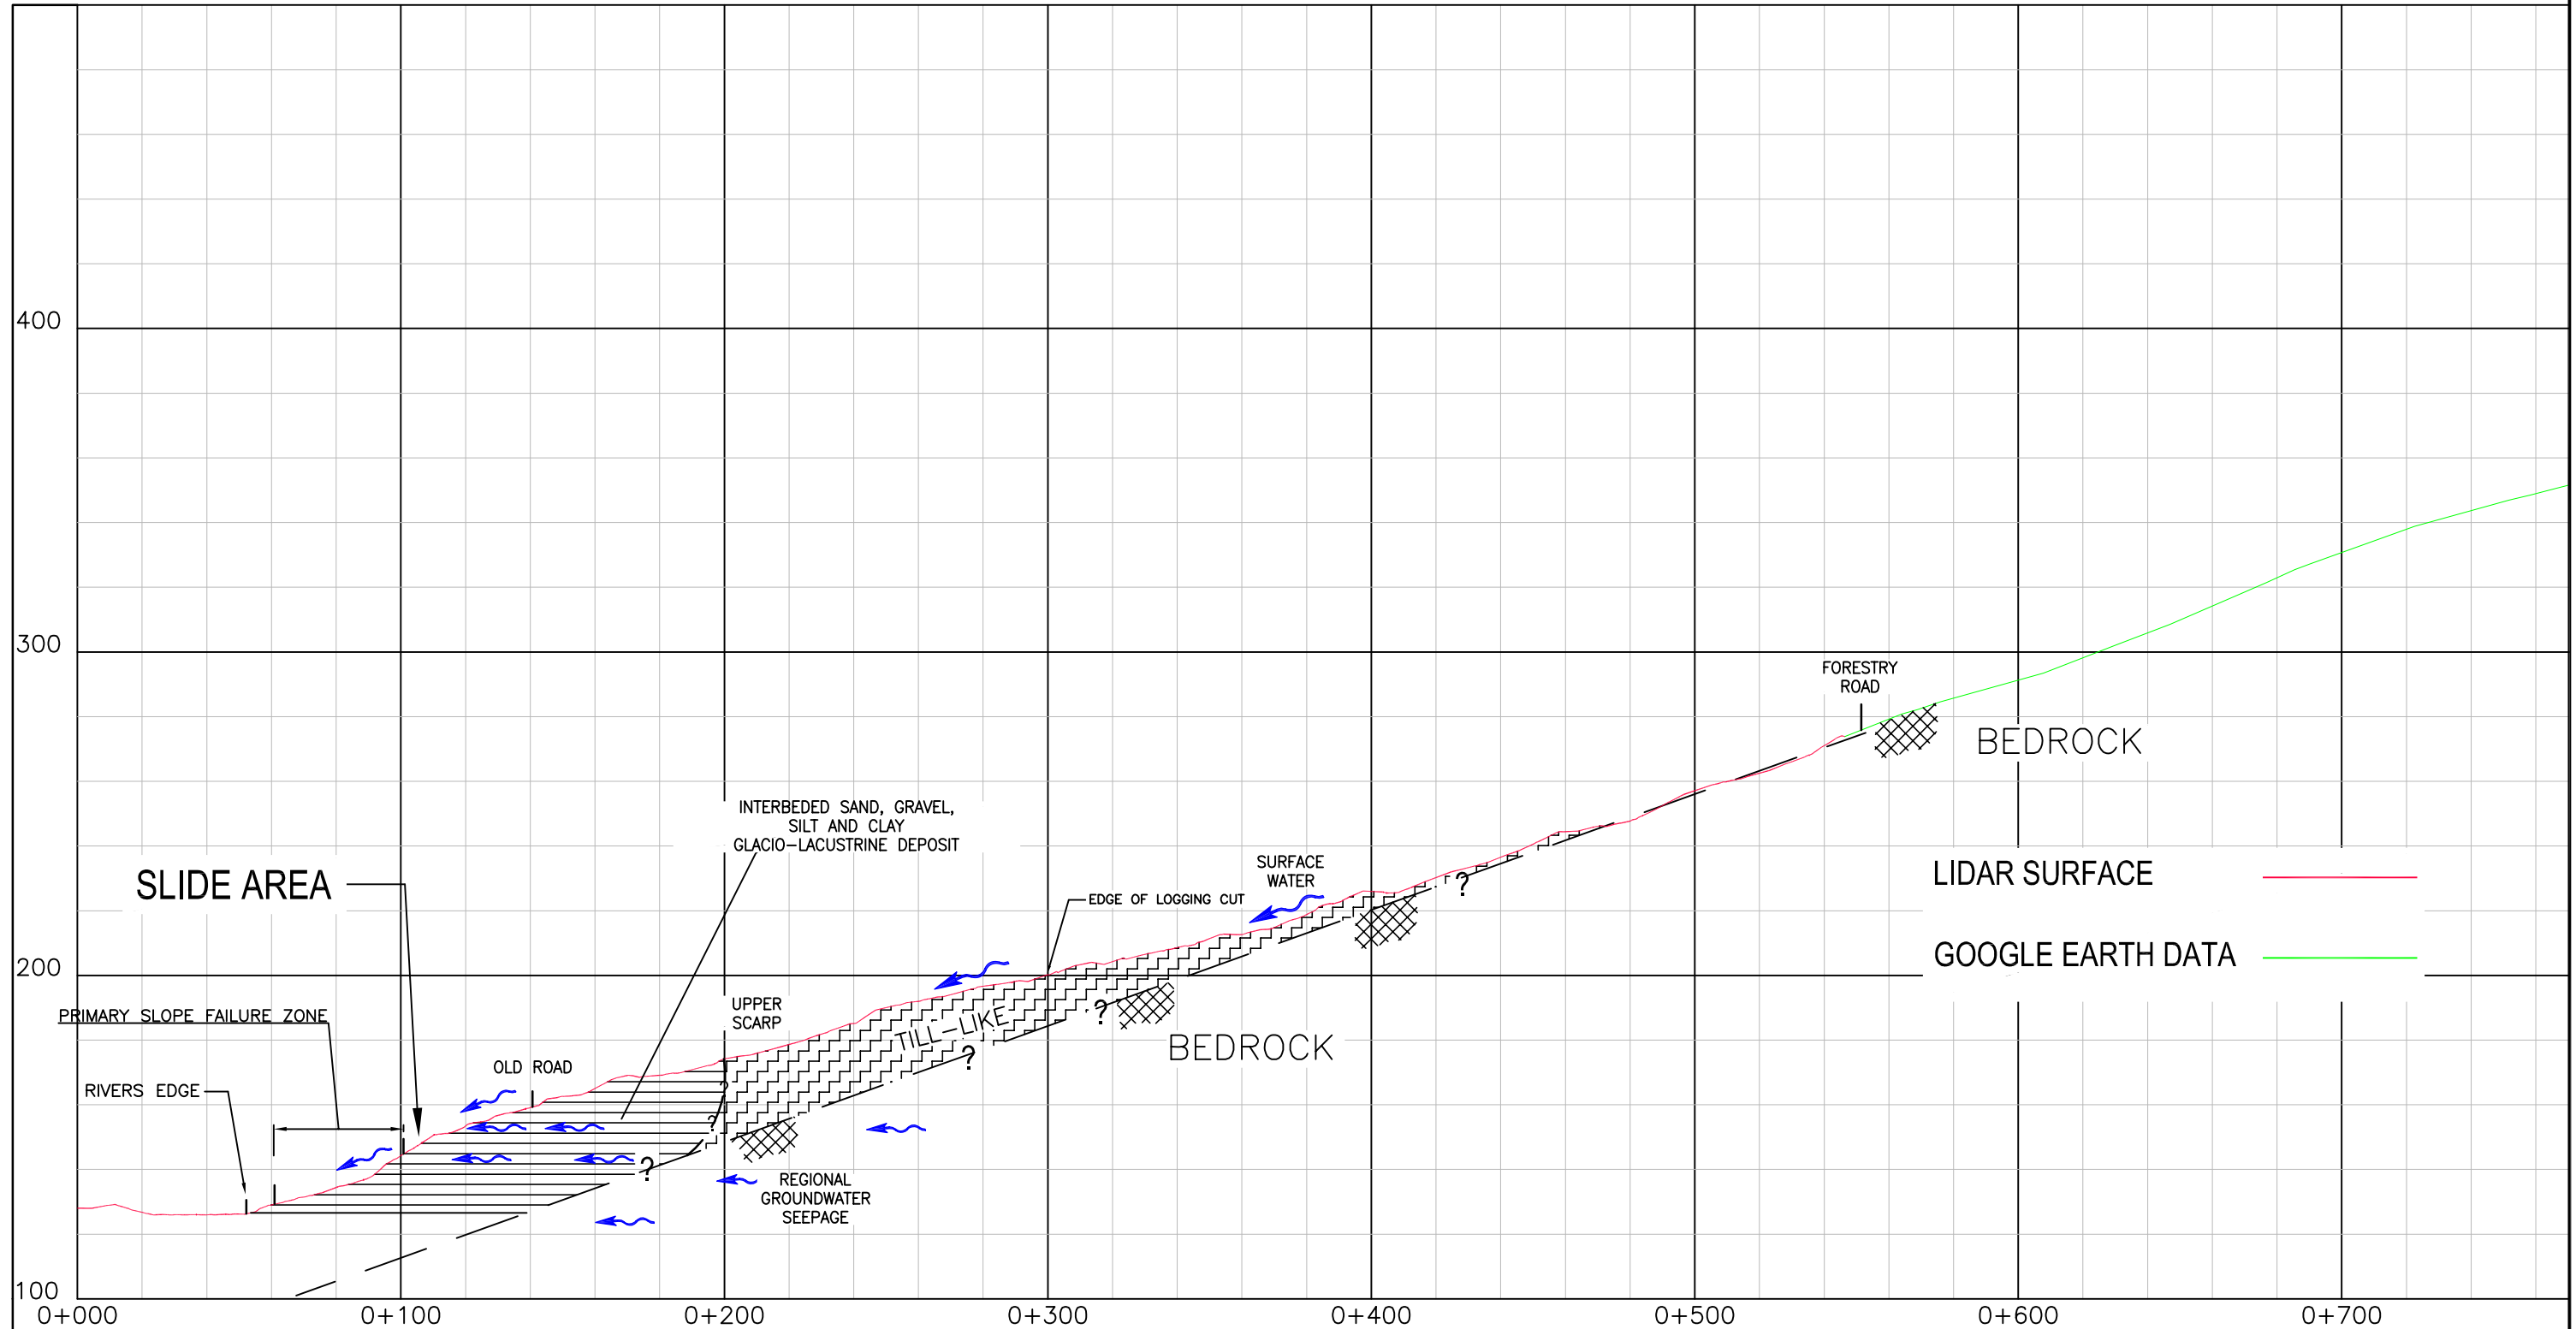
TITLE:		
CROSS SECTION		
LIDAR SURFACE & GOOGLE EARTH DATA		
DATE	SCALE:	DWG NO.
JAN, 2010	1:2000	091-02075-03

instabilities are a result of increased surface runoff and seepage flow with the slopes back from the rivers edge. We expect that rainfall infiltration within mountain areas upslope from the river makes it way through soil and bedrock into the glacio-lacustrine deposits close to the river edge. The increased flow and seepage pressures causes saturation and erosion of loose soils within veneer zones of existing slopes. This increase in regional groundwater flow is likely increasing pore pressures within the soil structure forming the core of existing slopes, which can reduce the stability of slopes leading to larger scale failures toward the river. As the more active soil failures appear to be very recent (over the last few years), a change in the water drainage patterns in the mountain slope areas above the river edge slopes may be responsible for the recent activity. The stratigraphy of the active soil failures near OP #9 (sand and gravel overlain with silt and clay) support this opinion. In addition, wetland vegetation observed at the toe of several of failure scarps indicate groundwater is coming to surface near these locations. A sketch of the possible mechanism is shown on Drawing 091-02075-03.

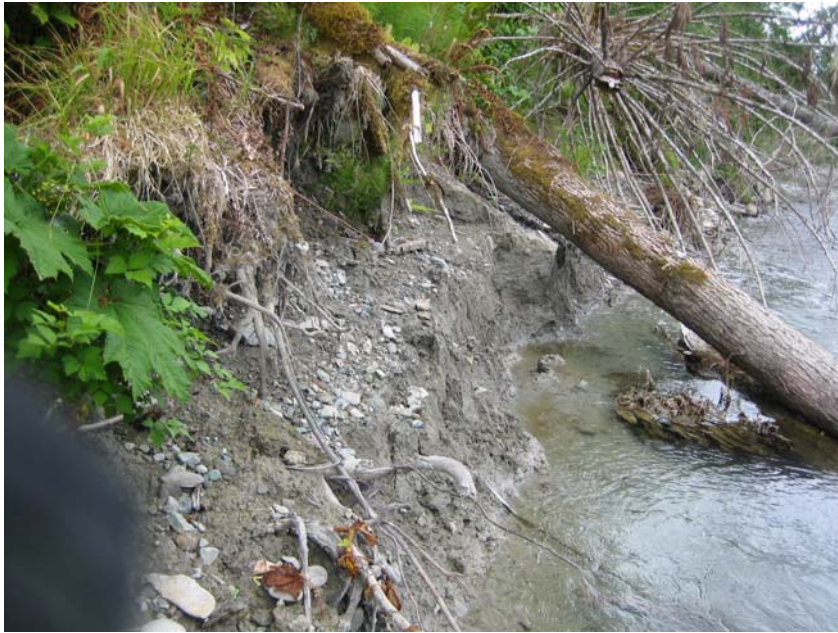
PHOTO 1 – OP #1 – Erosion of River Bank
(July 7, 2009)

In order to mitigate erosion of the river bank, rip rap could be placed along the bank. This would provide some protection for the soil bank. It may be possible to construct the rip rap bank in such a way as to create catchment areas for soils generated from nearby slope failures above the rivers edge.

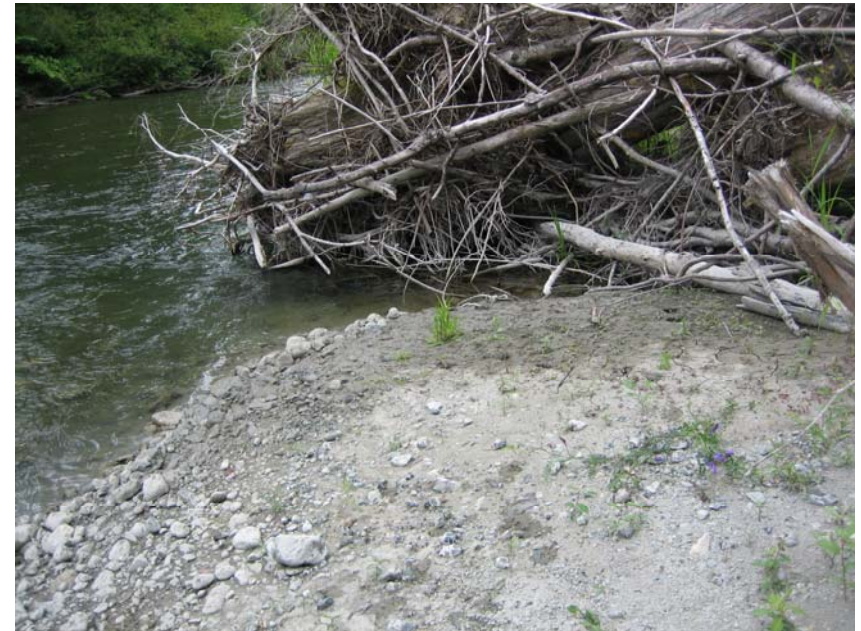
PHOTO 2 – OP #3 – Soil Deposits in River from
nearby Bank Erosion/ Sloughing
July 7, 2009

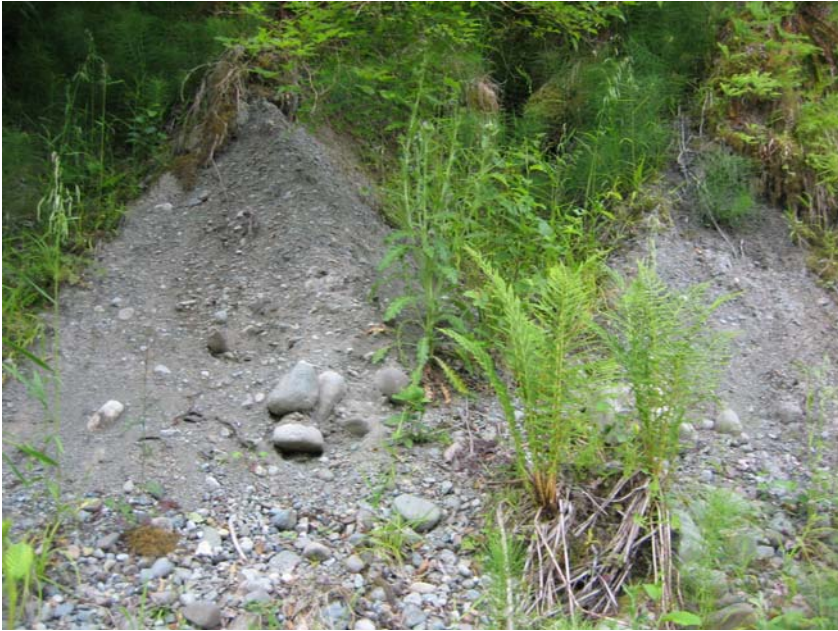
PHOTO 3 – OP #4 – Sand and Gravel Deposits
on River Bank
July 7, 2009

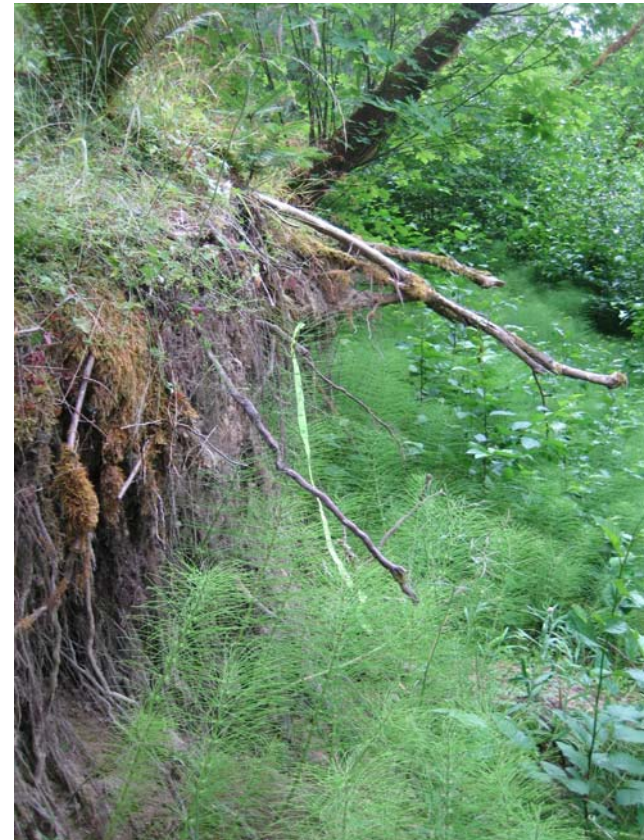
PHOTO 4 – OP #8 – Scarp approximately 1.5m in Height
July 7, 2009

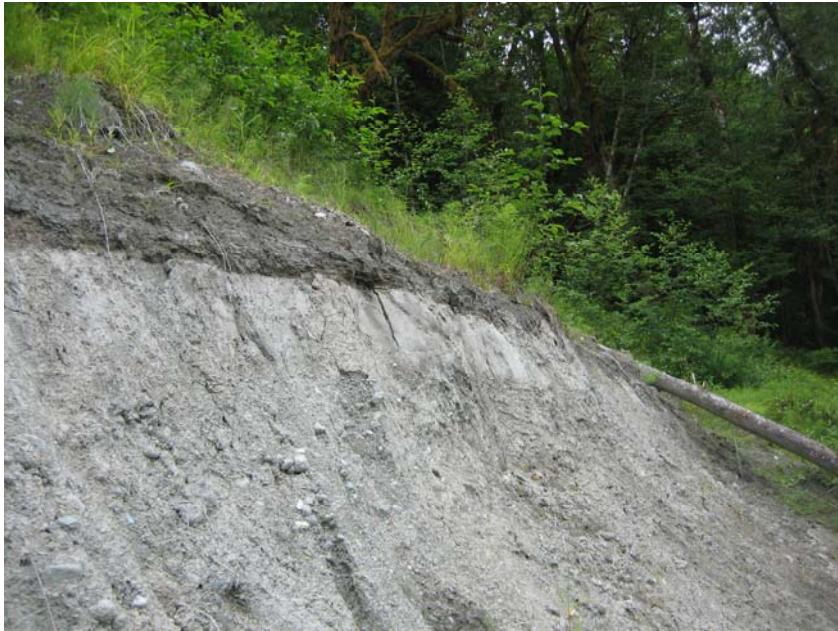
PHOTO 5 – OP #9 – Scarp and subsequent Erosion
July 7, 2009

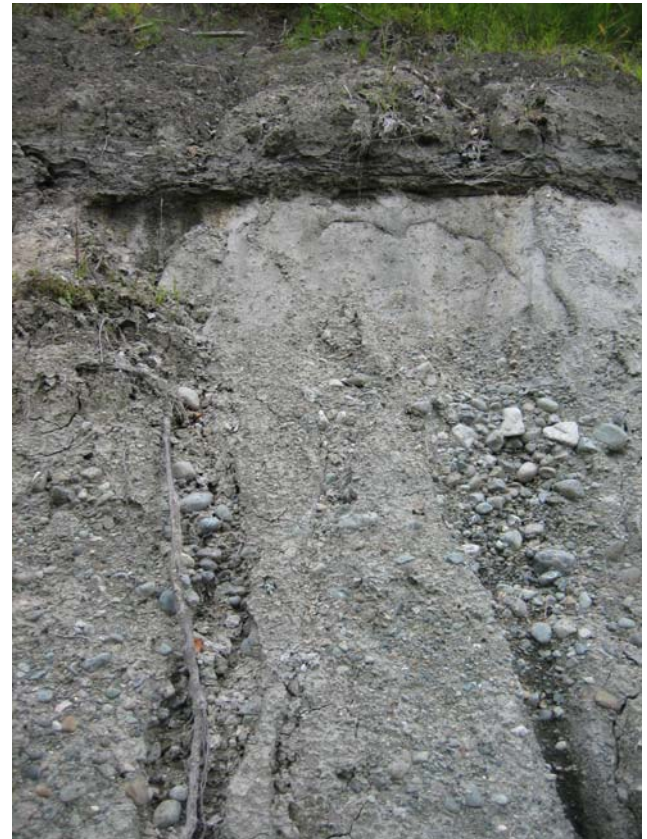
PHOTO 6 – OP #9 – Scarp
Note Clayey SILT layer overlying Sand and Gravel
July 7, 2009

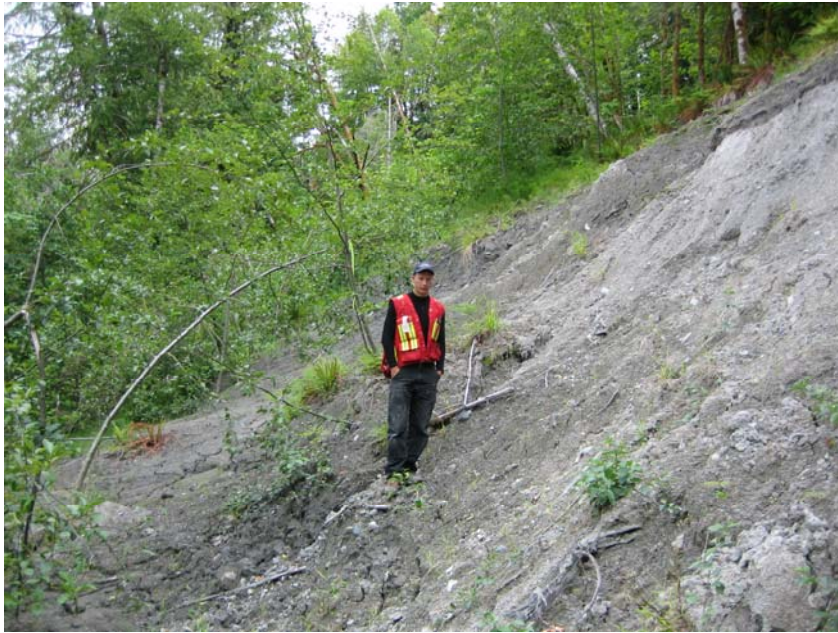
PHOTO 7 – OP #10 – Slide/ Erosion Deposition
July 7, 2009

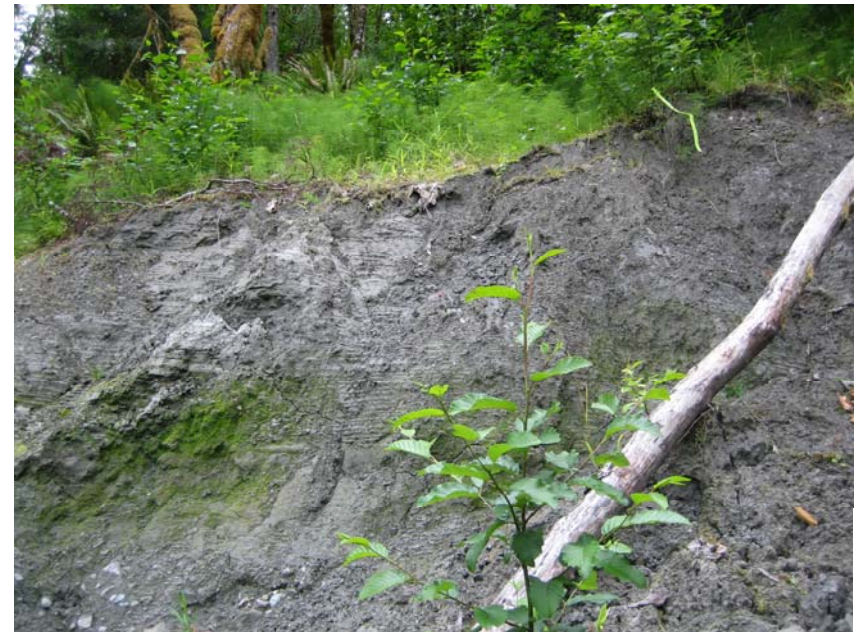
PHOTO 8 – OP #11 – Slide Scarp approximately 8m in Height
July 7, 2009

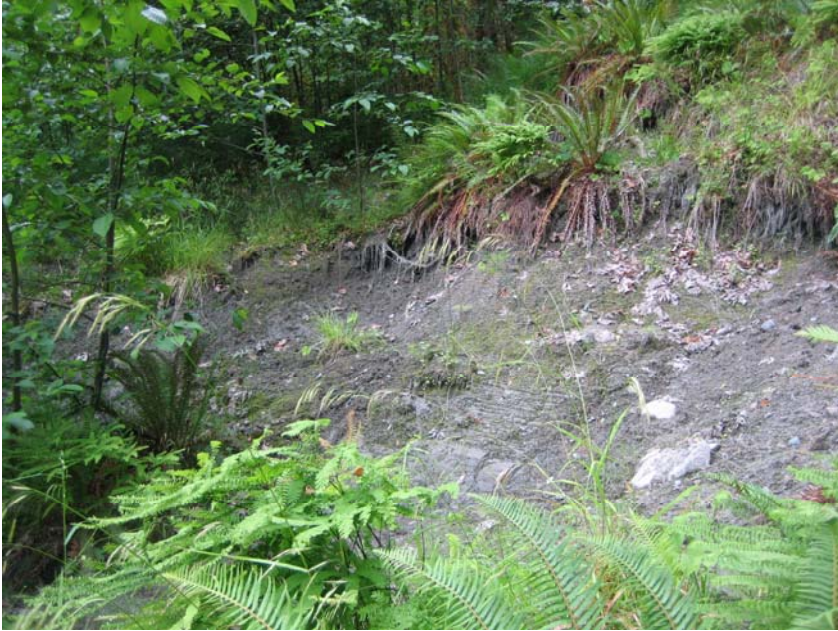
PHOTO 9 – OP #12 – Scarp
July 7, 2009

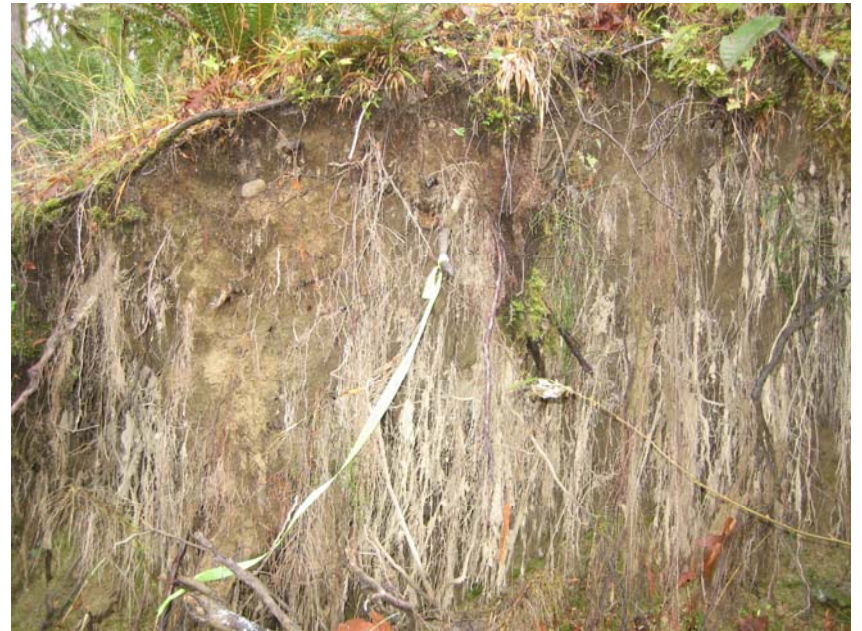
PHOTO 10 – OP #8 – Scarp
November 2, 2009

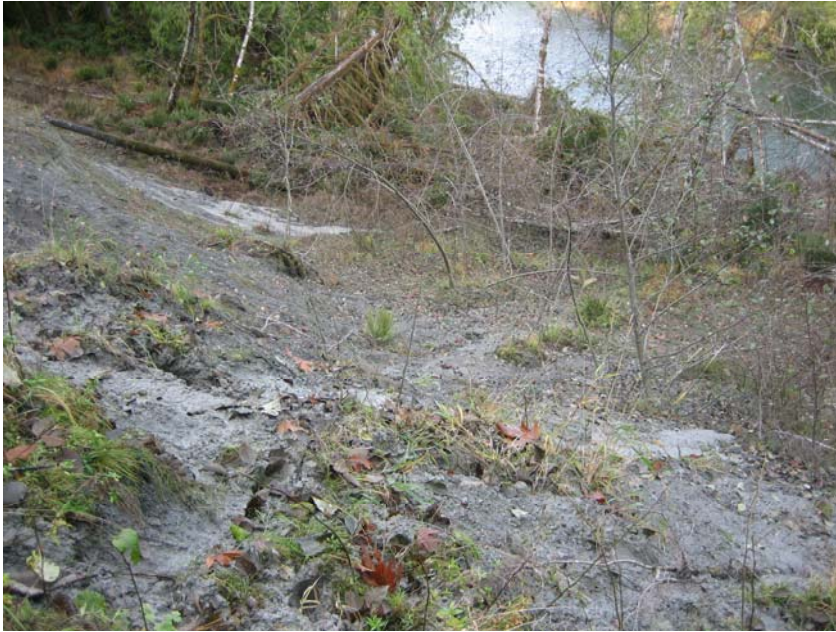
PHOTO 11 – OP #9 – Deposition of Soil
November 4, 2009

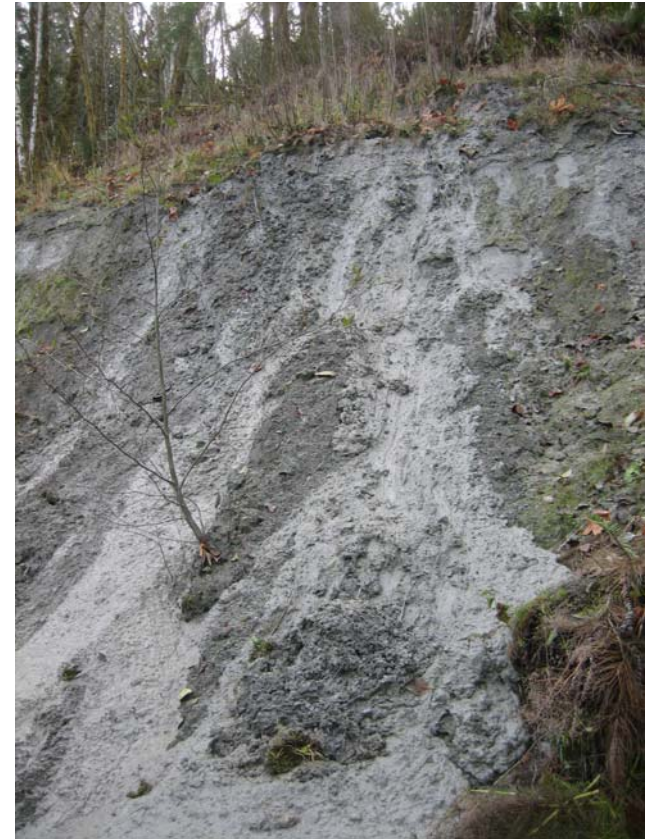
PHOTO 12 - OP #9 – Soil Flows
November 4, 2009

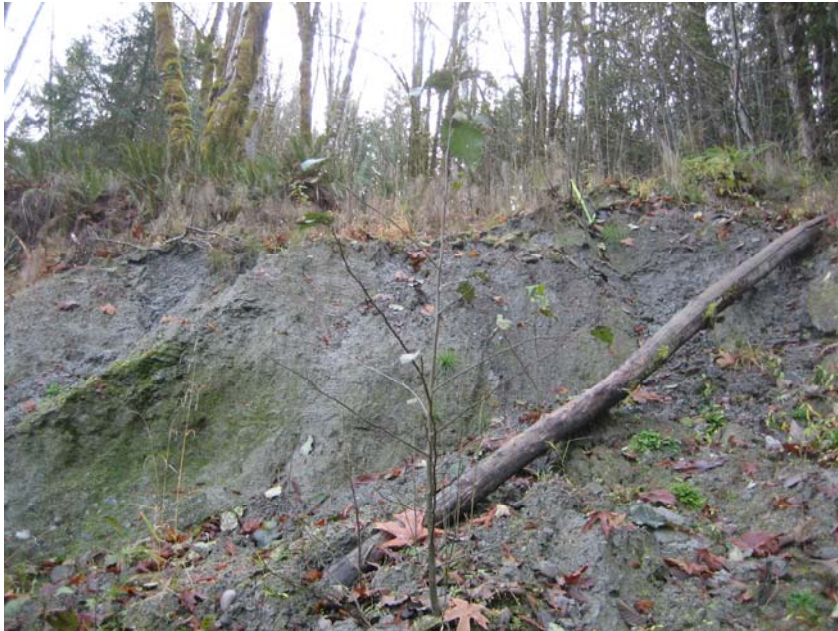
PHOTO 13 – OP #11 – Scarp
November 4, 2009

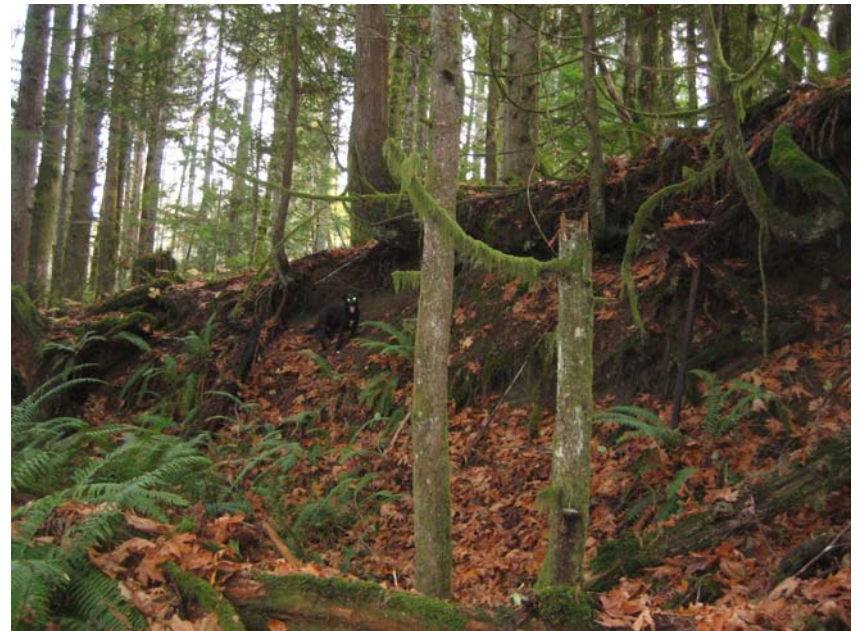
Approximately 200m from the river, a long continuous near vertical scarp approximately 2 to 3m in height was noted trending sub-parallel to the river. Topography immediately above the crest of the scarp appeared to flatten with the ground surface below the scarp appearing hummocky. Soils exposed in this scarp were generally very dense silty SAND with some gravel, cobbles and small boulders (till-like soils). Vegetation in the area of the scarp generally consisted of ferns and deciduous trees with some stumps likely left from previous logging. No changes to the scarp from the Summer reconnaissance were noted during our Fall reconnaissance.

The larger scarp above an active slope area (OP #20) appears to be much older than soil failures noted closer to the river. Re-activation of this failure would likely have a significant impact on the river in terms of soil deposition as this feature may involve movement of the entire slope between the scarp and the river. Should this older failure re-mobilize, it is possible soil debris could move into the river will restricting flow and generating a large silt load.

PHOTO 14 – OP #20 – Scarp
approximately 2 to 3m Height
November 4, 2009

As discussed previously, there is potential for large scale slope failures to occur. These failures could possibly impact the river by impeding flow and/or generating increased SILT load. Our expectation is that movement of these large scale failures would be progressive (incremental with time) rather than a sudden large scale movement. Therefore, monitoring of slope movement could be considered as a means of characterizing the rate of slope movement and the risk that this movement may present to the river. Monitoring should encompass the area from the river bank to a point above the large scarp about 200m

from the river. Data collected should include horizontal and vertical positions of points marked in the field in such a manner as to be easily found for several years. Measurements taken approximately every 6 months should be sufficient to assess the extent of possible slope movement. Should significant slope movement be identified by monitoring, increased frequency of monitoring should be undertaken and mitigation plans developed if necessary.
