**Detailed Terrain Stability Mapping
In the Ellis Creek Community Watershed
and the Steward Creek Watershed,
Penticton Forest District, BC**

PGL File #648-02.01

November 2000

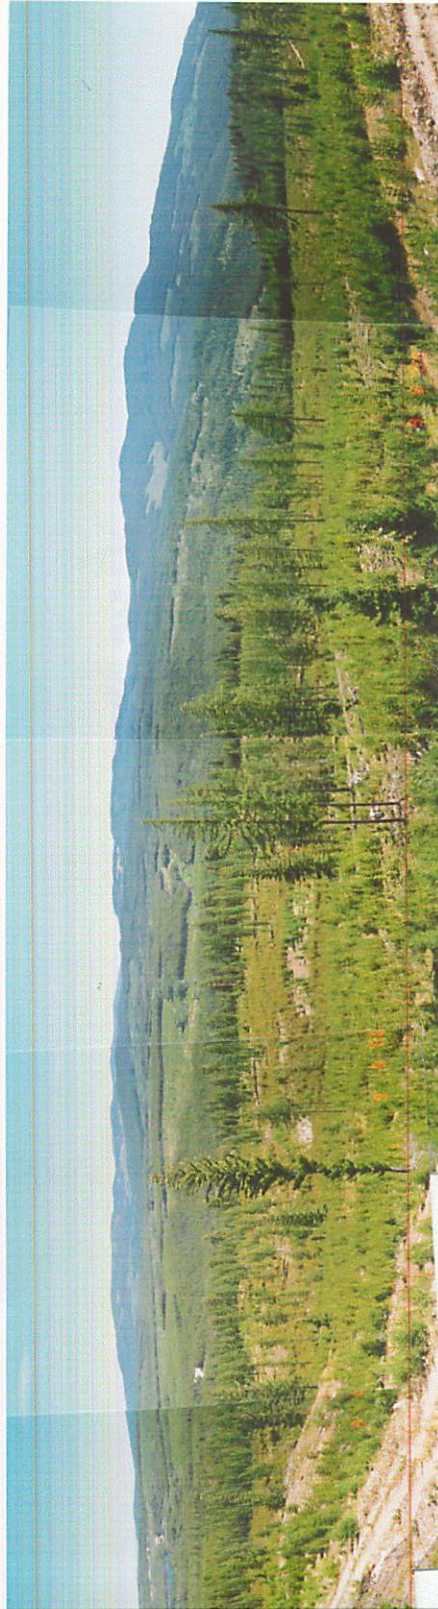
The study area is within the Okanagan Highlands subdivision of the Interior Plateau physiographic region (Figure 1; Photo 1). Elevations extend from 540m a.s.l. where Ellis Creek crosses the study area boundary to roughly 2,000m a.s.l. in both the north and south. The largely bedrock controlled topography can be divided into two general areas: the fluvial/glaciofluvial channel through Ellis Canyon along the lower sections of Ellis Creek and North Ellis Creek and the rolling highlands and glacially rounded mountains and ridges to the east and to the north and south respectively.

Gently sloping topography of largely glacial origin exists over much of the study area between the elevations of 1,200m and 1,600m a.s.l. (Photo 1). The largest portion of this highland is situated between the main stem of Ellis Creek and South Ellis Creek. It is characterized by variably thick glaciolacustrine and till deposits surrounded at higher elevations by thick accumulations of glaciofluvial sands. In the northwest of the study area, the highland is strongly bedrock controlled, with rock drumlins locally evident on the surrounding ridges. A peat bog large enough to support commercial production occurs at the headwaters of Steward Creek, where a mantle of till and local glaciofluvial terraces even out the underlying bedrock topography.

Glaciofluvial deposits range from large kame terraces at roughly 1,100m on the rim of Ellis Canyon (Photo 1) to more isolated smaller tributary fans at 1,600m a.s.l. (Photo 8). Meltwater channel sediments are abundant above roughly 1,600m a.s.l. on Ellis Creek and North Ellis Creek and above roughly 1,400m a.s.l. on South Ellis Creek. Common textures observed include coarse sand and rounded to sub-rounded gravel, cobbles and boulders. Cobble and boulders are predominantly granitoid in composition. Weak bedding is marked by rare discontinuous beds of silt and fine to coarse sand (Photo 9). Meltwater channels include ridged deposits of sub-angular to sub-rounded boulders (Photo 10). Eskers, the remnants of meltwater streams deposited at the base or within melting glacier ice, are infrequent on the plateau.

Photo 1 - View to south overlooking Ellis Creek watershed with Mount Christie on the skyline to the right side. The Ellis penstock is situated at the extreme left. Note the gentle rolling topography to the central highland area and the glaciofluvial terrace (field inspection site DWT-129) extending across the foreground to the far right.

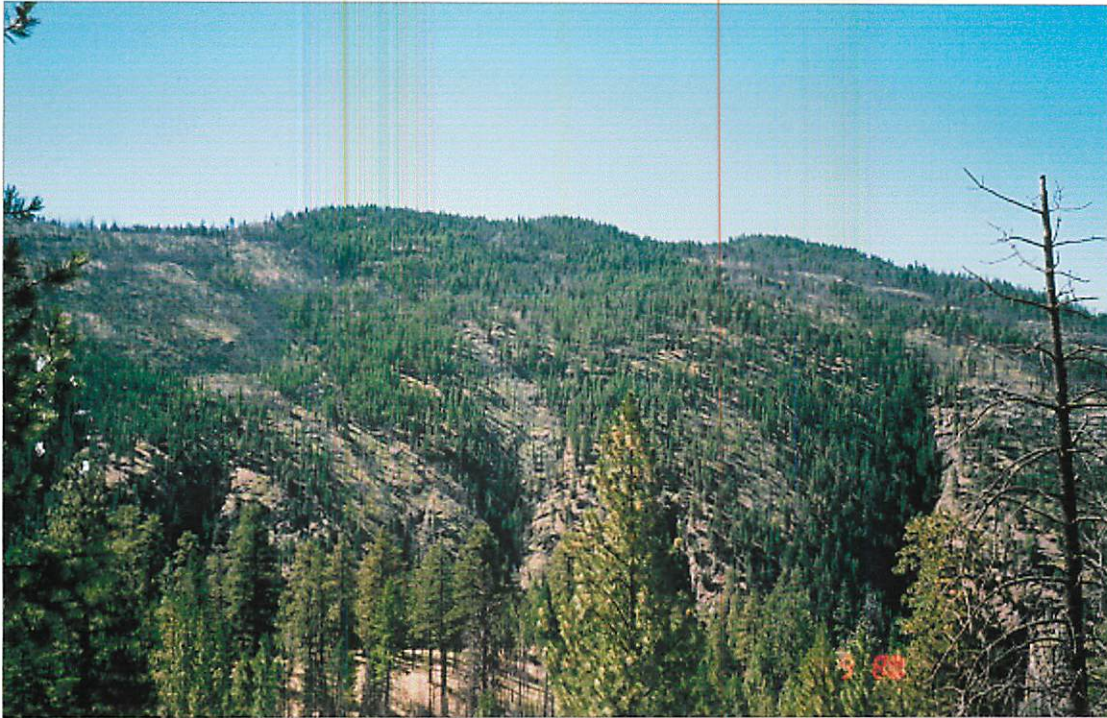
Ellis Canyon is a steep, stream-cut bedrock channel ranging between 100 and 300 metres deep (Photo 2). Surficial deposits within the canyon are limited. In the lower sections, bedrock failures and minor rock fall contribute to cones of colluvium that are generally localized within gullies. Surficial deposits are more abundant in the upper sections of the canyon where paleo-channel sediments have been preserved under a compact veneer of moraine. Glaciofluvial terraces are common along the upper edges of the canyon.

Photo 2 - View to south of lower Ellis Canyon and bedrock hillocks typical of the west part of the Study area.

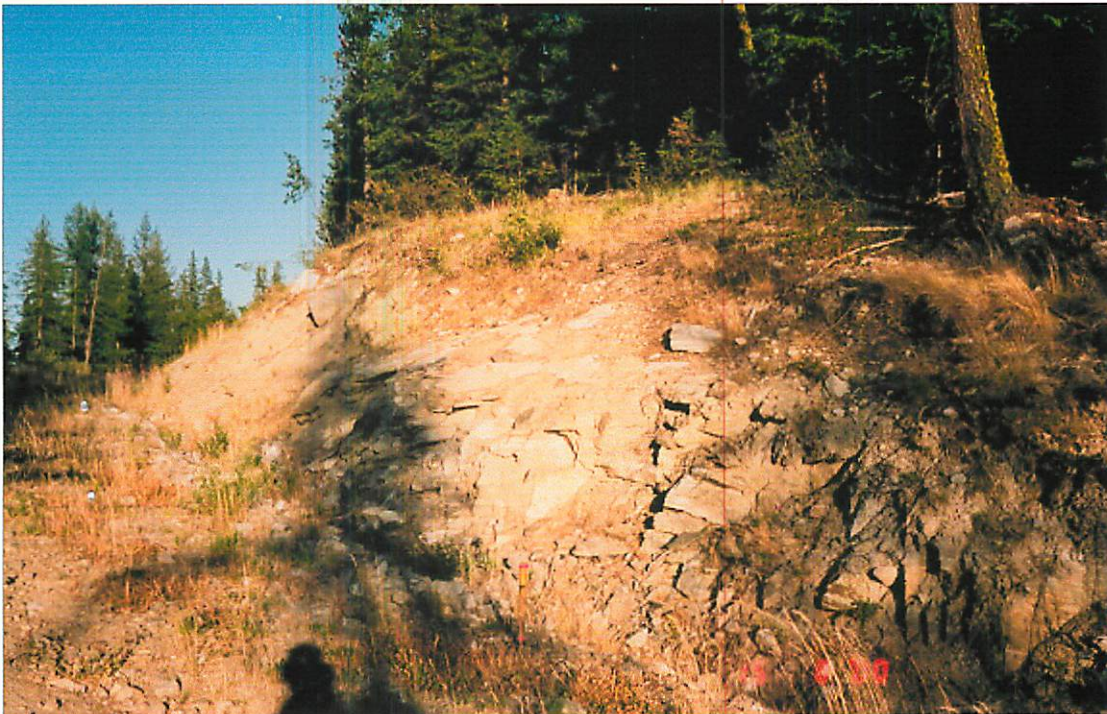
Photo 3 - Rolling topography typical of the lower slopes of Mount Christie. Note bedrock controlled mantle of moraine (field inspection site DWT-110).

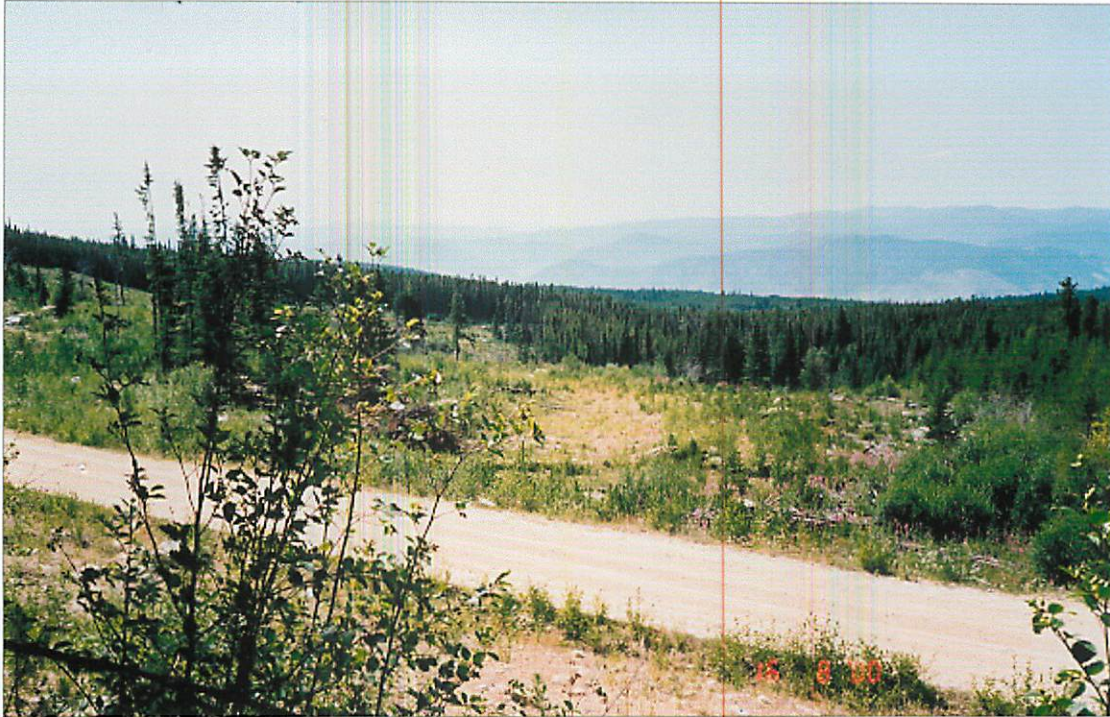
Photo 4 - View to west looking into the Steward Creek watershed from Ellis Creek FSR near the north boundary of the study area. Note gentle rolling topography of bedrock controlled moraine (field inspection site DWT-118).

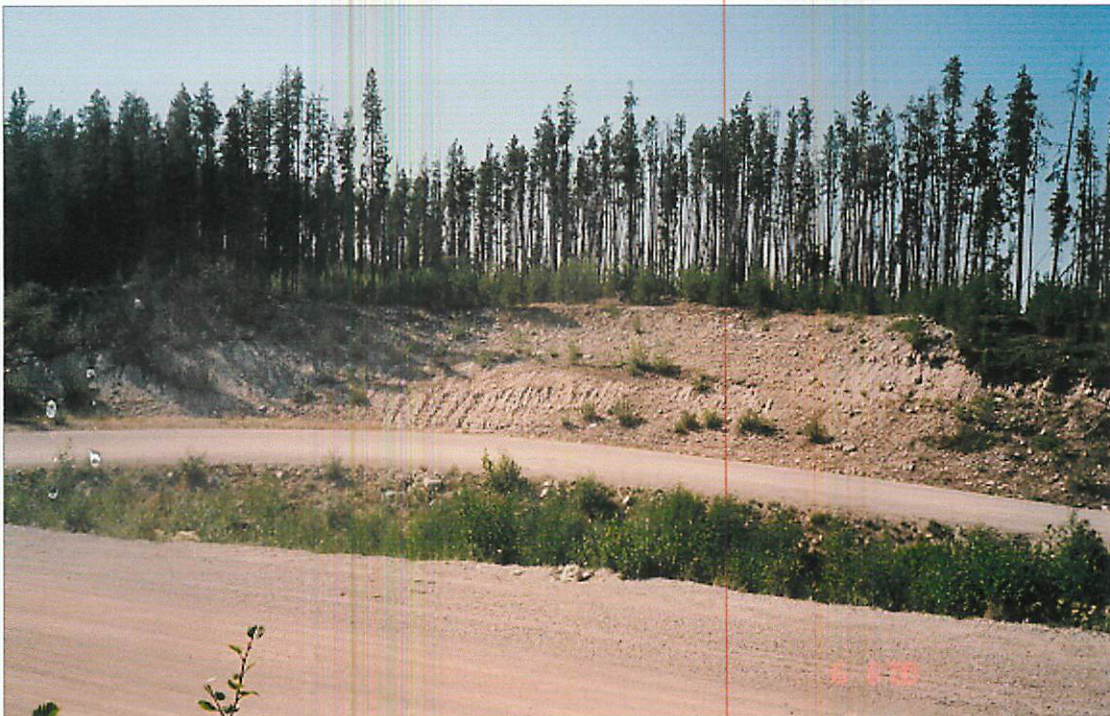
Photo 5 - Glaciofluvial blanket over moraine located at roughly 32km on the 201 FSR. Note rills developed in moraine (field inspection site DWT-120).

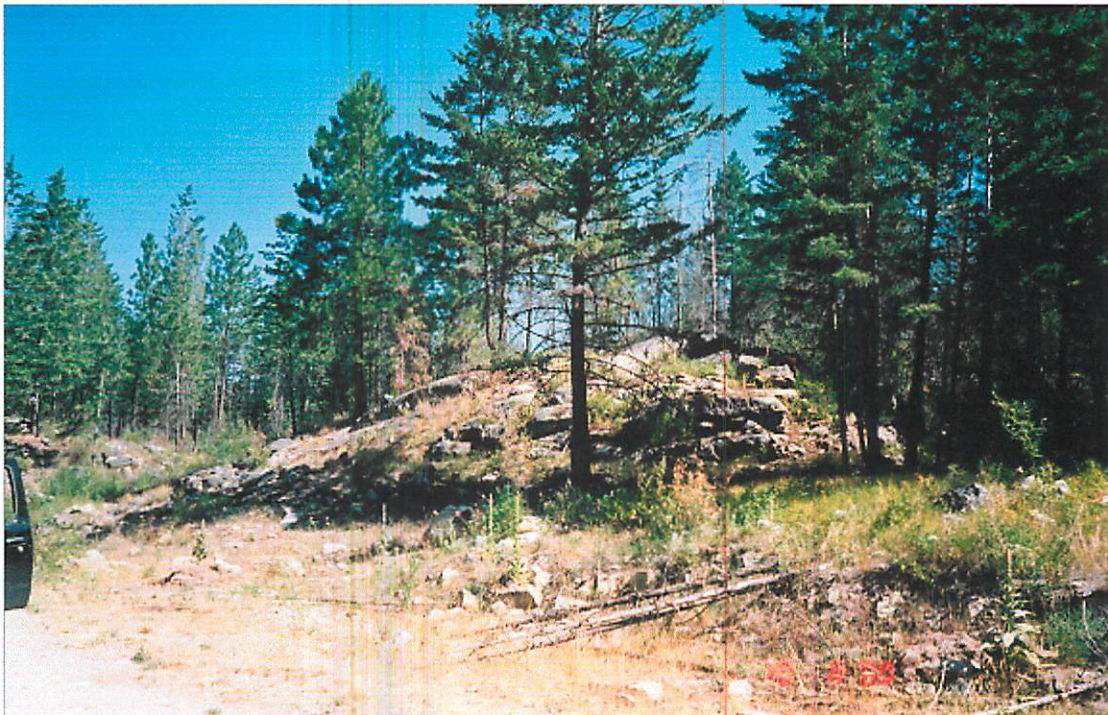
Photo 6 - Rolling bedrock ridges and moraine infilled depressions typical of the northwest part of the study area. Located on the Steward Creek FSR (field inspection site DWT-14).

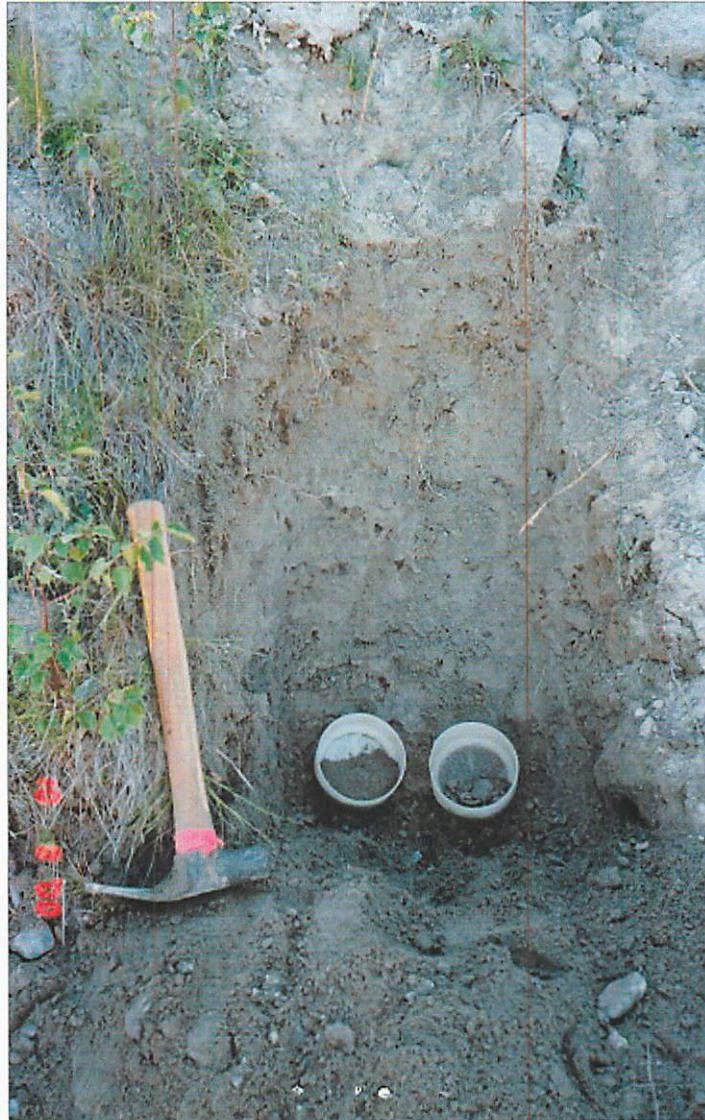
Textures found in the basal till are dominated by a matrix of silt with 10%-50% coarse sand and abundant clasts of sub-angular to sub-rounded pebbles and cobbles of granitoid gneisses and intrusives (Photo 7). Clay is only present in minor proportions.

Photo 7 - Exposure of moraine with plus and minus 2mm fractions shown. Minus 2mm fraction is comprised predominantly of silt with less than 20% sand (field inspection site DWT-11).

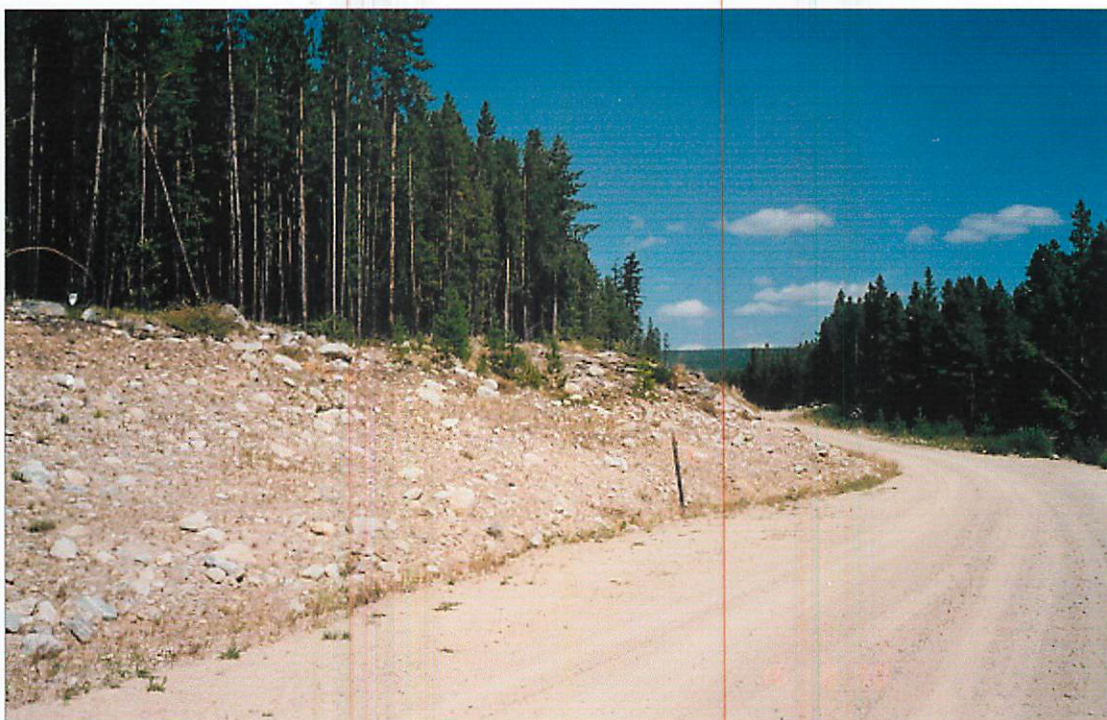
Photo 8 - Isolated glaciofluvial fan deposited directly on bedrock located at an elevation of 1,550m a.s.l. on the Ellis Creek FSR. (field inspection site DWT-125)

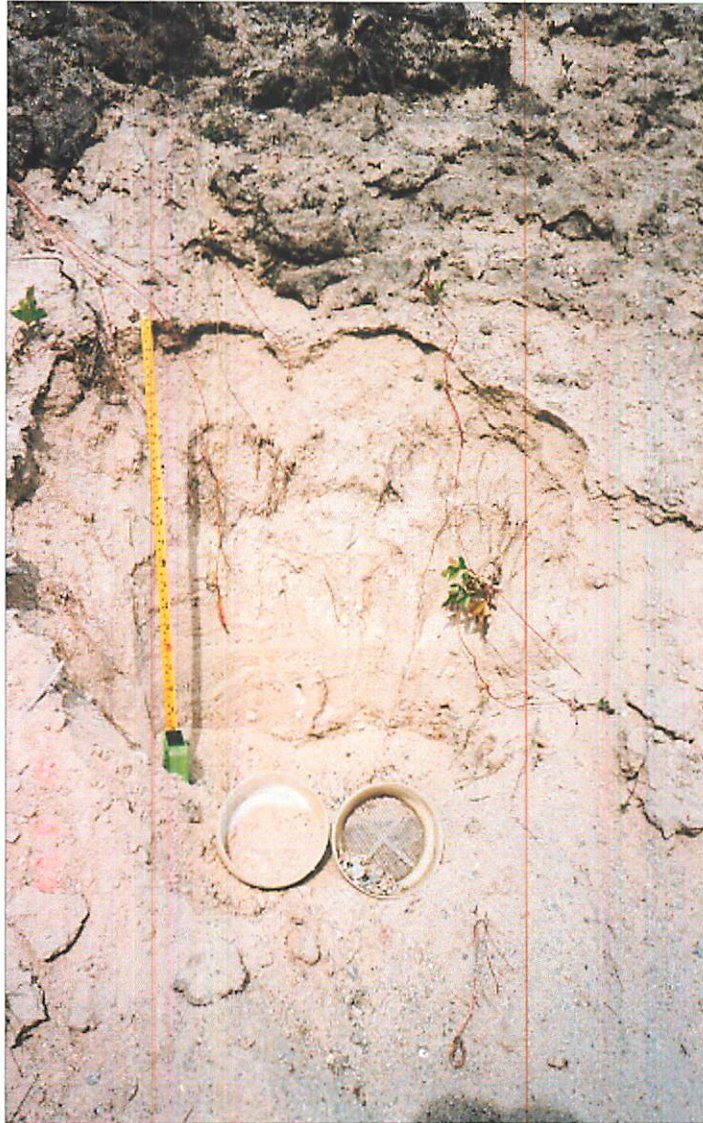
Photo 9 - Exposure of glaciofluvial sand and gravel with plus and minus 2mm fractions shown. Minus 2mm fraction is composed predominantly of medium grained sand with minor silt. Note weak bedding in the exposure. Sediments shown overlie glaciolacustrine sediments shown in Photo 12. Location is at roughly 1km on the Ellis Creek FSR (field inspection site DWT-20).

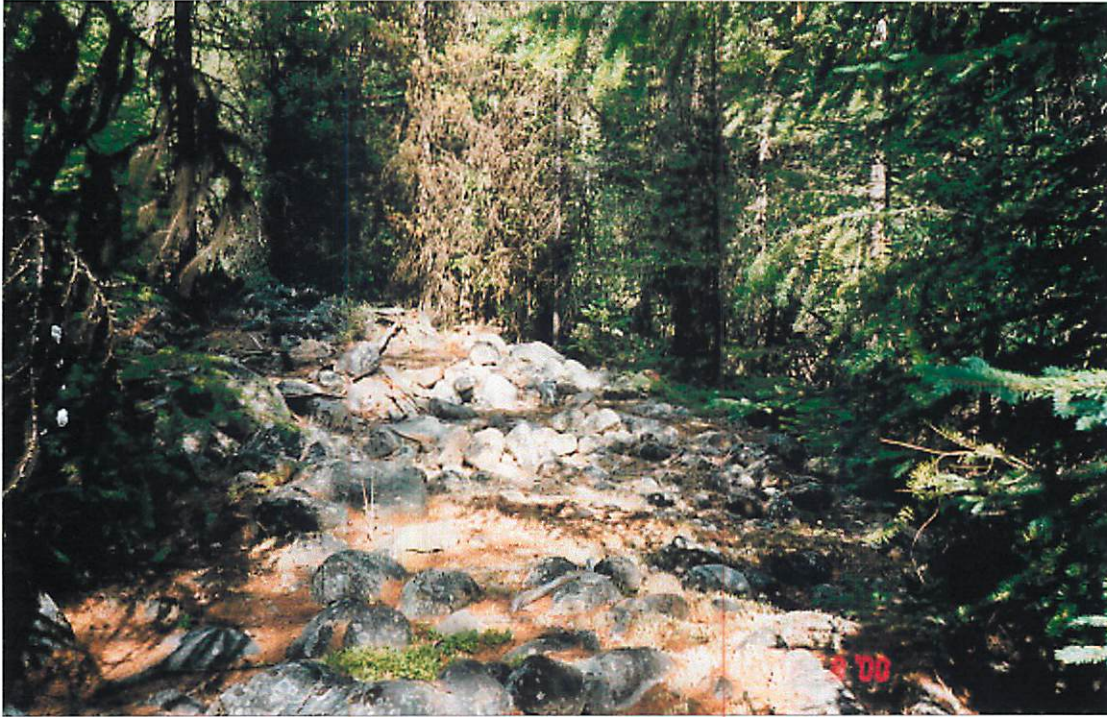
Photo 10 - Glaciofluvial deposit of boulders mark meltwater channel along the edge of the present Ellis Creek channel. Located near the Ellis Canyon FSR bridge (field inspection site DWT-59).

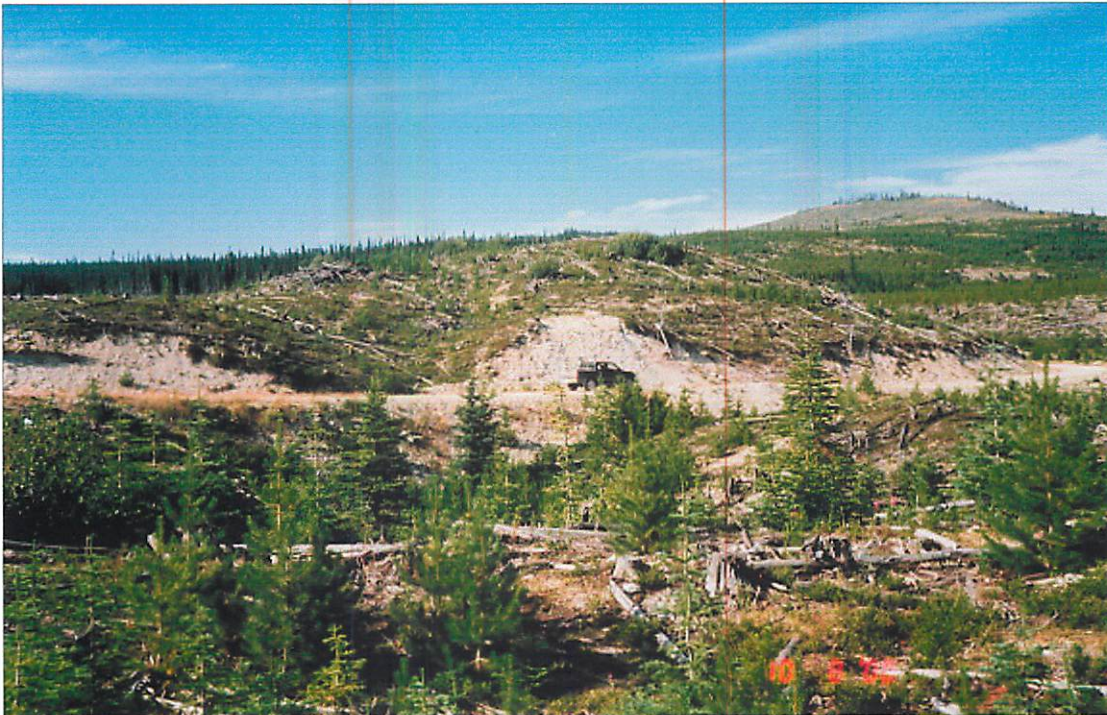
Poorly consolidated glaciolacustrine and glaciofluvial sediments are particularly susceptible to undercutting by excess runoff flows. These conditions are limited, as most streams in the plateau are underfit relative to the channel they occupy. Undercutting occurs during seasonally elevated flows along the meltwater channel now used as a spillway for the Ellis Penstock (Photo 23). Steep rock cliffs formed by glacial meltwater occur along the ridges that form the study area boundary. Stability issues are largely limited to minor rockfall. Sandy glaciofluvial deposits are susceptible to minor ravelling along road cuts (Photo 11).

Photo 11 - Glaciofluvial deposits typical of the mid-elevation slopes surrounding the headwaters of Ellis Creek. Note abundant boulders in road-cut exposures and large kettle depression in foreground. Located at an elevation of 1,640m a.s.l. on the Ellis Carmi FSR (field inspection site DD-75).

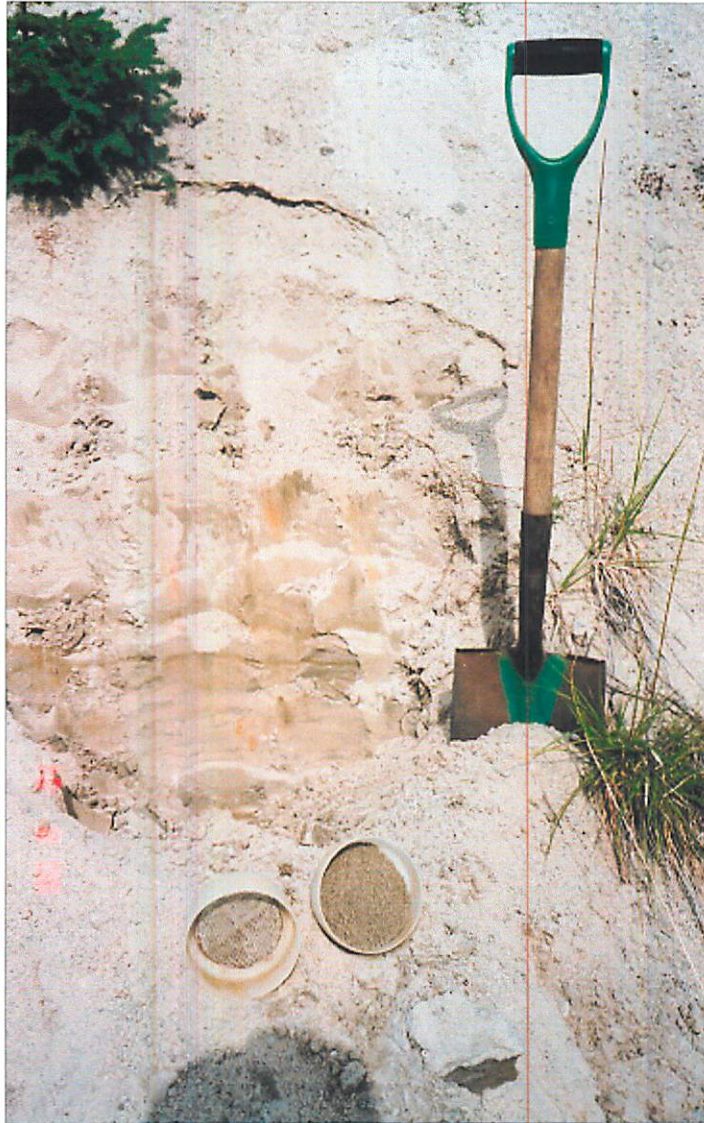
Photo 12 - Exposure of glaciolacustrine silt and fine sand with plus and minus 2mm fractions shown. Entire exposure is composed of silt and minor fine grained sand. Note weak bedding in the exposure. Sediments shown underlie glaciofluvial sediments shown in Photo 11. Location is at roughly 1km on the Ellis Creek FSR (field inspection site DWT-20).

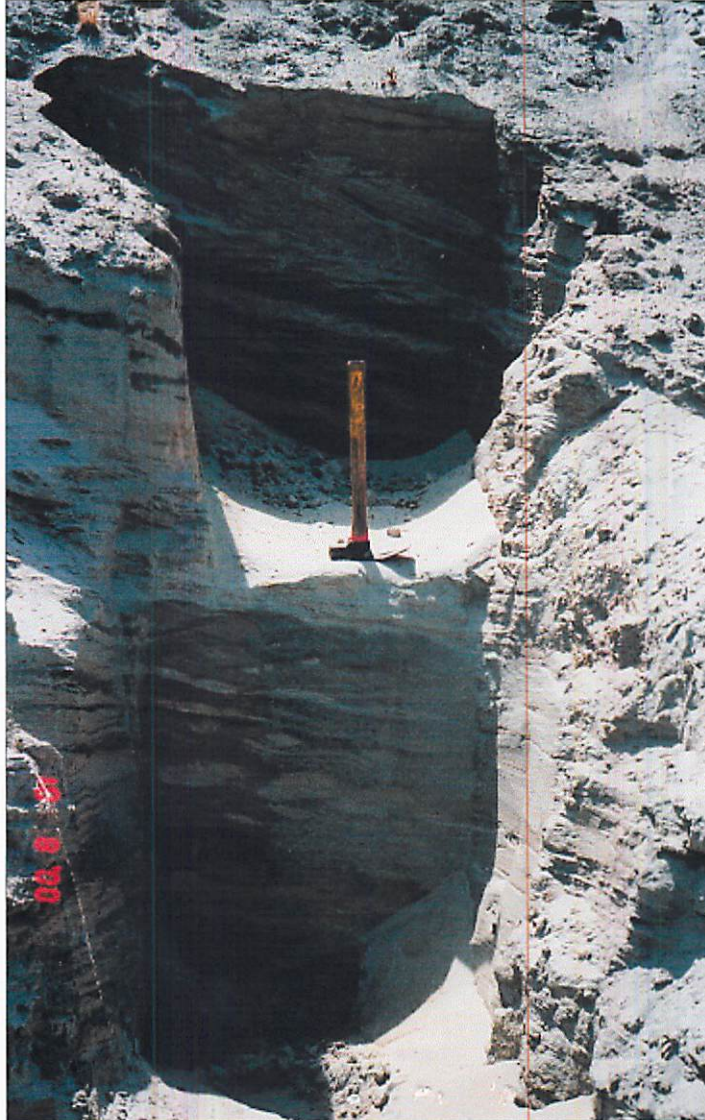
Photo 13 - Exposure of glaciolacustrine sand looking south. Total depth of deposit is greater than 6m. Note cross bedding indicating progradational deposition from left to right (east to west). Location is at roughly 12km on the Beavertell Road (field inspection site DWT-17).

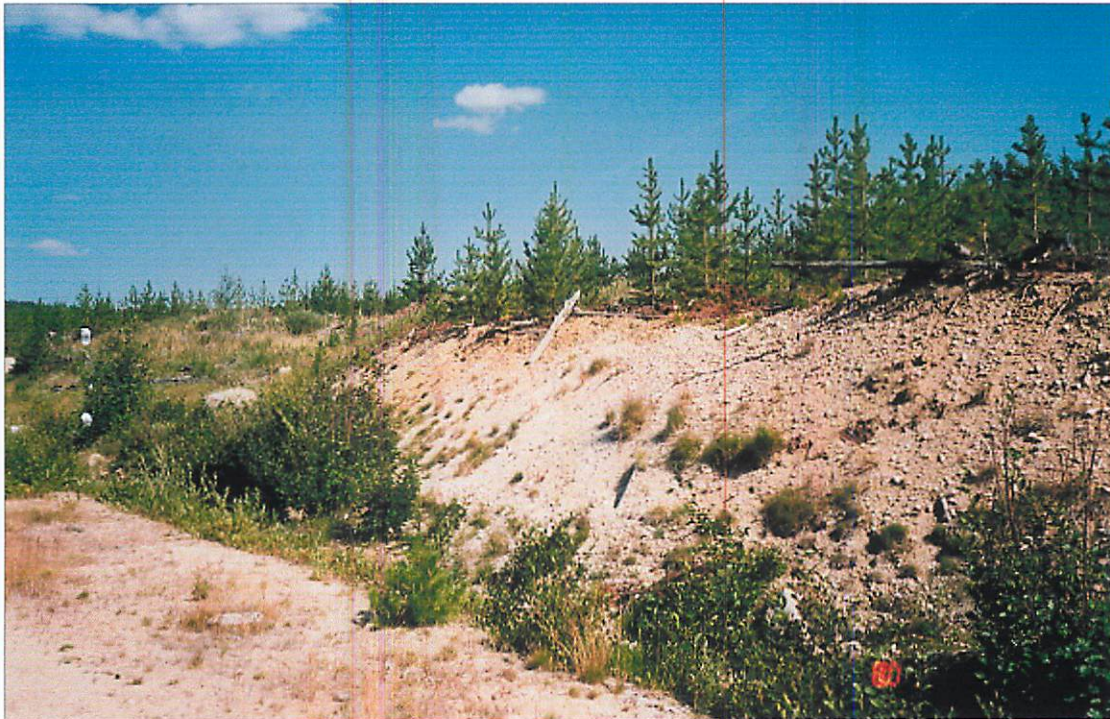
Photo 14 - Raised beach deposit of gravel and sand located just east of 27.5km on the 201 FSR (field inspection site DWT-121).

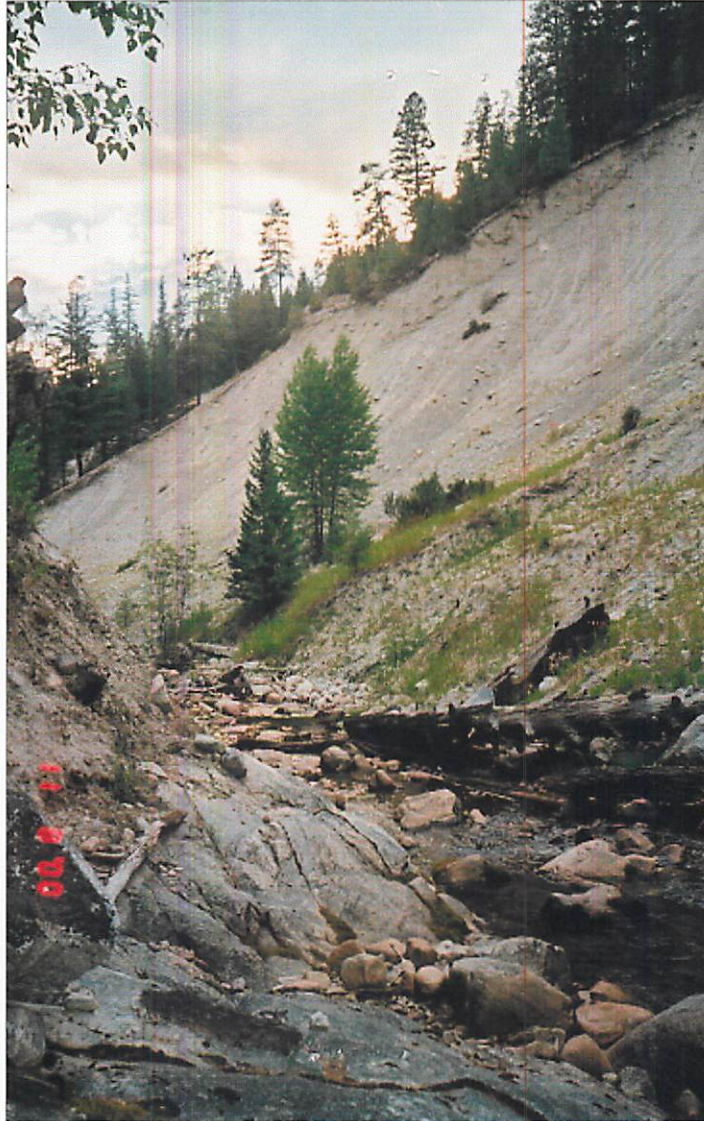
Colluvial deposits are limited in extent within the study area. They are found primarily at the bases of the over-steepened slopes of Ellis Canyon along the lower reaches of Ellis Creek and North Ellis Creek below 1,200m a.s.l. Deposits of sand, gravel and angular boulders form steep cones on the lower slopes and gullies at the base of the rocky cliffs along the lower sections of North Ellis Creek and Ellis Creek. Colluvium from the failure of over-steepened surficial deposits of glacial till and glaciofluvial deposits forms convex fans along Ellis Creek from its confluence with North Ellis Creek (Photo 15). The fans are often truncated by the stream below.

Photo 15 - Cliff exposure of moraine and colluvium in the upper section of Ellis Canyon on Ellis Creek. Note the bedrock in foreground and low amounts of fine sediments in the creek bed in spite of colluvial debris being cut by the creek. Located roughly 300m upstream from the mouth of South Ellis Creek (field inspection site DWT-29).

Extension of the operability boundary east to include the steep, unstable cliffs of surficial material below 1,200m a.s.l. between the mouth of South Ellis Creek and the Ellis Canyon FSR bridges on both Ellis and South Ellis Creeks is also recommended (Photos 15 and 17).

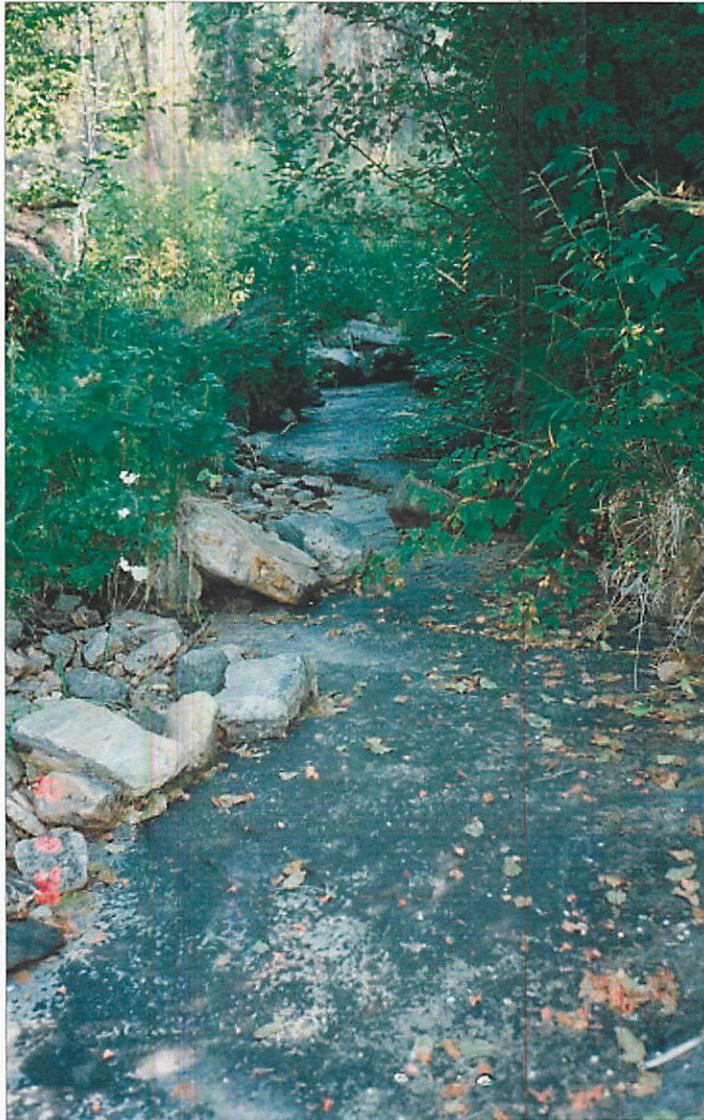
Photo 16 - Main channel of Steward Creek at an elevation of 1,120m a.s.l. (field inspection site DWT-30). Note the lack of fine sediments and dry, shallow bedrock basement.

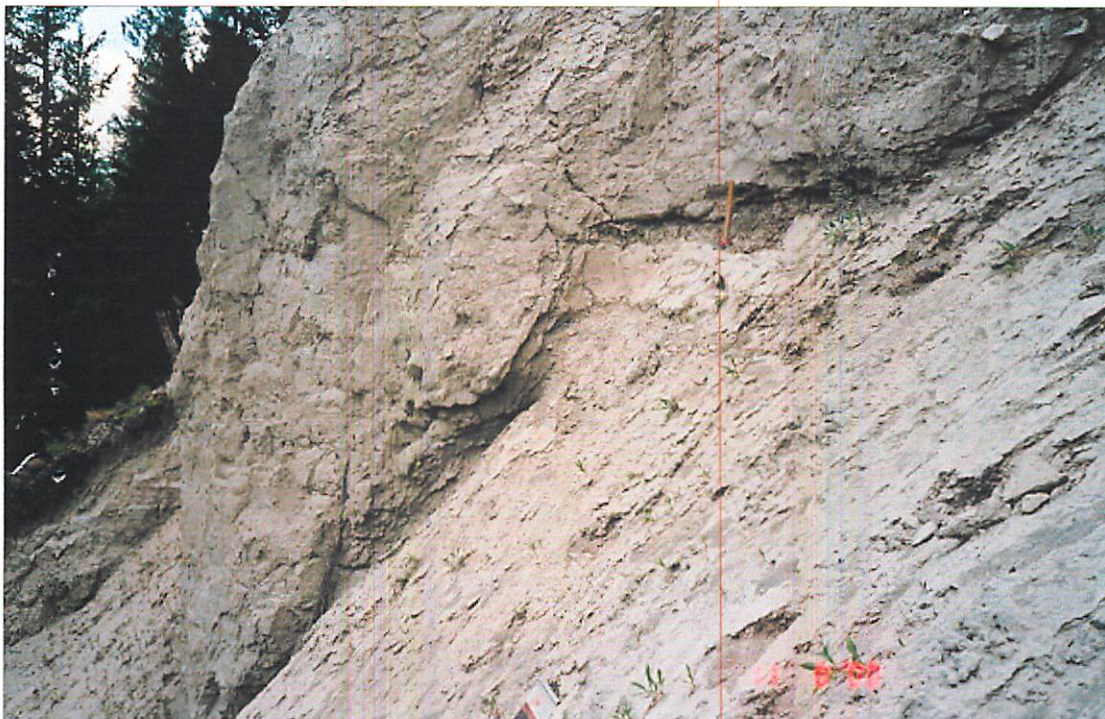
Photo 17 - Blanket of moraine overlying Pre-Wisconsinian sediments of silt, sand, gravel and (not in picture) cobbles and boulders. Note hammer resting on horizon of fine sand. Moraine displays a fabric perpendicular to the eroded face of the underlying sediments. Located roughly 500m upstream of the mouth of South Ellis Creek (field inspection site DWT-28).

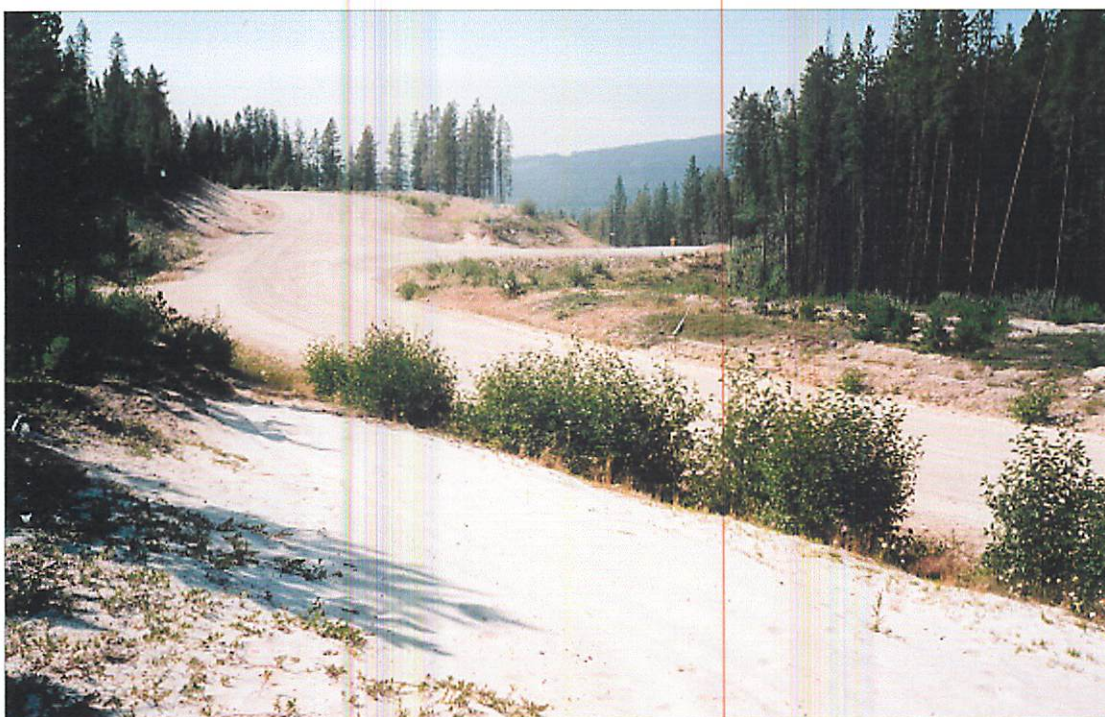
Eolian deposits are minor in the study area. Immediately following deglaciation of the area, the exposed unvegetated surfaces would have been susceptible to wind transport and redeposition. A thin veneer is likely present over much of the plateau area, but does not form a significant, easily recognizable stratigraphic horizon. A small number of locations of fine, very well sorted quartz sand were noted that were likely deposited as dunes. The most notable of these occurs where the Beaverdell Road meets the 201 FSR (Photo 18).

Photo 18 - Eolian sand deposit located at the junction of the Beaverdell Road and the 201 FSR (field inspection site DWT-132). Roadcuts in the background composed of sand with 10% to 20% gravel.

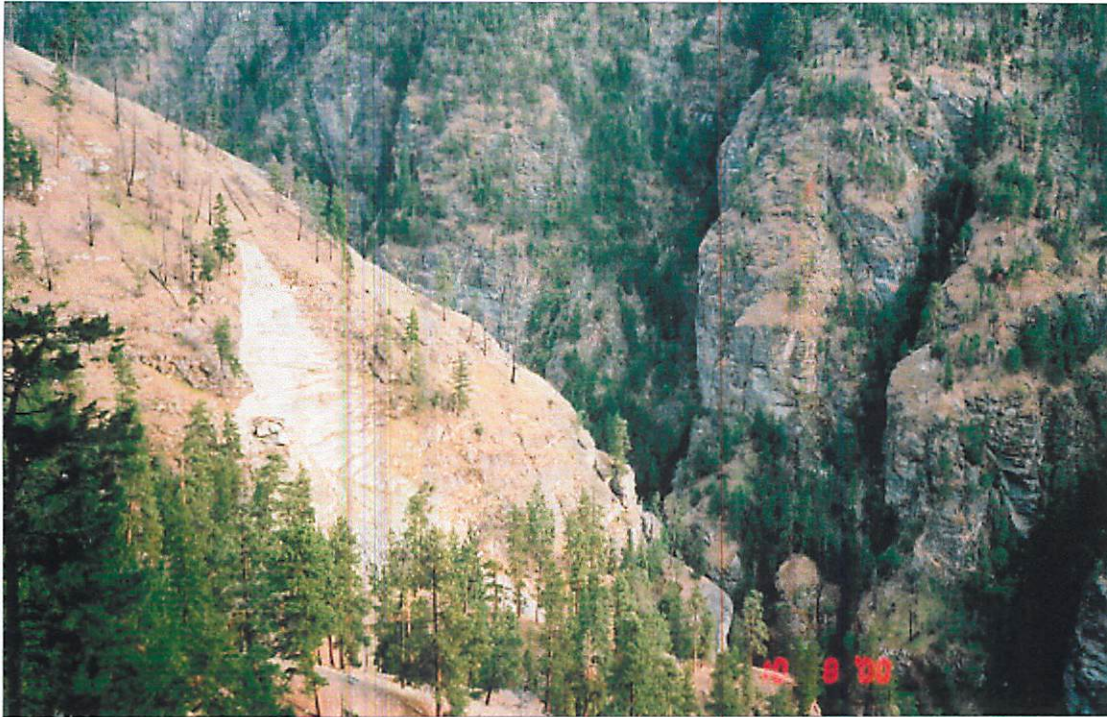
Photo 19 - Steep rock cliffs and gullies of Lower Ellis Canyon viewed from the Ellis Canyon Lookout (field inspection site DWT-24). Note large rockslide on ridge to left and moderate slopes above the rim of the canyon covered with a veneer of moraine and colluvium.

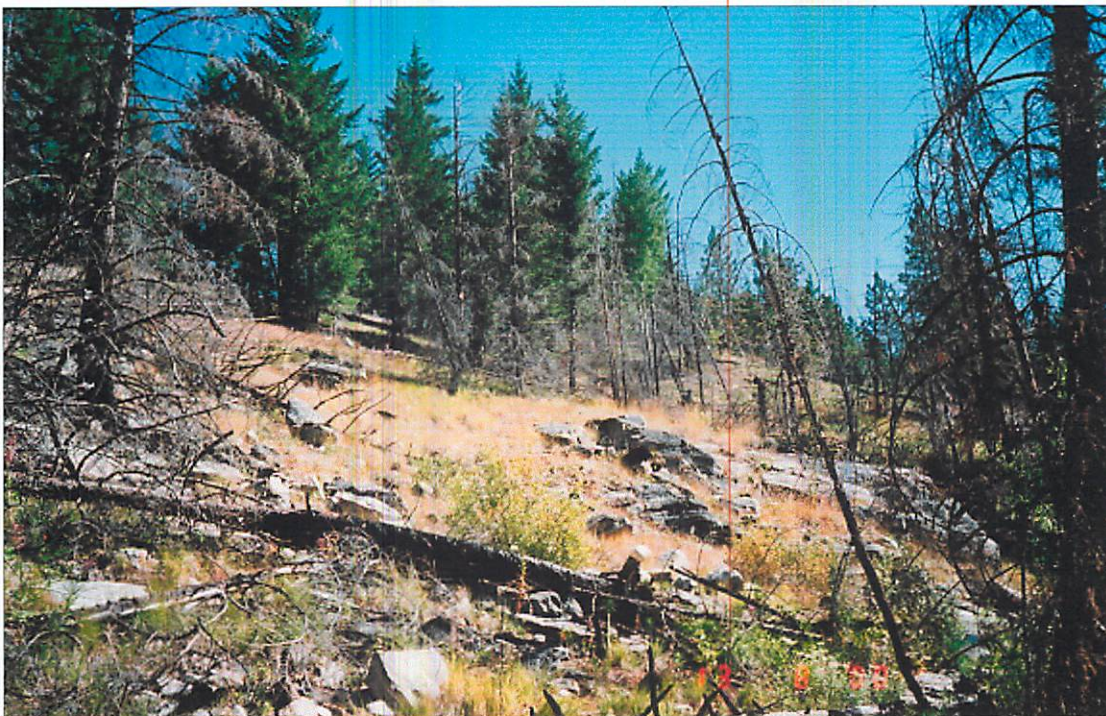
Photo 20 - Mantle of moraine, glaciofluvial sediments and colluvium material forming a moderate slope above the rim of the canyon. Note bedrock exposure to right. Located below Forest Service campground at the Carmi cross-country ski area (field inspection site DWT-51).

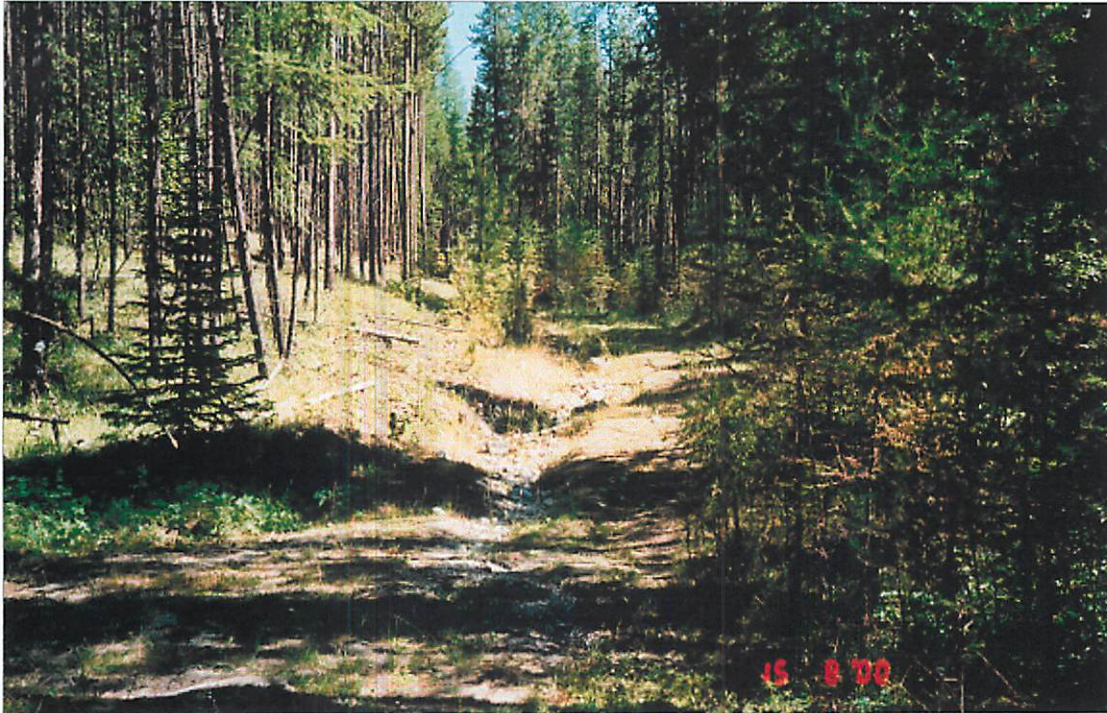
Photo 21 - Old road in South Ellis Creek watershed not properly deactivated (field inspection site DWT99). Note meltwater channel in roadbed and lack of waterbars or culverts. Area was logged some time prior to the 1960s. Site is located roughly 70m upslope from failure shown in Photo 22.

In addition to the above recommendations, it is suggested that an inventory be done of the older, secondary forestry roads in the area. Roads without adequate surface water control measures should be deactivated to standards in keeping with the FPC, specifically in areas of groundwater seepage and surface water runoff on the north facing slopes of Mount Christie. More specifically, waterbars should be installed at the first opportunity on the secondary road above the Ellis Canyon FSR in the lower section of the South Ellis Creek drainage (field inspection site DWT-99). A road running up the fall line of the slope located above the Beavertell Road just west of North Ellis Creek also requires deactivation (field inspection site DWT-16).

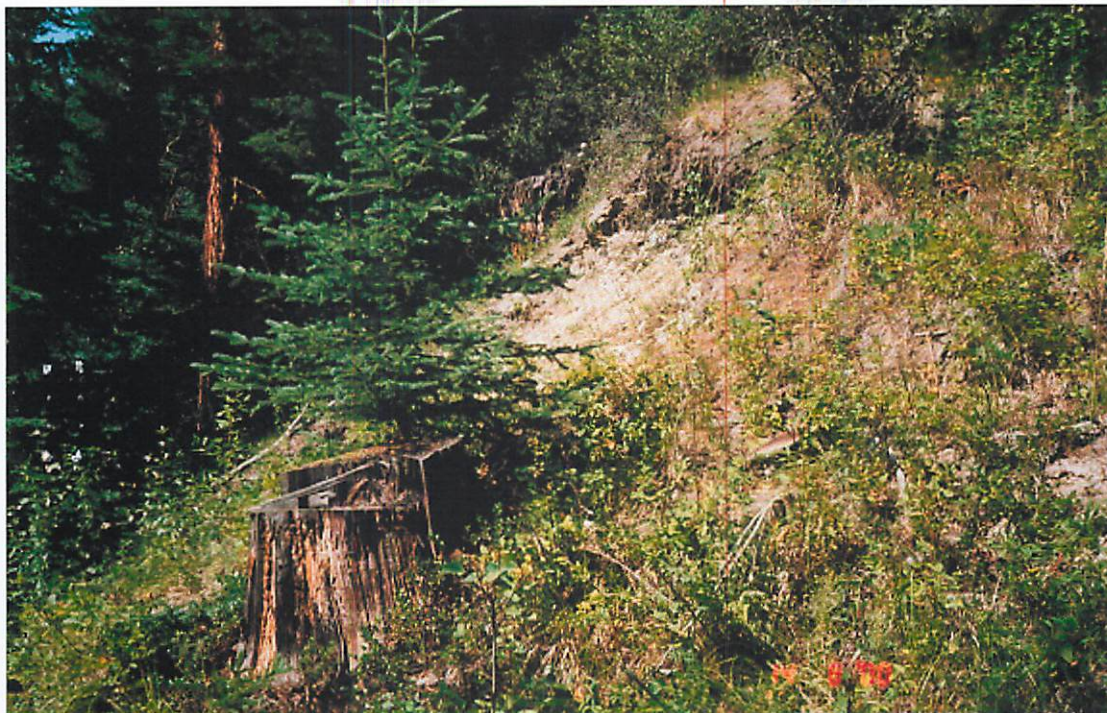
Terrain stability issues are limited in the highland areas. Areas of concern include moderate to steep slopes of moraine where groundwater seepage and surface water collects, typically at the base of long slopes that have been cut by meltwater channels. These conditions occur on the north slopes of Mount Christie, in particular along South Ellis Creek and its tributaries. In one instance along the east bank of South Ellis Creek, poor management of surface water runoff and groundwater seepage along an old road is concentrating flows (Photo 21; field inspection site DWT-99), resulting in a slow mass movement roughly 70m downslope (Photo 22; field inspection

site DWT-84). The failure has occurred on a slope with a gradient of only 50%.

Photo 22 - Slow mass wasting failure in moraine on east bank of meltwater channel located roughly 400m upstream from the South Ellis Creek bridge (field inspection site DWT-84). Site is located roughly 70m downslope from road shown in Photo 21.

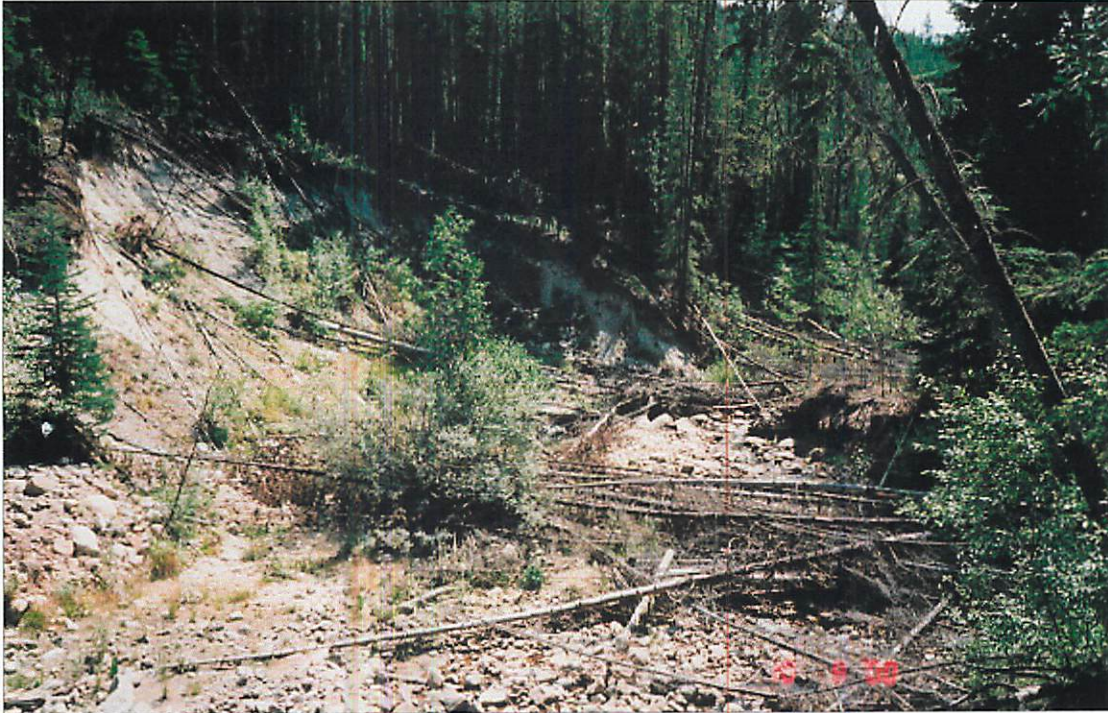
Photo 23 - Meltwater channel where flows from Ellis penstock spillway have undercut glaciolacustrine sediments (field inspection site DWT-18). Note sedimentation in streambed. Located at roughly 12km on the Beavardell Road at the same site as Photo 13.
