**UPGRADE OF
TERRAIN CLASSIFICATION, TERRAIN STABILITY, SURFACE
EROSION POTENTIAL, AND SEDIMENT DELIVERY
POTENTIAL OF
TRANQUILLE-WATCHING AND PETERSON-ROSEN
COMMUNITY WATERSHEDS**

WEYERHAEUSER COMPANY LIMITED
Kamloops Operating Unit

Denny Maynard, M.Sc., P.Geo
DENNY MAYNARD & ASSOCIATES LTD.
North Vancouver, BC

March 2002

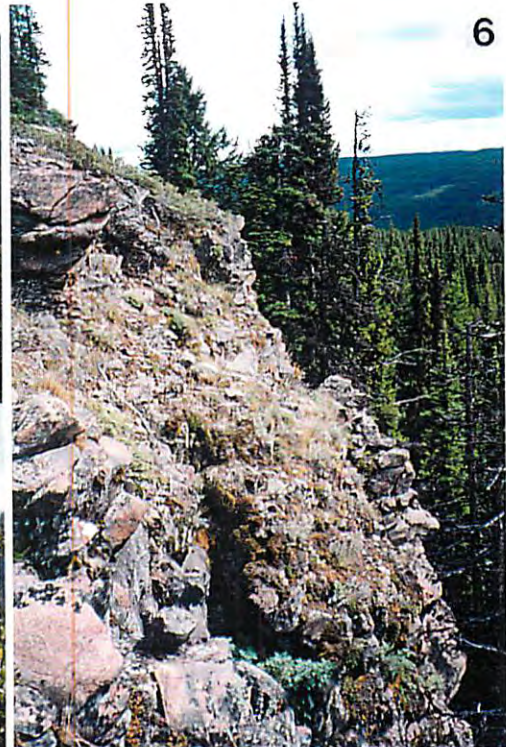
- Photo 6 Typical cliff-face exposure of plateau lava, bordered on top by subdued rocky terrain (usually class II) and at the toe slope by gentle to moderate-gradient surficial deposits (may be class I, II, or III). These cliffs are rated class IV because of steepness; this is site DM 211 along the south side of Porcupine Ridge.

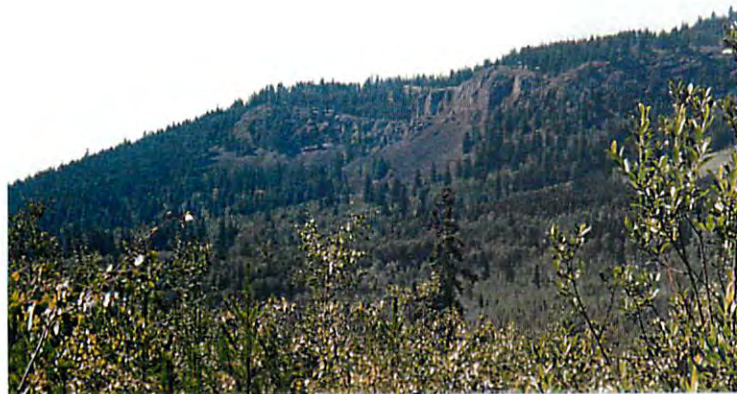
- Photo 5 West of mid Watching Creek (site DM 42) this prominent plateau-lava cliff features a relict landslide. An apparent slump block of intact rock can be seen surrounded by talus; movement was probably in association with the loss of buttressing support during deglaciation. The steep rock-colluvial face is mapped as stability class IV.

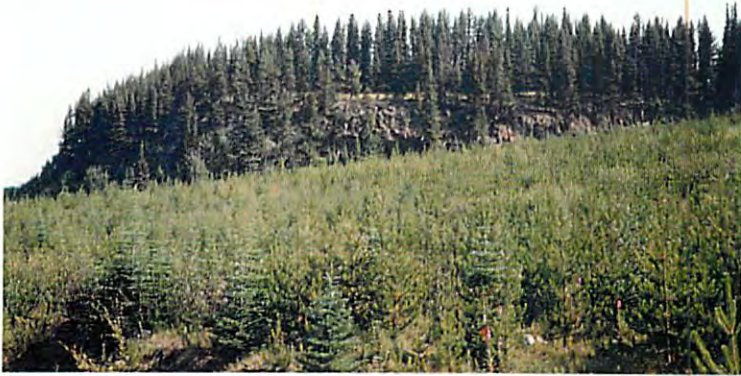
- Photo 7 Horizontal view of a typical plateau-lava cliff line. Although this is a different location than in photo 6 (site TR 29), the terrain is similar with a subdued class II upland, a class IV steep cliff, and till-mantled class II-III toe-slopes.

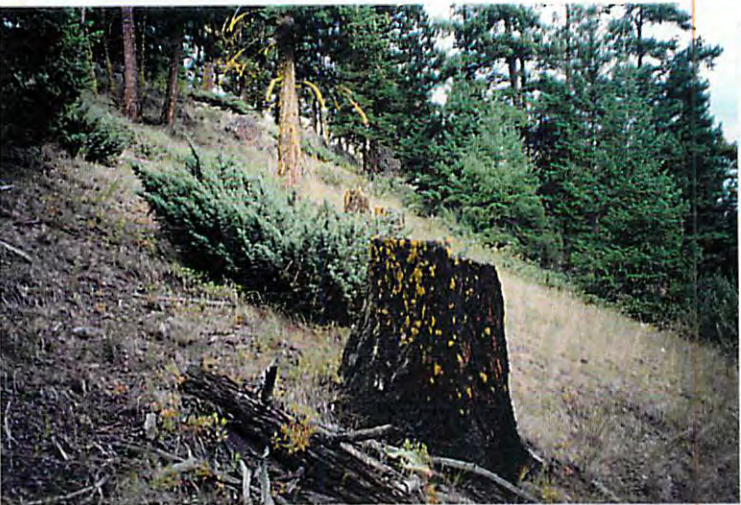
- Photo 11 Coarse colluvial rubble and blocks are often found directly below higher cliffs. Minor rockfall may occur but the steep faces are considered to be class IV (site DM 249 near Peterson Creek). Uniform colluvial slopes at less than 70% gradient are stability class III.

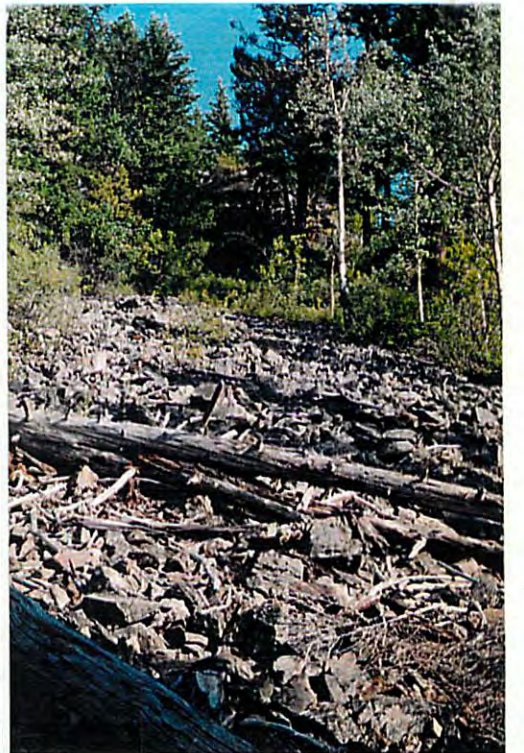
- Photo 12 Large blocks of volcanic rock have broken from the adjacent cliff creating a band of open talus. Much of this weathering was probably early deglacial and is not considered an active process.

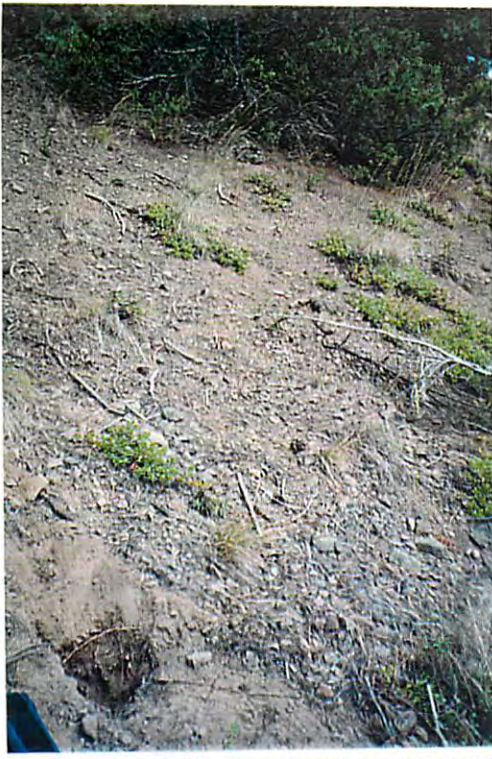
- Photo 13 Active creep on thick, sandy rubbly colluvium (site DM 147); slope gradient at site is only 45% and the amount of bare soil may be the result of high-use winter range on the south-westerly aspect, valley wall above Tranquille River.

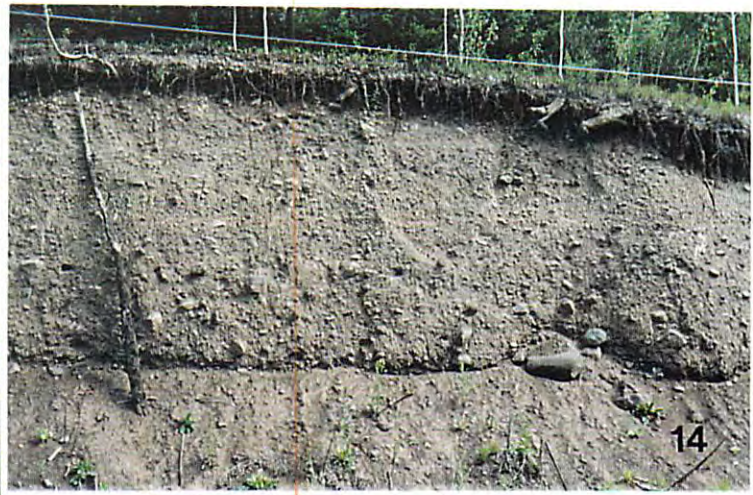
- Photo 14 Exposure of typical basal till (site DM 207) seen in a Tranquille Valley road-cut.
- Photo 15 Headwall of a failure along Watching Creek scarp (site DM 39) exposes about 5 m of till (gray material in background) overlying weathered bedrock (brownish foreground); stability class V and high erosion potential.

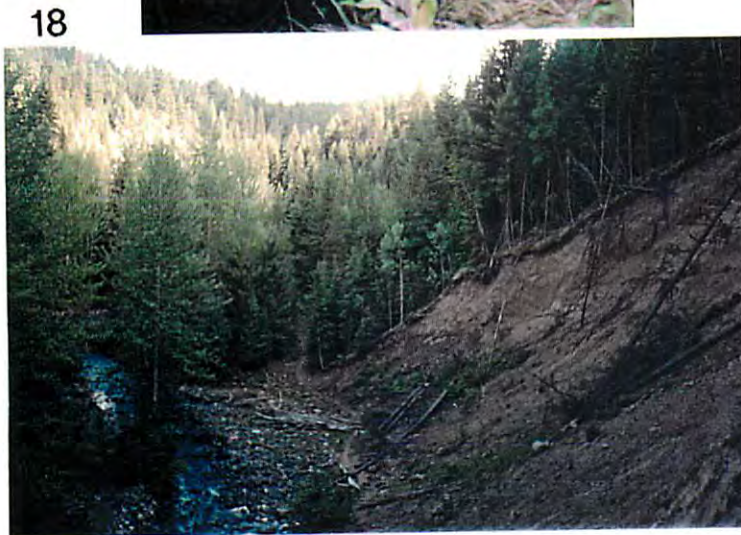
- Photo 18 Thick sequence of gravels and sand in a high glaciofluvial terrace scarp bordering Tranquille River (Site TR71) is actively destabilized by seasonal undercutting during high flows.

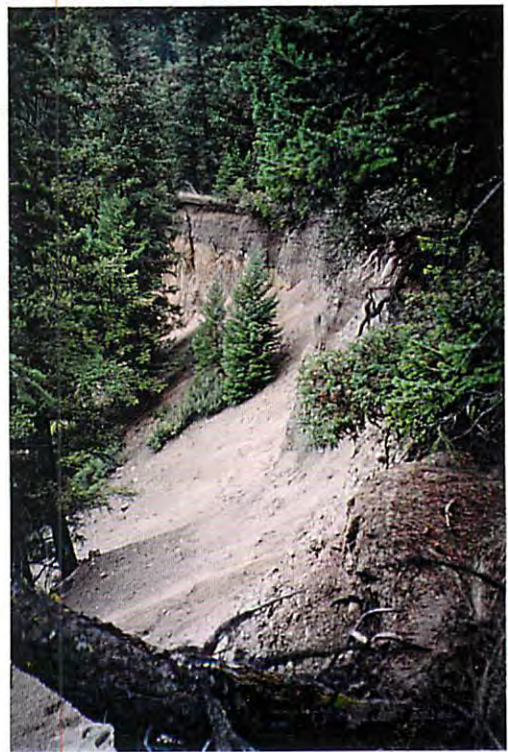
- Photo 17 Prominent landslide headwall in thick till along the scarp bordering upper Tranquille River (site DM 228); stability class V and very high erosion potential occur in this area.

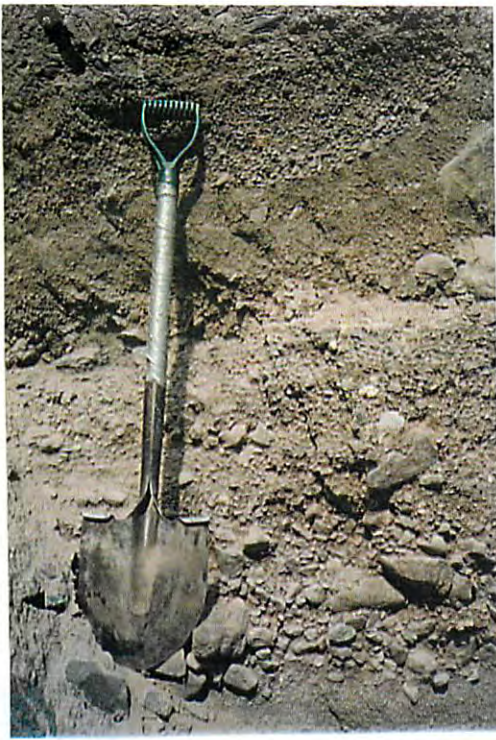
- Photo 19 Sorted pebbles and sands occurring in the scarp seen in photo 18.
- Photo 20 Small debris slide in a dry, but steep scarp segment of glaciofluvial gravels bordering mid Watching Creek (site TR 23); stability class V.
- Photo 21 Small slump-flows initiate on steep, fine-textured till scarp bordering upper Watching Creek (site DM 32); stability class V.
- Photo 22 Old slump scar on a low till scarp south of Tranquille Lake (site DM 76). Failure may have followed wildfire disturbance as slope gradients are not extreme nor is the site excessively wet; a small polygon is given a stability class IV rating.
- Photo 23 High confining bank of Watching Creek (site DM 35, upstream from photo 21) is failing where being actively undercut. Ravelling colluvium and crumbling bedrock are undermining till at the scarp crest; stability class V.
