CANOE CREEK INDIAN BAND

COMPLETION REPORT CONCERNING IMPROVEMENTS
TO THE DOG CREEK VILLAGE SPRING

PACIFIC HYDROLOGY CONSULTANTS LTD.
OCTOBER 13, 1989

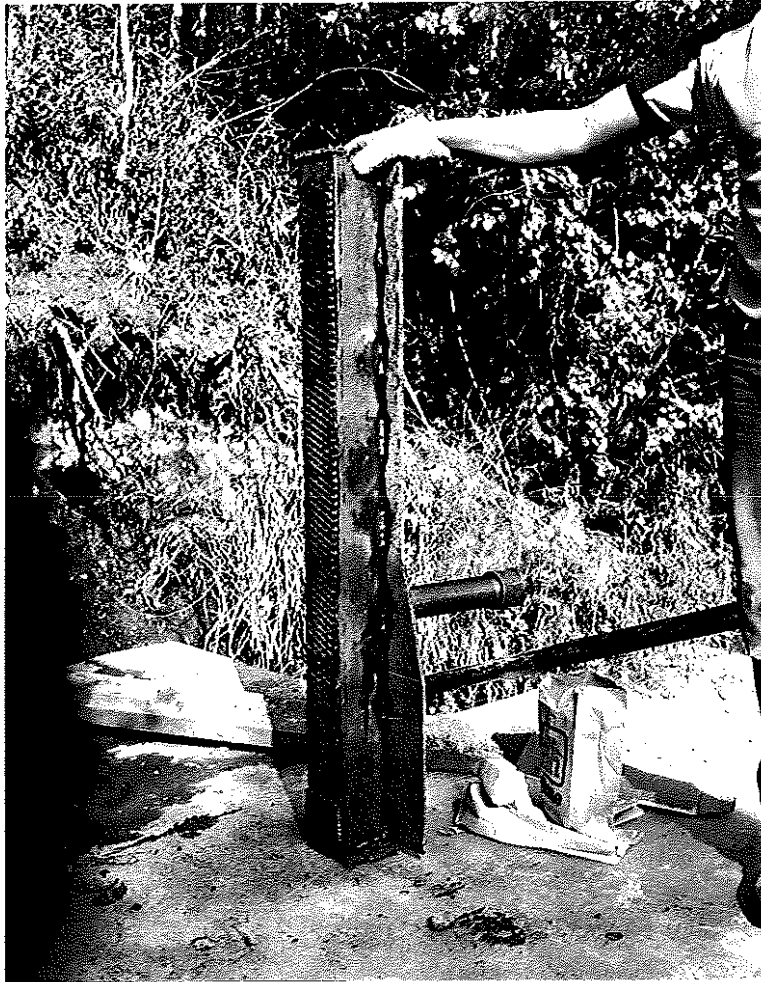
Photograph 1.

extends about 5 cm (2") below the bottom of the square tubing and several centimetres above it and beyond both ends, as shown on Photograph 1 in the attachments.

Collector for west spring discharge fabricated from square steel tubing, 6 mm ($\frac{1}{4}$ ") plate and expanded metal. Photograph is a bottom view showing the plate extending below the tubing; the outlet pipe can be seen on the right.

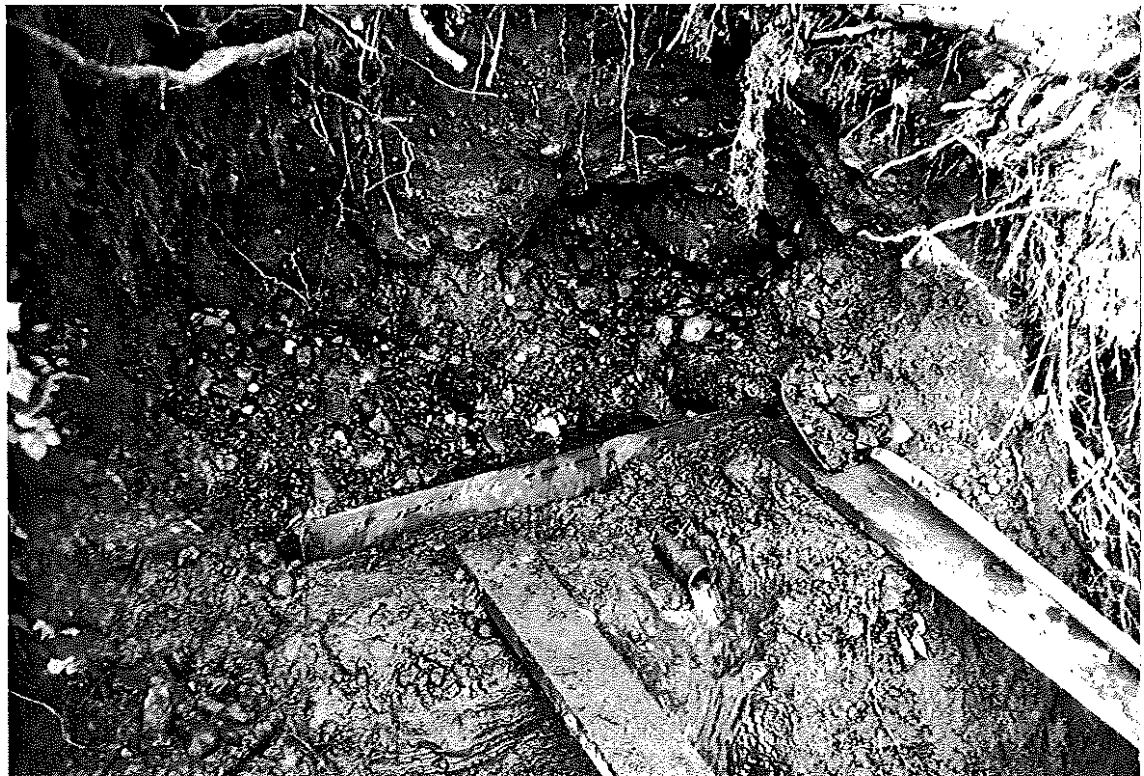
Photograph 2. View of West Collector in place showing the gravel pack sloping away from the spring discharge.

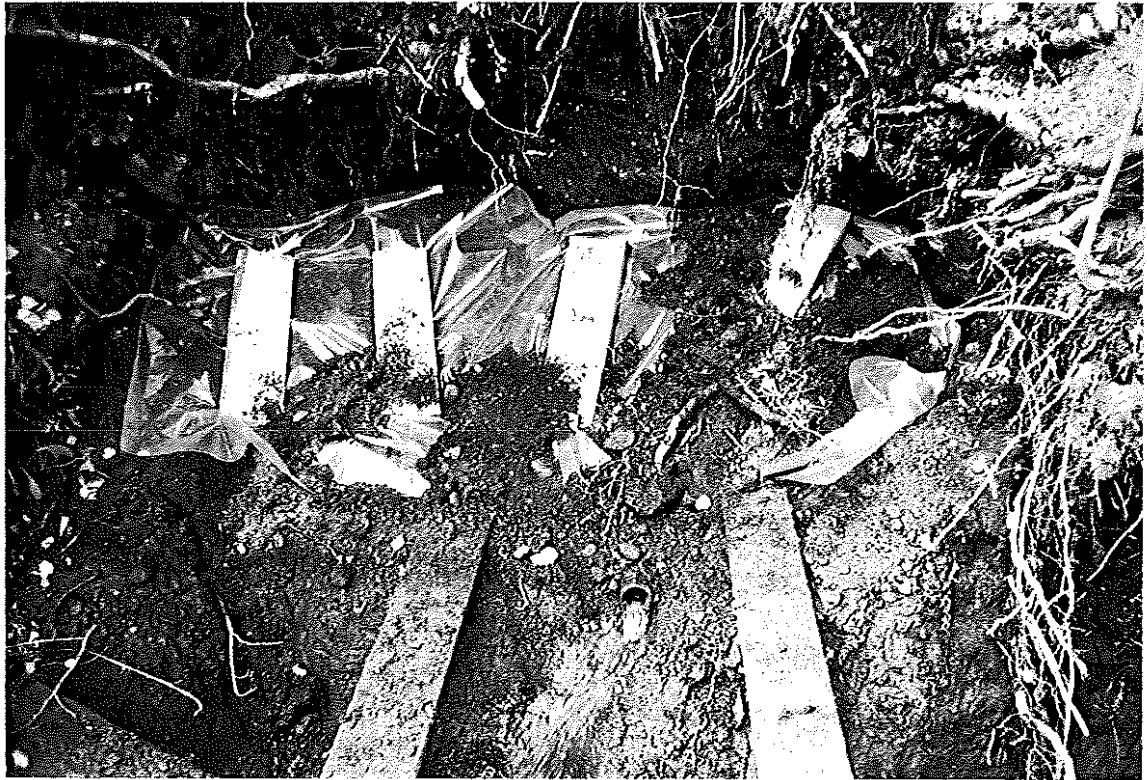
Photograph 3. West Collector with plastic sheet in place over the gravel pack.

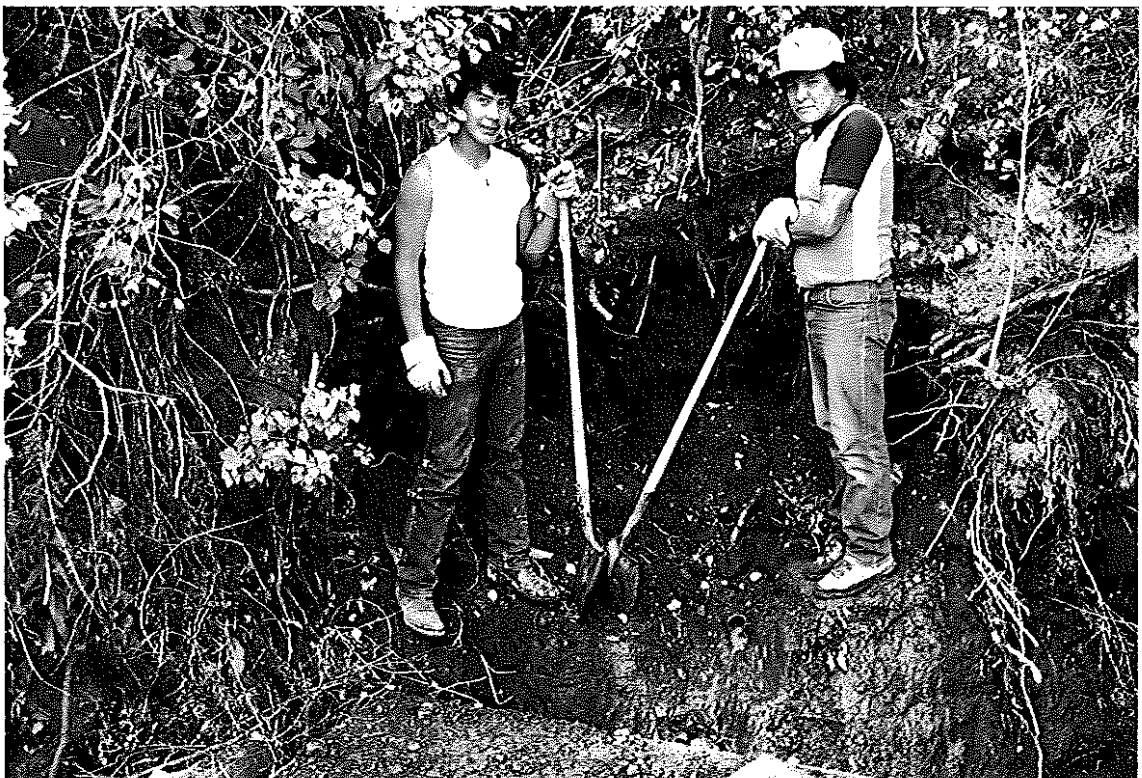
Photograph 4. West Collector completed.

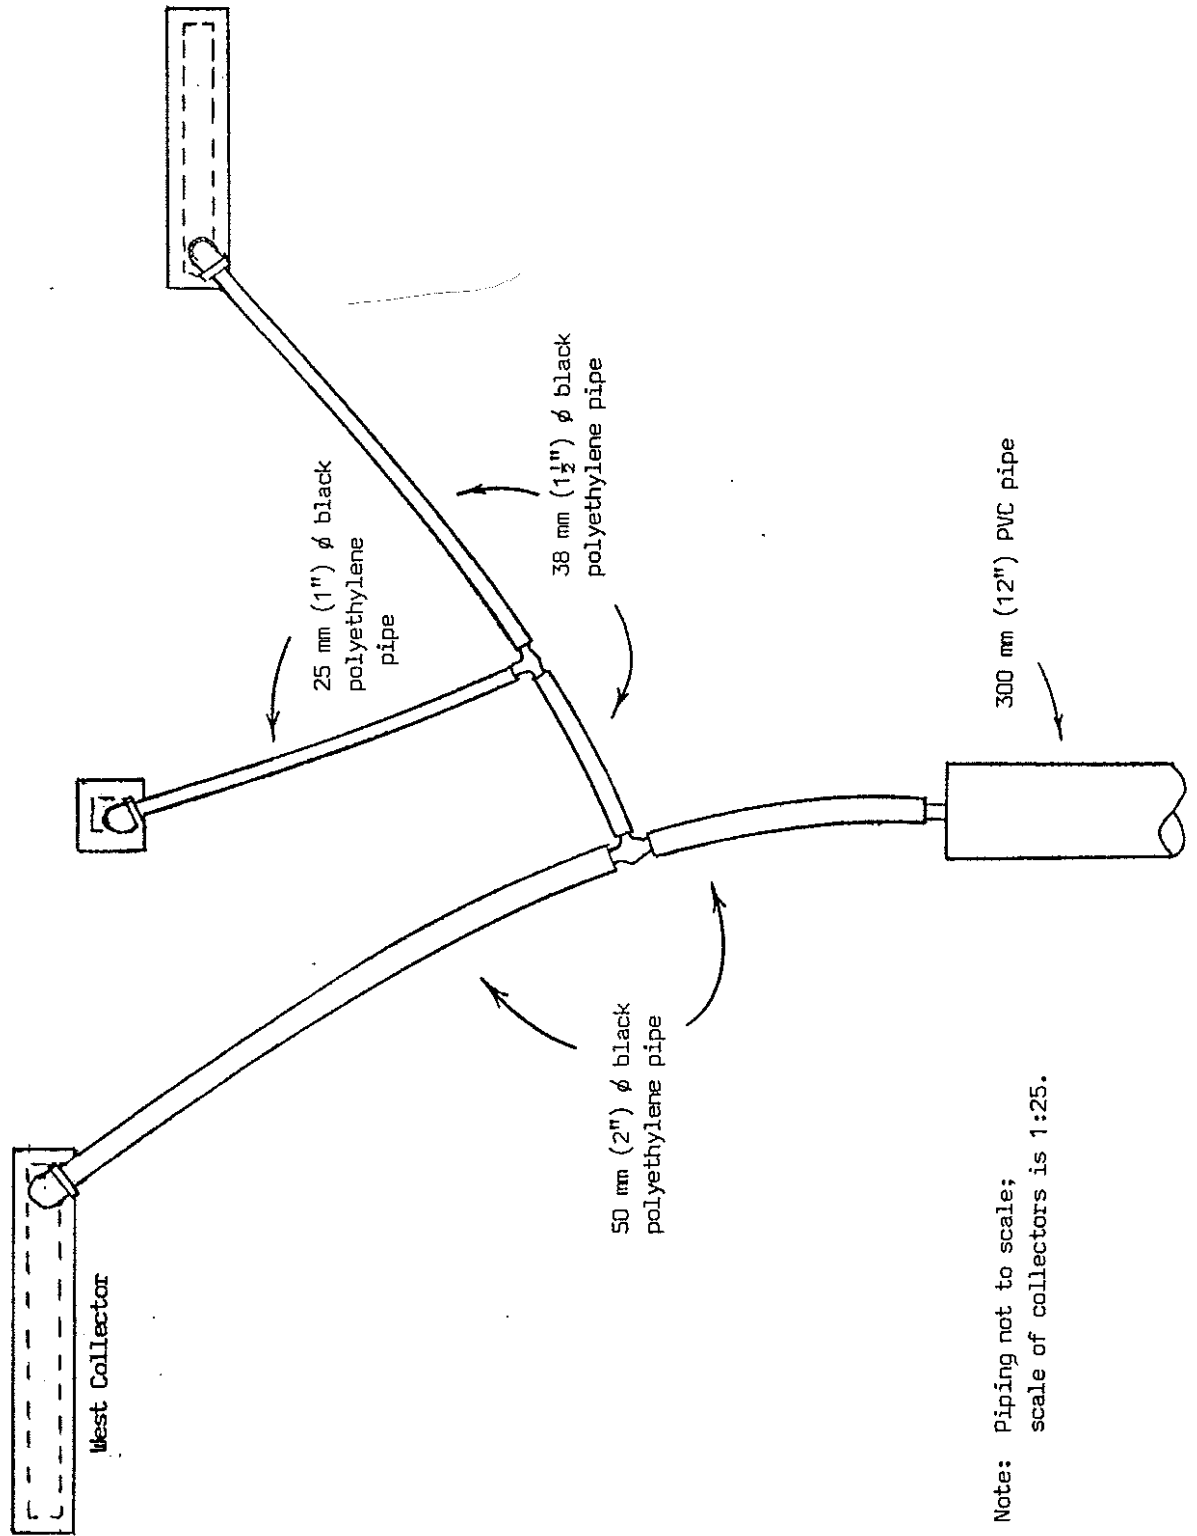
FIGURE 1

ARRANGEMENT OF COLLECTORS AT DOG CREEK VILLAGE SPRING
