COMPLETION REPORT

PRODUCTION WELL No: 1

PENINSULA DEVELOPMENT LTD.

SECHELT PENINSULA
BRITISH COLUMBIA

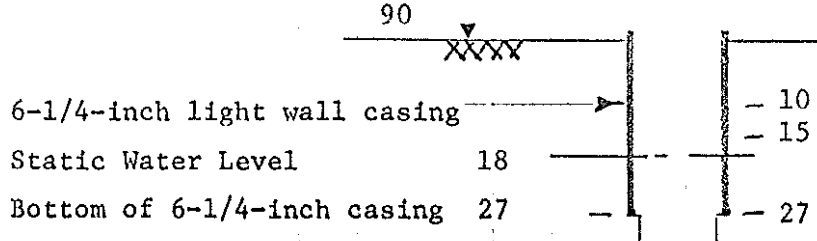
The overburden material was drilled using an 8-inch diameter bit. When bedrock was encountered at a depth of 27 feet, 6-1/4 inch light wall casing was set and seated tightly into the top of the rock. The rock was then drilled using a 6-1/4 inch diameter drill bit (see well log Fig: 2). Water-bearing fractures were encountered at 65, 132, 185 and 210 feet depths. When each fracture was encountered the flow of water from the hole was noted. These flows are given in Fig: 2, which shows that the major quantity of water comes from the fracture below a depth of 210 feet.

x 65 (1/2)
 x 132 (1)
 x 185 (4)
 x 190 (6)
 x 210 (45)
 x 211

1. x = location of fracture in bedrock
2. (1/2) = approx. flow of water blown from hole while drilling; gpm

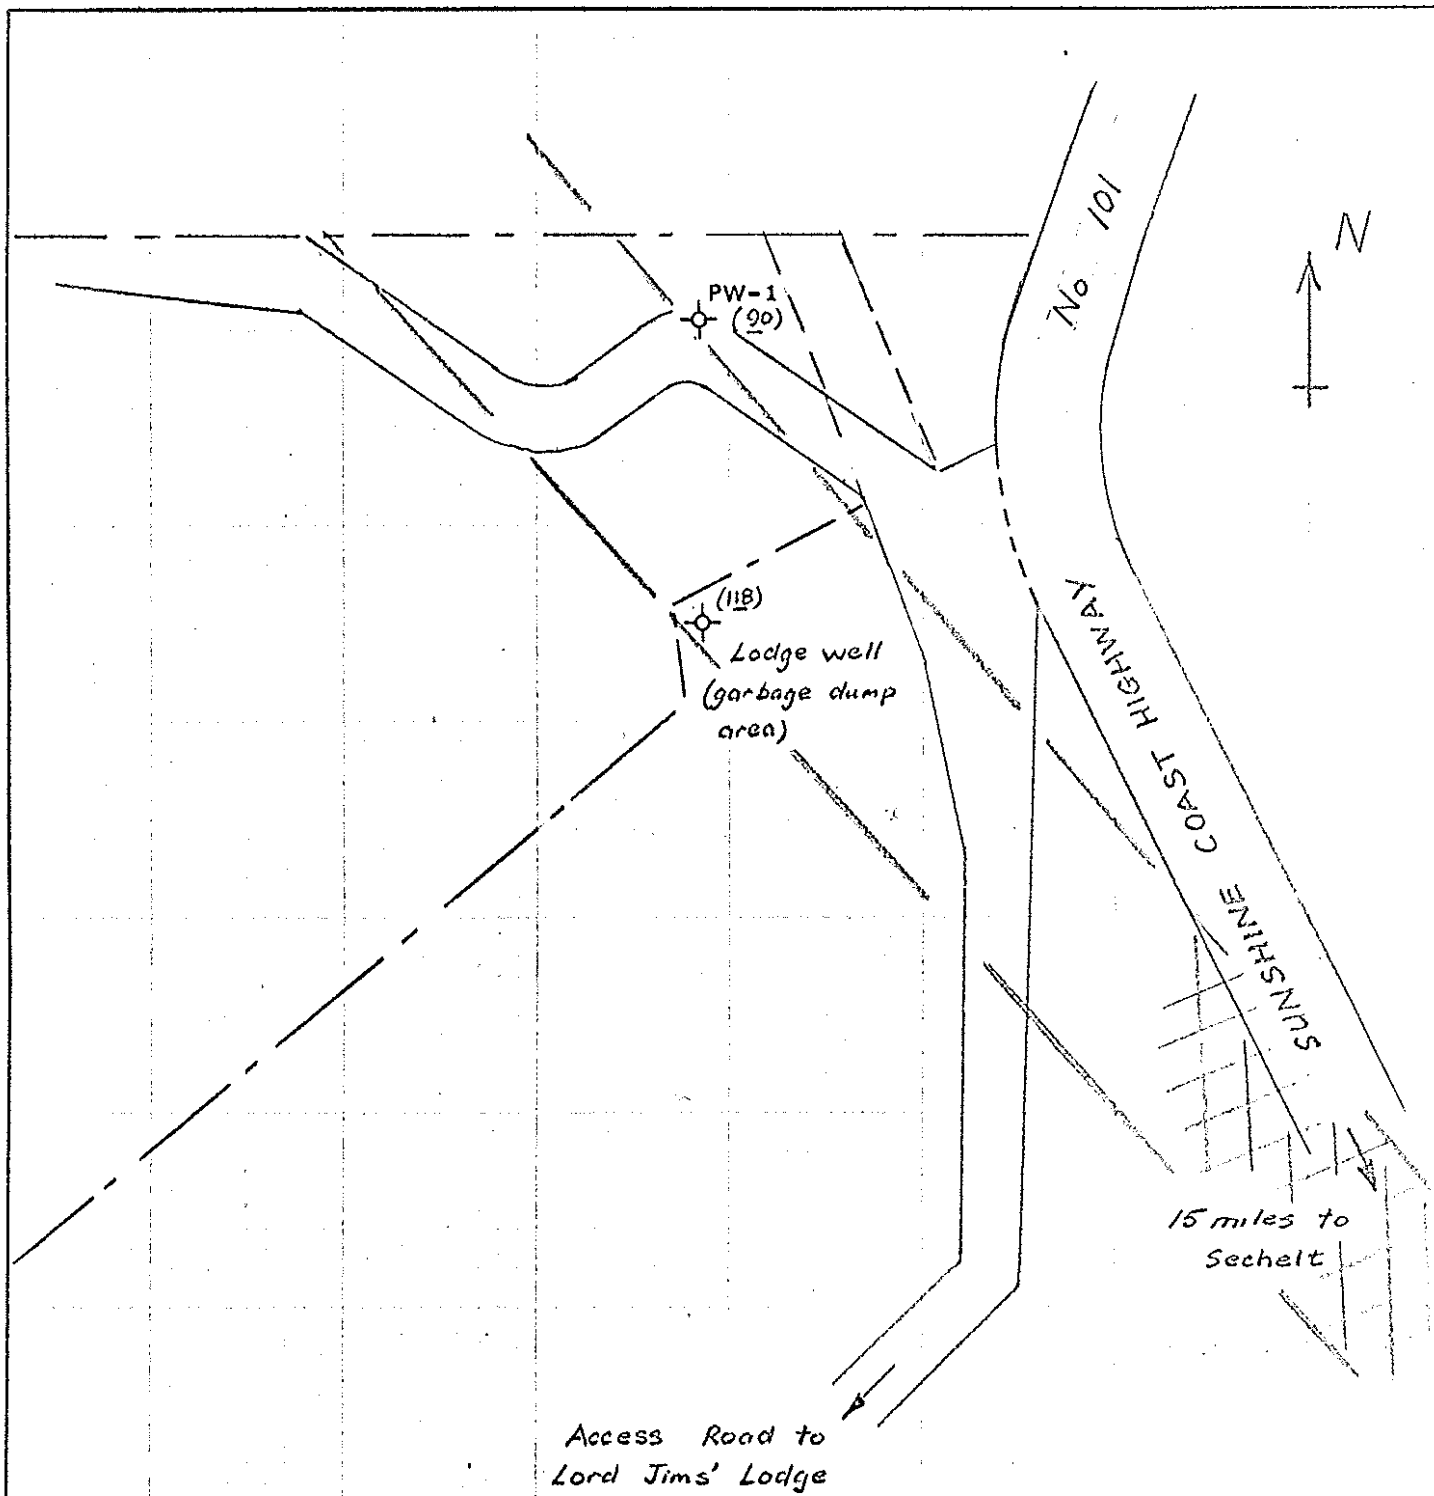
| SECHELT PENINSULA, B. C. | | MAY 1972 | Fig: 1 |

Two fracture zones cut across the subject property. These fractures are shown on Figure: 1 of this report.

Production Well No. 1 (PW-1) is located on one of these zones. Lord Jim's Lodge well is located just off the other zone. The bedrock is a diorite which was moderately hard to drill.

From data on the pump test we were able to determine that the fractures are clear and open. The fracture transects the major fracture which crosses the Sunshine Coast highway to the southeast of the property. This fracture is also connected to the fractured rock beneath the large swampy area to the north of the property. The unexpected high permeabilities are responsible for the well's high productivity.
