(District of Mission Subdivision Application S89-53)

HYDROGEOLOGIC EVALUATION
IN REGARD TO DISPOSAL OF WASTEWATER AND STORM WATER
ON A PROPOSED SUBDIVISION AT 10056 STAVE LAKE STREET
IN THE DISTRICT OF MISSION

PACIFIC HYDROLOGY CONSULTANTS LTD.

OCTOBER 23, 1989

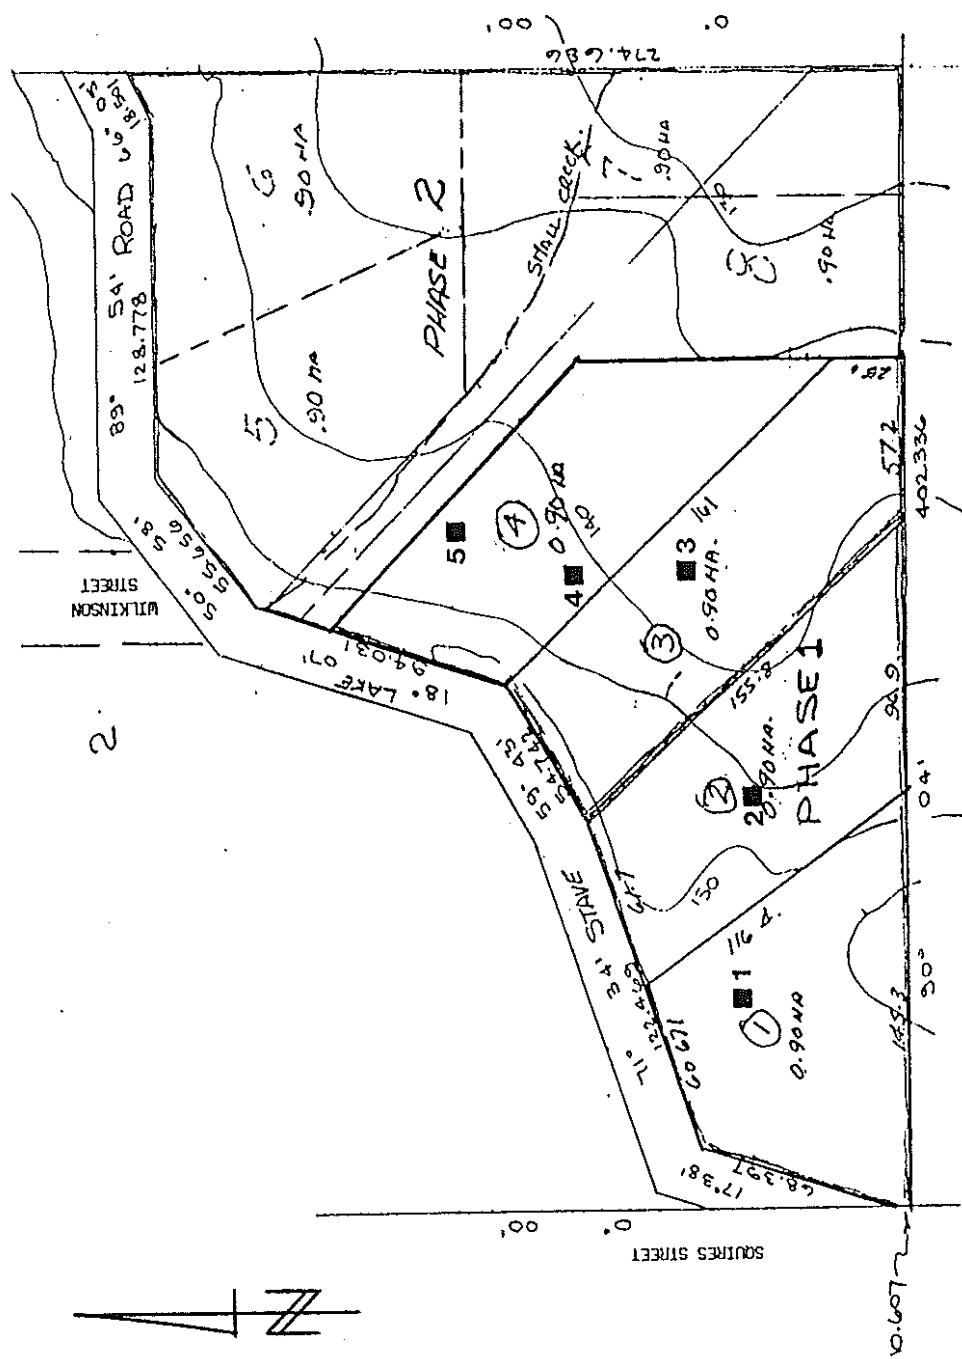
FIGURE 2

1. Test Pit 1 on Lot 1 was dug in permeable materials with good filtering properties and there was no evidence that the water table ever reaches within two metres of surface. Conditions on the terrace making up the cleared part of the Lot near Stave lake Street are quite suitable for proper operation of a wastewater disposal field.

2. Test Pit 2 on Lot 2 encountered similar conditions to those in Test Pit 1 on Lot 1. Test Pit 2 is located part way down the slope of the terrace on which Test Pit 1 is located. The conditions at Test Pit 2 are suitable for satisfactory operation of a disposal field and conditions are also expected to be suitable everywhere at a similar or higher elevation on the Lot. However, the suitable conditions shown by Test Pit 2 are unlikely to extend to the lower part of Lot 2 which is in a groundwater discharge area. There is certainly plenty of area for a disposal field on the favourable part of the Lot; however, if a house were built on the lower part of the Lot, it would be necessary to use a pumped disposal system with the disposal field on the upper part of the Lot. The design of such facilities is thoroughly discussed in modern publications, including the aforementioned **Design Manual Onsite Wastewater Treatment and Disposal Systems**.

3. Test Pits 4 and 5 on Lot 4 show that conditions on the upper (northwest) parts of Lots 3 and 4 are also suitable for onsite wastewater disposal although the underlying till seems to be more compact. Test Pit 3 on the lower part of Lot 3 shows mottling in sand at a depth about one metre below surface. This mottling indicates that the water table rises to that level occasionally - probably annually; therefore, conditions on the lower parts of Lots 3 and 4, and probably also on the lower parts of Lots 6, 7 and 8 of Phase 2, are not suitable for conventional disposal fields.

TEST PIT LOCATIONS ON LOTS 1, 2, 3 AND 4 OF A PROPOSED SUBDIVISION
 AT 10056 STAVE LAKE STREET, DISTRICT OF MISSION

1. Locate the disposal field on Lot 1 on the terrace on the upper (northern) part of the Lot; locate the disposal field on Lot 2 at the same elevation or higher on the slope than Test Pit 2.
2. Confirm that conditions on the upper part of Lot 3 are suitable for onsite wastewater disposal by digging an additional test pit.
