LEACH LAKE 3-WAY WATER CONTROL UPGRADE

FINAL PROJECT REPORT – MARCH 2009

Marc-André Beaucher
Creston Valley Wildlife Management Area

FOR
FISH & WILDLIFE COMPENSATION PROGRAM

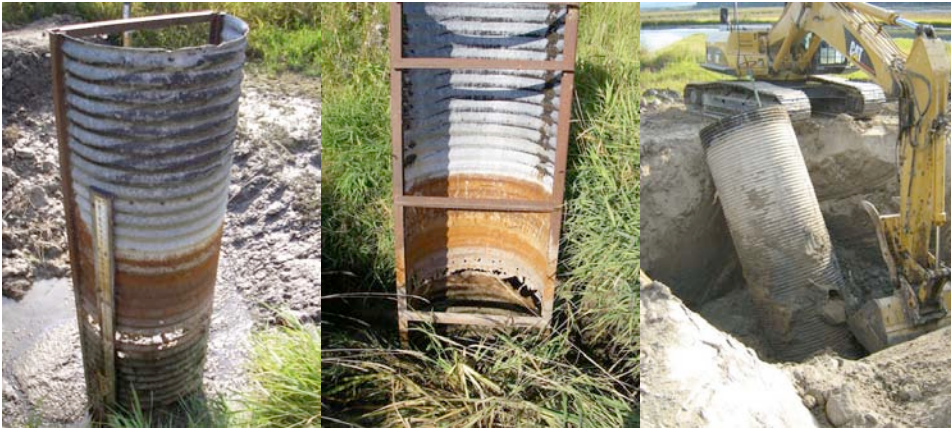
Figure 5 Old perforated half-round stop log structures (left and center) and 3-way control (right) before and during removal.

On 1 October 2008, the old water control structures were dug out and removed from their existing location (Figure 5).

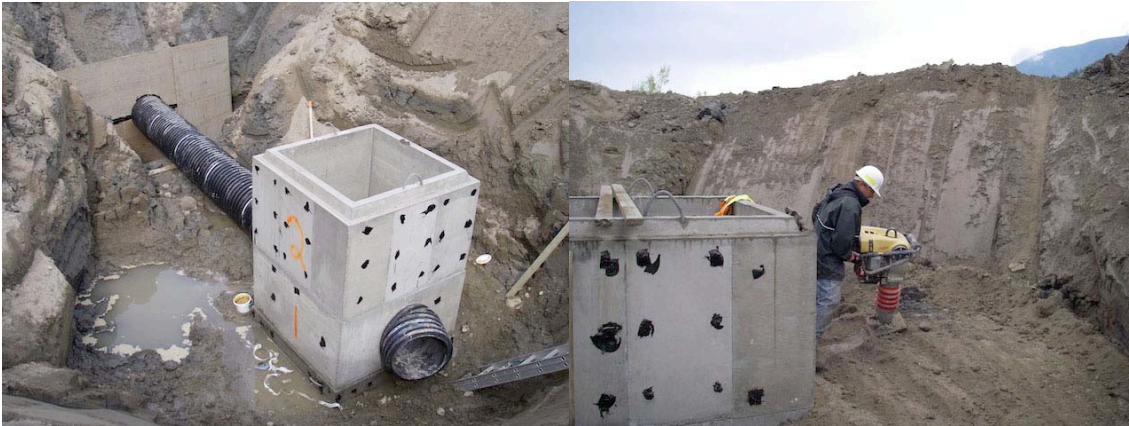
Figure 7 Seepage collar on pipe (top left) and worker compacting the ground with a jumping jack (right).

On 3 October 2008, part of the outlet to the Kootenay River was added to the control structure; two 6-m sections of pipe were put together and a seepage collar was built onto the pipe to

prevent water from seeping along it. The sections of pipe were buried and the ground was compacted with a jumping jack (Figure 7).

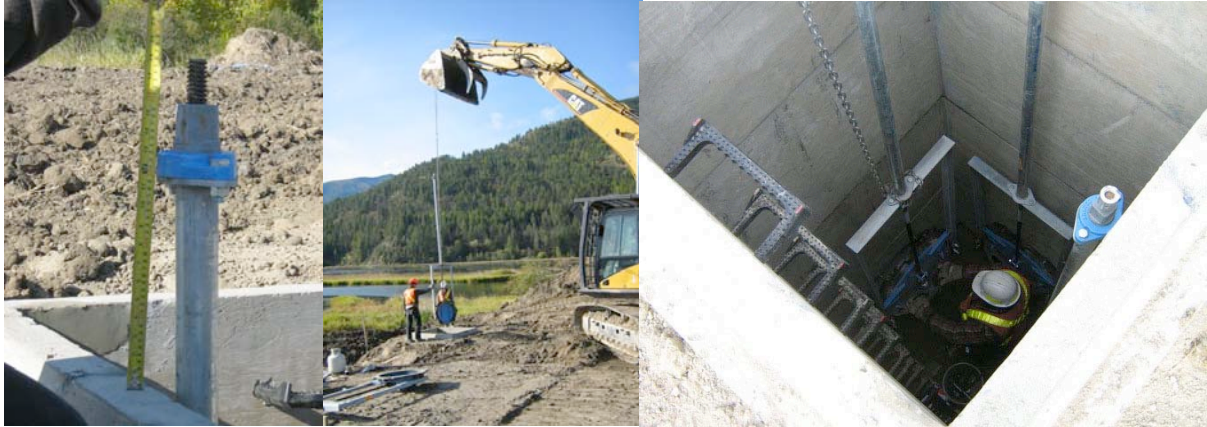
Three slide gates were anchored to the control structure on 9 October 2008. Some modifications to the gate stems were necessary as the stems were a bit too long and would have extended out of the control structure lid. The stems were shortened by 30 cm. The lid was also put in place on that same day to conclude the construction of the water control structure.

Figure 9 Photos showing the length of stem that was removed (left) on all 3 gates, and slide gate being lowered (center) and anchored to the concrete structure (right).

The project was completed with few challenges in great part due to the experience of the construction manager. The main challenge was encountered before the work began when some concerns were voiced over the level of the Kootenay River possibly being too high to build an earth dam. However, the weather “cooperated” and the level of the river actually decreased during the construction work eliminating the concerns. A second challenge was encountered with the stems being too long but was quickly resolved by cutting and welding the stems back together.

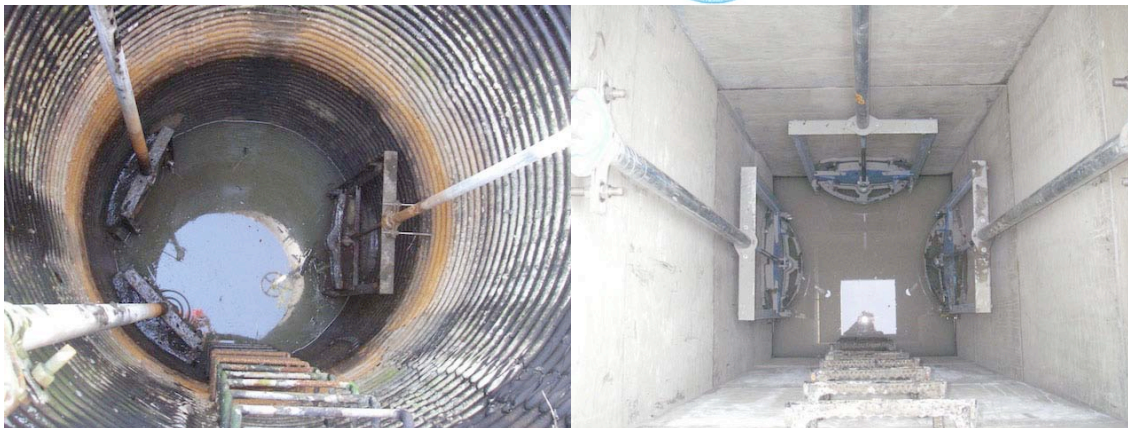
The 3-way control was tested in the fall of 2008 and functioned properly as anticipated. It will be used more extensively before the freshet of 2009 to let out excess water accumulated over the winter of 2008-2009. The materials used in the construction should increase the life expectancy of the water control structure over the old structure (Figure 12) – by at least two fold (or 50+ years).

Figure 12 Old galvanized water control with old slide gates and new concrete water control with new slide gates.
