***Gitanyow Fisheries
Authority***

**The 2007 Upper Kitwanga River Stream
Crossing Assessment and Stream
Crossing Deactivation Project**

**Submitted to: B.C. Ministry of Forests
Smithers, B.C.**

March 25, 2007

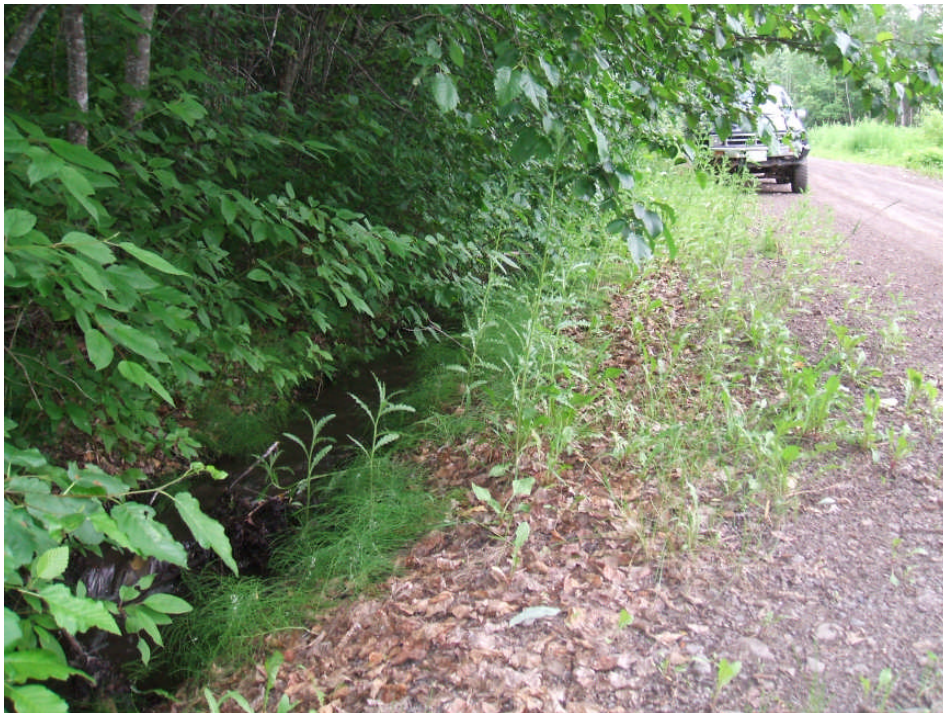
depth; 5 percent gradient) it could potentially provide important spawning and rearing habitat. Downstream of the culvert, the stream descends down a shallow grade through dense deciduous vegetation. Upstream of the culvert the stream consists of 3 smaller streams that converge at the culvert inlet with the main flow running down the left road upper ditchline for a distance of approximately 70 meters. Approximately 150 meters upstream of this crossing is 3 culvert crossings on Hwy 37 N (Site 85), one culvert for each stream that converges at the Site 95 inlet. The main flow passes Hwy 37 N through the most southerly culvert, which was also deemed as a partial velocity barrier due to excessive velocity for juvenile salmonids (Site 85 is discussed later in this section). The total length of stream barred was estimated at 700 meters (approximately 1,100 m²), representing 82 percent of the total stream length.

Photo 1: Site 95 – stream flowing along ditchline.

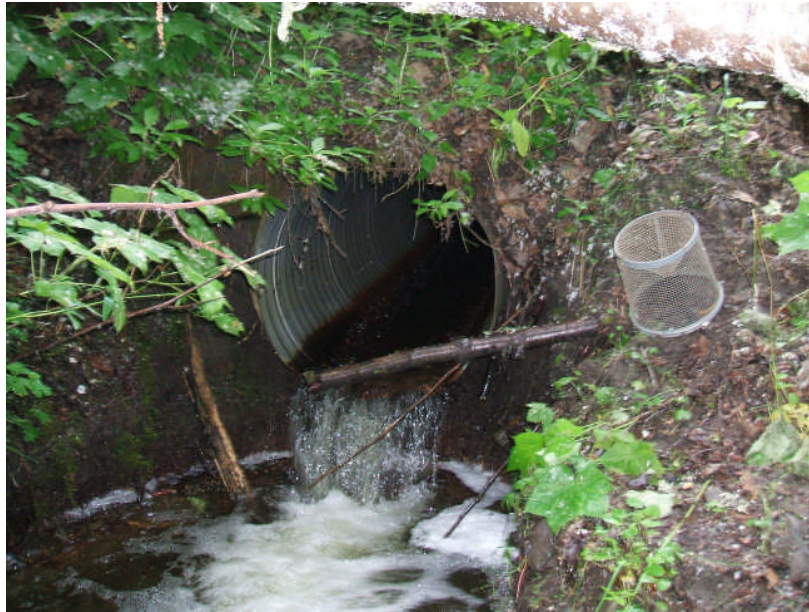
Fish habitat value was considered moderate downstream due to its close proximity to Gitanyow Lake and low upstream due to steep gradient (16 percent). The downstream reach was comprised mainly of shallow riffles with some deep pool habitat (1.4 meter bankfull width; 20 centimeter bankfull depth; 9 percent slope) and could provide important rearing habitat for juvenile salmonids. Habitat upstream of the culvert was comprised of shallow cascades and pools and although the gradient was measured at 16 percent immediately above the culvert, the gradient lessens near the Highway 37 N crossing (9 percent) approximately 150 meters upstream (Site 86). The Highway 37 N crossing was also deemed as a partial barrier due to excessive velocity for juvenile salmonids (Site 86 is discussed later in this section). If the Highway 37 crossing was fixed, the total length of stream barred was estimated at 700 meters (approximately 975 m²), representing 82 percent of the total stream length. However, without replacing the Highway 37 N crossing, the length of new habitat would be approximately 150 meters or 240 m².

Photo 2: Site 96 – culvert outlet.

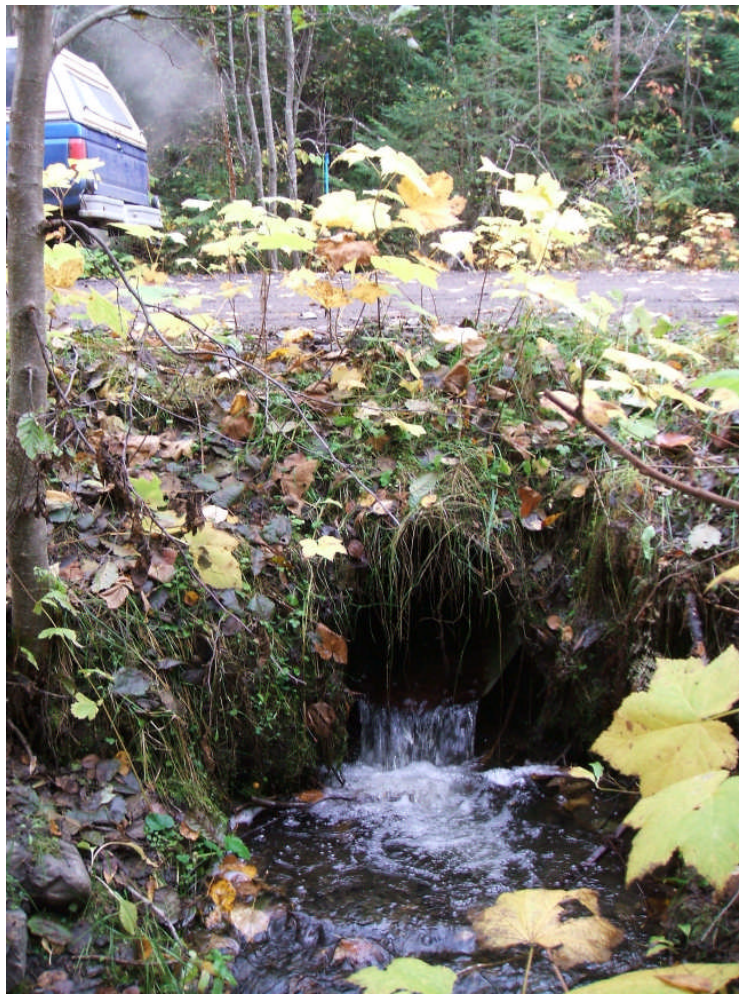
important spawning and rearing habitat. Approximately 200 meters upstream of this crossing, another culvert crosses Hwy 37 N (Site 87), which was also deemed as a partial velocity barrier due to excessive velocity for juvenile salmonids (discussed later in this section). If the Highway 37 N crossing was fixed, the total length of stream barred was estimated at 650 meters (820 m²), representing 87 percent of the total stream length. However, without replacing the Highway 37 N crossing, the length of new habitat would be approximately 200 meters or 250 m².

Photo 3: Site 97 – culvert outlet.

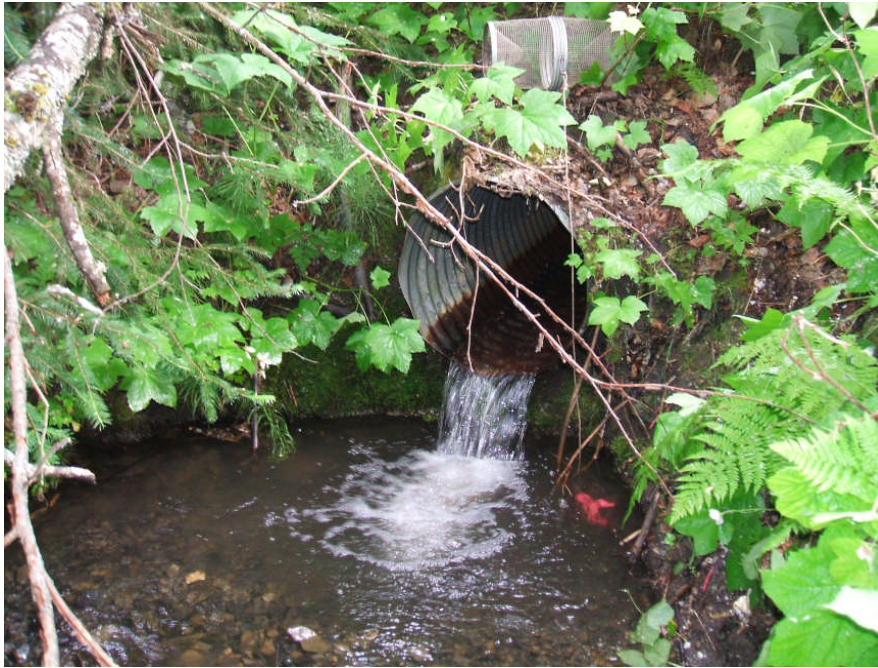
Fish habitat value was considered moderate. The downstream reach was comprised mainly of shallow riffle and pool habitat (1.6 meter bankfull width; 33 centimeter bankfull depth; 7 percent slope) and it could provide important spawning and rearing habitat. Upstream of the culvert the stream consists of 2 smaller streams that converge at the culvert inlet. Approximately 150 meters upstream of this crossing, another culvert crosses Hwy 37 N (Site 88), which was also deemed as a partial velocity barrier due to excessive velocity for juvenile salmonids (Site 88 is discussed later in this section). If the Highway 37 N crossing was fixed, the total length of stream barred was estimated at 600 meters (980 m²), representing 91 percent of the total stream length. However, without replacing the Highway 37 N crossing, the length of new habitat would be approximately 150 meters or 250 m².

Photo 4: Site 98 – culvert outlet.

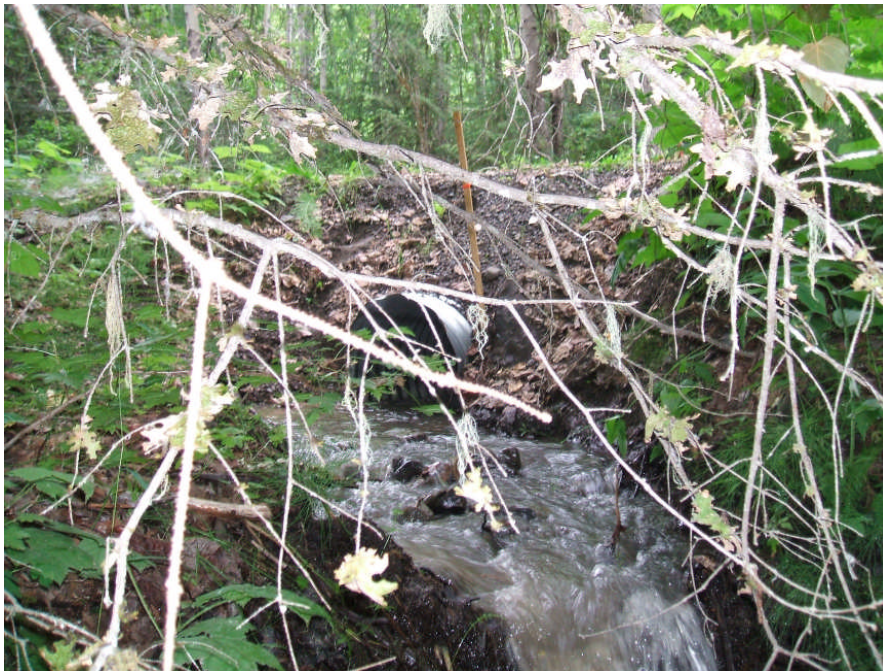
335), which was also deemed as a partial velocity barrier due to excessive velocity and jump height for juvenile salmonids (Site 335 is discussed later in this report). If the Highway 37 N crossing was fixed, the total length of stream barred was estimated at 900 meters (1300 m²), representing 88 percent of the total stream length. However, without replacing the Highway 37 N crossing, the length of new habitat would be approximately 120 meters or 200 m².

Photo 5: Site 334 – culvert outlet.

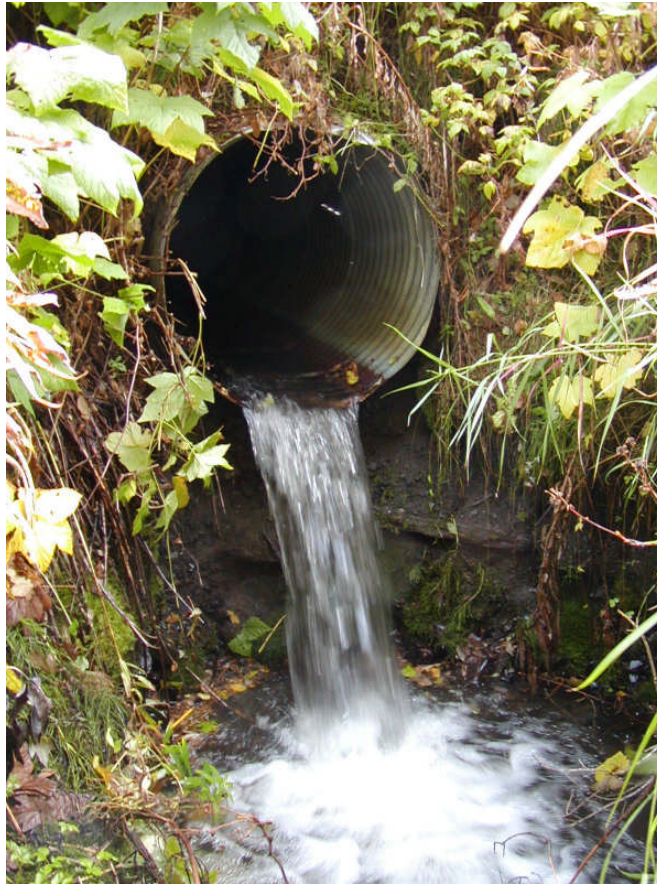
Photo 6: Site 67 – culvert outlet (Source: Johnston and Saimoto 2002).

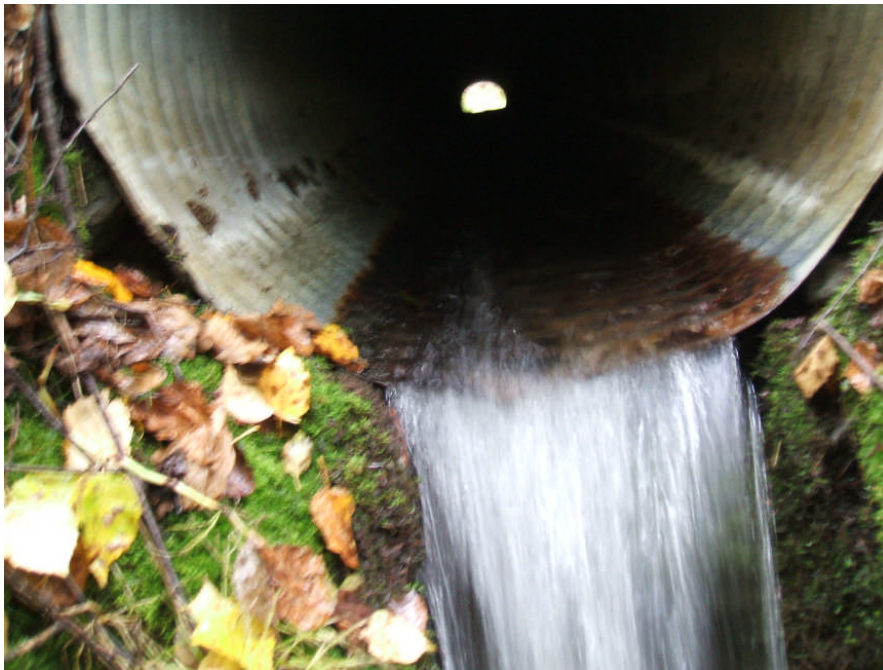
Fish habitat value was considered moderate overall. The upstream and downstream reach was comprised mainly of shallow riffle/pool habitat (0.6 meter bankfull width; 17 centimeter bankfull depth; 15 percent slope), and could provide important rearing habitat for juvenile salmonids. Approximately 150 meters downstream of this crossing, another culvert crosses East Kitwancool Lake Road (Site 334), which was also deemed as a partial velocity barrier due to excessive velocity. The total length of stream barred was estimated at 720 meters (430 m²), representing 71 percent of the total stream length.

Photo 7: Site 335 – culvert outlet.

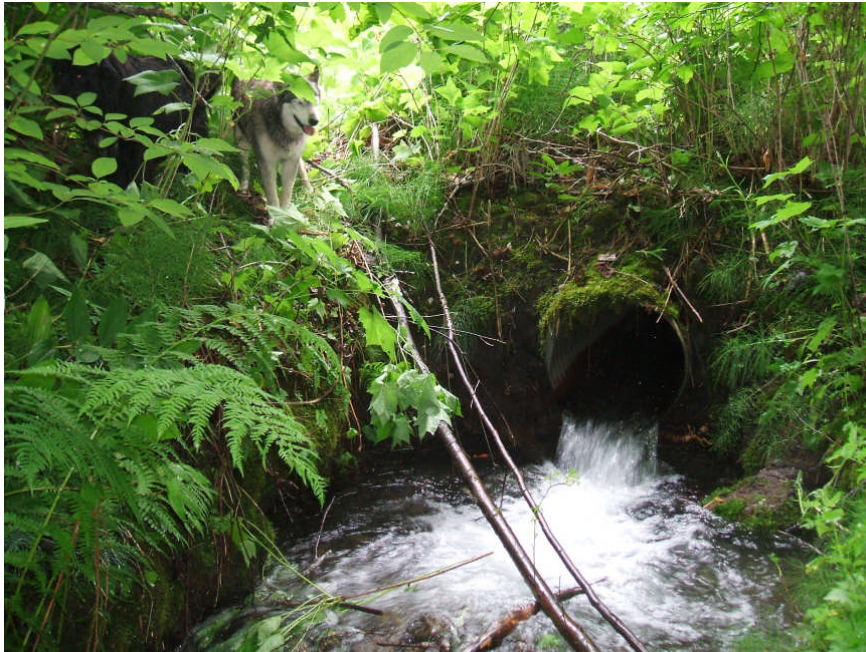
Fish habitat value was considered good downstream of Site 81 due to its close proximity to the Gitanyow Lake, while upstream habitat was considered poor due to minimal amounts of deep pools and LWD (1.7-meter bankfull width; 27 centimeter bankfull depth; 7 percent slope). A barrier falls was found 400 meters upstream of Hwy 37 N (100 meters upstream of Site 15). The total length of stream barred was estimated at 400 meters (660 m²), representing 73 percent of the total stream length.

Photo 8: Site 81 – culvert outlet.

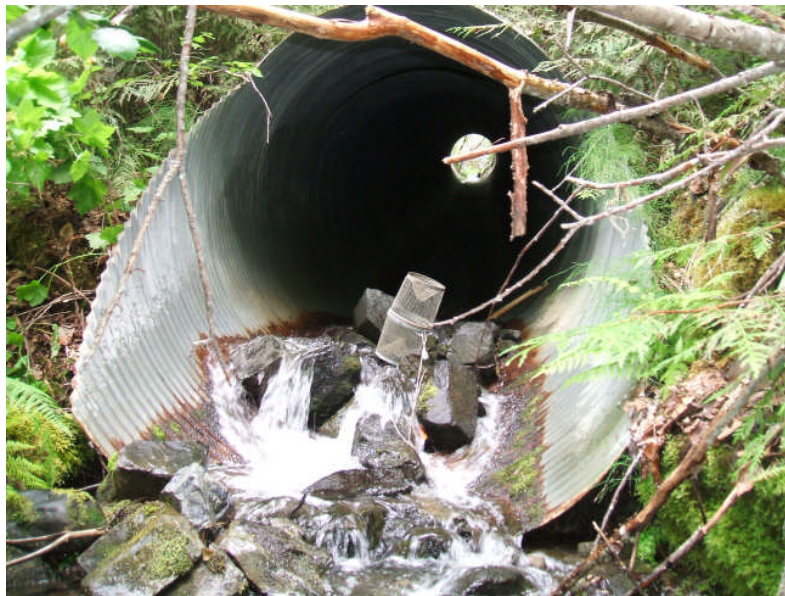
Photo 9: Site 31 – culvert outlet.

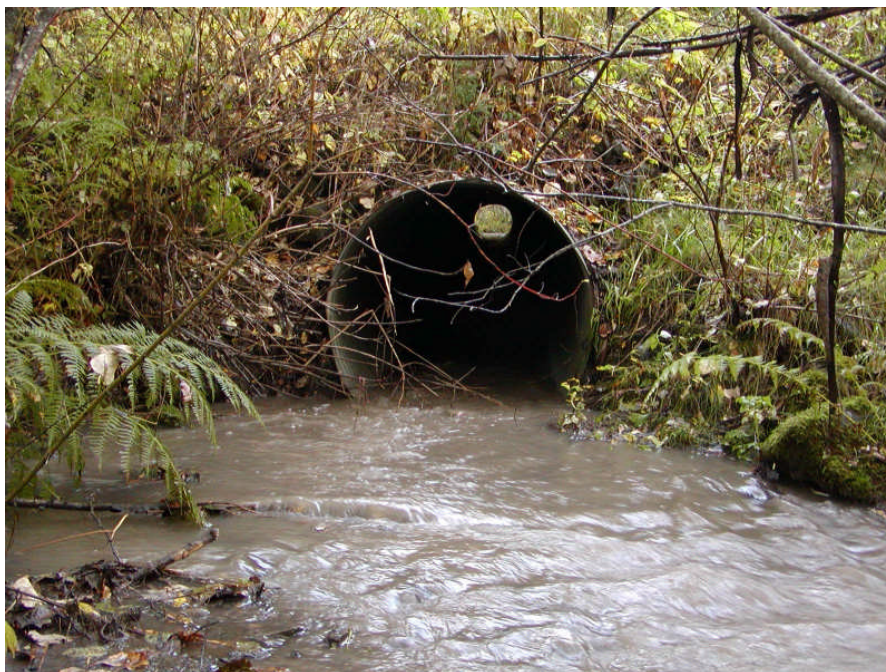
This culvert crossing was considered a partial barrier due to the excessive water velocity inside the culvert. The culvert slope was considered steep (3 percent) creating high water velocity (1.03 meters/second), which exceeded the swimming capability of juvenile salmonids (Johnston and Saimoto 2002). The culvert outlet was not suspended. The Q100 round culvert diameter was calculated to be 2280 millimeters. The 1200-millimeter culvert currently in place is insufficient to accommodate a 100-year flood event and should be replaced. The fill depth above the culvert was 5 meters.

Photo 10: Site 80 – culvert outlet (Source: Johnston and Saimoto 2002).

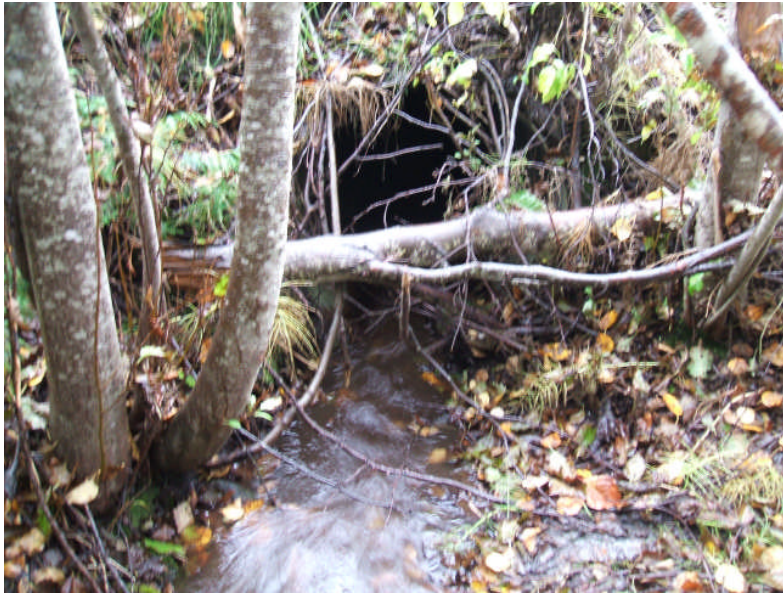
Photo 11: Site 85 – culvert outlet.

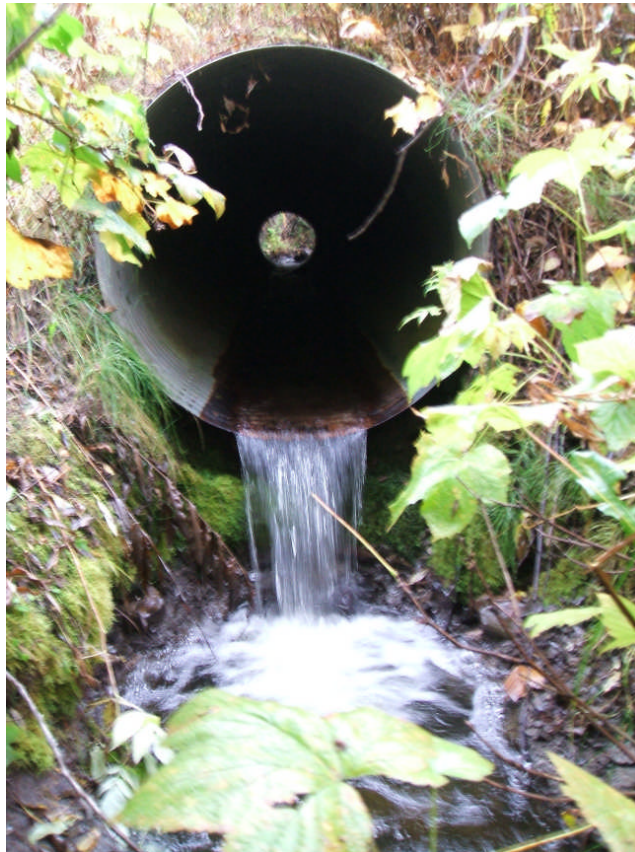
Photo 12: Site 86 – culvert outlet.

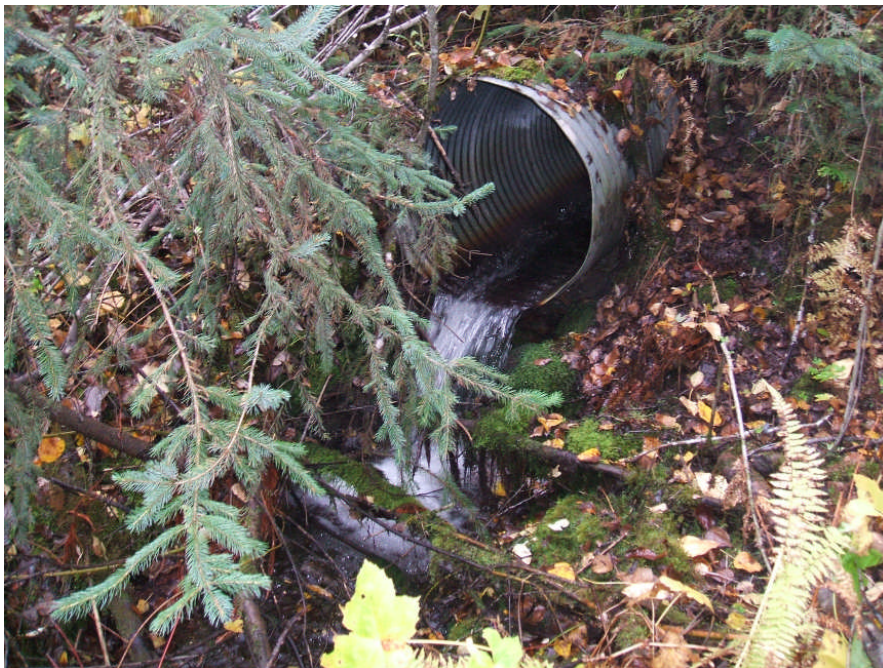
Photo 13: Site 87 – culvert outlet.

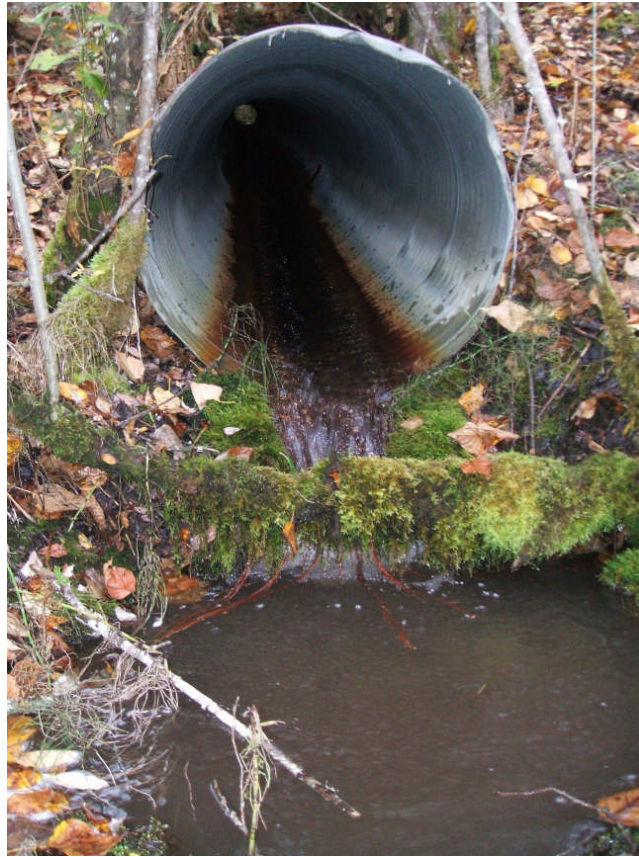
Photo 14: Site 88 – culvert outlet.

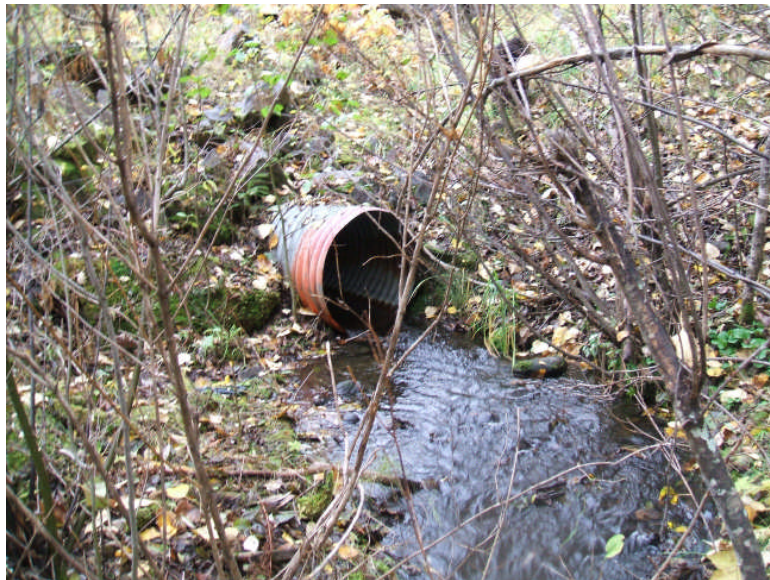
Fish habitat value was considered moderate upstream (shallow riffle pool, 1 percent slope, abundant cover) and poor downstream (cascade/riffle/pool complex, 20 percent slope, frequent debris jams). Located approximately 400 meters downstream is a deactivated crossing along an old grown-in logging road, which was visited in 2006 and deemed as passable to fish and well vegetated (McCarthy 2007). The total length of stream barred was estimated at 1500 meters (3,640 m²), representing 68 percent of the total stream length.

Photo 15: Site 61 – culvert outlet.

One culvert crossing was identified as a partial barrier due excessive at water velocity for juvenile salmonids (Site 61, Unnamed Tributary, Kitwanga FSR, UTM 9U.549762.6140303). In order to justify culvert replacement or modification, GFA recommends undertaking a FHAP (Johnston and Slaney 1996) on all 10 streams beforehand from their confluence upstream to the limit of fish distribution. In order to justify culvert replacement or modification, GFA recommends undertaking a FHAP (Johnston and Slaney 1996) from the confluence with the Upper Kitwanga River upstream to the limit of fish distribution. In close proximity to Site 61 is Site 3 (Chernobel Creek), which was identified as a partial barrier in 2006 due to excessive water velocity for juvenile salmonids. Because these crossings are located near each other, a FHAP should be carried out on both streams.

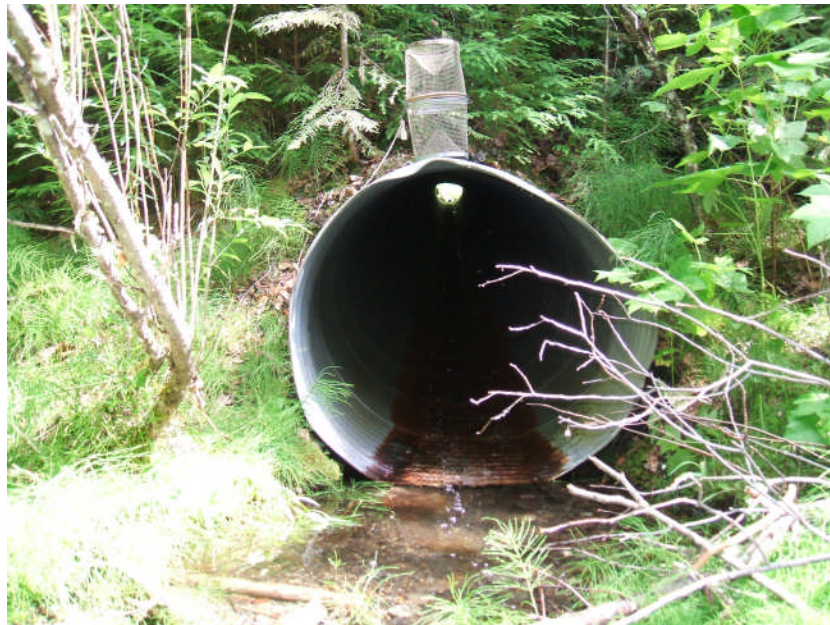
Photo 16: Site 284 – culvert outlet.

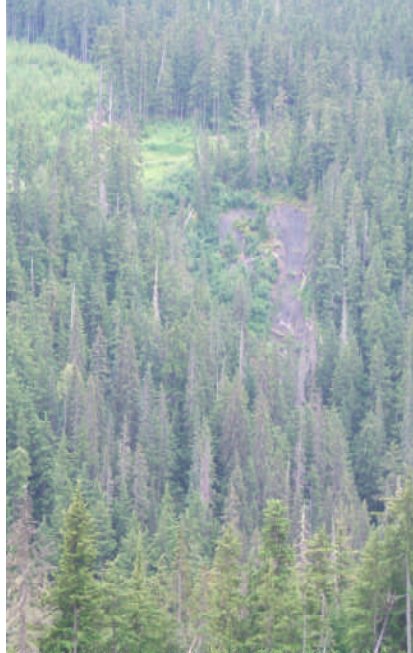
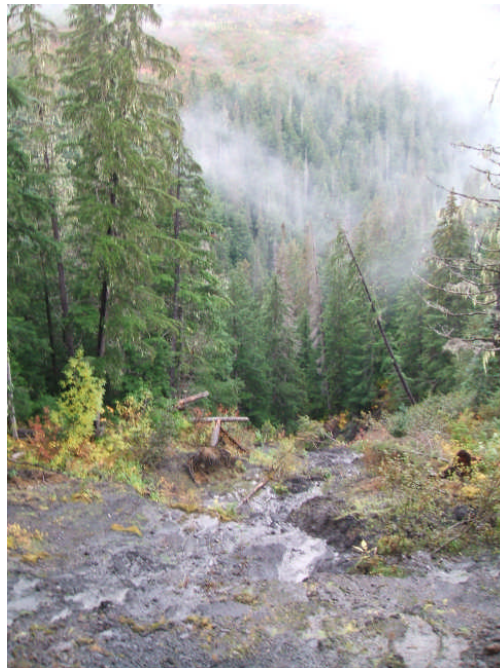
Site 48 received a WQEE score of 303 m³ (extreme ranking). Downstream of this crossing multiple horizontal fractures measuring 20 to 30 meters in length extend down-slope for approximately 30 meters. The uppermost fracture has reached the stream 15 meters downstream of culvert crossing. Further down-slope of these fractures is an active landslide measuring approximately 100 meters long x 30 meters wide at a 55 percent slope (Photos 17 and 18). One vertical crack extends upslope across the road into the forest, which has created a 0.5-meter slump in the roadbed (Photo 19). This hillslope appears extremely unstable and there is a high potential for a massive landslide into the Upper Kitwanga River. Although it is uncertain if this slide is road related, it does deserve serious attention from the MOF.

This slide was report by Biolith (1999) at the confluence of Tributary 69 and the Upper Kitwanga River. Biolith (1999) noted that the slide appeared to carry sediment from the main road down into the important fish habitat in Reach 12 of the Kitwanga River and this slide may

have been related to construction of the Kitwanga FSR and at other road crossings further upstream as well as logging on its east side.

Photo 17: Site 48 – Massive landslide down-slope of Kitwanga FSR. Photo taken from across the valley facing south from Ronald McDonald FSR.

Photo 18: Site 48 – Massive landslide down-slope of Kitwanga FSR. Photo taken from top of slide facing downhill.

wasting that led directly into the stream channel. The most significant mass wasting issue was at Site 48 where a massive landslide extends from the Kitwanga FSR down the Upper Kitwanga River mainstem. Horizontal and vertical fractures are evident immediately downslope of the Kitwanga FSR and across the road itself. There is potentially a high risk of a massive hillslope failure at this site, which could create a barrier within the Upper Kitwanga River mainstem and introduce a large amount of sediment into downstream reaches. A road engineer should address mass-wasting issues immediately.

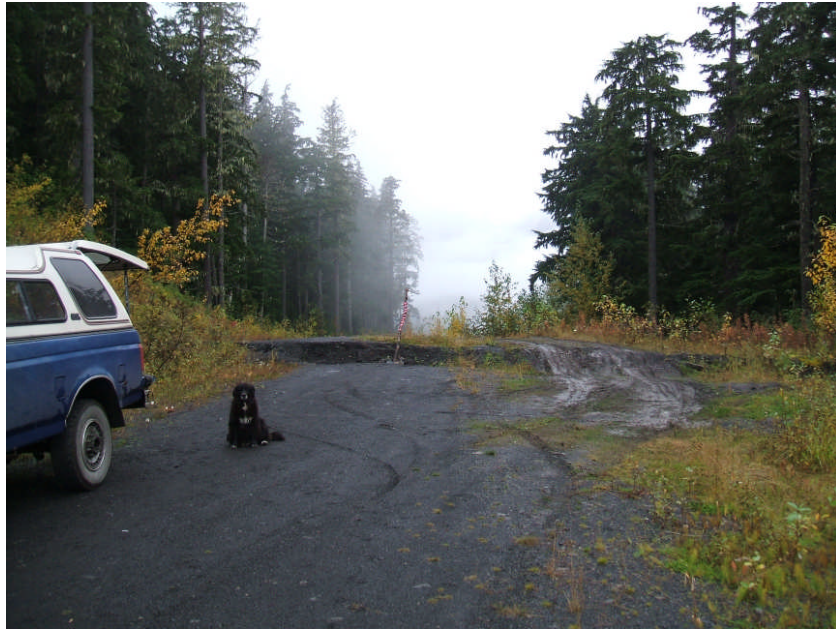
Photo 19: Site 48 – Road fracture on Kitwanga FSR above landslide.

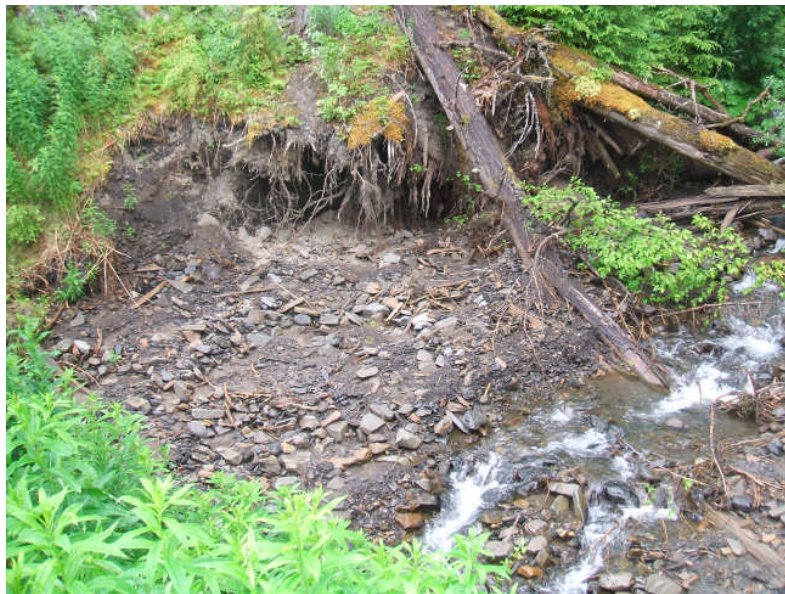
Site 91 received a WQEE score of 60 m³ (extreme). Mass wasting has occurred on the right bank immediately upstream of the crossing and appears to be caused by water being backed up at the culvert inlet that is creating a scouring force on the stream bank (Photo 20).

Photo 20: Site 91 – Mass wasting upstream of crossing.

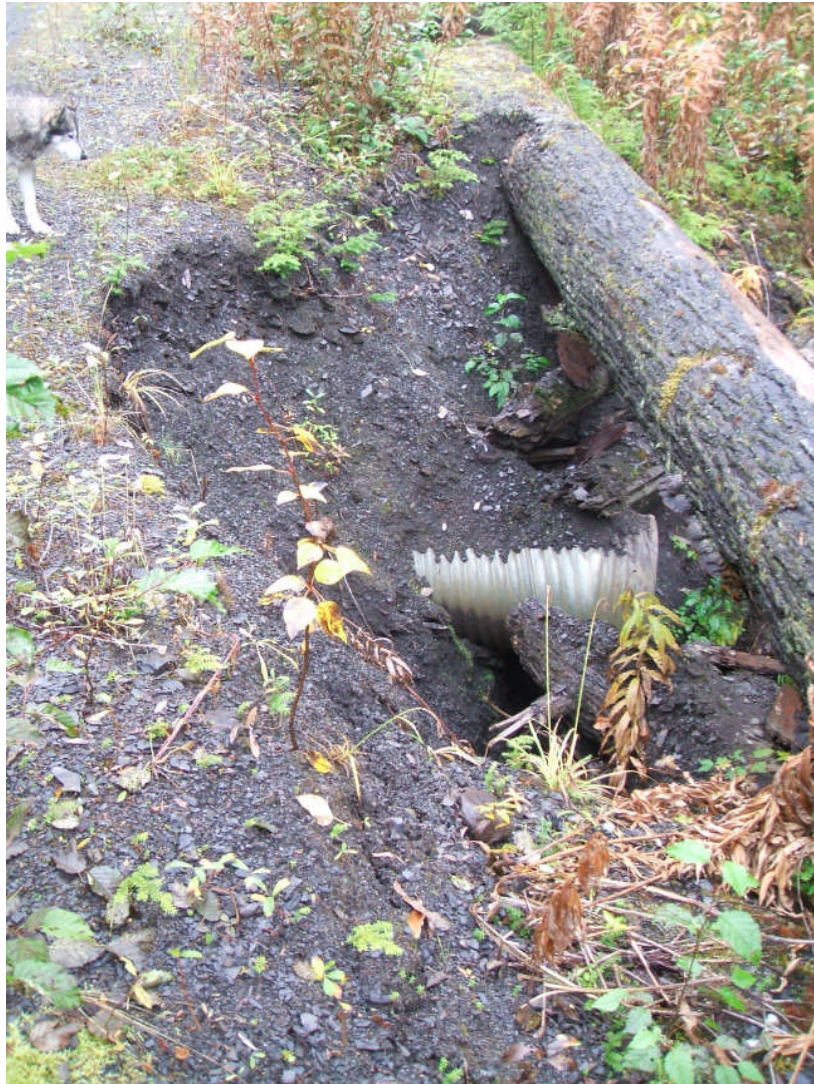
Site 332 received a WQEE score of 25 m³ (very high). Mass wasting has occurred in the road fill over the culvert outlet.

Photo 21: Site 332 – Mass wasting at culvert outlet.

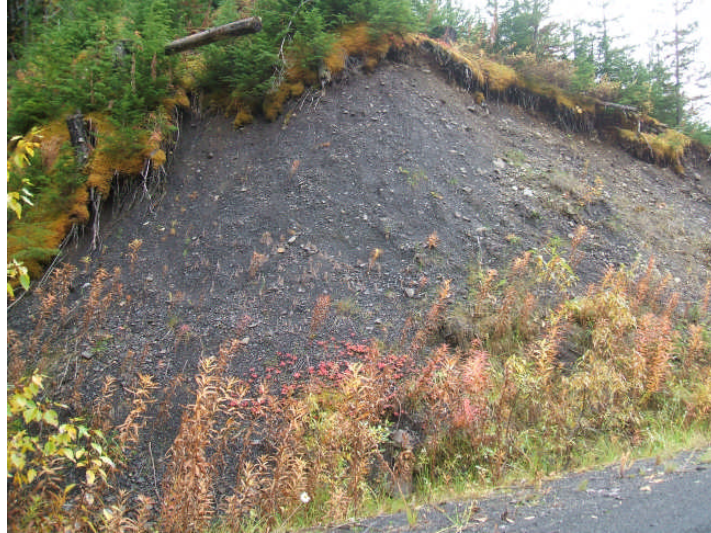
Site 42 received a WQEE score of 7.2 m³ (high). Mass wasting has occurred on the left road cutbank adjacent to the stream channel.

Photo 22: Site 42 – Mass wasting on left-road cutbank adjacent to stream.

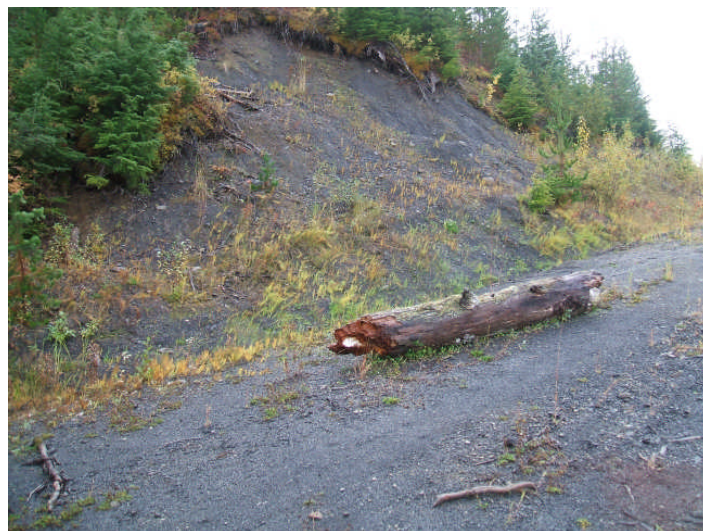
Site 35 received a WQEE score of 6.0 m³ (high). Mass wasting has occurred on the left road cutbank adjacent to the stream channel.

Photo 23: Site 35 – Mass wasting on left-road cutbank.

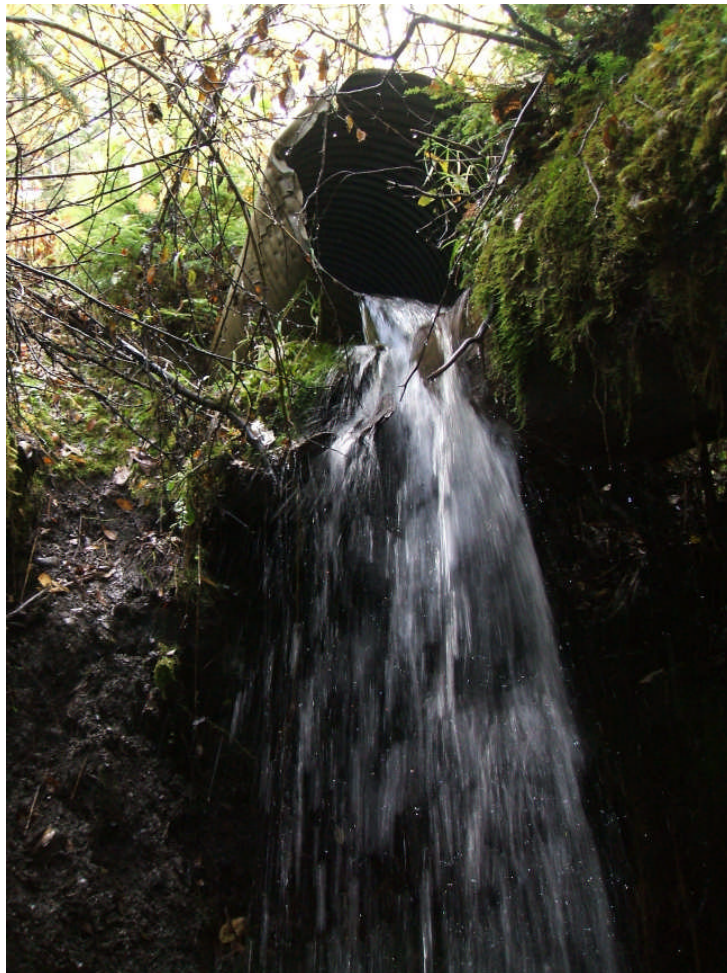
Site 61 received a WQEE score of 4.0 m³ (moderate). Mass wasting has occurred in the road fill around the culvert outlet.

Photo 24: Site 61 – Mass wasting at culvert outlet.

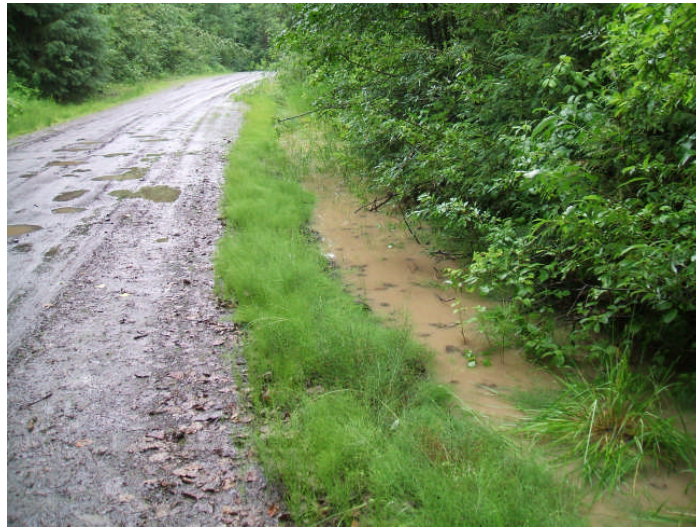
Site 98 received a WQEE score of 1.4 m³ (moderate). The roadbed and upper ditchline contain a relatively high proportion of erodible fine material.

Photo 25: Site 98 – Muddy right-road surface and upper ditch.

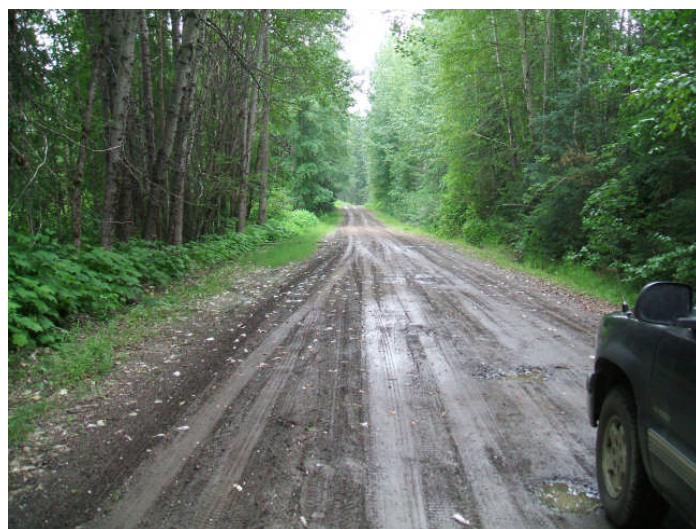
Site 96 received a WQEE score of 1.1 m³ (moderate). Similar to site 98, the roadbed and upper ditchline contain a relatively high proportion of erodible fine material.

Photo 26: Site 96 – Muddy right road surface.

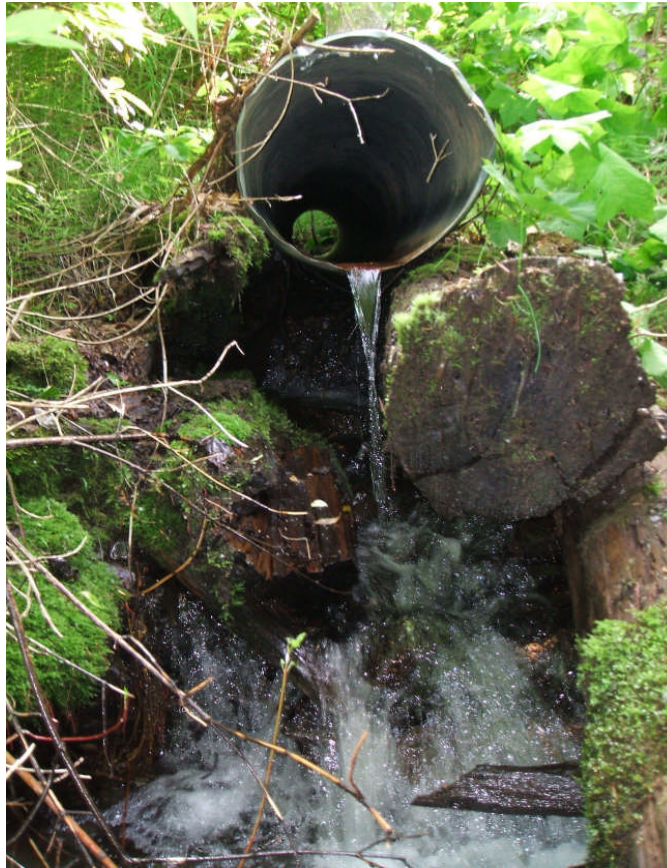
The stream habitat value was considered poor within 50 meters of the crossing since the stream was comprised mainly of shallow riffles downstream of the culvert and a cascade/riffle/shallow pool complex upstream (average 7 percent gradient / 1.2 meter wetted width). Approximately 200 meters downstream of this crossing is Hwy 37 and further downstream is a slow moving low gradient reach containing a series of beaver ponds. Upstream of the culvert the gradient increases sharply and small rock/wood debris jams occur frequently, which may limit the upstream movement of fish. The total length of stream barred was estimated at 800 meters (approximately 2400 m² of fish habitat), which represents 50 percent of the total stream length.

Photo 27: Site 14 culvert outlet prior to deactivation. Water was flowing mostly through the log corduroy in the underlying roadbed.

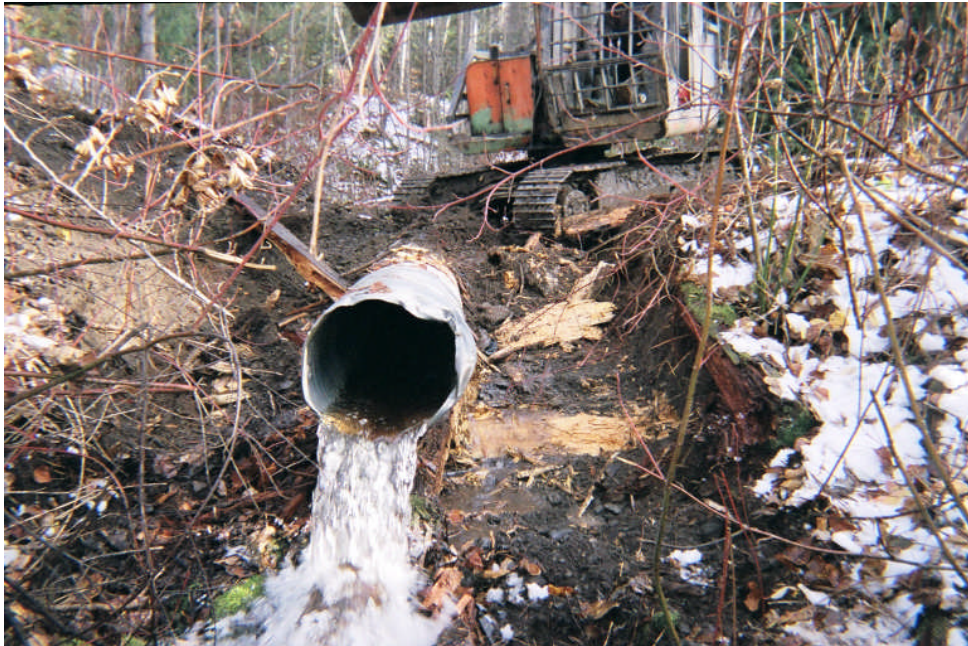
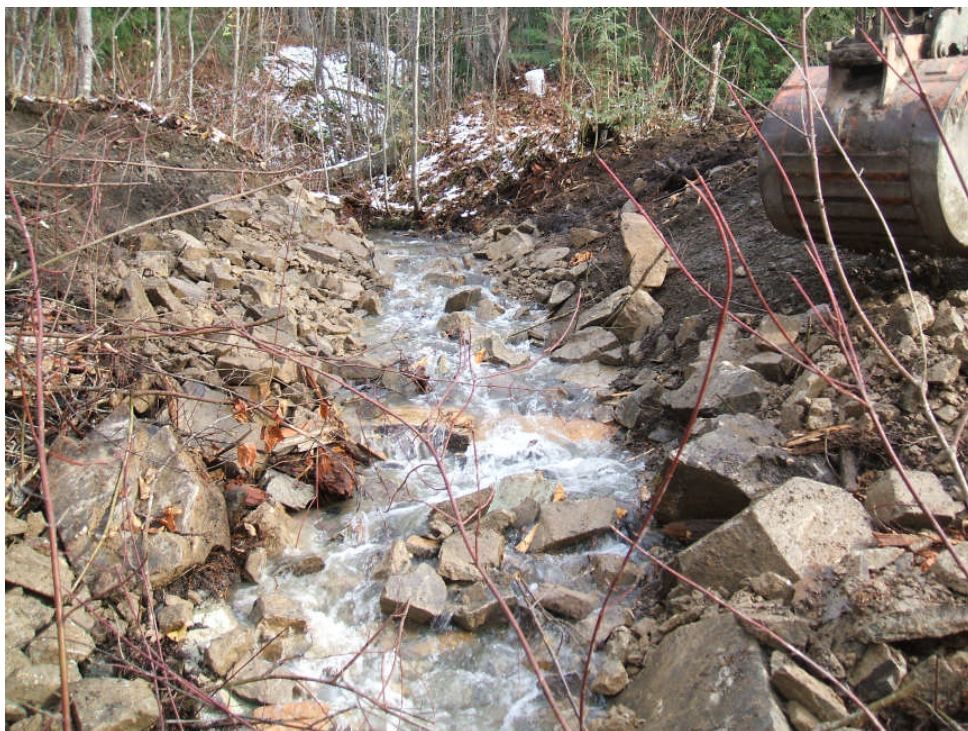
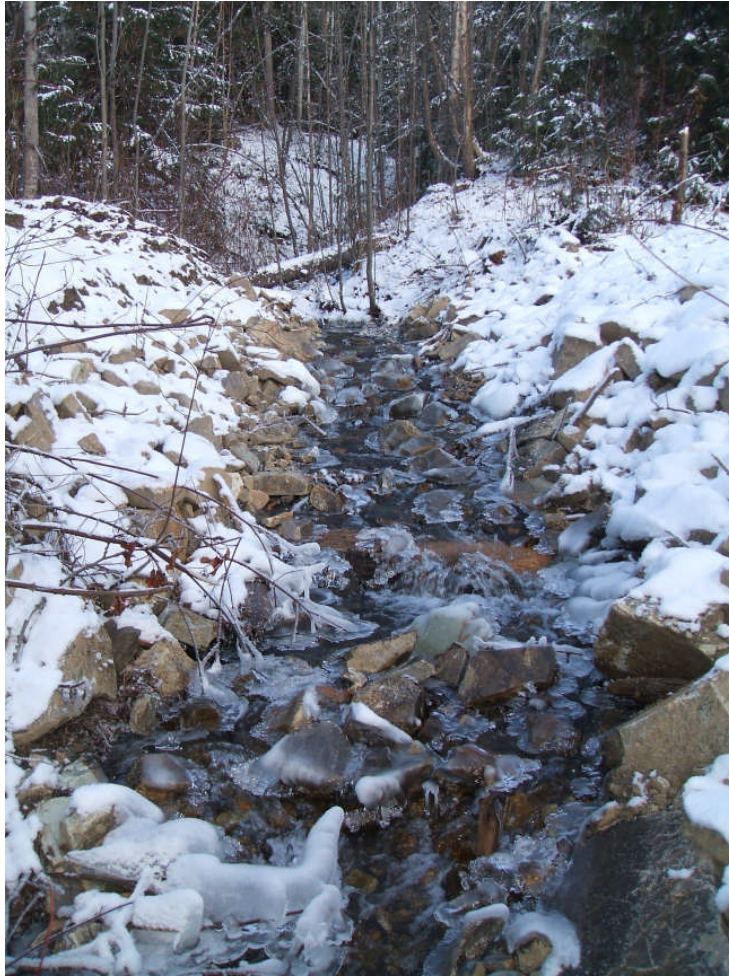
Photo 28: Removing culvert fill material at Site 14.

Photo 29: Site 14 with new channel near end of completion.

Photo 30: Site 14 on December 1, 2007 approximately 5 weeks following deactivation.

and large boulders were placed within the channel to create habitat cover and velocity breaks (Photos 29 and 30). A complete photo series for the FHAP and the deactivation is presented on CD in Appendix II in a Folder entitled Site 14 FHAP and Deactivation.

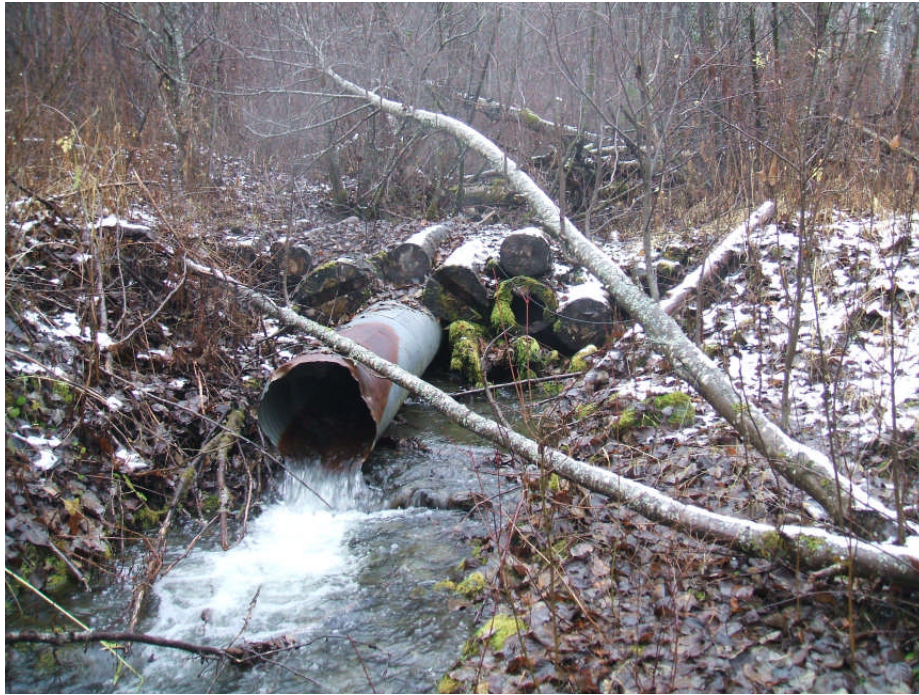
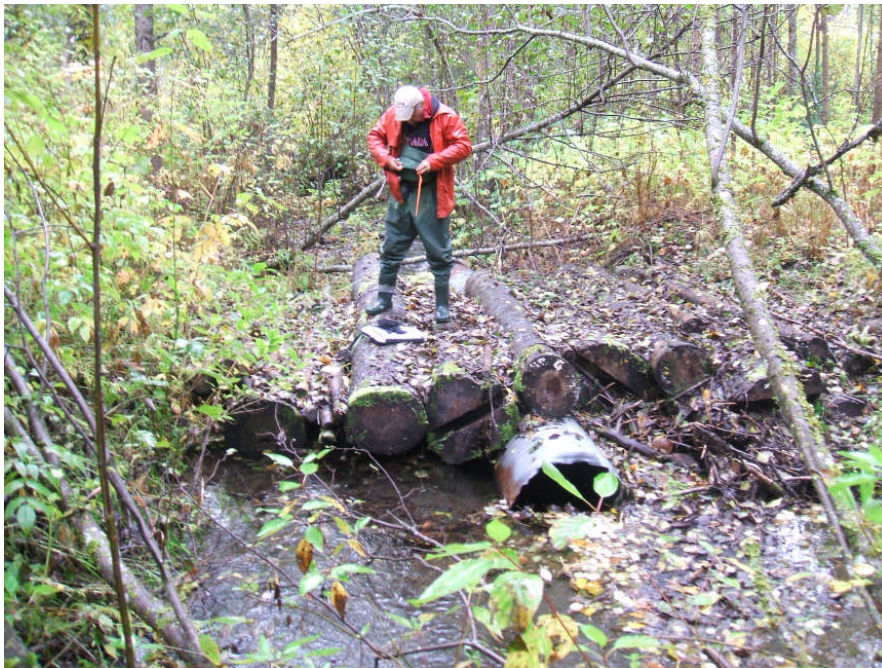
In 2006, a log fjord was found in a stream that crossed the Lower Mitten FSR (2.2 kilometers west of Wagon Creek Road). This site was given high priority because the channel was completely filled with logs, and appeared to significantly impede fish passage (Photos 31 and 32). A culvert was still imbedded in the stream channel, however the stream had eroded a new channel beside the culvert that was later filled with logs to allow for vehicle access. Very little water was flowing through the culvert during this assessment.

Photo 31: Log fjord and culvert outlet before deactivation.

Photo 32: Log fjord and culvert inlet before deactivation.

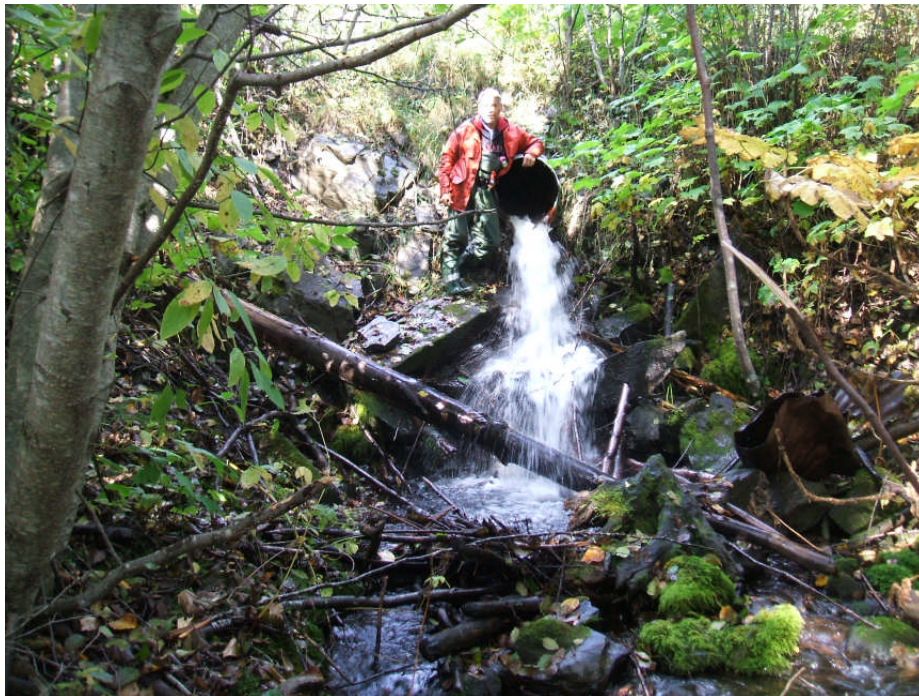
approximately 50 meters downstream of the crossing. The log fjord was located 277 meters upstream of the confluence and by removing the logs it would improve access to approximately 1,300 meters of useable fish habitat up to Site 47 on the Mitten Main FSR (approximate area of 3900m²). The Mitten Main FSR culvert crossing is impassable to fish however it should be noted that the cost of replacement is beyond the budget allocated for rehabilitation works planned for this year (Photo 33). A FHAP was not conducted upstream of the Mitten Main FSR in this field season, but is recommended that it be performed in the 2008 field season to determine the fisheries benefits of replacing this culvert.

Photo 33: Suspended culvert at Site 47 located along the Mitten Main FSR.
