***Gitanyow Fisheries
Authority***

**The 2007 Upper Kitwanga River Stream
Crossing Assessment and Stream
Crossing Deactivation Project**

**Submitted to: B.C. Ministry of Forests
Smithers, B.C.**

March 25, 2007

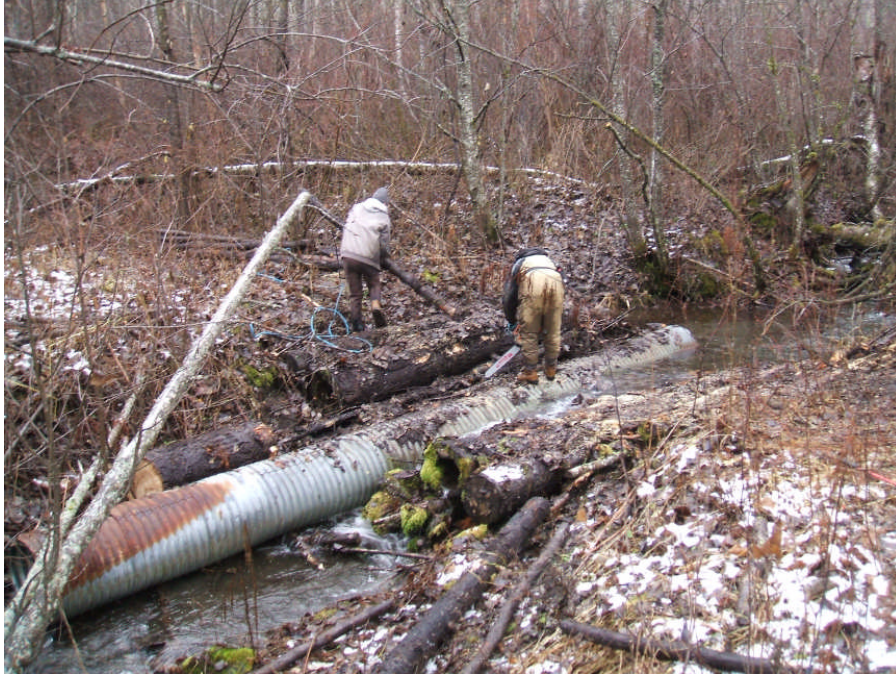
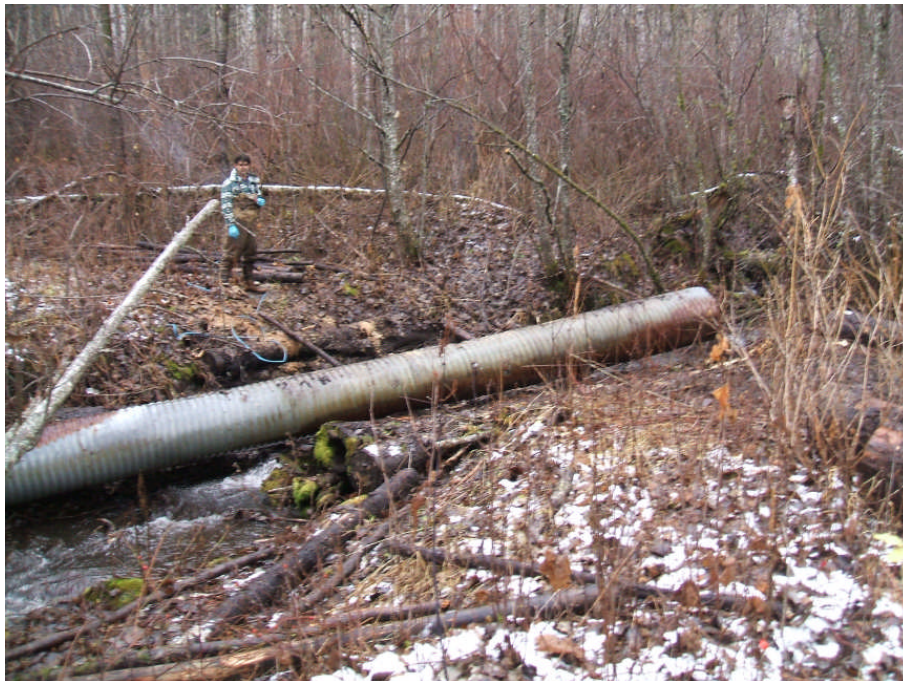
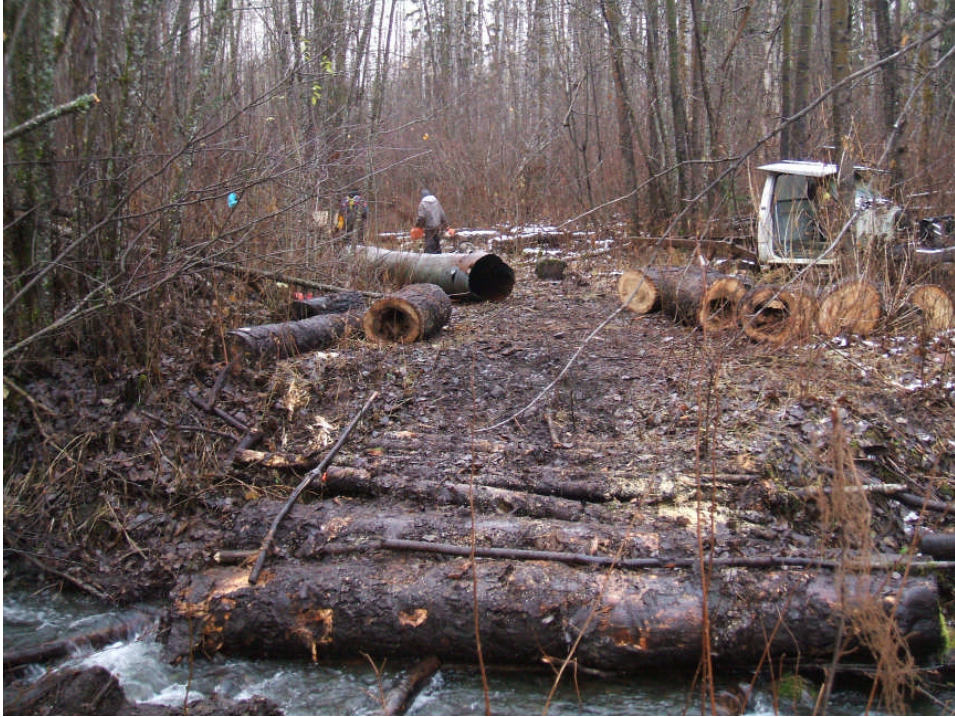
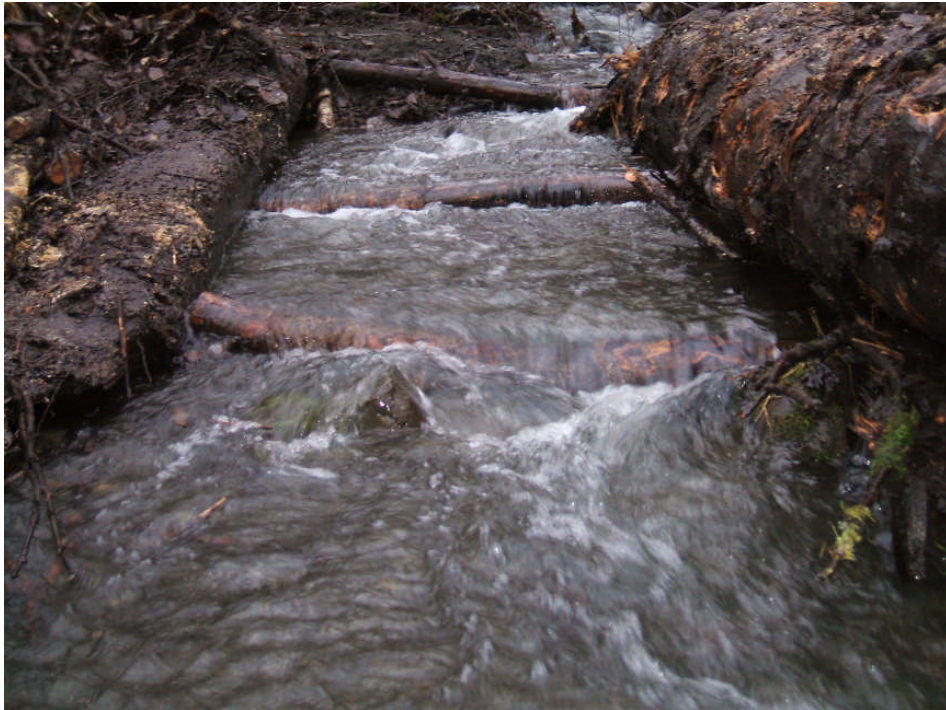
Photo 34: Removing logs over culvert during deactivation at Site 48.

Photo 35: Removing culvert using ATV during deactivation at Site 48.

Photo 36: Culvert and logs removed from streambed and placed on left road surface.

Photo 37: Completed deactivation at Site 48.

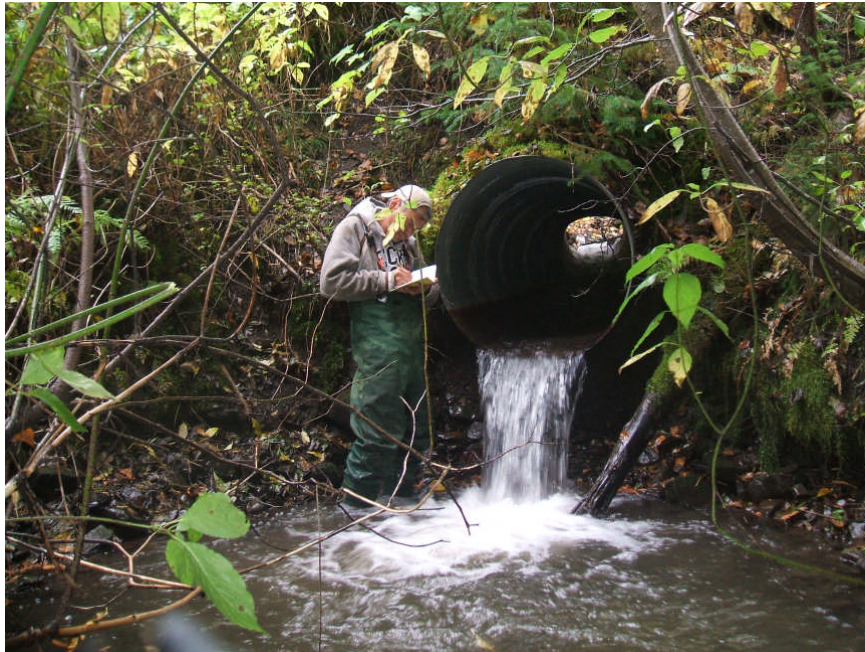
This crossing was considered a full barrier due to the excessive water velocity and insufficient water depth inside the culvert, and an extreme outflow drop at the outlet (Photo 38). The culvert slope was considered steep (10 percent) creating high water velocity (1.05 meters/sec) and low water depth (7cm) inside the culvert. The water velocity exceeded the swimming capability of all juvenile salmonids. A suspended outlet was considered a barrier to all salmonids as it created 66-centimeter high plunge falls into a 35-centimeter deep pool. The intake was partially blocked with wood/rock debris creating a 20-centimeter waterfall over bare culvert. The culvert was partially collapsed midway creating a steeper gradient towards the intake. The Q100 culvert diameter was calculated to be 1970 millimeters for a round culvert. The 1000-millimeter diameter culvert that was in place was insufficient to accommodate a 100-year flood and needed to be removed or replaced. The fill depth above the culvert was 1 meter.

Photo 38: Site 61 culvert outlet prior to deactivation.

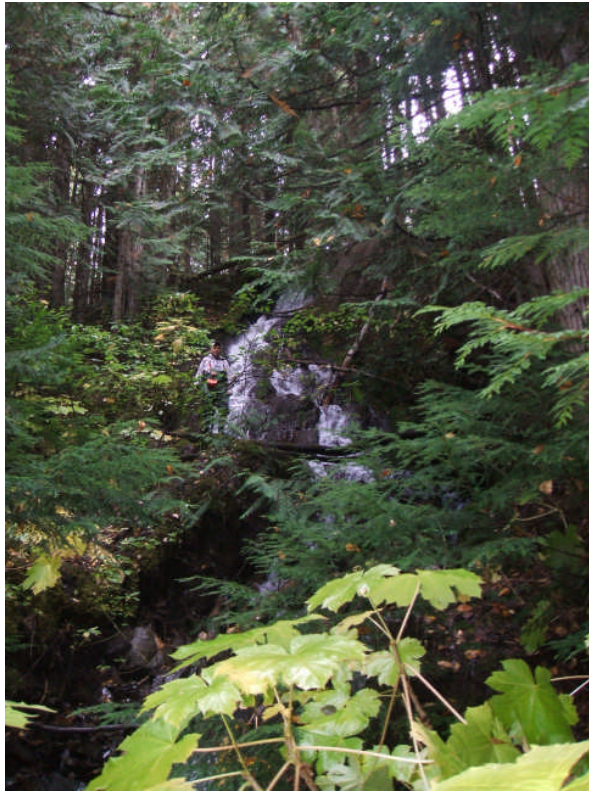
Reach 4 (0+360 meters to 0+420 meters) was a steep section (28 percent average gradient) consisting of cascade-pool morphology. DP and LWD were the main cover types. At the upstream end of this reach is a 30-meter high cascade-waterfall that was considered the upstream limit of fish distribution (Photo 39). This reach is considered marginal fish habitat.

Photo 39: Bedrock falls on the south tributary located 420 meters upstream of Site 61 crossing.

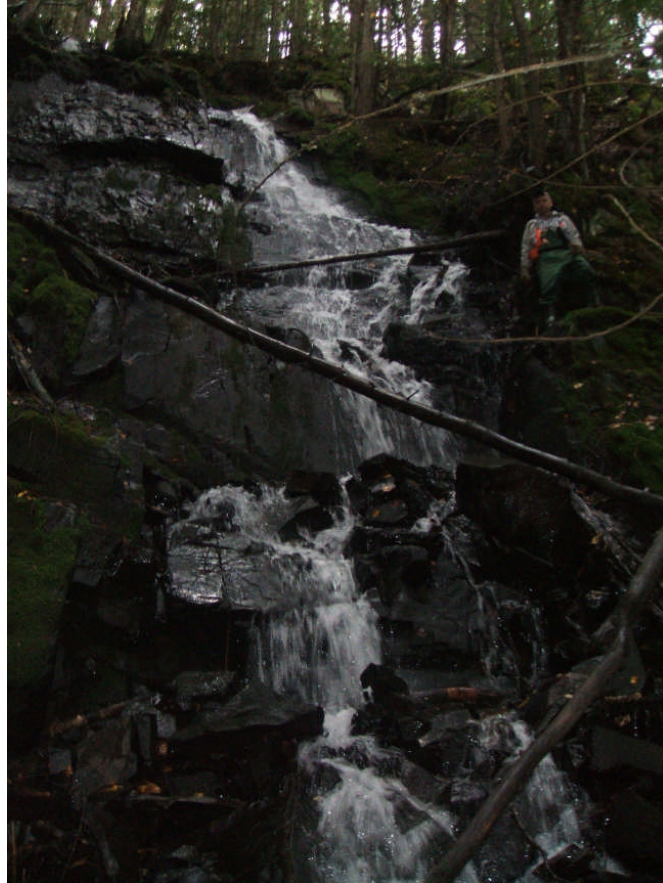
fish distribution (Photo 40). This waterfall is located along the same bluff as the waterfall found along the south tributary and are approximately 70 meters apart. This reach provides marginal fish habitat.

Photo 40: Bedrock falls on the north tributary located 246 meters upstream of the confluence with the south tributary.

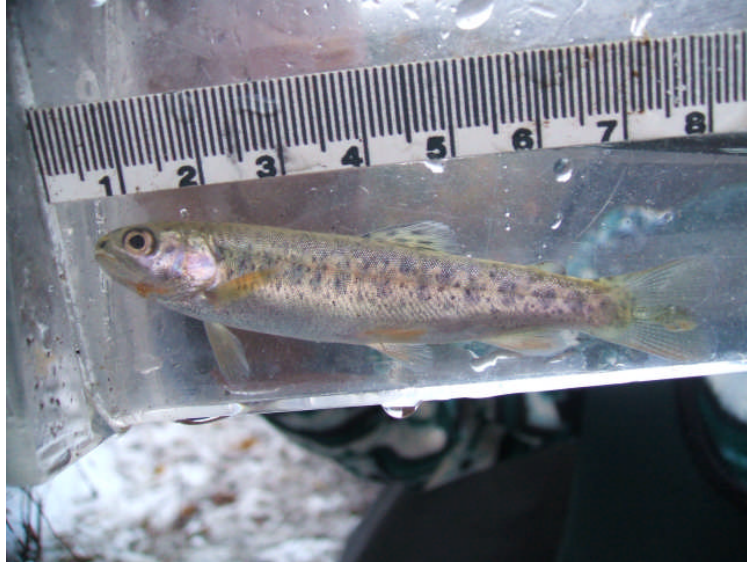
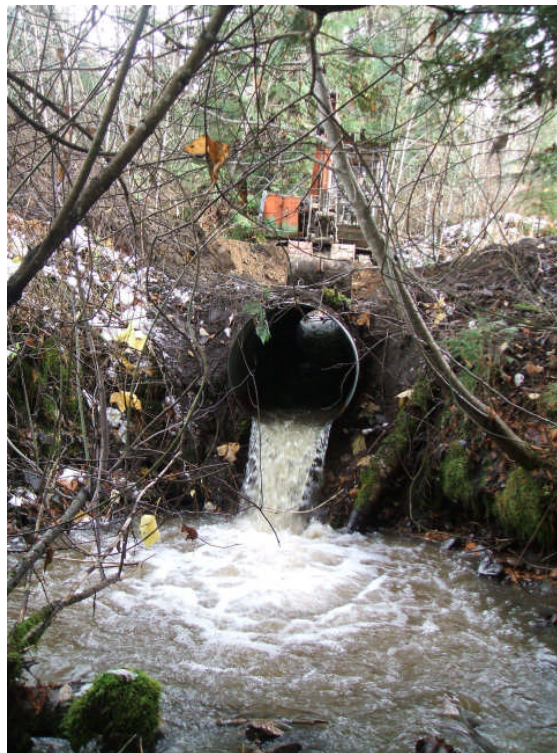
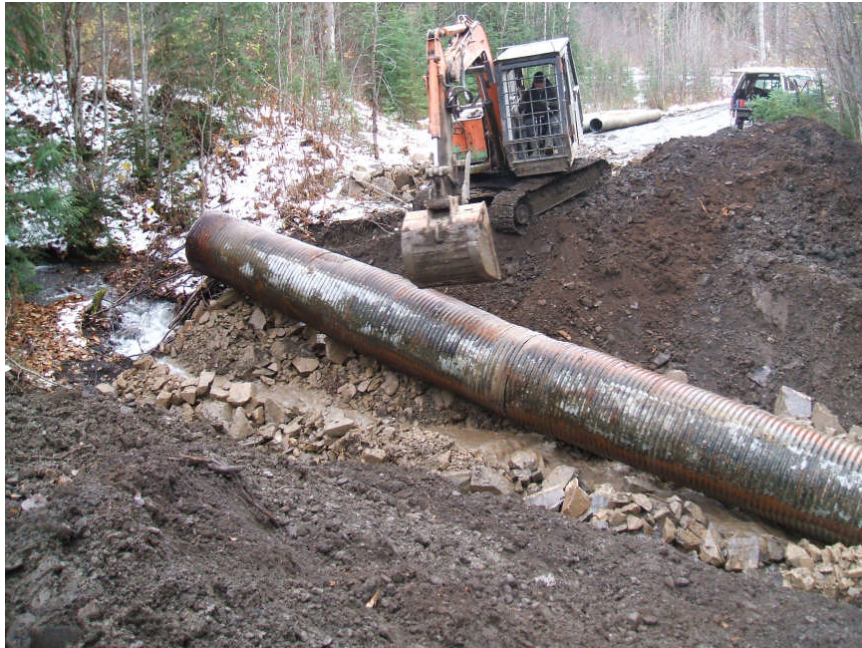
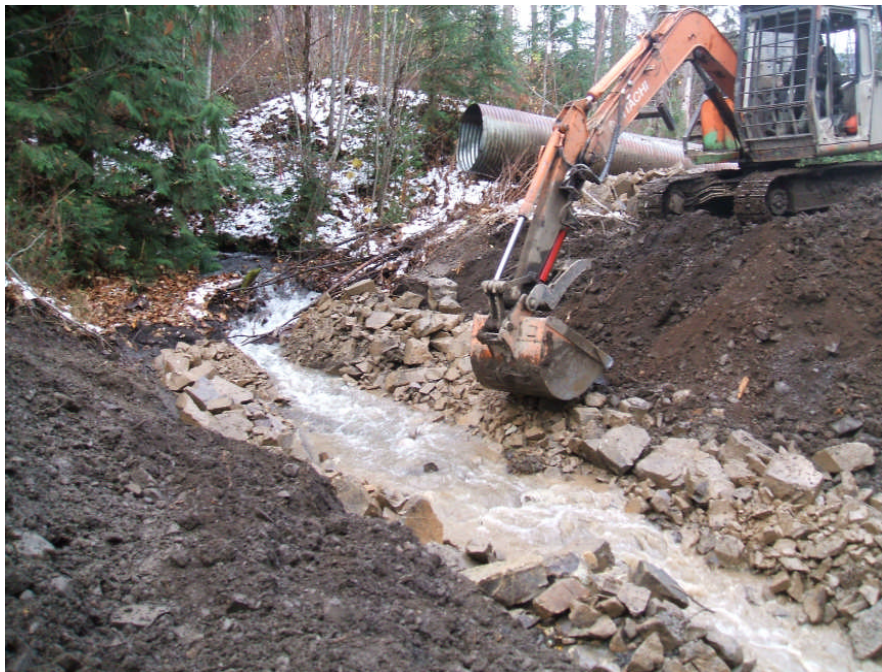
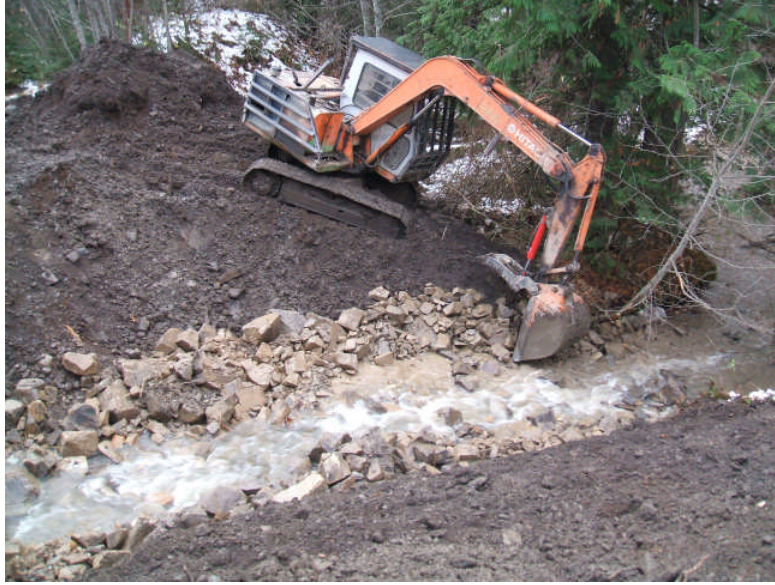
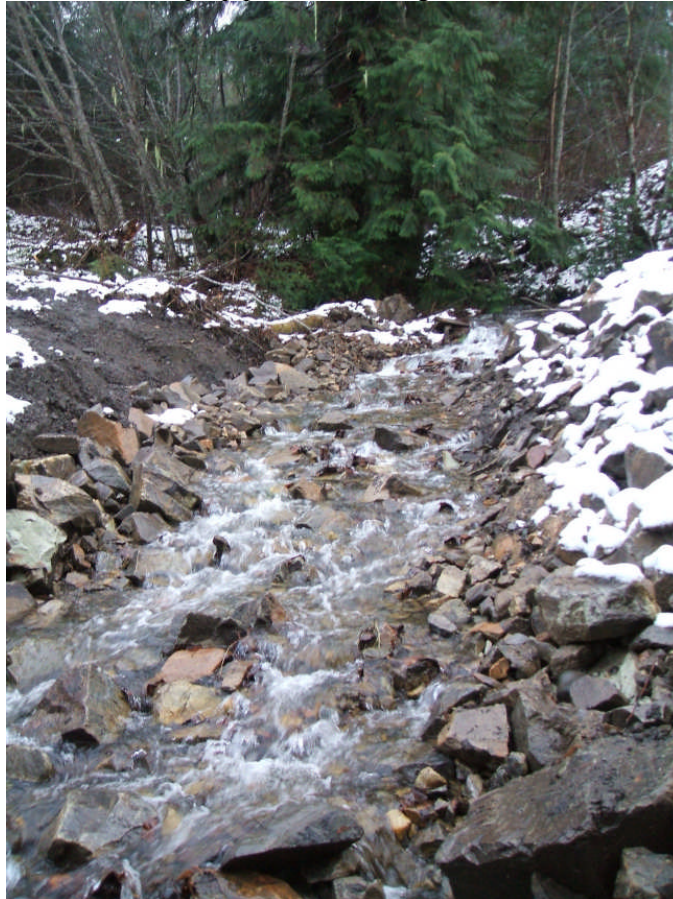
Photo 41: Cutthroat trout captured below Site 61 culvert outlet prior to deactivation.

Photo 42: Removing fill material over Site 61 culvert outlet.

Photo 43: Removing culvert from streambed at Site 61.

Photo 44: Riprap placement along new channel at Site 61.

Photo 45: Final riprap placement along new channel at Site 61.

Photo 46: Site 61 on December 1, 2007 approximately 5 weeks following deactivation.

were placed within the channel for habitat cover and velocity breaks (Photos 44, 45, and 46). A complete photo series for the FHAP and the deactivation is presented on CD in Appendix II in a Folder entitled Site 61 FHAP and Deactivation.

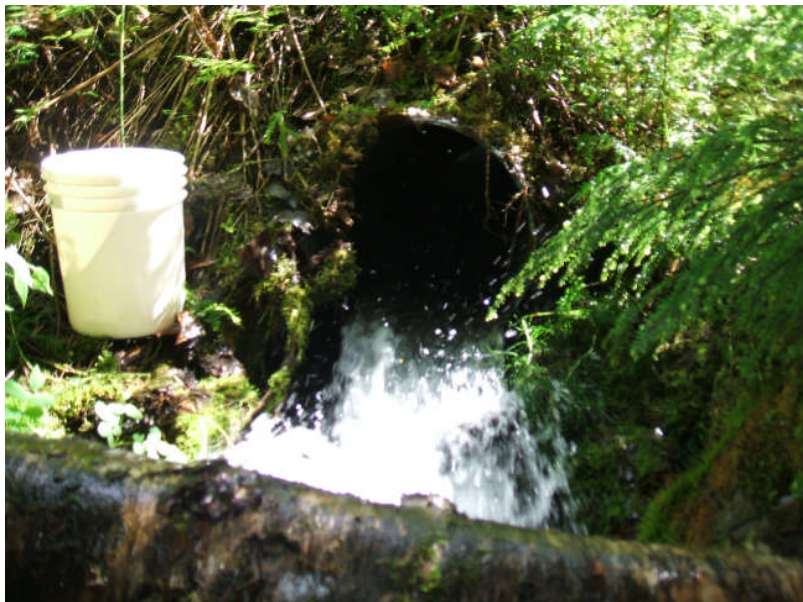
This crossing was considered a full barrier due to the excessive water velocity inside the culvert and an excessive outflow drop. The culvert slope was steep (9 percent), creating a water velocity of 1.16 meters/second over an 8-meter distance, which exceeded the swimming capability of most juvenile salmonids. Also, the culvert outlet drop was unacceptable for fish passage (40 centimeter drop / 14 centimeter outfall pool). The Q100 culvert diameter was calculated to be 1200 millimeters for a round culvert, which is twice the size of the 600-millimeter diameter culvert currently in place. The fill depth above the culvert was 1.5 meters.

Photo 47: Site 15 culvert outlet.

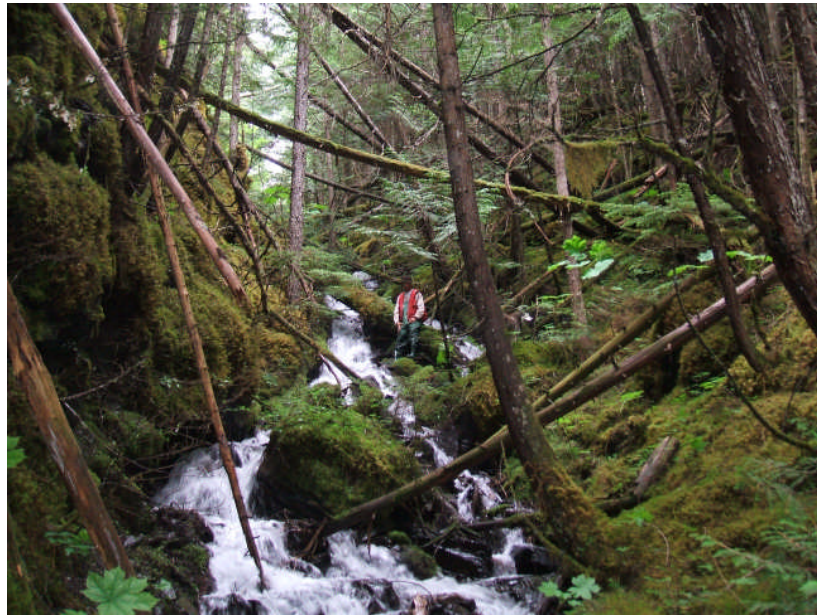
Reaches 9 and 10 (0+572 to 0+828 meters) were moderate to steep gradient reaches (11 and 18 percent respectively) with mainly cascade/pool morphology. Although the gradient was relatively steep, no significant barriers were found. At the upstream end of Reach 10 is a cascade/falls over bedrock and is considered the upstream limit of fish distribution (Photo 48). These reaches provide moderate to marginal fish habitat.

Photo 48: Bedrock waterfalls located approximately 256 meters upstream of the Site 15 crossing.
