EN12TCF048

Fish Passage Assessments - Lower Fraser Watershed Group

March 2012

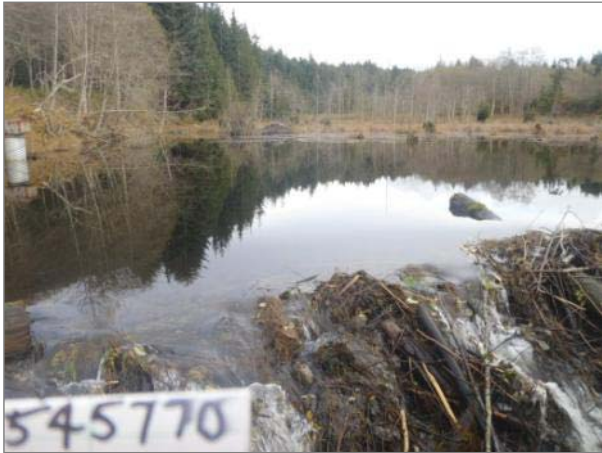
545770

Good habitat. Small woody debris, deep pools and gravels abundant downstream. Upstream is beaver pond with dam immediately upstream of inlet. Inlet drop is 2 m high. Needs repair. Candidate for outlet pond works with fish passage pools and drops/jumps installed.

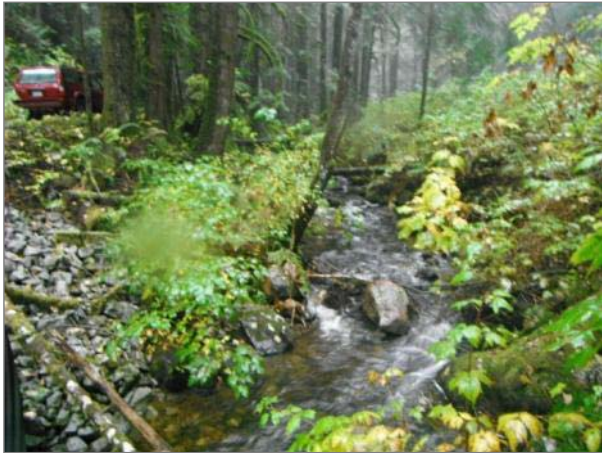
545983

Excellent habitat upstream, lower gradients at 5%. Gradient great downstream at 12 %. Abundant cover, but little gravel. Looks like newer culvert. Stream is too steep for any treatments or open bottom arch type of replacement. Candidate for steel bridge, likely 6 meter span on 2M substructure.

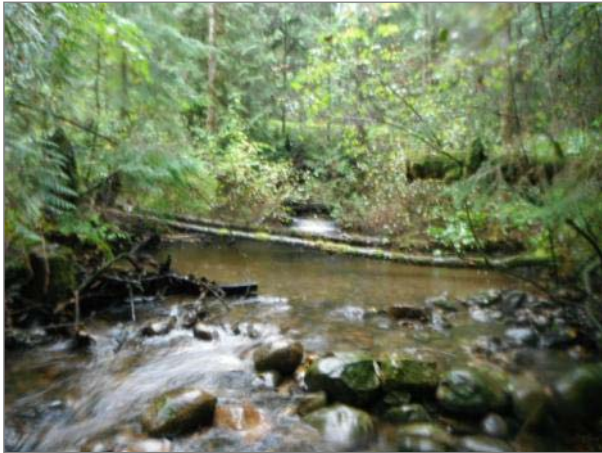
546061

Excellent habitat, deep pools, abundant cover, LWD, undercut banks. Deep pool at outflow. Candidate for streambed simulation devices along haunch, likely on one side. Addition of substrate recommended with outlet weir required for backwatering. Inlet step structure likely required due to stormflows, infilling evident and continued maintenance expected unless inlet and outlet weirs designed to accommodate natural bedload movement.

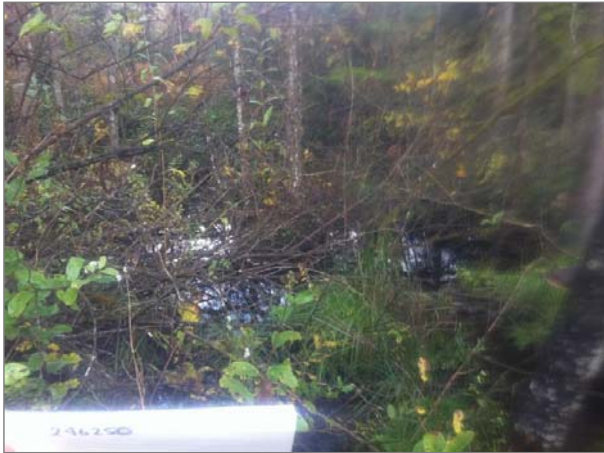
546250

Beaver activity upstream, lots of rearing habitat. Several private crossings downstream. Cutthroat present downstream. Candidate for backwatering. Too small for embedment and too long. Paved road and urban setting preclude replacement early. Backwatering is a best choice for fish rehab. Alternatively, open bottom arch (2.1 x 22m).

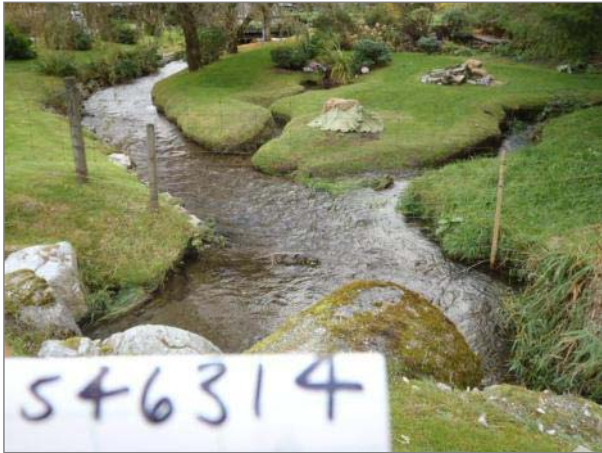
546314

Twin culverts passable, Chum present downstream. Discussed with neighbour, fish used to move upstream but not observed this year. Candidate for concrete panel bridge.

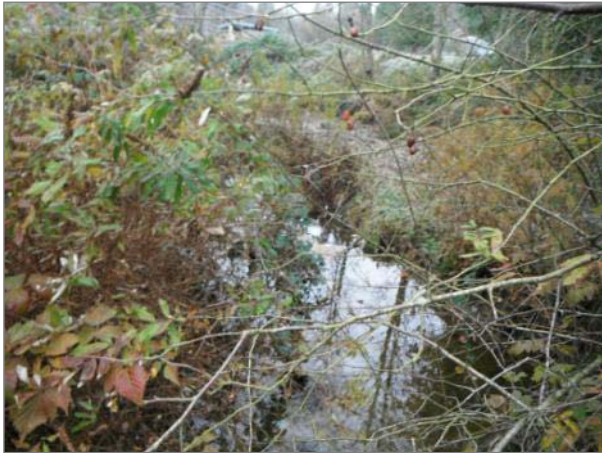
Crossing 546351 is located on a tributary to Kanaka Creek (WSC: 100-037400-33200-19400), 950 m upstream of crossing 546435. Habitat was considered excellent at this crossing, with abundant cover from deep pools, undercut banks and over stream vegetation. This crossing was given a moderate priority for remediation as it will provide access to ~1.8 km of additional habitat. Backwatering and substrate addition at a cost of \$60,000 was recommended for remediation.

Excellent habitat, low gradient, abundant cover deep pools, undercut banks, and overstream vegetation. Gravel present for spawning. Electric fence downstream. Candidate for substrate installation with retaining devices or implements and backwatering. Or replace with open bottom arch (3.4 x 25 m).

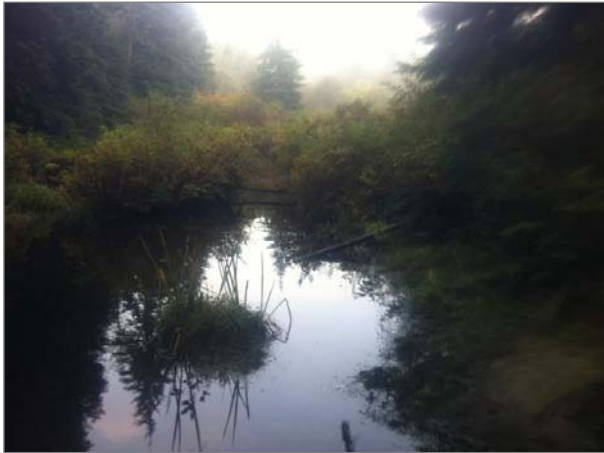
546427

Beaver dam u/s at manmade rock groin. Nice ponds u/s. Cutthroat reported upstream. Candidate for backwatering. Ultimately replace with open bottom arch (3.4 x 30 m).

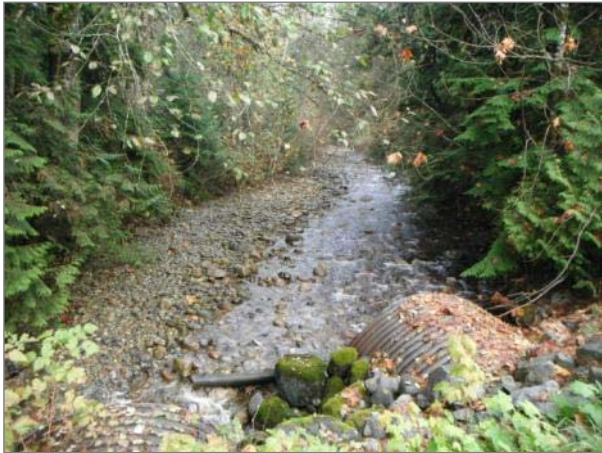
Crossing 546433 is located on the mainstem of Kanaka Creek under the Dewdney Trunk road. Resident cutthroat trout have been observed within adjacent reaches of the stream, although downstream barriers prevent access for anadromous fish species. Habitat value at the crossing was considered high with low gradient (1%) and abundant cover available in the form of boulders, deep pools, and overhanging vegetation. No gravels were observed. This crossing was considered a candidate for baffle installation, substrate addition and backwatering. Alternatively, installation of a concrete bridge (12 m span) is recommended. Waterfalls are present approximately 1.3 km and 3.3 km upstream of the crossing. No information is available on the lower waterfall, however pictures of the upper waterfall indicate it is impassable at all flows.

Excellent habitat. Low gradient. Cover in the form of boulders, deep pools, overhanging vegetation. No gravels observed. Candidate for installing baffles, substrate addition and backwatering. Alternatively concrete bridge installation (12 m span).

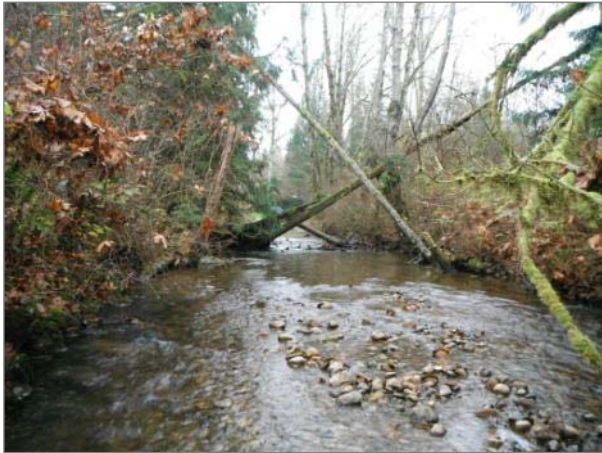
Crossing 546435 is located on a tributary to Kanaka Creek (WSC: 100-037400-33200), approximately 1.8 km upstream of a 6 m waterfall. Habitat value was rated as high with abundant deep pools, large woody debris, overstream vegetation and gravels suitable for spawning. The crossing, which consists of a twin culvert, is a candidate for works on the southern smaller pipe including backwater and substrate addition. Alternatively, the crossing could be replaced with a steel bridge. Cutthroat trout have been reported upstream of 546435 approximately 1 km (FISS) and 3 km (Whitford, 2009). The presence of cutthroat trout upstream indicates the remediation of this culvert would serve to restore connectivity within the stream. A priority rating of moderate was given for remediation of this crossing.

Twin culverts, 4 m each span. No fish observed but fish bearing. Excellent habitat with abundant deep pools, large woody debris, overstream vegetation. Gravel abundant for spawning. Candidate for works on the southern smaller pipe including backwater and substrate addition. Outlet weir works will be extensive due to accommodating flow in the large pipe and enabling step-pool and/or backwater weir . Alternatively, replace with bridge.

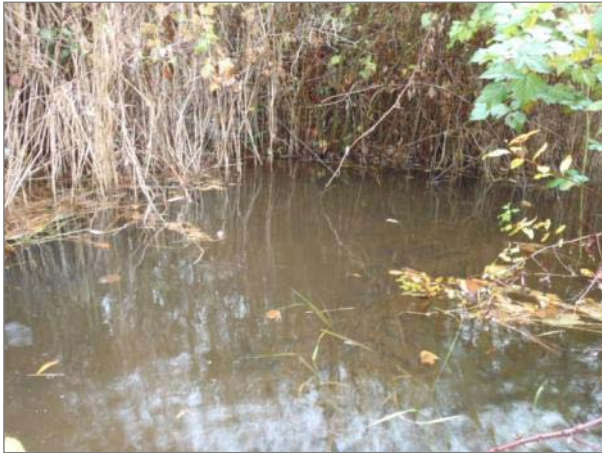
546473

Ditches u/s and d/s. Backwatered by beaver dam 100m downstream, therefore adjusted SWR (Stream is 4.1 m). Low gradient. Culvert probably not passable if beaver dam removed. Further action recommended. Candidate for open bottom arch.

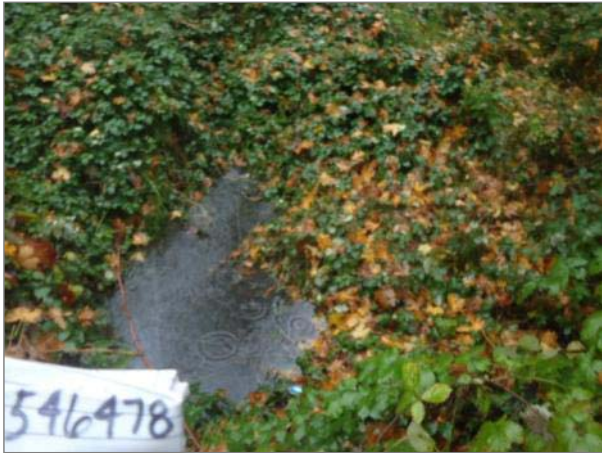
546478

Revegetation project along creek with browse protection. High volume and turbid during precipitation events. Heavily covered in vegetation. Potential for CO rearing. Embedded, difficult to determine due to high turbidity. Small size of pipes would normally preclude streambed simulation, however this site has two pipes, one of which could be a candidate for backwatering to a deeper level with a creative split-type outlet weir. Replacement structure is a 2440mm x 1270mm Open bottom arch.

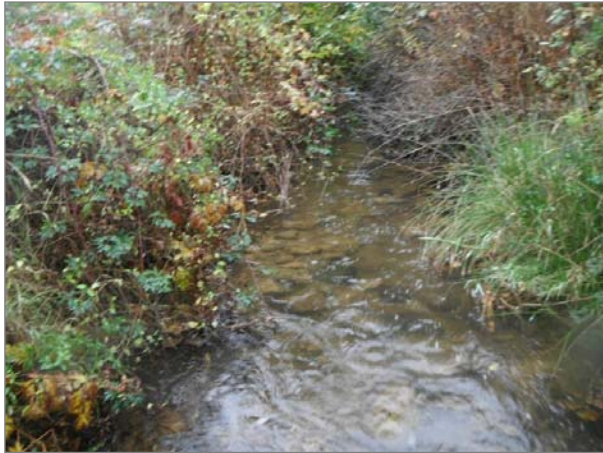
Crossing 546512 on Kenworthy Creek was identified as high priority for restoration (Table 6). Habitat at the crossing was rated as high at the crossing location. Coho and 'unidentified salmon' (AO) have been reported at the crossing (FISS), and 2.49 km of modeled fish bearing stream is present upstream. A concrete bridge at an estimated cost of \$175,000 is recommended to remediate this crossing.

Large outlet pool. Nice habitat upstream. Recommend further action. Secondary culvert (0.8) dry. Candidate for concrete panel bridge.

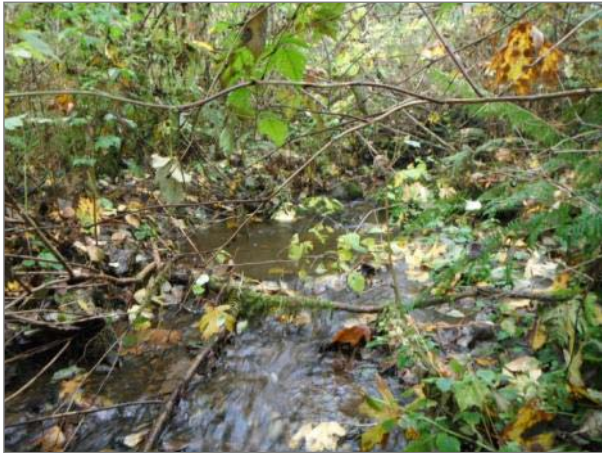
546588

Box culvert for top part of culvert 2 m wide, last third of culvert oval metal culvert. Fix recommendation is add substrate in one of the culverts and install outlet weir.

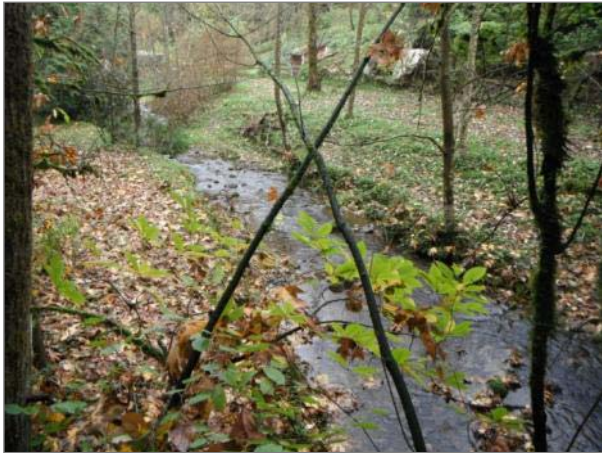
546699

Main cover overstream vegetation. Little deep pools. Could put baffles in culvert. Passable for larger fish. CM and CO recorded in stream. Twin box concrete culvert (2 x 1.9 m). Inlet drop on left culvert with some debris accumulation. Fix recommendation is add substrate in one of the culverts and install outlet weir.

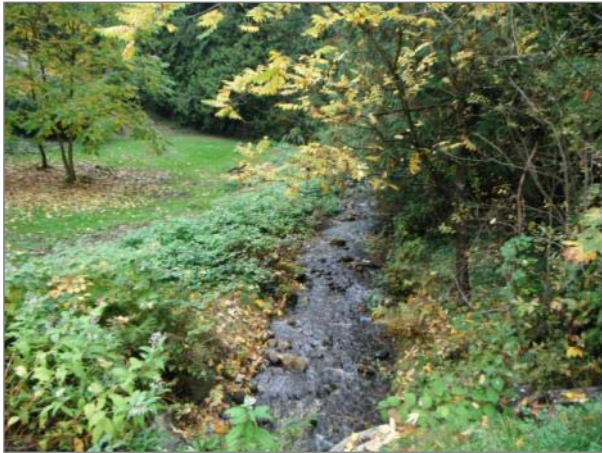
546722

Round culvert with concrete bottom and baffles. Was installed 2-3 years ago (pers com neighbour). Outlet drop is a barrier. 1 Chum observed downstream of culvert. Candidate for outlet structures particularly a stepped outlet to enhance fish passage. Not only backwatered but outlet step-drops installed and maintained. Remedial works require RP Bio and P. Eng working together.
