Gitanyow Fisheries Authority

The 2008 Kitwanga-Cranberry River Watershed Restoration Project

Submitted to: B.C. Ministry of Forests and Range
Smithers, BC

Prepared by: Mike McCarthy HBSc
Gitanyow Fisheries Authority

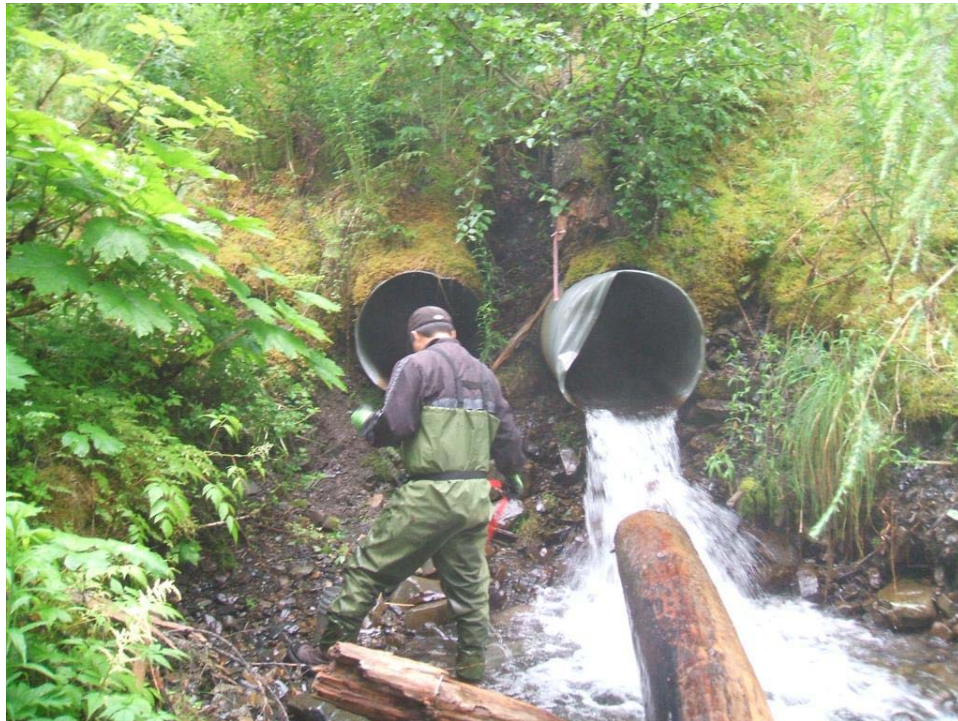
Photo 1: Suspended culvert outlets at Site 91 prior to deactivation.

The prescription for this site was to remove the culverts and deactivate the crossing. Structural replacement was considered too costly for the NWFREP restoration funding available for 2008. Following project approval by the Gitanyow Hereditary Chiefs and the BC MoFR, the GFA and McElhanney Consulting Services prepared a detailed deactivation plan, which is presented in Appendix I. Works began on February 8th, 2009 and was completed in approximately 6 working days. Machinery on site included 2 excavators, a crawler tractor, and a dump truck. Machines excavated down to natural streambed and removed culverts in sections beginning at the downstream end (Photos 5 and 6). The stream banks and channel bed were then armored with riprap. An ATV trail was constructed on the upstream side of the crossing and the remaining approaches were graded to a 2H : 1V slope (Photo 7). All exposed soils were seeded with grass and fertilized, and the approaches leading to the stream were covered with straw mulch to aid seed germination (Photos 8 and 9).

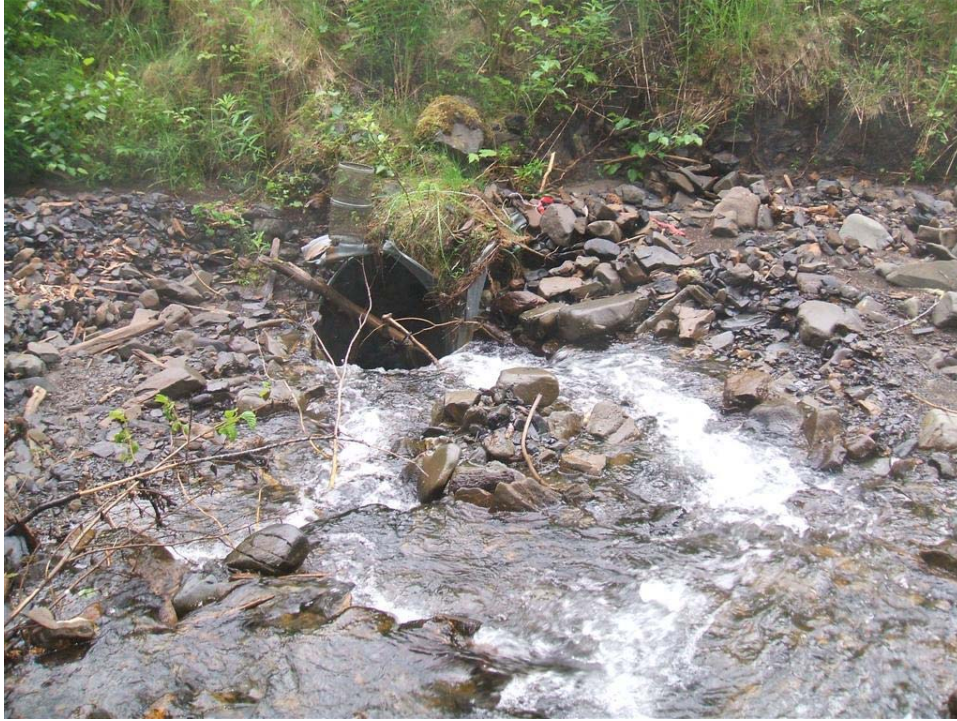
Photo 2: Partially blocked left culvert intake and completely blocked right culvert intake at Site 91 prior to deactivation.

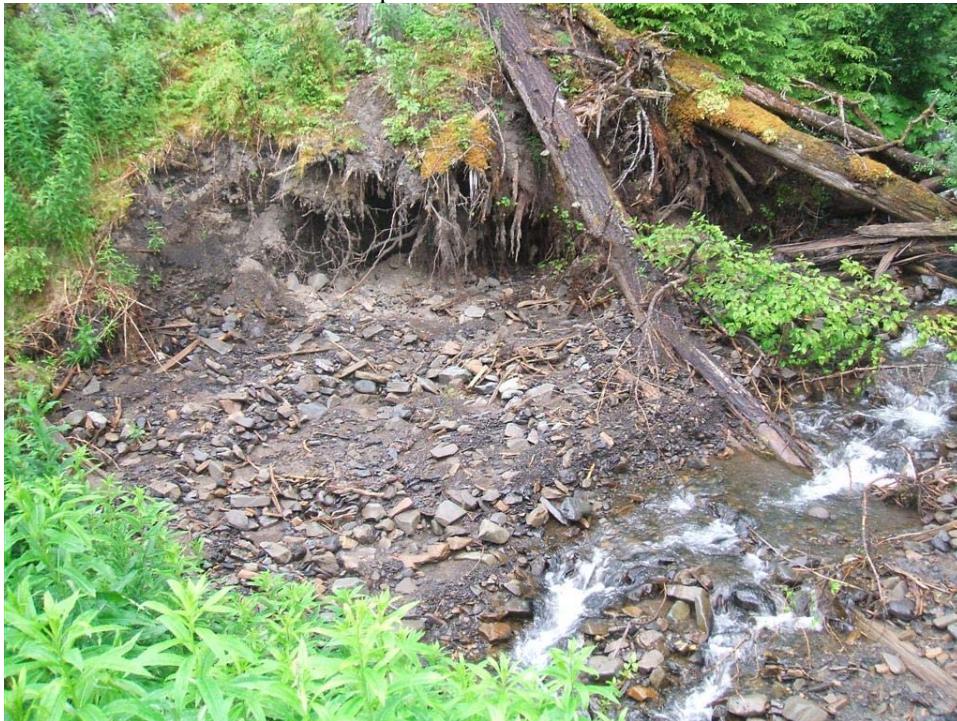
Photo 3: Mass wasting on the upstream right bank at Site 91 prior to deactivation.

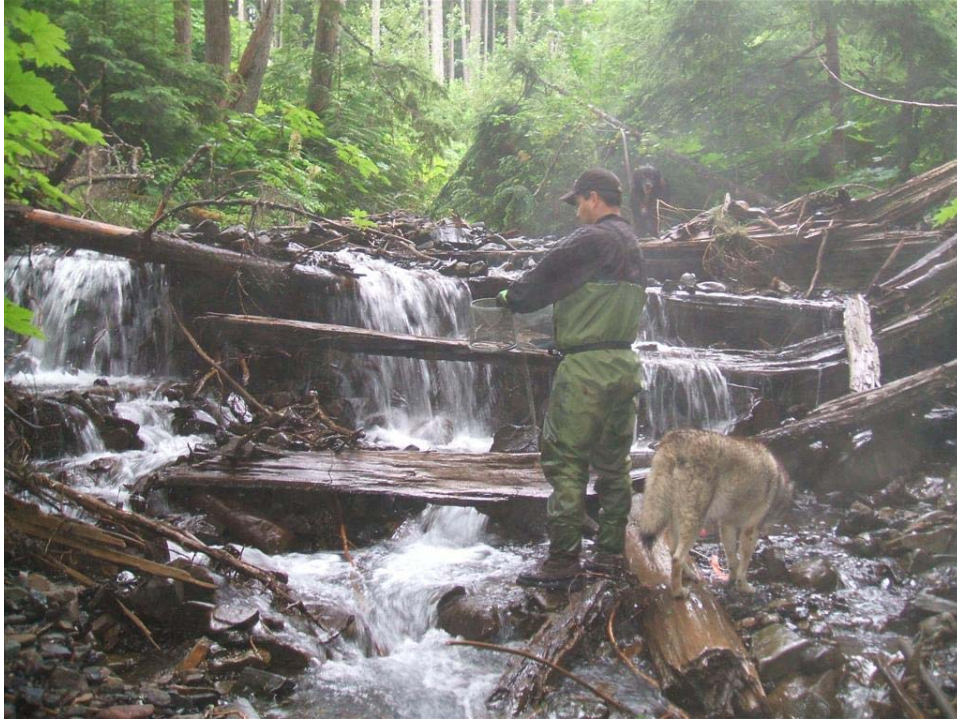
Photo 4: Waterfalls created by rock/wood debris jam at 150 meters downstream of the Kitwancool Lake FSR.

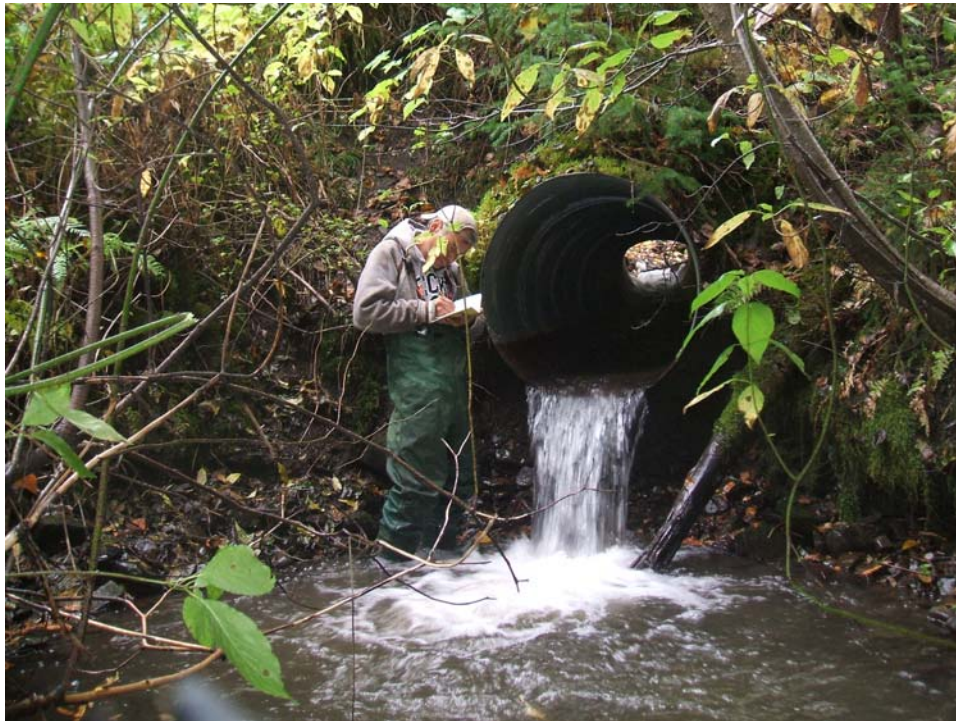
In 2006, Site 61 was identified as a fish barrier (McCarthy 2007, Photo 10) and was subsequently deactivated in 2007 (McCarthy 2008, Photo 11). Initial treatment of the disturbed site was undertaken on May 22nd, 2008 when grass seed, fertilizer, and erosion control blankets were applied to approximately 340 m² of exposed soil (Photos 12 to 15). This site is located 50 meters from Hwy 37 N and was revisited on six occasions throughout the growing season, mostly while on-route to other destinations (June 4th, 9th, 17th, 27th; August 19th; and October 1, 2008; additional photos on CD in Appendix I). By June 9th, a large portion of the grass seed had germinated and was beginning to penetrate through the ECBs. By June 27th most of the seed had germinated and by October 1st (final visit), the entire area was well vegetated. No further works are recommended for this site.

Photo 10: Suspended culvert outlet at Site 61 prior to deactivation (2006).

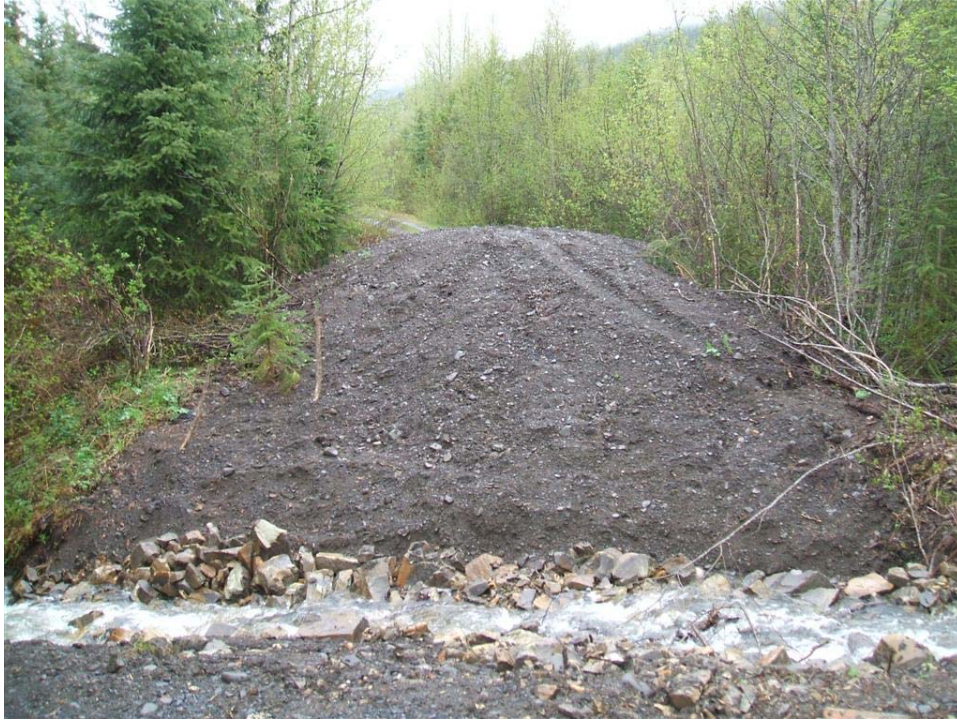
Photo 11: Exposed right bank following the 2007 deactivation of Site 61 (May 22, 2008).

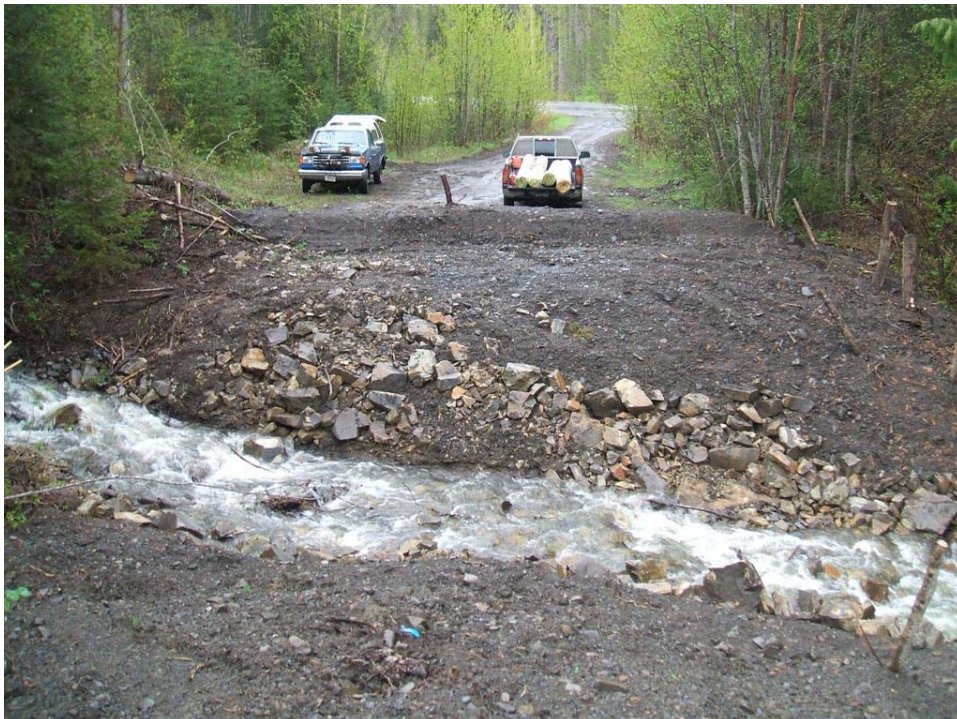
Photo 14: Exposed left bank following the 2007 deactivation of Site 61 (May 22, 2008).

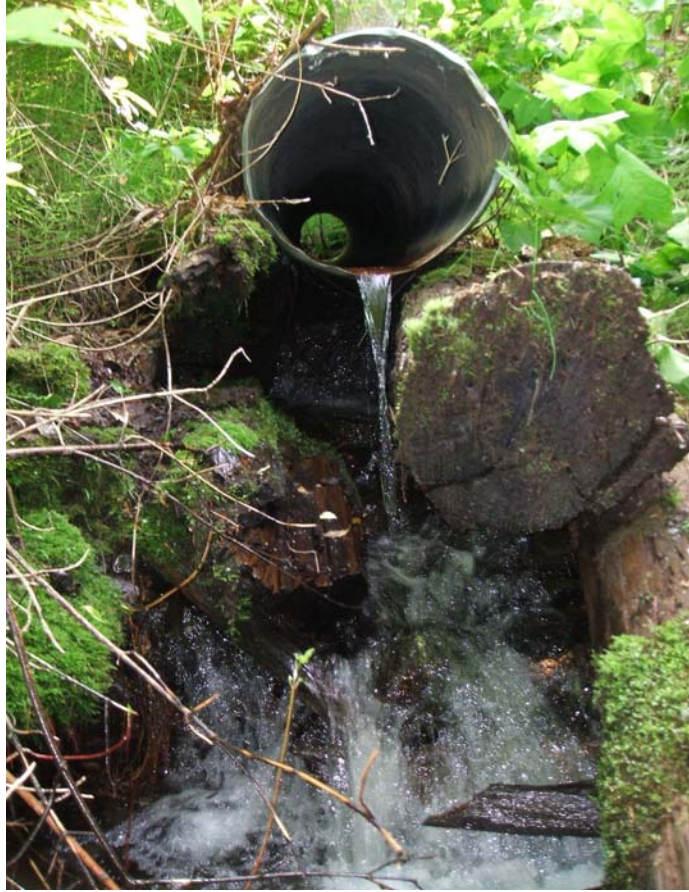
In 2006, Site 14 was identified as a fish barrier (McCarthy 2007, Photo 16) and was subsequently deactivated in 2007 (McCarthy 2008, Photo 17). Initial treatment of the disturbed site was undertaken on May 23rd, 2008 when grass seed, fertilizer, and erosion control blankets were applied to approximately 200 m² of exposed soil (Photos 18 to 22). When revisited on July 17th, 2008 most of the grass seed had germinated and penetrated through the ECBs. By October 1st, 2008 (final visit) the entire site was considered completely vegetated. No further works are recommended for this site.

Photo 16: Suspended culvert at Site 14 prior to deactivation (October 2007).

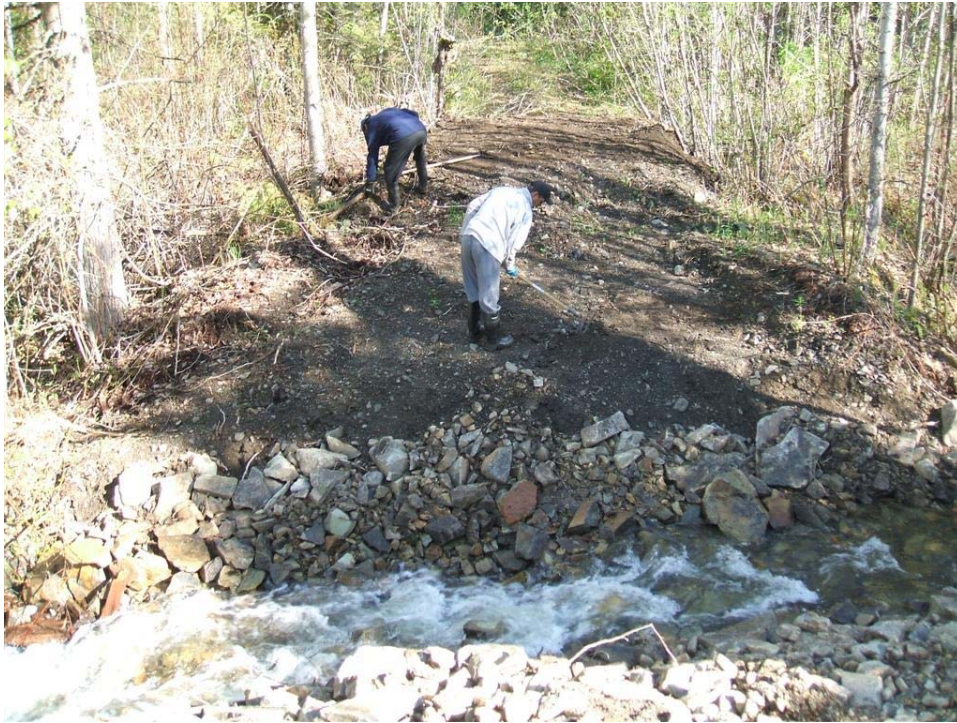
Photo 18: Preparation of exposed right bank and piled road fill prior to treatment at Site 14 (May 22, 2008).

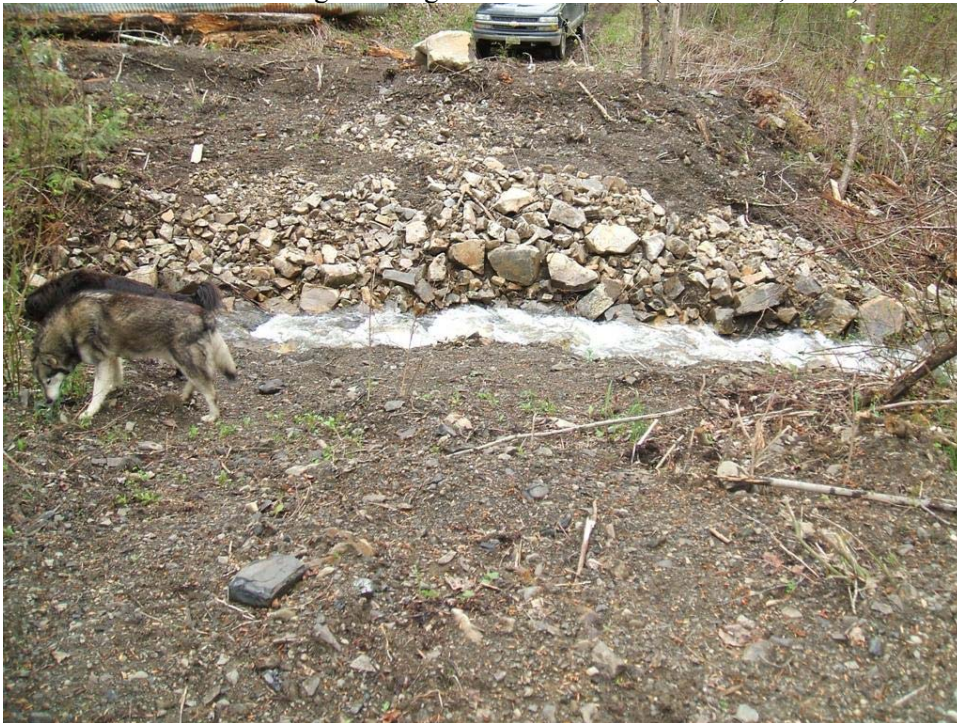
Photo 21: Exposed left bank prior to treatment at Site 14 (May 22, 2008).

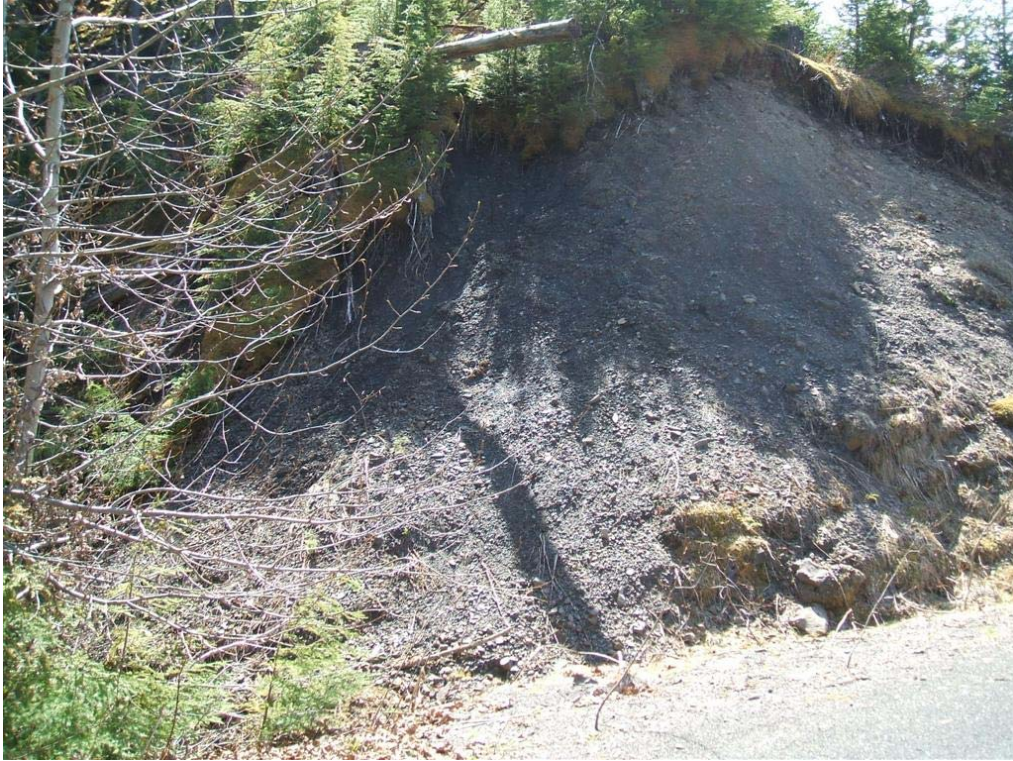
In 2007, Site 42 received a high WQEE score of 7.2 m³ (McCarthy 2008). Similar to Site 35, mass wasting has occurred on a steep left road cutbank (85 percent slope approximately) adjacent to the stream channel (Photo 26). Initial treatment was undertaken on May 26th, 2008 when grass seed, fertilizer, and erosion control blankets were applied to approximately 200 m² (Photos 27 and 28). When revisited on July 17th, 2008 only a minor amount of grass seed had germinated and had yet to penetrate through the ECBs. By October 14th, 2008 (final visit) approximately 95 percent of the area treated with grass seed and ECBs was well vegetated (Photo 29). An adjacent area treated with grass seed only was less successful with approximately 30 percent coverage (Photo 29). No further works are recommended for this site.

Photo 26: Exposed left road cutbank at Site 42 prior to treatment (May 26, 2008).

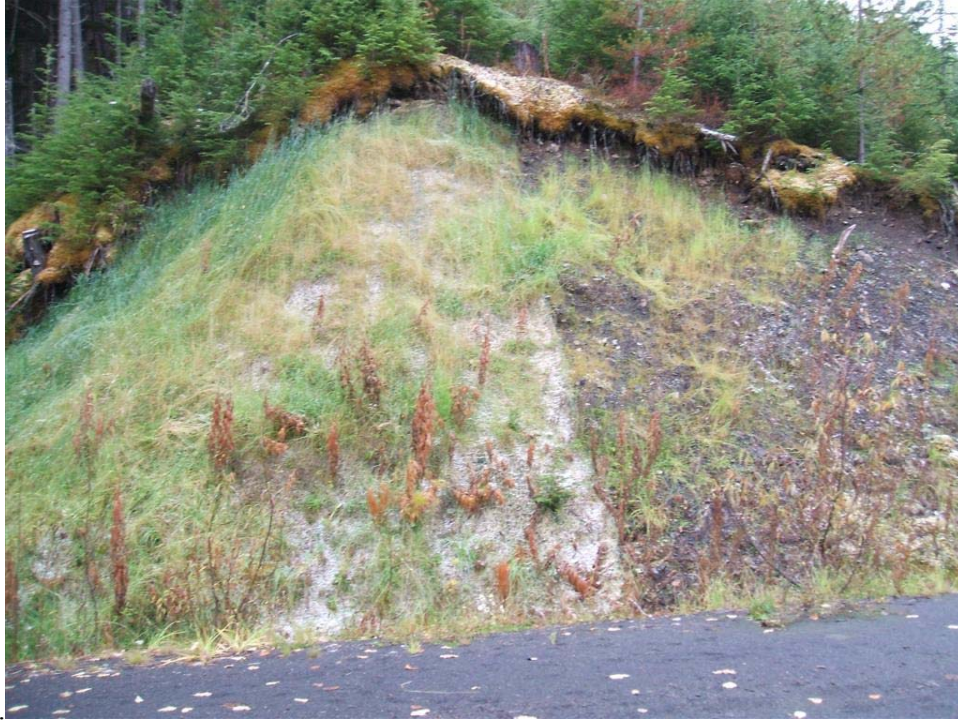
Photo 30: Noticeable difference between seeded areas treated with ECBs (left) vs. seeded area treated without ECBs (right) at Site 42 (October 14, 2008).

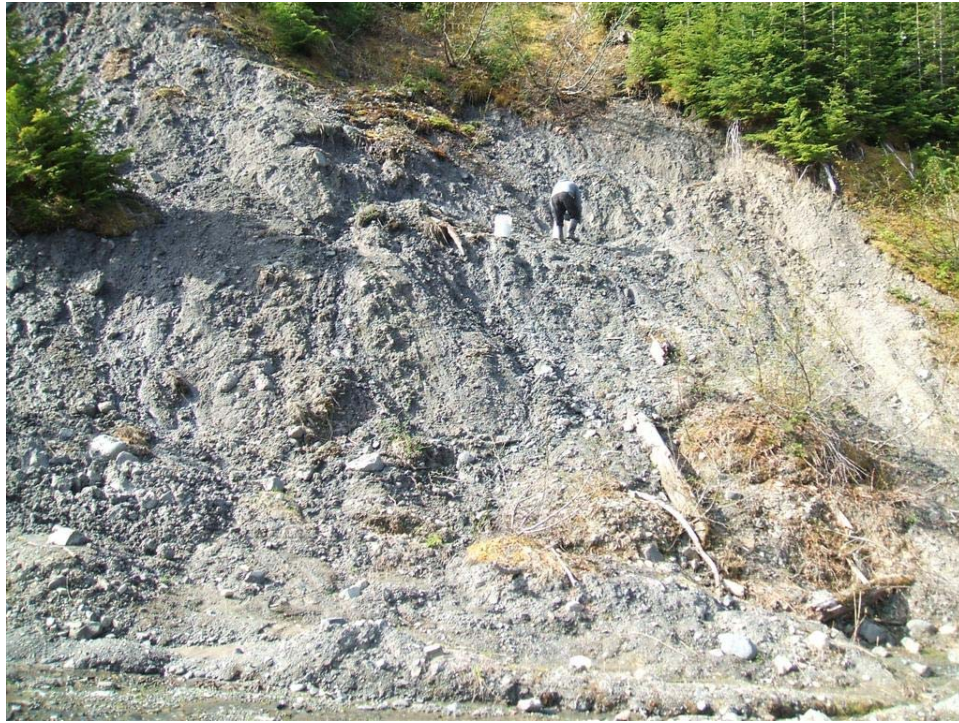
In 2007, Site 186 received a very high WQEE score of 514 m³ (Koch and McCarthy 2008). The greatest sediment contributor was from four sections of mass wasting along the RRC (Photos 31 and 32). Initial treatment was undertaken on May 27th, 2008 when grass seed and fertilizer was applied to approximately 1000 m² of exposed soil. ECBs were not applied due to the irregular surface of this site (rills, rock, slumping). A best management practice for ECB installation involves smoothing the treatment area before application (Anonymous 2005), however this would have required the use of heavy equipment. By the time of the final visit on October 1st, 2008 it was estimated that 30 to 50 percent of the area was vegetated and these areas were scattered in clumps (Photos 33 and 34). This was the result of the downhill movement and concentration of seed and fertilizer into pocket depressions following application. GFA recommends that this site be smoothed (remove rills) and reseeded in early in 2009 and that the application of straw mulch and brush mats be included in the work plan. The straw mulch will aid in holding the seed and fertilizer in position until germination.

Photo 31: Exposed right road cutbank at Site 186 prior to treatment (looking across road; May 27, 2008).

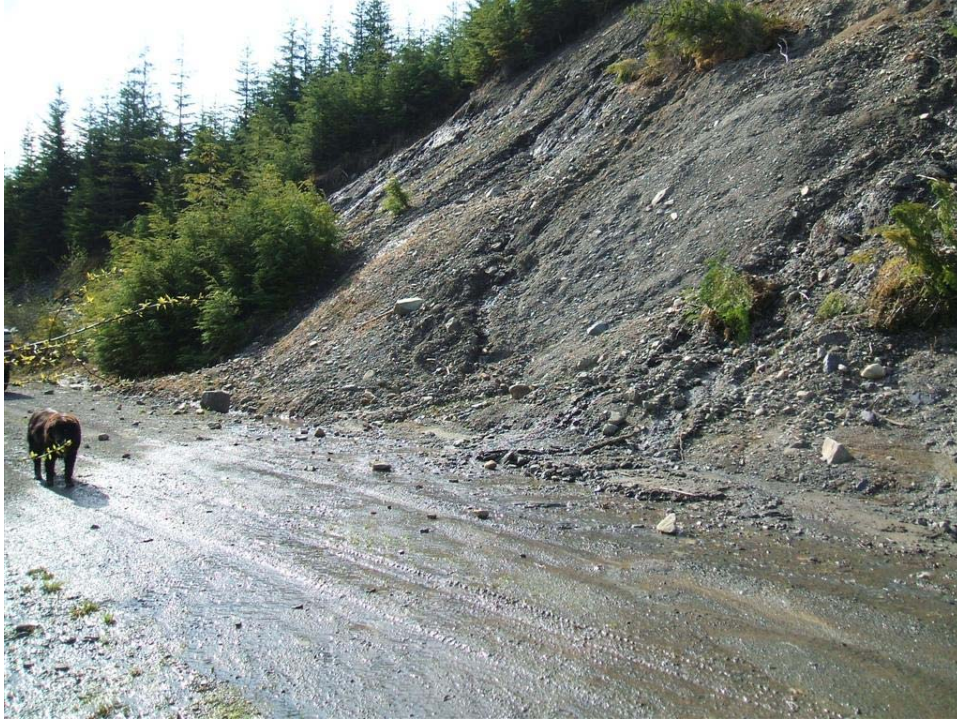
Photo 32: Exposed right road cutbank at Site 186 prior to treatment (looking away from stream, May 27, 2008).

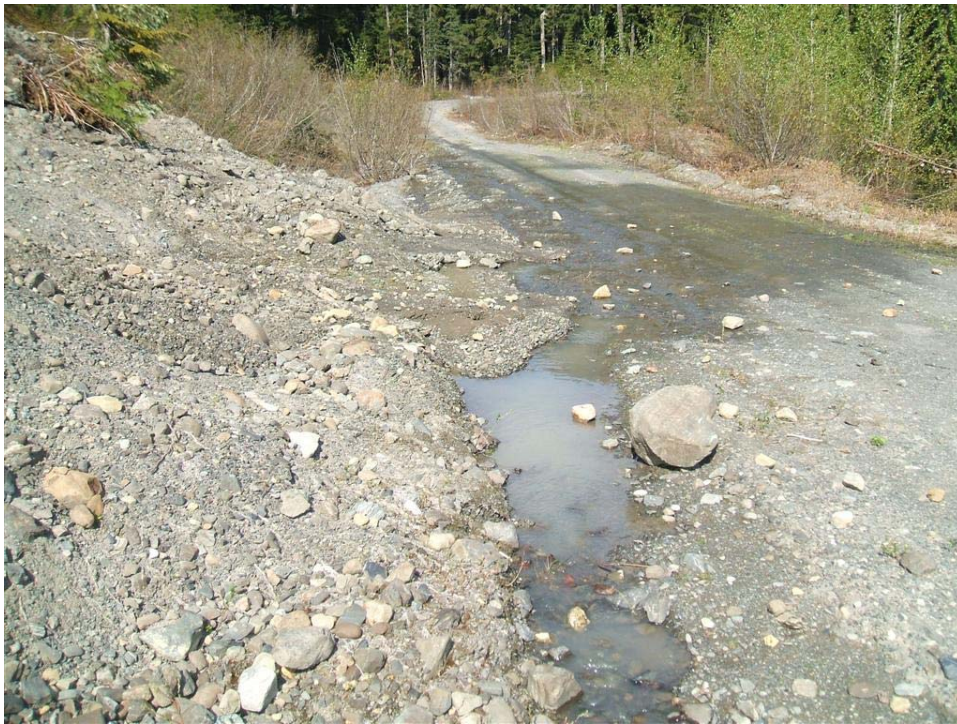
At the time of initial treatment sediment-laden groundwater was seeping out of the cutbanks and flowing down rills onto the road surface below. The ditch was completely filled with cutbank sediment (Photo 35). The GFA crew hand-shoveled a temporary ditch to direct water away from the road surface into a series of sediment retention ponds downslope (Photo 36). Although the temporary ditch remained intact until the final visit on October 1, 2008, it is anticipated that it will be filled with sediment during 2009 freshet and water will again flow over the road. GFA recommends that this ditch be reinstated properly and monitored regularly for infilling.

Photo 35: Ditch covered with cutbank sediment and water flowing over road surface at Site 186 (May 27, 2008).

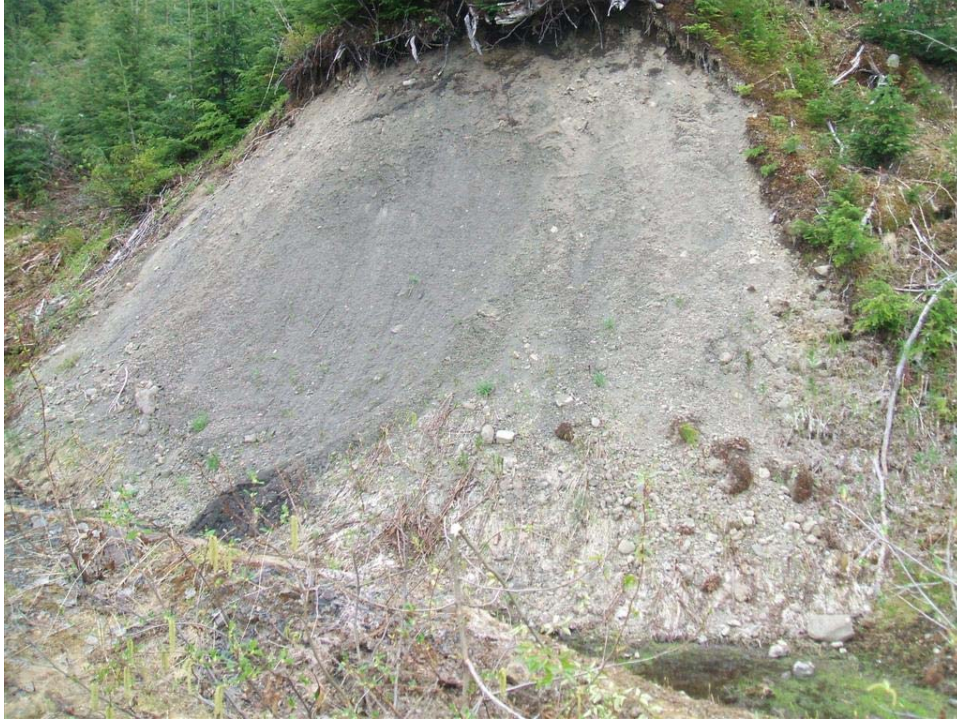
In 2007, Site 313 received a high WQEE score of 12 m³ (Koch and McCarthy 2008). Mass wasting has occurred on a steep right road cutbank (90 percent slope approximately) adjacent to the stream channel (Photo 37). Initial treatment was undertaken on May 28th, 2008 when grass seed, fertilizer, and erosion control blankets were applied to approximately 130 m² (Photos 38). When revisited on July 17th, 2008 only a minor amount of grass seed had germinated and had yet to penetrate through the ECBs. By October 1st, 2008 (final visit) approximately 80 percent of the treatment area was well vegetated, however a large portion of grass cover had yet to penetrate through the ECBs (Photos 39 and 40). No further works are recommended for this site.

Photo 37: Exposed right road cutbank at Site 313 prior to treatment (September 25, 2007).

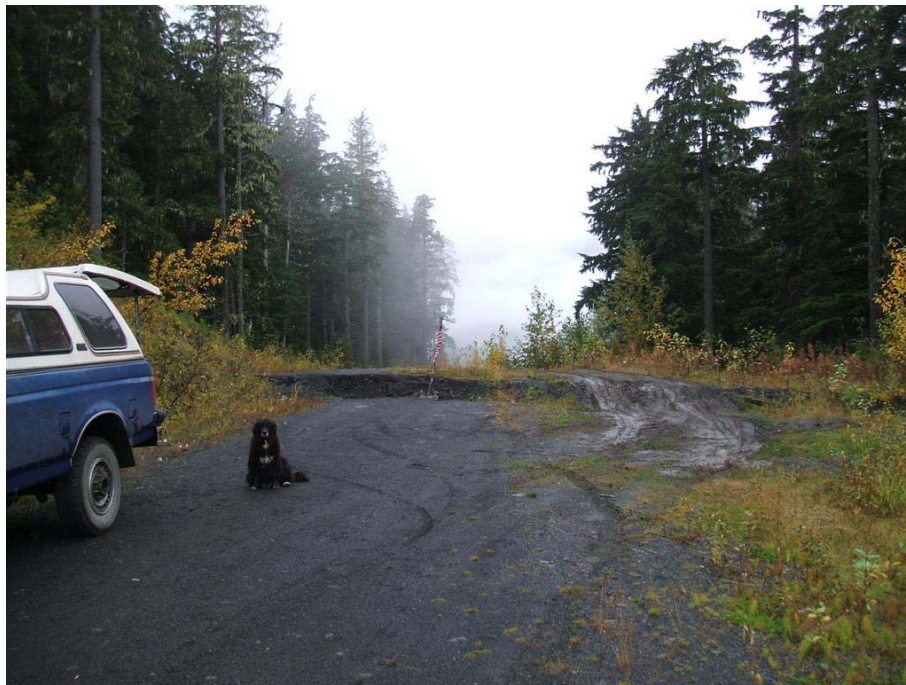
In 2007, Site 48 was assessed erosion potential and received an extreme WQEE score of 303 m³ (McCarthy 2007). A mass movement event occurred sometime between the fall of 2006 and the spring of 2007. A large fracture extends across the Kitwanga FSR where a road section dropped approximately 60 centimeters (Photo 43). Downstream of this crossing multiple horizontal fractures measuring 20 to 30 meters in length extend down-slope for approximately 30 meters. The uppermost horizontal fracture has reached the stream 15 meters downstream of culvert crossing. Further down-slope of these fractures is an active landslide measuring approximately 100 meters long x 30 meters wide at a 55 percent slope (Photo 44 and 45). Upslope of the Kitwanga FSR a continuous fault line extended south through the forest, east across the stream and into a cutblock, and then turned back towards the Kitwanga FSR to the north (Photo 46).

Photo 43: Road fracture along the Kitwanga FSR (October 4, 2007).

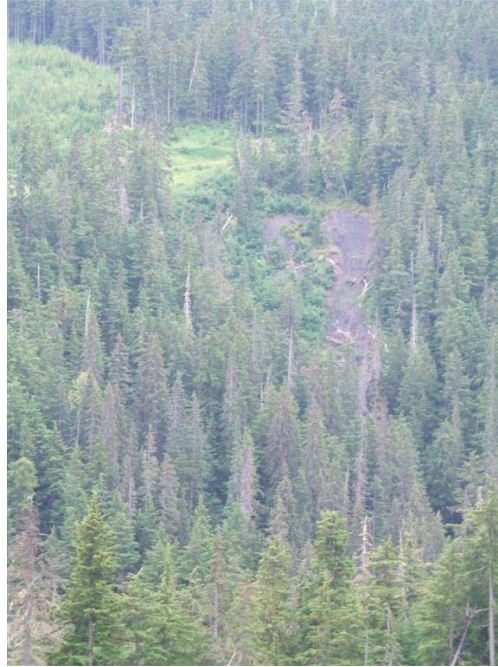
Photo 44: Slope failure at Site 48 viewed across the valley from Ronald McDonald FSR (July 13, 2007)

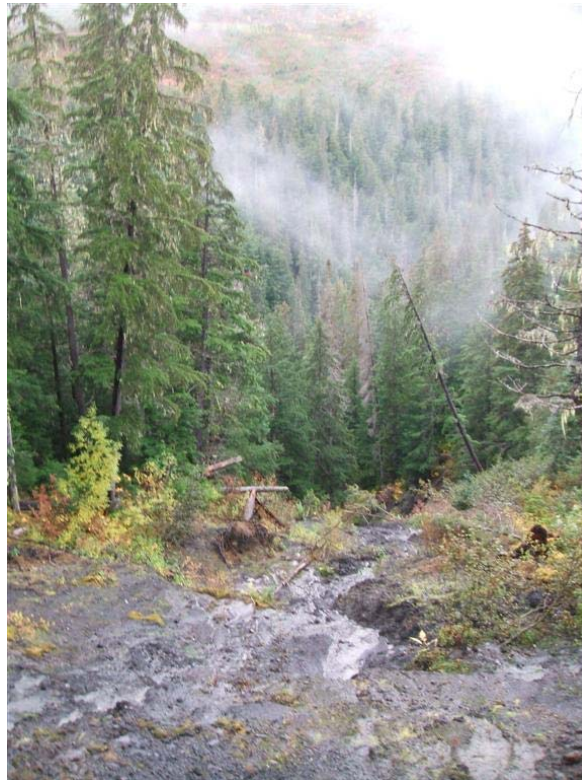
Photo 45: Slope failure looking downhill towards the Upper Kitwanga River (October 4, 2007)

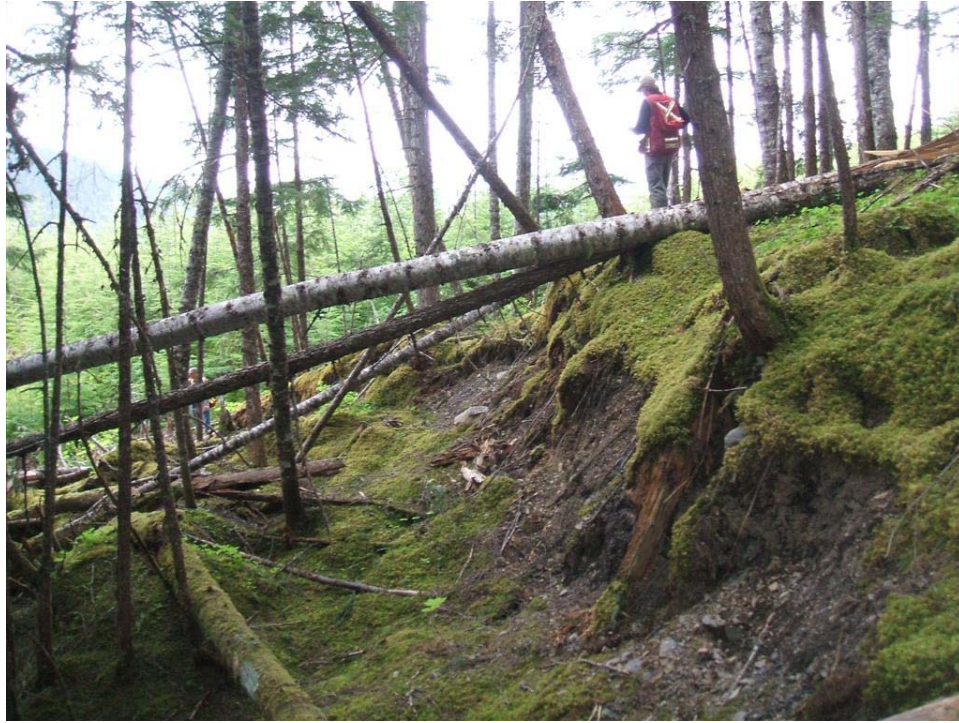
Photo 46: Fault line through the forest upslope of the Site 48 road crossing.

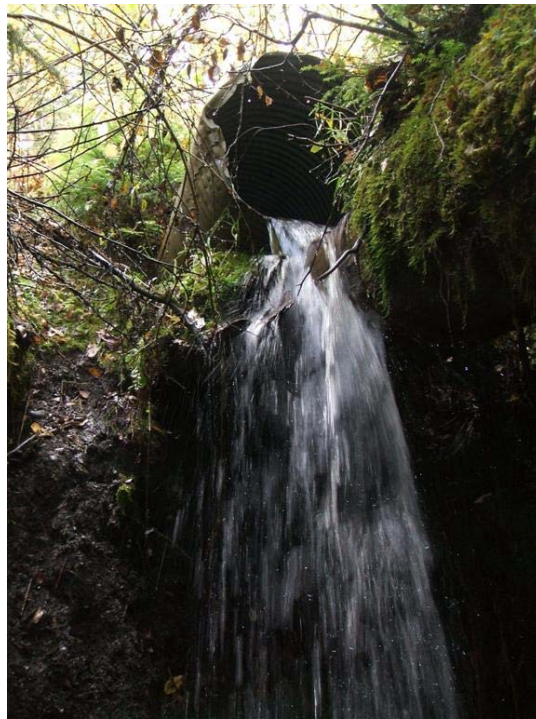
Photo 52: Suspended culvert outlet at site 60.

GFA recommended the placement of boulder riprap below the culvert outlet to eliminate streambed scouring. Works began with the installation of a temporary overhead trough to divert water away from the work site (Photo 53). The streambed and eroding side banks were then lined with geotextile held in position by 2" x 2" stakes (Photo 54). A haul truck delivered one load of rock to the site and a small size excavator placed the rock in position below the culvert (final photos are not available for this report). No further works are recommended at this site.

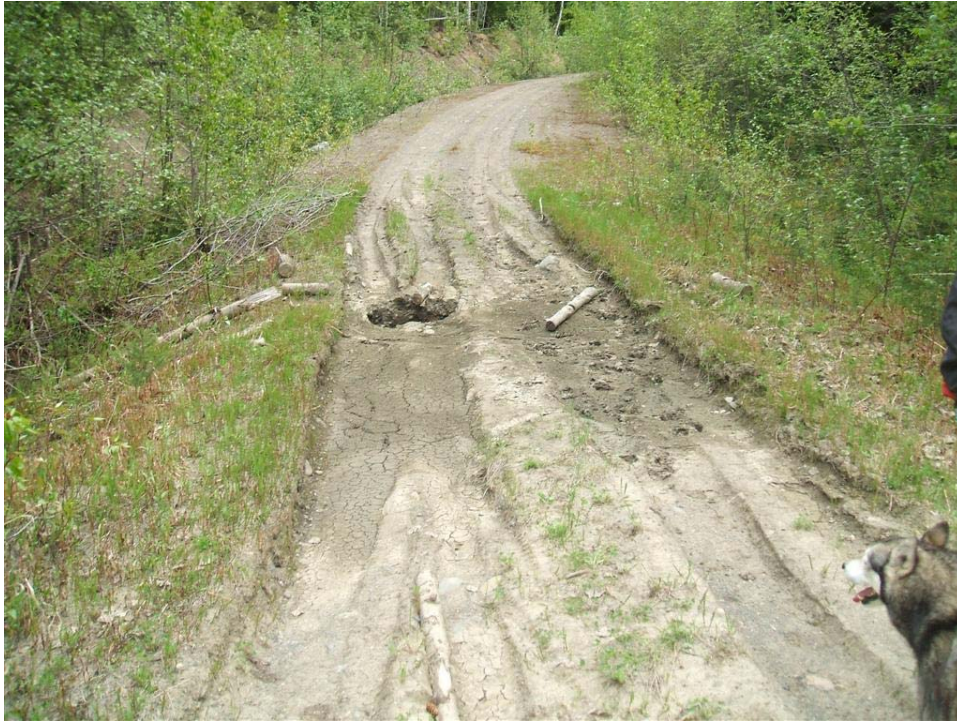
Photo 55: Wood box culvert collapsing into stream at Site 21.

GFA recommended that these four road crossings be deactivated and re-vegetated between the Canoe Creek FSR junction and Site 277 (total distance of 3 km). Following project approval by the Gitanyow Hereditary Chiefs and the BC MoFR, the GFA and McElhanney Consulting Services prepared a detailed deactivation plan (Appendix II). The early onset of winter and a

deep snow pack prevented the deactivation of this site. GFA recommends that this road be deactivated following freshet in the 2009 field season.

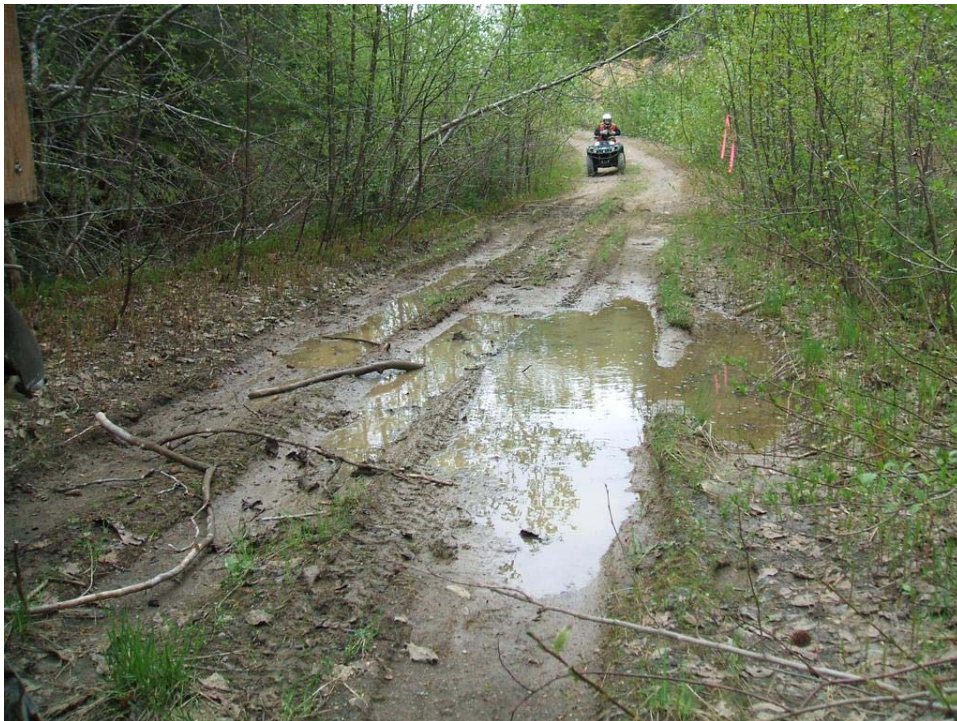
Photo 56: Muddy road surface at Site 279.

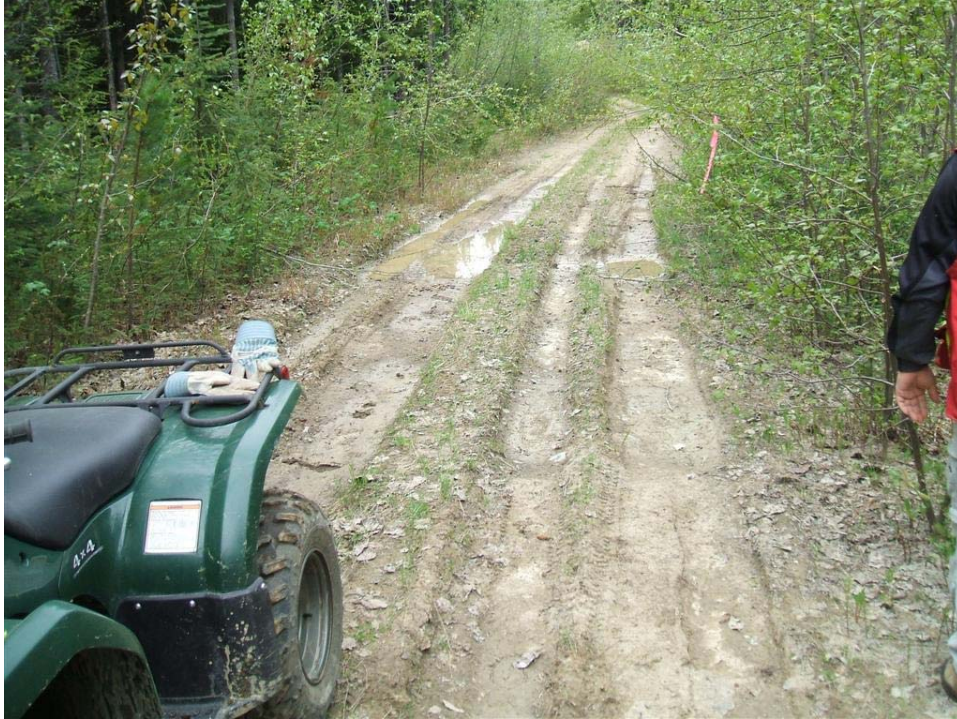
Photo 57: Muddy road surface at Site 278.

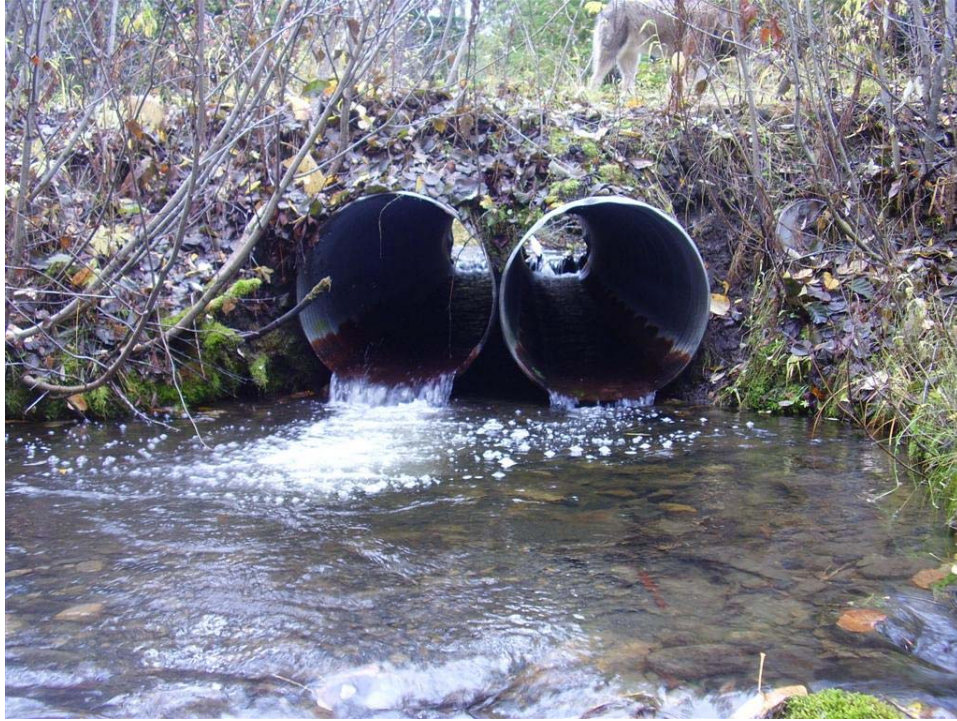
Photo 59: Culvert outlets at Site 3 (Kitwanga FSR).

Culvert replacement was recommended for this site. Funding was only available for the preparation of detailed site plan. McElhanney Consulting Services was contracted to complete this plan, which involves the installation of an open-bottom arch culvert. This site plan was submitted as a supplemental document to this report and is on file at the BC MoFR, Smithers.

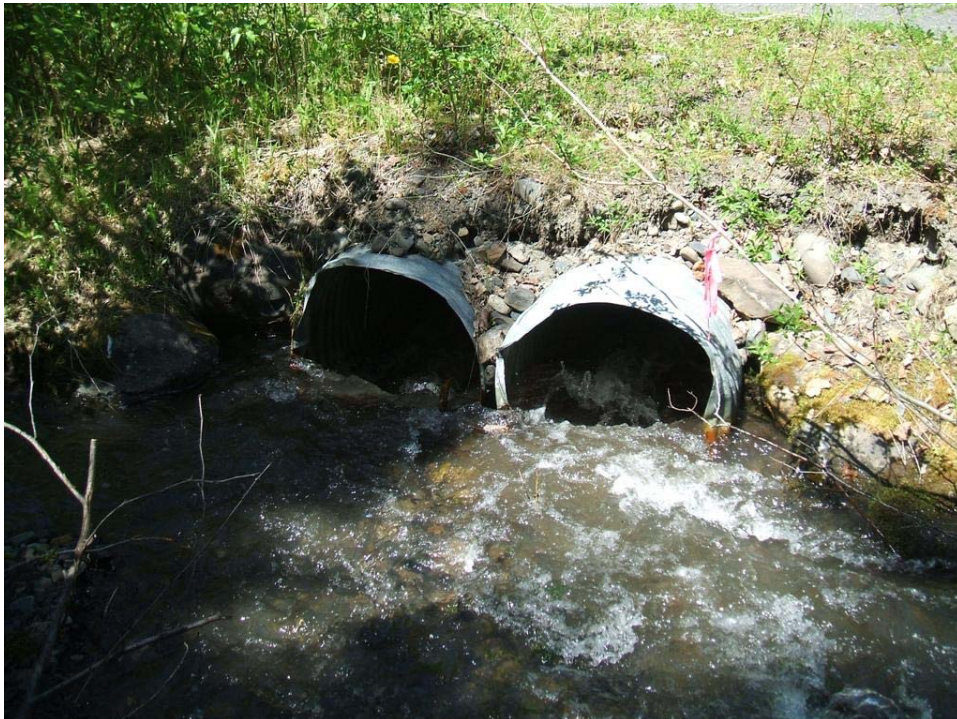
Photo 60: Partially plugged culvert inlets at Site 3 (Chernobel Creek).

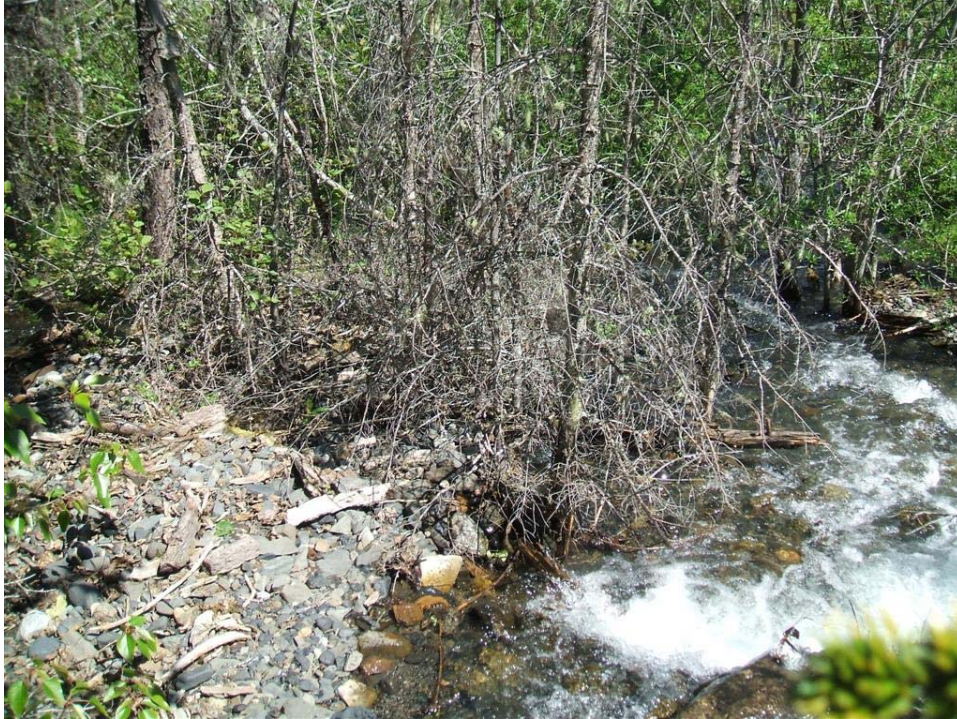
the stream to flow through a young cutblock for a distance of 400 meters before reentering the original channel (Photos 61 and 62). More details can be found from digitized FHAP forms in Appendix III.

Photo 61: Rock/wood avulsion diverting flow into cutblock at upstream end of Reach 5 (Chernobel Creek).

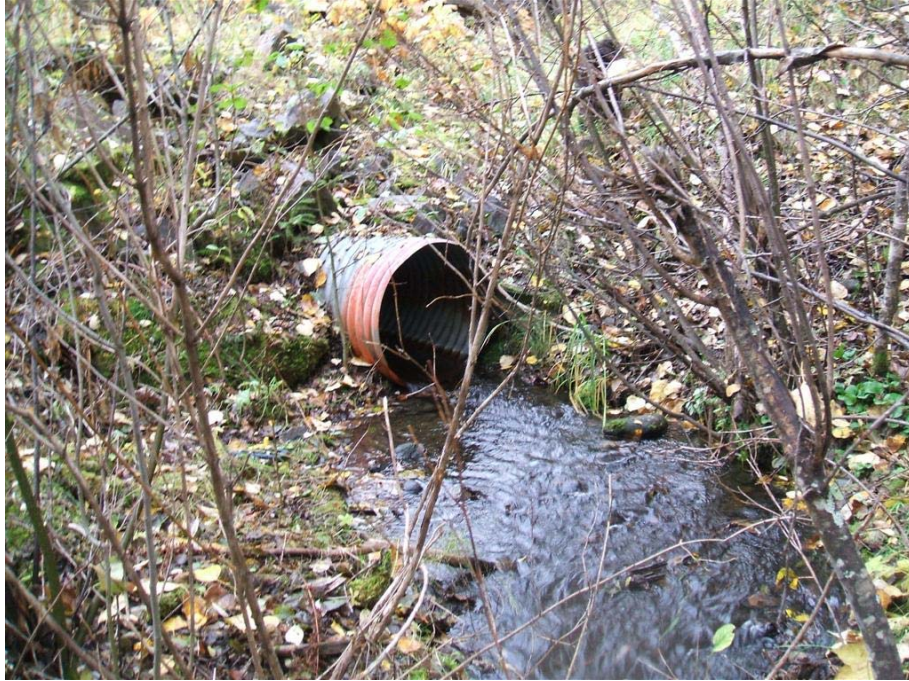
Photo 63: Culvert outlet at Site 61 prior to treatment (Kitwanga FSR).

GFA recommended installing a series shallow rock levees at the culvert outlet to create slower moving backwater inside the culvert and removing a wood/rock debris jam located approximately 15 meters downstream. Works began with the dismantling of the debris jam. Prior to removal all the stream flow was channeling through a buried hollow log suspended over the stream channel below, which was considered a definite fish barrier (Photo 66). The GFA crew removed this log using hand tools, however the streambed could not be contoured to a slope that would allow for easy fish passage (Photo 67). This section requires further assessment and planning to create a channel passable to fish. A rock levee was installed below the culvert outlet. Prior to installation the water depth inside the culvert was approximately 5 centimeters. Rock was collected from the

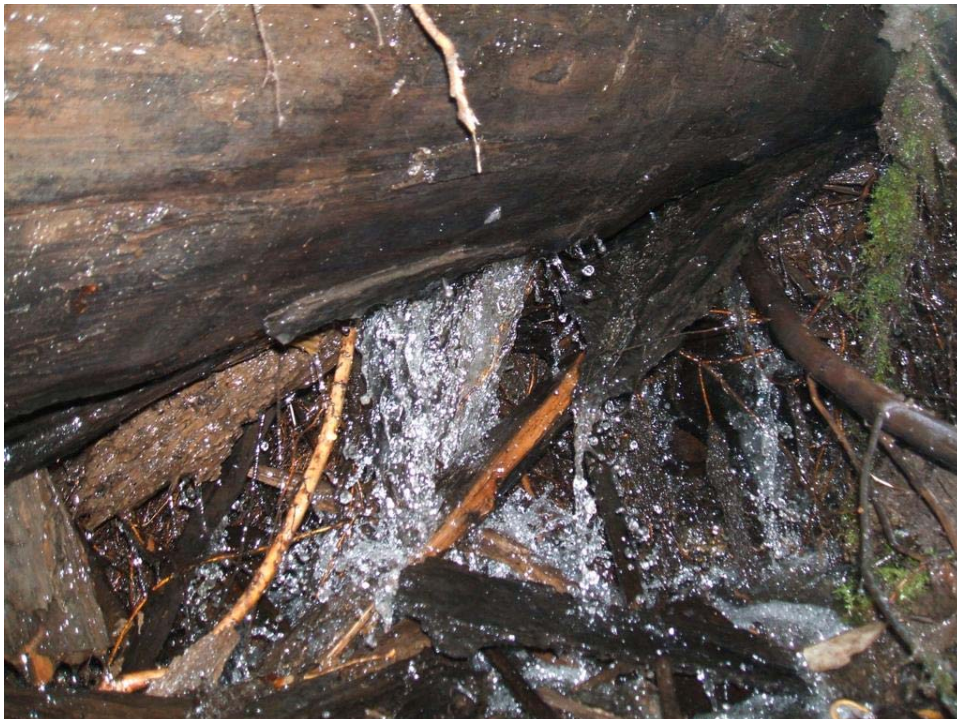
Photo 66: Water flowing through a hollow log 15 meters downstream of Site 61.
