Gitanyow Fisheries Authority

The 2008 Kitwanga-Cranberry River Watershed Restoration Project

Submitted to: B.C. Ministry of Forests and Range
Smithers, BC

Prepared by: Mike McCarthy HBSc
Gitanyow Fisheries Authority

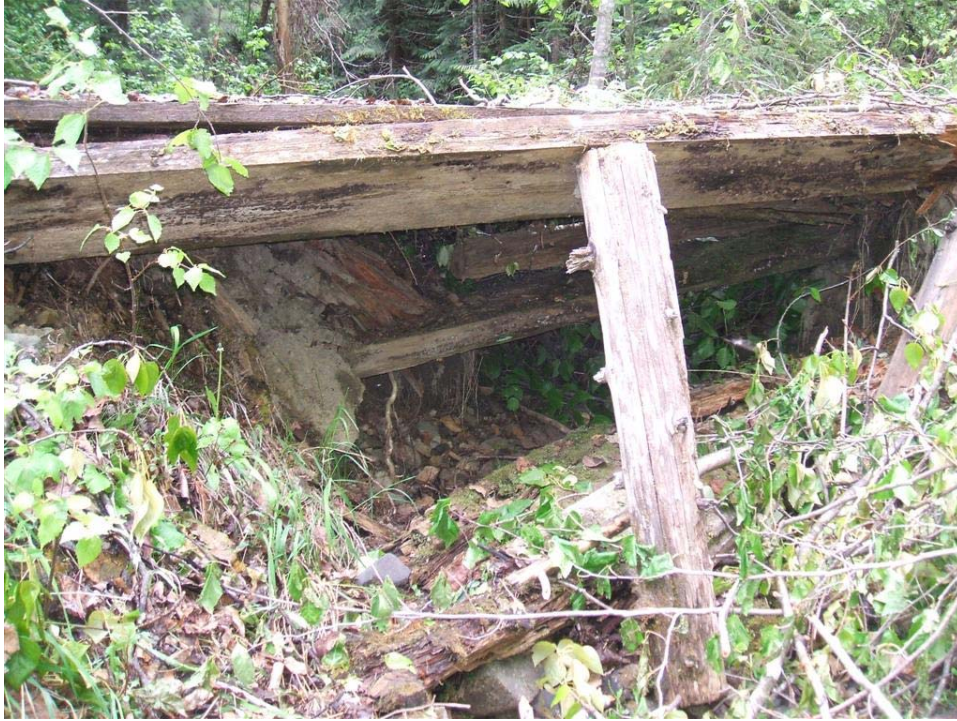
Photo 70: Collapsing bridge deck at Site 347 (11 Mile Road Branch).

Deactivation was recommended in 2007, however since this stream is likely non-fish bearing and provides only marginal fish habitat upstream of the crossing, minimal benefits would be expected from this action. No further works are recommended for this site.

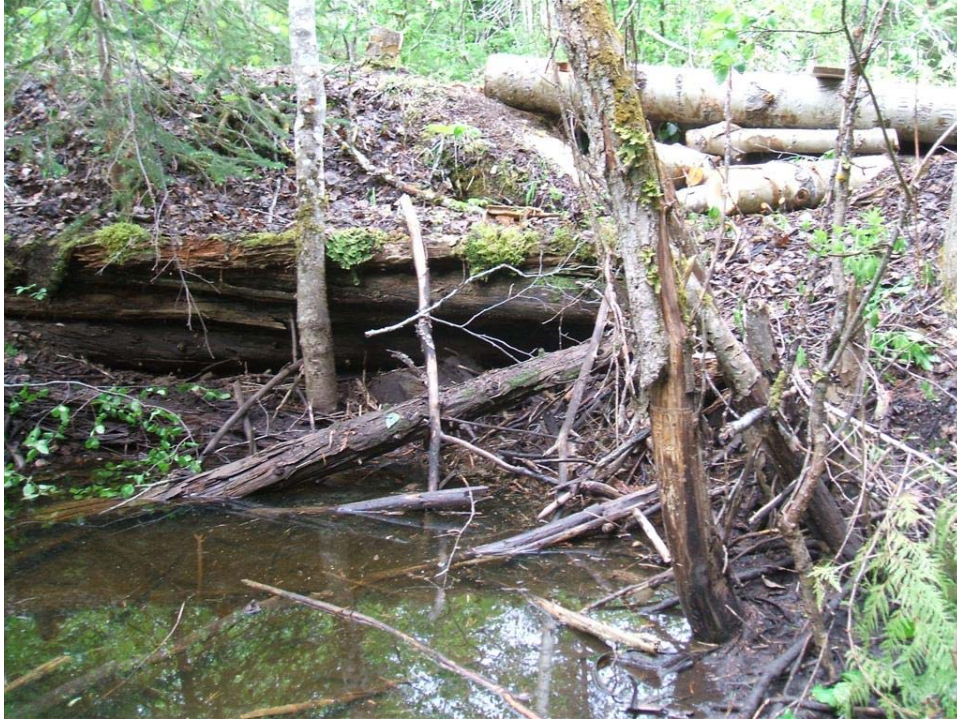
Photo 72: Dammed pool created by collapsed road material upstream of Site 347 (Reach 1).

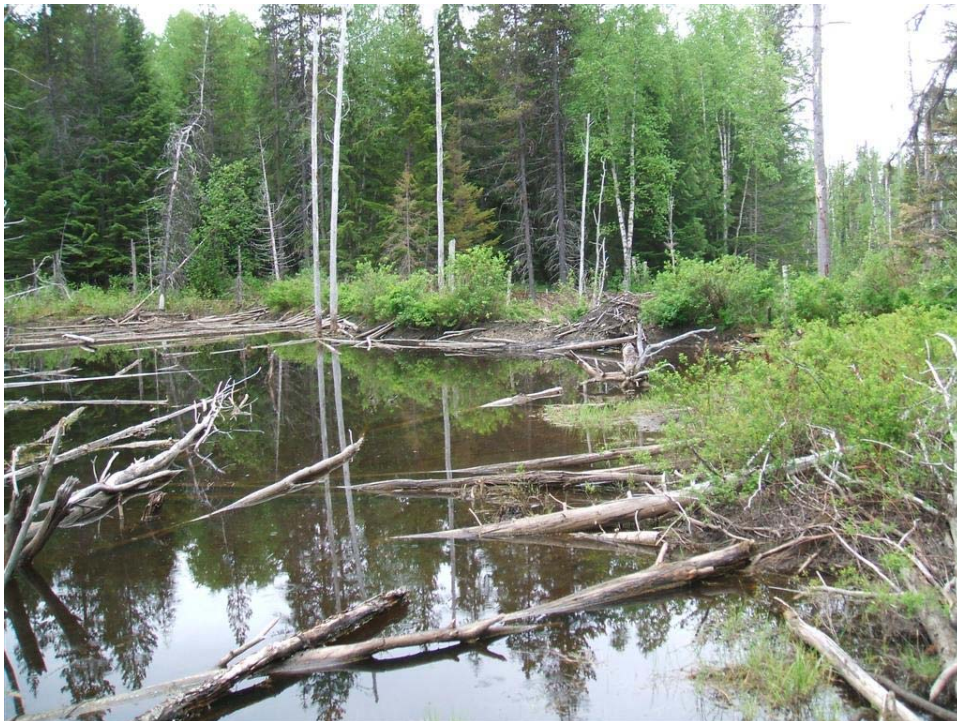
Photo 73: Abandoned beaver pond downstream of Site 347 creating subsurface flow.

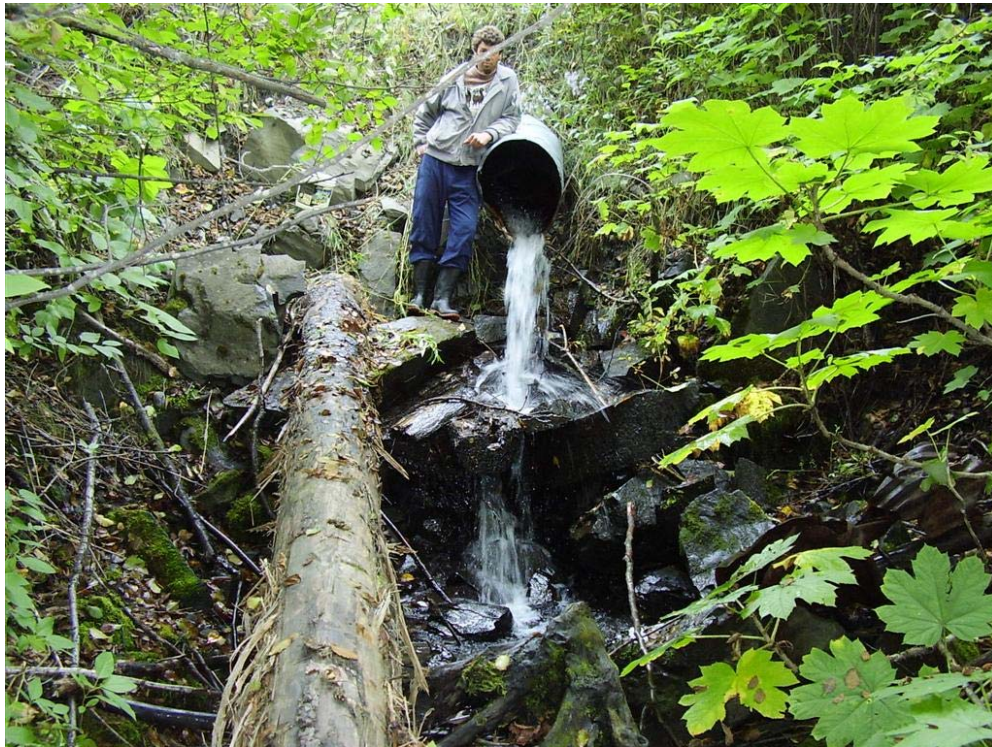
Photo 74: Site 47 looking upstream at suspended outlet.

Fish sampling was attempted along Reach 2. Ten Gee traps set for 6 hours and spot sampling using an electrofisher in deep pools yielded no fish and no fish sighted throughout the survey. It is possible that the stream is no-fish bearing above the bedrock sections encountered at 30 and 100 meters upstream of the Mitten Main FSR (Photo 70). As such, replacing this culvert with an open bottom structure would provide minimal benefit.

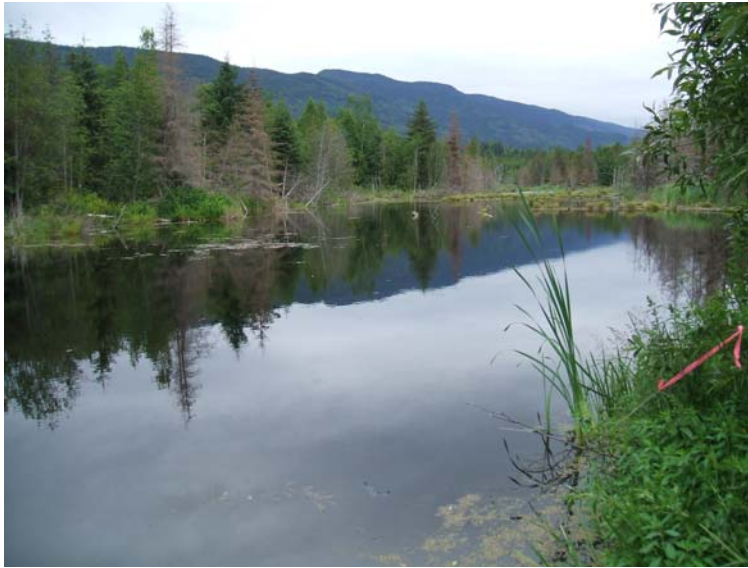
Site 38 separates two large active beaver pond wetlands (Photo 77). A blocked culvert and a dam built against the upstream road edge caused water to flow over the road in several locations (Photo 78). Without a beaver management plan, deactivating this crossing would produce minimal benefits. No further works are recommended for this site.

Photo 77: Large beaver pond complex upstream of Site 38, Wagon Creek Road.

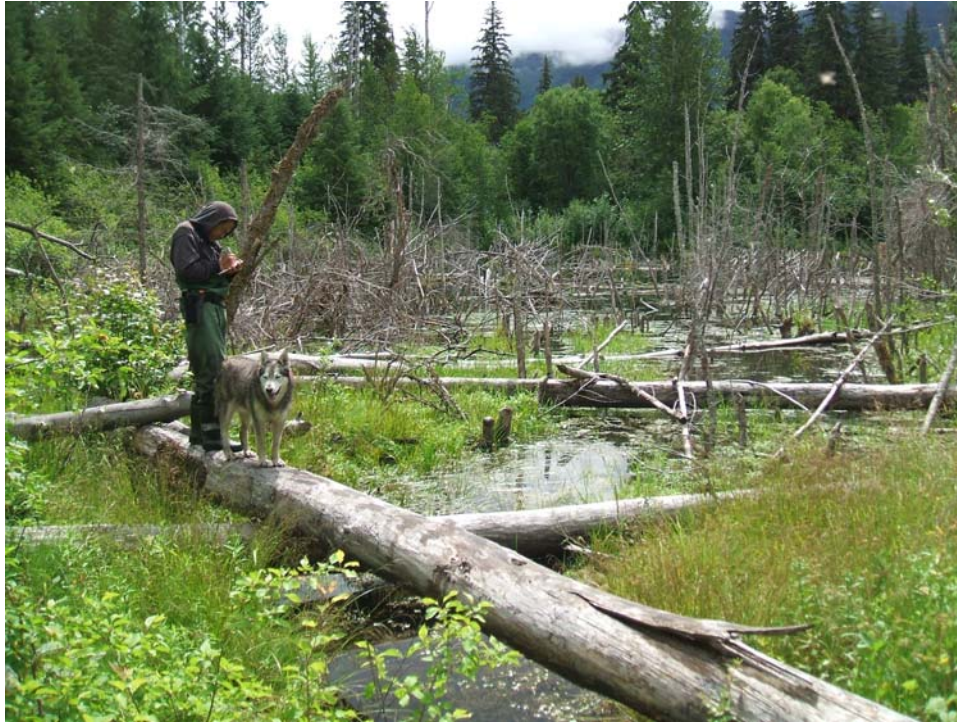
Site 40 separates an active beaver pond upstream from an abandoned pond downstream (Photo 79). A blocked culvert and a dam built against the upstream road edge caused water to flow over the road in several locations (Photo 80). There was no defined channel downstream and water was flowing subsurface or consisted of stagnant pools. This stream provides poor fish habitat and therefore deactivation would produce minimal benefits. No further works are recommended for this site.

Photo 79: Beaver pond upstream of Site 40, Wagon Creek Road.

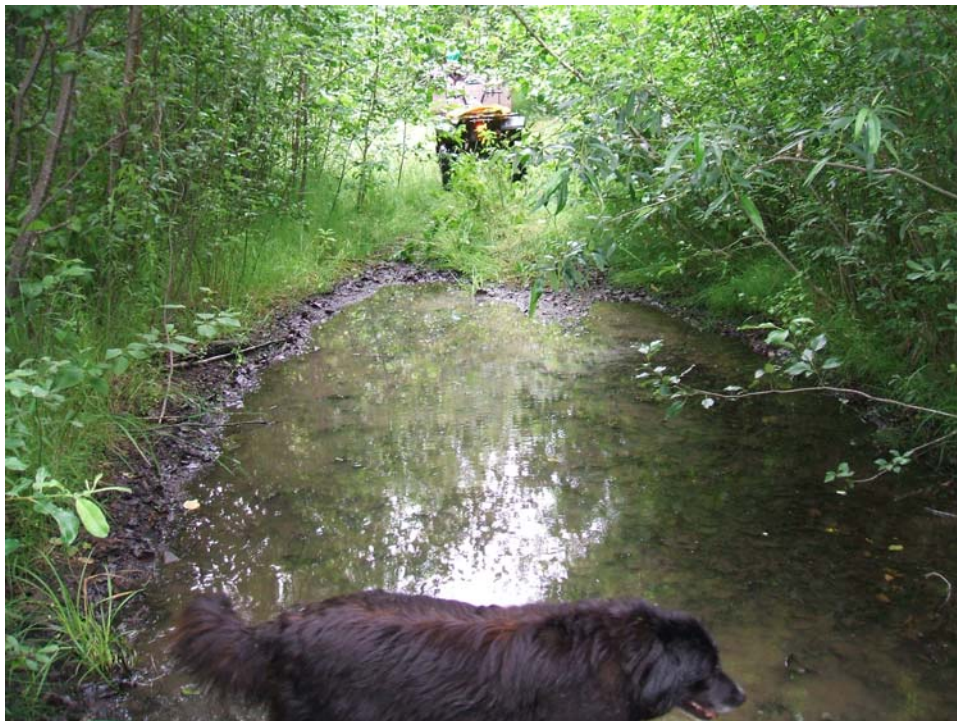
Photo 80: Water flowing over the road at Site 40, Wagon Creek Road.

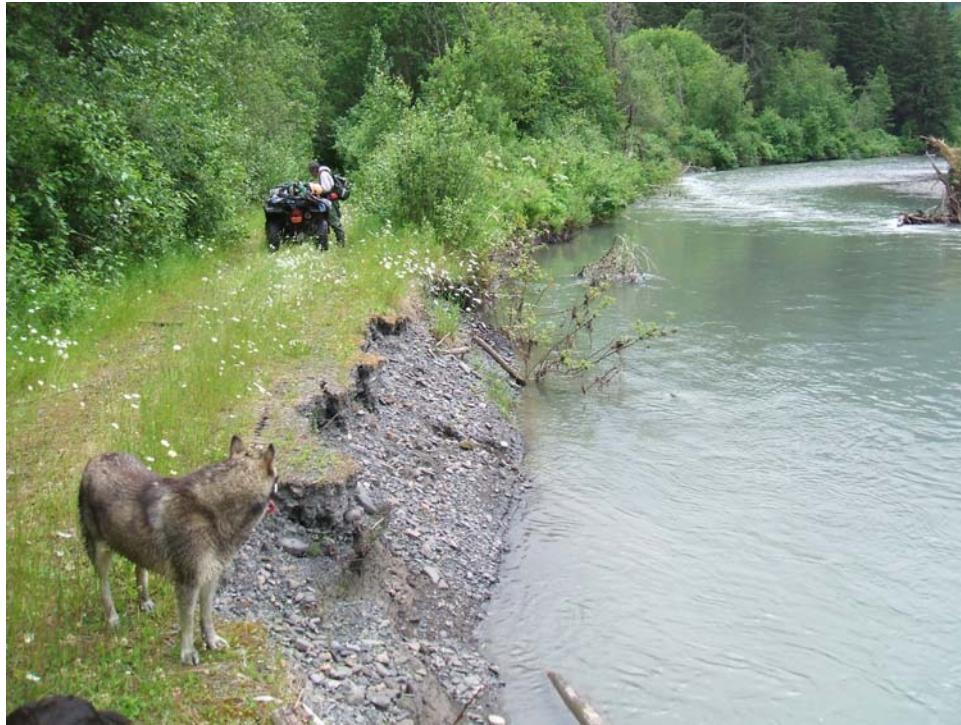
Two safety hazards were identified along this roadway. The first hazard is located 900 meters from the Hwy 37 N junction where the Cranberry River is eroding the roadbed (9U.540401.6157144; Photo 85). The second hazard is located 3.5 km from the Hwy 37 N junction where a large hole has developed in the roadbed from a collapsed wood-box culvert over a small seepage stream (Photo 86).

Photo 85: Cranberry River eroding Wagon Creek Road.

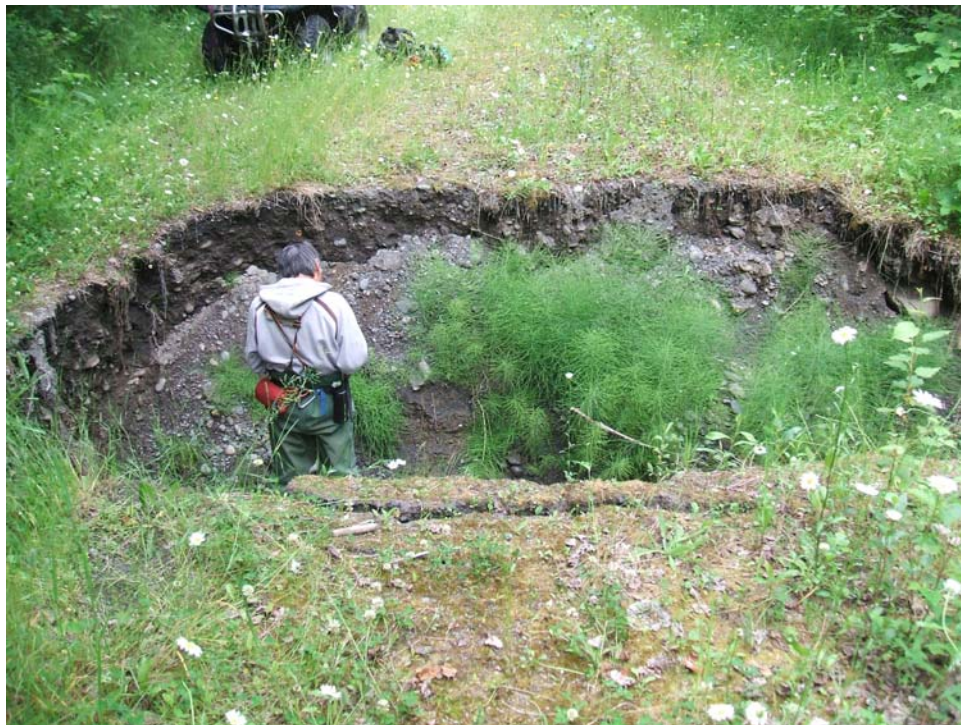
Photo 86: Large hole from collapsed wood-box culvert along Wagon Creek Road Km 3.4.
