Ministry of  
Environment  
and Parks  
WATER MANAGEMENT  
BRANCH

Re: Trout Creek Landslide

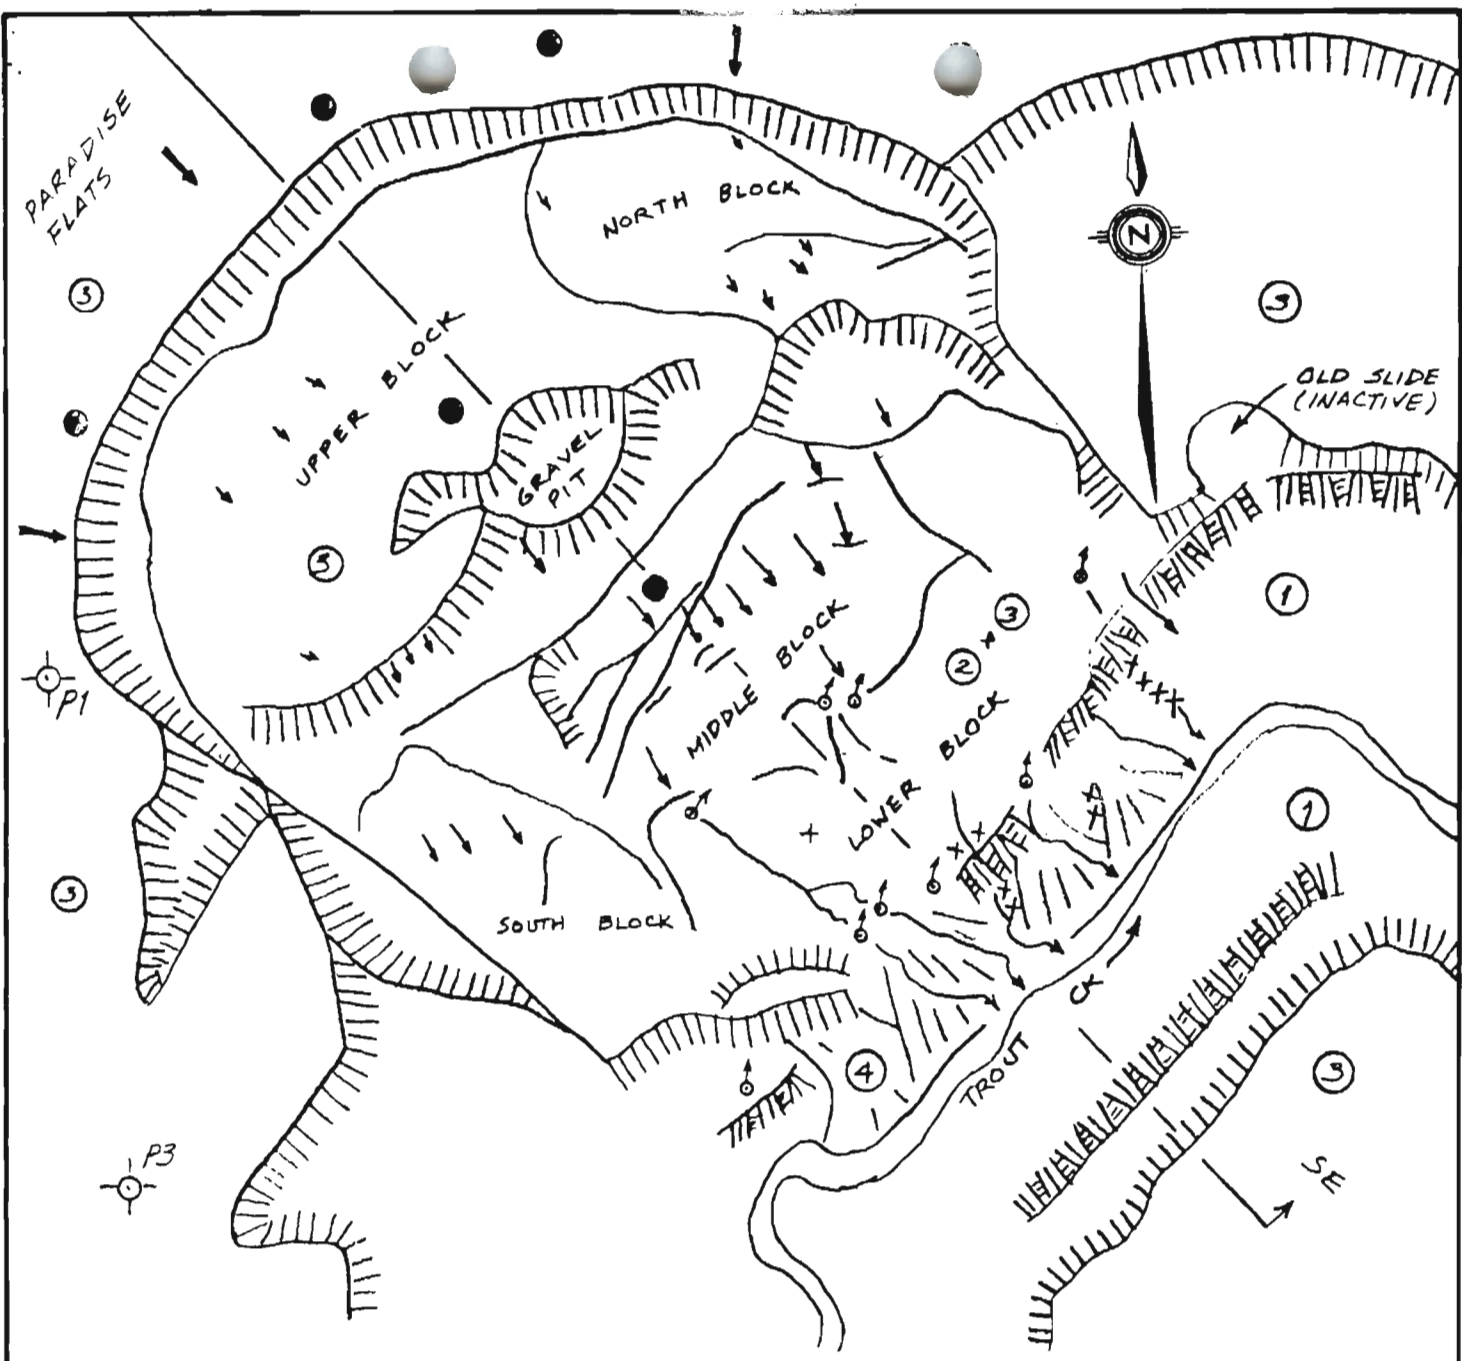
M. WEI ENGINEER  
FILE No. 82E/12 DWG No. FIGURE 2

Three main slide blocks - the upper, middle, and lower blocks - occupy most of the slide (Figs. 2 and 3). Failure surfaces separate these main blocks as a result of differential movement. Numerous other failure surfaces exist within the main blocks themselves especially in the middle and lower blocks as a result of differential movements within the blocks. The appearance and geometry of the slide indicate that differential slumping and backward rotation has occurred and that the blocks have also moved laterally downhill.

Overall, the slide measures a maximum 1,400 feet in length from head to toe and maximum 1,400 feet from side to side (Fig. 2). However, the slide volume is unknown because the bounding failure surface beneath the slide is unknown.

Much of the lower block appears saturated. Upper springs occur along the head of the lower block and the spring water either collects in hollows further down the lower block and then resurfaces at the toe as lower springs or incises a steep channel in the slide material (Figs 2 and 3). On reaching the toe of the slide the water flows over the granitic bedrock lip and then down to Trout Creek. Spring water continually erodes and moves the slide material to the toe where it sloughs bit by bit onto the talus slopes below. Spring flow over the lower part of the slide and down the loose, steep talus becomes silt laden as it reaches Trout Creek (Photos 4&5) Total discharge in June, 1987 is estimated at a few hundred gpm. Nowhere else along the Canyon Wall is groundwater discharge as obvious as at the slide.

measurements by Riglin (1977) and Madsen (1974) and from inspection of air photos covering different years show that, in general, recent movements increase from the upper block (about 1 foot/year) downhill to the lower block (up to 35 feet/year) and from the sides to the centre of the slide (Figs. 2 and 3). Within a year the rate of movement seems to coincide with the rate of spring discharge, occurring greatest in late fall (Riglin, 1977).

1. drill up to five testwells to determine water levels, hydraulic gradients, groundwater flow, hydraulic conductivities and storativities of the slide materials. The testwells should be located along the slide cross-section where accessible and along the area back of the slide. The testwells should be drilled through the sand and gravel unit and underlying till-clay-weak Tertiary bedrock assemblage to the surface of the granitic bedrock. The testwells should be drilled by the cabletool method with continuous tube sampling and completed with screens and pump tested to determine aquifer characteristics. Cost of five 8-inch, 200-foot deep testwells would cost up to roughly \$110,000 excluding engineering supervisory costs (Appendix I). After well completion and testing, the wells should be fitted with automatic water level recorders to monitor fluctuation of the water level in the slide area.

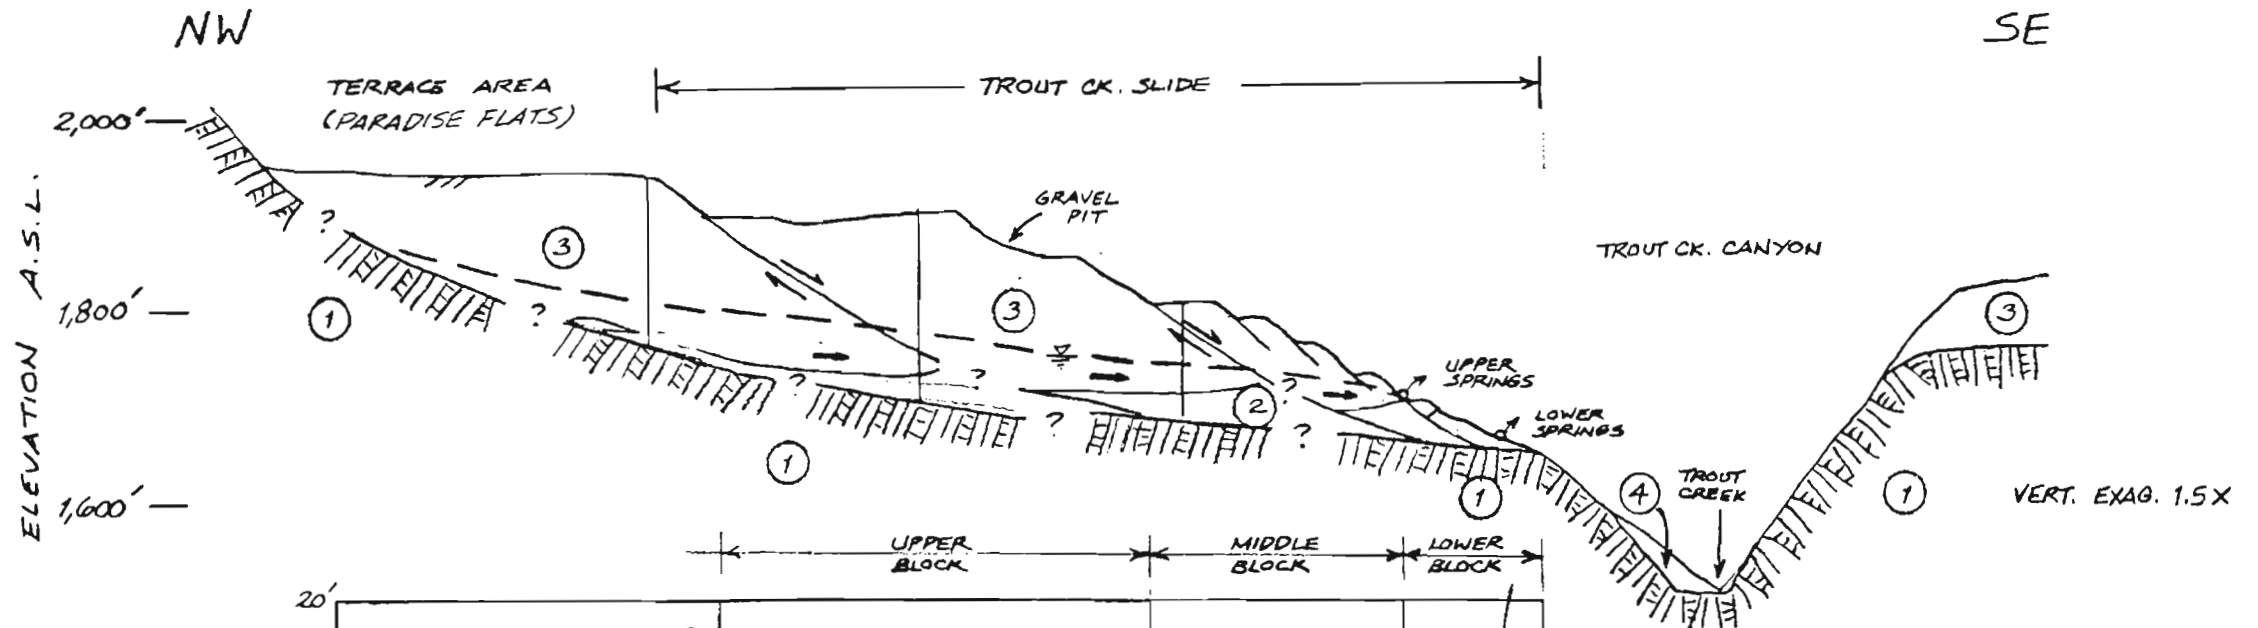
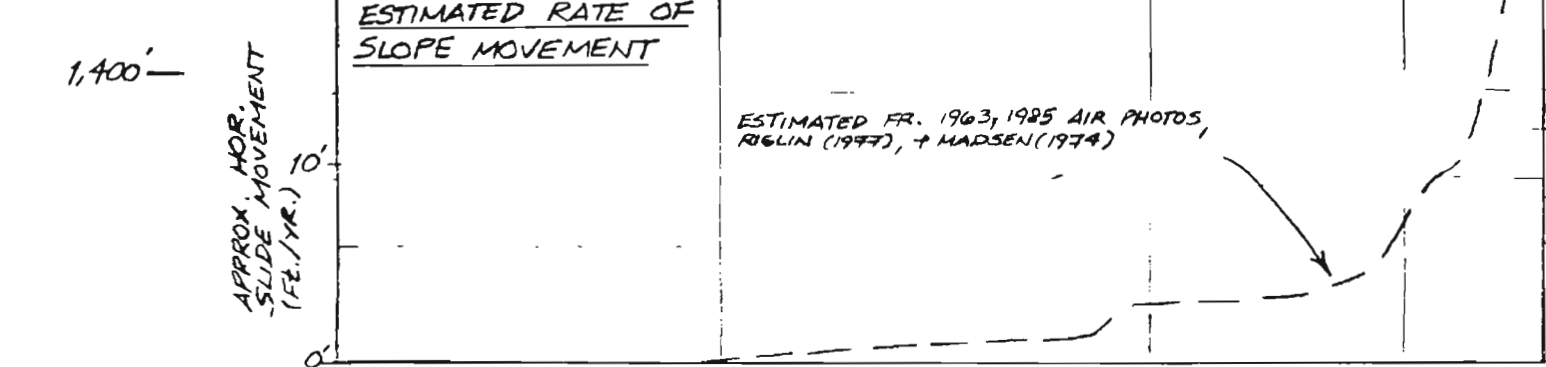
SCALE: VERT. 1" = 200'	DATE 14/12/87
HOR. 1" = 300'	
M. WEI ENGINEER	
FILE No. 82E/12	DWG No. FIGURE 3

Much of the slide involves the unit of glaciofluvial sand and gravel which is saturated at its bottom section (Figs. 2 and 3). The overall thickness and saturated thickness of this unit beneath the slide is unknown. Beneath this sand and gravel unit is a thinner assemblage of till, clay, and silt and weak bedrock comprised of light-grey volcanic sandstone, claystone, and coal. This weak bedrock may be part of the Tertiary volcanics mapped by Church (1980). This assemblage is exposed only in the lower block along the toe and is broken up, sheared, and repeatedly upthrust (Photo 3). Along the toe, the failure surface occurs within this weak assemblage and above competent orange and green granitic bedrock (probably the Pre-Tertiary basement rocks) which forms the Canyon Wall (Photo 4). The slide doesn't appear to involve the granitic rock, but only the materials overlying it.

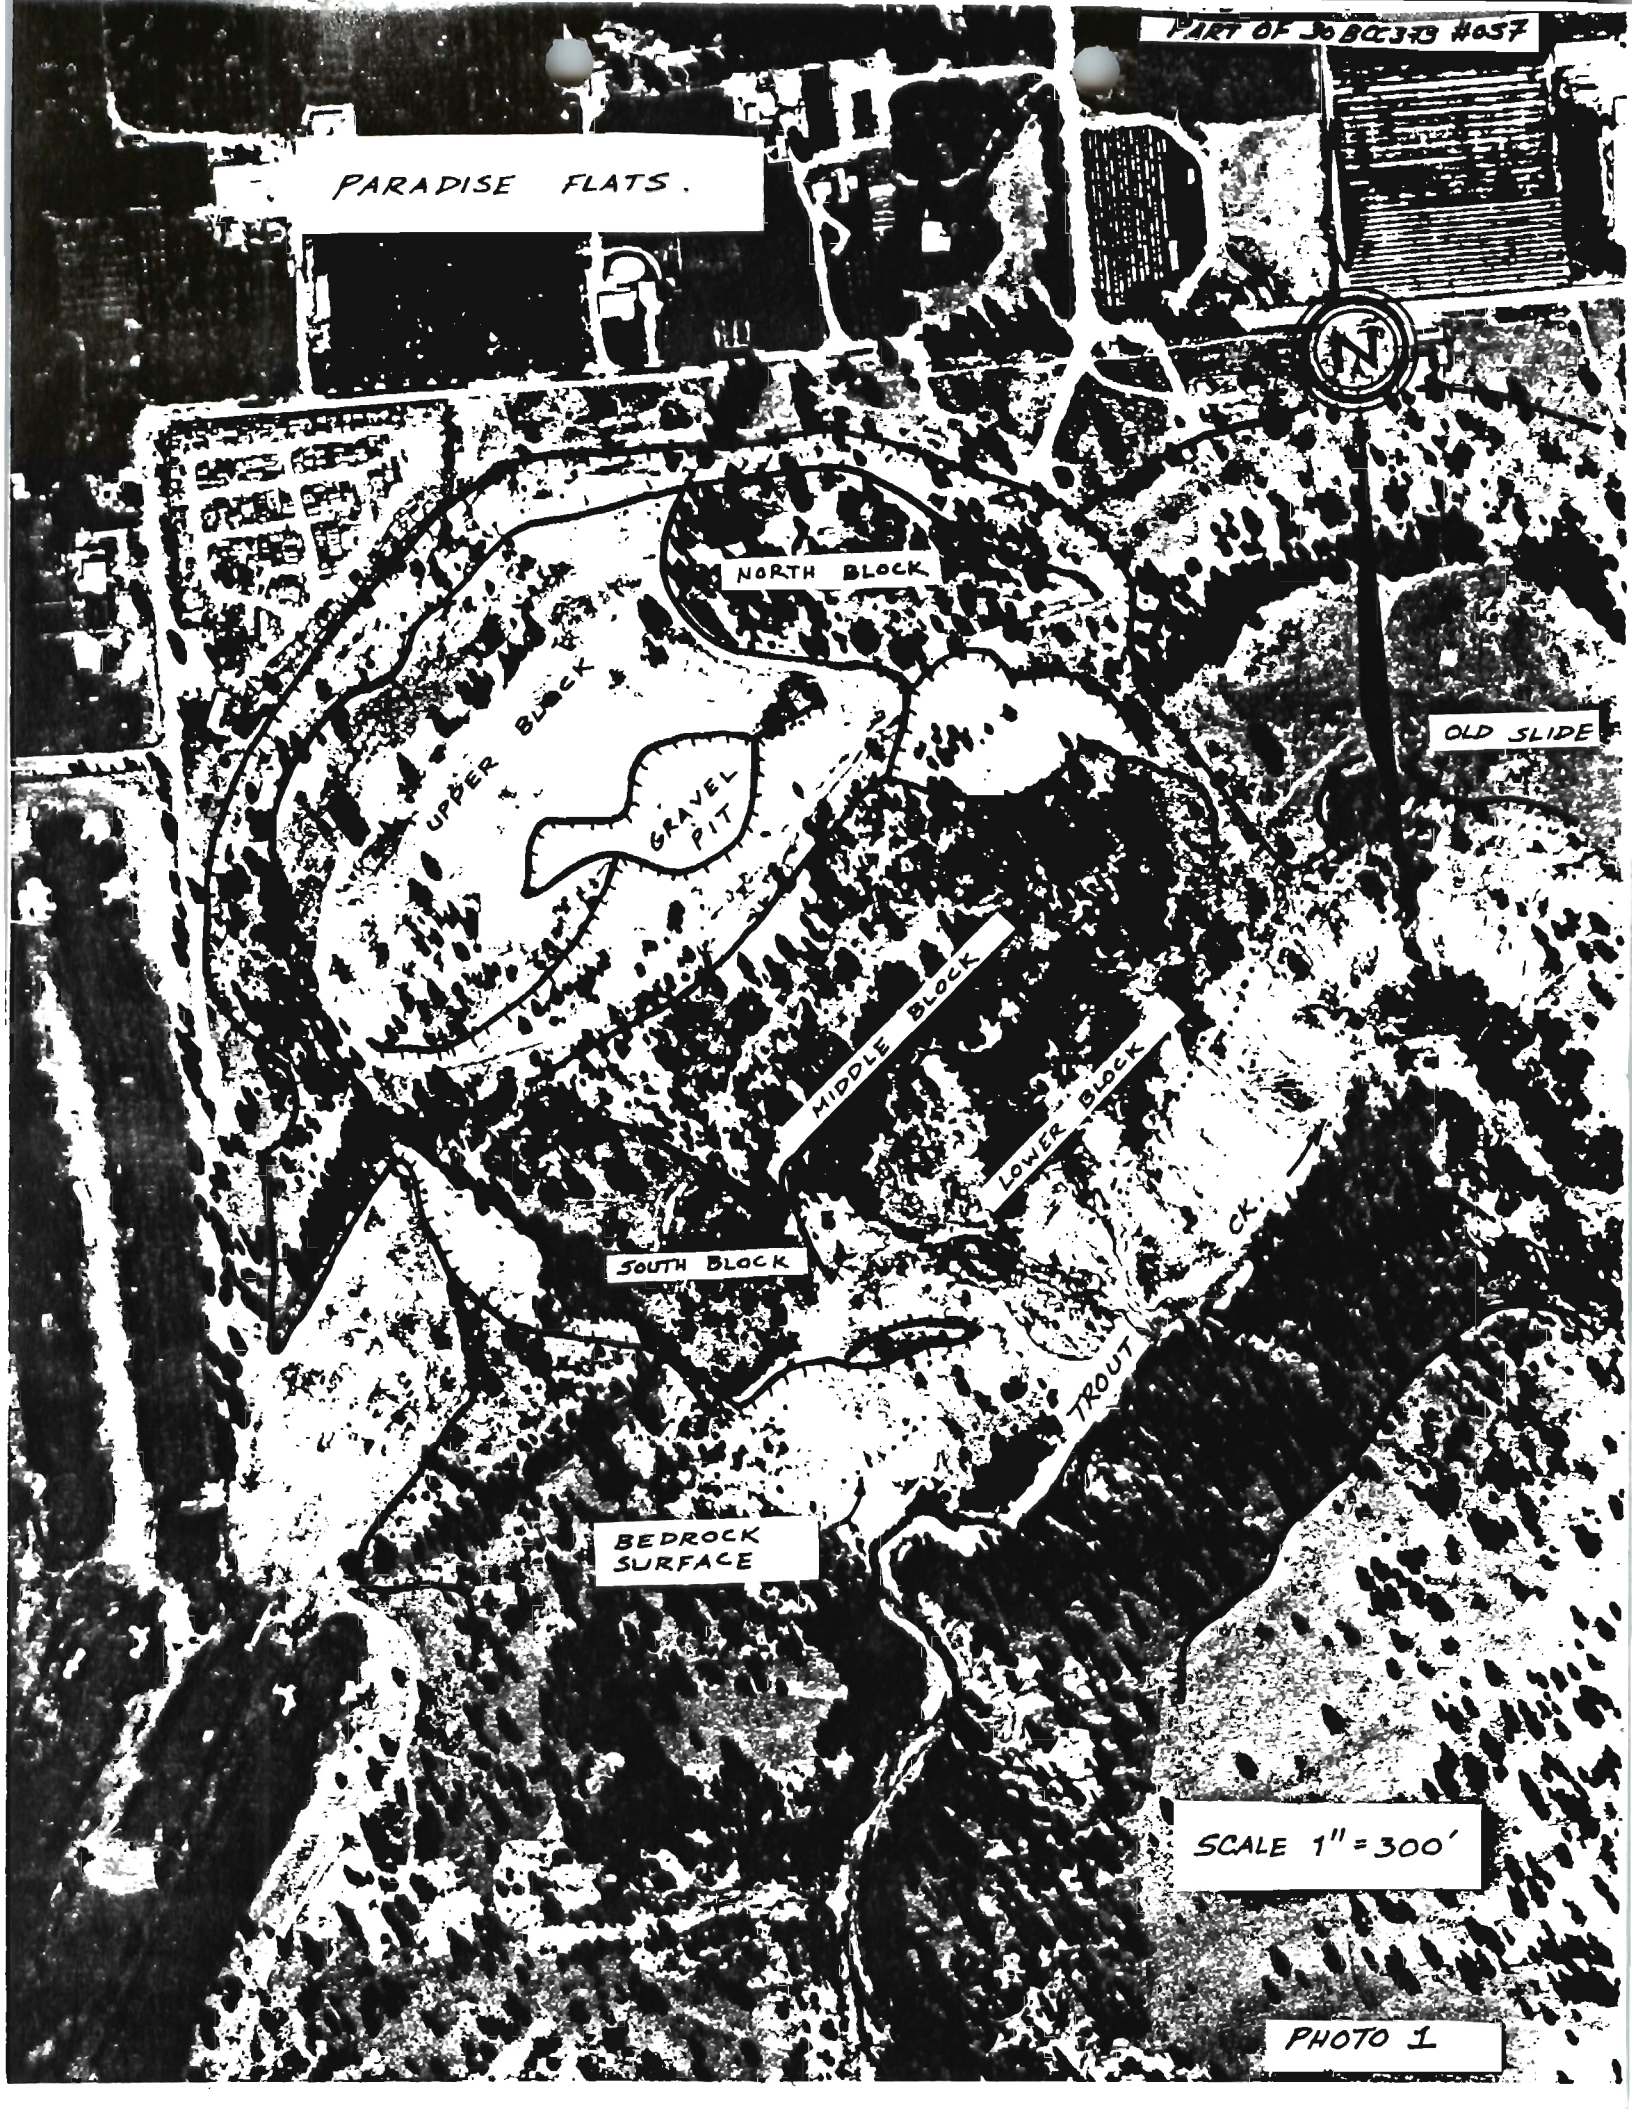
PHOTO 1

The slide has developed along the edge of a sandy terrace above Trout Creek. From the ground (and from air photos) the slide is obvious and well defined (Photo 1 and 2). The bounding failure surface is evident along the back and side scarps and is exposed along the toe, 150 feet above the creek. Within the slide the land surface is stepped in appearance and has an overall slope of about 22%.

In recent years, much of the overburden cover on the upper block was stripped away and part of the block was mined for gravel (photo 1). This would tend to enhance infiltration of any precipitation and irrigation runoff into the upper block which would promote greater slide movement.

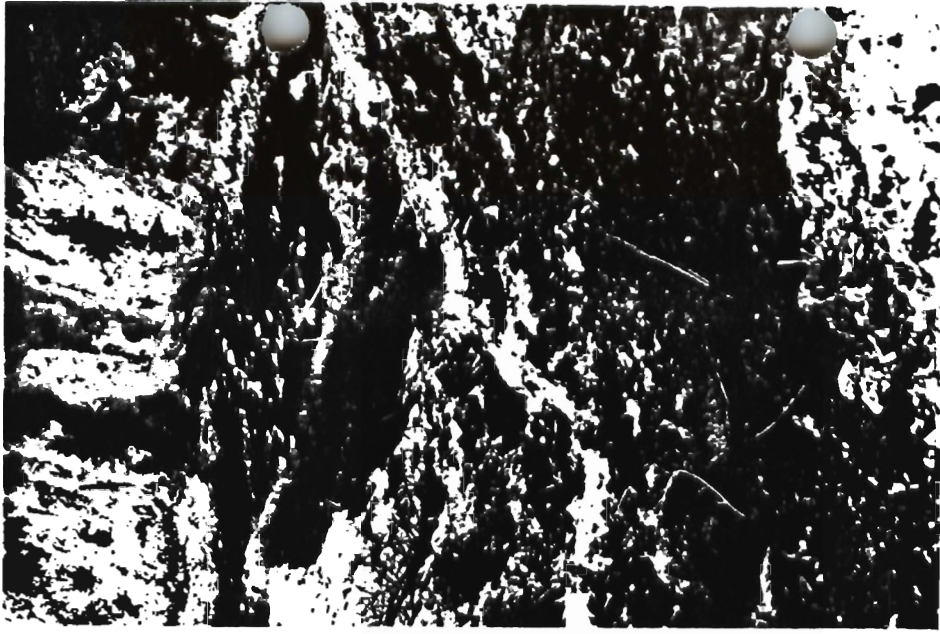
Steep talus cones have formed below the lip of the slide down to the bank of Trout Creek as a result of accumulation of sloughed material from the lower block (Photo 2). The slope ravel constantly trying to adjust its slope angle. Material is continually being added to the talus slopes from the top and removed from the bottom by Trout Creek. This erosion at the bottom apparently also contributes to the creek silt load especially during freshet. In June 1987, however, it was apparent that spring flow was bringing more silt into the creek than that caused by erosion of the talus slopes (Photo 5). Movement of the talus slope has not been well studied.

PHOTO 5. SILT-LADEN SPRINGS  
DISCHARGE ENTERING TROUT CREEK.
