GOVERNMENT OF BRITISH COLUMBIA

MEMORANDUM

TO Dr. J. C. Foweraker, Head Grovater Section	FROM	A. P. Kohut Senior Geological Engineer Groundwater Section	
Hydrology Division		July 12,	1977
SUBJECT Water and Drainage Problems, Webster P	roperty,	OUR F	OLE 0239013

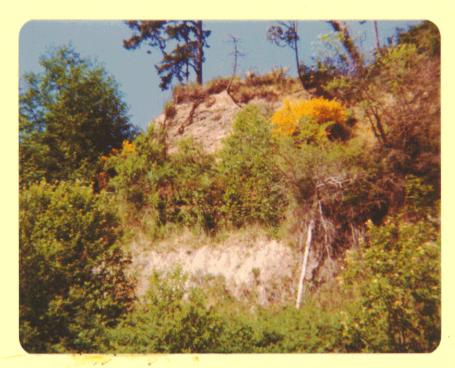
3619 Farhill Road, Metchosin, B.C. East of A. Webster's Property May 1977 Gravel Pit Development Complaint

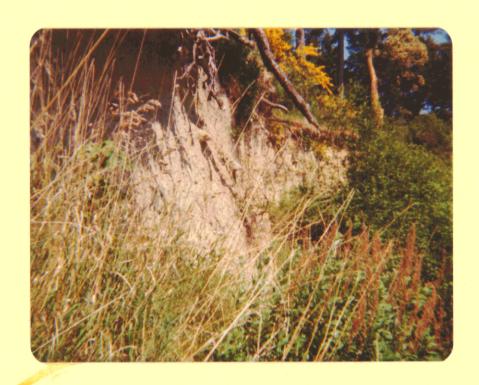
3619 Farhill Road, Metchosin, B.C. Further East on Upper end of Beach Trail of A. Webster's Property May 1977 Gravel Pit Development Complaint

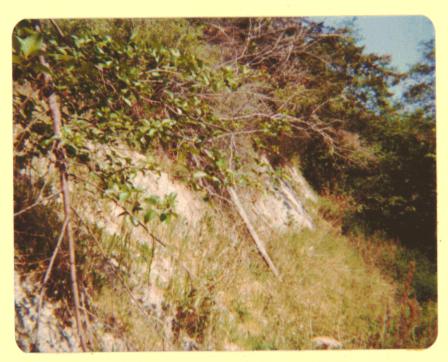
3619 Farhill Road, Metchosin, B.C. East of A. Webster's Property May 1977 Gravel Pit Development Complaint

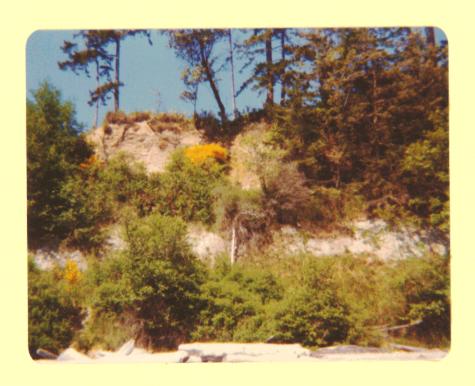
3619 Farhill Road, Metchosin, B.C. East of A. Webster's Property May 1977 Gravel Pit Development Complaint

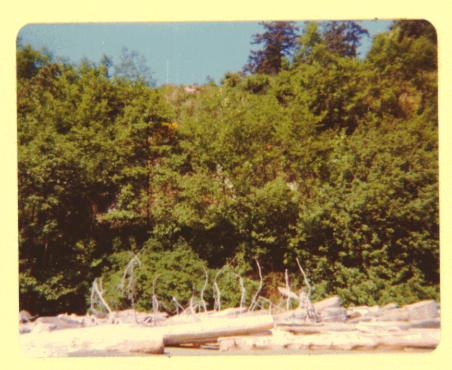
3619 Farhill Road, Metchosin, B.C. A. Webster's Property May 1977 Gravel Pit Development Complaint

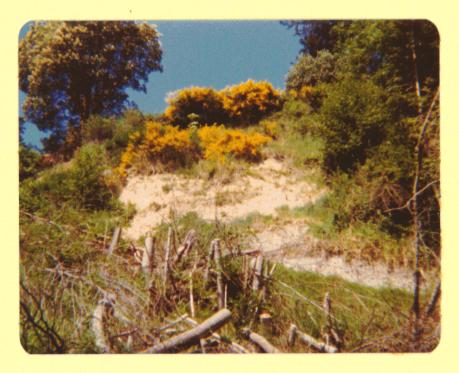
3619 Farhill Road, Metchosin, B.C. West of A. Webster's Property May 1977 Gravel Pit Development Complaint

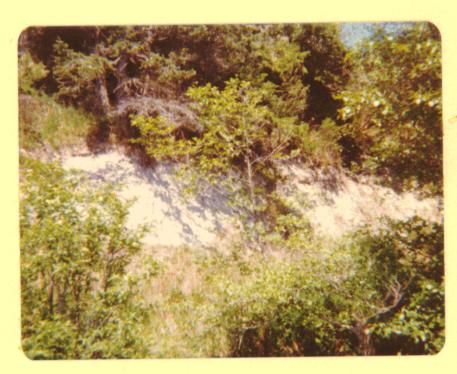
3619 Farhill Road, Metchosin, B.C. Further east on Beach trail from A. Webster's Property May 1977 Gravel Pit Development Complaint

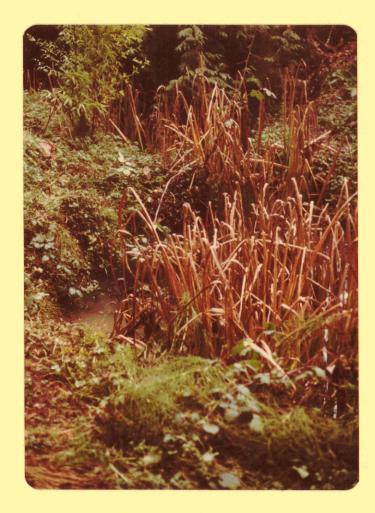
Webster Complaint - Fish pond on Webster property, licenced spring after being dug, January 1977

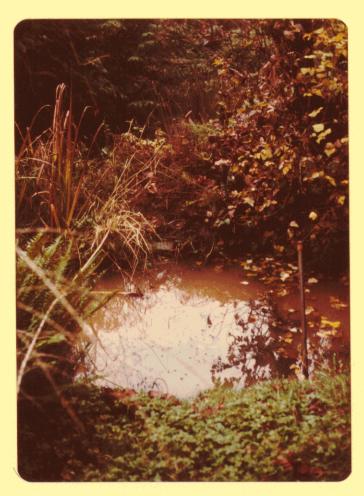
Webster Complaint - Dug spring, fish pond on Webster property, January 1977

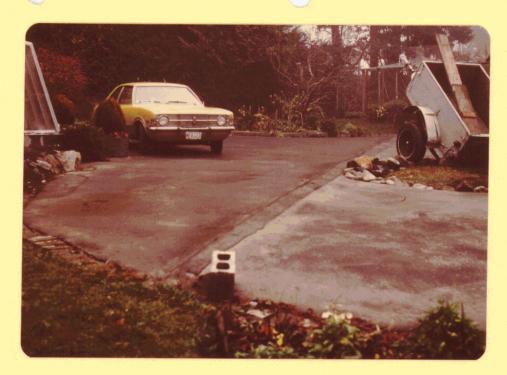
Webster Complaint - Asphalt driveway above low area on Webster Property, January 1977

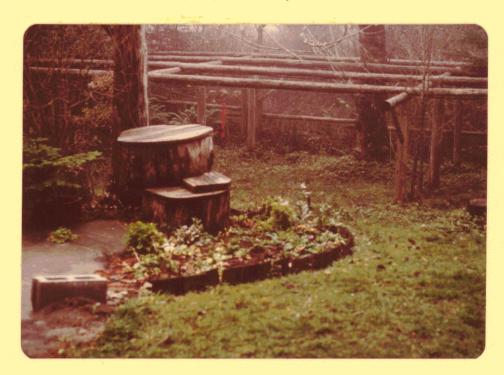
Webster Complaint - Low area on Webster property that is boggy, January 1977

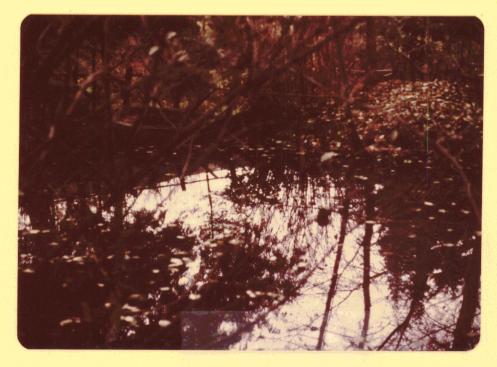
Webster Complaint - Spring on Burr property, January 1977

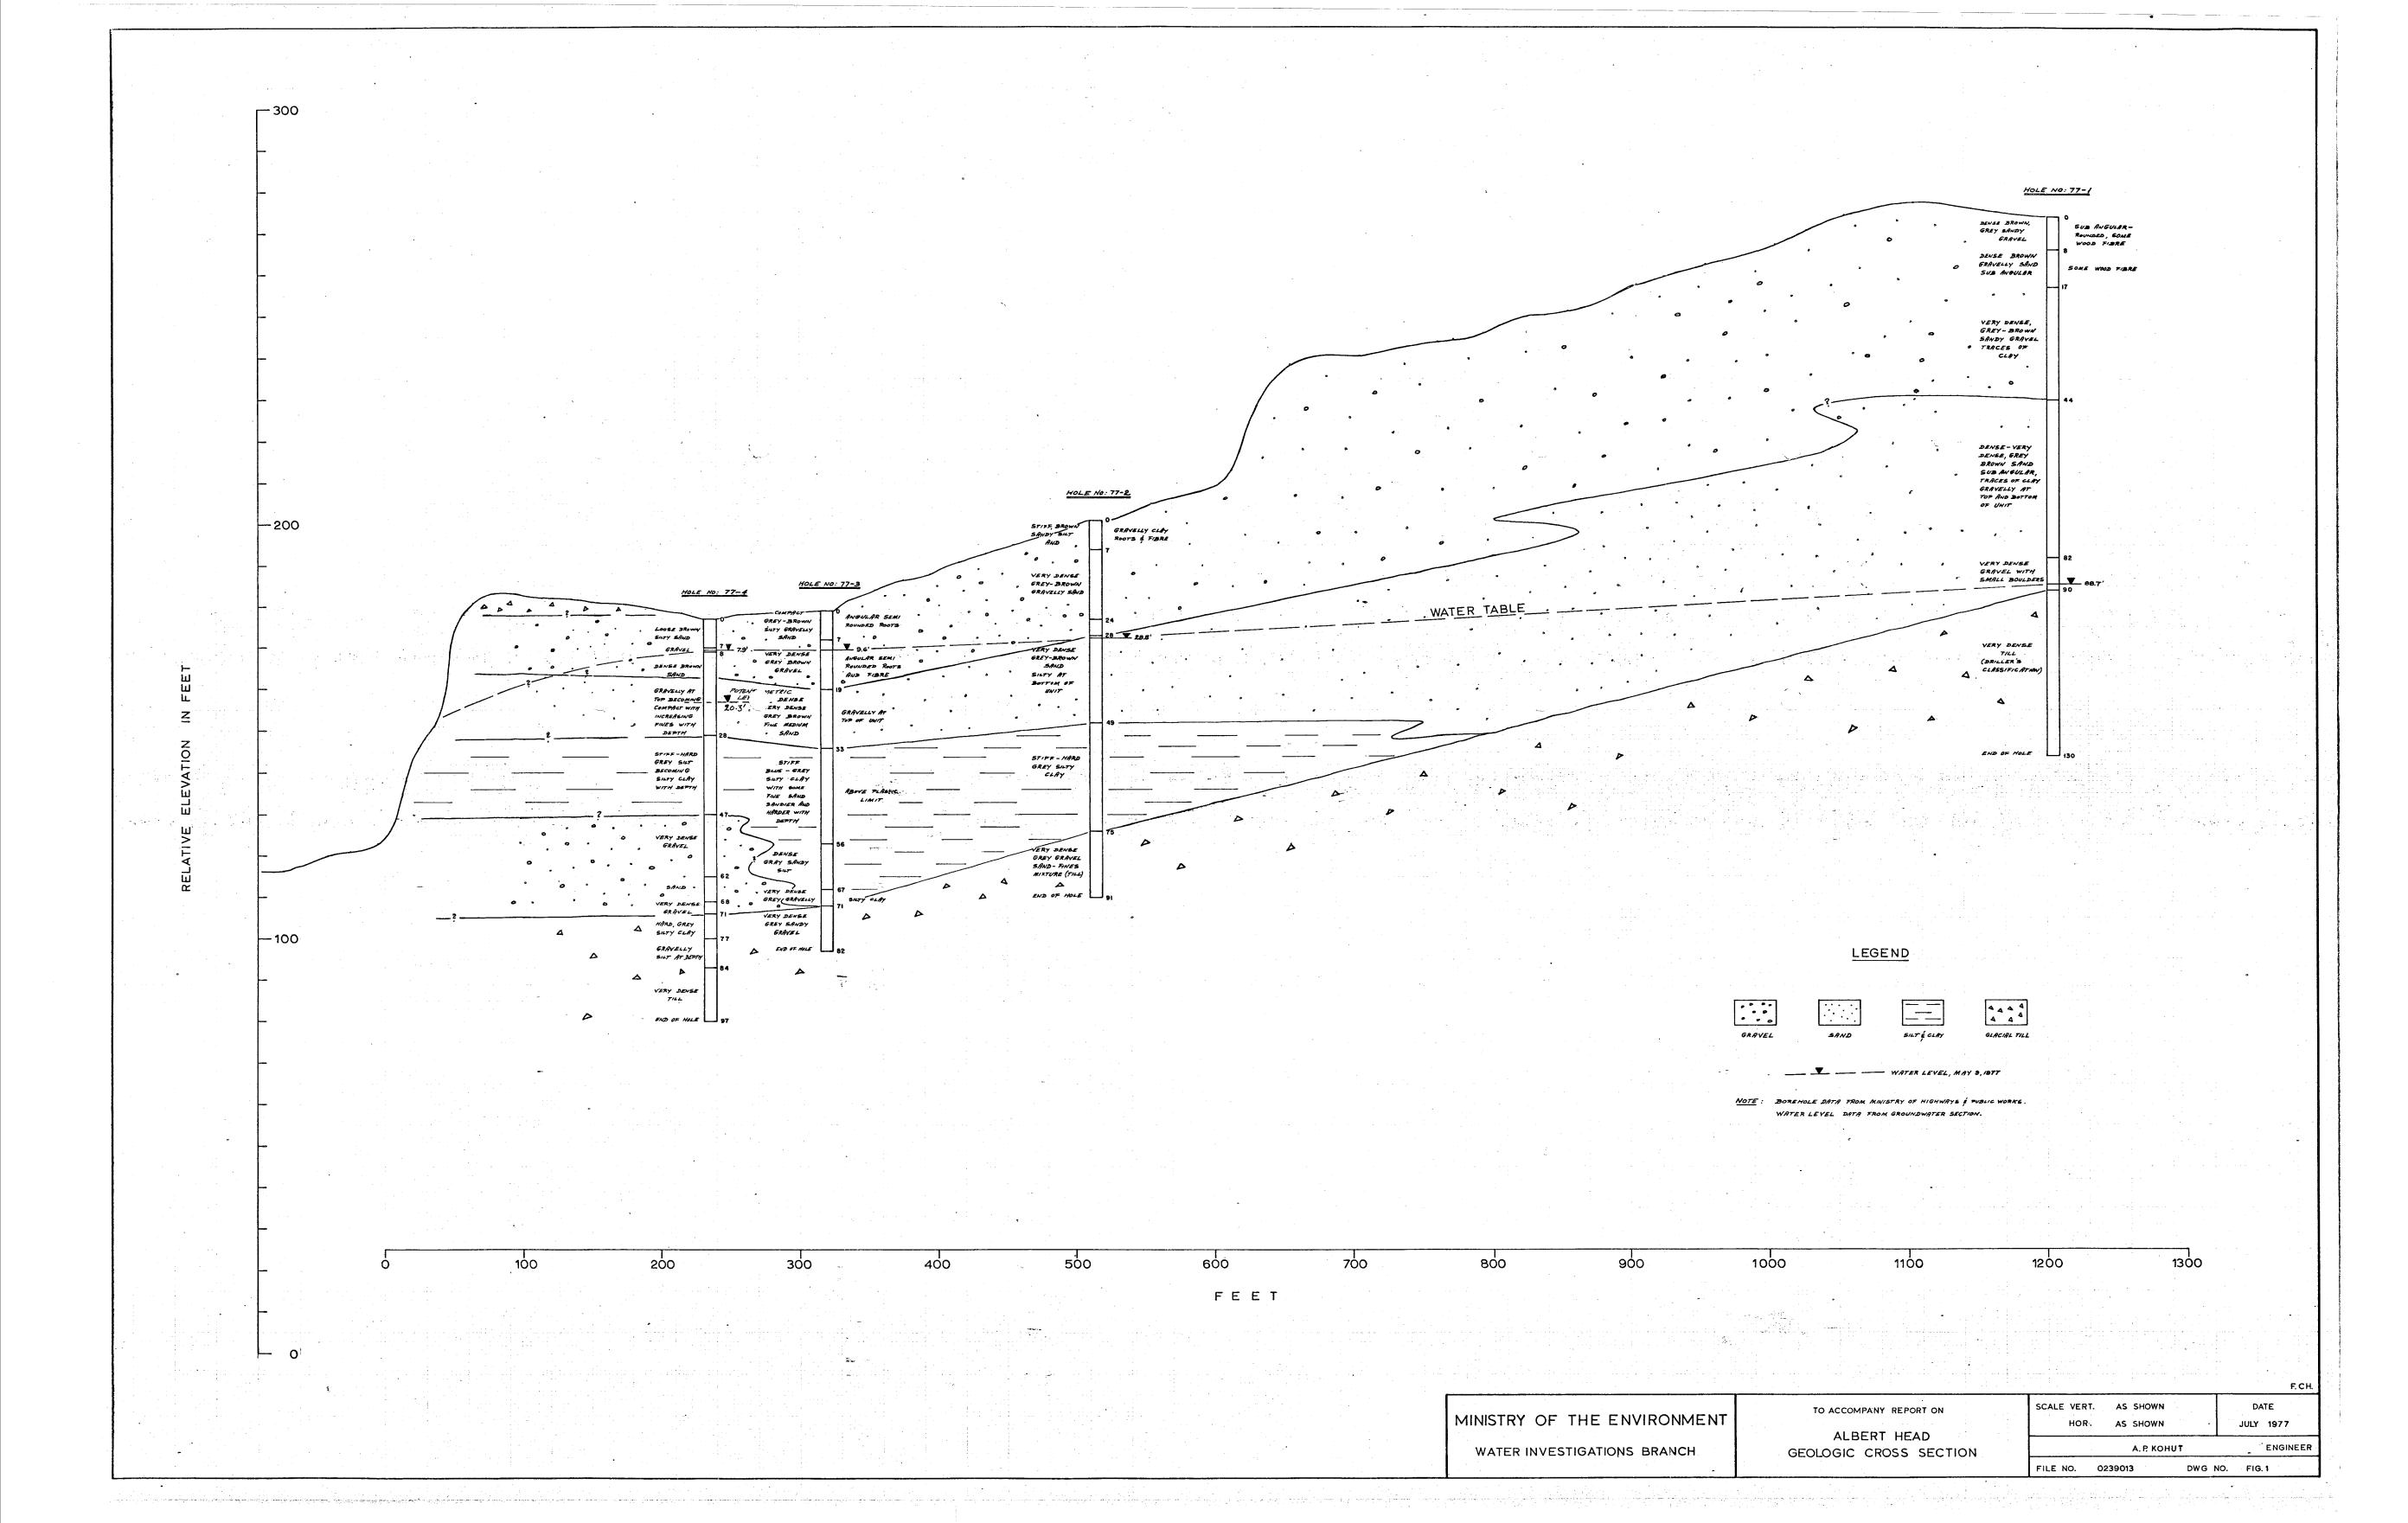
Although local variations are evident in the stratigraphy encountered in the test holes, the general succession of unconsolidated materials is comprised of 20 to 45 feet of sand and gravel overlying 15 to 40 feet of dense gray-brown fine to medium-grained sand, underlain by glacial till and/or stiff blue-gray silty clay. A silty clay and sandy silt unit varying from 19 to 38 feet in thickness is present in test holes 77-2, 77-3 and 77-4, but does not occur upslope in test hole 1. Test hole 77-4, moreover, intersected 24 feet of very dense gravel between the overlying silty clay and underlying glacial till. The silty clay unit and underlying gravel unit in test hole 77-4 was not noted previously in any of the exposures along the sea-facing cliff (Kohut, 1976). A very hard stony clay observed in the cliff exposures was noted immediately below the surficial sands and gravels. It is not known whether this material is equivalent to the silty clay encountered in the test holes or is in fact the underlying till material. If it represents the latter, this suggests the till surface may be highly irregular.

Static water-level data for May 9, 1977 plotted in Figure 1 indicates the water-table surface slopes under a natural gradient of 13 feet in 700 feet (1.9×10^{-2}) between test holes 77-1 and 77-2. Variable depth piezometers in test holes 77-3 and 77-4, moreover, show a decrease in head with depth. Of significance is the hydraulic head, within the confined sand and gravel unit (77-4), which is 12 feet lower than the head in the overlying water-table aquifer. Piezometer response tests show that all piezometers are functioning.

The new data, however, does not prove conclusively that excavation of the gravel pits is the major cause of seasonally higher water-table conditions downslope in some areas. Continuous long-term water-level monitoring is required to assess the effect of the gravel pits on groundwater recharge. One possible solution for dewatering the water-table aquifer locally as discussed earlier in correspondence from the Ministry of Highways, would be to construct a vertical drain connecting the surficial aquifer and the underlying confined aquifer since there is a difference in the hydraulic head between these two aquifers. This could, however, cause decreased slope stability on the lower sea cliff opposite the lower aquifer or interfere with licensed springs nearby to the south. Additional drilling and pump testing (aquifer testing) would be required to assess the practicality of this solution.
