North River Consulting Ltd.

FISH PASSAGE ASSESSMENTS

Prince George Forest District: Willow, Tabor and
Bowron Watersheds – 787 locations

Contract: PD14TGB003

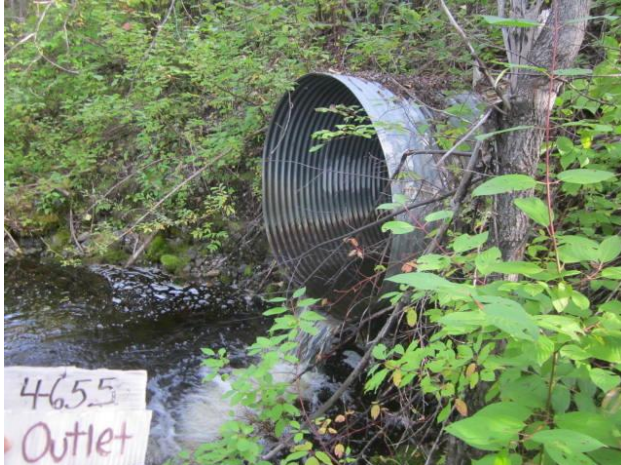
The current crossing structure constricts the stream with a 1.8m closed bottom culvert on a 4.2m stream (see Appendix 2, photos 1-2). The large scoured outlet pool provides evidence that the stream is severely constricted and the 0.48m outlet drop prevents fish access to the culvert. The stream contains medium value fish habitat. The stream has a medium habitat gain index. The stream contains moderate spawning, rearing and overwintering habitat.

Photo 1, Site 4655 – Medium value habitat and barrier score of 34. 0.48m outlet drop.

It is recommended that the current crossing structure is replaced with an open bottom structure such as a clear span bridge.

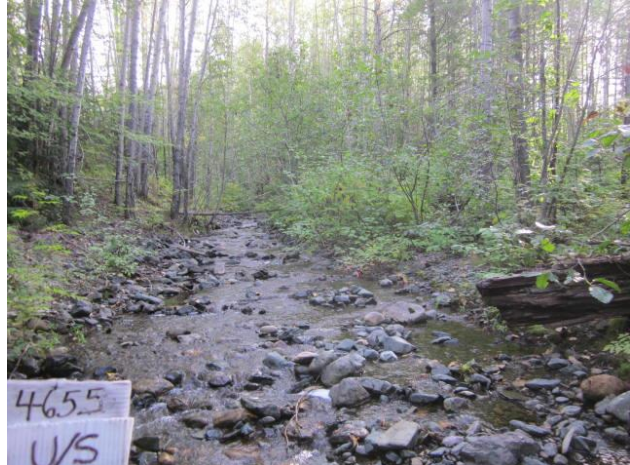
Photo 2, Site 4655 – Upstream view of good rearing and spawning habitat with cover provided by boulders and vegetation.

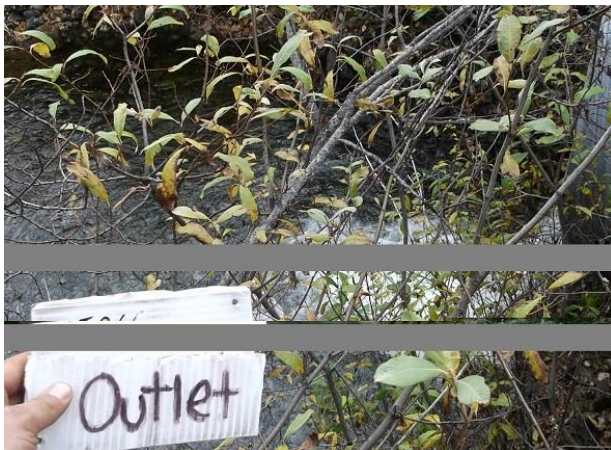
The current 1.8m culverts (two) constrict the 4m stream channel (see Appendix 2, photos 3-4). This has caused scouring of the outlet which has created a large pool and resulted in the culvert outlet being perched 1.0m resulting in the crossing structure being a barrier to fish passage. This stream is a tributary to fish-bearing Wendle lake. The stream contains medium value habitat and the habitat gain index for this stream is medium.

Photo 3, Site 5266 – Medium value habitat, 1m outlet drop.

It is recommended that the current crossing structure is replaced with a clear span bridge.

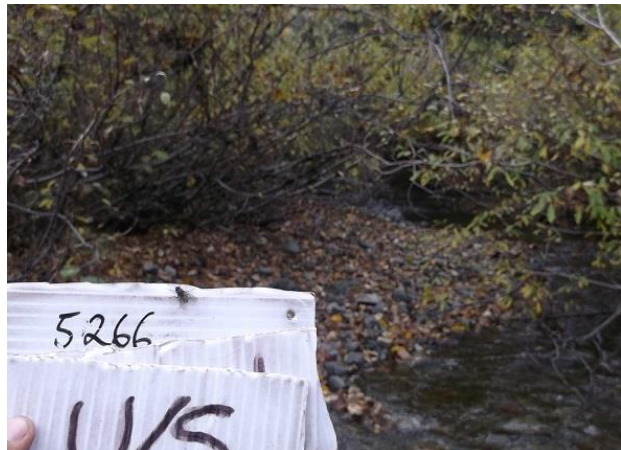
Photo 4, Site 5266 – Upstream view of cover provided by overhanging vegetation. Suitable spawning substrate.

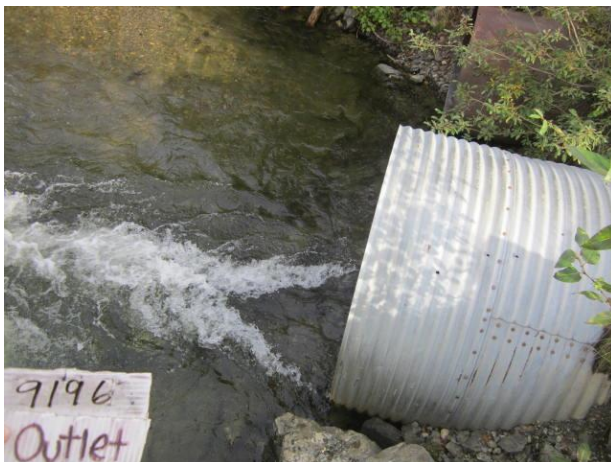
The current crossing structure constricts the stream with a 1.8m closed bottom culvert on an 8m stream (see Appendix 2, photos 5-6). The cobble and gravel in the stream provide good spawning habitat, with good rearing habitat provided by pools and overhanging vegetation. Overall, the stream contains high value habitat.

Photo 5, Site 9196 – High value habitat, perched culvert 0.5m

It is recommended that the current crossing structure is replaced with an open bottom structure such as a clear span bridge.

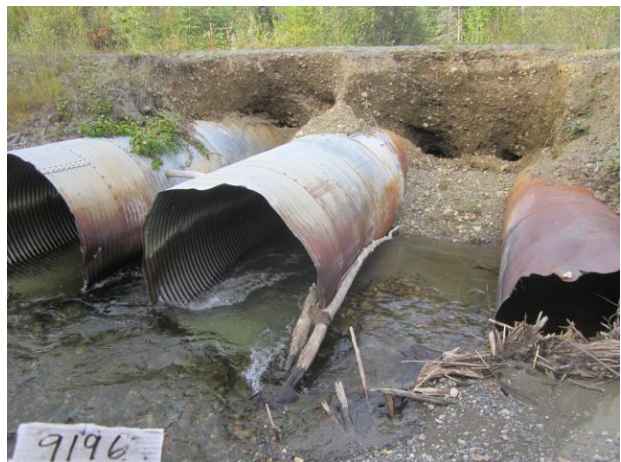
Photo 6, Site 9196 – Culvert inlets partially washed out.

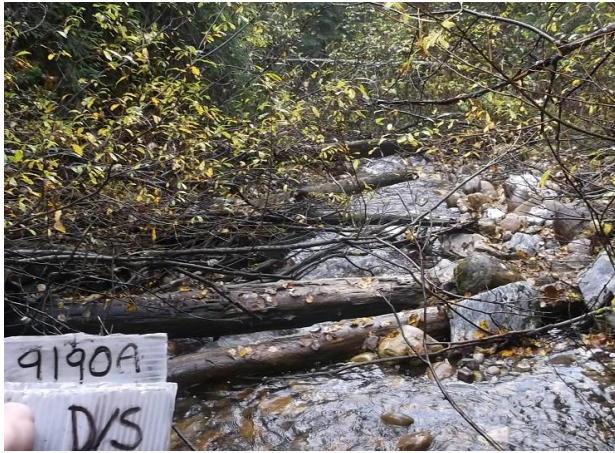
The current crossing structure constricts the stream with a 1.1m closed bottom culvert on a 2.3m stream (see Appendix 2, photos 7-8). The culvert has an outlet drop of 1.5m. Medium value fish habitat is provided by overhanging vegetation and cobble and gravel substrate. The stream has a very low habitat gain index rating.

Photo 7, Site 9190A – Downstream view of stream channel.

It is recommended that the current crossing structure is replaced with an open bottom structure such as a clear span bridge.

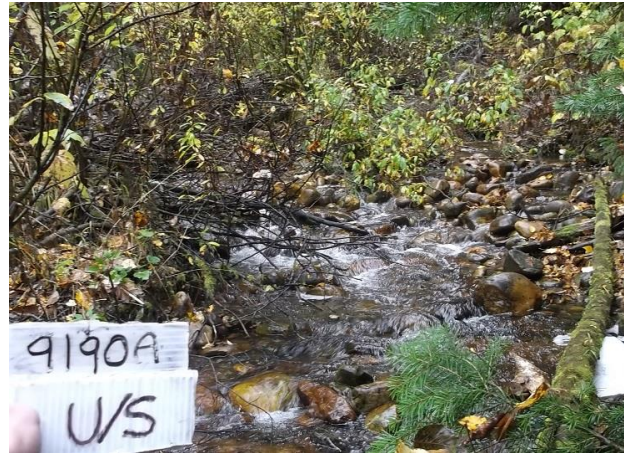
Photo 8, Site 9190A – Upstream view of stream channel.

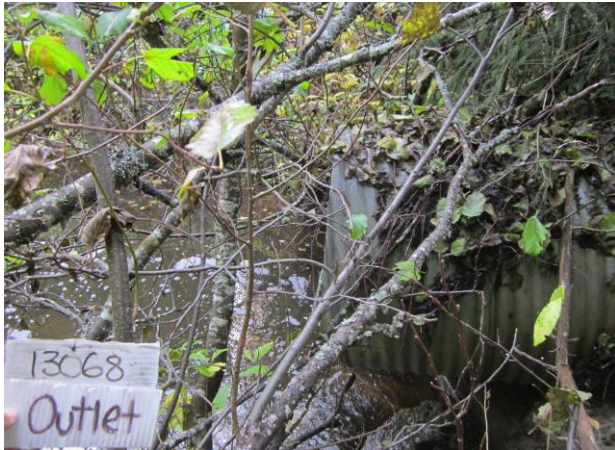
The current crossing structure constricts the stream with a 1.1m closed bottom culvert on a 3.0m stream (see Appendix 2, photos 9-10). Upstream there is a large beaver pond created by the partial beaver dam on the upstream side of the crossing. This has partially buried the culvert inlet, which results in potential for a washout at the site. Overall, the stream contains medium value habitat.

Photo 9, Site 13068 – Outlet drop of 0.4m.

It is recommended that the current crossing structures are replaced with an open bottom structure such as a clear span bridge.

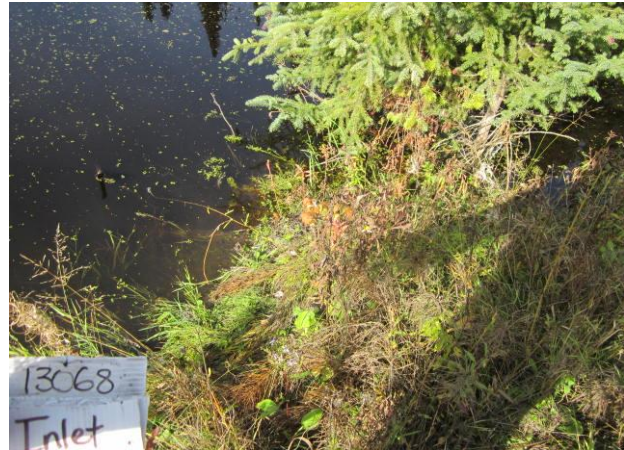
Photo 10, Site 13068 – Culvert inlet obstructed with large beaver pond upstream.

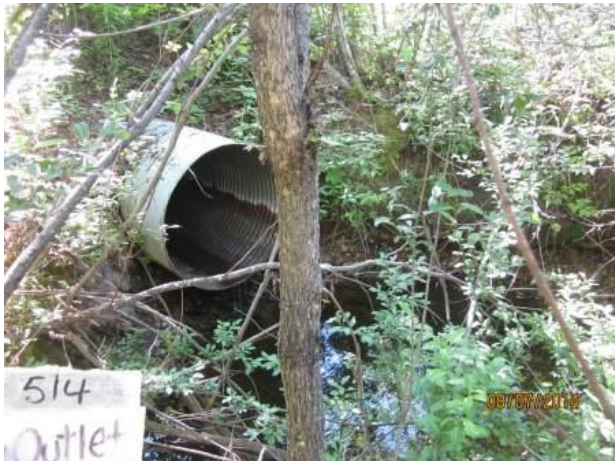
The current crossing structure constricts the stream with a 1.7m closed bottom culvert on a 3.0m stream (see Appendix 2, photos 11-12). The inside of the culvert is partially collapsed. The stream has a very low habitat gain index rating. Gravel and cobble substrate provides suitable spawning habitat, and overhanging vegetation and pools provide suitable rearing habitat. Overall, the stream contains medium value habitat.

Photo 11, Site 514 - Culvert outlet drop of 0.34m

It is recommended that the current crossing structures are replaced with an open bottom structure such as a clear span bridge.

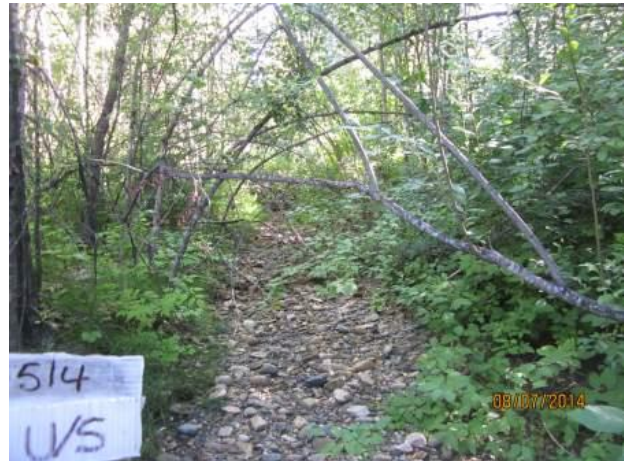
Photo 12, Site 514 – Upstream view of stream channel showing medium value habitat.

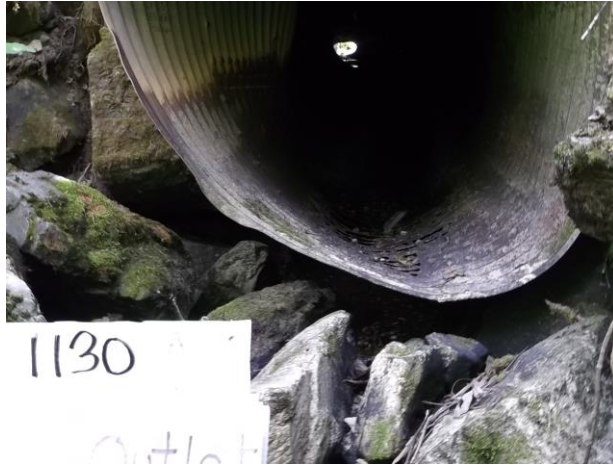
The current crossing structure constricts the stream with a 1.2m closed bottom culvert on a 1.8m stream (see Appendix 2, photos 13-14). The culvert outlet has rusted through resulting in water not flowing to the end of the pipe which contributes to this structure being a fish barrier. This stream has a high habitat gain potential and with fish observed in the outlet pool this site is a high priority for replacement. Overall, the stream contains medium value habitat.

Photo 13, Site 1130 – Culvert outlet perched and rusted through resulting in no flow at the end of

It is recommended that the current crossing structures are replaced with an open bottom structure such as a clear span bridge.

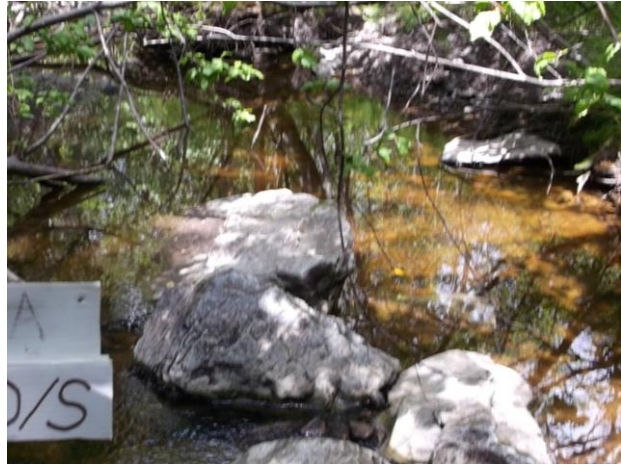
Photo 14, Site 1130 – Medium value habitat downstream from site.

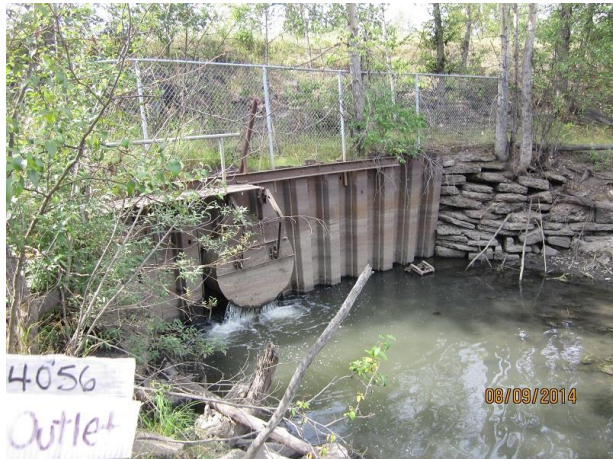
The current crossing structure constricts the stream with a 1.7m closed bottom culvert on a 4.0m stream (see Appendix 2, photos 15-16). The culvert is perched 0.3m, however this height is likely influenced by the level of the Fraser River. The outlet has a backflow valve which would prevent fish ascent during high flow periods. This stream is located in an urban area in the City of Prince George with a paved road which would make it costly to replace and it is unknown if there is a fish passable solution to replace the backflow structure. Additional investigation should be conducted prior to completing replacement works. However this stream would likely provides very high value rearing habitat for various salmonids including Chinook as it is located close to the Fraser River confluence. It would provide important backwater rearing habitat and overwintering. The stream has a moderate habitat gain index rating and contains overall high value habitat. Fish were observed at the crossing.

Photo 15, Site 4056 – 0.3m perched culvert with outlet backflow control structure (for Fraser River).

It is recommended that the current crossing structures are replaced with an open bottom structure such as a clear span bridge.

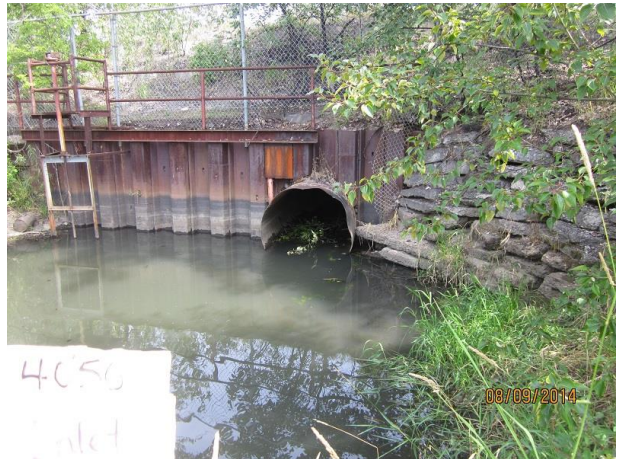
Photo 16, Site 4056 – Downstream view of inlet. Good rearing and overwintering potential.

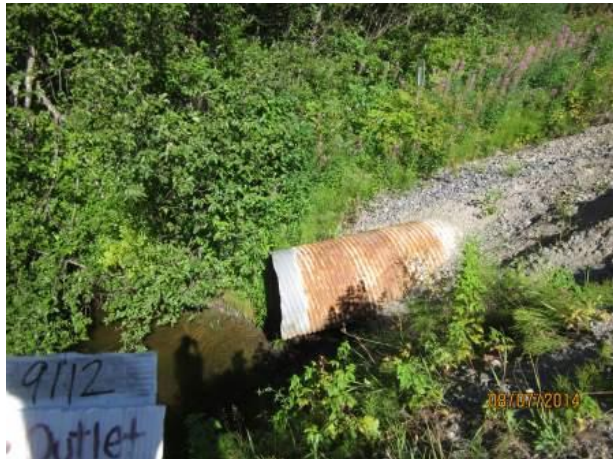
The current crossing structure slightly constricts the stream with a 1.2m closed bottom culvert on a 1.7m stream (see Appendix 2, photos 17-18). The culvert is perched 0.61m which hinders fish ascent. Fish were observed in the outlet pool and the stream contains suitable spawning and rearing habitat with an overall contains moderate value habitat rating.

Photo 17, Site 9112 – 0.61m perched outlet.

It is recommended that the current crossing structure is replaced with a clear span bridge.

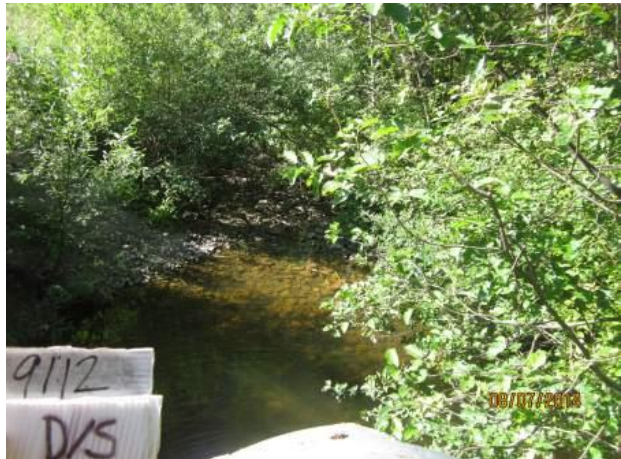
Photo 18, 9112 – Downstream overview showing overhanging vegetation and outlet pool.

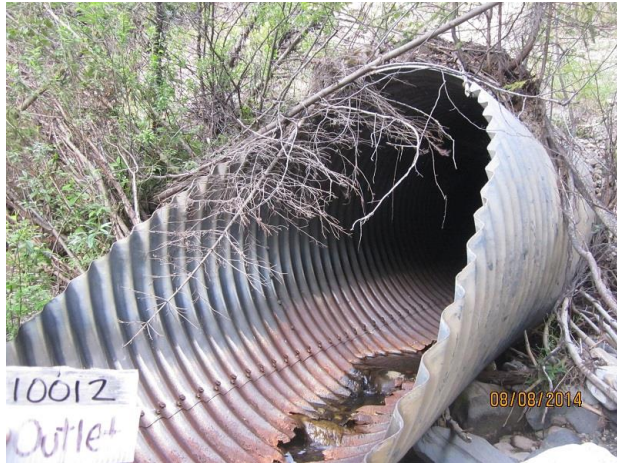
The current crossing structure constricts the stream with a 2.4m closed bottom culvert on a 5.0m stream (see Appendix 2, photos 19-20). The culvert outlet has rusted through and is perched 0.3m which hinders fish ascent. The stream crossing has a high habitat gain index rating. The stream contains good rearing and spawning habitat, and overall contains high value habitat. Fish were observed on the downstream side of the crossing.

Photo 19, Site 10012 – Outlet perched 0.3m and rusted.

It is recommended that the current crossing structure is replaced with an open bottom structure such as a clear span bridge. It should be noted that this crossing has a deep 15m fill depth which will increase costs for replacement.

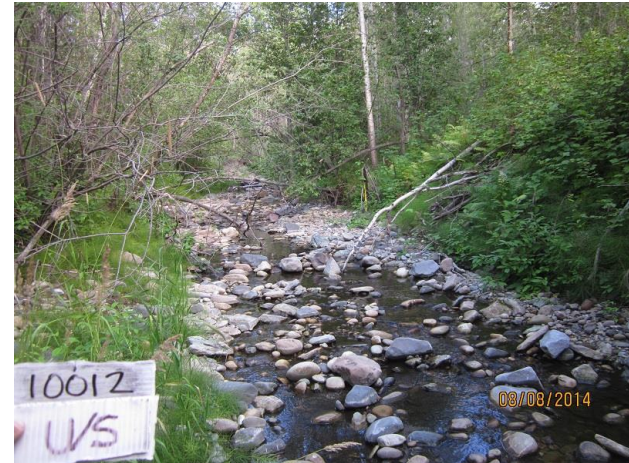
Photo 20, Site 10012 – Upstream view of high value fish habitat with cover provided by boulders and overhanging vegetation.

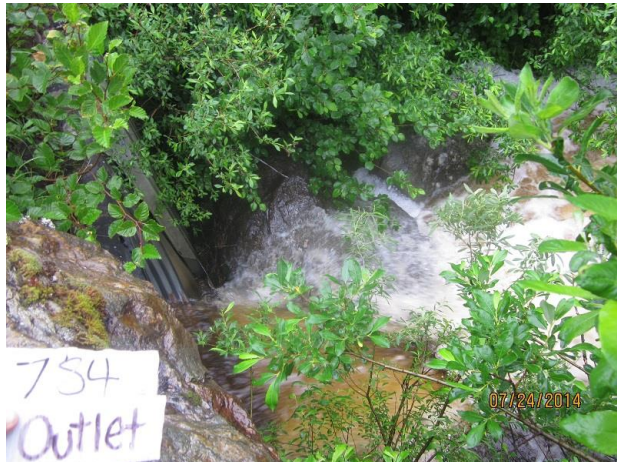
The current crossing structure constricts the stream with a 2.1m closed bottom culvert on a 2.5m stream (see Appendix 2, photos 21-22). The culvert is perched 1.0m which prevents fish ascent. The stream has a moderate habitat gain index rating. The stream contains good rearing habitat provided by dense overhanging vegetation and boulders, and overall contains medium value habitat.

Photo 21, Site 784 – Culvert outlet perched 1.0m,

It is recommended that the current crossing structure is removed and replaced with a clear span bridge.

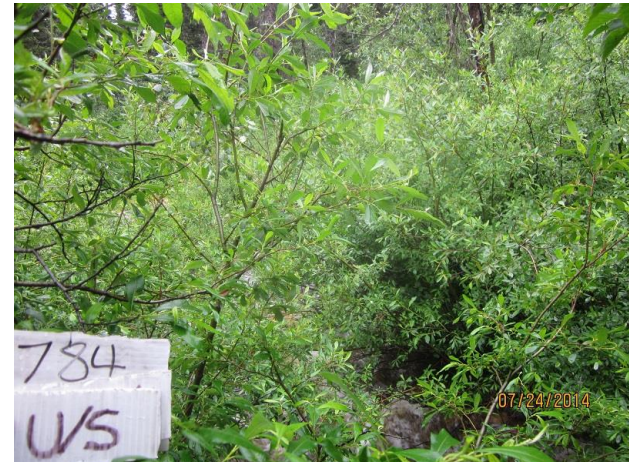
Photo 22, Site 784 – Upstream view of dense overhanging vegetation.

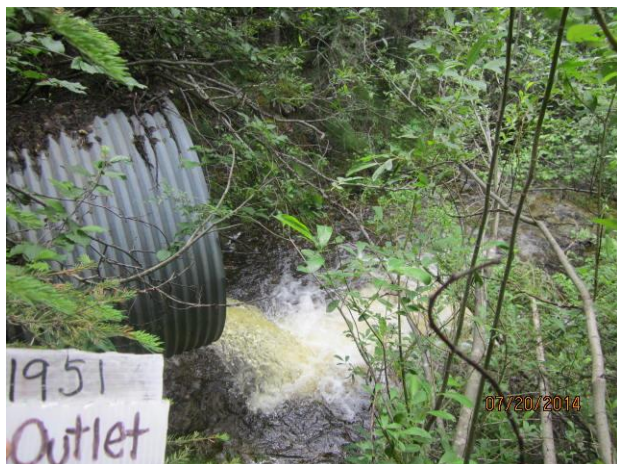
The current crossing structure slightly constricts the stream with a 1.8m closed bottom culvert on a 2.0m stream (see Appendix 2, photos 23-24). The culvert is perched 1.1m which prevents any fish ascent. The stream has a moderate habitat gain index rating. The stream contains good spawning habitat, and overall contains medium value habitat. A notation on the FPCI maps indicates that Rb are present in this stream.

Photo 23, Site 1951 – Culvert outlet perched 1.1m.

It is recommended that the current crossing structure is removed and replaced with a clear span bridge.

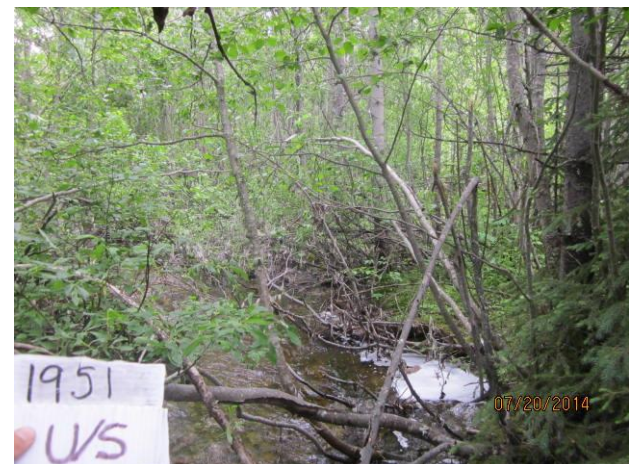
Photo 24, Site 1951 – Upstream view of good rearing habitat with cover provided by overhanging vegetation. Cobble substrate.

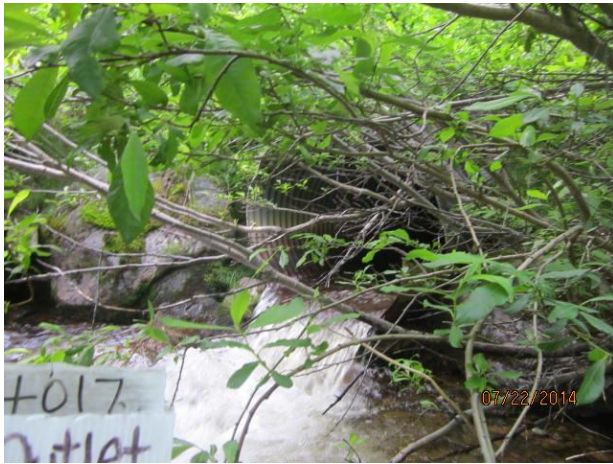
The current crossing structure constricts the stream with a 1.4m closed bottom culvert on a 2.5m stream (see Appendix 2, photos 25-26). The culvert is perched 0.6m. The stream has a moderate habitat gain index rating. The stream has good rearing habitat with cover provided by large woody debris, boulders, and overhanging vegetation. The stream has an overall rating of medium value habitat. A notation on the FPCI maps indicates that Rb and Bt are present in this stream.

Photo 25, Site 4017 – Outlet perched 0.6m.

It is recommended that the current crossing structure is removed and replaced with an open bottom structure such as a bridge.

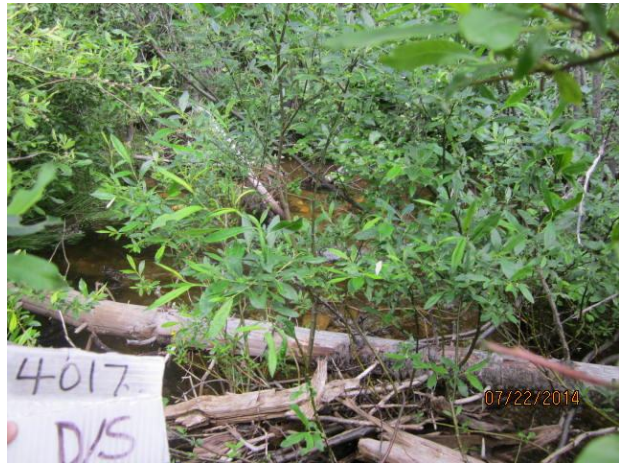
Photo 26, Site 4017 – Downstream view of instream large woody debris.

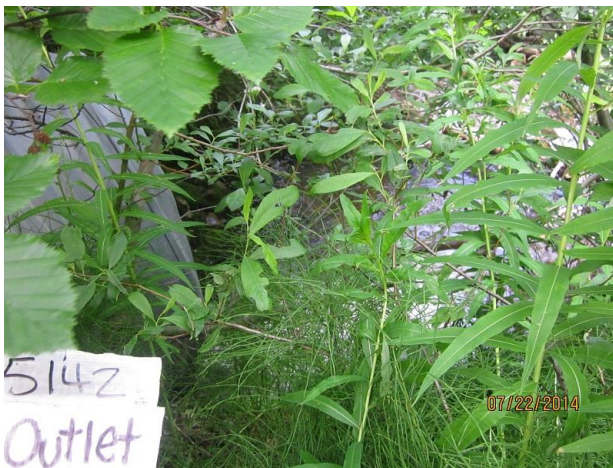
The current crossing structure constricts the stream with a 1.2m closed bottom culvert on a 2.5m stream (see Appendix 2, photos 27-28). The culvert is perched 0.6m. A notation on the FPCI map indicates that Rb and Bt are present. The stream has a moderate habitat gain index and an overall rating of medium value habitat.

Photo 27, Site 5142 – Outlet perched 0.6m.

It is recommended that the current crossing structure is removed and replaced with an open bottom structure such as a bridge.

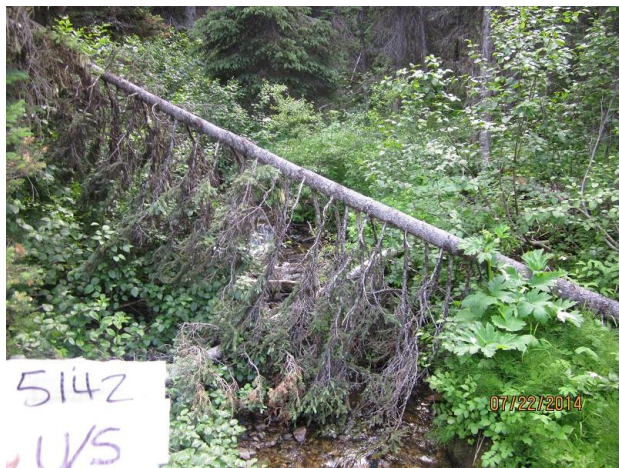
Photo 28, Site 5142 – Upstream overview of cobble substrate and overhanging vegetation.

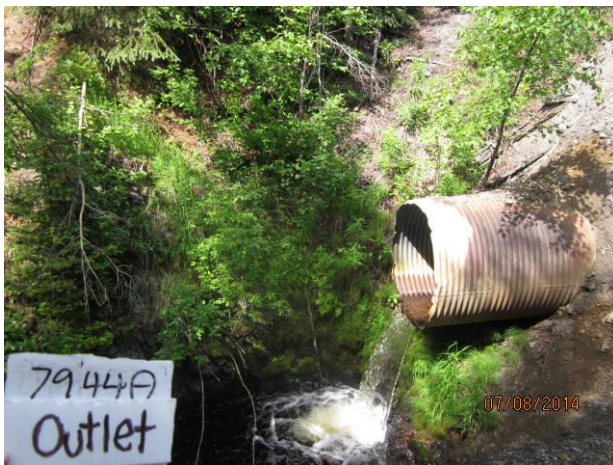
The current crossing structure constricts the stream with a 1.5m closed bottom culvert on a 4.0m stream (see Appendix 2, photos 29-30). The culvert is perched 1.2m which prevents fish ascent. The stream has a moderate habitat gain index. The stream has gravel/cobble substrate that is suitable for spawning and good rearing habitat with an overall rating of medium value habitat.

Photo 29, Site 7944A – 1.2m perched culvert.

It is recommended that the current crossing structure is removed and replaced with an open bottom structure such as a bridge.

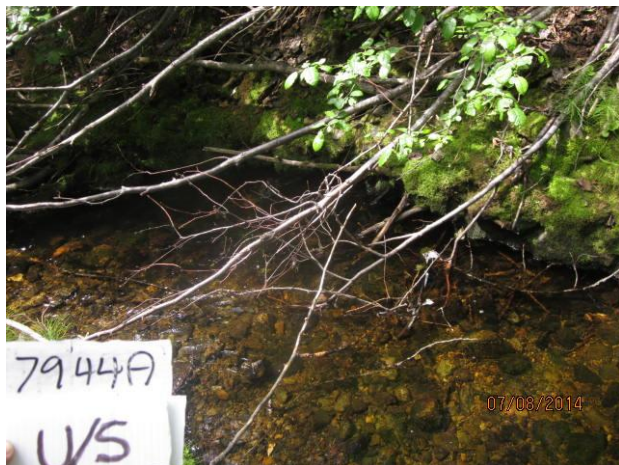
Photo 30, Site 7944A – Upstream view of cobble and gravel substrate.
