Mr. T.A.J. Leach, Asst. Chief Engineer

J.C. Foweraker, Geological Engineer

B.C. Water Resources Service

Preliminary Geological Investigation
of Stocking Lake Dam Site

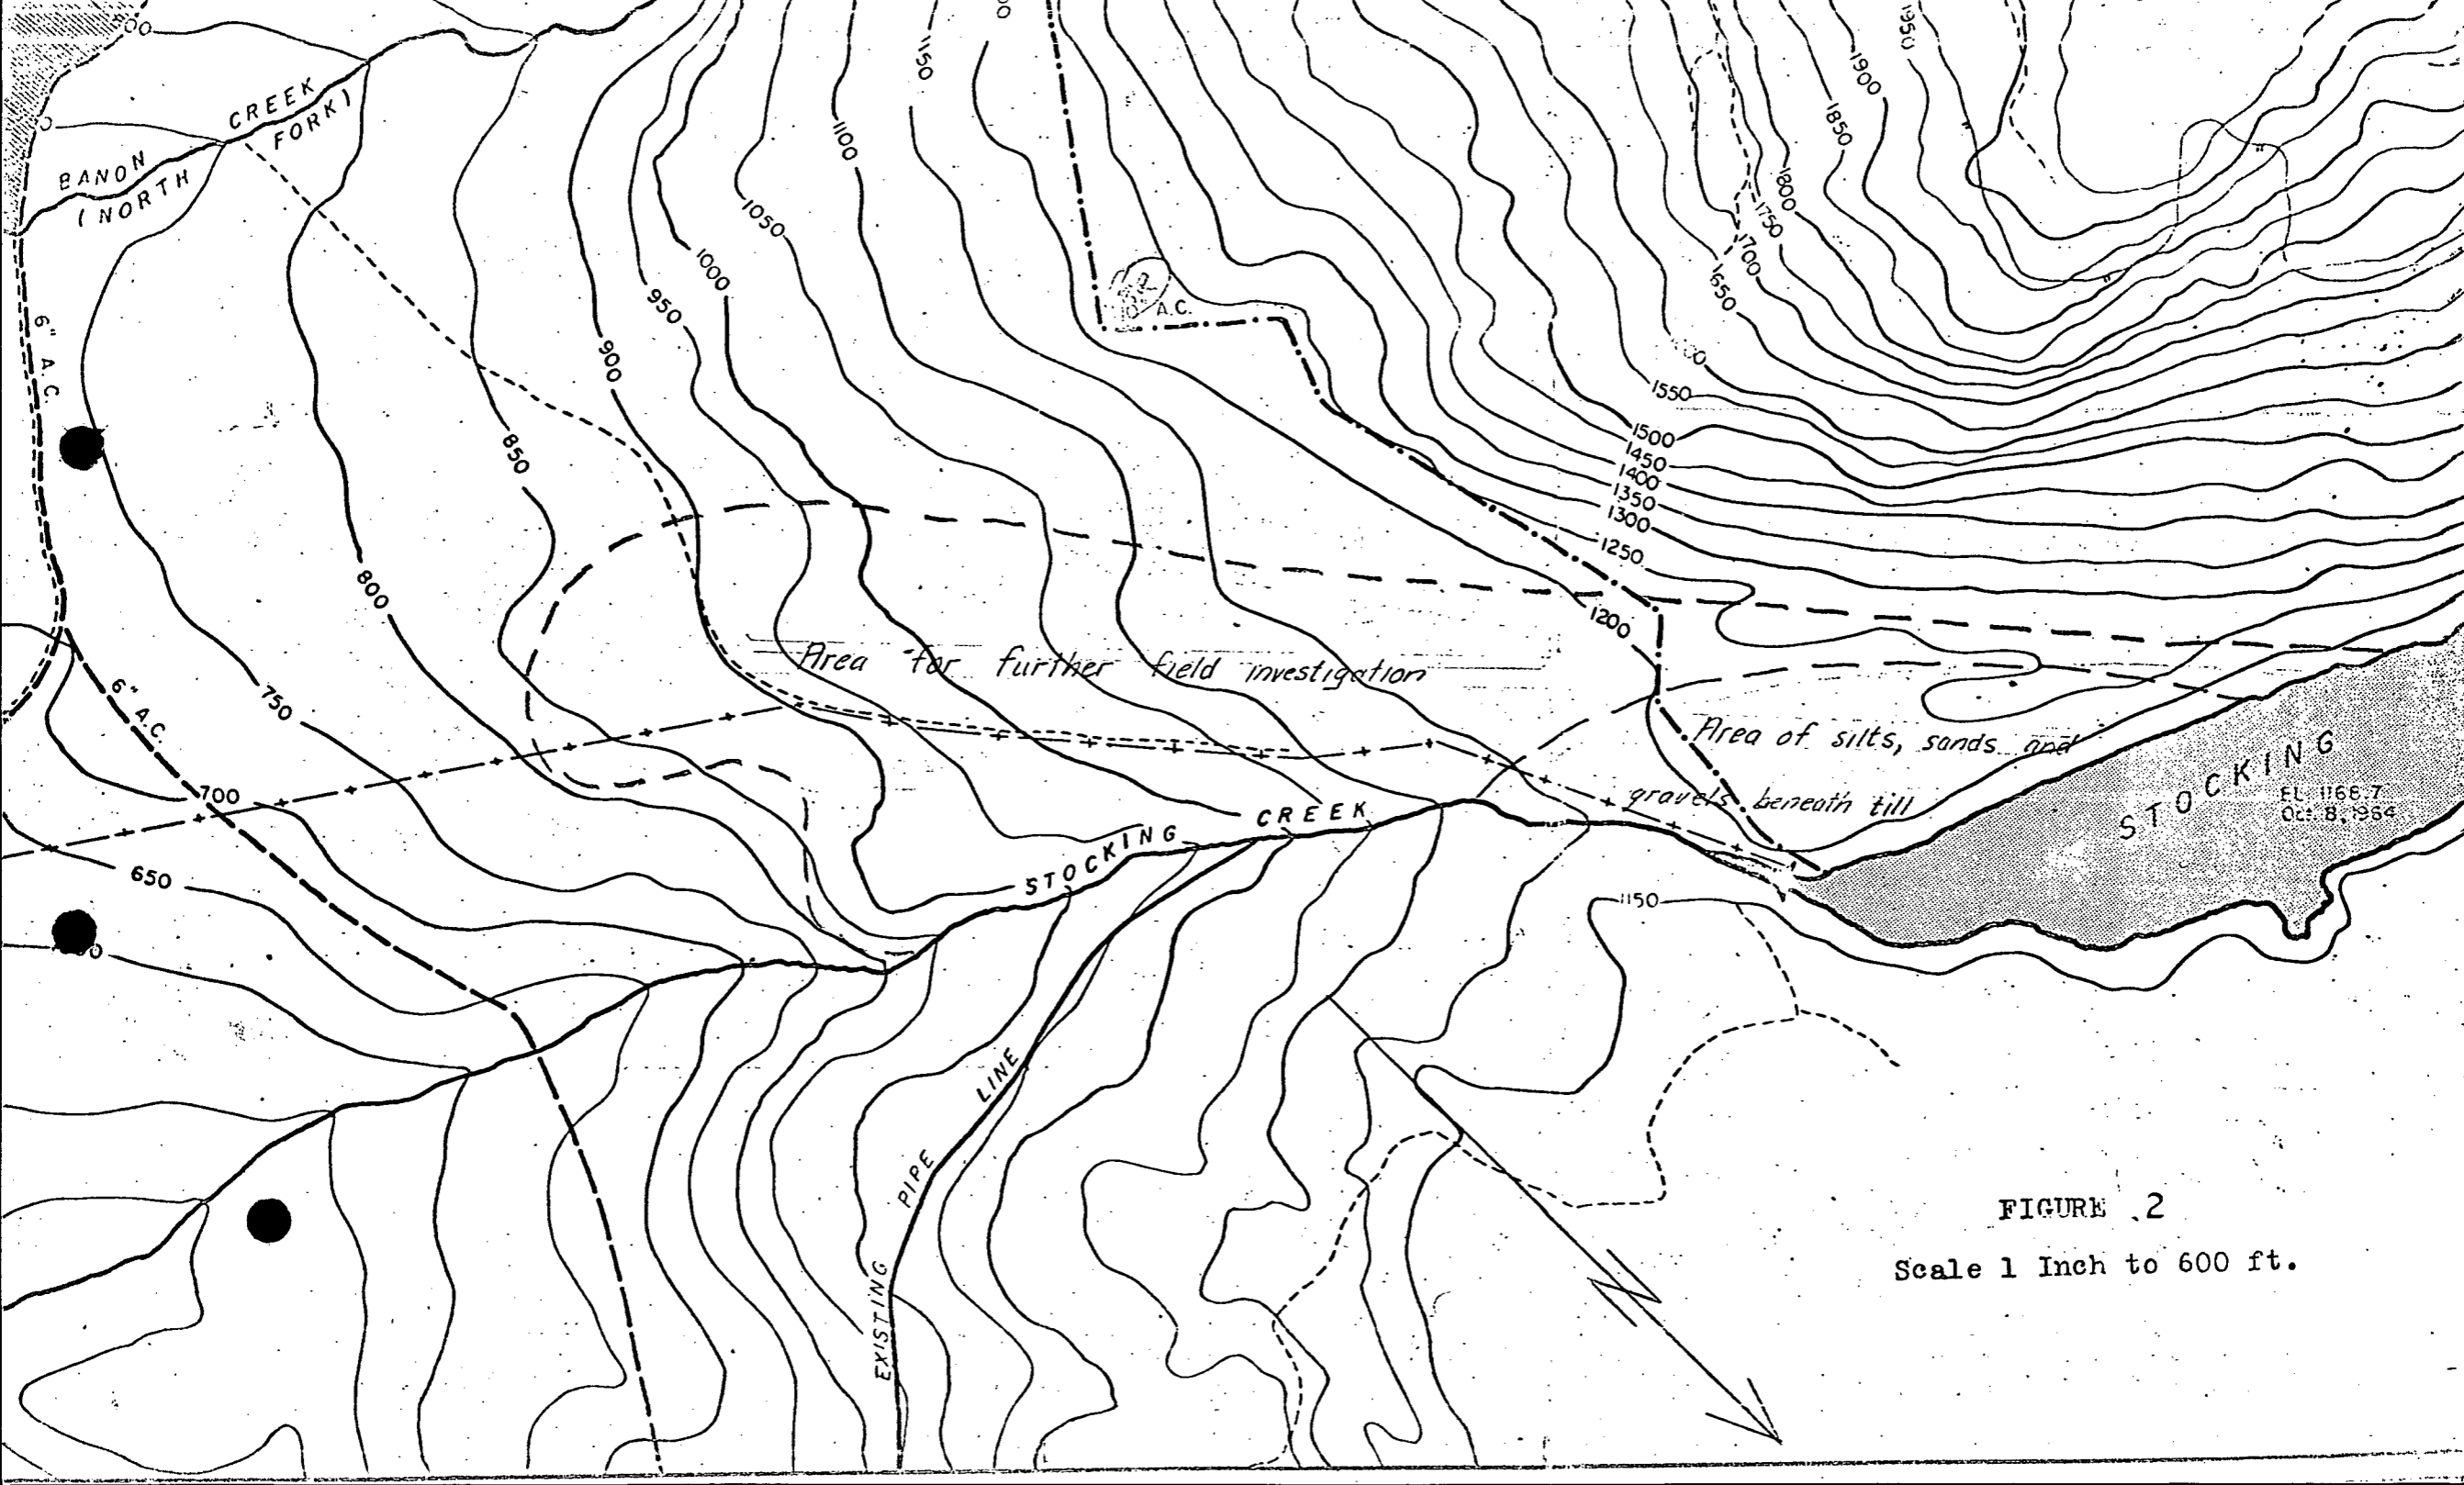
FIGURE 2
Scale 1 Inch to 600 ft.

At Stocking Lake damsite, silts, sands and gravels which appear to be old channel deposits, are found to the right or west of the outlet trench. These deposits appear to be lying below till, however, it is not known whether this till seals off these deposits effectively from the waters of Stocking Lake. The possible extent of these deposits is shown in Fig. 2.

This exposure and others occurring in the right bank of the spillway (see Fig. 4) are interpreted as being the remnant of an old channel deposit, overlain by till. The possible areal extent of the deposit is shown in Fig. 2.

If a higher dam structure is to be contemplated in the future, it would be advisable to undertake a program of exploratory drilling within this area outlined in Fig. 2. A rotary drilling machine could do this work relatively quickly and easily. Initially, test holes could be put down in a line close to the proposed crestline of the dam, and depending on the results of the first few holes, further test holes could then be put down, if necessary, along a projection of this line to the southwest of the dam site. Additional holes could be put down along the northern boundary of the area outlined in Fig. 2, near to the edge of Stocking Lake. Adequate sampling procedures should be used.

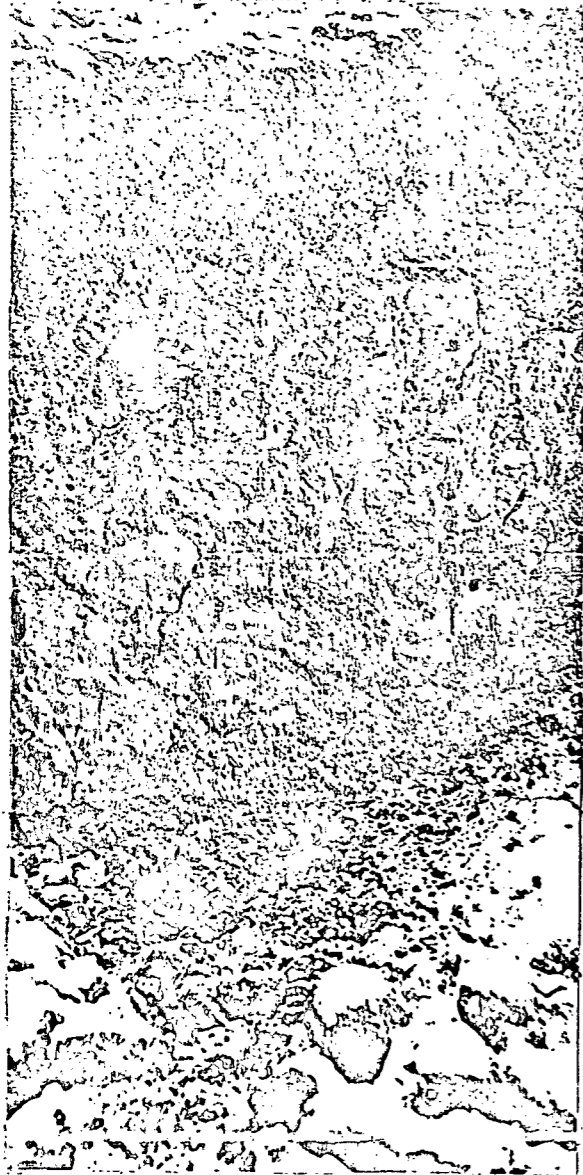
1. RIGHT BANK

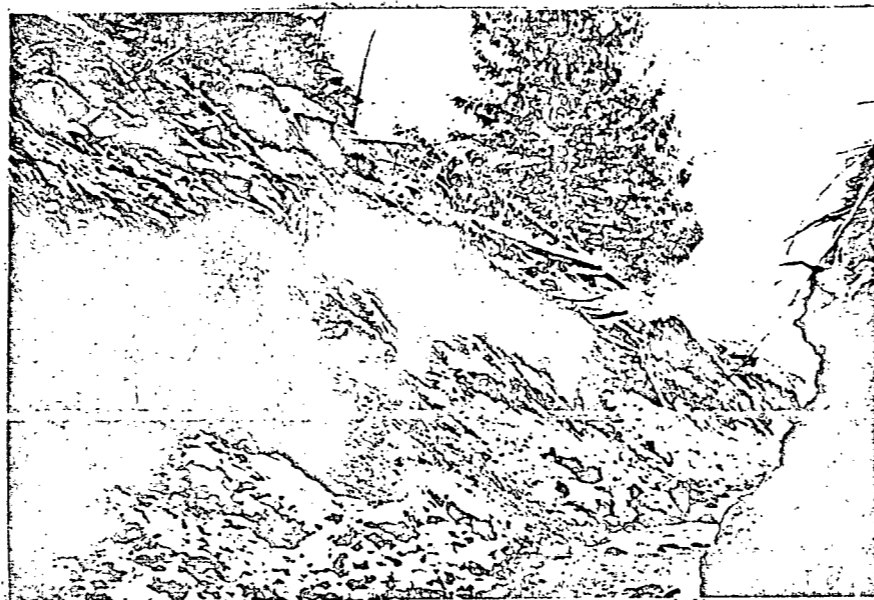
3. RIGHT BANK
LOOKING UPSTREAM.

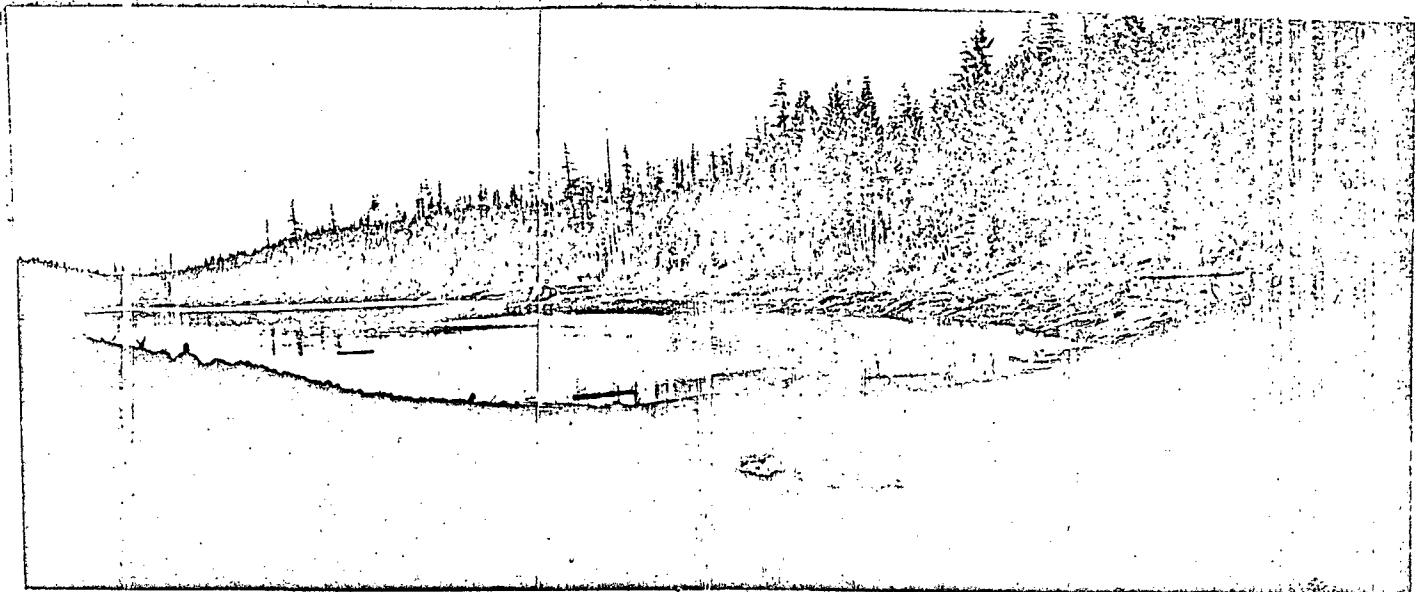
3. STOCKING LAKE
FROM OUTLET TRENCH

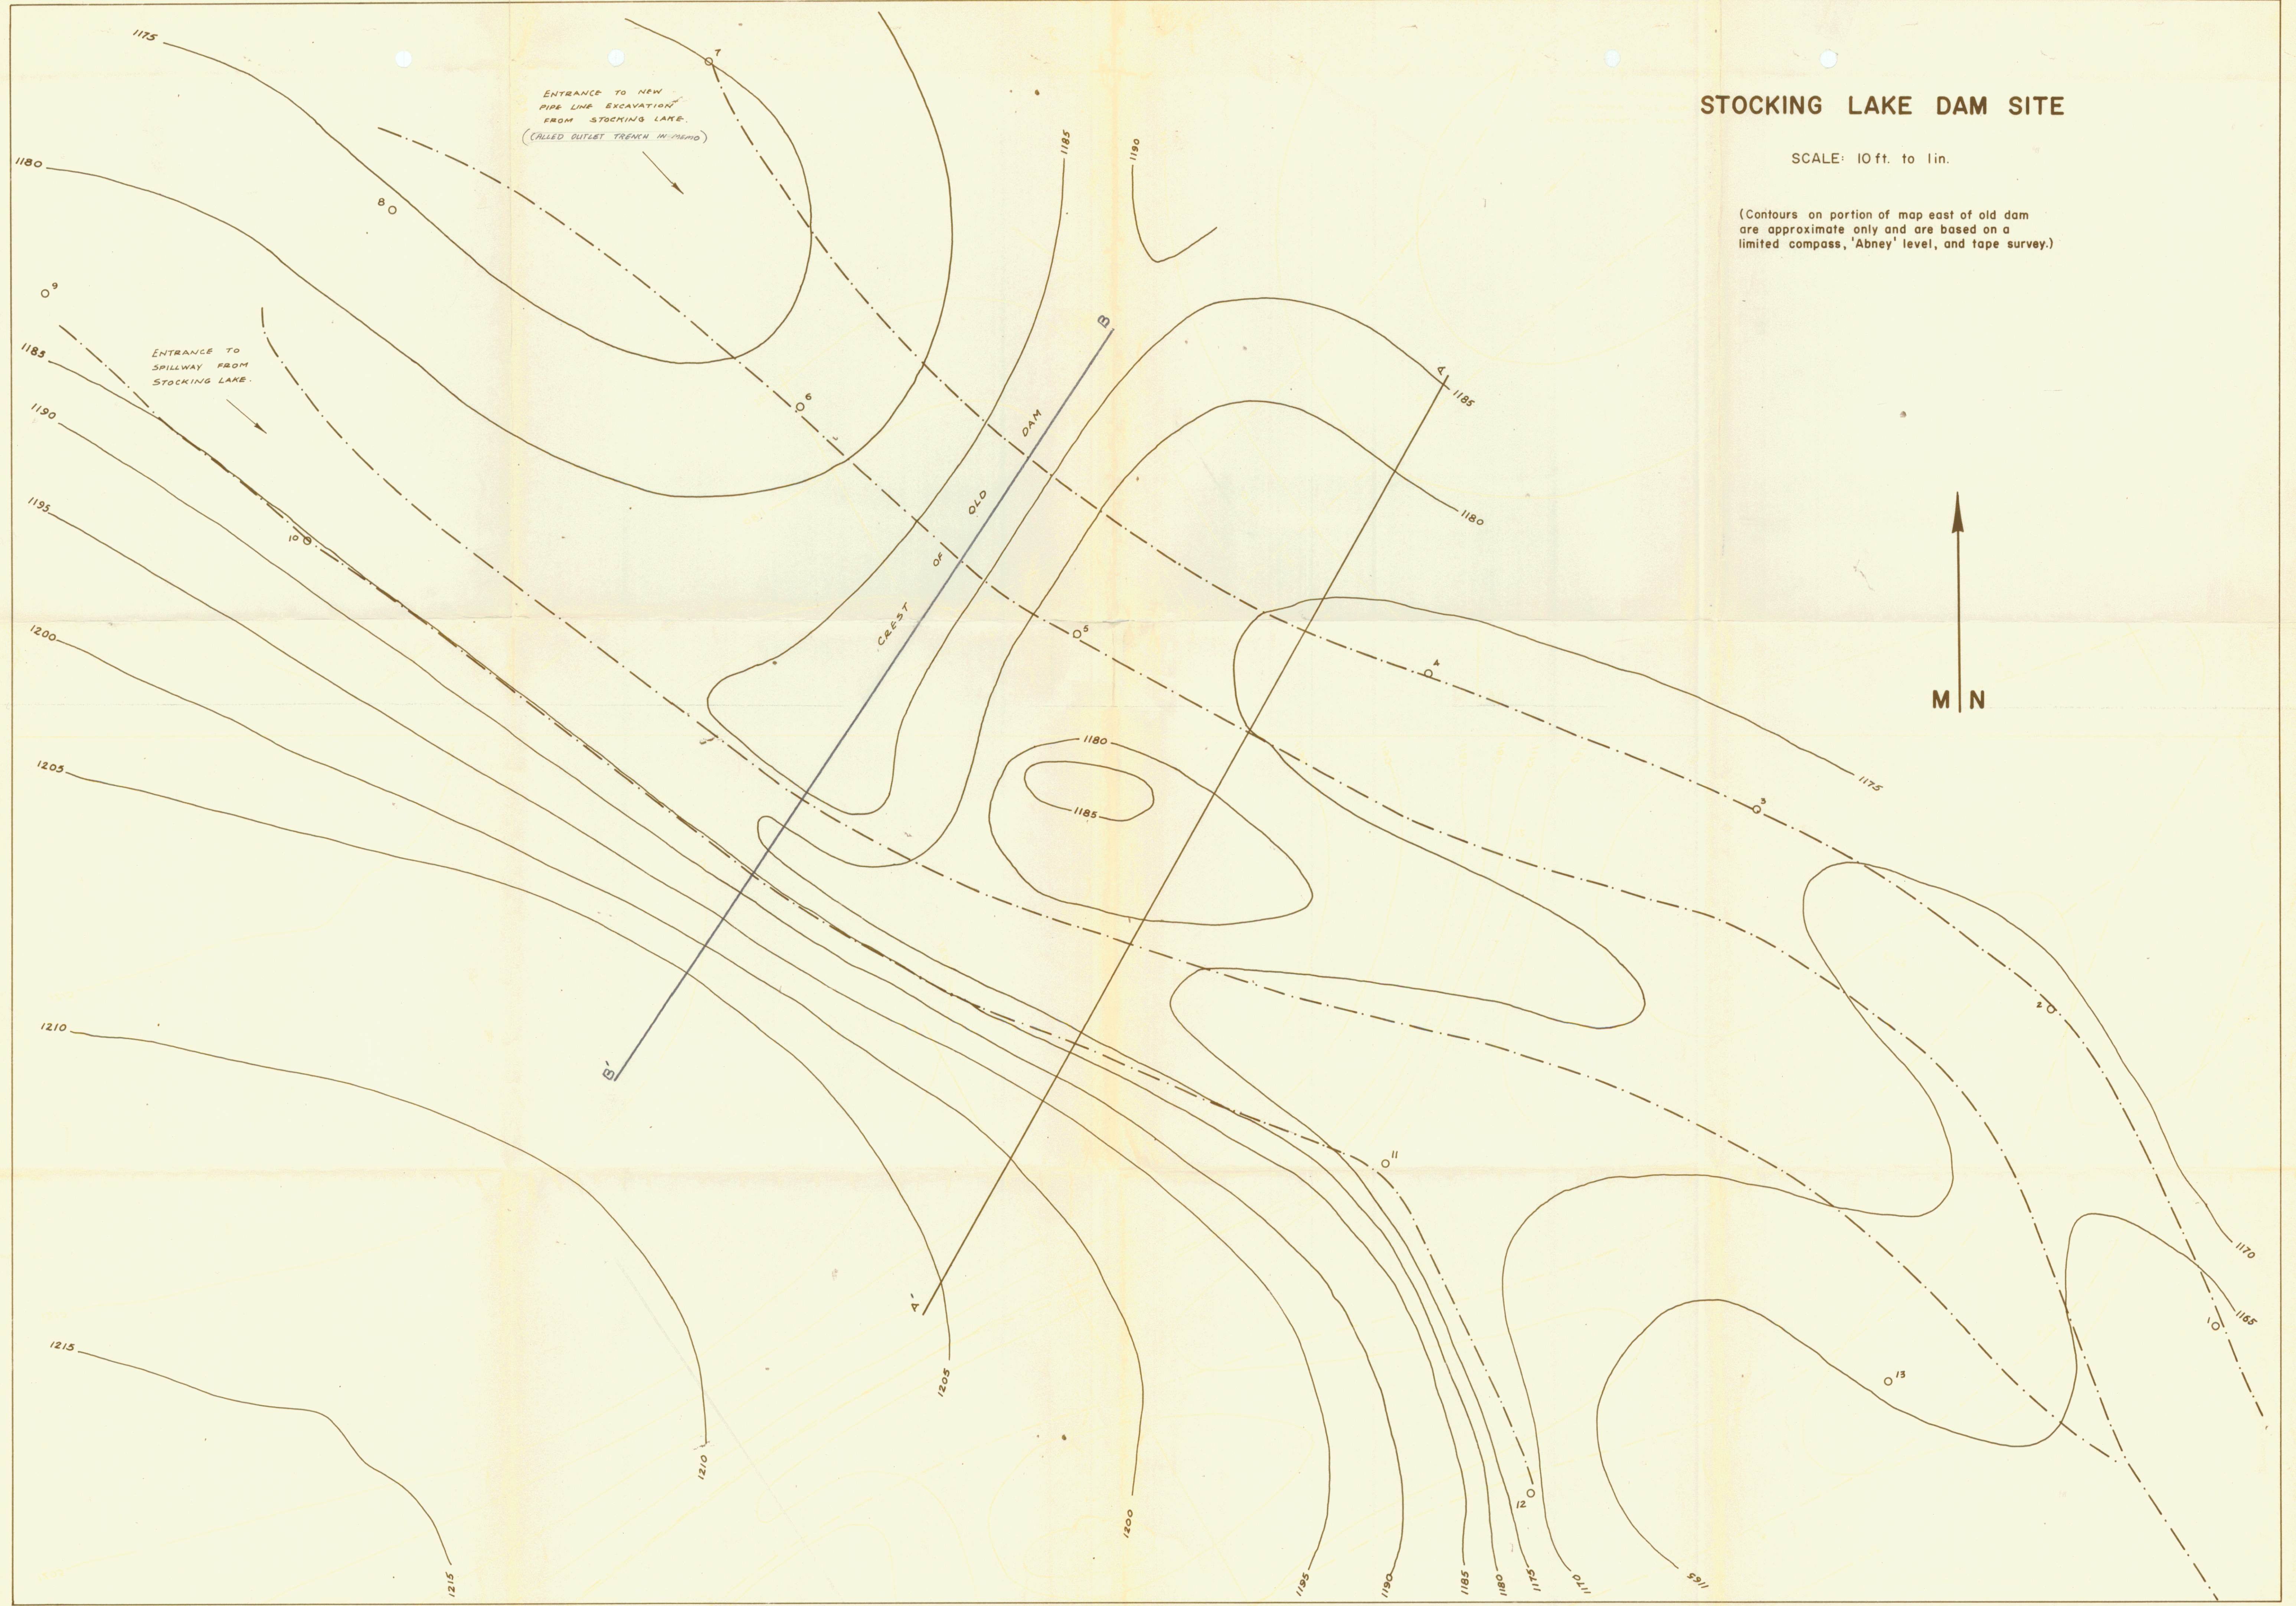
STOCKING LAKE DAM SITE

Water has been observed seeping out of sands below till, which is exposed in the right bank of the outlet trench, at a location opposite Station 2 in Fig. 3. Similar sand-beds below till are exposed elsewhere in the right bank of the outlet trench, as in Sections A-A' and B-B' (Figs. 4 and 5).

<u>Feet</u>	<u>Description of Beds</u>
4-6	Grey till (similar to above)
2½	Lense only of fine grey silty sand.
2-3	Soft saturated sand containing boulders. Water was observed to be seeping out of these sands.

Along the left bank of the outlet trench, downstream from the rock outcrop which terminates at station 4 (Fig. 3), there occurs an exposure of brown fine silty clay containing numerous angular pieces of bedrock. It has been suggested by Mr. Livingston that this silty clay may be slope wash debris, which has collected at the base of this slope.

Water supply outlet pipes from Stocking Lake should be laid on the left side of the outlet trench where bedrock is known to be present. This would be preferable to locating them on the right side, where sand is exposed at the bottom of the trench.

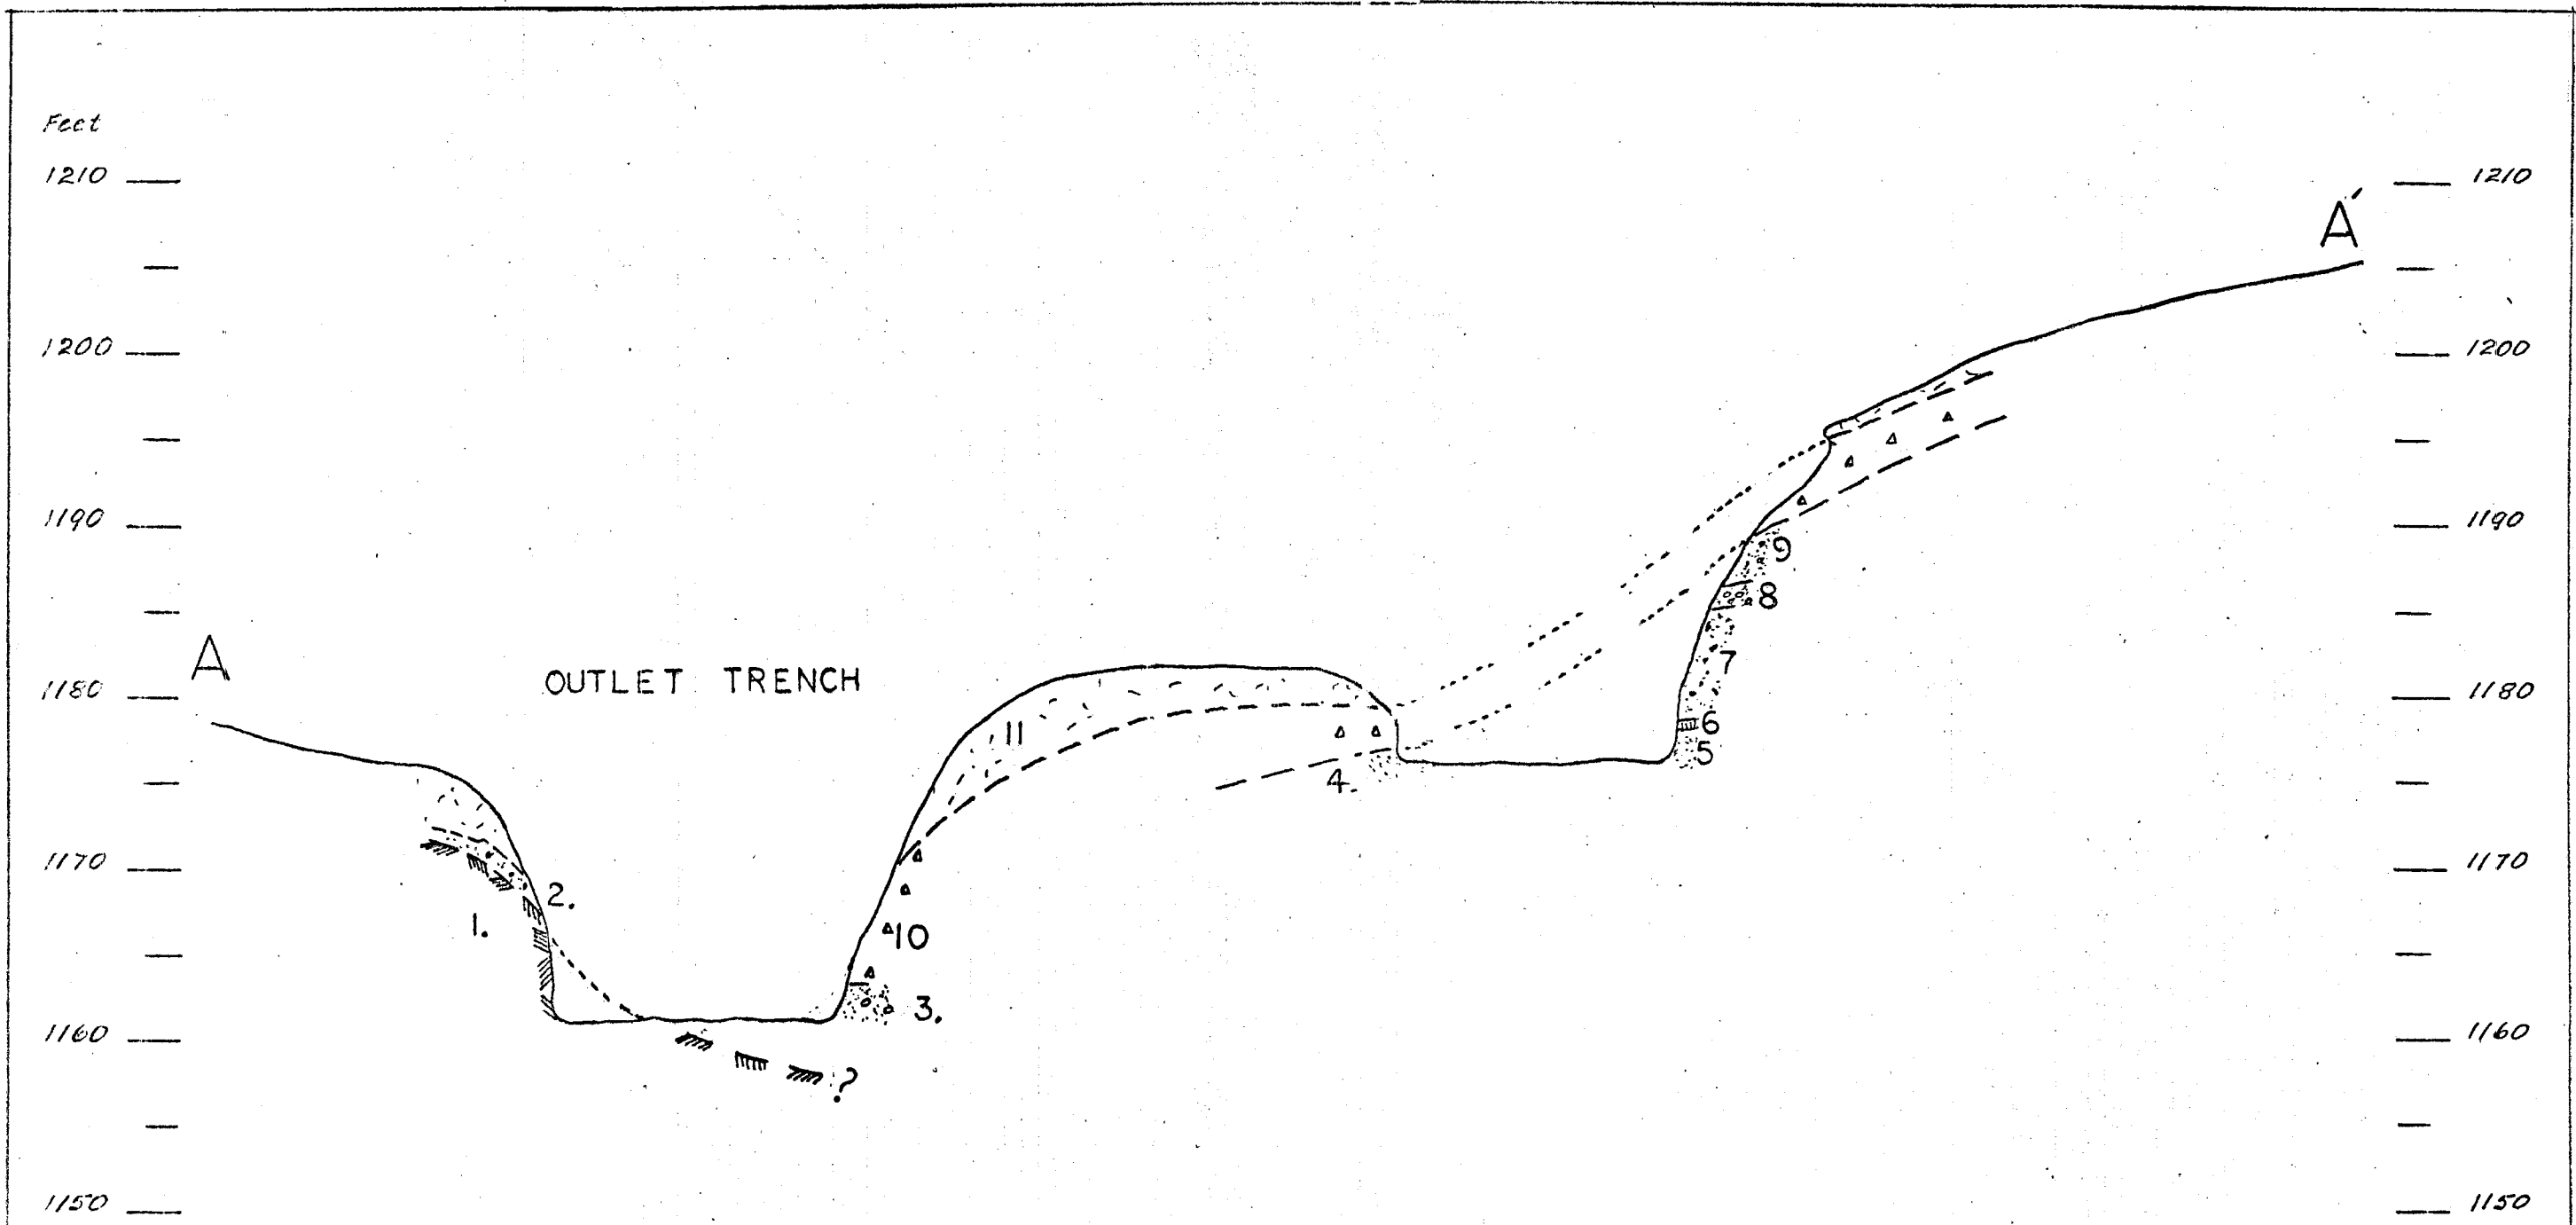
FIGURE 4

Section A-A' (Fig.4)

Bedrock (1) is exposed in the left bank of the outlet trench to a height of 6½ feet. The rock is described here from hand specimens as a medium-grained andesite belonging to the Sicker group of probable Permian age. A more detailed petrographic description will be available when thin sections of this rock are cut for study. The rock is open-jointed and "blocky" in near surface exposures.

Overlying bedrock on the left bank is a thin veneer of sands and fine gravels (2), which in turn, is overlain by soil, rock fragments, till, boulders, etc.(11). Till which in general blankets the area, has either been removed by erosion or is covered over with overlying surface debris at this location.

At the time of the first field inspection, the floor of the outlet trench was covered with a thickness of wet mud, which was removed when the lake began to empty through the outlet trench. However, considerable coarse material remains on the bed of the outlet stream and no exposures are evident. Bedrock has been blasted out on the left portion of the floor of the outlet trench during excavation so in part then, at section A-A', the trench floor is composed of bedrock. (See Fig. 4).

At the base of the right bank of the outlet trench occurs a 2½-foot exposure of fine grey silty sands (3), containing cobbles and boulders. Possibly the boulders are associated with the overlying till deposit (10), or alternately, the sands may represent only a bed within a thicker till sequence. (See Plate 1, Photo 1). This till is almost 7 feet thick on the right bank at section A-A'. The till is grey in colour, firm, fairly compact, and contains some large-sized boulders (see Photo 1), within an assorted grain-size matrix. It is just possible that the lower part of this grey till section may be older than the brown till that is exposed in the spillway trench. The colour differences however, could be due to weathering and location with respect to the water table.

At the base of both banks on the spillway trench at section A-A', are brown fine-grained sands (4), (5), which on the left bank are overlain by a fairly compact and firm brown till. On the right bank above the sands (5), is a thin 6-inch band of silt (6), which is overlain by a 6½-foot thickness of coarse sand and fine gravel (7). Many of the grains are angular and coated with silt and clay. Overlying bed (7), occurs a bed, 1½ feet thick, of coarse gravels and cobbles with a sand matrix (8); above (8) occurs a 3-foot bed of a very badly sorted coarse sand and gravel (9), many of the grains in this bed are coated with silt and clay. Unconformably overlying this section is a variable thickness of till, firm and compact, brown and somewhat weathered and containing a boulder about 8 feet in length.
