To: A.P. Kohut
Senior Geological Engineer
Groundwater Section
Hydrology Section

Date: September 12, 1986
Our File: 92 B/14

Re: Flowing Well on Mayne Island

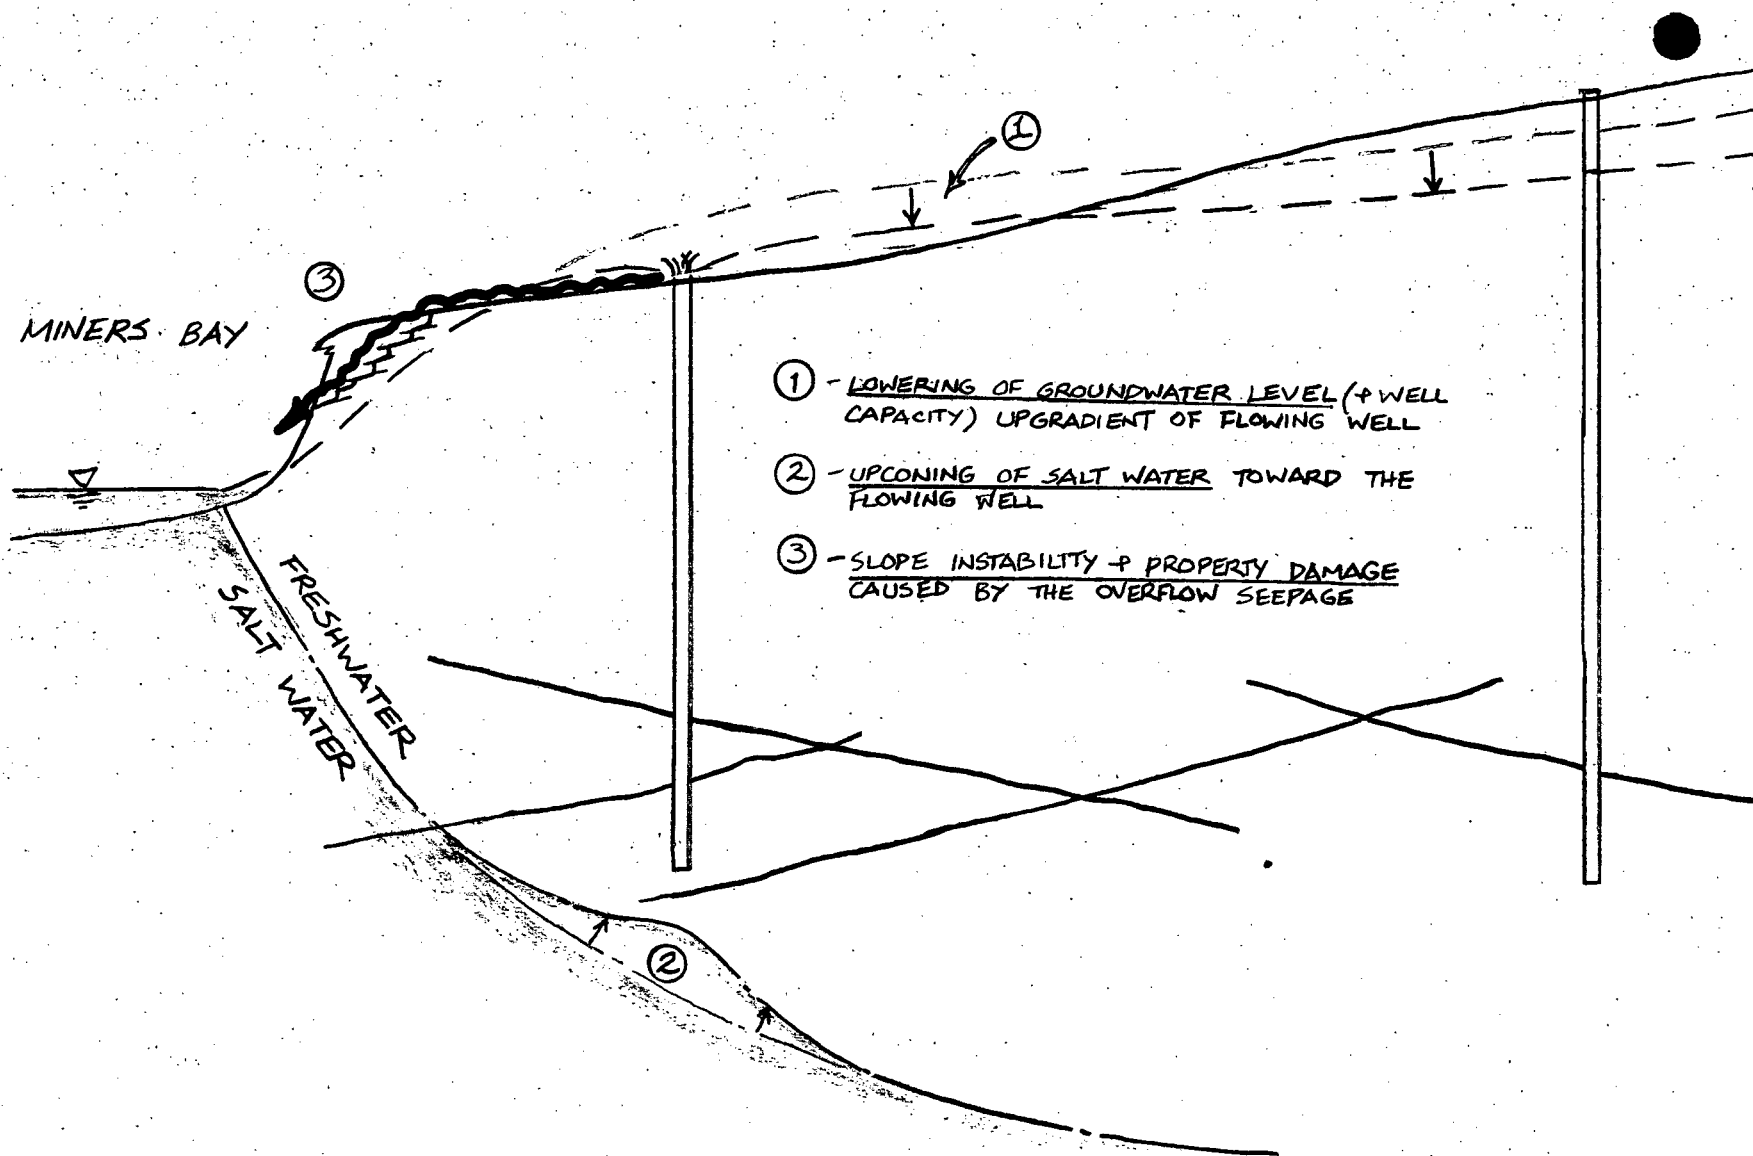
DWG. No. FIGURE 2

The affect of the flowing Bennett well on the regional groundwater level, and on the capacity of the neighbouring wells (interference), though possible (Figure 2), does not appear under present conditions to be significant. Monitoring the water level in the upgradient wells would be necessary to confirm this. However, the Bennett well is located at the end of the groundwater flow system where the water flushes out to the sea. The flow of 3 USgpm is equivalent to a drawdown of a few feet at the well (depending on the aquifer transmissivity) and represents a very small amount of water drawn from the watershed. This flow likely induces an equally small degree of upconing of saltwater toward the well. This amount of flow would also not likely contribute significantly to slope instability along the shore downslope; this can be checked by the Highways personnel. It is likely that the flow from the well will increase in the winter months as the regional groundwater level rises in response to rainfall. Well interference and seawater intrusion may become problematic if the well is put into production at 50 gpm. A 3-day pumping test during the dry season would be necessary to assess the actual capacity taking into account these concerns.

POSSIBLE EFFECTS OF A FLOWING WELL AT MINERS BAY

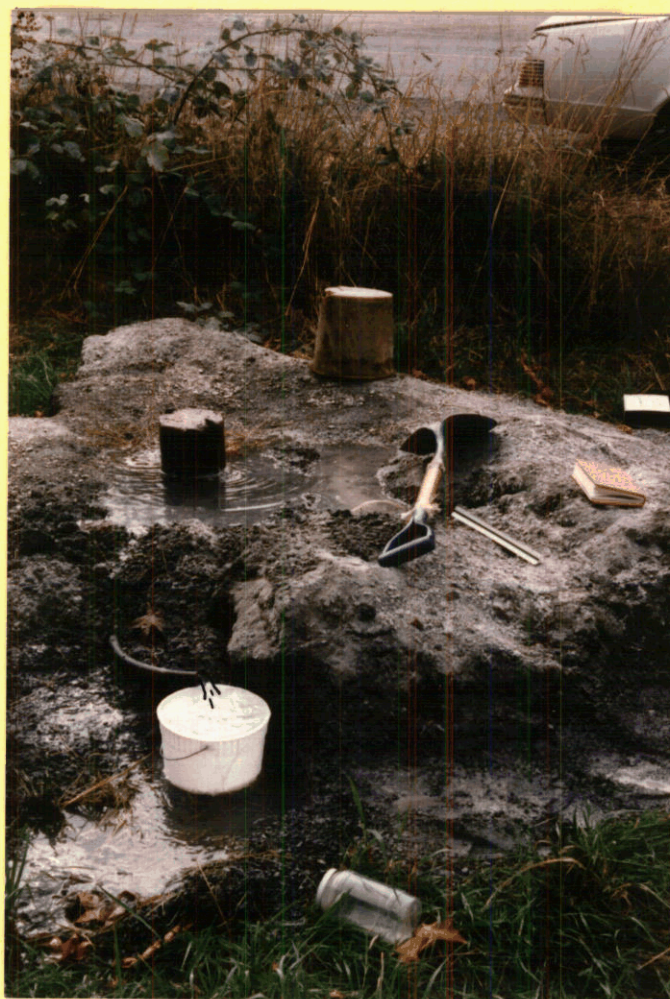
The 6-inch casing was installed by drilling an oversized hole and slipping the casing into the hole; no surface seal was constructed. The well is fitted with a cover plate but the water is allowed to flow quite freely out between the plate and the casing (Photo 1). This is a common drilling completion practice in the area. Mr. W. Fudge, local resident, said that the flow was greater earlier in the summer just after it was drilled. Presently, the flow disappears into the ground immediately downslope; no seepage was detected at the ditch along Georgina Point Road about 50 feet downslope of the well. Some natural slope stability problems do occur along this road downslope which Highway personnel have been aware of for some years. The well is located about 100 feet from shore. Salt content of the flowing well water is quite low ($\text{NaCl} = 100 \text{ mg/L}$).

Picture 1. The Bennett well flowing at 30USgpm,
Miners Bay, Mayne Island.

It appears the well could be left as it is with no major problems but several alternatives are available for stopping the flow:

1. Extra casing can be added on as stickup. Five or more feet of casing may be necessary. This would require welding equipment and a pump to lower the water level in the well before welding.
2. The well can be sealed with a well cap. Water may, however, leak out along the outside of the 6-inch casing to saturate the ground around the well.
3. A liner can be grouted in place to just above the water producing zone to prevent leakage along the outside of the casing and then the well can be capped. This would require mobilizing a drilling rig and grouting equipment.
