MEMORANDUM

SUBJECT Saltspring Island
Field Investigations

3. Isabella Point Road Investigations

Isabella Point Road Landslide -
Saltspring Island

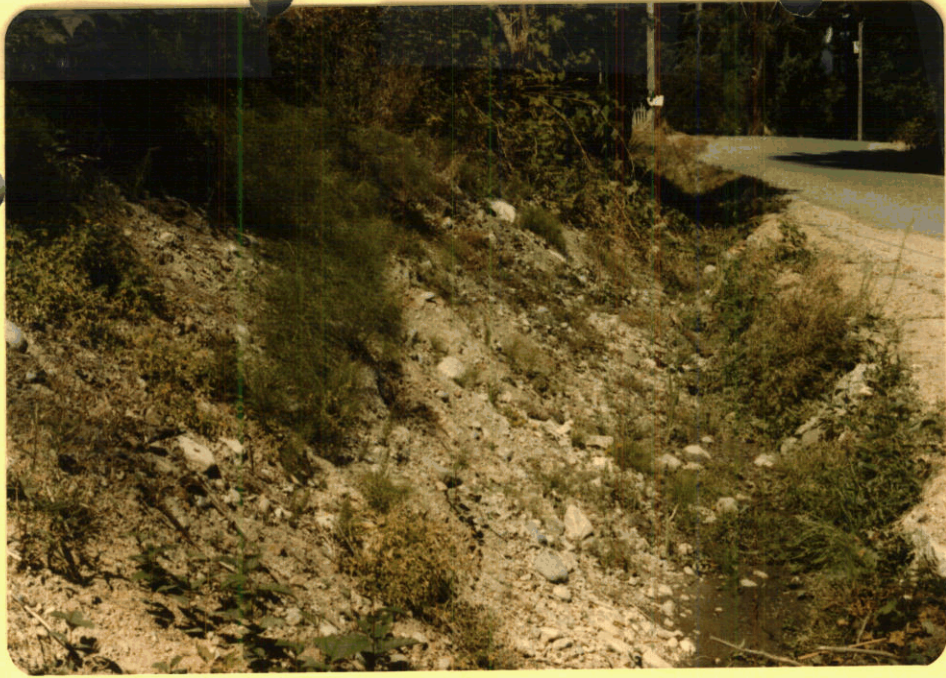
Looking northeast along toe of
Isabella Point Road

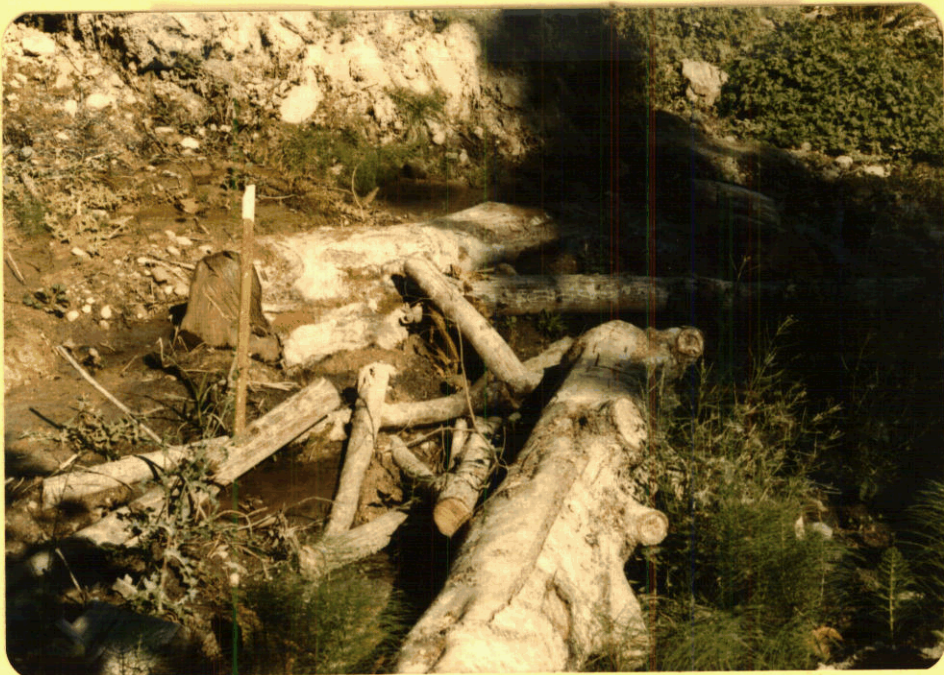
1. The slump or depression is located on Lot 3, Plan 6654 off Isabella Point Road.
2. The major portion of the slump is approximately 20' wide by 50' long and borders on Isabella Point Road.
3. Mr. Archer's spring is approximately 8' west of the immediate slump area and water is gravity fed to a holding tank on the other side of Isabella Point Road.
4. The material in the immediate slump area consists of dark silty sand and sand with some sand and gravel interbeds. Some cobbles and large boulders were noted. Some clay was present near the centre of the slump retaining some water.
5. The material above the area is mainly rotting logs lying on sandy topsoil with some large boulders present. The area behind the slump area is heavily treed with Cedar and Alder and beyond this area is open pasture land (Lacy Property)?

1. The material present in and around the study area consists of mainly very permeable dark sand and silty sand, permitting considerable infiltration and subsurface runoff.

2. The area surrounding the study area slopes considerably towards Isabella Point Road promoting rapid surface and subsurface runoff.
3. In the process of widening Isabella Point the Highways Department excavated the toe of the highway at the area where the slump occurred (June 1977?). Removal of material here can be assumed to be the major cause of the area slumping.
4. Many large trees have been removed from the slump area on Lot 3. Disturbance of root growth has undoubtedly been another major cause of the slumping noted.
5. The sloping open pasture land behind the heavily treed area on Lot 3 contributes rapid surface runoff towards the slump area.

Looking directly into slump area

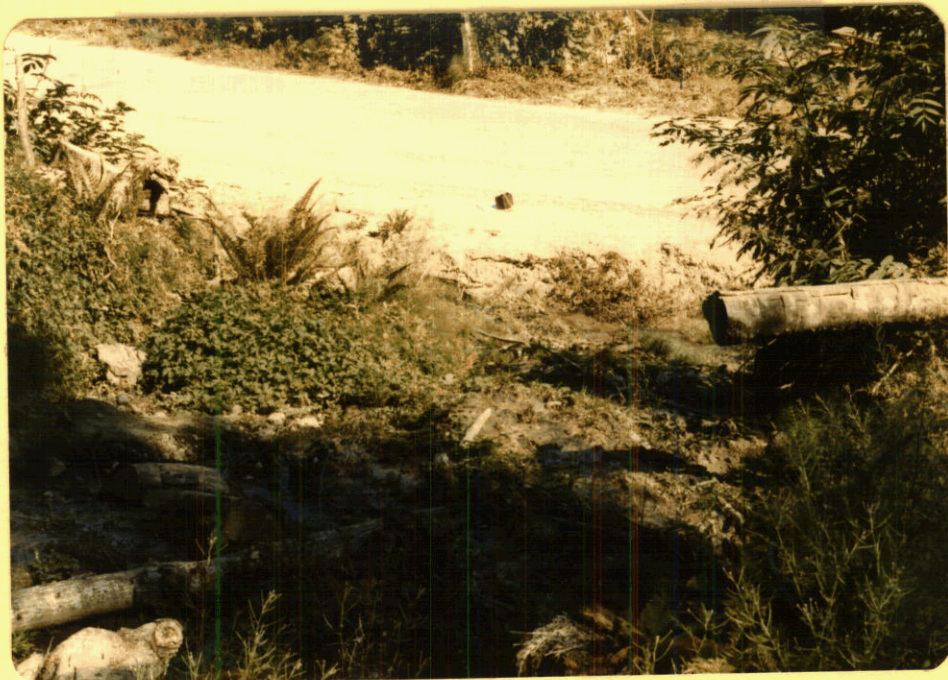
Looking northwest towards Isabella Point Rd.
Standing on West Bank of slump

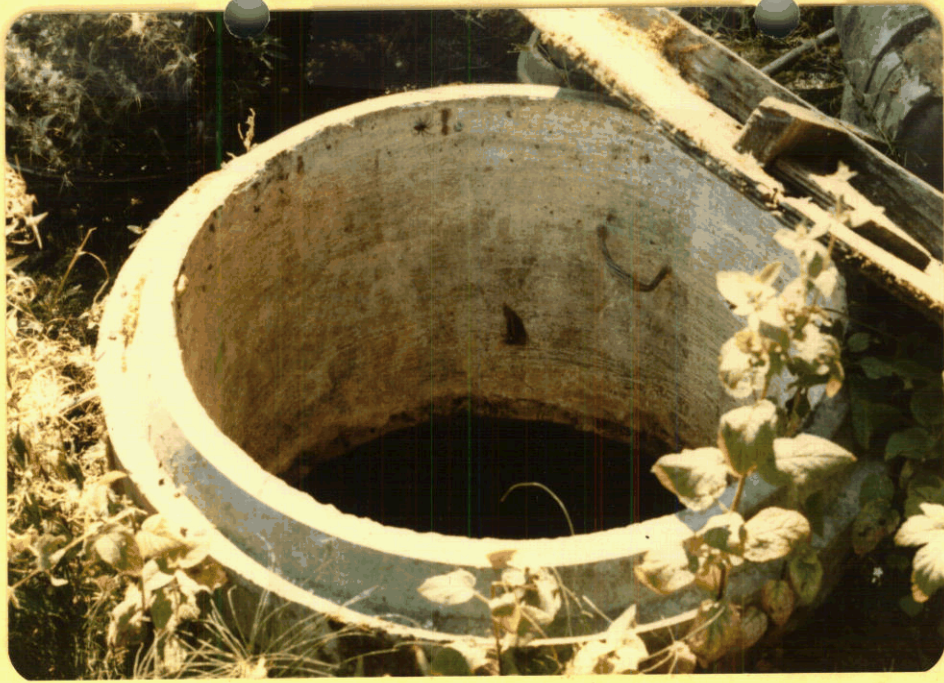
Concrete Cribbing (30") Retaining Spring
water 8' west of slump- 40' from Isabella Point Rd

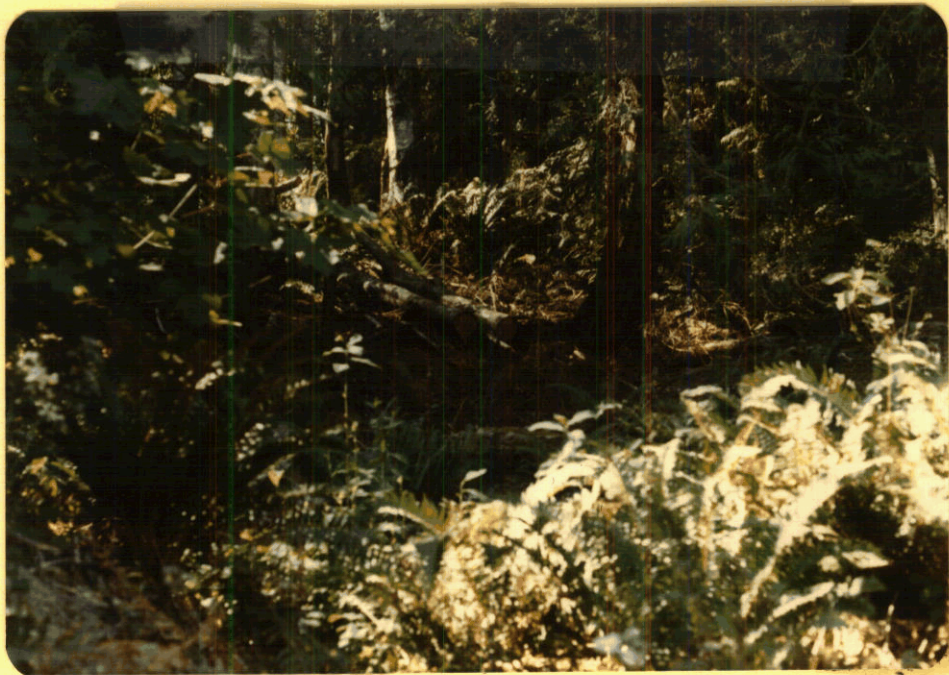
Looking southeast behind slump area.

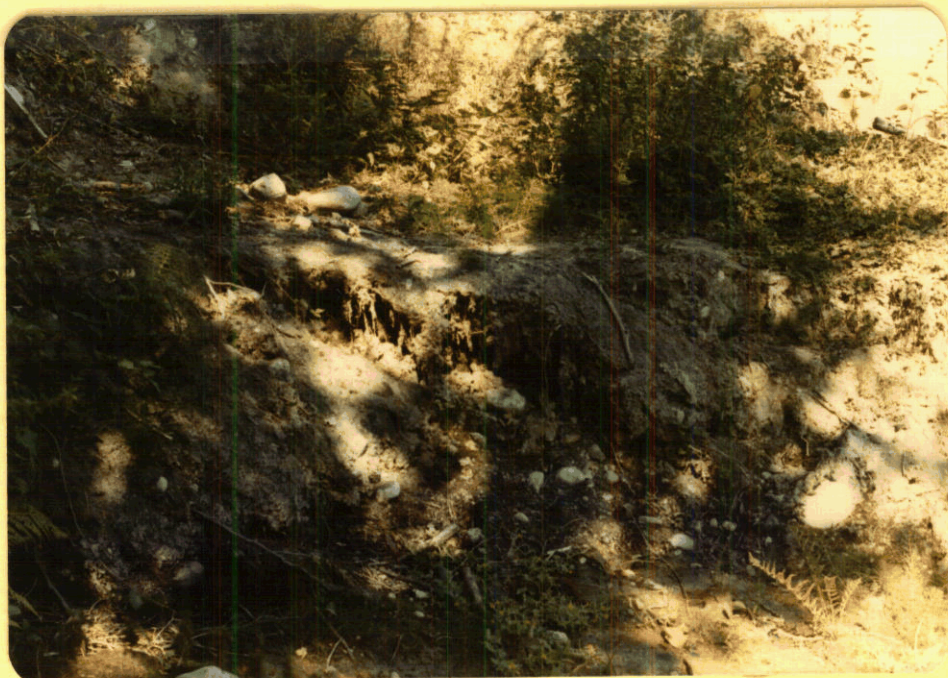
Material on east bank of slump area.
